## **Barrier Breaching Processes and Barrier Spit Breach, Stone Lagoon, California**

*U.S. Army Engineer Research and Development Center  
Coastal and Hydraulics Laboratory, 3909 Halls Ferry Road  
Vicksburg, MS 39180, Nicholas.C.Kraus@erdc.usace.army.mil*

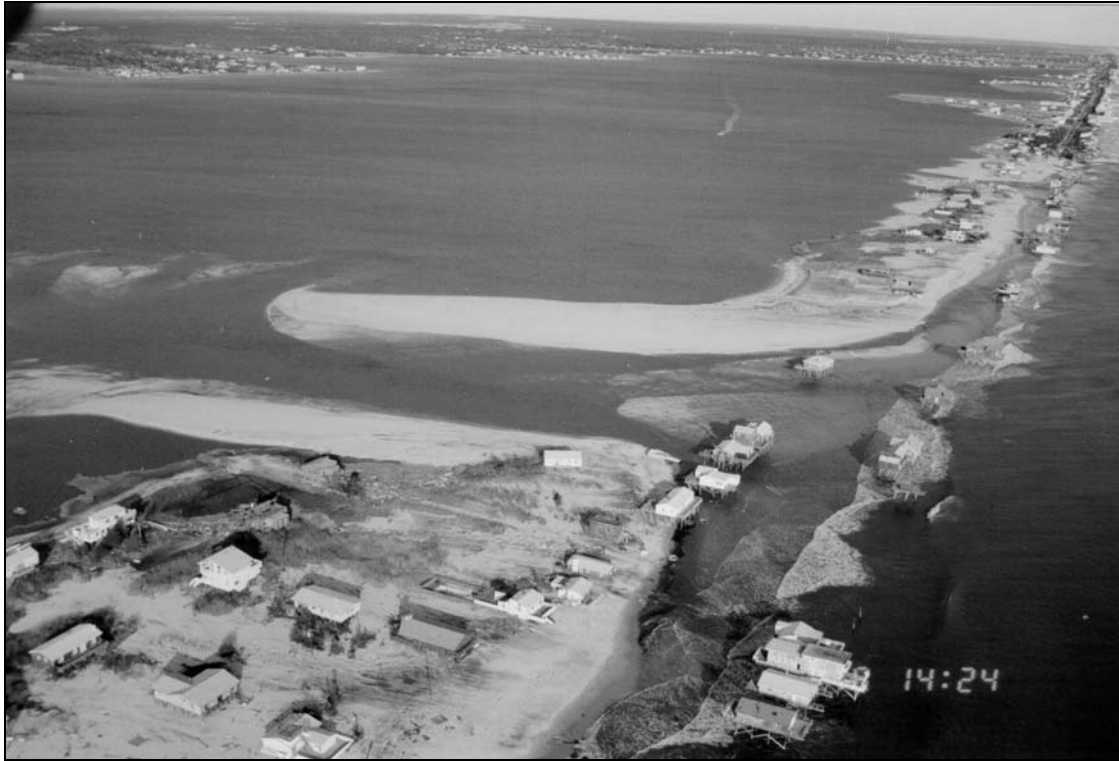
**Figure 2.** Little Pikes Inlet (barrier island breach), Long Island, New York, shortly after opening (photograph by N. Kraus, December 18, 1991; looking east toward Westhampton Village, with Atlantic Ocean on the right).

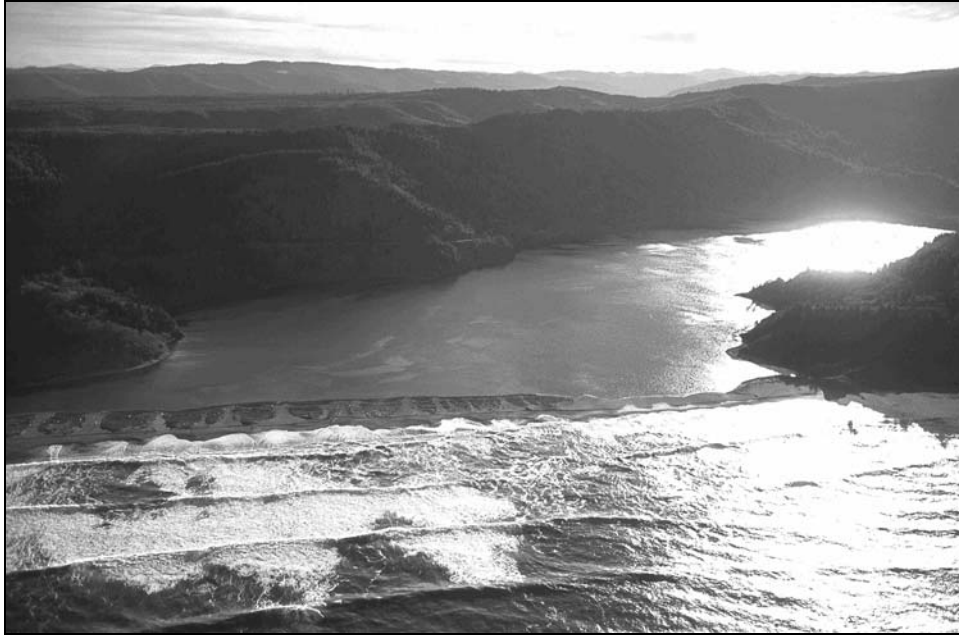
Figure 6. Stone Lagoon, looking northeast, December 1999 (photograph by G. Todoroff).

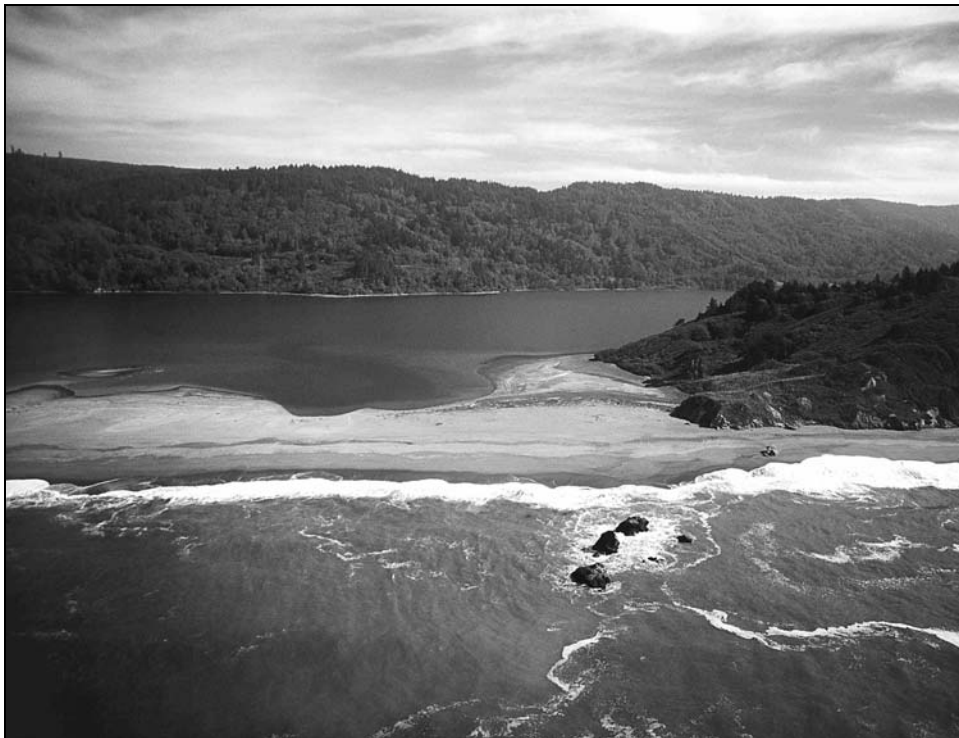
Figure 7. Southern end of Stone Lagoon spit, looking east, October 10, 2001 (photograph by G. Todoroff).

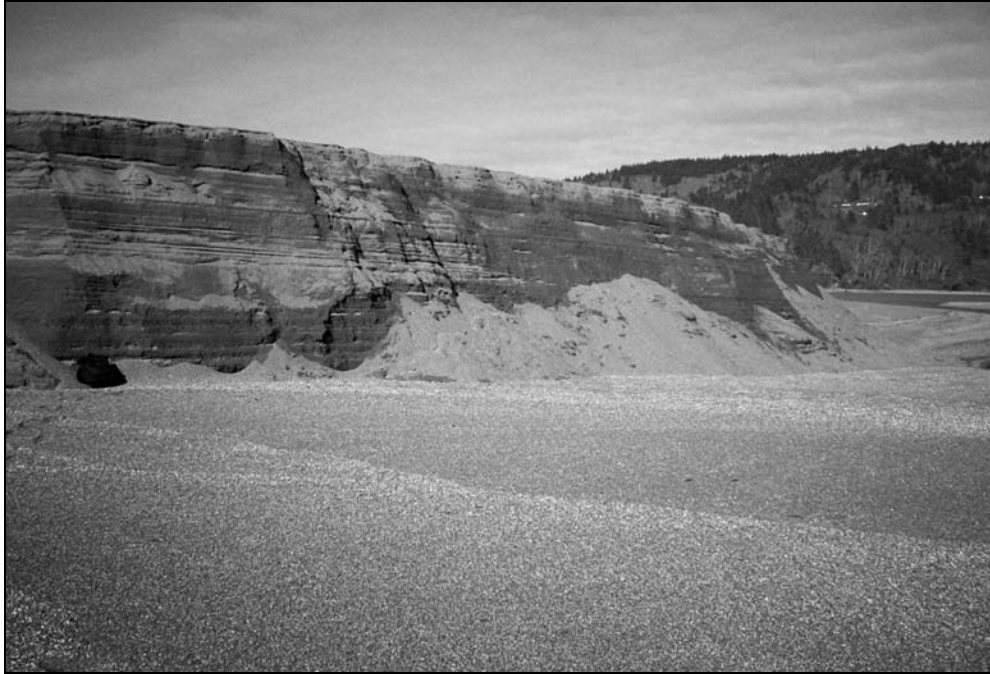
Figure 10. Stone Lagoon breach, looking east, March 18, 2002 (photograph by A. Militello).

Available photographic documentation of the March 2002 breach is summarized in Table 3. The collection includes many photographs, of which only a few can be presented here. The first ground photographs were taken from the eastern bluff (eastern side of Stone Lagoon) on March 16. Figure 8 shows a calm sea, wing spit on the northern side of the breach, and a large multi-crested flood shoal at relatively low tide. Ground photographs were taken near low tide on March 18 from within the breach on the north side. A large log was found lying on the edge of the south bank of the breach (Figure 9), and the horizontal portion on top of the spit berm was measured to be 8 m long. This log was visible in the aerial photographs and served as a scale in their rectification and comparison. Figures 9 and 10 show the presence of steep side banks, estimated on site to be 3.4 m high from crest to toe, along with another 1-m elevation estimated from the toe to the edge of the water in the breach at low tide.

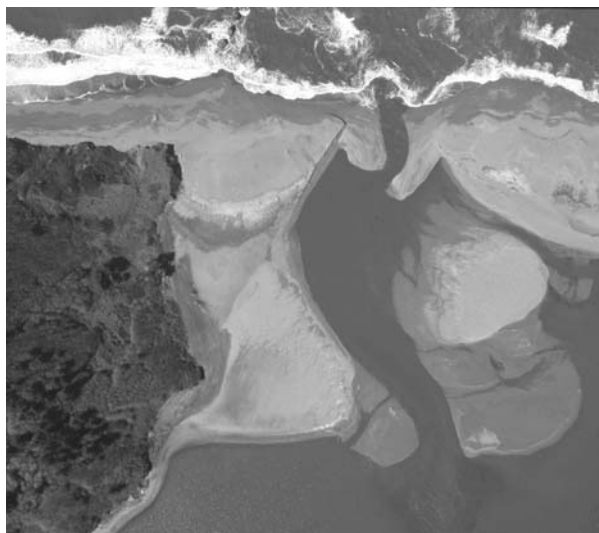
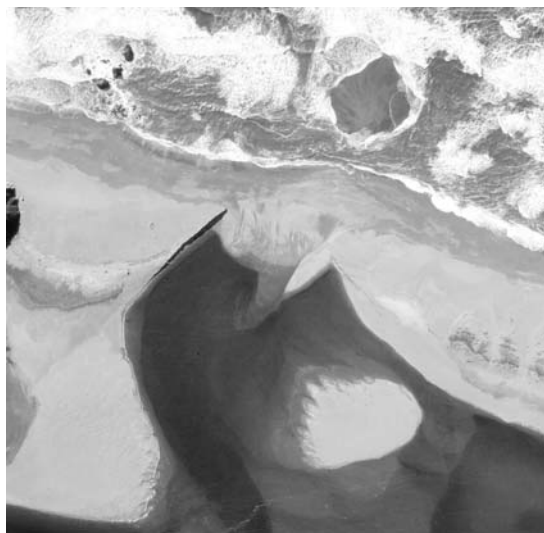
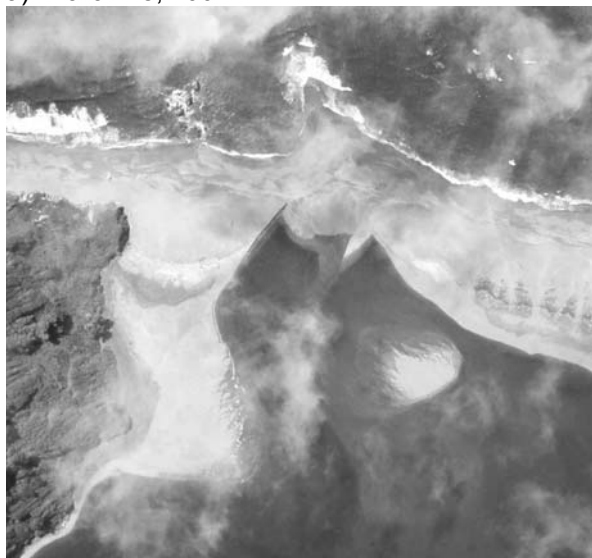
**Figure 11. Time sequence (a-d) of vertical aerial photographs, Stone Lagoon breach, with Pacific Ocean at top of pictures (photographs by G. Todoroff).**

a) March 18, 2002

b) March 27, 2002

c) April 6, 2002

d) April 18, 2002

Vertical aerial photographs for March 18, March 27, April 6, and April 18 are shown in Figure 11. The photographs were taken near predicted low tide (Table 3) and can be compared at approximately the same water level. The breach initially cut through the barrier spit at a mild

oblique angle from shore normal, trending northwest to southeast, as evidenced by the shear bank on the south side. Within a few days (March 18), a broad spit had formed on the south side, and a narrower wing spit had also formed on the north side, redirecting the flow along a southwest-to-northeast axis. The minimum width of the breach was 91 m  $\pm$  5 m as determined from the March 18 photograph. An ebb shoal deposit is observed on March 27 that is located slightly to the north with respect to the breach, a location consistent with the inferred initial orientation of the breach. By April 6, the breach had closed at low tide, but was observed to have water in it on higher tide. The ebb shoal had begun welding to shore, and it evidently spread north and south to form a wide deposit across the breach by April 18. The flood shoal appears to diminish in area; however, there is no transporting force to remove sediment from this shoal. The apparent diminution in areal extent of the flood shoal and breach margins is an artifact of water level in the lagoon that rose after the breach closed.
