SECOND GENERATION WEAPONARY IN SEA

10 SEPTEMBER 1970

HQ PACAF

Directorate, Tactical Evaluation CHECO Division

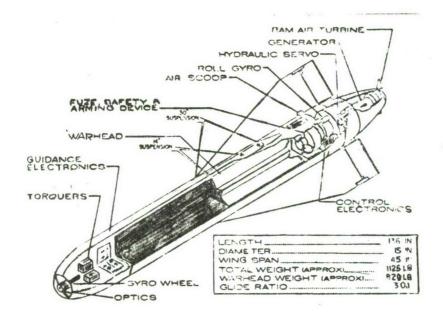
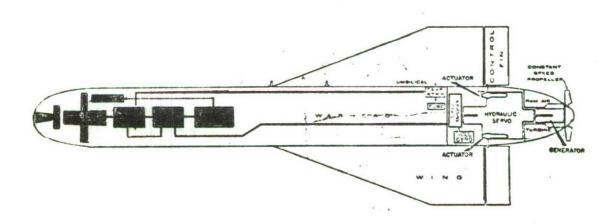
FIGURE 1

Aircrews believed the two-man concept of the F-4D constituted a definite advantage in technique for use of the AGM-62. After visually acquiring and identifying his target, the aircraft commander placed it under his gunsight pipper. This allowed him to keep his head up out of the cockpit and, since the weapon was in boresight mode, place the target near the center of the video display. The Guy in Back (GIB) then located and identified the target on his display and aligned it in the "gate" (four intersecting lines constituting a 2.6 mil look-angle in the center of the display, within which the missile tracked upon release), and locked-on. After lock-on, and while the aircraft was in the delivery envelope, the aircraft commander verified the target on his display and assumed the lock in the front seat. After his launch, the pilot was free of any requirement to guide it visually and he could take whatever evasive action was deemed necessary. The weapon continued to "home" on the area of greatest contrast within the 2.6 mil tracking gate. The flexibility of the weapon/airframe combination allowed electronic countermeasures (ECM) pod formation to be flown up to, and even during, simultaneous launch; or, if outside SAM threat areas, a fluid four formation could be flown for better MIG defense. (Fig. 1 shows schematic

WALLEYE FUNCTIONAL BLOCK DIAGRAM

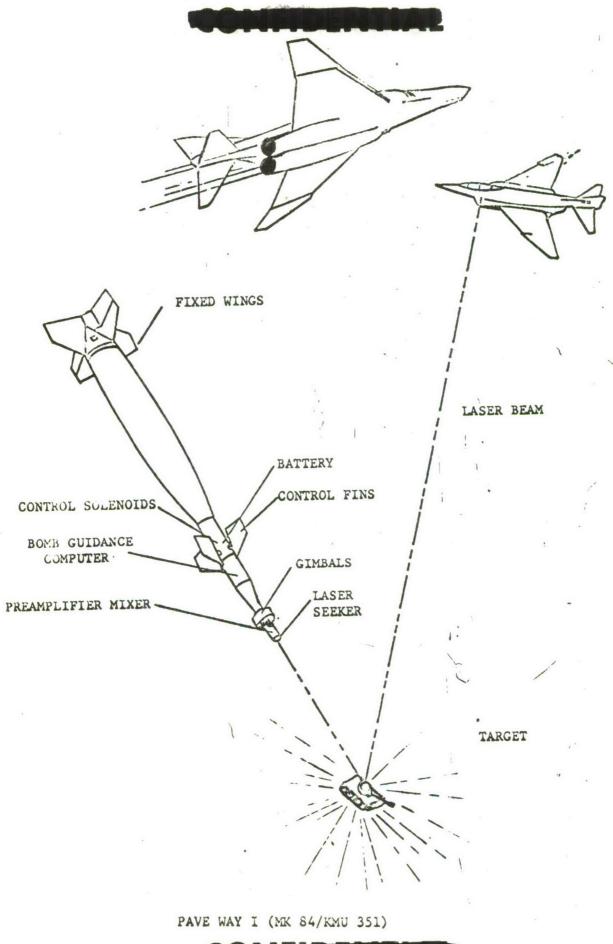
Having "found" its illuminated aiming point, the seeker attempted to keep the target centered at the intersection of its four-quadrant silicon detector. Through adapted plumbing for the SHRIKE missile control system, the seeker activated canard fins which directed the bomb toward its target. The movable fins operated in an "on-off" fashion, either fully deflected or released to return to the slipstream as directed by the seeker unit. The fins made the flight of the bomb what aircrews described as an undulating glide rather than a smooth continuous arc toward the target. To compensate for the abrupt moments of force imposed by the canard controls, augmented roll stabilization fins were attached to the MK-84 body. (Fig. 2)

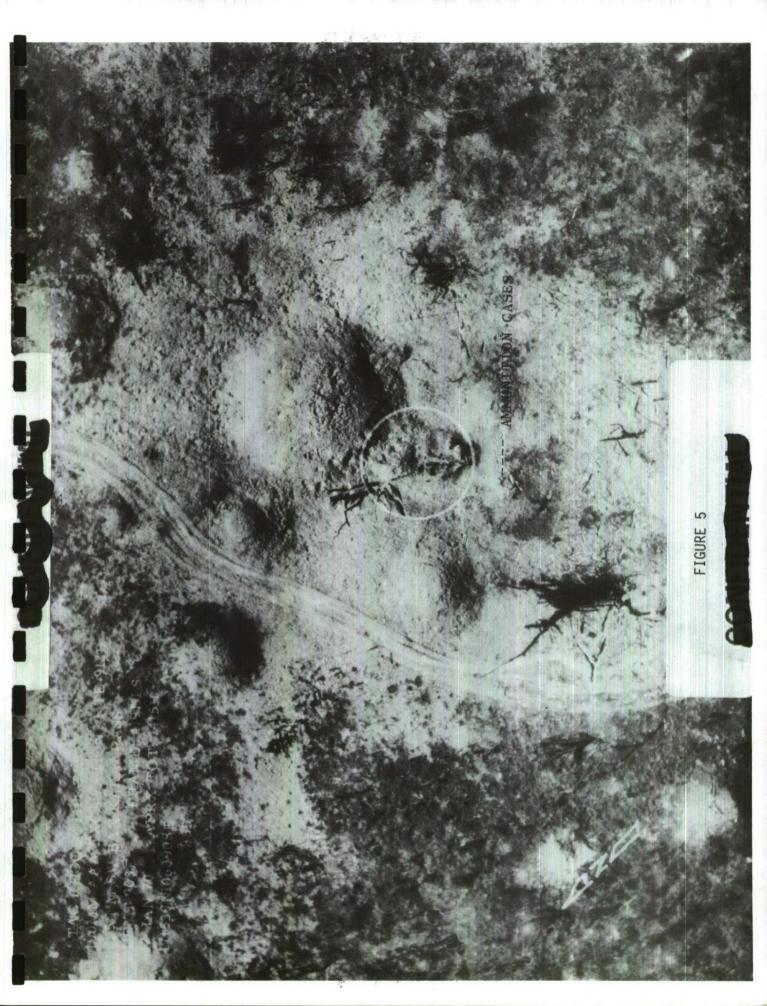
FIGURE 6

-CARRIAGE

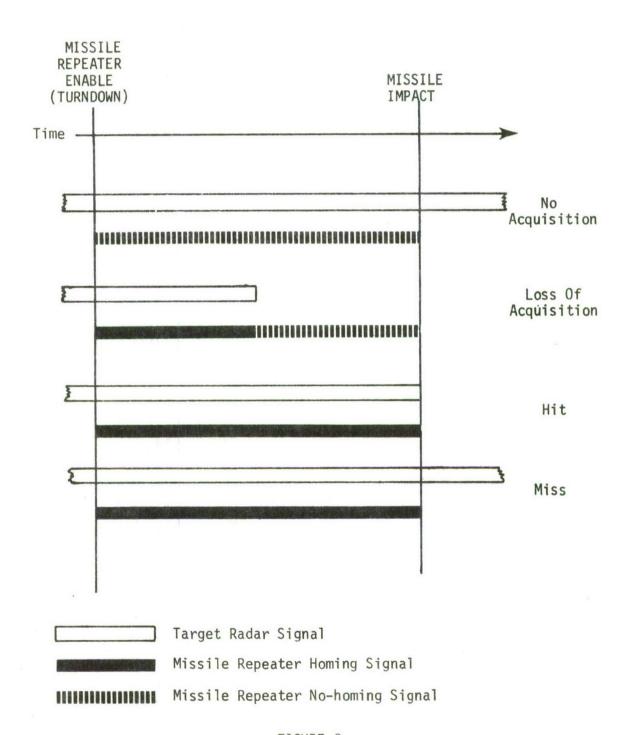
AGM-78 Electronic BDA Logic and Indications

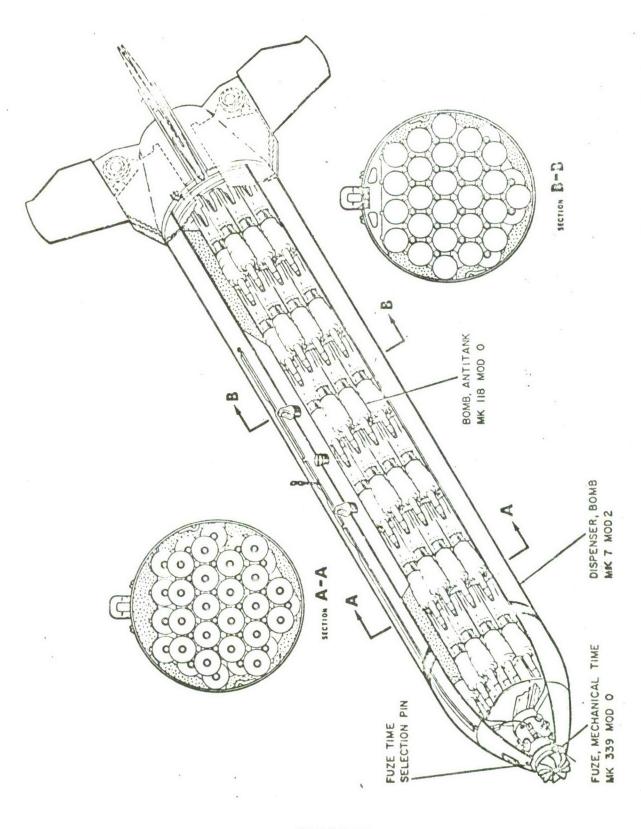
- Cutaway of ROCKEYE II showing full bomblet load.

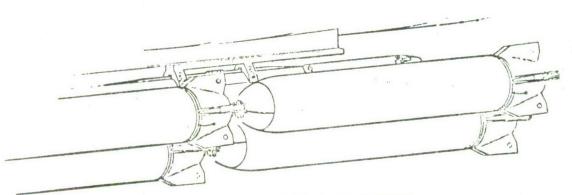
ROCKEYE I MULTIPLE EJECTOR RACK CARRIAGE

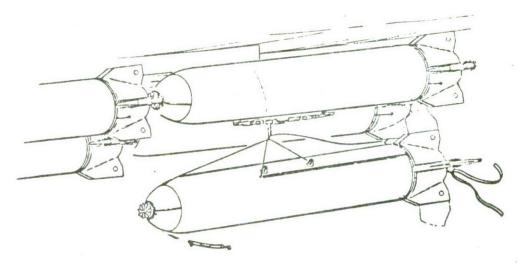
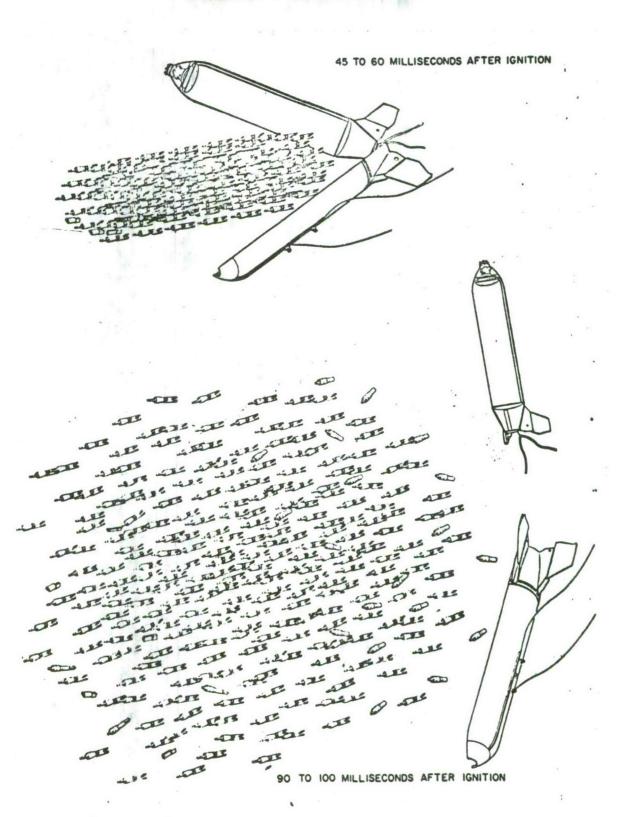
FIGURE 14

ARMING WIRE EXTRACTION
FIN RELEASE BAND SEPARATION
FUZE RELEASE BAND SEPARATION
FUZE TIMING STARTS

15 TO 25 MILLISECONDS AFTER IGNITION

-- ROCKEYE II operational sequence.

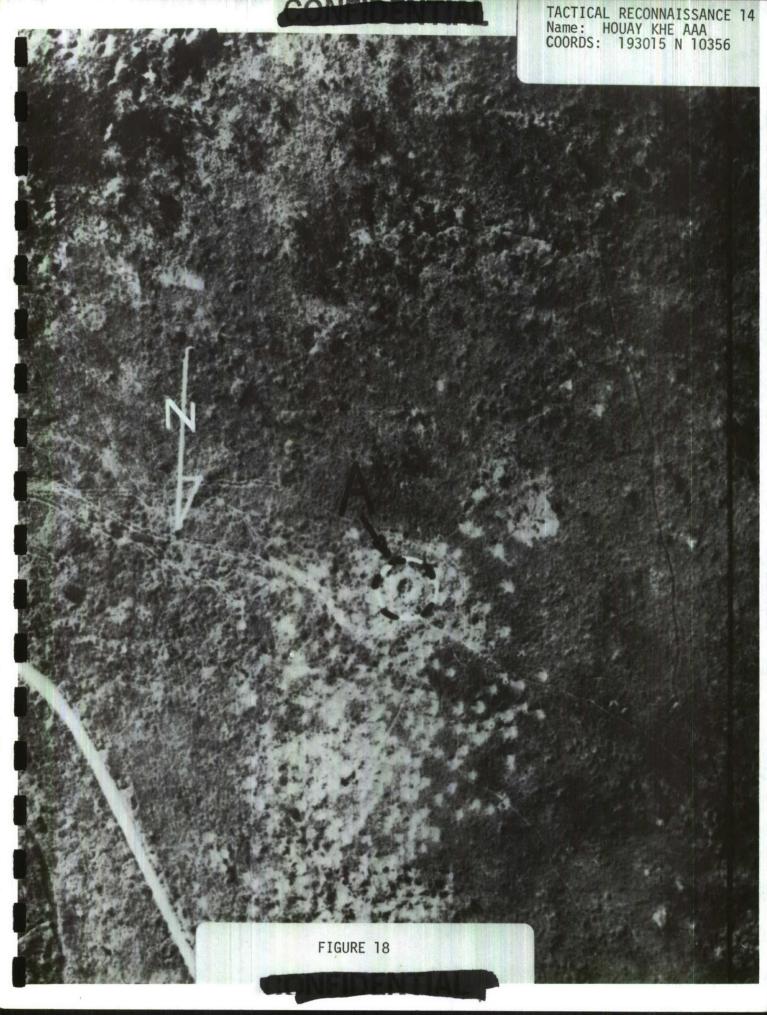
PROJECT ROCKEYE II POST_STRIKE PHOTO TARGET HOUAY KHE ANASITE MSN.563ADT /3/12 CAM POS VI-022 PRODUCED BY 438 RTS - 250' FIGURE 17
