Technical Report ARMET-TR-08023

## **GALVANIC CORROSION STUDY ON STAINLESS STEEL CARTRIDGE DESIGN**

**U.S. ARMY ARMAMENT RESEARCH, DEVELOPMENT AND  
ENGINEERING CENTER**

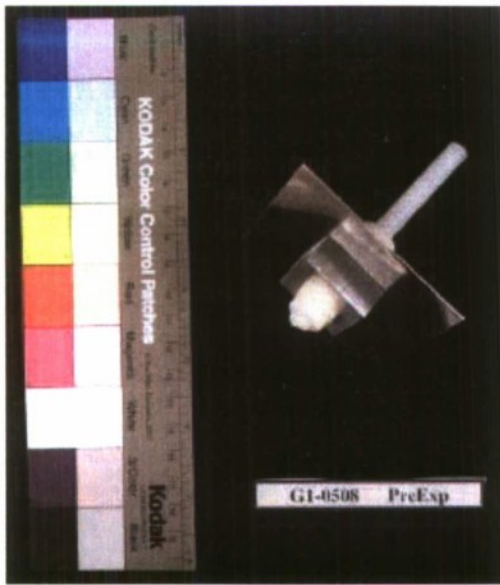
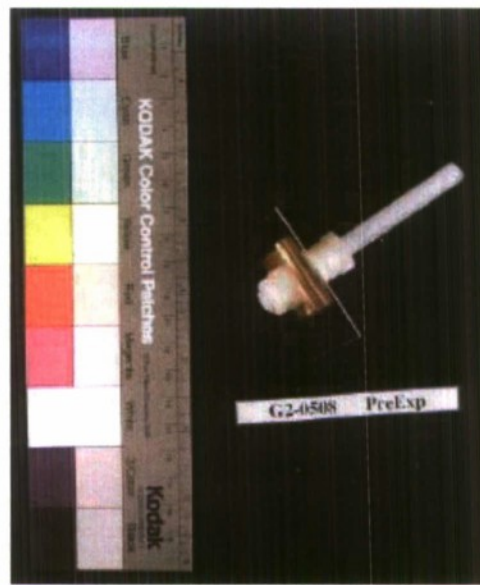
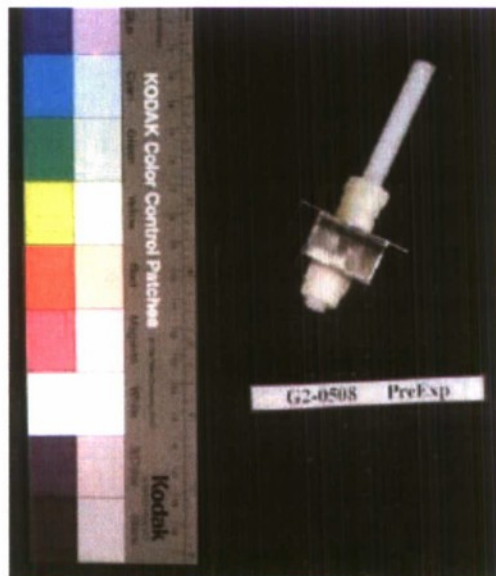
(a)  
Aluminum with stainless steel

(b)  
Copper alloy with stainless steel

(c)  
Carbon steel and stainless steel

Figure 1  
Galvanic couple specimens before atmospheric exposure  
(Materials are held together using nylon rods and nuts.)

Nylon rod coupled specimens (figs. 1 and 2) were placed on rack A in the corrosion instrumented test yard (CITY) located at the U.S. Army Armament Research, Development and Engineering Center (ARDEC), Picatinny Arsenal, New Jersey in compliance with ASTM G50 (ref. 4). Three sets of triplicate specimens and two sets of control specimens were exposed for 1 month, 3 months, and to be decided. Digital pictures were taken on a regular basis and post-exposure examination was conducted.

Nylon rod coupled specimens (figs. 1 and 2) were placed in 500 mL plastic containers completely submersed in ASTM D1141 (ref. 5) artificial seawater. Specimens were held vertical and evenly spaced using additional nylon rods and nuts. Separate containers were used for the aluminum-stainless steel couples and the copper alloy-stainless steel couples. One set of replicates for each specimen type were removed after 2.5 weeks of immersion and after 5 weeks of immersion. Digital pictures were taken on a regular basis and post-exposure examination was conducted.

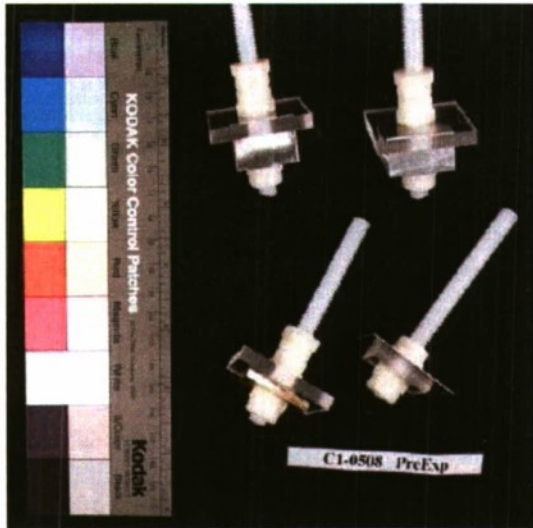
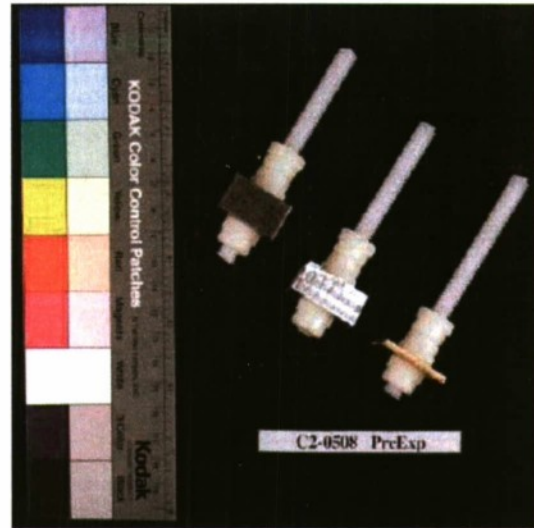
(a)  
Control type 1 (with plastic backing)

(b)  
Control type 2 (without plastic backing)

Figure 2  
Uncoupled specimens (controls) before atmospheric exposure  
(Materials are held together using nylon rods and nuts.)

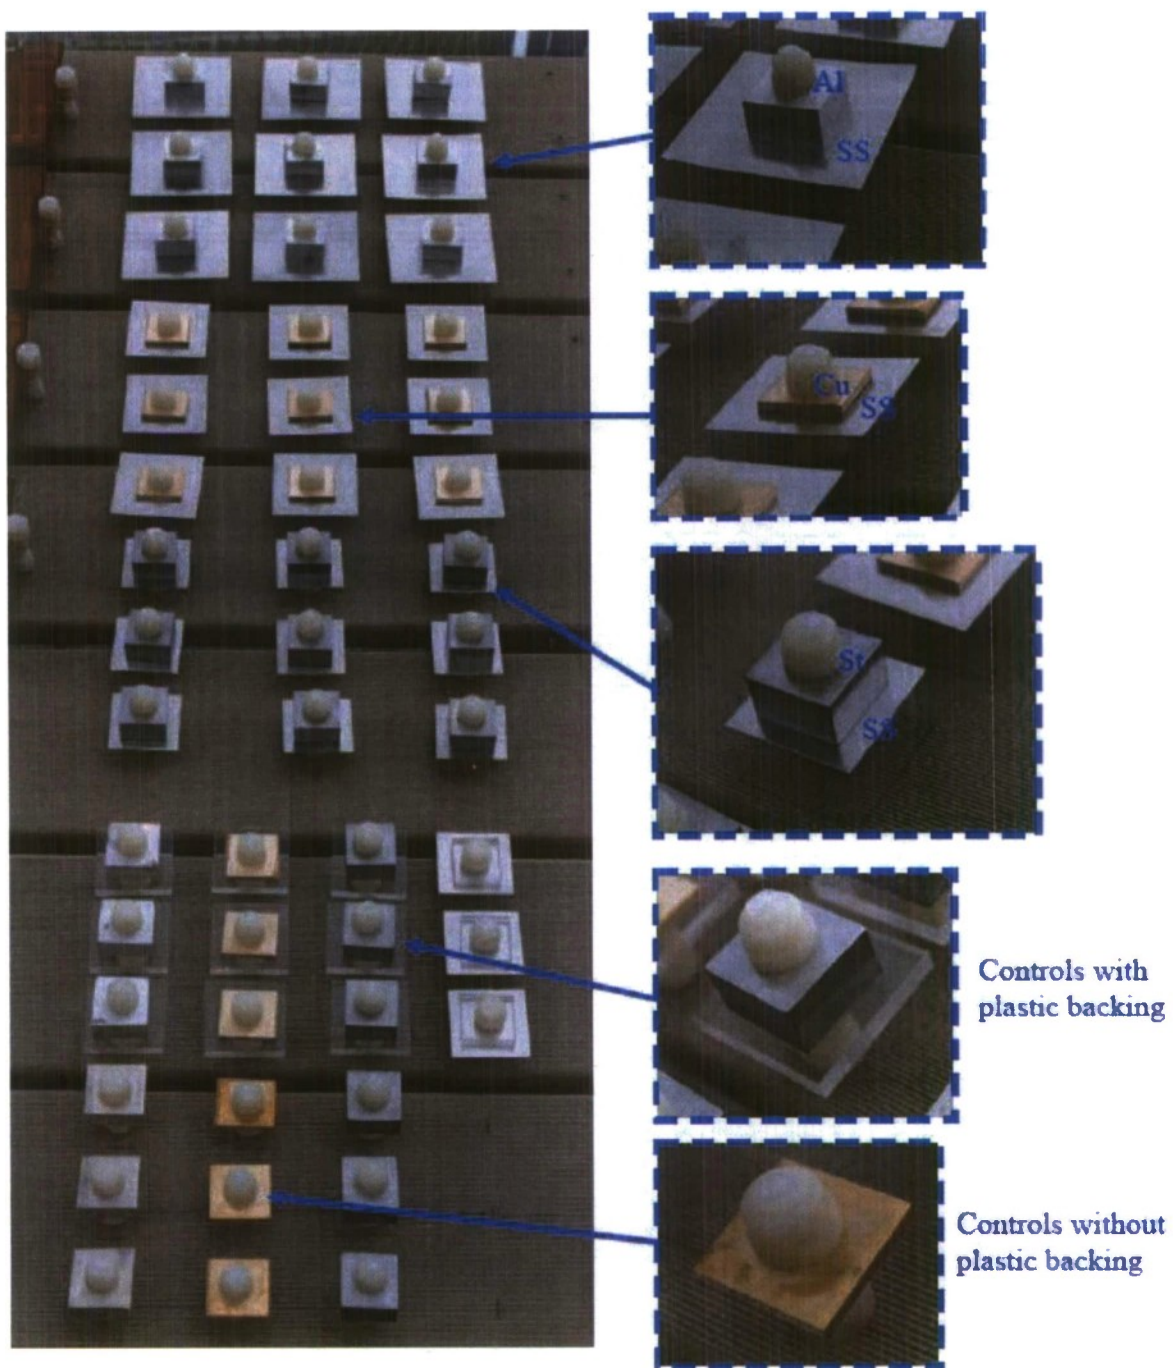
Figure 3  
All atmospheric specimens after initial exposure in CITY

Figure 3 shows specimens after initial exposure in the CITY. Several sets of replicates for each type were tested to accommodate removal after different exposure durations.

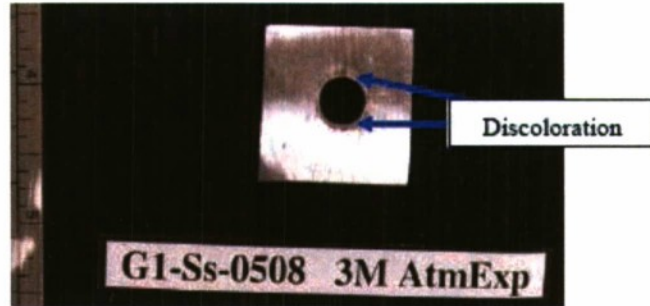
Figure 4

Slight discoloration on aluminum backside that was mated with the stainless steel

No significant difference was visible between the aluminum-stainless steel coupled and uncoupled materials after 1 month and 3 months of exposure. This was expected because both aluminum and stainless steel form strong passive oxide layers in the presence of oxygen in the atmosphere. These oxide layers protect the substrates from further corrosion. Only slight discoloration on the aluminum was noticed on the face that was mated with the stainless steel after 3 months of exposure (fig. 4). Some pitting was apparent on the stainless steel possibly due to the slight crevice created from the aluminum-stainless steel interface. The crevice corrosion control specimen supported this theory. Figure 5 shows the pitting.

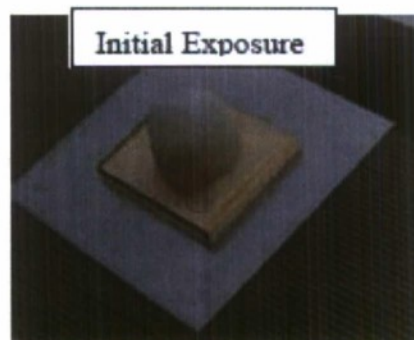
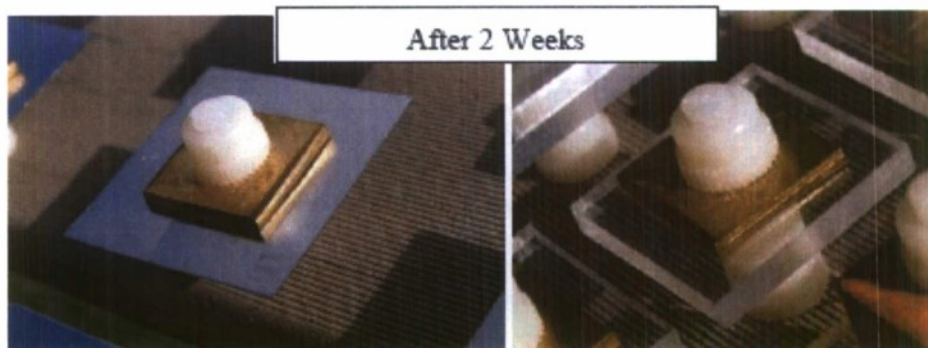
Galvanic couple (copper alloy-stainless steel) after initial exposure

Galvanic couple (copper alloy-stainless steel)  
after 2 weeks exposure

Control specimen (copper alloy-plastic backing)  
after 2 weeks exposure

Figure 6  
Tarnishing of copper surface during atmospheric exposure

As in the case of the aluminum-stainless steel couples, the copper alloy-stainless steels materials did not corrode significantly different when coupled versus uncoupled. The surface of the copper alloy did tarnish after 2 weeks of exposure. This was apparent on the fronts of all three copper alloy specimens (fig. 6). The corrosion on the backside of the galvanic couple specimen was more evident than that of the plastic-backed specimen (fig. 7). The crevice formed in both setups appears to have contributed to the degradation, but the galvanic couple provided a stronger driving force. The stainless steel specimens (both coupled to the copper alloy and the plastic) exhibited pitting (fig. 5) from the crevice formed.

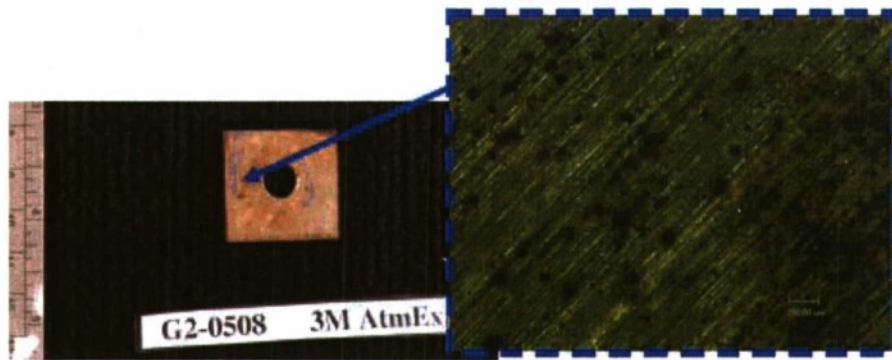
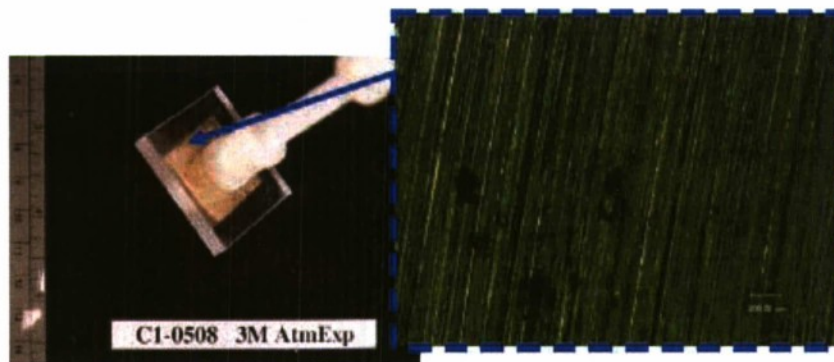
(a)  
Face coupled to stainless steel

(b)  
Face coupled to plastic backing

Figure 7  
Corrosion after 3 months atmospheric exposure on copper alloy  
(Images on right side were taken at 100x magnification.)

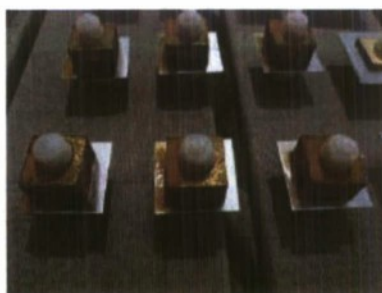
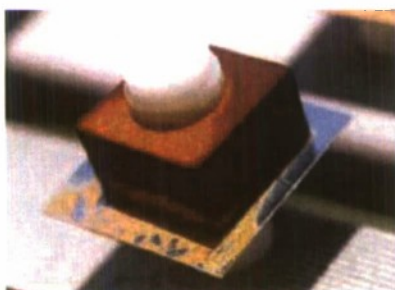
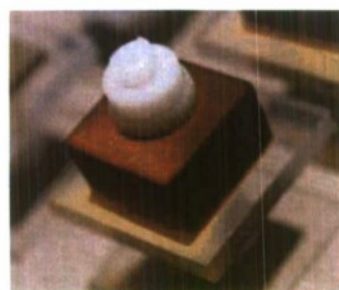
(a)  
After 1 week

(b)  
Galvanic couple (carbon steel-stainless steel) after 3 months

(c)  
Control with plastic backing after 3 months

Figure 8  
Corrosion of carbon steel specimens during atmospheric exposure

As expected, the carbon steel specimens exhibited the most atmospheric corrosion degradation of all the materials. However, the corrosion was not significantly different in the coupled as compared with the uncoupled arrangement. General corrosion was apparent on the surface of all carbon steel specimens after 1 week of atmospheric exposure (fig.8a). After 3 months, the carbon steel corrosion on the galvanic couple specimen was consistent with the corrosion on the control specimen (with plastic backing) (fig. 8a and b).

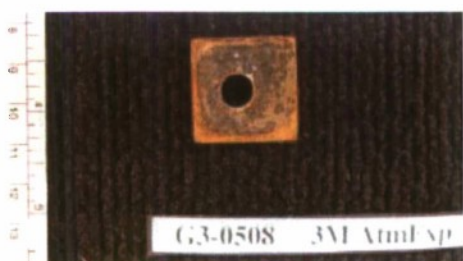
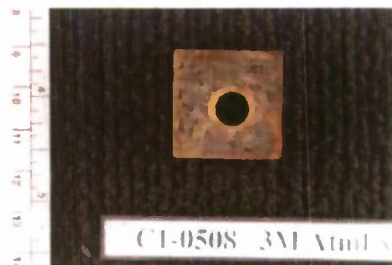
(a)  
Galvanic couple specimen

(b)  
Plastic-backed specimen

Figure 9  
Corrosion product on carbon steel surfaces after 3 months atmospheric exposure

The corrosion on the backside was a little more interesting. In both the coupled and plastic-backed setups, the degradation was similar although there was slightly more red corrosion product in the galvanic couple specimen (fig. 9). This could be due to the galvanic reaction between the carbon steel and the stainless steel and the penetration of water from the less tightly fitting galvanic couple setup.

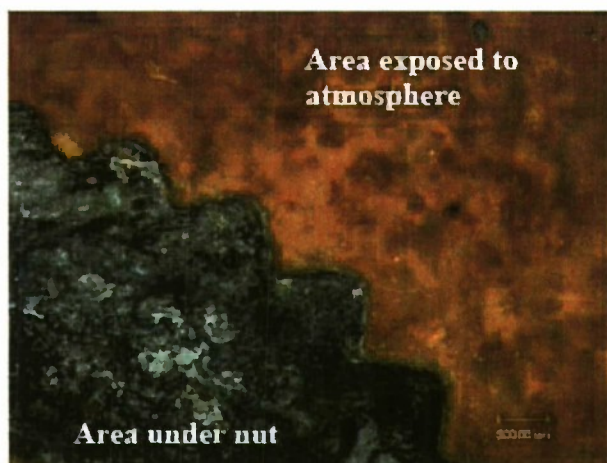
Border of crevice created by nylon nut on front face of carbon steel specimen after 3 months of atmospheric exposure (Image taken at 50x magnification.)

The black iron oxide (magnetite) formed due to lack of oxygen in the crevice while red iron oxide (hematite) formed on the exposed surfaces. Figure 10 shows evidence of this on the front side of a carbon steel specimen at the border where the nylon nut created a crevice.

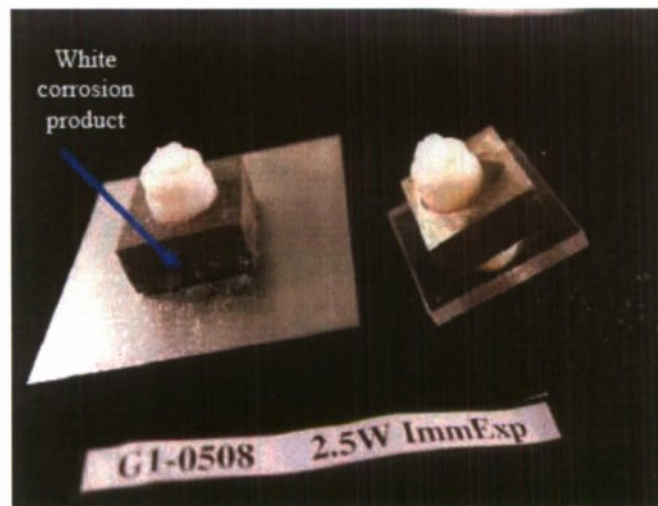
Figure 11

Specimens removed from constant immersion in artificial seawater after 2.5 weeks  
[Left - aluminum coupled with stainless steel and right - aluminum with plastic backing]

After 2.5 weeks of immersion in artificial seawater, the galvanic coupled aluminum had a considerable large amount of white corrosion product (fig. 11). When the couples were separated for further examination, it was very clear that the galvanic couple had accelerated the aluminum corrosion rate. There was a greater amount of white corrosion product than on the uncoupled aluminum sample (with plastic backing) after 2.5 and 5 weeks of immersion (fig. 12).

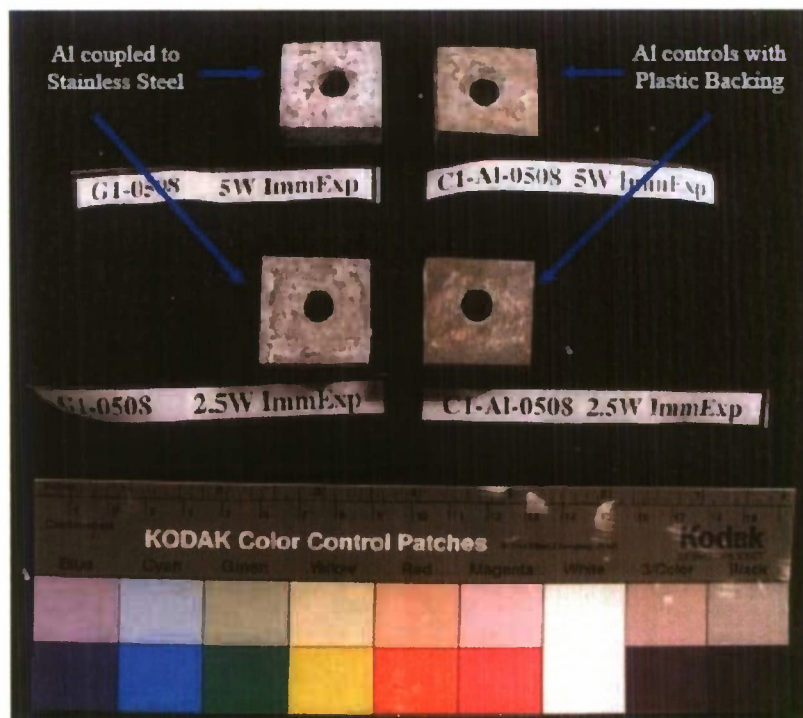
Figure 12

Aluminum specimens after 2.5 weeks (bottom row) and 5 weeks (top row) of constant immersion in artificial seawater (Left side specimens were coupled to stainless steel and right side specimens has a plastic backing.)

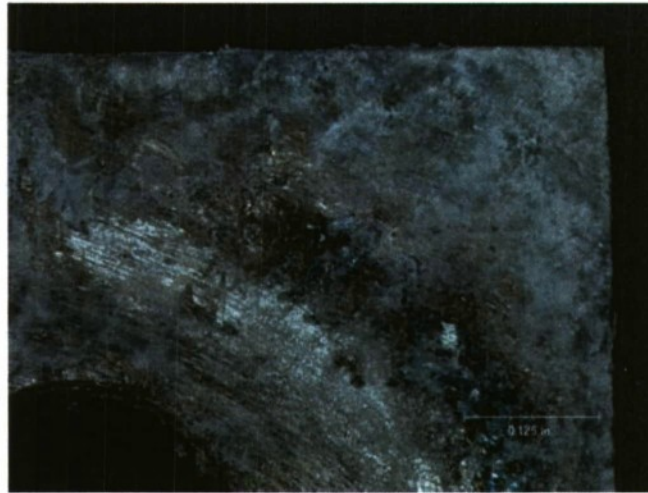
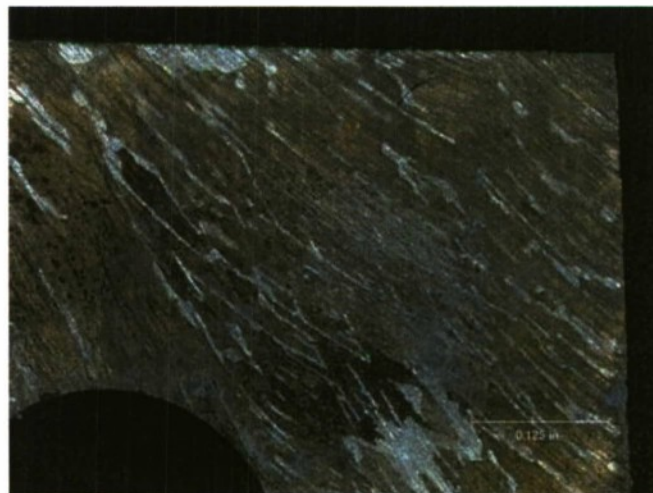
(a)  
Coupled with stainless steel

(b)  
Plastic backing

Figure 13  
Digital microscope images at 20x magnification of aluminum specimens after 5 weeks of constant immersion in artificial seawater

Higher magnification digital pictures were taken to better illustrate the difference in corrosion products between the galvanic couple aluminum and the plastic-backed aluminum. Figure 13 shows there is clearly a difference in corrosion damage. The galvanic coupled aluminum has a significant amount of white corrosion product covering the surface. Alternatively, the plastic-backed aluminum has discoloration, but no corrosion product build-up. A reddish material was evident in the coupled specimen, which later turned to white with exposure to air. This material will be further investigated.

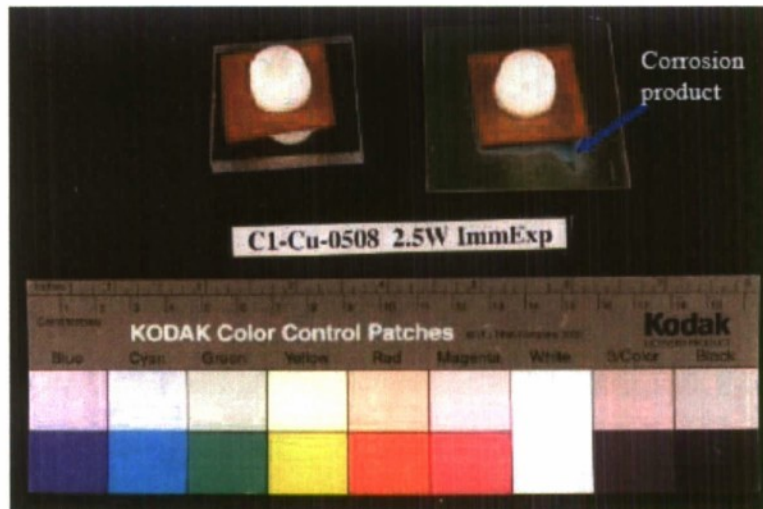
Figure 14

Images after 2.5 weeks of constant immersion in artificial seawater  
(Left side is the control copper alloy specimen with plastic backing and the right side is the galvanic couple of the copper alloy and stainless steel.)

After 2.5 weeks of immersion in artificial seawater, one set of specimens was removed for inspection. It was already apparent that the galvanic couple copper alloy was corroding more than the plastic-backed specimen. In figure 14, the blue/green corrosion product can be seen coming off the copper alloy at the copper-stainless steel interface. The surface corrosion on both specimen types is very similar (fig. 15). The area underneath the nylon nut is still untarnished.

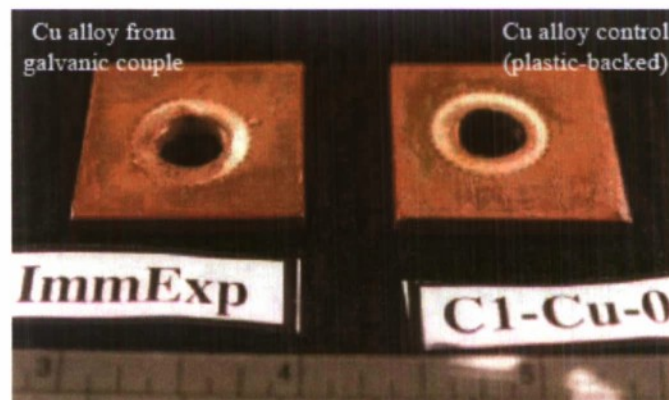
Figure 15

Front sides of copper alloy specimens after being separated from coupling setups  
(These specimens were exposed for 5 weeks in artificial seawater.)

Although the front sides were similar, the sides in contact with the coupling material had different results. Figure 16a shows the copper alloy that was coupled to the stainless steel corroded in distinct areas. The copper alloy specimen that was coupled to the plastic did not show as distinct of corrosion areas (fig. 16b). The damage was more spread out and not as extensive.

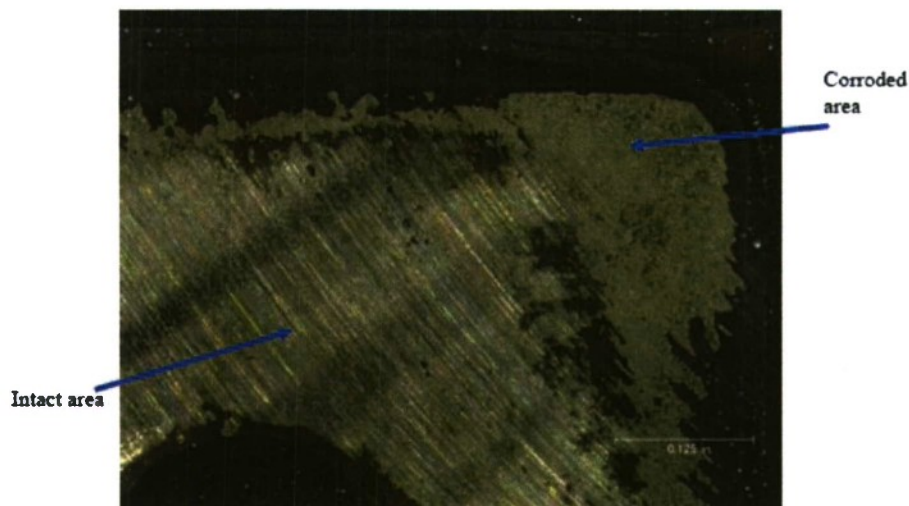
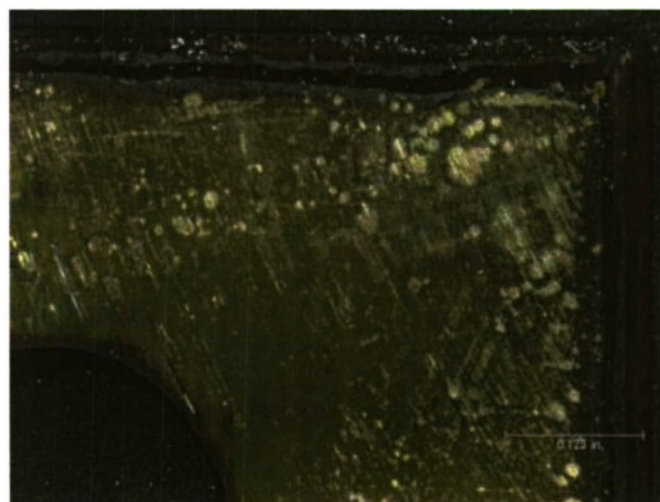
(a)  
Coupled with stainless steel

(b)  
Plastic backing

Figure 16  
Digital microscope images at 20x magnification of copper alloy specimens after 5 weeks of constant immersion in artificial seawater

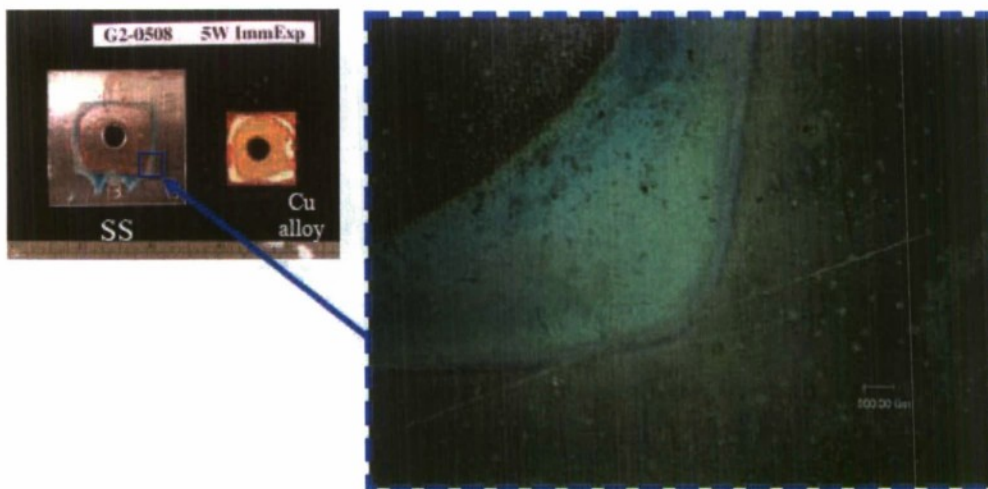
Digital microscope image at 30x magnification of corrosion product residue from the copper alloy on the stainless steel specimen after 5 weeks of immersion in artificial seawater

Further analysis was conducted on the corrosion product that remained on the stainless steel specimen that was coupled to the copper alloy. Figure 17 shows a closer look at the blue/green corrosion product at the corner where the two specimens met. The analysis of this corrosion product (included in appendix D) supported the idea that the corrosion product was from the copper alloy. The Energy Dispersive X-ray Analysis (EDXA) also showed that the red material contained a large amount of calcium and sulfur (possibly some type of calcium sulfate residue).

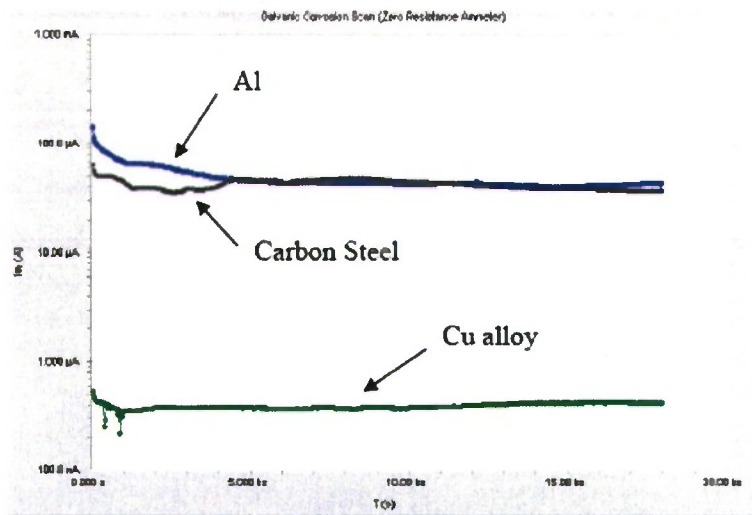
Figure 18  
Plot of galvanic current (log A) versus time (s) for different materials coupled with stainless steel in artificial seawater

A plot of the galvanic current recorded during the test is shown in figure 18. The current was plotted on a log scale. Higher current correlates to higher corrosion rates. From these results, it is apparent that when coupled with stainless steel (1:1 area ratio) in artificial seawater the aluminum and carbon steel corroded at a faster rate than the copper alloy. Figure 19 is a plot of the corrosion potentials as a function of time. The low corrosion potentials of the aluminum-stainless steel and carbon steel-stainless steel system demonstrate their sacrificial protection of the stainless steel. A SCE was used as the reference electrode in this system.

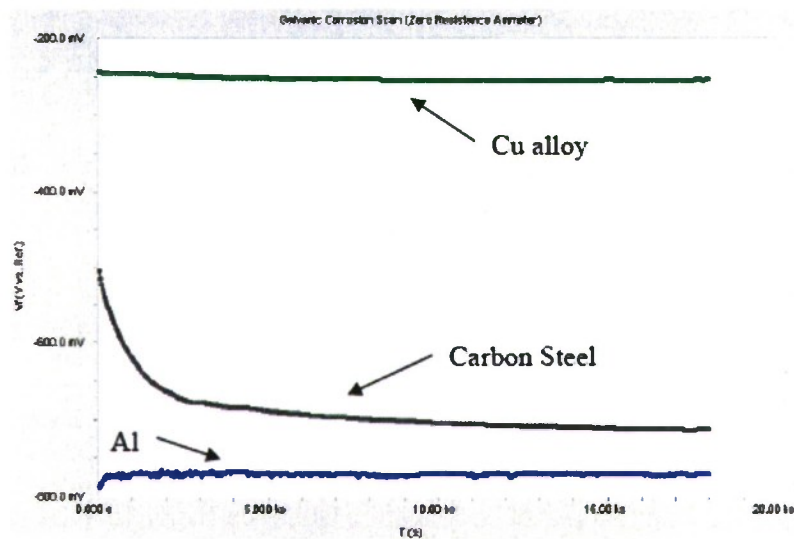
Figure 19  
Plot of corrosion potential (mV versus SCE) versus time (s) for different materials coupled with stainless steel in artificial seawater

In each of the three galvanic couple ZRA experiments (aluminum-stainless steel, copper alloy-stainless steel, and carbon steel-stainless steel), the stainless steel remained intact while the other coupled material corroded. Images of this corrosion are shown in figure 20. This confirms that the galvanic current recorded was a result of the stainless steel acting as a cathode (more noble) during the ZRA experiments.

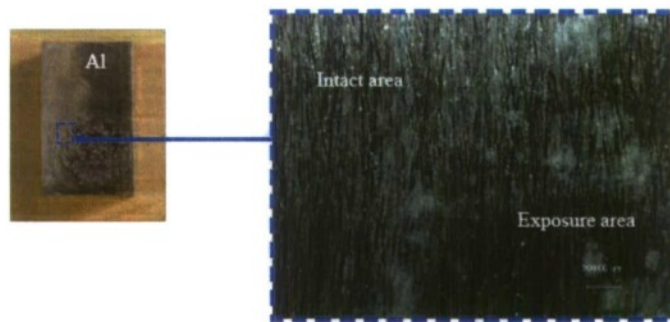
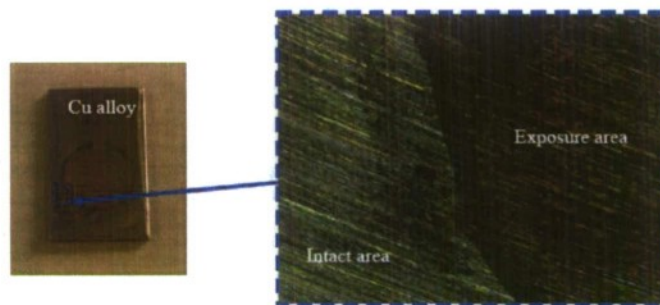
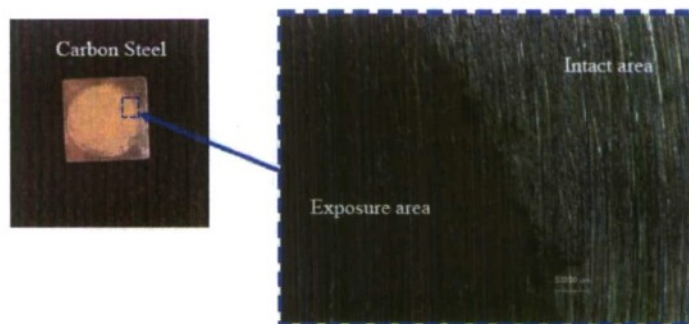
(a)  
Aluminum coupled with stainless steel

(b)  
Copper alloy coupled with stainless steel

(c)  
Carbon steel coupled with stainless steel

The circles of discoloration shown on the left side are where the electrolyte (artificial seawater) was in contact with the material.

Figure 20  
Digital microscope images at 50x magnification of exposure areas from galvanic corrosion ZRA experiments

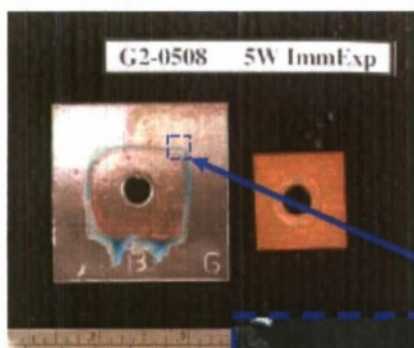
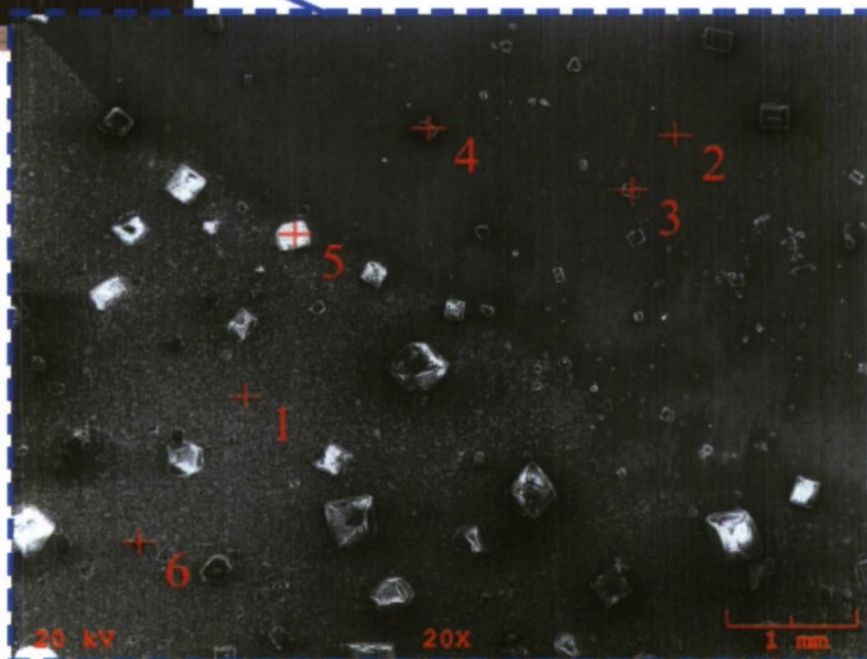
EDXA analysis of Cu alloy corrosion product residue and salts on Stainless Steel surface after 5 weeks of constant immersion in artificial seawater.

Secondary e<sup>-</sup> SEM micrograph
