ECBC-TR-670

EFFECTS OF VAPORIZED DECONTAMINATION SYSTEMS ON SELECTED BUILDING INTERIOR MATERIALS: CHLORINE DIOXIDE

February 2009

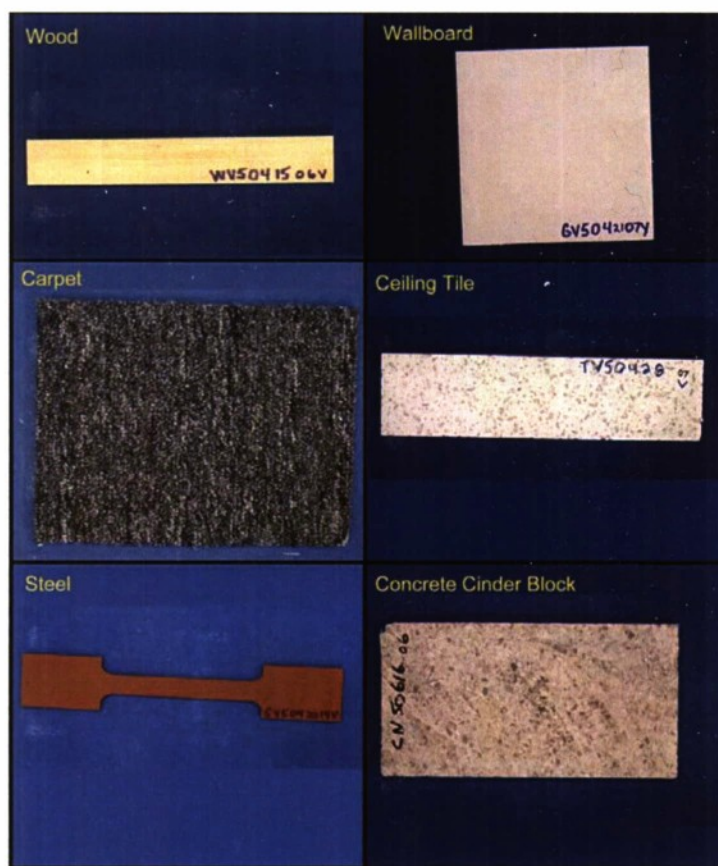
*Coupons are not shown to scale

Figure 1. Representative photograph of the test coupons.

The Material Compatibility studies also investigated materials related to electrical breaker connections, such as intact circuit breakers and component metals aluminum, copper, and steel. The circuit breakers were one-pole circuit breakers (HOM120, 2400 W, 120/240 V, 20 A).

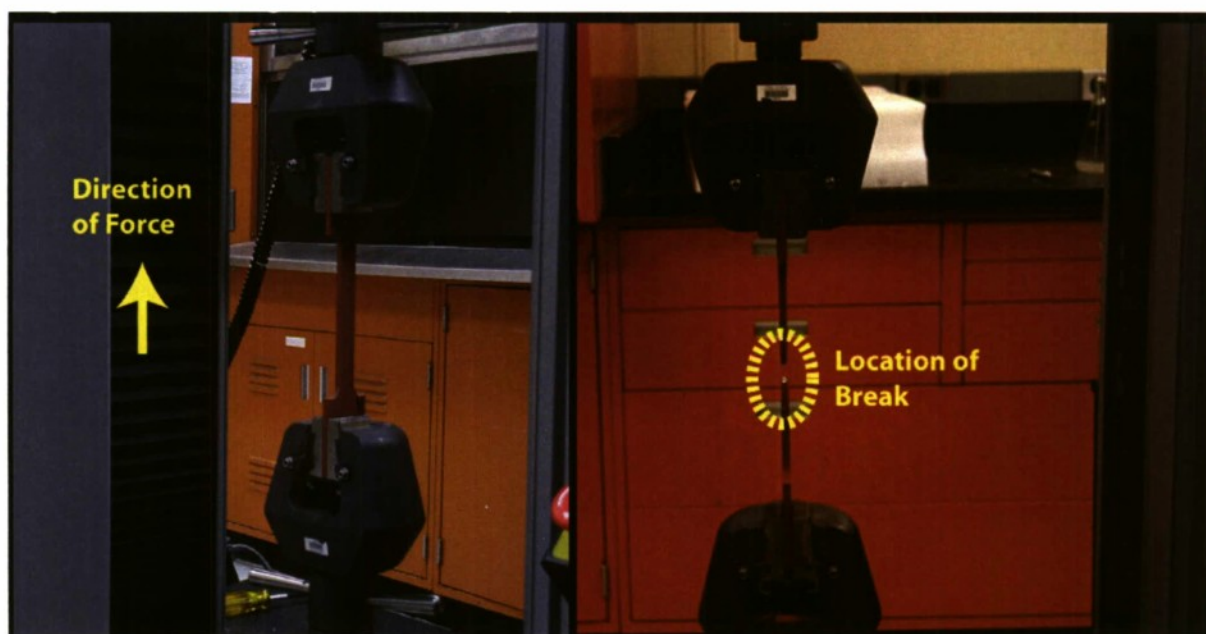
Figure 2. Steel coupon test representative photograph.

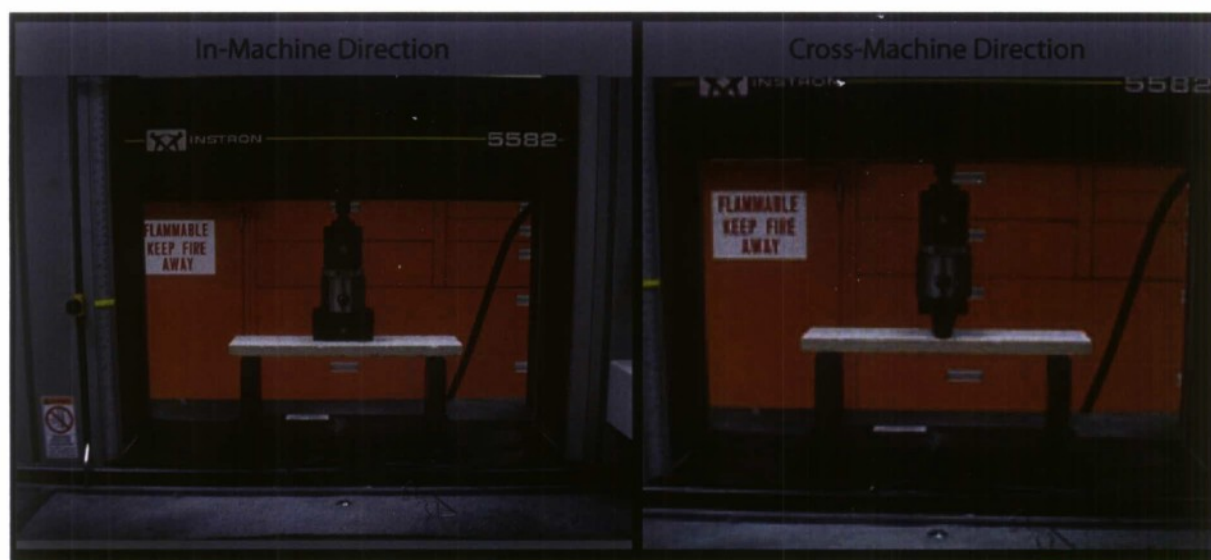
Figure 4. Representative photograph of the acoustical ceiling tile coupon test.

The Modulus of Rupture (MOR) was calculated according to the test method using Equation 1. P is the maximum load, N (lbf). L is the length of span, mm (in.). Variables b and d are the specimen width and thickness, respectively in millimeters.

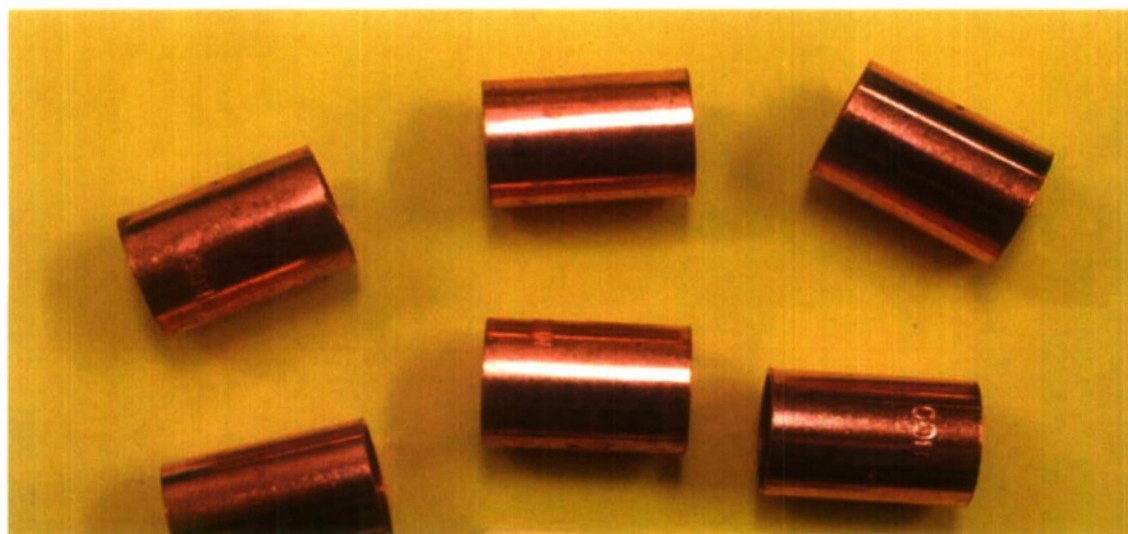
Figure 12. Photograph of copper tubing prior to exposure to ClO_2 .

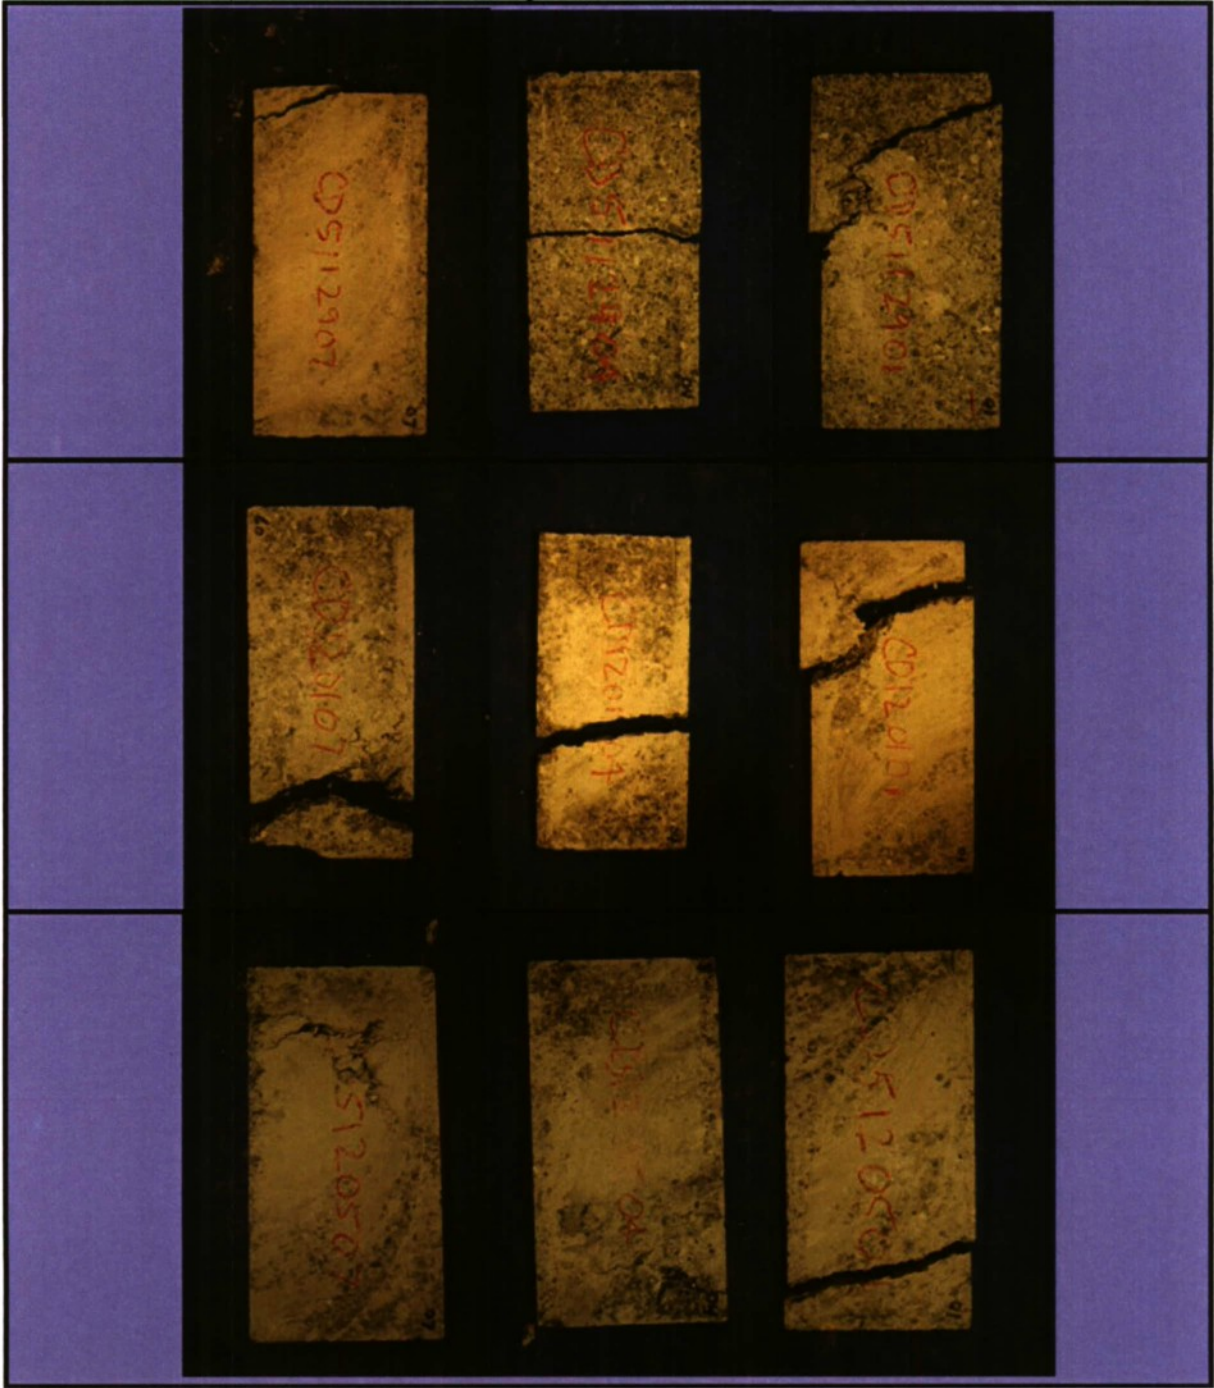
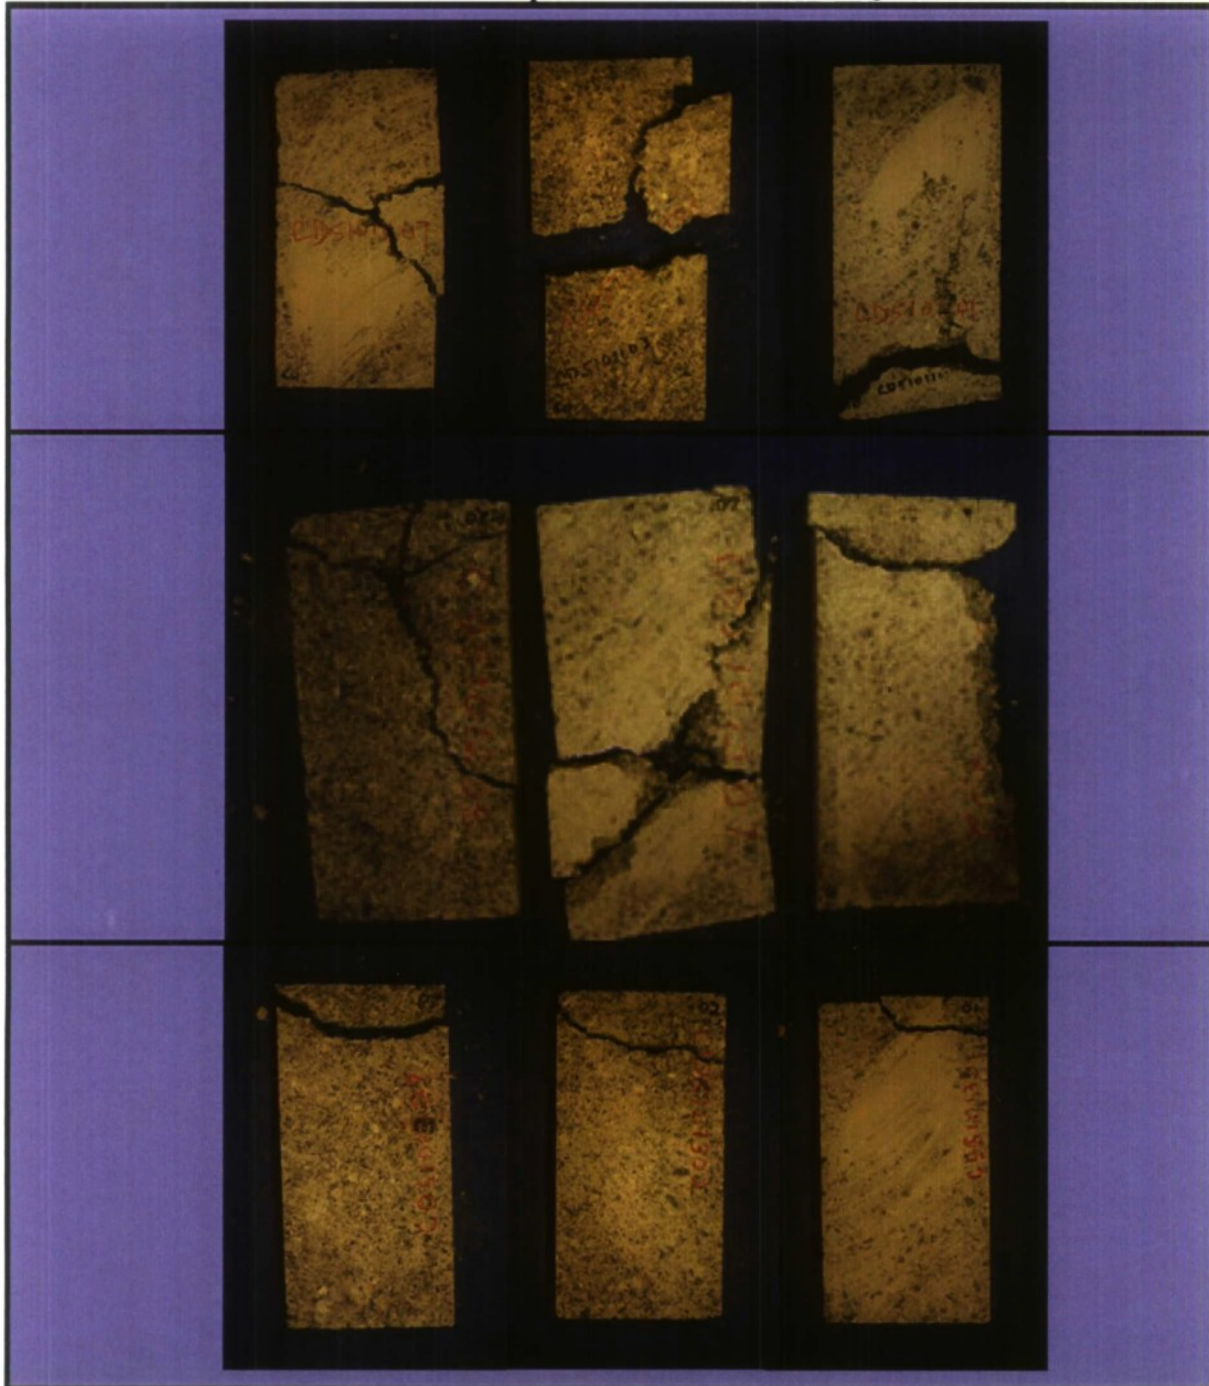
There is no requirement for reporting the location of the break; however, concrete block is a variable material and differences in location were observed. This appendix provides additional information through test photographs. Yellow arrows are used on samples where the photograph contrast may not clearly show the location of the break.

Concrete cinder block coupon location of break: ClO_2 control set

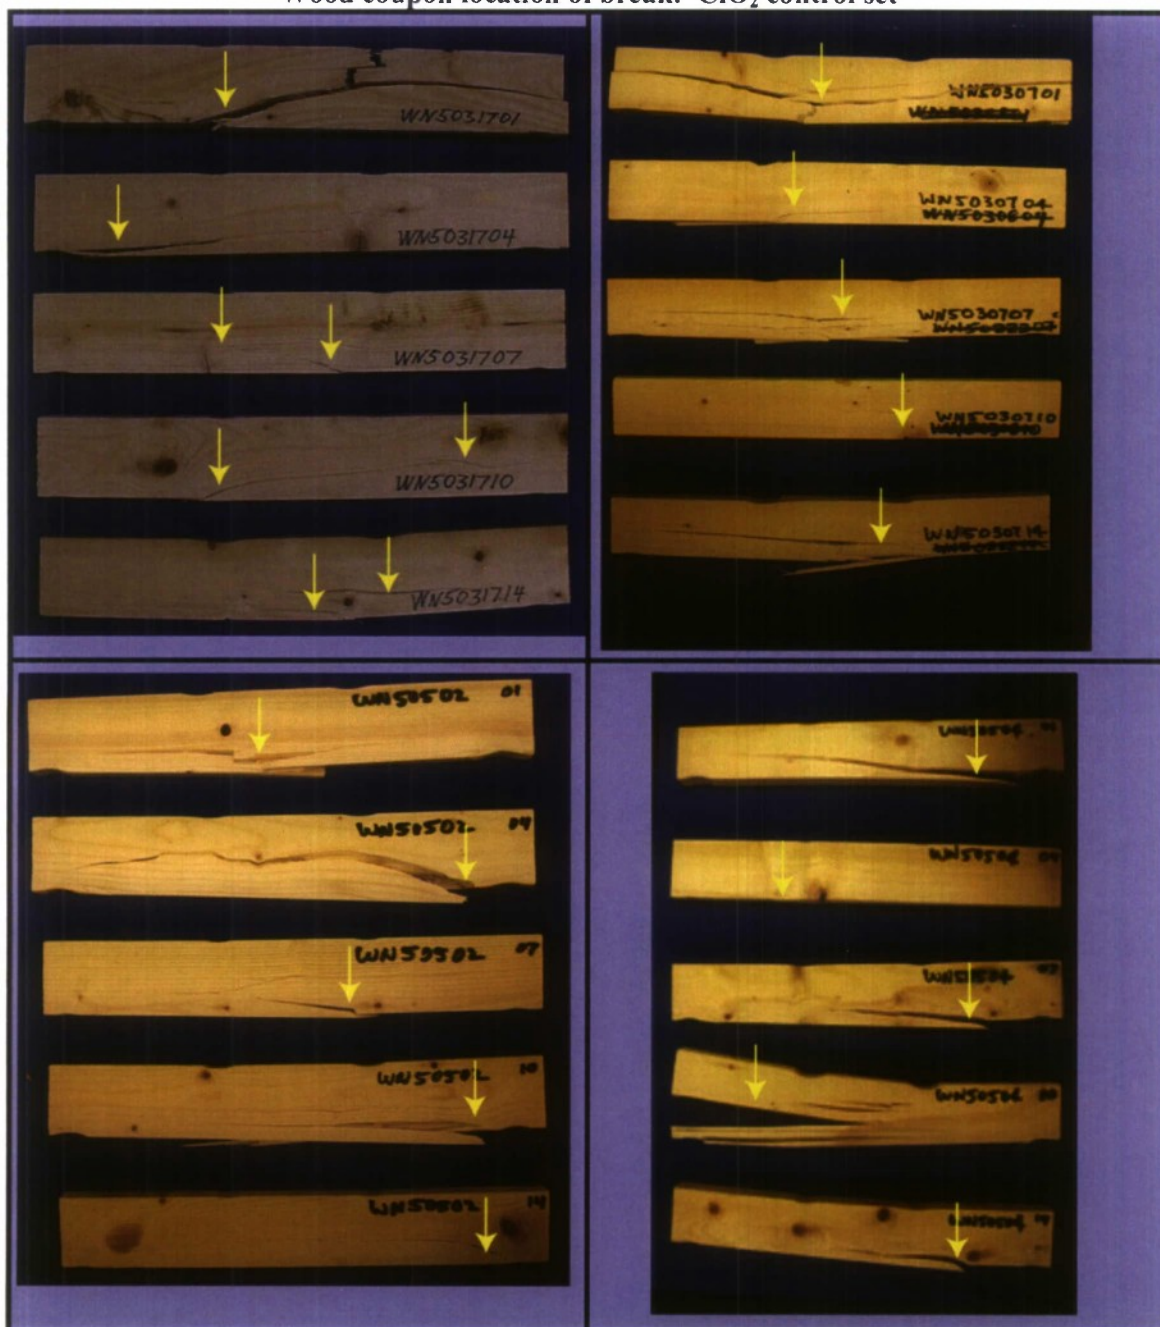
The ASTM test method requires reporting the location of the break for each wood sample. This appendix provides this reporting information in pictorial form. Yellow arrows are used on samples where the photograph contract may not clearly show the location of the break.

Wood coupon location of break: ClO₂ control set

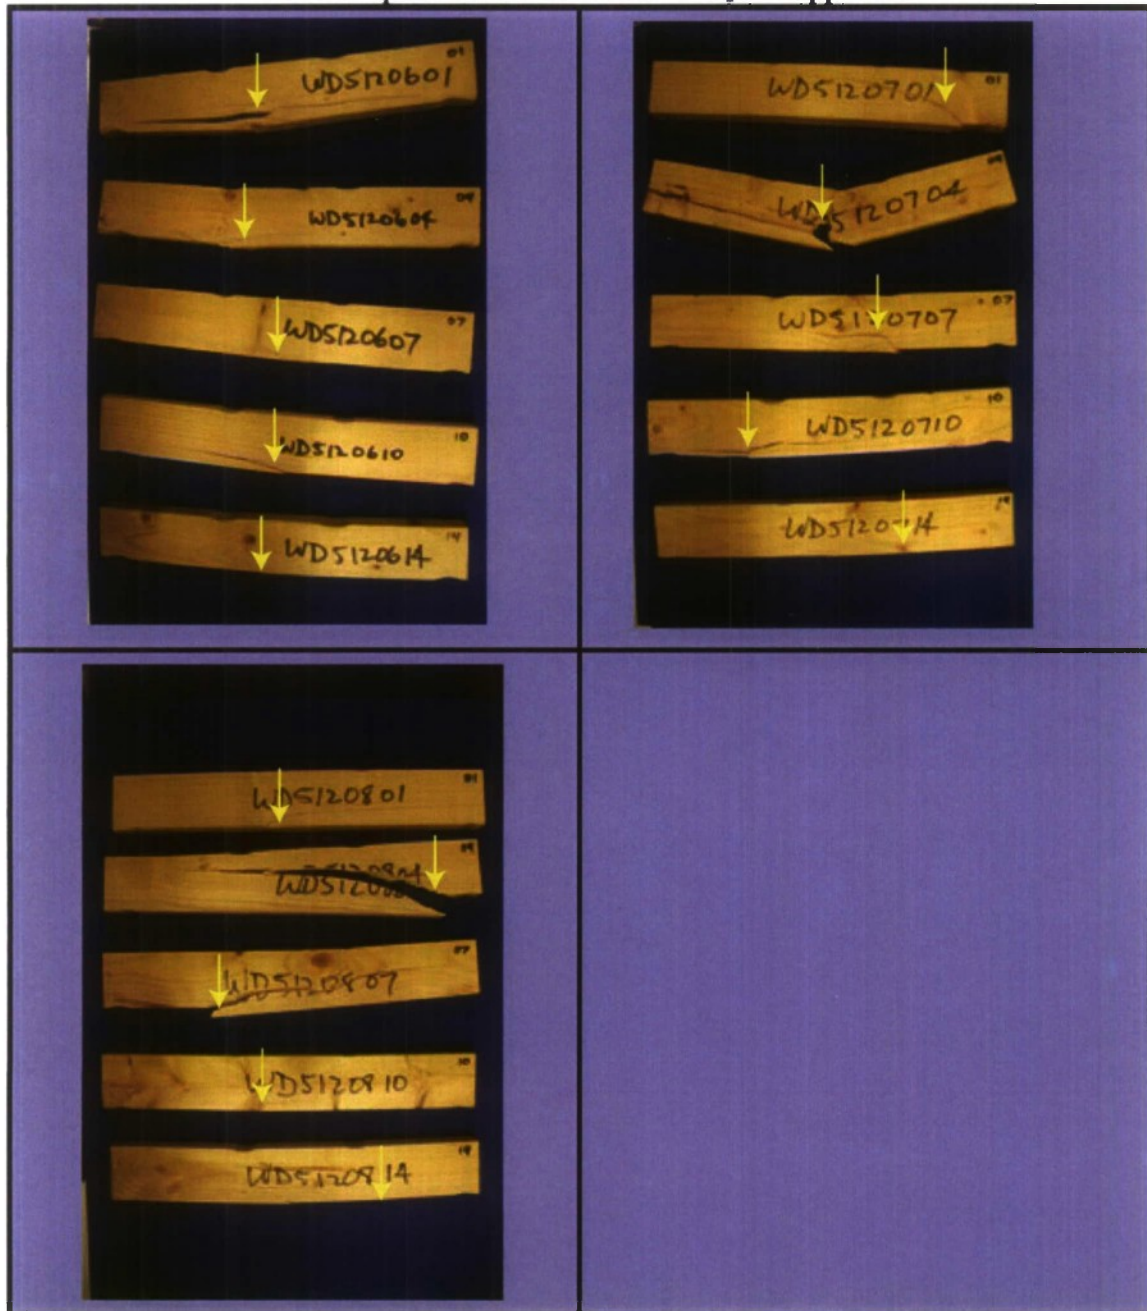
Wood coupon location of break: ClO₂ 2000 ppm set
