HIGH PERFORMANCE MAGAZINE CERTIFICATION TEST NO. 3: PLANNING AND RESULTS

Robert N. Murtha Naval Facilities Engineering Service Center, Port Hueneme, CA

> 28th DDESB Seminar Omni Rosen Hotel Orlando, FL 18-20 August 1998

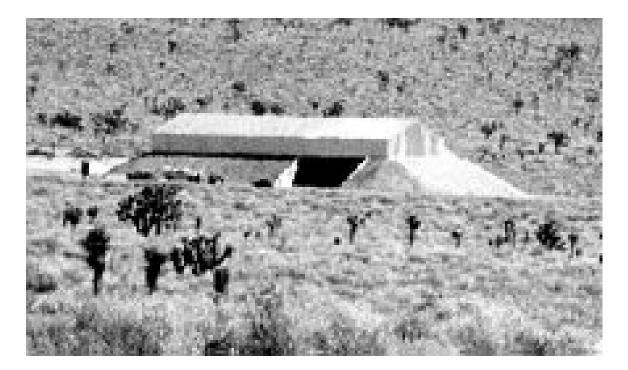
Figure 9. Exterior view of CT3 structure.

The floor plan of Story-1 is shown in Figure 6. The exterior walls of the Entrance Area and SRA, plus the structure floor and foundation are normal weight reinforced concrete. The exterior walls around the storage area and the transport aisle walls are lightweight structural concrete. The gross internal volume of the structure is 133'-0" x 52'-0" x 28'-3" (LxWxH). The top of the earth berm is 3'-0" above the storage area height. An exterior photograph of the completed structure is shown in Figure 9.

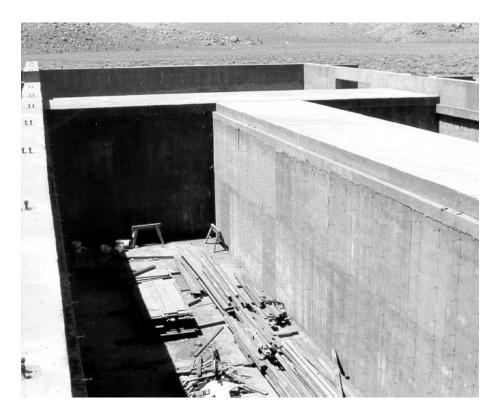
Figure 10. Portion of transfer aisle walls.

The SRA and storage transfer aisle walls use a lightweight, structural concrete (80 pcf) with a compression strength, f_c , of 2500 psi and a strain capacity (at nearly constant crushing strength of f_c) of about 45%. The lightweight concrete reduces kinetic energy, absorbs strain energy, and provides thermal insulation to mitigate acceptor loads from the design hazard scenarios. A sand fill is used to reduce the kinetic energy of these walls on impact with the acceptor. The cross-section (15'-0" total thickness) of the SRA transfer aisle wall is 3'-0" of lightweight concrete and 12'-0" of sand. The cross-section (12'-0" total thickness) of the storage transfer aisle wall is 3'-0" of lightweight concrete and 9'-0" of sand. The HPM CT1 aisle wall was so successful, the aisle wall for CT3 was redesigned to use lightweight concrete (vs. CBC) and sand (vs. steel grit). The overall cross-section was increased, but total wall cost will be much less. A photograph of a portion of the transfer aisle walls is shown in Figure 10.

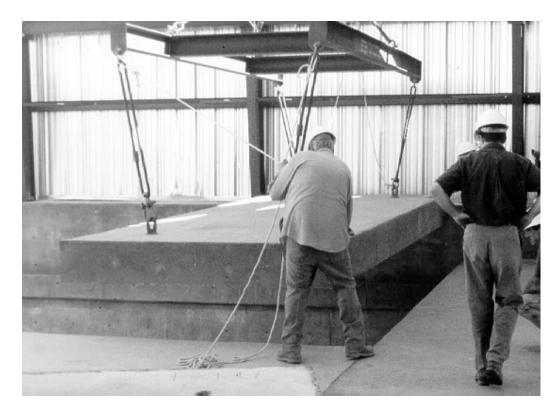
Figure 11. Pit cover.

Pit Cover. The pit cover is primarily required in the HPM to prevent SD of ordnance in adjacent storage cells during aisle transport and temporary ordnance storage. It is not feasible to design the pit covers to remain intact after an accidental detonation. Therefore, the pit covers are designed to remain in place only long enough to stop fragments from the aisle transport donor. Consequently, the pit covers must be constructed in a way that ensures that SD is prevented when the pit cover impacts acceptor ordnance. The pit cover has been designed, based on finite element and hydrocode analysis, and test data from HPM CT2 The selected pit cover is 12" of lightweight reinforced concrete with a 3/16" steel cover plate. This cross-section stopped fragments from a Mk84 bomb (HPM CT2) and analytically kept critical acceptor response well below the design threshold levels (e.g., relative case deformations < 25 percent, and explosive fill pressures < 4.0 kbar for thick-case acceptors) for the HPM (Reference 5). A photograph of a pit cover being placed over a storage cell is shown in Figure 11.

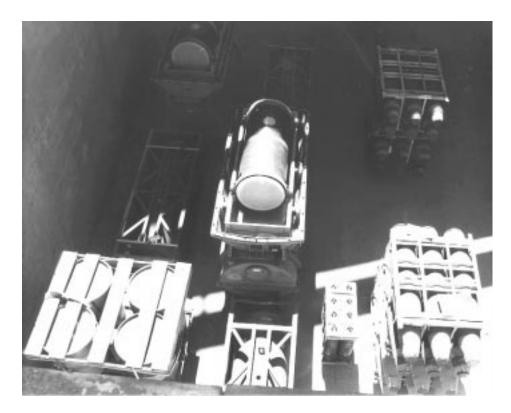
Figure 13. Acceptor ordnance inside Cell A1.

- <u>Cell A1.</u> Acceptor Cell A1 is literally surrounded by donor ordnance. This cell tested SG 4 acceptors (Mk82 bombs and M107-155mm projectiles) and SG 8 acceptors (Mk55 mines, Mk103 & Mk107 torpedo warheads, and WAU-17 Sparrow warheads) opposite the SRA transfer aisle wall from Donor D1, beneath the pit cover from Donor D2, and opposite the cell wall from Donor D3. Most acceptors were oriented perpendicular to these walls. The M107-155mm projectiles and Mk103 torpedo warheads, which are stored vertically, are parallel to all walls. Since the loading environment behind a cell wall is greater than behind the aisle walls (and the M107-155mm projectile is parallel to both), this cell is considered the more critical location for the projectiles. Acceptor A1 is exposed to a greater threat than the other two acceptors. A photograph of the ordnance in Cell A1 is shown in Figure 13.

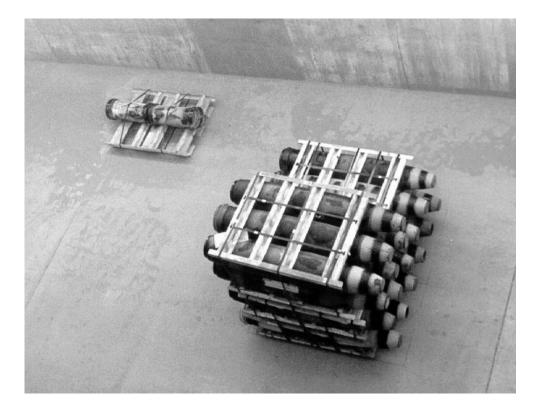
Figure 14. Acceptor ordnance inside Cell A2.

- <u>Cell A2.</u> Acceptor Cell A2 is the least threatened of the acceptors. This cell tested SG 4 acceptors (Mk82 bombs) and SG 8 acceptors (WAU-17 Sparrow warheads) opposite the SRA transfer aisle wall from Donor D1, beneath the pit cover from Donor D2, and opposite the storage transfer aisle wall from Donor D3. Acceptor loads from these walls are not expected to be critical. Primary damage to the acceptors will be caused by the pit cover impact from Donor D2. All acceptors were oriented parallel to the storage transfer aisle wall. A photograph of the ordnance in Cell A2 is shown in Figure 14.

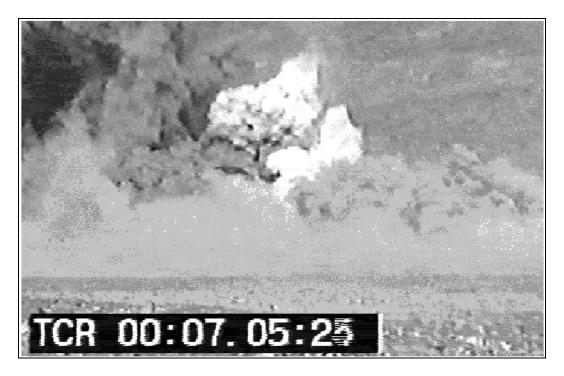
Figure 17. CT3 site: Video image at T_D +20 sec.

The list is based on analyses of the video tapes and direct on-site observations by NFESC, NAWC, and ISA personnel. Low resolution images captured from these tapes are shown in Figures 17 and 18. Figure 17 shows the white smoke from the early-time ($T_D + 20$ sec) burning explosives which eventually burned out when the explosives were consumed. Figure 18 shows the 3rd late-time

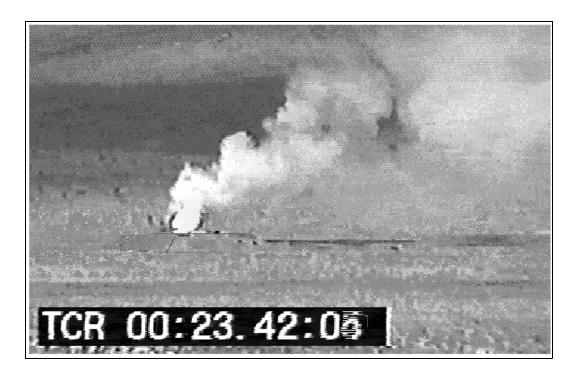
Figure 18. CT3 site: Video image at T_D +16 min 57 sec.

reaction in Cell A1 at $T_D + 16 \min 57$ sec.

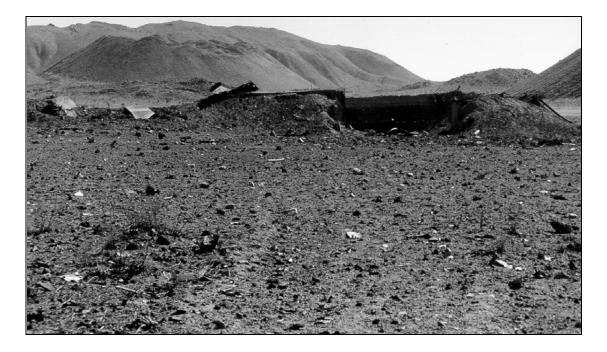
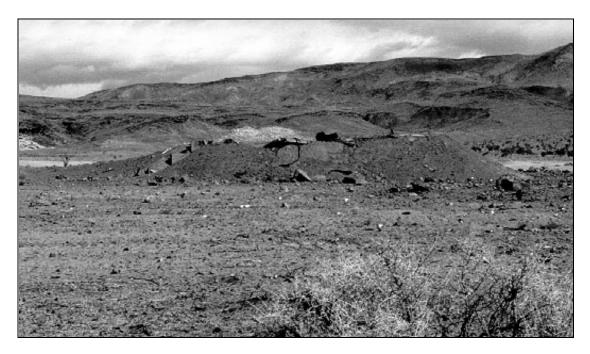
Figure 19a. Post-test views of CT3 structure.

Figure 19b. Post-test views of CT3 structure.

Photographs taken the next day of the exterior CT3 site are shown in Figure 19. None of the 2nd story structure remained. Closer views of the interior damage to the CT3 structure are shown in Figures 20, 21, and 22. The exterior concrete walls of Cell D3 were destroyed and small pieces of concrete were thrown outside the structure. The exterior walls of the SRA and the three acceptor cells were rotated outward against the soil berm. The following internal nonpropagation walls were destroyed and completely missing:

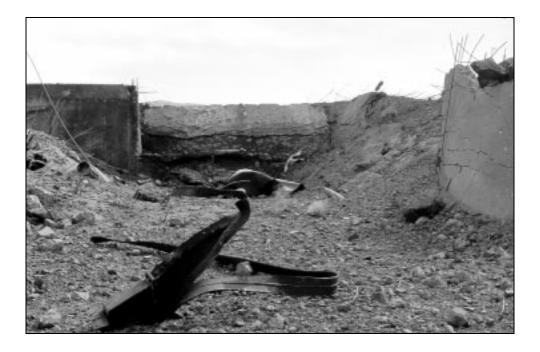
Figure 20. View of CT3 structure: SRA.

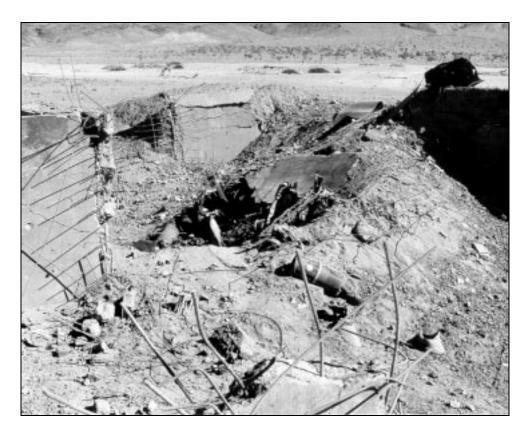
Figure 21. View of CT3 structure: Cell A3.

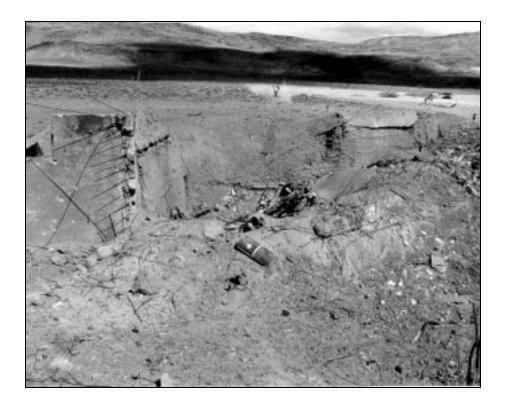
Figure 22. View of CT3 structure: Cells A1 and D3
