# **TESTING OF PROTOTYPE CONDUIT**

**INTERIM REPORT  
TFLRF No. 401**

**U.S. Army TARDEC Fuels and Lubricants Research Facility  
Southwest Research Institute<sup>®</sup> (SwRI<sup>®</sup>)  
San Antonio, TX**

**for  
U.S. Army TARDEC  
Force Projection Technologies  
Warren, Michigan**

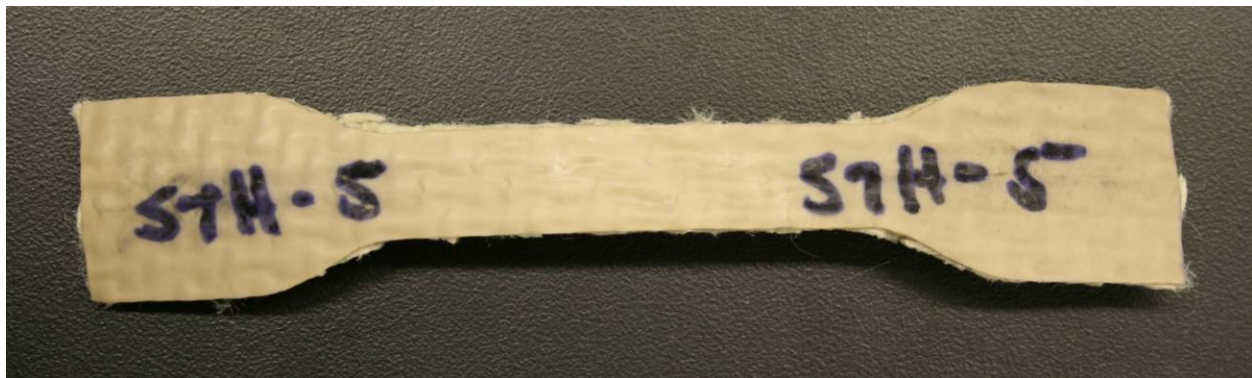
Figure 6.2 - Representative Tensile Coupon after Removal from Parent Hose Material

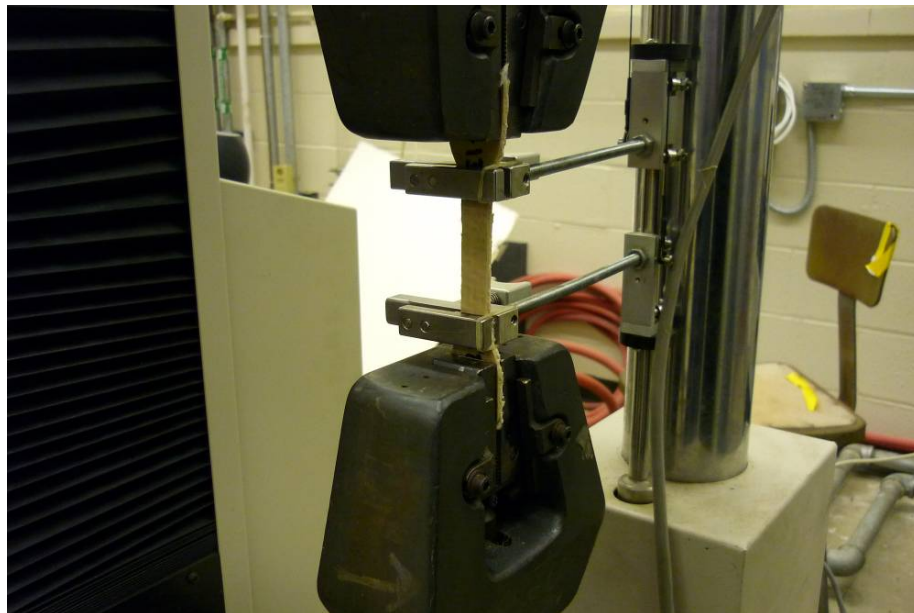
Testing was performed per ASTM D412 at a displacement rate of 20 in/min. A 20-kip servomechanical test frame (Figure 6.3) was used with a 2.5-kip load integrated into the load train given the anticipated loads. Mechanical clamping grips were used to secure each coupon end during testing. A high elongation extensometer was utilized to measure gage length extension during each test. The initial gage length for each test was 2-in and the post-test strain calculations were based on a nominal gage length of 2-in. Testing was performed in laboratory ambient conditions; nominally 72°F and 30-40% RH. It is important to note that the conditioned coupons remained in a bath of their respective conditioning fluid until just prior to testing.

**Figure 6.3 – Test Sample Mounted in Tensile Test Frame**
