ZAKHO MILITARY ACADEMY  
ZAKHO, IRAQ

**SIGIR PA-06-039**  
**APRIL 12, 2006**

SUBJECT: Report on the Project Assessment of the Zakho Military Academy, Zakho,  
Iraq (Report Number SIGIR-PA-06-039)

## Zakho Military Academy, Zakho, Iraq

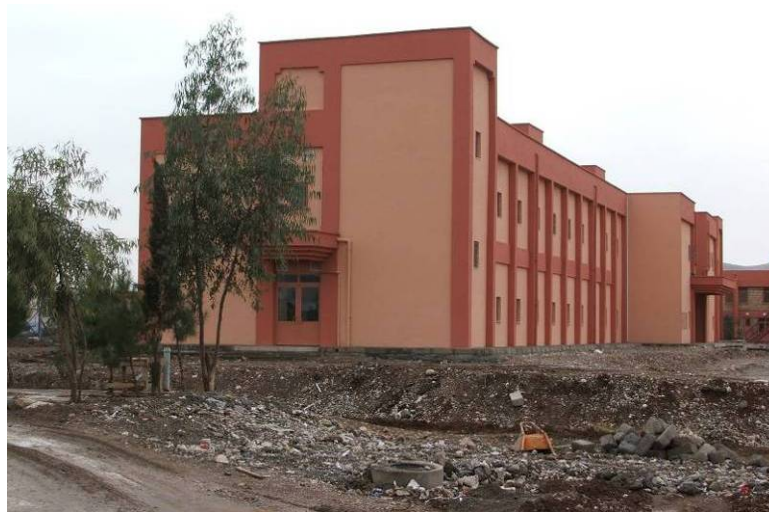
**Site Photo 8. Exterior of new barracks facility**

block walls. The building design included centrally located latrines, a laundry, and a lounge on both floors, flanked by student rooms in each wing. The barracks contained 76 rooms for student billeting, with each barracks room approximately 3 m wide by 4.8 m long. Finished rooms included painted gypsum plastered walls and suspended acoustical tile ceilings with granite tile floors. Site Photo 7 shows the barracks first floor hallway. Site Photo 8 is an exterior view of the barracks.

Based on the review of the contract requirements, the design, and our observations on site, the construction of the barracks met the requirements of the contract. However, since our site visit was in January, which typically is a wet month, the grounds of the military academy were muddy and there was a great deal of standing water. The construction around the academy exacerbated these problems. Since there were few sidewalks interconnecting buildings, there were few places to walk between buildings without having to walk in the mud. As a result, a large amount of mud was being tracked inside the barracks, particularly into the latrines.

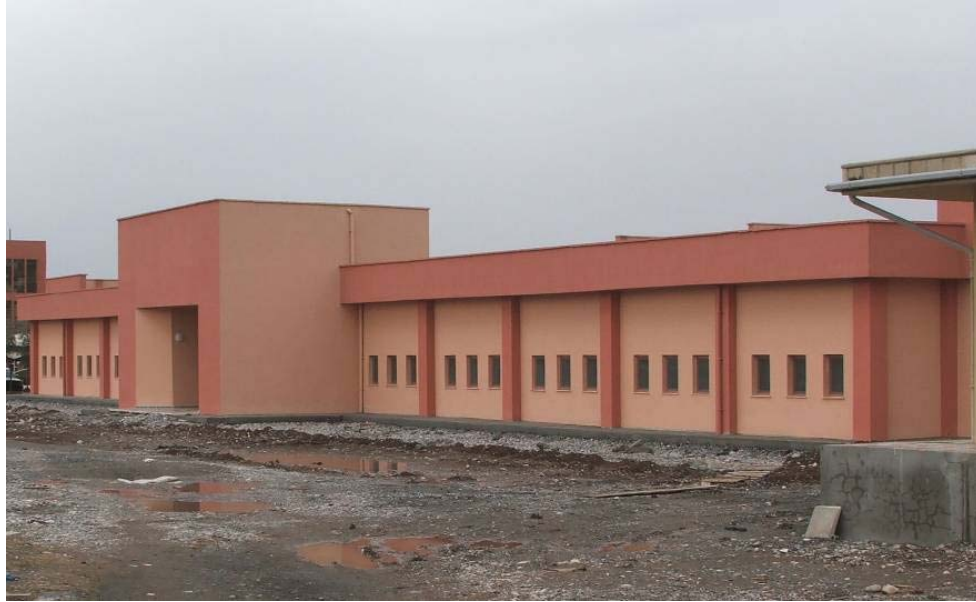
**Site Photo 12. Exterior view of the headquarters building**

The architectural style of the headquarters building is similar to the barracks. As shown in Site Photo 12, the structural concrete frame of the headquarters building was infilled with concrete block walls and covered with a painted cement-stucco finish. The color scheme of the headquarters building matched the exterior color scheme of the barracks, as well as the two dining facilities and the training building.

The completed construction of the headquarters building met the requirements of the Task Order. There were no noticeable defects in the interior finishes and with the exterior of the building, including the roof.

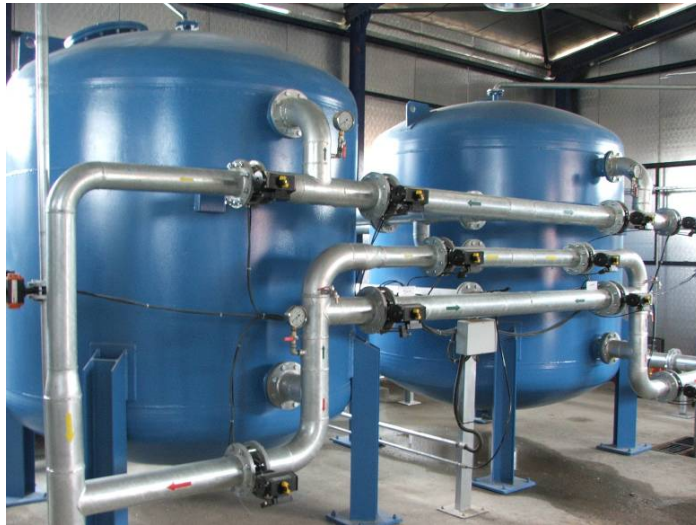
**Site Photo 15. Tanks enclosing the 15 micron filters**

At the time of our assessment, the construction of the WTP was complete and all equipment installed. The pumps, filtration units, and RO units were housed in a pre-engineered metal building constructed by the contractor. Site Photo 15 shows the tanks containing the 15 micron (quartz sand/anthracite/activated carbon) filter system and Site Photo 16 shows the pressure vessels containing the RO thin film membrane elements.

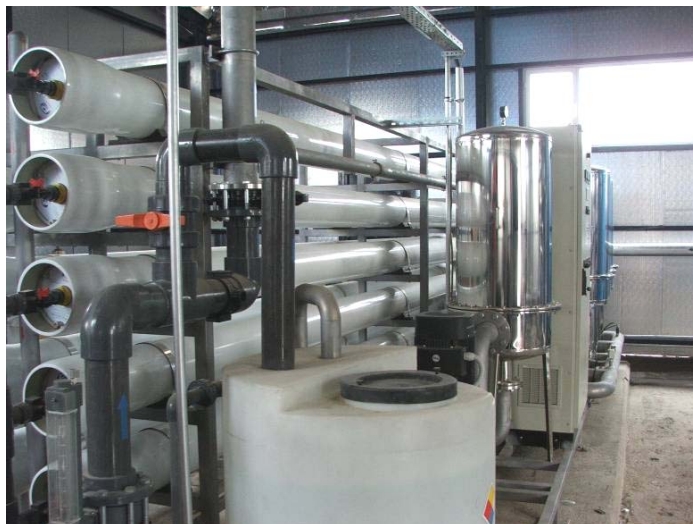
**Site Photo 16. Reverse osmosis purification units**

Although the WTP components were in place and interconnected according to the design and specifications, the treatment plant was not yet operating. The commissioning and start-up of the WTP, as well as the new wastewater treatment plant (WWTP), were contingent on the completion of electrical power upgrades being made to the academy under a separate USACE contract (W917ER-05-C-

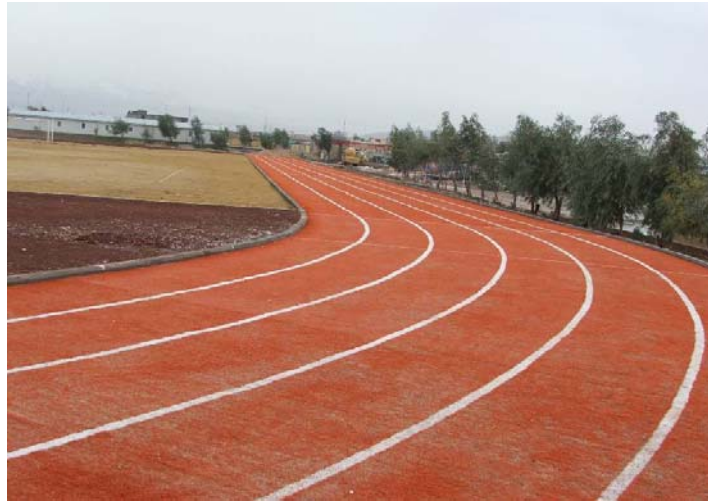
**Site Photo 19. Synthetic track surface on the outside of the soccer field**

The track and soccer field construction was completed and turned over to the military academy in December 2005. When we toured the area and checked the track, we did not find any problems associated with the construction. The track was level, marked properly with stripped lanes, and free of bumps, rips, or other defects in the surface. Site Photo 19 shows the track and one half of the soccer field.

The soccer field was sodded in September 2005 and appeared to drain well. There was no standing water. The grass was dormant because of the colder winter weather in Zakho, but a review of QAR's progress photos indicate the sod was placed properly and irrigated prior to the winter months.
