OFFICE OF THE SPECIAL INSPECTOR GENERAL FOR IRAQ RECONSTRUCTION

CRITICAL CARE UNIT IBN AL BITAR HOSPITAL BAGHDAD, IRAQ

> SIGIR-PA-06-066 SEPTEMBER 12, 2006

SUBJECT: Report on Project Assessment of the Critical Care Unit at the Ibn Al Hospital, Baghdad Iraq (Report Number SIGIR-PA-06-066)

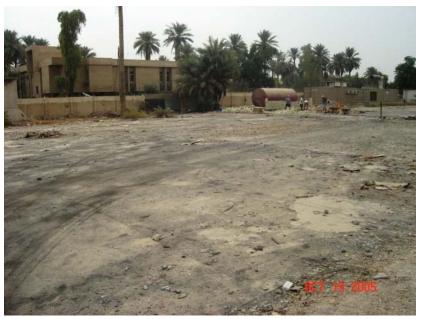
The description of the facility (pre-construction) was based on information obtained from the contract SOW and the USACE project file. The project site, located within the grounds of the Ibn Al Bitar Cardiac Hospital, in Baghdad, Iraq, was also the location of the previous CCU. The looters, who completely destroyed the previous CCU, left nothing standing with only the concrete foundation and ground floor concrete slab remaining. Site Photo 1 shows the clinic site and parts of the ground floor concrete slab.

Site Photo 1. Old and new site of the Ibn Al Bitar Hospital Cardiac Care Unit (Photo provided by USACE)

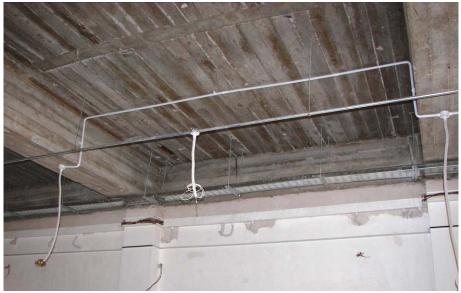
At the time of the site visit, the suspended ceiling had not been completely installed so the assessment team could see the upper portions of the ground floor columns and beams. We did not observe any noticeable defects with the concrete workmanship such as honeycombing, segregation, or exposed reinforcing steel. Site Photo 4 shows some of the structural concrete work at the CCU.

Site Photo 4. Structural concrete supporting the first floor

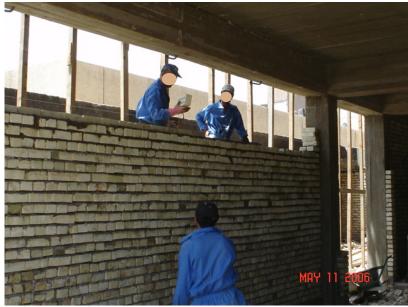
The BOQ listed a requirement to use clay bricks for the ground floor walls. The design required a wall thickness of 24 cm for the exterior and interior walls, except the public bathrooms, which were required to be 12 cm thick. The design required the exterior walls to be plastered with a cement mortar and rendered with a textured finish. The surface finish requirement for interior walls included gypsum plastering and painting. Based on a review of the Quality Assurance reports, it appears the contractor adequately constructed the brick interior and exterior walls to meet the design requirements. Site Photo 5 shows an example of the brick work prior to plastering and Site Photo 6 shows one side of the CCU after the walls were plastered and rendered.

Site Photo 5. Exterior wall brick work (Photo provided by USACE)

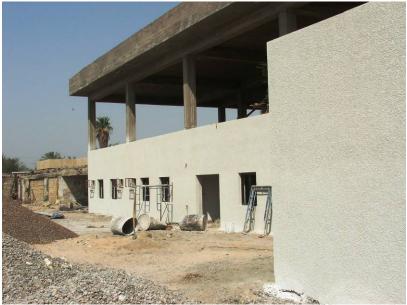
Site Photo 6. Exterior walls of the CCU after plastering and rendering.

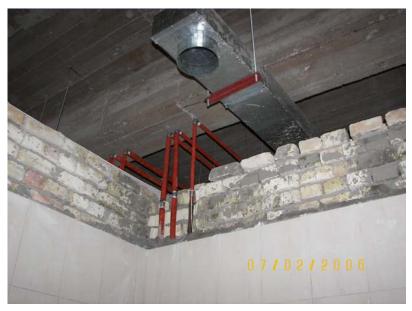
At the time of the assessment, the patient room walls had been plastered and painted. The contractor had also completed the installation of ceramic tile on the bathroom walls. The flooring and ceilings were not yet installed in any of the patient rooms including the bathrooms. Window frames were in place, but the glass was not yet installed. The frame for the window HVAC unit was in place, but the unit was not yet installed. The contractor was in the process of installing door frames. The contractor also began to rough-in plumbing for the toilets, wash basins, and showers. Site Photos 7 and 8 show the ongoing construction in one of the patient rooms. Site Photo 9 shows the above ceiling water lines and exhaust system ductwork for one of the bathrooms.

Site Photo 9. Water lines and exhaust system ductwork above one of the patient bathrooms

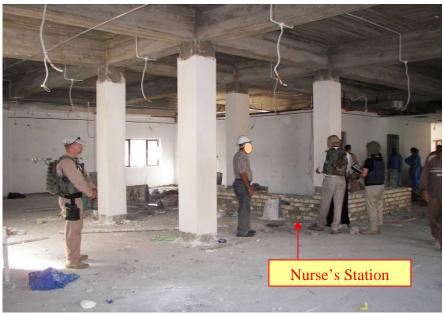
At the time of our assessment, the contractor had completed plastering and painting the exterior walls. Aluminum window frames were installed. Electrical conduits were in place, and the contractor was in the process of pulling wire to recessed boxes for outlets and switches. Site Photo 10 shows part of the open ward observed during the site visit.

Site Photo 10. Ward area under construction.

In addition to the building components, the contractor was also constructing a brick reception table base (Site Photo 10) for the nurse's station in the open ward area. The BOQ required a ceramic tile finish for the table.

Based on our observations, the work to date in the ward area appeared to meet the standards of the design.

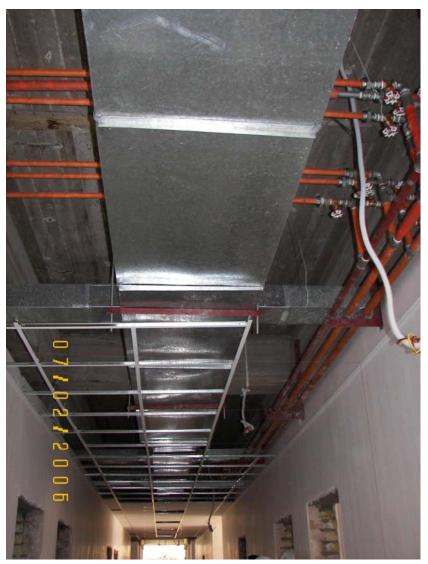
The CCU contained a central corridor (21.6 m in length) providing access to the patient rooms and the ward area. The corridor also provided an access way for the utilities (water, exhaust, and electric), located above the suspended ceiling. Site Photo 11 shows the water lines, the exhaust system ductwork, and the electrical drops installed by the contractor, as well as part of the suspended ceiling grid. The water supply system consists of three lines of various diameters [15 – 50 millimeters (mm)] of schedule 40 galvanized steel pipes for cold water, hot water, and recirculated hot water. No noticeable defects were found with the installation of these utilities and the quality of workmanship appeared adequate.

Site Photo 11. Utility installation above corridor suspended ceiling.

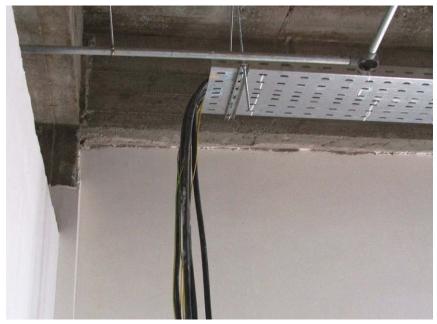
The design included an interior electric room. However, the electrical drawings provided to the assessment team did not show the location of the main electrical distribution panel and two sub-distribution panels that were listed in the BOQ. When we inspected the electrical room, the walls in the room were plastered and painted. The aluminum cable tray was installed and anchored to the concrete slab above the room. One of the contractor's employees indicated to us the location of the main distribution panel inside the electrical room. The contractor was running cable on the cable tray to the panel location as shown in Site Photo 12.

Site Photo 12. Cable tray and cable to connect the main distribution panel.

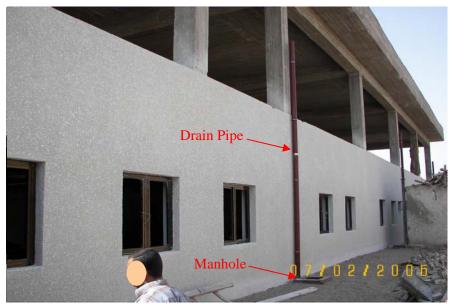
The BOQ listed a requirement for 80 linear meters of 100 mm (diameter) cast iron downspouts. The architectural drawings show the location of the seven roof drains along the column lines for the building. During the exterior inspection, we observed the cast iron downspouts in the locations noted on the design along the column line. We also noted the downspouts drained directly into the manholes, as shown in Site Photo 13, although the design drawings did not provide details showing the downspouts or connections into manholes.

Site Photo 13. CCU exterior with downspout feeding into sewer manhole.

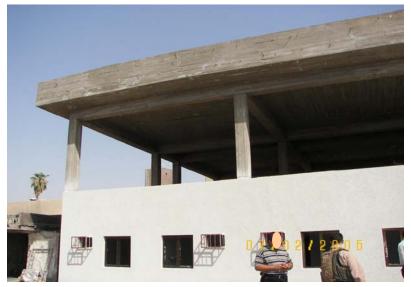
The assessment team planned to inspect the first floor and roof. However, because of recent activity in this area of Baghdad, security concerns prevented the team from going up to the first floor and to the roof. From the ground, we did walk around the building and looked at the exterior columns and beams of the first floor and roof parapet. We did not observe any noticeable defects associated with the concrete workmanship. Site Photo 14 shows the first floor and roof structural concrete work.

Site Photo 14. First floor columns and beams supporting roof
