## **Mechanical Response of Titanium Aluminide (TiAl<sub>3</sub>)**

**ARL-CR-0669**

**June 2010**

**Dynamic Science, Inc.  
1003 Old Philadelphia Rd., Suite 210  
Aberdeen, MD 21001**

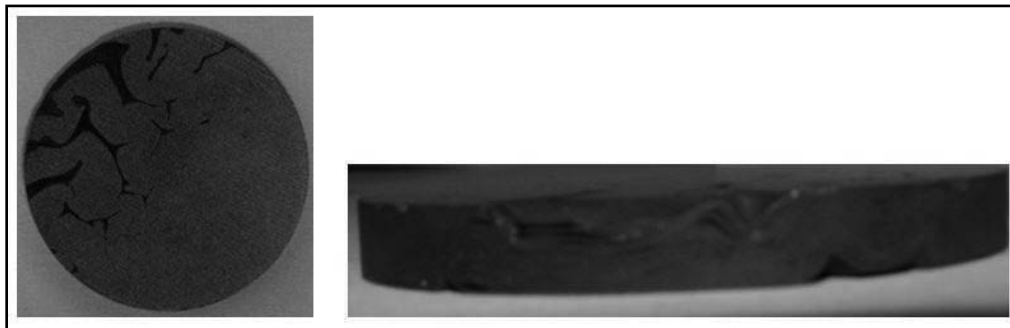
Figure 1. Photos of specimens used for ultrasound measurements.

Using a buoyancy method the density of the  $\text{TiAl}_3$  was found to be  $3282 \text{ kg/m}^3$ . The longitudinal and shear wave speeds were found using an ultrasonic pulse echo technique; for an example, see Bartkowski and Spletzer (2001). The wave speeds and elastic constants calculated from these values are reported in table 1. There was a significant amount of variation in the measurements due to specimen quality. The first and second pictures in figure 1 show surface flaws and incomplete layer bonding, respectively. The presence of these defects in the specimens negatively affected wave propagation through the material and caused variation in the data. Values for the highest quality specimen (#2, not pictured) were used for calculations found later in this report.

Specimens for the compression tests did not contain the obvious defects seen in figure 1, however, some surface irregularities (non-smoothness) were easily detectable with the naked eye. Unfortunately defects of this nature can serve as nucleation sites for fracture and affect the results discussed below.

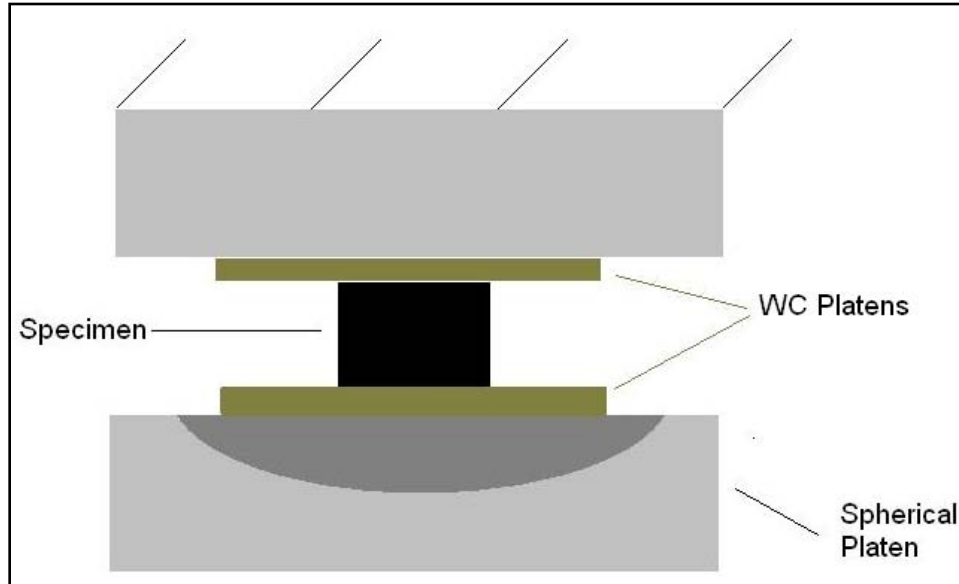
Figure 2. View of test setup with spherical platens.

Brittle materials can also be sensitive to non-centric loading due to non-parallel platens or even from their own loading surfaces. Three techniques were used to mitigate these issues. To eliminate any initial “settling” that was contributing to irregularities in the data some samples were loaded twice. In the table the notation “a” denotes a test where the specimen was loaded to a point below the yield stress and released. The “b” notation refers to the experiment in which the same specimen was compressed to failure. To deal with possible specimen irregularities, the loading faces of specimens 6–10 were finished (600 grit) with an Allied Techprep polisher, a machine designed for precise parallel polishing. Finally, specimens 7–10 were loaded with a spherically articulating platen in line with the load cell. This platen rotates slightly to minimize effects due to non-parallel load faces of either the specimen or the machine. A sketch of this test setup is shown in figure 2.

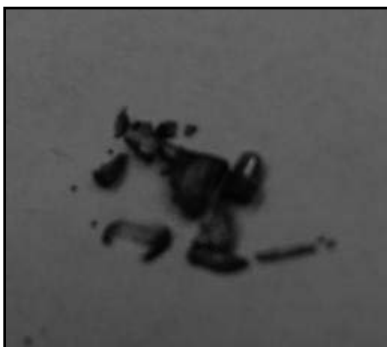
Figure 3. Typical failed low rate specimen.

As discussed above, most of the experiments were not well-suited to measure stress-strain curves and only the failure stress. All of the specimens failed catastrophically with little noticeable plastic deformation, see for example the recovered specimen in figure 3. This sort of behavior is typical of ceramic-like materials. Also, because of its low ductility, it is reasonable to assume  $\text{TiAl}_3$  to be linear elastic to failure ( $\sigma = E\epsilon$ ). To evaluate the accuracy of this assumption the stress-strain curves shown below include the assumed linear elastic curve with slope equal to the measured elastic modulus from table 1.

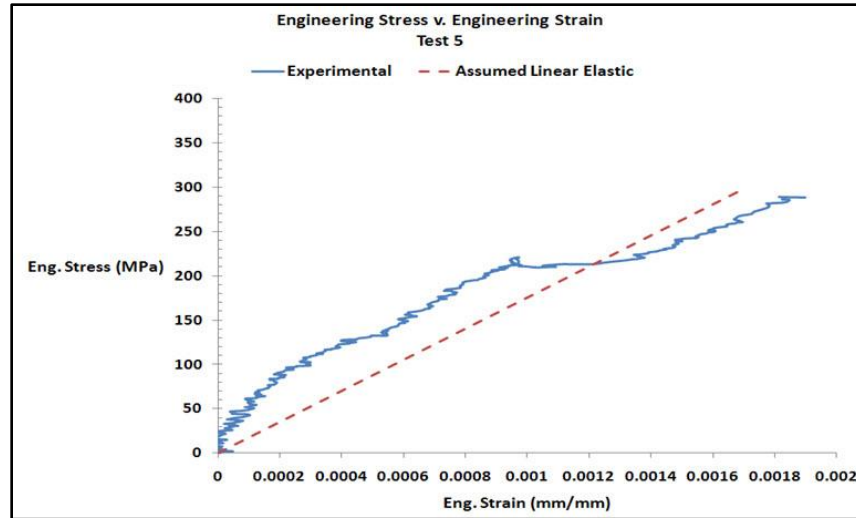
Figure 4 shows the stress-strain curve from Test #5. Specimen strain is measured with a strain gage mounted on the specimen. In light of the error associated with the small strain measurements the data is in good agreement with the assumed elastic modulus. It is noteworthy that at 230 MPa it appears as though the material begins to yield. It is unclear whether this portion of the graph represents actual material behavior or is the result of gage error. This specimen failed at a stress of 300 MPa, i.e., the strain gage survived the entire test.

Figure 4. Stress–Strain curves calculated from strain gage data and theoretical linear elastic behavior based on ultrasound measurements.

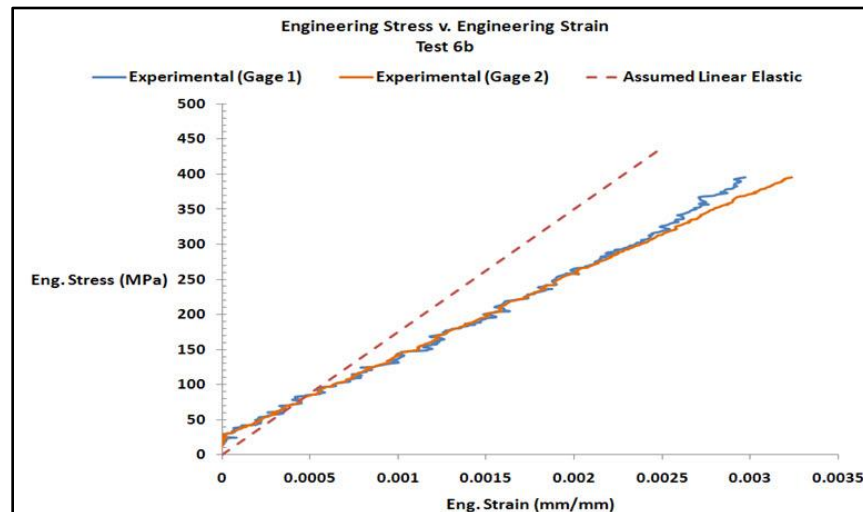
The results from Test 6b are shown in figure 5. Two strain gages were bonded to this specimen, diametrically opposed and oriented to measure longitudinal strain. The figure only shows the material response up to gage failure. During Test 6a, the initial loading of this specimen, not pictured) the gages did not measure identical strains, indicating some non-centric loading that was reduced as a result of the preloading. The elastic modulus from the data in figure 5 is approximately 131 GPa, about one quarter less than the value measured from ultrasound. It is, however, strongly linear.

Figure 5. Stress–Strain curve for pre-loaded specimen compared to theoretical linear elastic curve.

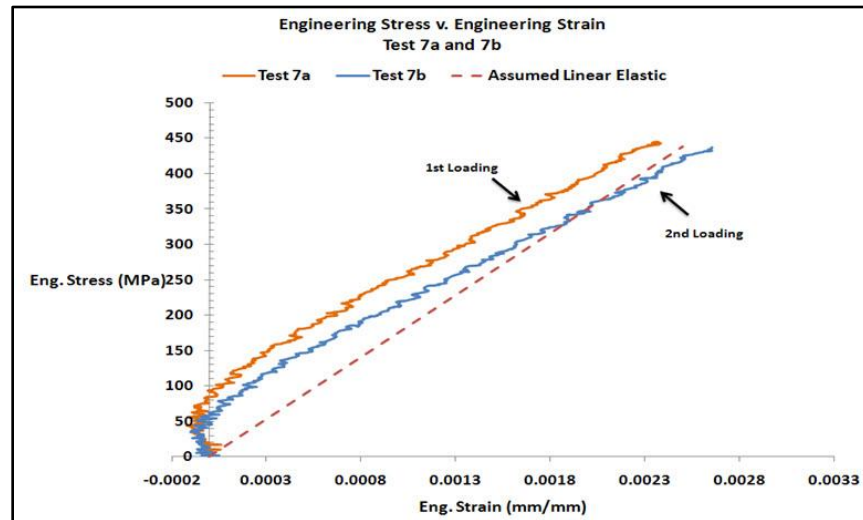
Tests 7a and 7b repeated the previous experiment, but incorporated a spherical platen. The results are shown in figure 6. The data suggests that an initial stress of 50 MPa was attained before the specimen began to compress, but this is attributed to measurement error rather than

actual material behavior. The specimen response was linear in both tests and was reasonably close the linear elastic line. This setup was used to conduct several more experiments, and yielded somewhat inconsistent results due to specimen variation.

Figure 6. Stress–Strain curves for Tests 7a and 7b incorporating spherical platen.

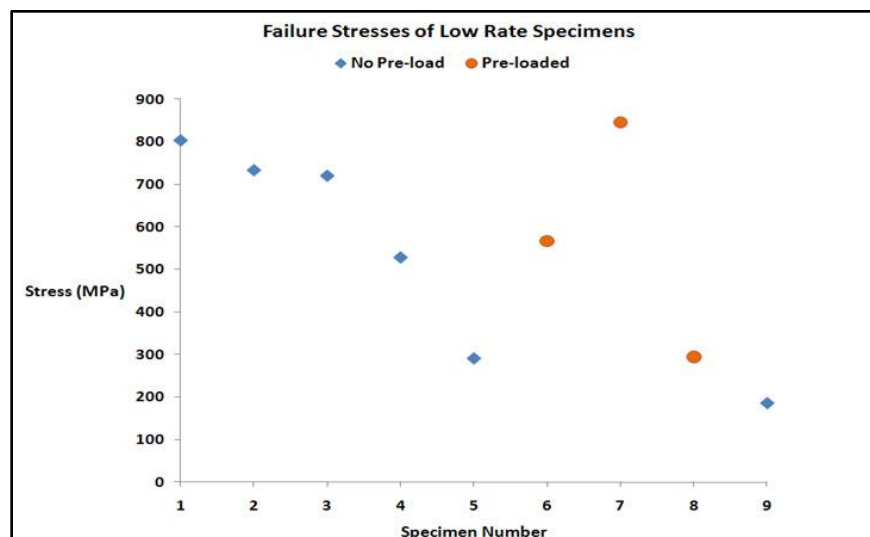
The failure stresses for each of the low rate experiments are reported in figure 7, and the strain rates can be found in table 3. As expected, there was difficulty pinpointing a single failure stress for the material as illustrated by the scatter in the graph. Despite incorporating a spherically articulating platen and sanding specimens the variation persisted. Defects in the specimens arising from the manufacturing process are suspected to be the cause of the scatter.

Figure 7. Failure stresses of low rate specimens.

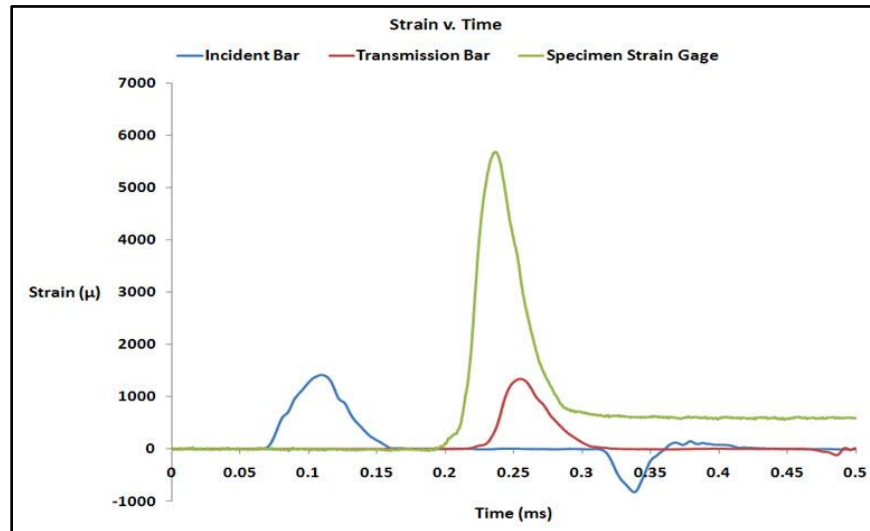
Figure 8 shows representative time dependent strain signals from one of the SHPB tests. The red and blue curves are the strain pulses that occur in the incident and transmission bars, respectively. The incident pulse is triangular due to the copper wave shaper that was placed on the impact end of the bar. Using the shaper allowed specimens to be tested at a constant strain rate and reduced wave dispersion in the bars. The green curve represents the data acquired from the strain gage on the specimen. The gage data shows that in this test the specimen was compressed at a roughly constant rate to approximately 6000 micro-strain, at which point it began to unload. The signal does not return to zero because some plastic strain was experienced.

Figure 8. Strain signals from SHPB test.

A stress strain curve was calculated from the signals in figure 8 and is shown in figure 9. The specimen used in this experiment was tested at a strain rate of approximately 400/s and did not fail. The specimen was loaded to approximately 900 MPa, experienced very little plastic strain, and then was unloaded. There is a strong agreement between the experimental data and the assumed linear elastic behavior. This provides some validation of the modulus of elasticity calculated from the ultrasound measurements and indicates that the strain gage data accurately measures real material behavior.

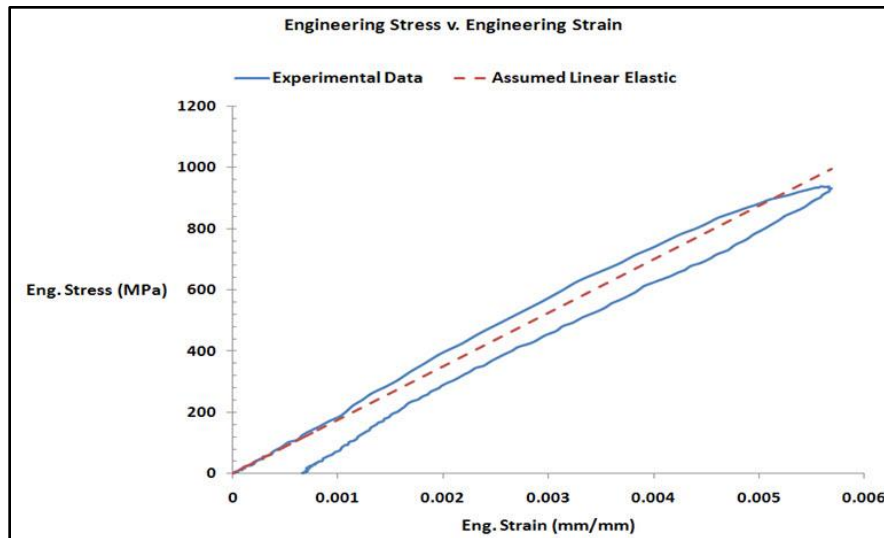
Figure 9. Stress–Strain curve from the third SHPB test. Strain is measured with a strain-gage mounted directly on the specimen.

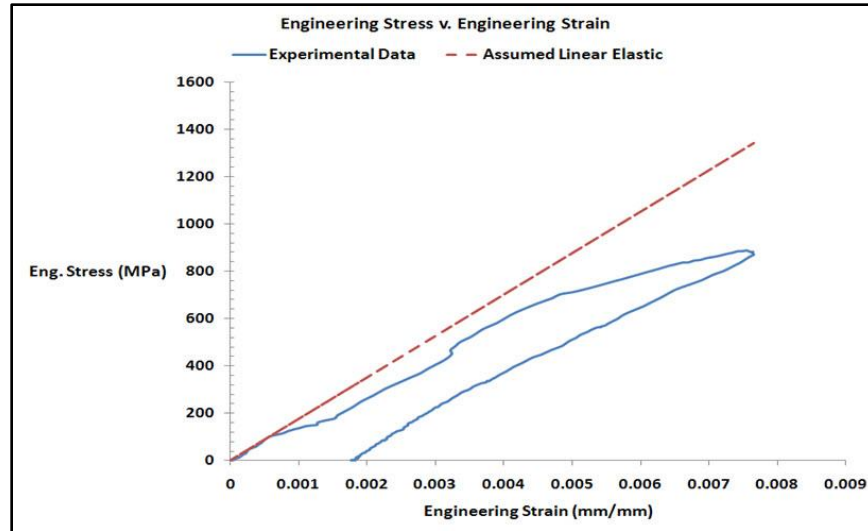
The results from the fourth SHPB test are shown in figure 10. As in the previous test, initially the experimental stress strain curve strongly agrees with the theoretical calculation, but the values begin to differ at approximately 200 MPa. The slope of the experimental data still closely follows that of the assumed elastic behavior, particularly during elastic unloading.

Figure 10. Stress–Strain curve from the fourth SHPB test. Strain is measured with a strain-gage mounted directly on the specimen.

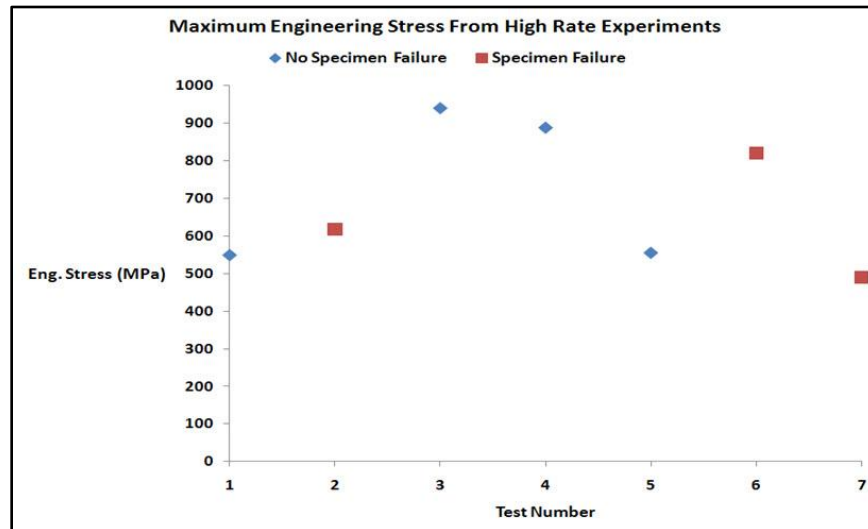
Figure 11 shows the maximum engineering stresses for the SHPB tests. As was the case with the low rate experiments it was difficult to find an exact failure stress for the material. Whereas all the specimens tested at low rates failed, this was not the case for the high rate experiments. Maximum stresses are reported in figure 11 for samples that did not fail because they represent lower bounds for failure stresses. Table 4 lists the strain rates from the high rate experiments for which data was available. The dynamic nature of the tests combined with the brittleness of the material made it difficult to obtain accurate strain rate estimates for every test.

Figure 11. Blue points represent maximum stress for specimens that did not fail and represent lower bounds for failure stresses. Red points are failure stresses for specimens that did fail.
