# **U.S. Army Engineer Research and Development Center: Rapid Repair of Levee Breaches**

SERRI Project: Rapid Repair of Levee Breaches

**U.S. ARMY ENGINEER RESEARCH AND DEVELOPMENT CENTER:  
RAPID REPAIR OF LEVEE BREACHES**

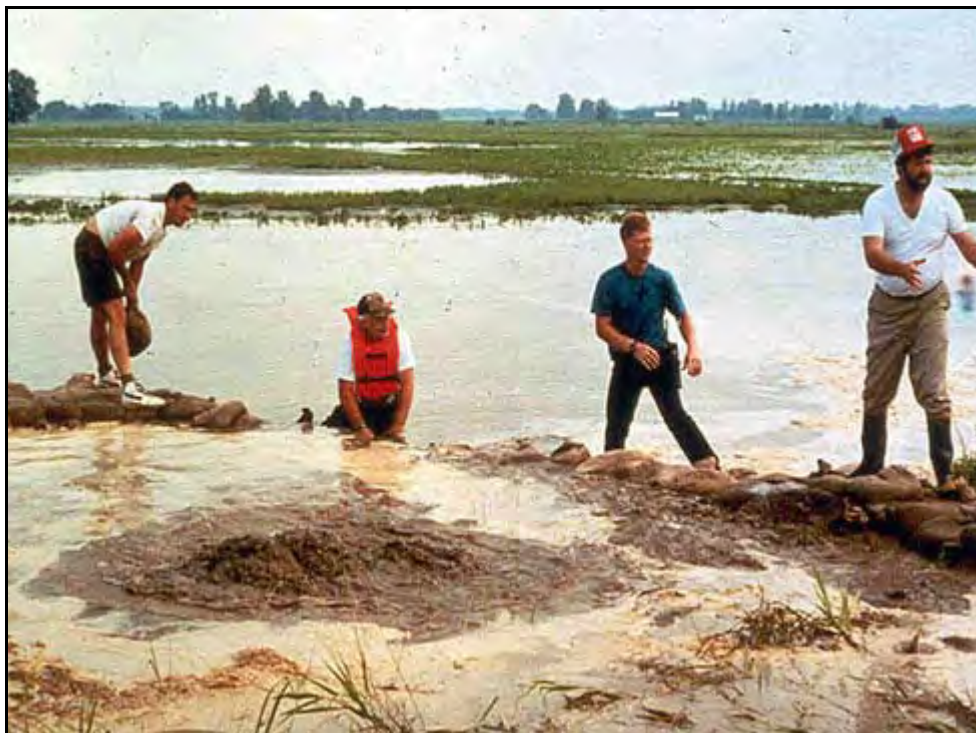
**Figure 2.13. Sand bag levee around sand boil on Kaskaskia River.**

Figure 2.13 shows a ring levee of sand bags around a sand boil on the Kaskaskia River levee. Ring levees are one of the existing rapid repair techniques that have been used for many years with great success. Ring levees are placed only to the level that stops movement of sediment with the water. If placed to a greater height to stop flow, the increased head will likely result in the piping connection blowing out somewhere else. Before this picture was taken, the ring levee had reduced the flow and stopped the movement of solid material. Suddenly the levee foundation material started moving again as shown in the figure. Efforts to further raise the sand bag levee and stop the material movement were unsuccessful and the full breach formed as shown in Figure 2.14.

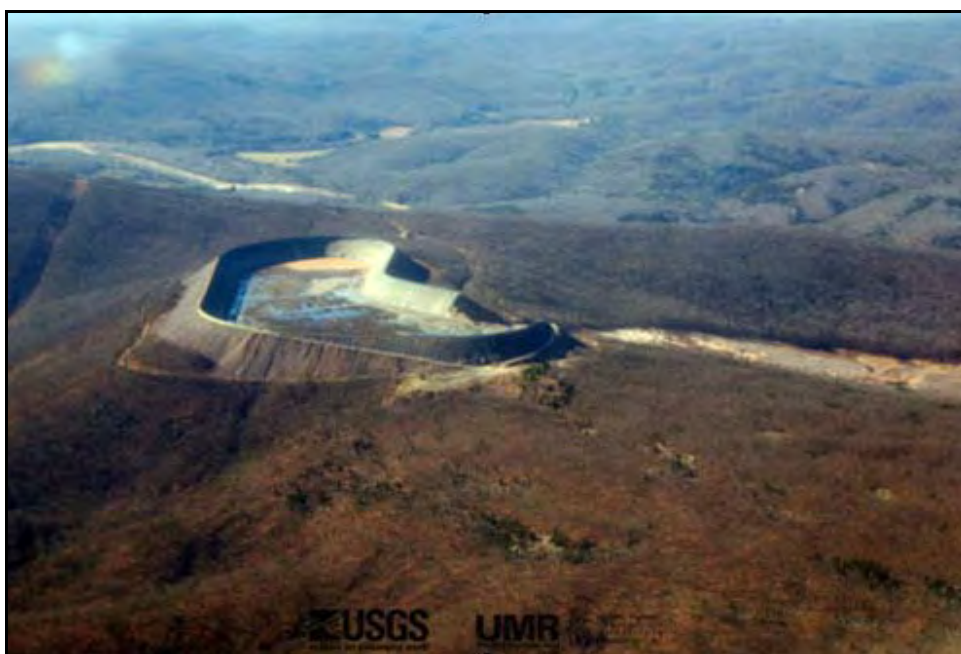
**Figure 2.17. Aerial photo of the Taum Sauk Upper Reservoir just after breach in December 2005.**

Normally a breach forms slowly by overtopping, scouring, or piping; but that is not always the case as exemplified by the failure of the Taum Sauk Upper Dam, Missouri, in December of 2005. Figure 2.17 shows a general view of the Taum Sauk Upper Reservoir near Ironton, Missouri, just after the breach.

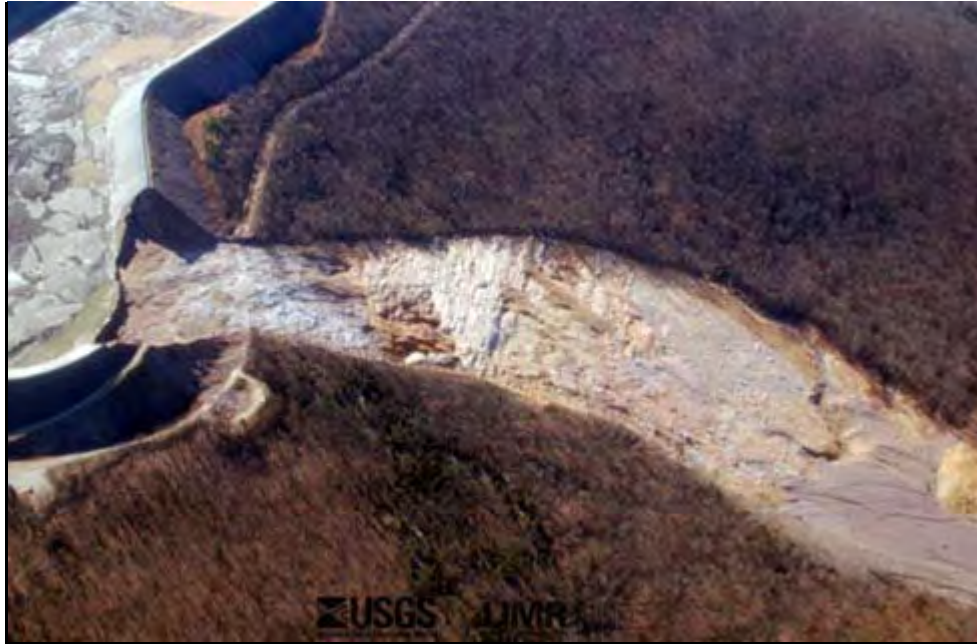
**Figure 2.18. View of emptied lake and vicinity.**

Figure 2.18 shows a closer view of the emptied lake and breach vicinity. In this case the lake wall was overtopped and also suspected of being undermined by seepage. When it collapsed, the lake was emptied in a matter of 12 to 15 min. It is suspected that the 17th Street breach in New Orleans failed catastrophically after some initial period of overtopping as well. Knowing that such documented cases exist, for this study a worst case scenario was considered as an instantaneous removal of the levee wall, allowing flow to cascade out of the breach.

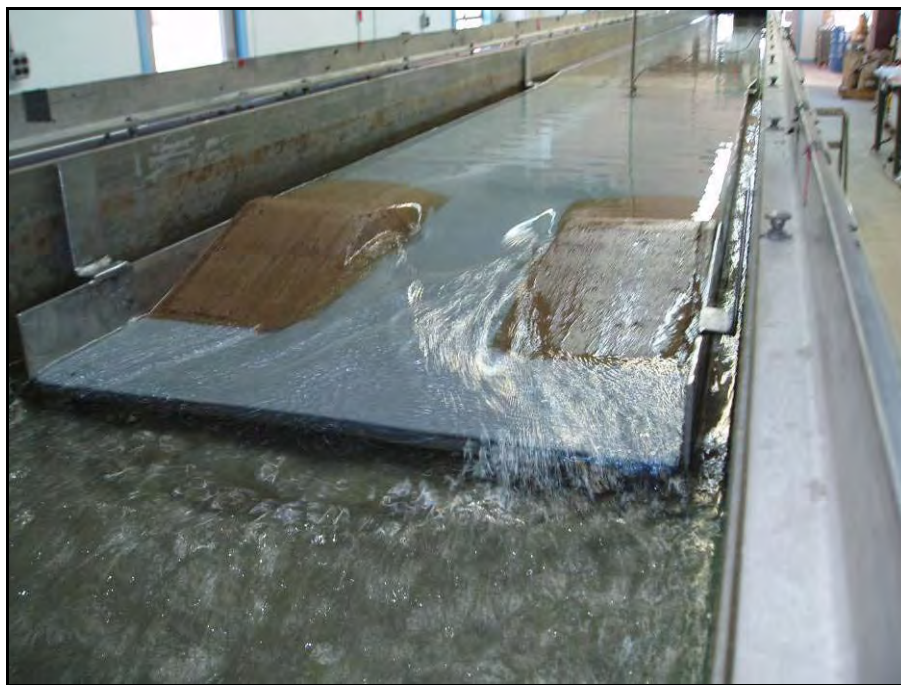
**Figure 2.25. Photo of flow through small-scale (1 : 50) breach.**

An 80 ft long tilting flume was used to provide a simulated levee breach and flow for testing the various closure methods discussed above. The flume cross section is 3 ft wide and 1 ft deep. The facility has pumps that can supply up to 5.5 ft<sup>3</sup>/s of flow capacity. To maintain a constant water level during the closure tests, a special side-weir-overflow device was constructed to fit within the flume. A simulated levee was constructed separately but made to fit exactly within the confines of this overflow device. The flume, overflow device, and simulated levee are all shown in Figure 2.25.

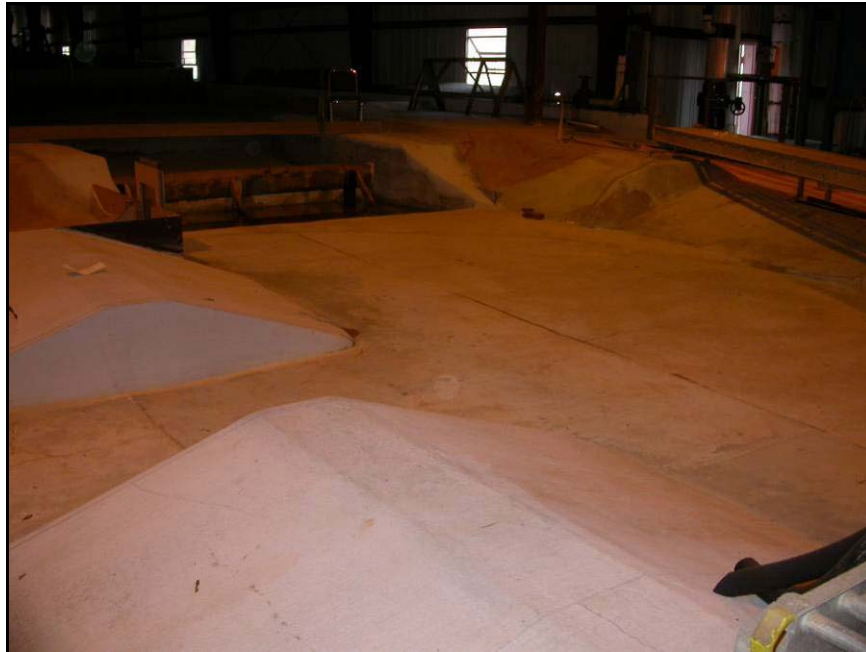
**Figure 2.31. Test basin for 1 : 16 scale physical model tests.**

During the early phase of this project we investigated a wide range of ideas of potential value to rapid levee repair; but many of those ideas were soon recognized as either impractical or beyond the state of the science that exists today. We knew that we could not continue to devote extensive amounts of time to all of these different ideas and still meet our specified timelines for large-scale demonstrations. To assist us with our down-selection, we knew that it would be extremely useful to have a physical basin that was substantially larger than the 1 : 50 scale flume described previously in this report. An existing physical model facility within ERDC was identified as having the best potential for providing a suitable basin for such testing of RRLB concepts. This basin was modified from its initial purpose to provide a flow capacity consistent with a 1 : 16 scale along a levee section (Figure 2.31). The model levee was constructed at an undistorted scale and represents a levee with a crest elevation of 20 ft (note: all dimensions are reported in prototype scale unless otherwise stated), side slopes on both faces of 1 : 3 (vertical : horizontal), and a crest width of 16 ft. The breach was 80 ft wide with 2 : 1 side slopes the full depth of the levee. Both the model basin and the levee were constructed of a concrete cap poured over a sand fill with inset aluminum templates to ensure the accuracy of the bathymetry and topography.

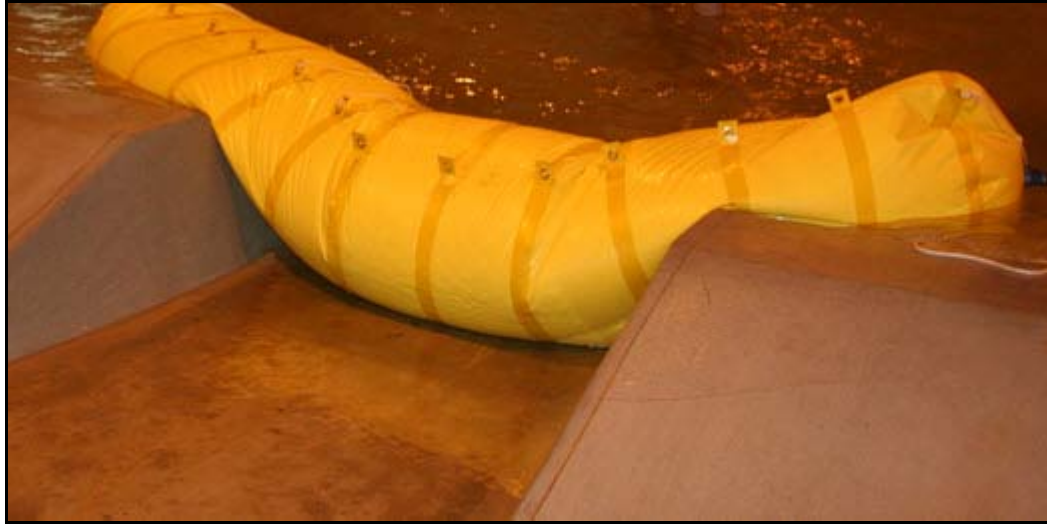
**Figure 2.35. Deep-breach closure with large tube filled to 60% fill volume.**

As noted earlier in this chapter, the breach tested in our model basin provided a substantial challenge because it represented an opening that was 18.5 ft deep and 80 ft wide. The primary successful tests of note for sealing this breach in the 1 : 16 basin involved variations with a single tube that would have a prototype length of 195 ft. Once we learned that the volume fill proportion for this tube could not be much less than 60%, essentially all tests managed to close all or close to all of the flow through the breach. Figure 2.35 shows a typical result obtained for a tube filled to a 60% capacity. As can be seen here, the performance is quite remarkable, with very little water passing through the breach after emplacement of the tube.

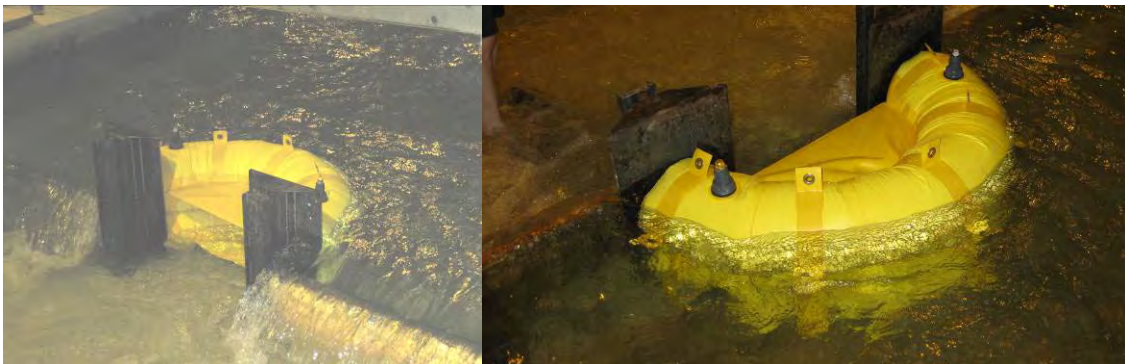
**Figure 3.1. Successful laboratory tests of a two-arch system for blocking flow through a simulated “gate” opening.** Actual distance spanned by the ARCH in these tests is about 1.5 ft.

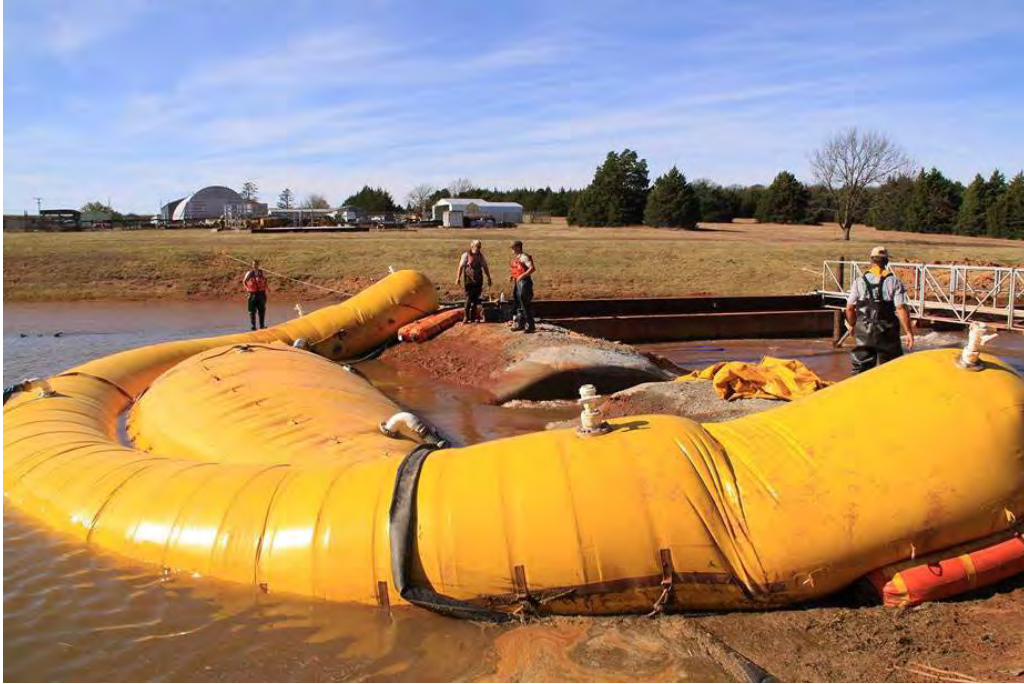
**Figure 3.4. Test of the modified ARCH system at Stillwater, Oklahoma, in November 2009.** The ballast tank seen behind the apex of the ARCH improved its ability to resist deformation under very high water levels.

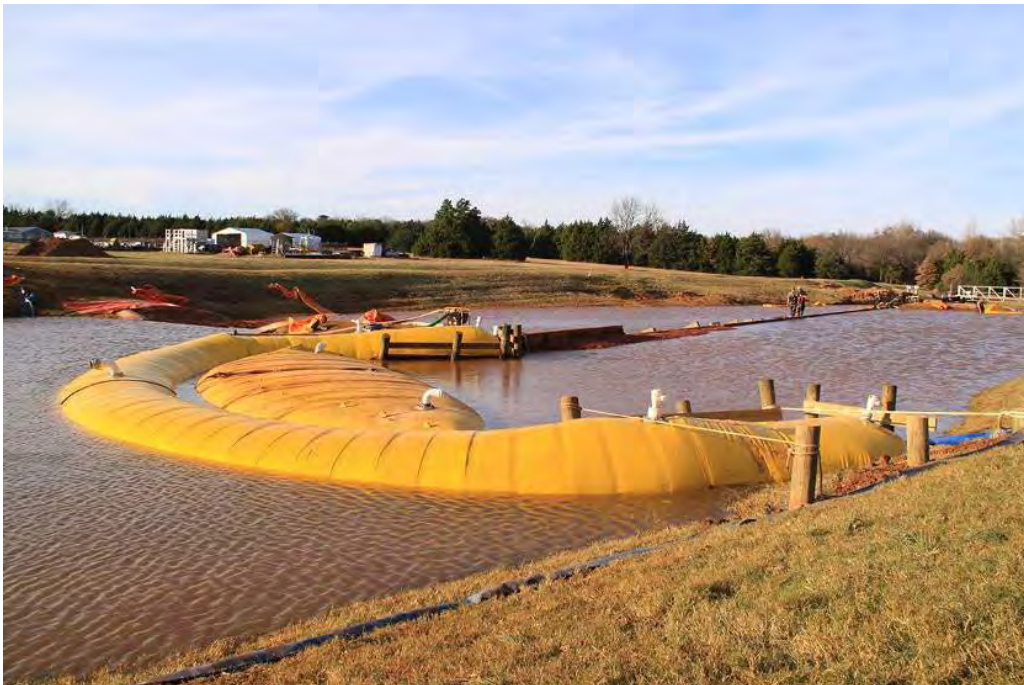
**Figure 3.5. Test of the modified ARCH at Stillwater, Oklahoma, in November 2009** showing its ability to block water from flowing into a channel about 40 ft wide with a water depth of about 4 ft.

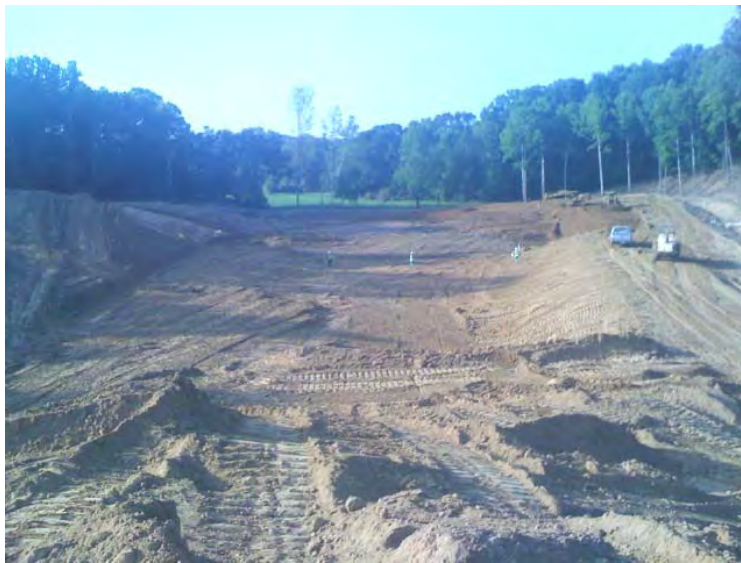
**Figure 4.1. Early stage of construction July 2010.**

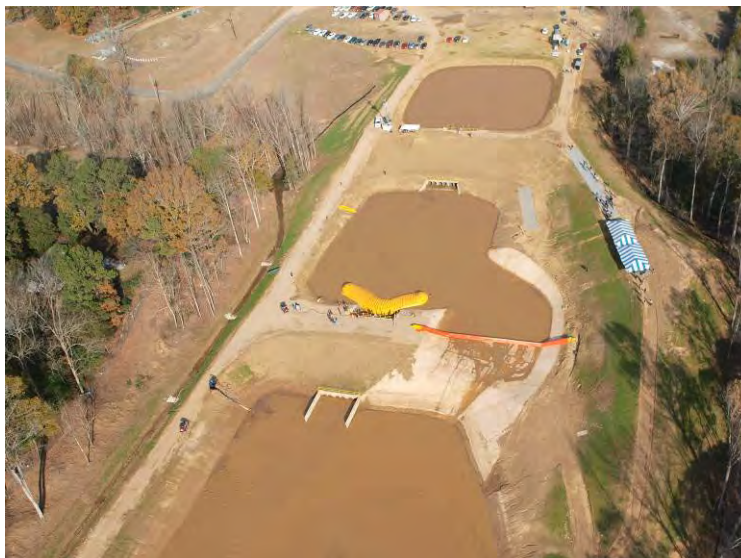
**Figure 4.2. Aerial photograph of full-scale test basin, December 15, 2010.**

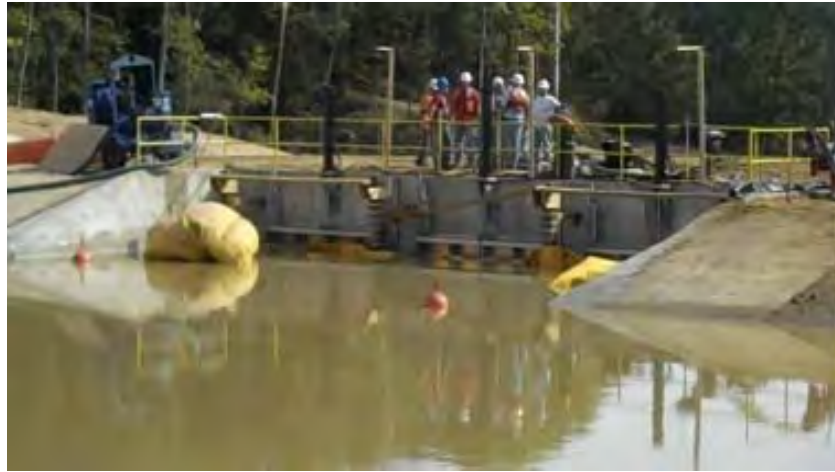
**Figure 4.3. First PLUG test culminated in a failure, with substantial damage to the gate protection system and tears to the PLUG.**
