**STRUCTURAL HEALTH MONITORING OF M114 HIGH MOBILITY
MULTIPURPOSE WHEELED VEHICLE ARMOR SYSTEM**

THESIS

FRANK T.J. SHA, CAPTAIN, USAF

AFIT/GEM/ENV/12-M19

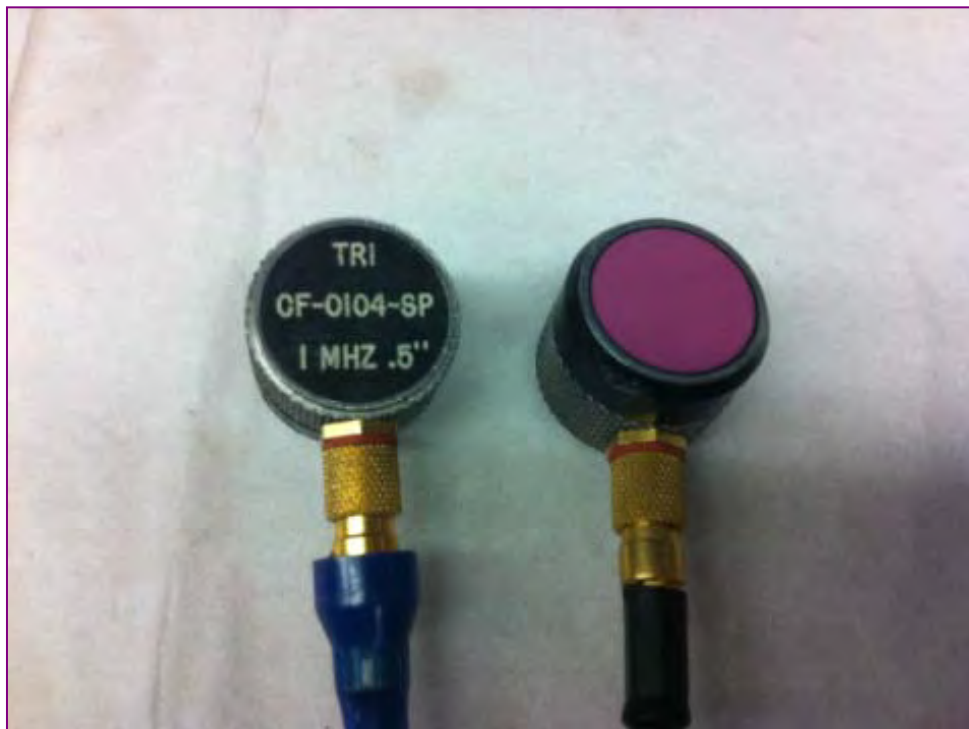
Figure 2.5. PZT Sensor used to Induce and Collect Wave Propagation

Lead zirconate titanate also referred to as PZT, these sensors are used to induce and receive ultrasonic Lamb waves, see Figure 2.5. PZT materials exhibit an effect whereby they expand or contract in the presence of an applied electrical field (Gautschi, 2002). The electrical source can be a waveform generator like the one on Figure 2.6. The propagated waves received by the PZT sensor will be outputted to the oscilloscope to collect data, see Figure 2.7.

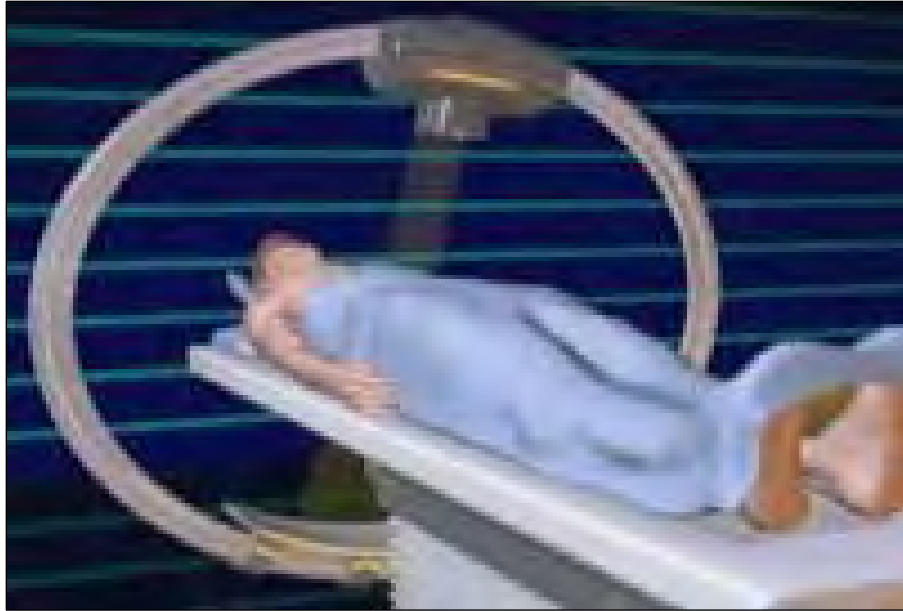
Figure 2.9. X-Ray Images Taken Around a Single Axis Rotation to Create a Three-Dimensional Image (Donaldson, 2010)

Computed tomographic reconstruction has been used in many industries. Since the 1970s, computed tomographic reconstruction has become a crucial tool in the medical industry. Tomographic reconstructions has been used for medical imaging of human internal organs and bone structures using conventional x-ray tomography, where the X-ray technician captures images of the body by moving an X-ray source and film in opposite directions during the exposure. Three-dimensional images are created by taking images around a single axis of rotation, see Figure 2.9.

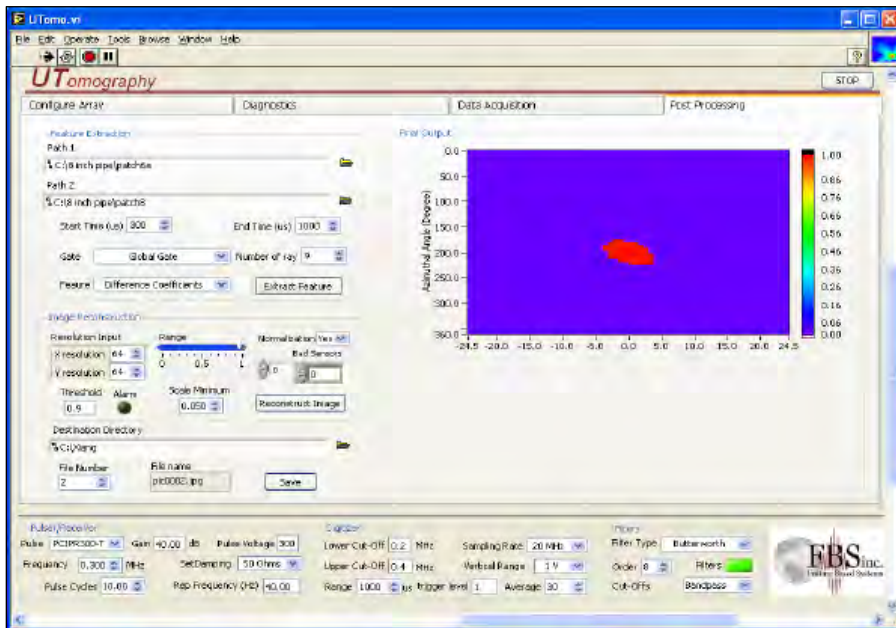
Figure 2.11. CT Image for the 10" Pipeline with Damage (Royer, Velsor & Rose, 2009)

Specific uses of ultrasonic Lamb waves on tomographic reconstruction have been used to monitor the structural integrity of pipelines. On Figure 2.10, PZT sensors are placed to form two vertical arrays around the circumference of a 10” steel pipe (schedule 40) at two different axial positions 48” apart (Royer, Velsor & Rose, 2009). Ultrasonic waves are induced and acquired between the two boundaries using all possible combinations of pitch-catch patterns between inducing and receiving sensor. Preliminary data sets were collected as a baseline data set for an undamaged pipe. Material was removed to form damage and new data sets were collected from the PZT sensors. A tomographic image was reconstructed by comparing the undamaged and damaged data, see Figure 2.11.

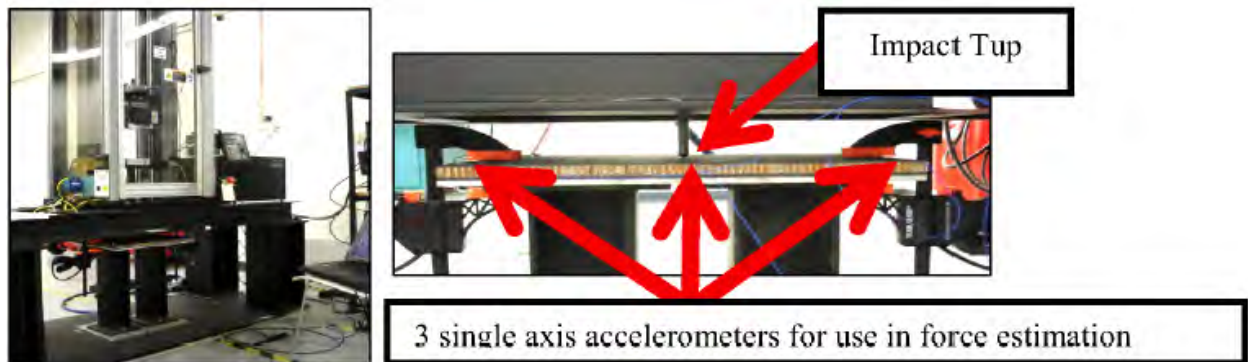
Figure 2.14. Passive Structural Health Monitoring on S-2 Composite Armor

In an experiment conducted by facility of University of Purdue in conjunction with the US Army Research Laboratory, vibration-based structural health monitoring was successfully conducted on one layer S-2 composite system, see Figure 2.14. The researchers were successfully able to passively identify the external force, identify the amount of damage, and quantify damage (Stities, 2007). Damaging impact energy (weighted hammer test) was applied to the test specimens and the passively measured frequency response of the armor was used to produce a dynamic model of the specimen

The researchers were able to correctly identify the location of the impact 93.4% of the time, while 100% identification was produced within a 1” of the actual impact location. Impact identification was done using a single tri-axial accelerometer to calculate the force impact. The major limiting factor of this research is that the impact was completed by dropping 4.5, 5.25, and 6.0 lb. weights on to the S-2 composite. This produced a small amount of damage compared to a .30 AP projectile. It is also limited to single layer sensing instead of two layers.

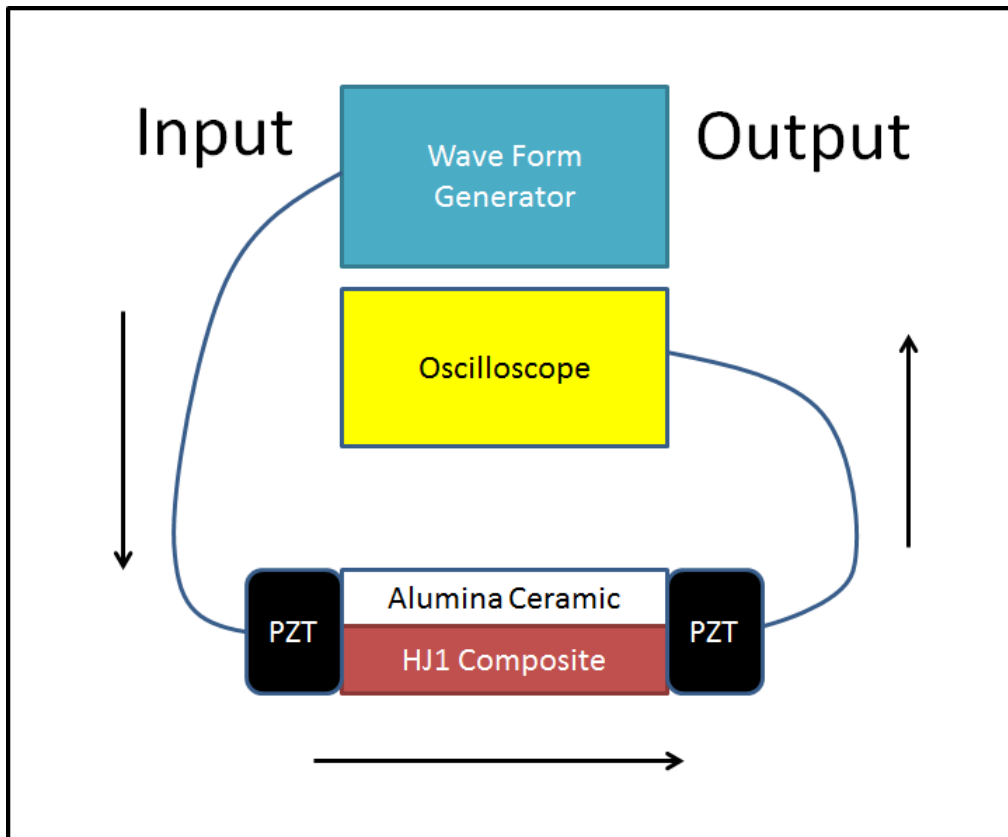
Figure 3.1. Base Line Experimental Setup

The intent of the base line portion of experimentation was to understand the physical characteristics of the material individually and together with and without controlled damage. By conducting base line testing in a laboratory where data can be collected during each step of procedure, it allowed for a controlled and logical understanding of the wave propagation characteristics of the two different materials. This controlled base line portion of the experiment was critical to understanding and simulating the physical changes after the two layer armor system that would have been damaged. The base line portion was to examine how the materials responded to different wave frequencies. Figure 3.1, demonstrates the overall layout of the experimental set up. Bursts of wave propagation are produced from the wave form generator and used as the input wave through the ceramic and composite. The wave propagation output through the ceramic and composite is captured and displayed on the oscilloscope.

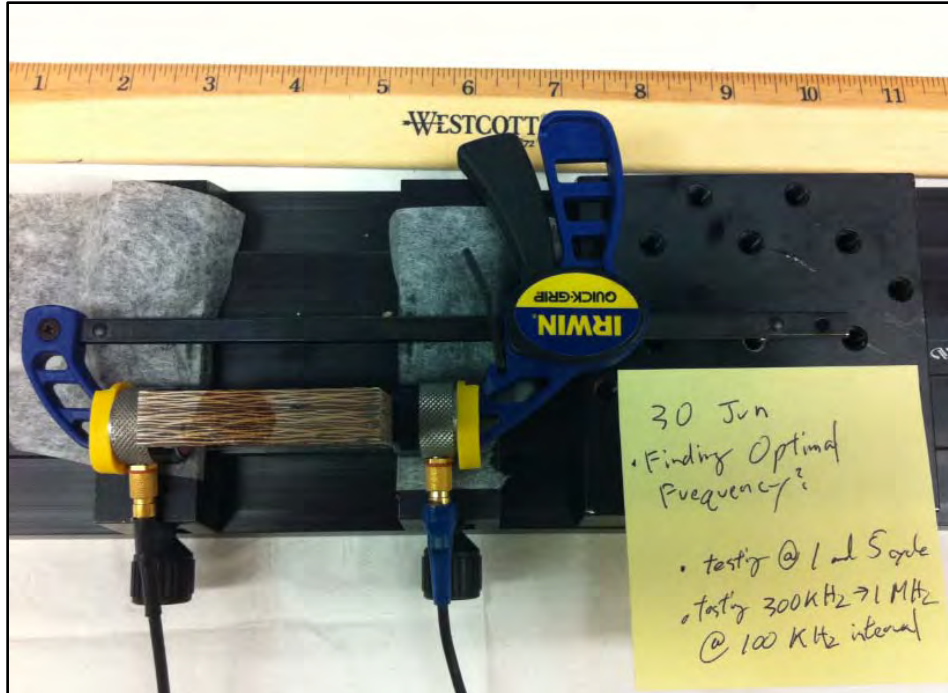
Figure 3.18. Top View of the Composite Coupon on the Mounting Platform with PZT Sensors Clamped on to the Coupon

- I. Place the composite on the secured mounting platform.
- II. Place a PZT sensor on each side of the composite with a small amount of coupling grease.
- III. Ensure that the PZT sensors are placed in a straight line to optimize capturing of the wave propagation data.
- IV. Use the Irwin Quick-Grip to secure the sensors in place.

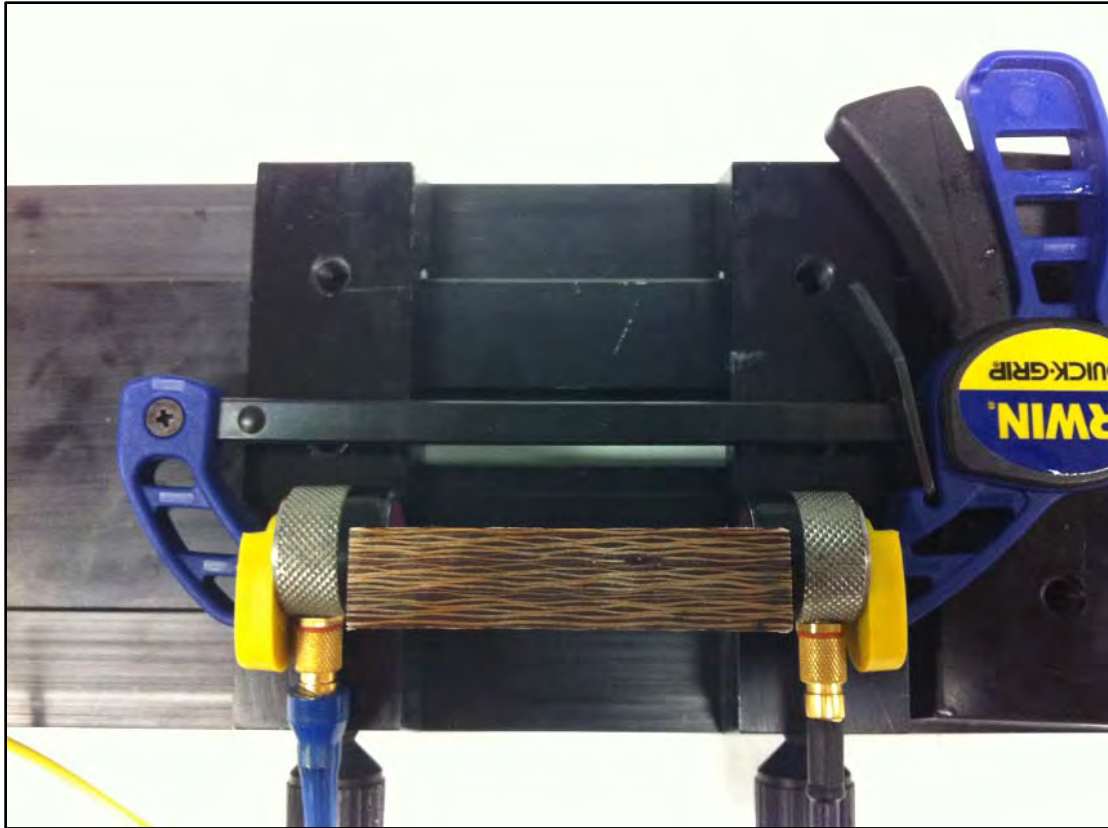
Figure 3.26. PZT Sensors Placed on the Composite in an Offset Orientation

9) Repeat step 7 without the composite, but with the sensors in the exact location as if the composite was still present. See Figure 3.26.

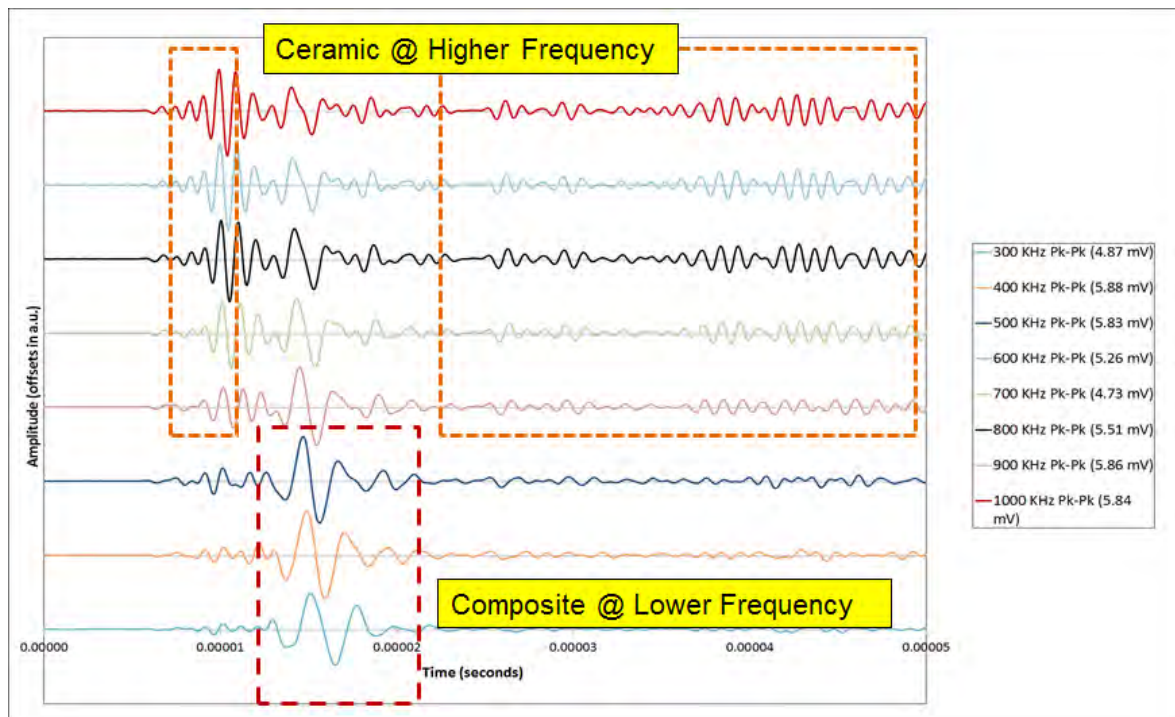
Figure 4.3. Wave propagation of Ceramic Coupon #4 and HJ1 Coupon #4 in 300-1000 KHz

range of frequency. From this analysis, 600 KHz was determined to be the optimal frequency to use to capture structural changes on both materials using only one sensor per side on both materials, instead of ones set of sensor on each sides of the material. 600 KHz was chosen because the wave propagation reflects both properties of the ceramic and the composite see Figure 4.4.

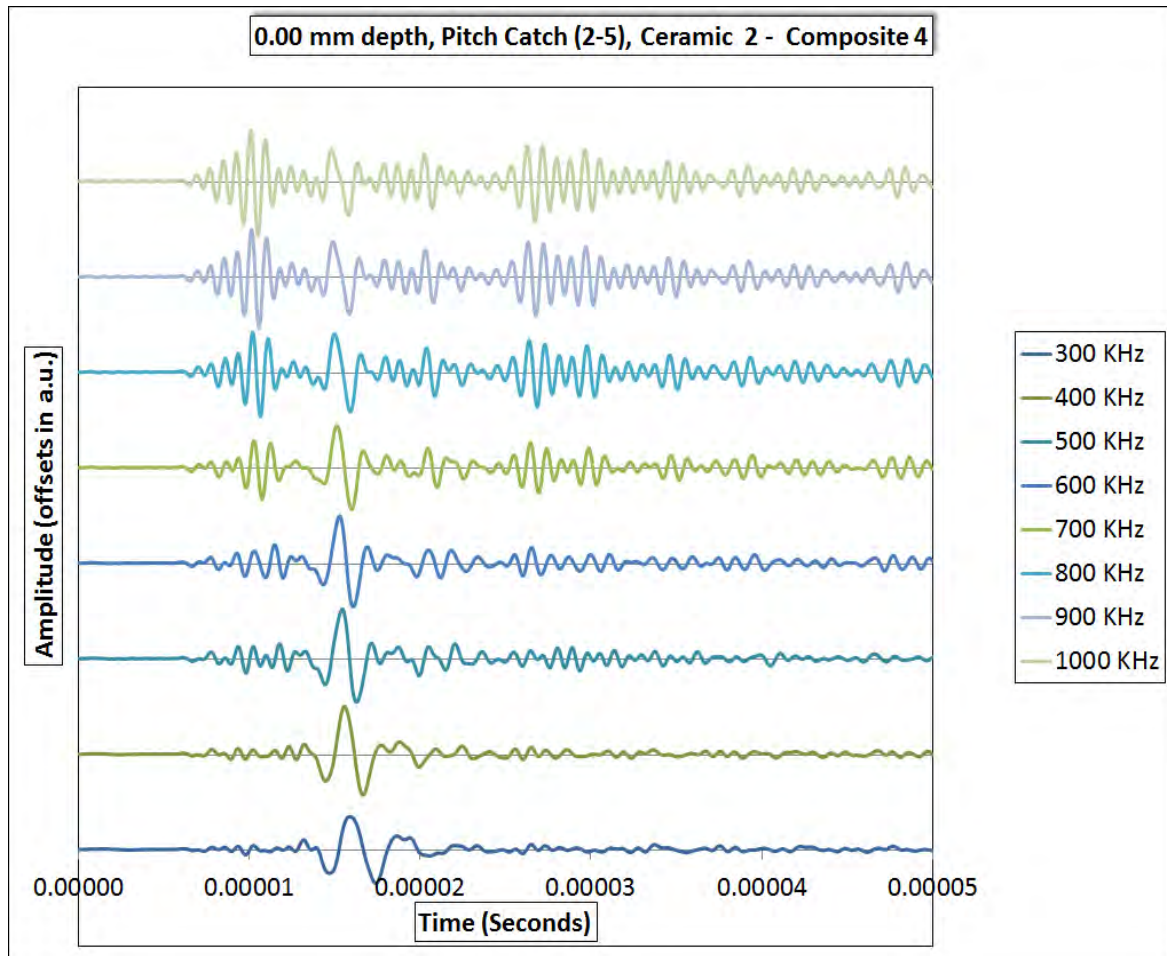
Figure 4.5. Wave Propagation from 300 KHz to 1000 KHz With No Damage, Pitch Catch from Section 2 to 5

The wave propagations on Figure 4.5 are of those using 300-1000 KHz with the ceramic coupon and composite coupons clamped together. Figure 4.5 will be used as a base line comparison to ceramic and composite combos with different amounts controlled damages.

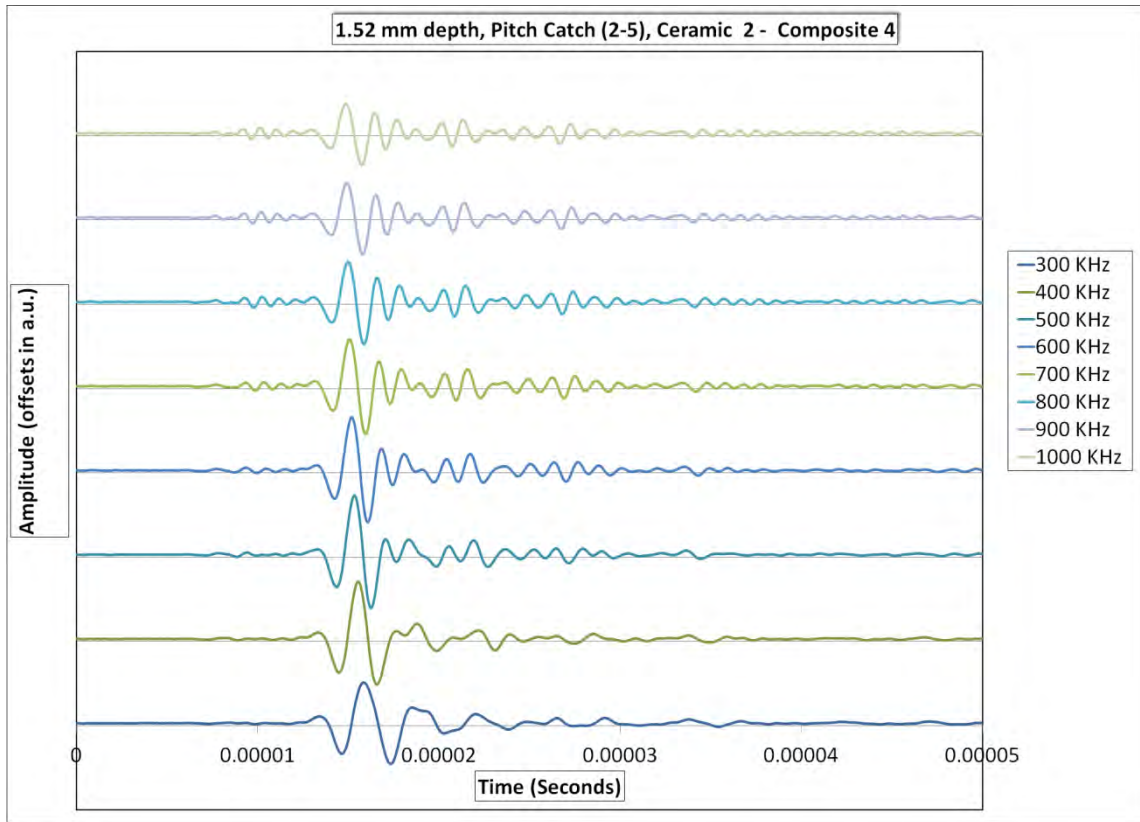
Figure 4.6. Wave Propagation with Damage at 1.52 mm Depth from 300 KHz to 1000 KHz

The wave propagations on Figure 4.6 are of those using 300-1000 KHz with the ceramic coupon and composite coupons clamped together, with a controlled circular hole (3.13 mm diameter) drilled 1.6 mm into the ceramic. The overall characteristic is consistent throughout the 300 to 1000 KHz range. This would indicate that input frequency changes will not affect the data capture and analysis of the structural change that has occurred.

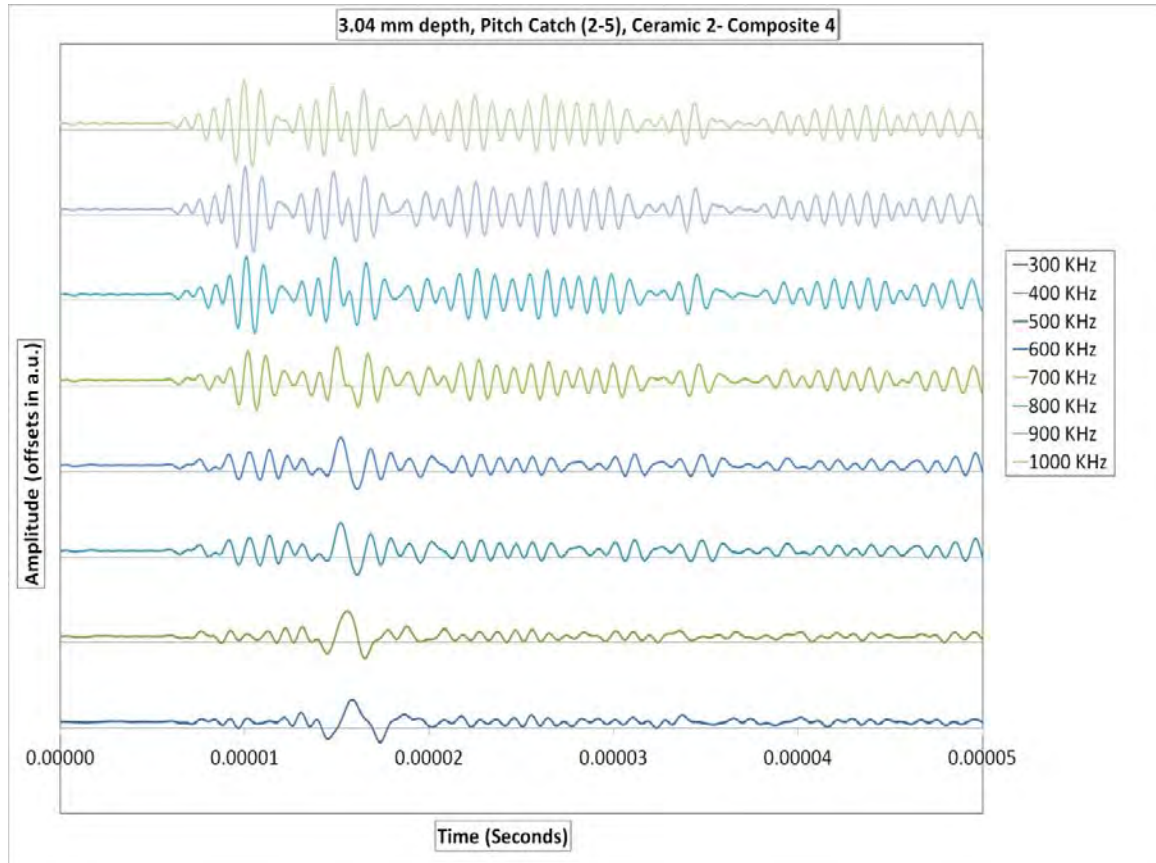
Figure 4.7. Wave Propagation with Damage at 3.04 mm Depth from 300 KHz to 1000 KHz

least within this procedure step, the overall characteristic is consistent throughout the 300 to 1000 KHz range.
