**Final Report**

**Electrospark Deposition for Depot- and  
Field-Level Component Repair and  
Replacement of Hard Chromium Plating**

**Project WP-0202**

**September 7, 2006**

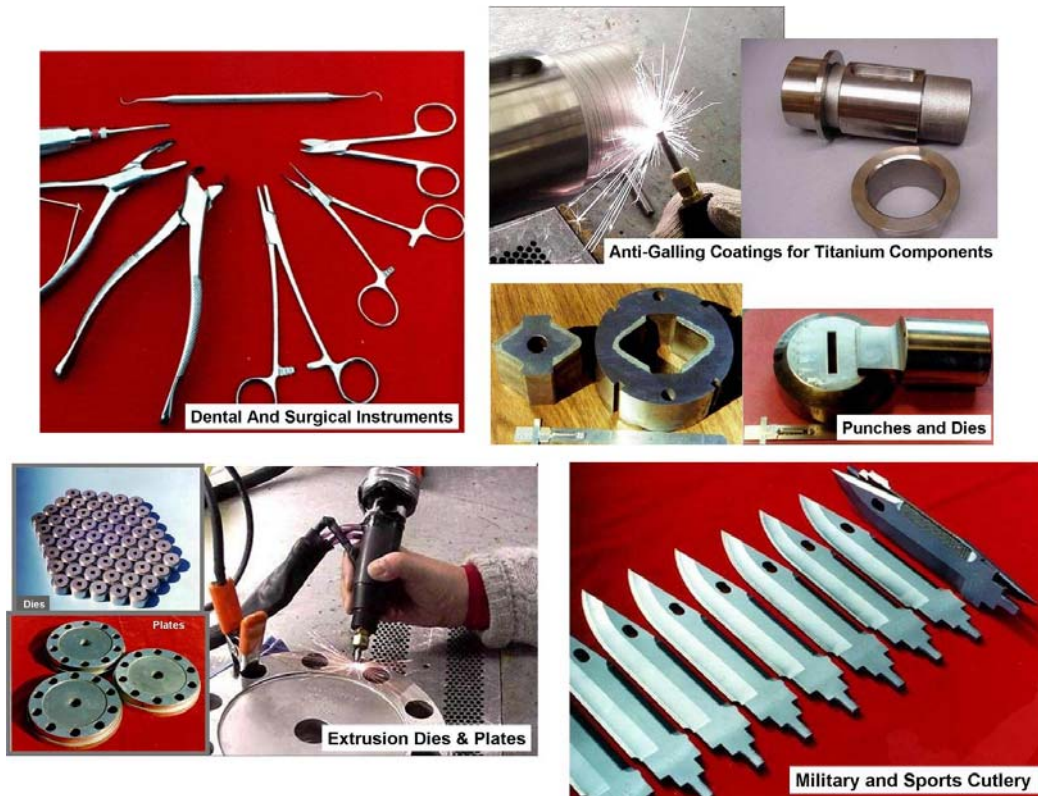
**Figure 2-4 ESD Coating Applications**

component surfaces can be reduced from 0.6 to less than 0.2 with an ASAP proprietary process. Corrosion applications frequently are addressed with iron-aluminide and nickel alloys such as IN-625 and Hastelloy C-22.

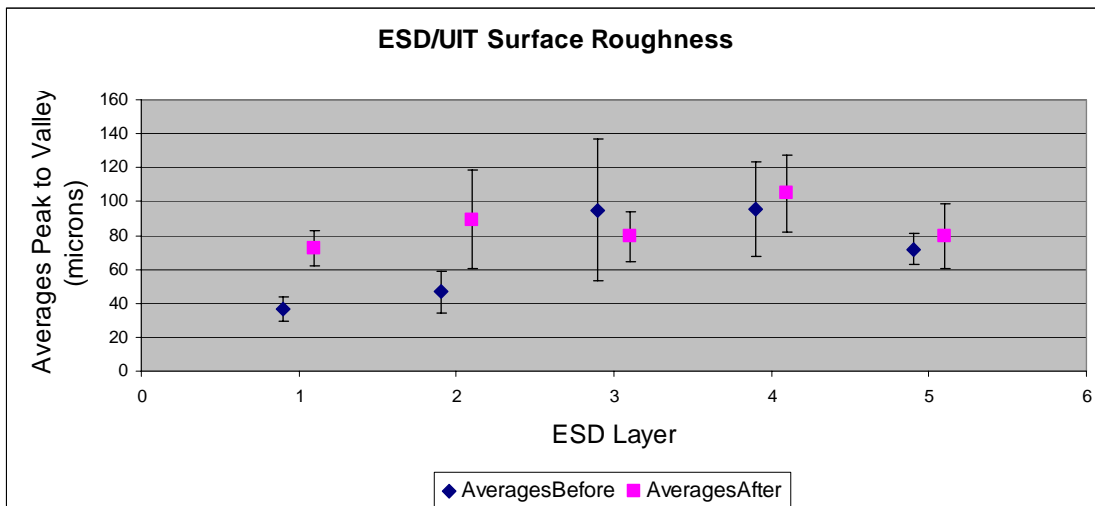
**Figure 3-28 Average for Each Layer on 11A Before and After UIT (Error Bars Represent Plus and Minus One Standard Deviation)**

Regardless of what the roughness data indicates, surfaces subjected to UIT are visually significantly smoother than as deposited ESD. The lack of agreement between the two is probably the result of the roughness parameter (maximum peak-to-valley distance) used. Although the surfaces treated with UIT are smoother, it is possible that peak-to-valley distances are similar to the surface of as deposited ESD. Stated another way, although there are significantly fewer peaks on a UIT treated surface, the average height of the peaks are approximately equal to a non-UIT treated surface.

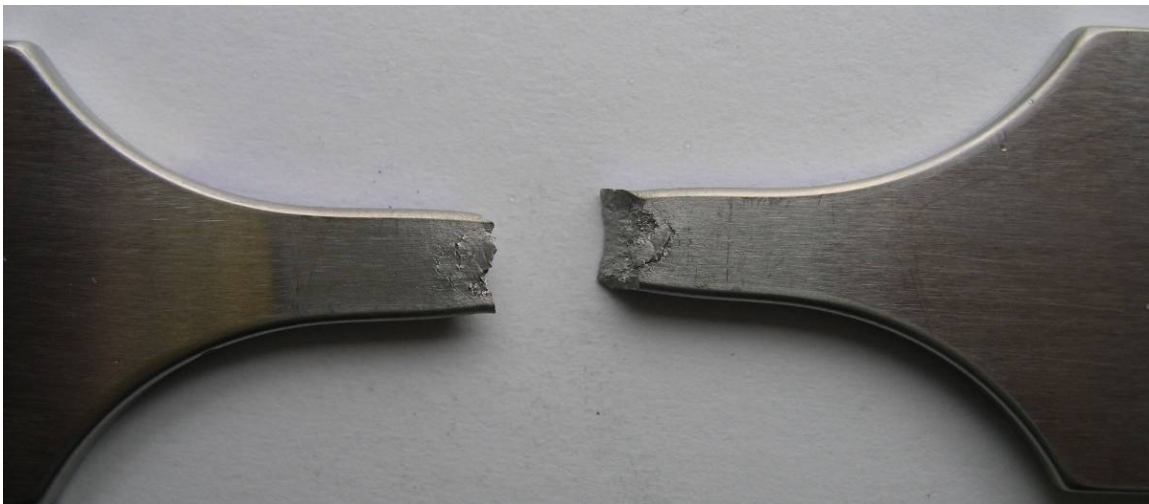
**Figure 4-60 Typical Fracture of #32 Tensile Bar.**

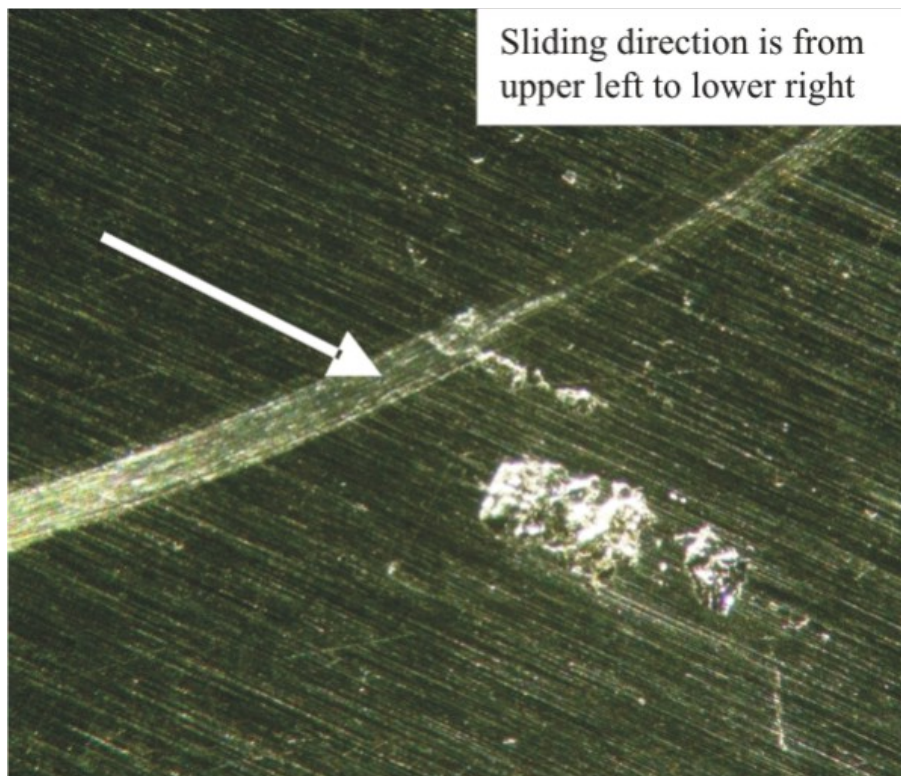
**Figure 4-71 Wear Groove Encountering ESD Void**

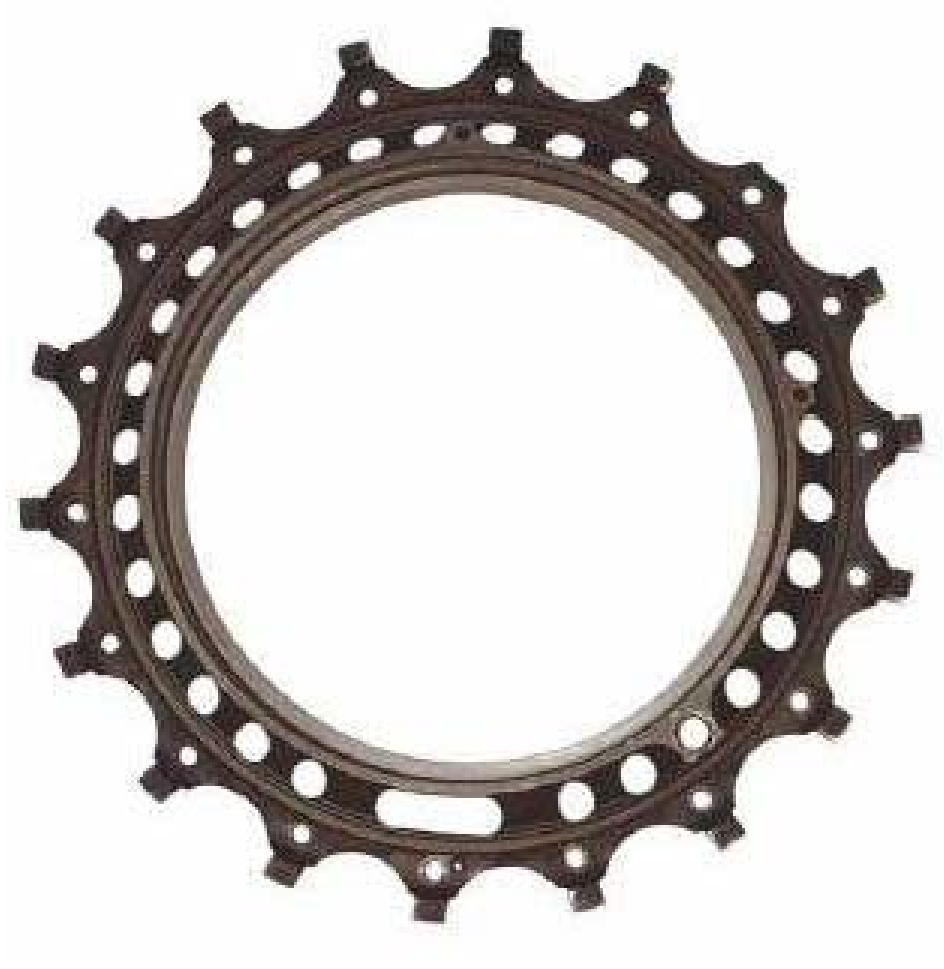
**Figure 4-101 #5 Bearing Housing**

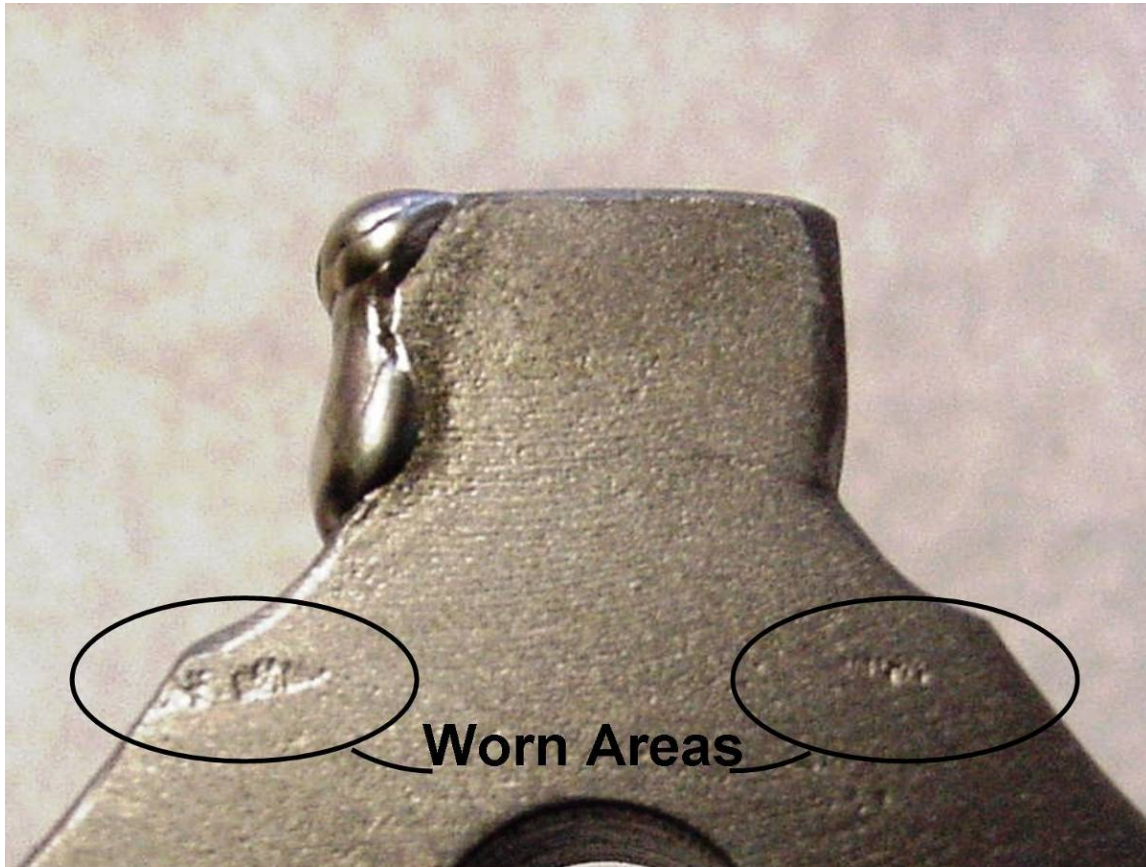
**Figure 4-102 Damaged Area to Receive ESD Repair**

the repair and dimensional restoration of the wear scars that occur on the front face of the housing (loss of material due to wear), as seen in Figure 4-102.

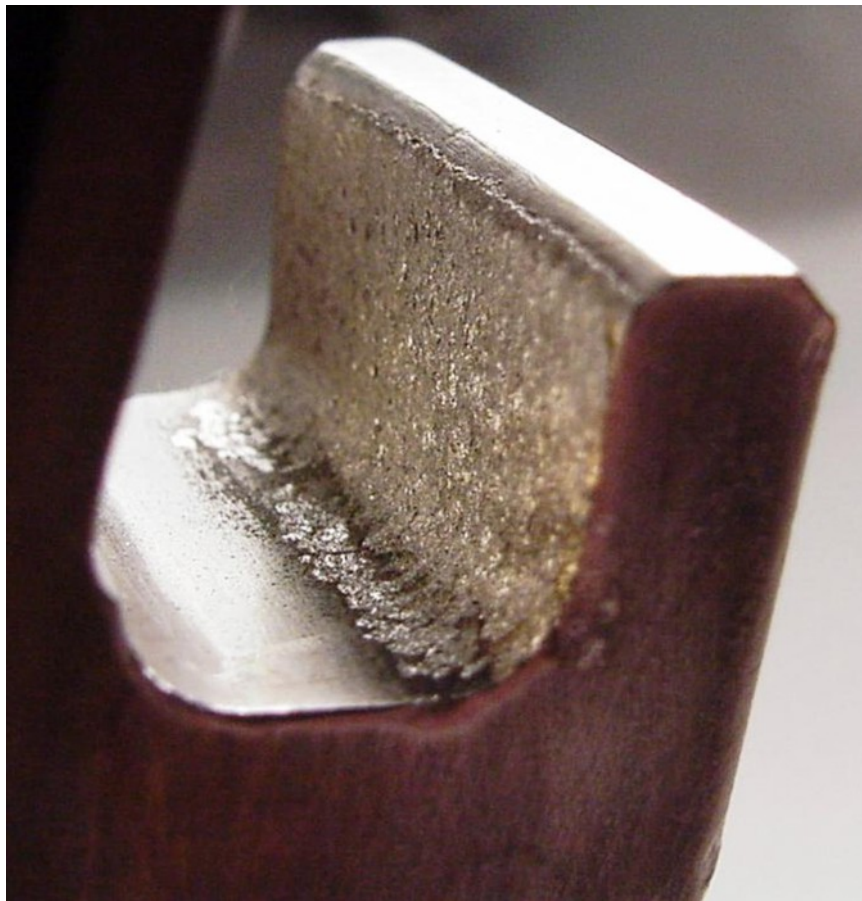
**Figure 4-112 Repaired Area on 10-12 Stator Segment**

This area was difficult to access and deemed a non-line-of-sight application. However, using unique ESD techniques and a custom applicator head, the area was excavated and repaired. The repaired area is seen in Figure 4-112.

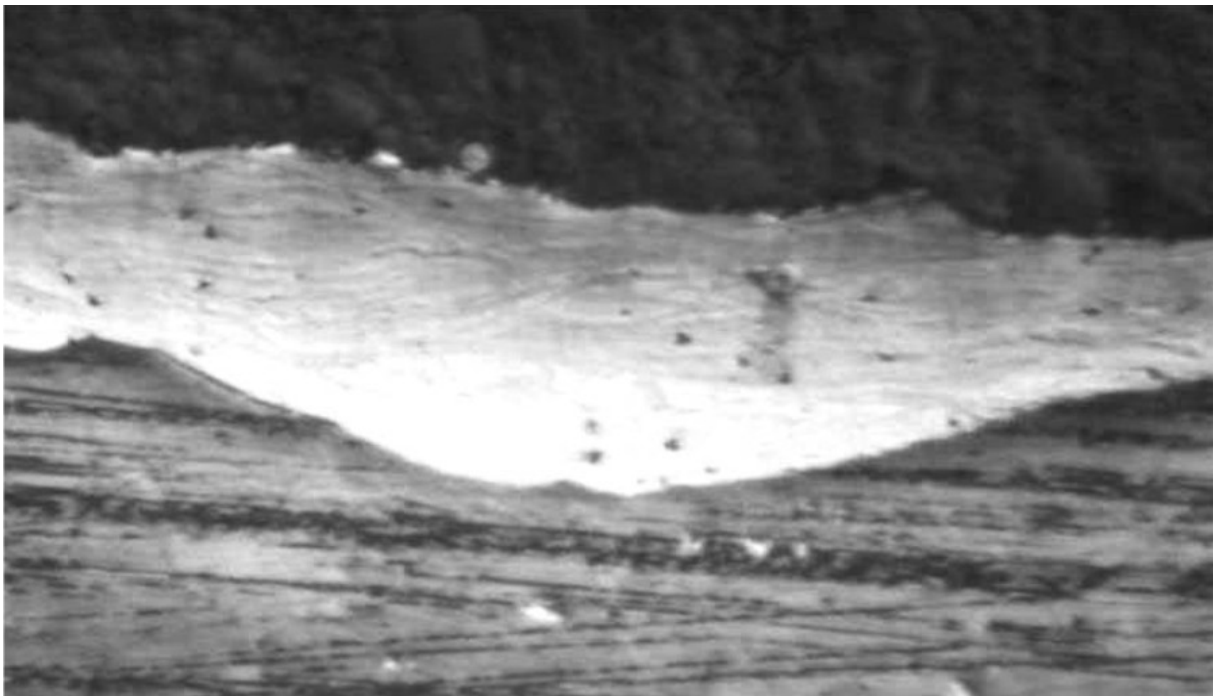
**Figure 4-119 Metallography of Repaired Hot Air Erosion**

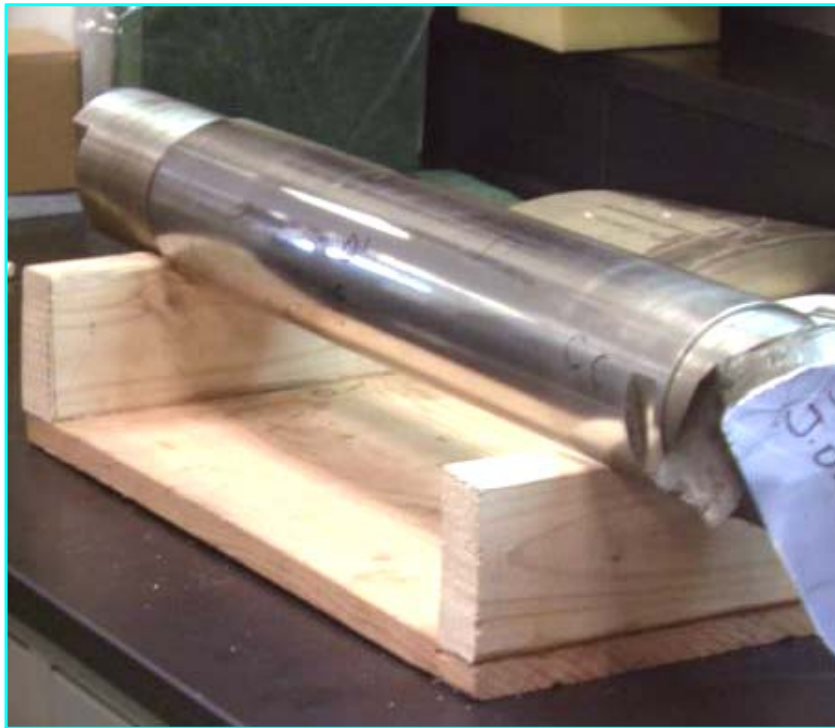
**Figure 6-3 Steering/Diving Control Rod Subsequent to Removal From Submarine**

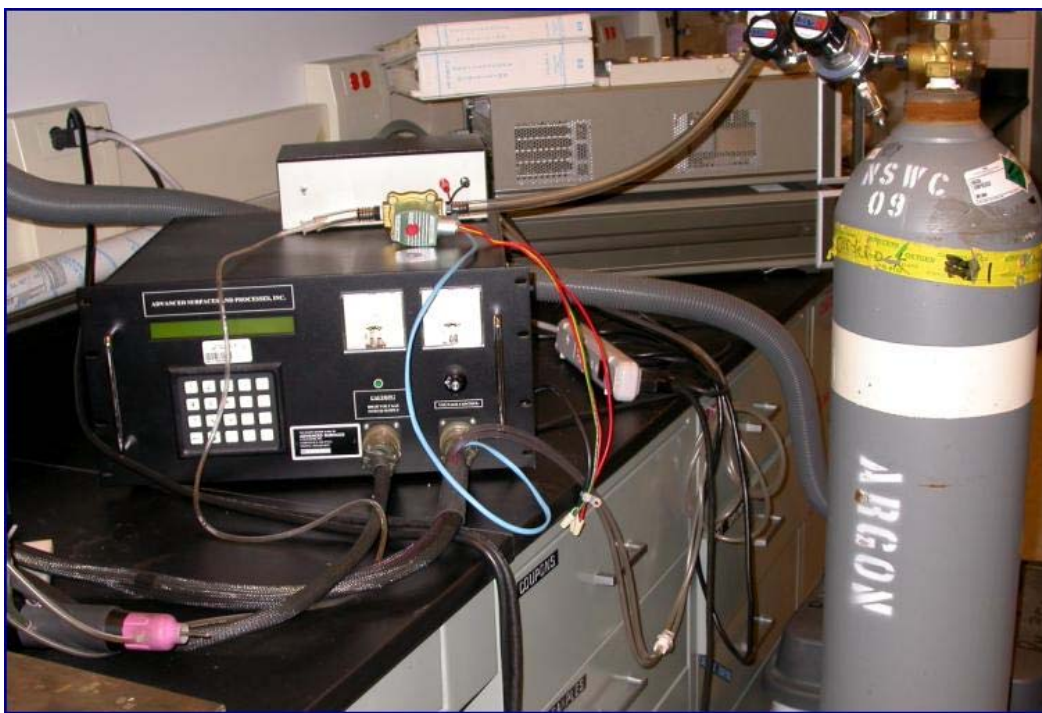
**Figure 6-4 ESD Equipment Located at NSWCCD Used for Materials Studies**

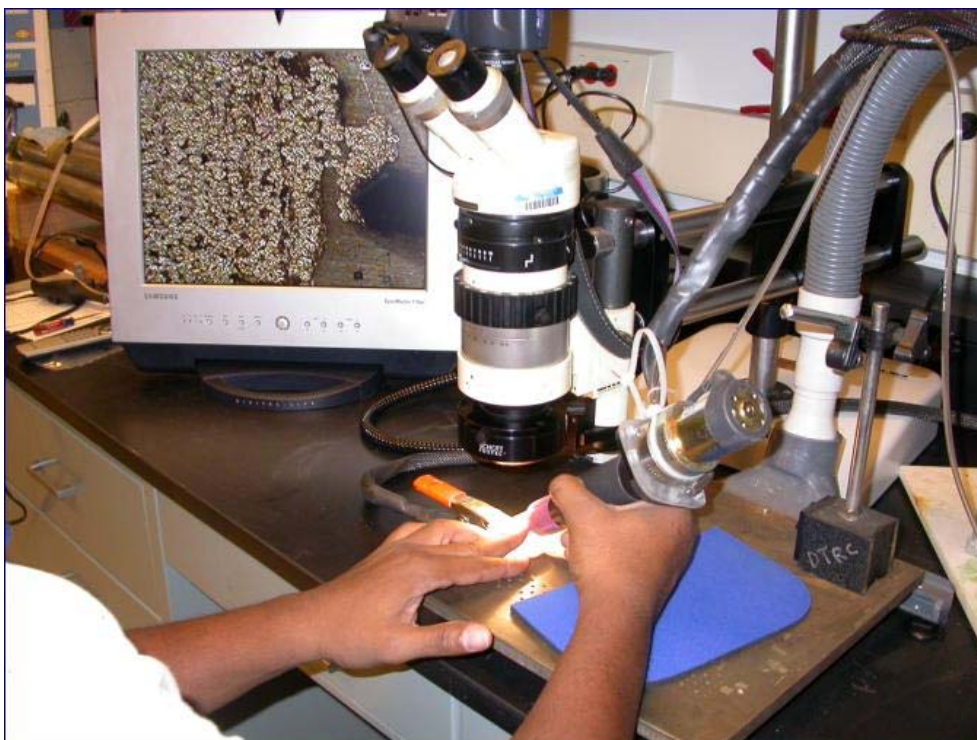
**Figure 6-5 Application of ESD Coating to Test Coupon**

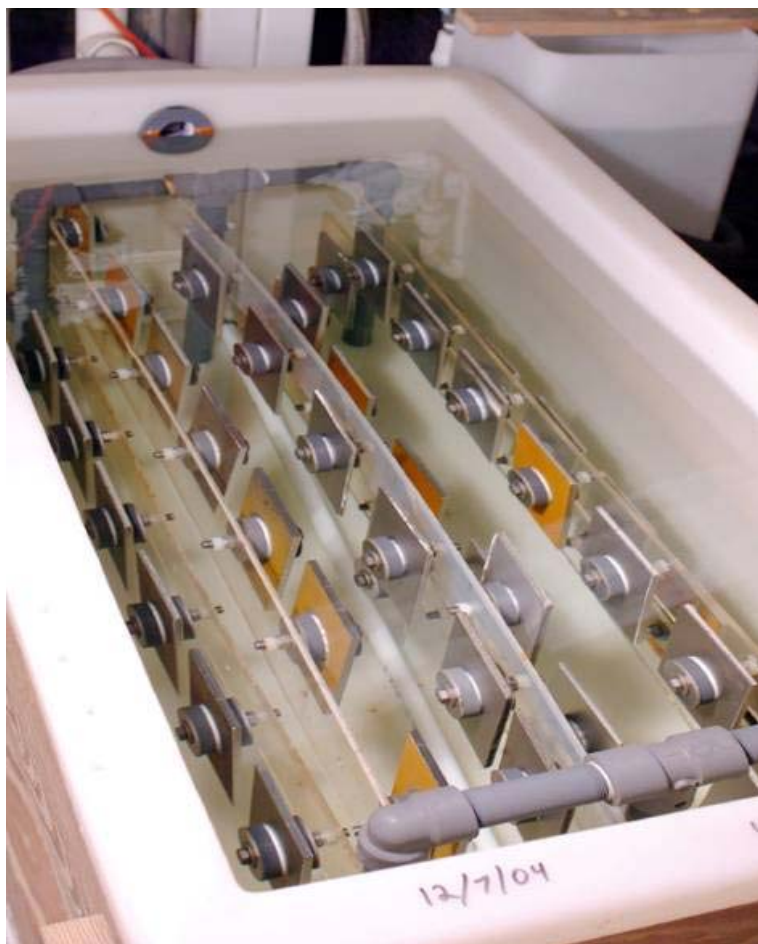
**Figure 6-18 Crevice Corrosion Test Assemblies Immersed in Seawater**
