# **Hydrolytic Stability of Polyurethane-Coated Fabrics Used for Collapsible Fuel Storage Containers**

**ARL-TR-6949**

**Weapons and Materials Research Directorate, ARL**

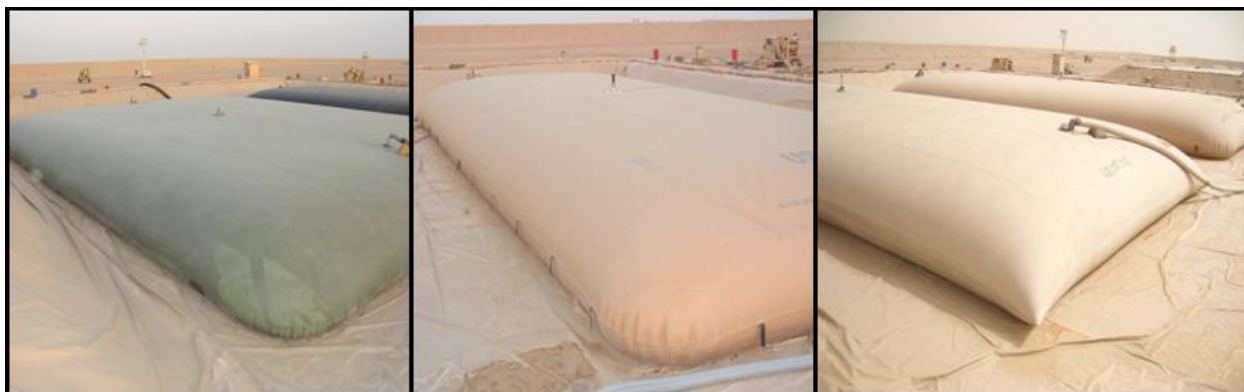
Figure 1. Examples of 50,000-gal fabric-reinforced elastomer tanks.

The Army currently has a large number of fabric-reinforced elastomer tanks ranging in size from 100 to 210,000 gal used for storing fuels and water in the field. Examples of 50,000-gal fuel tanks are shown in figure 1. Collapsible fuel tanks, fabricated from urethane-coated nylon fabric, were first introduced by the military during the Vietnam conflict. Their performance then and until recently, particularly in any humid tropic environment, has been less than satisfactory. Unless formulated and produced according to stringent limitations, urethane-based fabric coatings were extremely susceptible to ultraviolet and hydrolytic degradation. At that time, tanks had to hold high-aromatic gasoline as well as diesel and jet propulsion fuels (2). The only urethane that could handle the high-aromatic gasoline fuels was polyester urethane, which was more vulnerable to hydrolysis than polyether urethane. Advancements were made in better understanding the mechanism of the degradation process in the 1980s. Suppliers then added hydraulic stabilizers to the polyester urethanes to prolong their service life. The problem continued to linger resulting in the deterioration and ultimate failure of external tank surfaces and seams even when protective agents had been incorporated into the tank coatings.

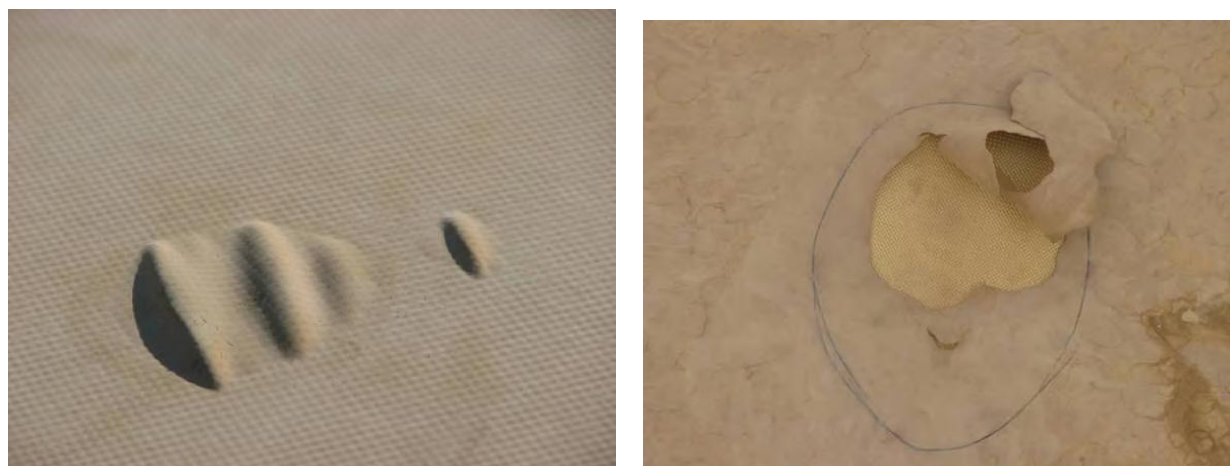
Figure 2. Fabric blistering due to hydrolysis.

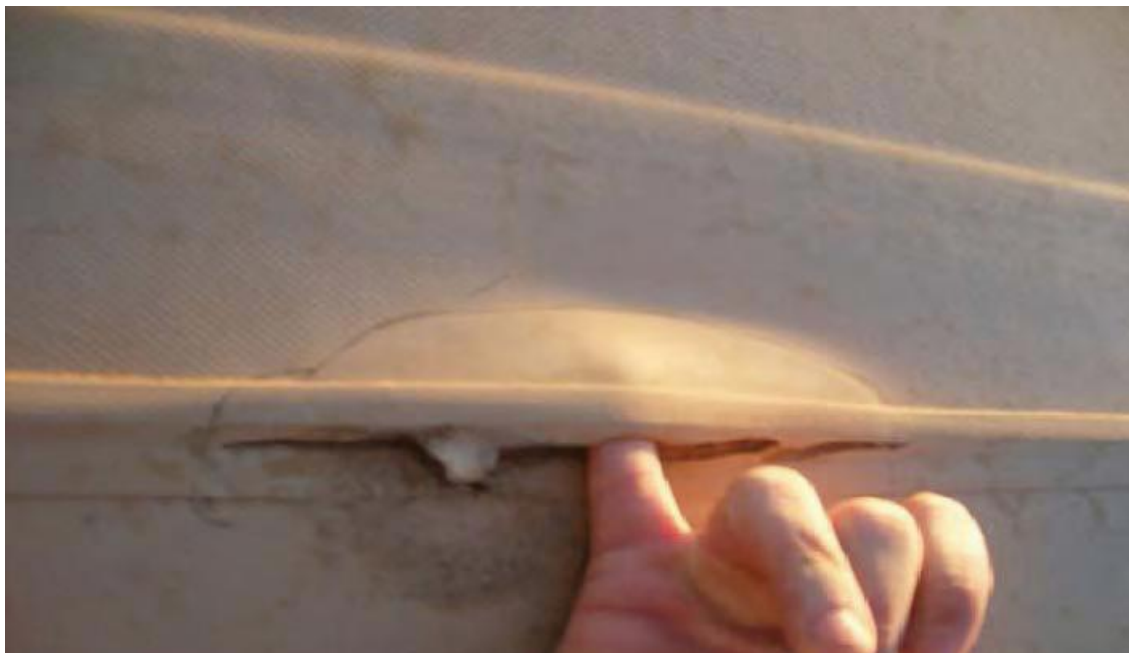
Figure 3. Fabric seams coming apart due to hydrolysis.

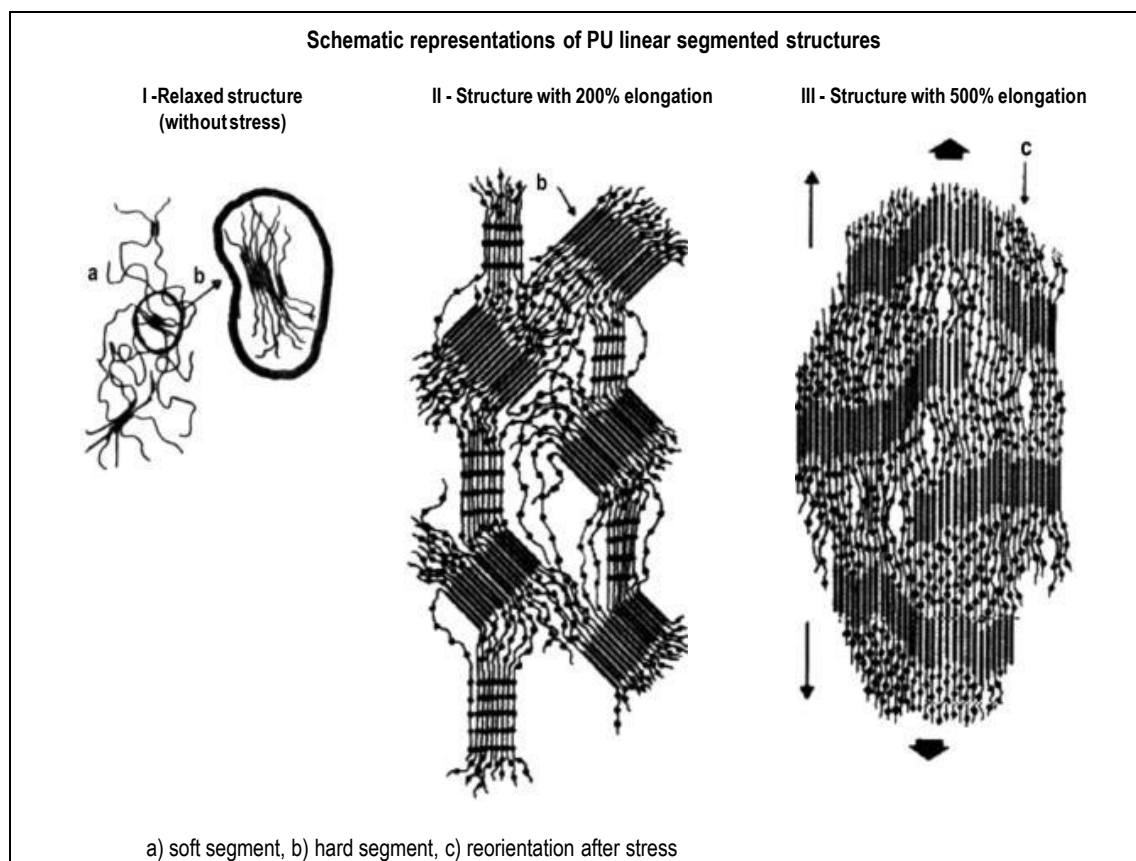
Figure 4. Schematic of urethane morphology.

Polyurethane elastomers are phase-segregated linear block copolymers that contain an ordered hard segment phase and a soft rubbery phase. The hard segment phase is responsible for the cross-linking in the elastomer. Figure 3 shows a schematic of this structure. These microstructures of polyurethanes are well known for controlling the physical properties of these phase-separated materials, such as tensile strength, tear strength, and puncture resistance. For this study, we obtained currently manufactured polyurethane-coated fabrics as well as several candidate coated fabrics. Samples were obtained from commercial coating sources familiar with fuel storage tank construction and fabrication. Seven polyurethane-coated fabrics were procured: three from Cooley Inc. (Cranston, RI), one from Reliance Coated Fabrics (Mansfield, TX), and three from Seaman Corporation (Wooster, OH). The polyurethane-coated fabric consists of nylon- or polyester-woven fabric that is coated on both sides with polyurethane rubber to create a rubber composite. Figure 4 shows a micrograph of the side view of this assembly for the Cooley Inc. polyurethane-coated fabric. Details about the coating method were not available. Coating thicknesses were all very consistent between manufacturers, ranging between 1.4 and 1.6 mm (approx .05 in.). Table 1 gives the relevant physical properties of these materials. Fabric densities ranged from  $41.6\text{ oz/yd}^2$  to  $45.2\text{ oz/yd}^2$ ; this is an important characteristic physical property because the increase in fabric densities results in heavier fuel storage containers, which are more difficult to deploy.

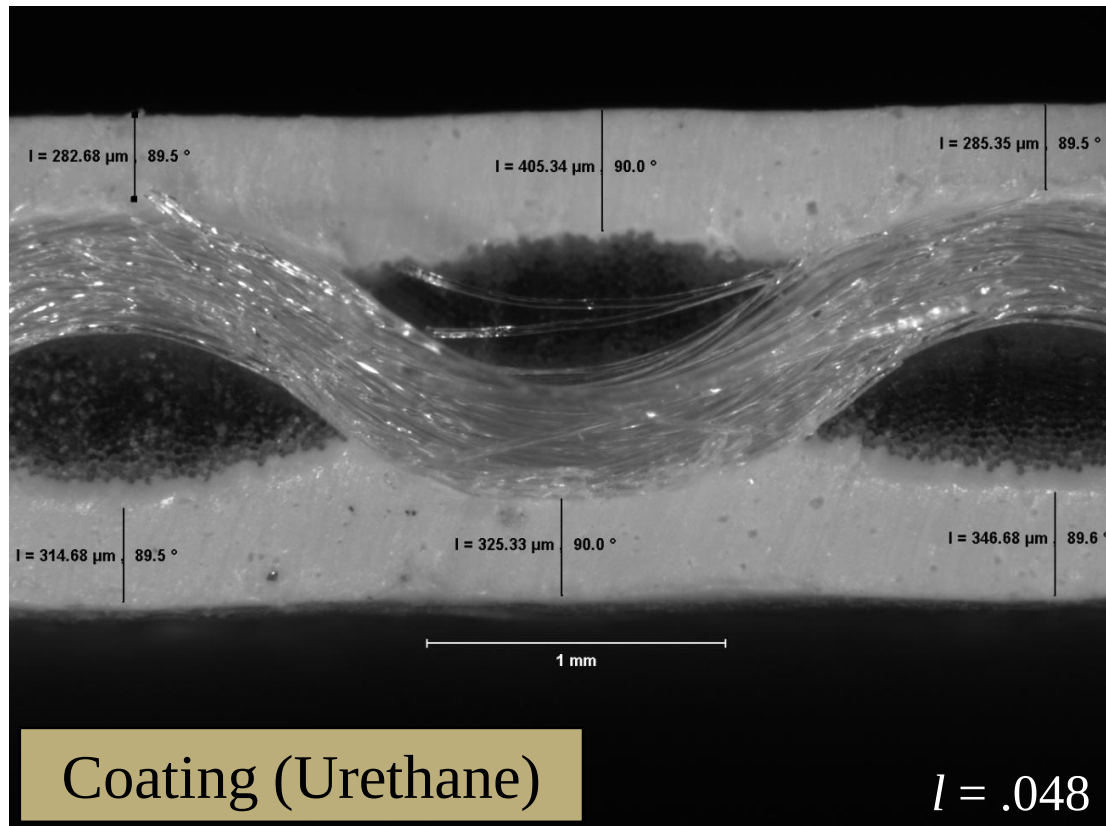
Figure 5. Side view micrograph of urethane-coated fabric.

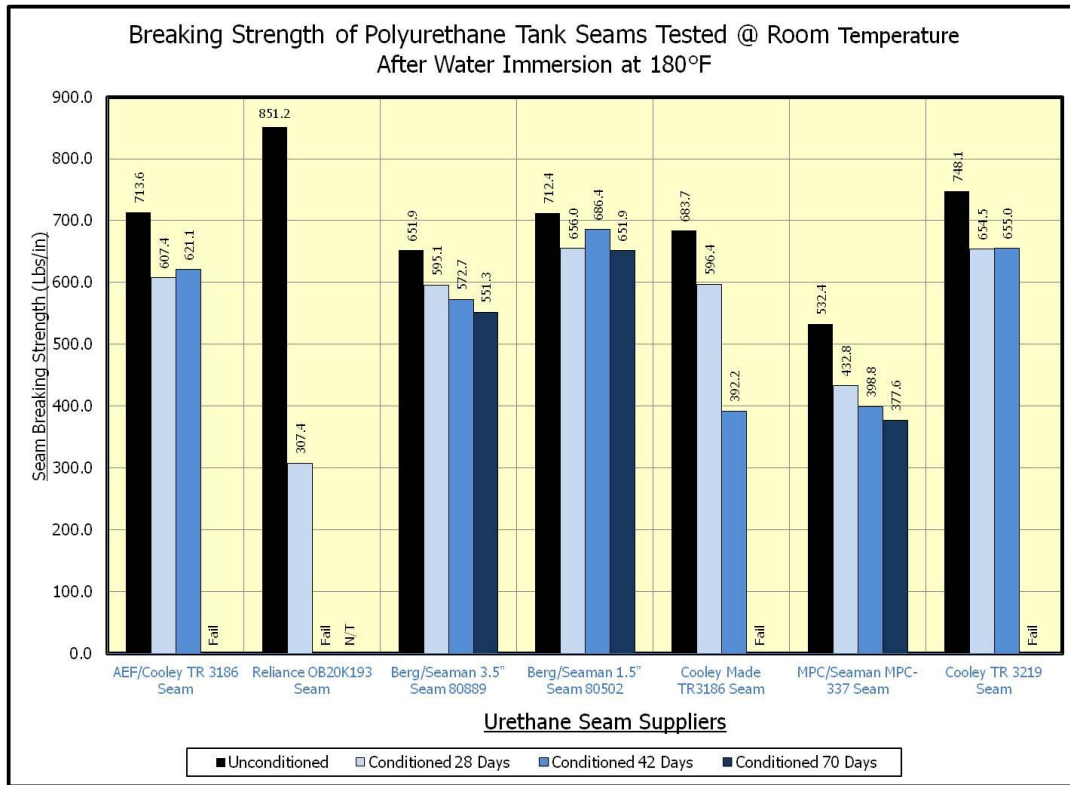
Figure 6. Breaking tensile strength of fabric seams after immersion in water at 180 °F.

Urethane coatings are particularly susceptible to undergo hydrolysis, which is a chemical reaction with water, resulting in chemical breakdown of the urethane coating, resulting in cracking or extreme softening of the urethane polymer. Hydrolysis can be quite rapid in certain urethane systems so we evaluated the resistance to hydrolysis of these urethane-coated fabrics. Since hydrolysis of the urethane coating would not affect the strength of the base fabrics due to the nylon/polyester woven fabric, accounting for all of the composite tensile strength, it is preferable to evaluate the hydrolytic stability in the bond line where the urethane coating is fully responsible for the mechanical strength. Figures 6 and 7 compare the seam-breaking strengths measured at room temperature after water immersion at 180 °F at time increments of 28, 42, and 70 days. All materials provided adequate mechanical integrity after 28 days of immersion; however, all of the materials' seam-breaking strengths decreased with water immersion. The inside coating of this tank material became hard and brittle after the samples that had been exposed to water for 42 days and beyond, which is indicative of a failure due to hydrolysis (see figure 8). The seams made from the Cooley TR 3186 and TR 3219 materials also failed after immersion in water for 70 days at 180 °F and exhibited cracks in the interior white coating from hydrolysis caused by water immersion. This type of deterioration normally happens with ester-type urethanes. The Cooley TR 3186 material was used by Avon Engineered Fabrics in recent years to manufacture and supply fuel tanks to the military.

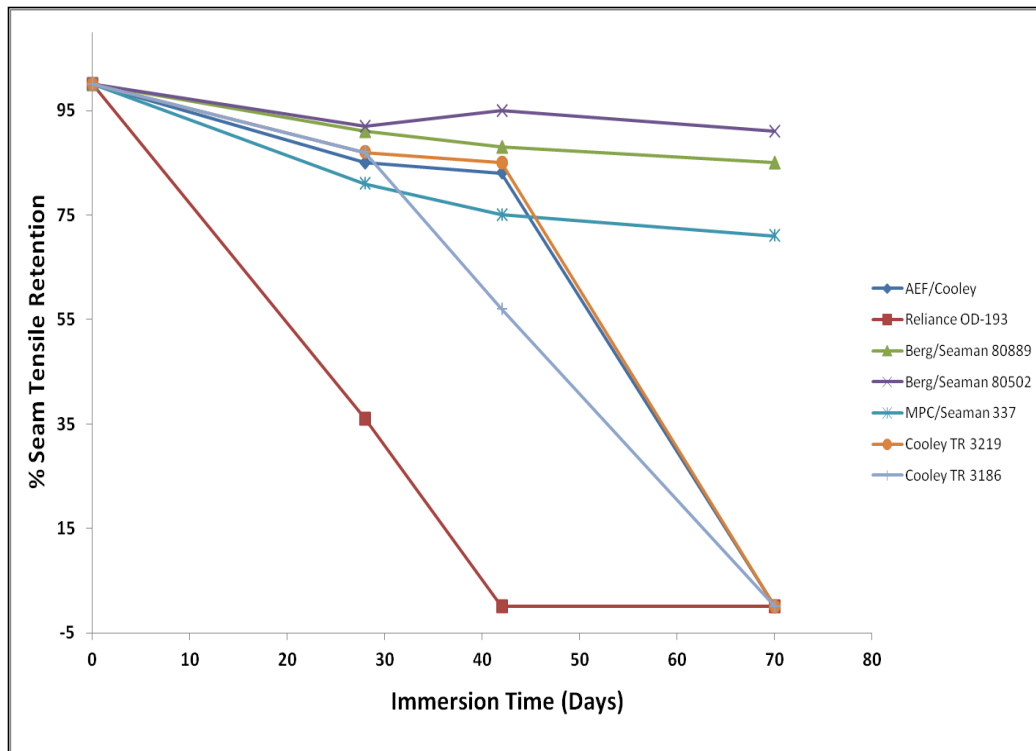
Figure 7. Seam tensile strength retention of fabric seams after immersion in water at 180 °F.

Figure 10 compares the seam peel adhesion measured at room temperature after water immersion at 180 °F for time increments of 28, 42, and 70 days. The seam peel adhesion is an excellent test method to determine the resiliency of the bond line to hydrolysis. As seen in the seam breaking strength results (figures 7 and 8), the Reliance seam performed very poorly in the peel adhesion testing. This seam failed to provide any peel adhesion strength after a 42-day water immersion cycle exhibiting significant surface cracking on the interior coating (fuel side). The seam provided a 5-lb/in. peel adhesion value after the 28-day immersion—a critical failure. All the other Cooley materials performed slightly better, though the seam structures failed the 70-day water immersion test. All the seams constructed with the Seaman fabrics performed well and provided excellent peel adhesion values even after immersion in water for 70 days at 180 °F. As with the seam tensile strengths, the Cooley and Reliance fabrics performed poorly. The Reliance fabric failed almost immediately while the Cooley fabric showed no strength retention after the 72-h immersion time. The Berg/Seaman 80889 and 80505 retained approximately 80% of its original seam strength while the MPC/Seaman 337 retained 60%.

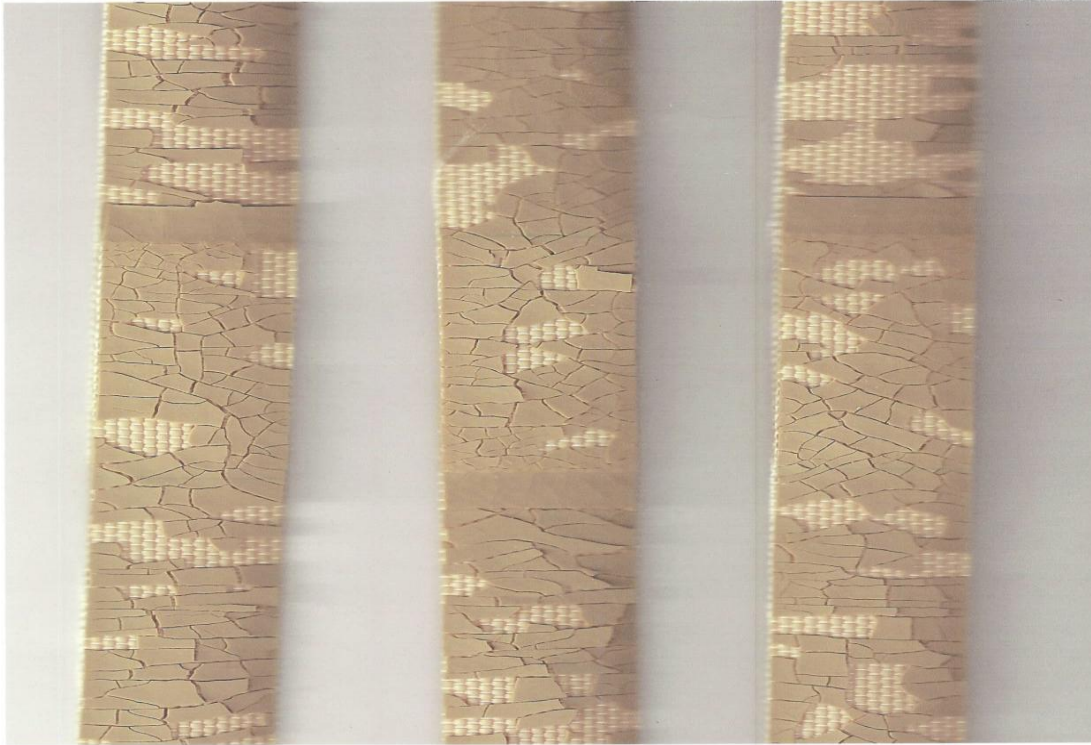
Figure 8. Reliance coated fabric after 42-day immersion showing advanced hydrolysis.

The urethanes studied in this work fall into two groups, those that underwent hydrolysis within the 72-h conditioning cycle and those that resisted hydrolysis during this time period. The polyurethane materials provided by Cooley and Reliance showed a vulnerability water attack, while all the materials provided by Seaman provided better resistance to water. The Cooley and Reliance exhibited no peel adhesion strength retention after 72 days in water at elevated temperatures, while the Seaman coated fabrics retained an average of 85% of original peel adhesion strength. It is expected that tanks made from these Cooley materials, and especially the Reliance materials, would have a shorter shelf life and service life in areas with hot, humid environments. Another problem could arise with tanks that have been used, cleaned, and returned to storage with some residual water. The picture of the Reliance-coated fabric after water immersion at 180 °F for 42 days is indicative of what the Cooley materials looked like after water immersion for 70 days at 180 °F.

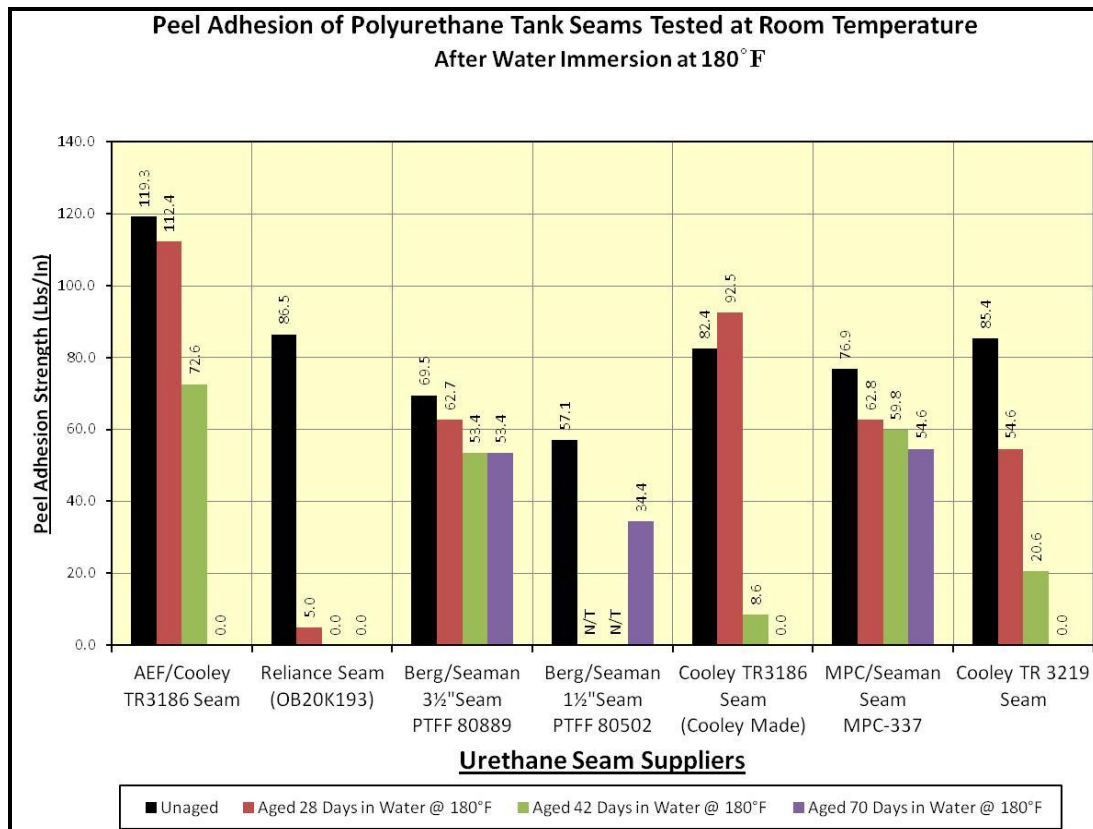
Figure 9. Peel adhesion of fabric seams after immersion in water at 180 °F.

The retention rates for all seven materials studied are presented in figure 9. This graph points out the poor performance of the materials manufactured by Cooley, in that all fabrics exhibited 0% retention after being immersed for 70 days. The Reliance material, used to manufacture 20,000 fuel tanks for the military in 2002, exhibited a significant amount of deterioration after only 28 days of immersion at 180 °F. As seen in figure 9, this seam retained only 36% of its original breaking strength after 36 h. The three coated fabrics from Seaman Corporation, the Berg/Seaman 80889 (3.5-in. seam width), Berg/Seaman 80505 (1.5-in. seam width), and MPC/Seaman 337, all performed well in our testing. The Berg/Seaman 80889 and 80505 retained approximately 95% of its original seam strength while the MPC/Seaman 337 retained 75%.

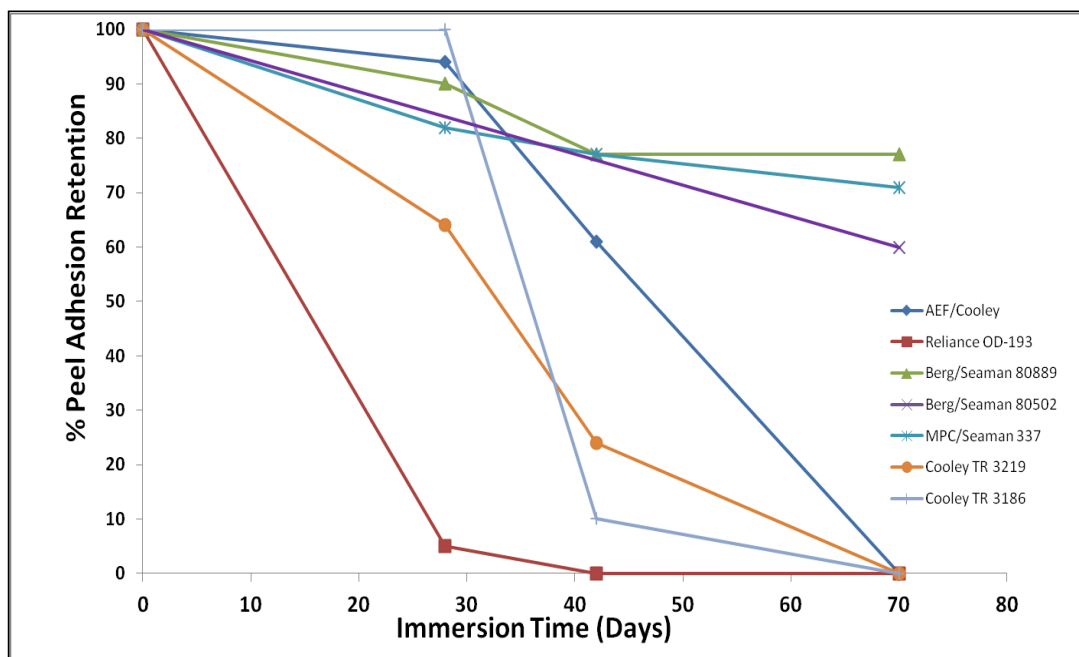
Figure 10. Seam peel adhesion strength retention of fabric seams after immersion in water at 180 °F.

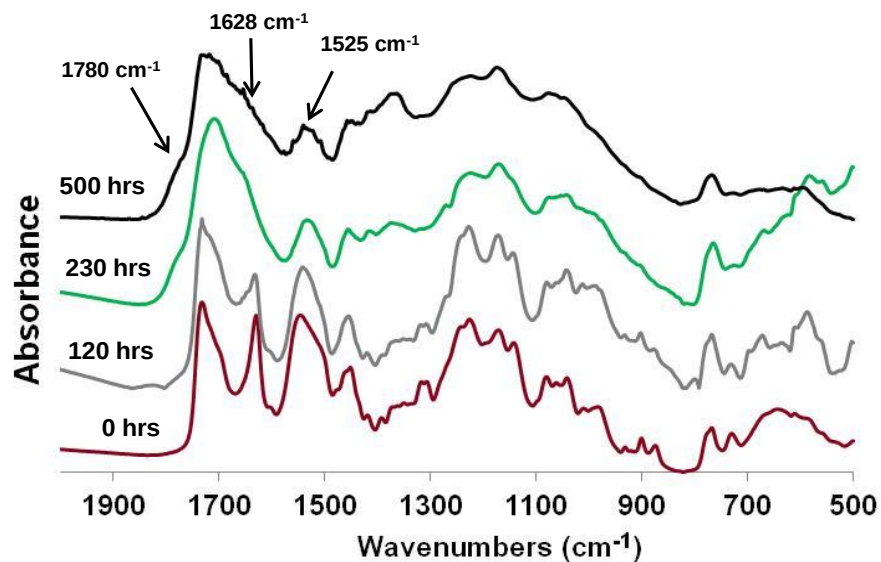
FTIR was conducted on these polymers to identify molecular changes occurring within the polymer domains. FTIR looks only at the chemical events occurring at the surface and does not yield information on the bulk polymer composite. Figure 11 shows the progression of the infrared spectra with immersion time of the Seaman coated fabric. The FTIR spectrum at 0 h show two carbonyl peaks at  $1700\text{ cm}^{-1}$  and  $1720\text{ cm}^{-1}$ , which can confidently be assigned to a hydrogen-bonded carbonyl and a nonhydrogen-bonded carbonyl (16), respectively. The  $1700\text{-cm}^{-1}$  band appears to shift to lower frequencies ending at  $1660\text{ cm}^{-1}$ . The FTIR spectra show growth of two new carbonyl peak formations at  $1778\text{ cm}^{-1}$  and  $1750\text{ cm}^{-1}$  with increasing water immersion time. The  $1778\text{ cm}^{-1}$  is due to an acidic carbonyl that results from the reaction of a urethane carbonyl and water molecule. In addition, a decrease in  $1525\text{ cm}^{-1}$  is associated with the amide II band ( $\nu(\text{C-N})$ ), and a decrease in  $1628\text{ cm}^{-1}$  is associated with the amide I band [ $\nu(\text{C=O})$ ], indicating urethane bond cleavage (17–19). These molecular groups are responsible for cross-linking the urethane chains to provide mechanical and structural integrity. While the urethane inherently contains ether groups as part of the molecular backbone, new ether groups form as evident from the widening of IR bands in the  $1300\text{- to }1000\text{-cm}^{-1}$  region. This is a result of direct insertion of OH groups into the urethane linkage.

Figure 11. Progression of FTIR spectra with immersion time in water at 180 °F.

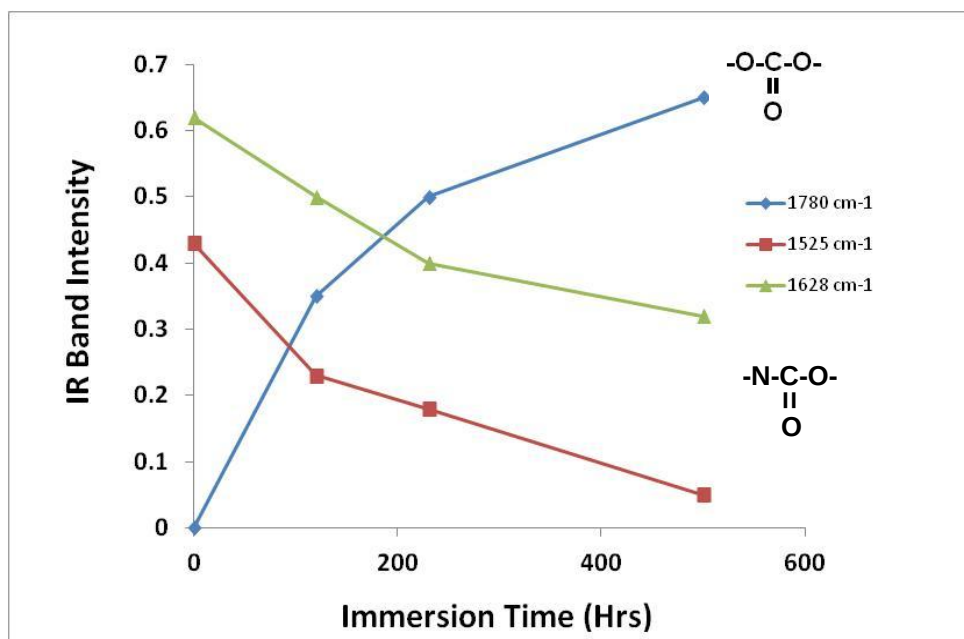
Figure 12 graphs these changes. The appearance of ether groups coincides with the decrease of the urethane links. Identical structures were identified for all seven coated fabrics studied in this report.

Figure 12. FTIR individual IR band changes with immersion time in water at 180 °F.
