WATERTOWN ARSENAL LABORATORY

NO. WAL. 640/140

WELDING OF ARMOR

.40% C Experimental 1-1/2 Inch Thick
Rolled Homogeneous Armor Plate

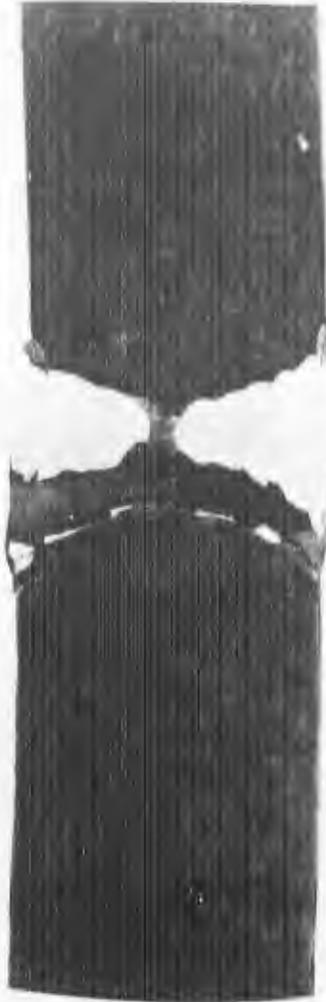
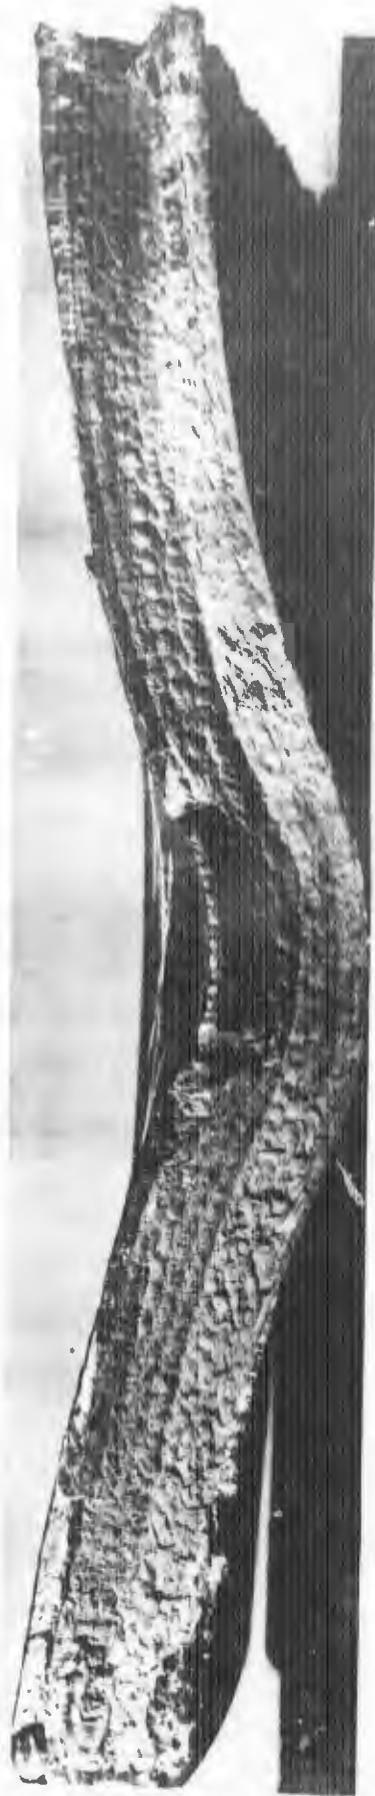
Macroetched transverse section through undamaged portion of weld joint.

Macroetched transverse section through ballistic fracture.

Ballistic fracture surface, weld metal side.

Macroetched Section and Ballistic Fractures from 1 1/2 Inch Thick Austenitic Hand Welded .40% C Republic Armor "H" Plates - Initial Joint Design.

The plates were returned to Watertown Arsenal Laboratory for examination. Figure 1 shows a macroetched transverse section through the ballistic fracture, an edge photograph of a ballistic fracture (weld metal side), and a macroetched section through an undamaged portion of the weld. Bend fracture tests* were made on bars taken across undamaged sections of the welds in these plates. These bars reproduced the ballistic fracture which proceeded almost entirely through weld metal, approximately .002 inches from the bond metal. A thin scale of weld metal was visible on the plate metal side of the fracture (see Figures 1 and 2). This type of failure has been identified in two other investigations of samples from commercially welded armor joints⁽⁵⁾, and found to proceed through an area where very fine non-metallics are precipitated parallel to the fusion line in austenitic weld metal (Figure 2). This condition, which will be discussed more fully in a forthcoming report, does not appear to be related to the carbon content or hardenability of the experimental .40% C armor plate.

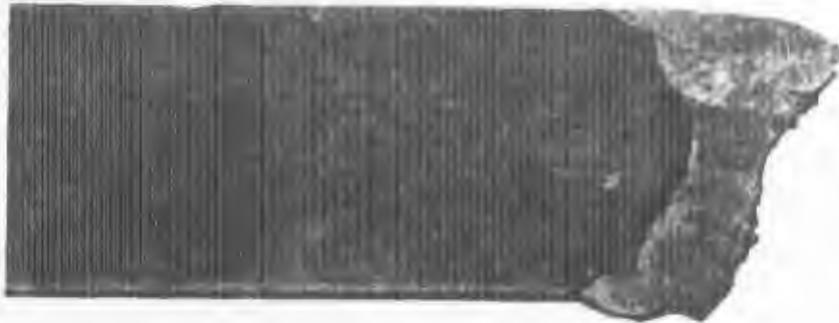
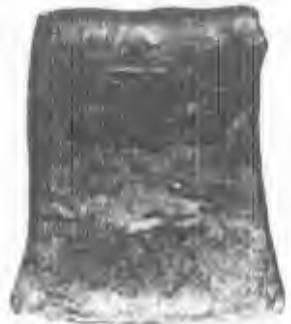
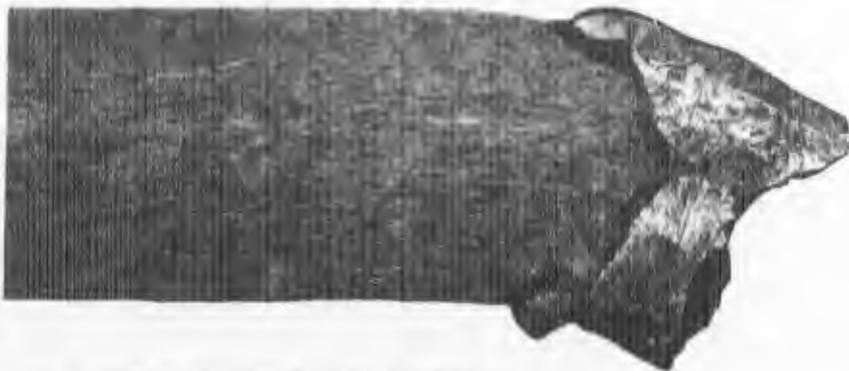
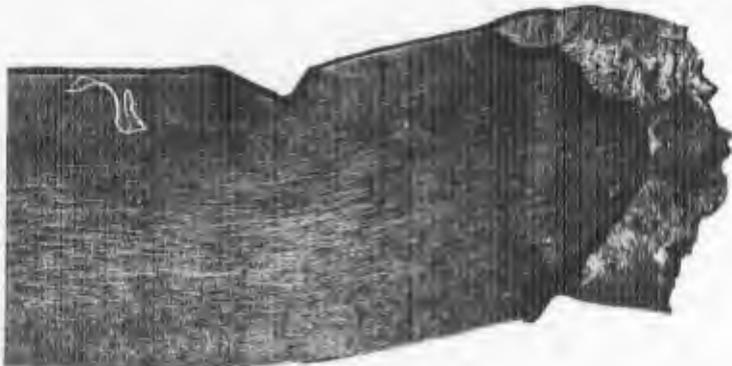
.26 C JONES AND LAUGHLIN ARMOR -45° DV BEVEL -
GEOMETRY IMPROVED WITH LARGER ANNEALING BEADS.

.40 C REPUBLIC ARMOR -45° DV BEVEL
GEOMETRY IMPROVED WITH LARGER ANNEALING BEADS.

.40 C REPUBLIC ARMOR -45° DV BEVEL -
GEOMETRY IMPROVED BY BEVELING CORNERS TO
GIVE A 67½° ANGLE AT CROWN.

FIG. 3 BEND BAR FRACTURES OF 1½ INCH THICK ROLLED AUSTENITIC HAND WELDED ARMOR PLATE
SHOWING INFLUENCE OF WELD JOINT GEOMETRY ON PATH OF FAILURE. WTN.121-595

Almost identical fractures were obtained in bend fracture tests from joints made with similar joint design and welding procedure in Carnegie and Jones & Laughlin armor plates of approximately .26% C. An attempt was next made to improve the bend fracture by changes in the joint design. The use of a 60° rather than a 45° included angle did not change the type of failure. The use of larger beads (3/16 instead of 5/32 inch diameter electrodes) at the weld plate junction for both crowns of the double V joints, did effect considerable improvement both for .26% C Carnegie and Jones & Laughlin and the experimental .40% C armor plates. A further improvement was brought about by grinding additional bevels (1/4 inch wide) at the top corners of the crowns, and continuing the use of the 3/16 inch diameter electrode for the corner beads. Photographs of three bend fracture bars from this series of welds are shown in Figure 3. The improvement is obviously a result of relocating the stress-concentrating notch, which is unavoidably present at the junction of the weld and plate surfaces, so that failure is not initiated in the fusion zone, and of breaking up the straight line fusion zone contour observed in the photomicrographs of Figures 1 and 2. It is well established that if ballistic cracking is

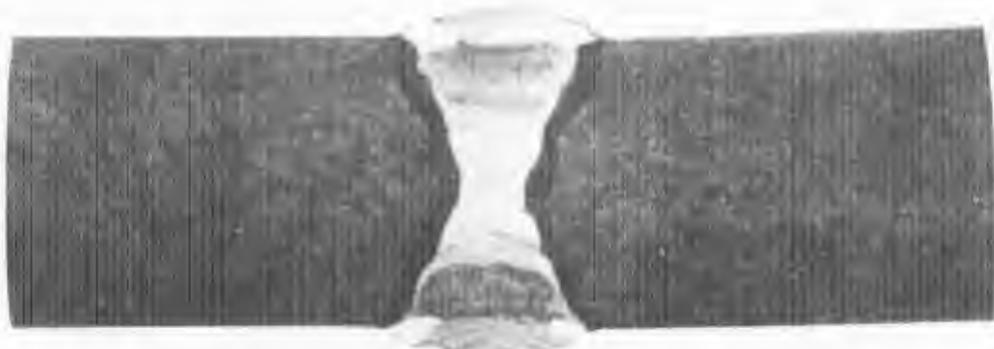
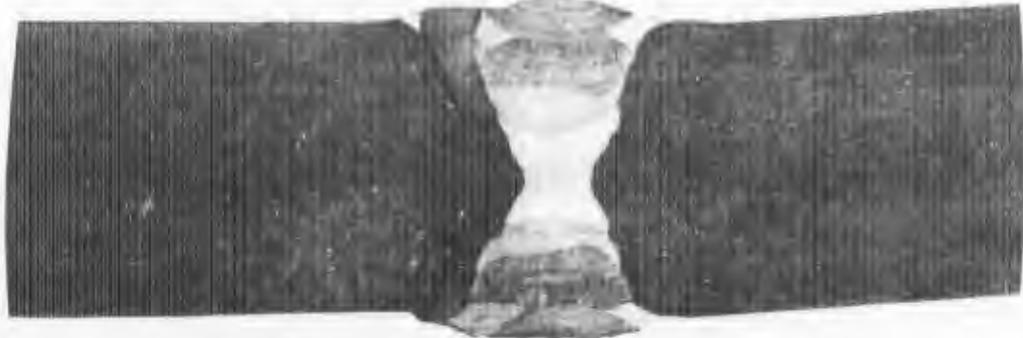
Figure 5

Macroetched transverse section through undamaged portion of weld joint.

Macroetched transverse section through ballistic fracture.

Bend bar fractures.

Macroetched Sections and Bend Bar Fractures from 1 1/2 Inch Thick Austenitic Hand Welded .26% C Jones and Laughlin Armor "H" Plate WA-10 - Initial Joint Design.

Figures 4 through 9 show photographs of the two Jones & Laughlin and one experimental plates after ballistic testing; macroetched sections through ballistic impacts; macroetched sections through undamaged portions of welds; bend fracture tests from undamaged portions of Jones & Laughlin welds; and nick-break fracture*. The limited depth of ballistic cracks which appear to have initiated in the tempered band at the outer edge of the weld heat-affected base metal, and the favorable bend fracture for plate with improved joint design may be noted. The nick-break fracture test was made for comparison purposes and will be discussed in a later section on ferritic welds.

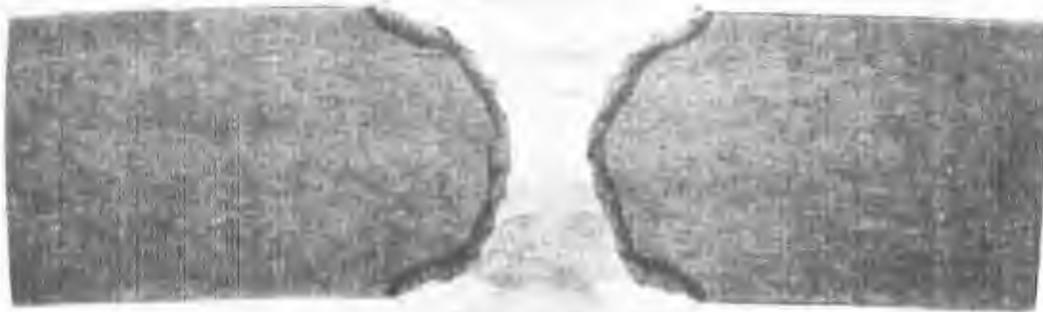
Figure 7

Macroetched transverse section through undamaged portion of weld joint.

Macroetched transverse section through ballistic cracking.

Bend bar fractures.

Macroetched Sections and Bend Bar Fractures from 1 1/2 Inch Thick Austenitic Hand Welded .26% C Jones and Laughlin Armor "H" Plate WA-12 - Improved Joint Design.

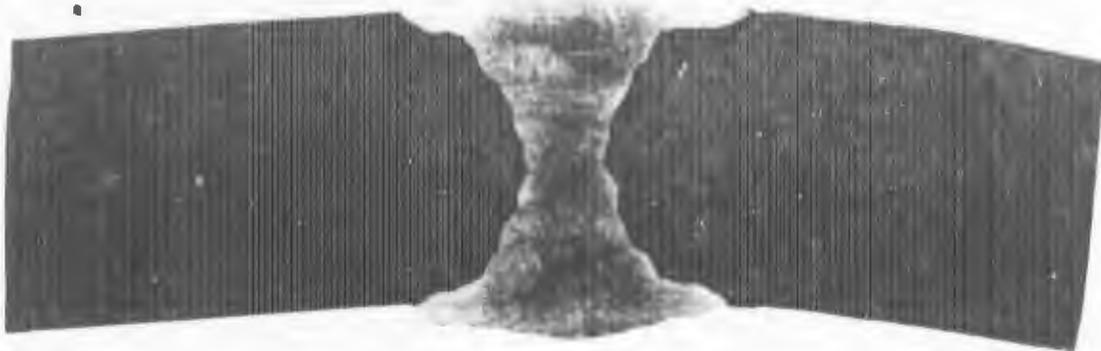
Figure 9

Macroetched transverse section through undamaged portion of weld joint.

Macroetched transverse section through ballistic cracking.

Nick-break fracture.

Macroetched Sections and Nick-Break Fracture from 1 1/2 Inch Thick - Austenitic Hand Welded .40% C Republic Armor "H" Plate WA-9 - Improved Joint Design.

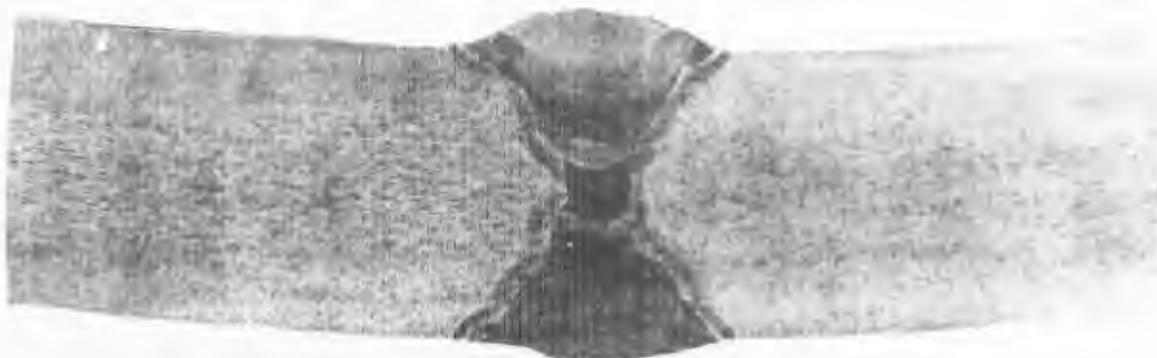
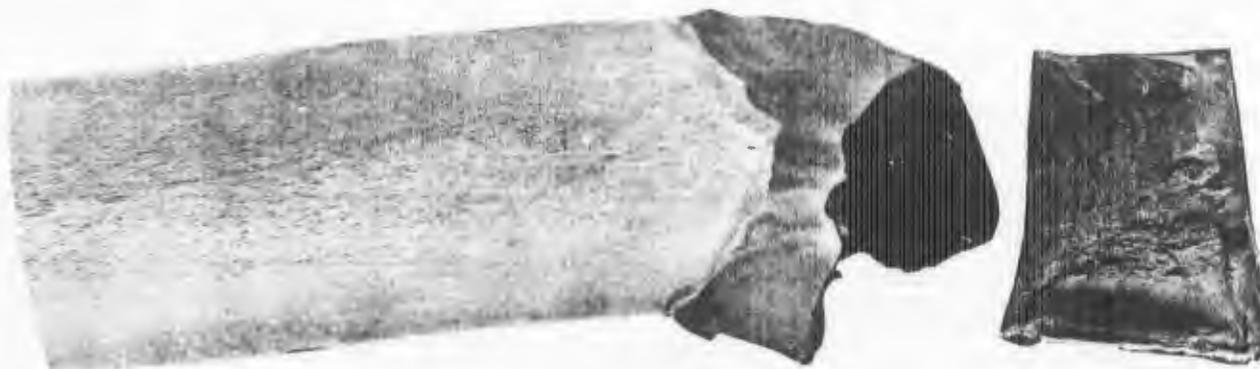
Figure 11

Macroetched transverse section through undamaged portion of weld joint.

Bend bar fracture.

Nick-break fracture.

Macroetched Section and Fracture Specimens from 1 1/2 Inch Thick Ferritic Hand Welded .40% C Republic Armor "H" Plate WA-7.

Two "H" plates, WA7 and WA8, were welded at Baldwin Locomotive Works with ferritic electrodes. The Harnischfeger AW20 electrode with stainless type (lime base) coating was used. Preliminary welding on plate WA4 indicated that a 200° F. preheat was insufficient to prevent excessive weld metal cracking (detectable during welding) and this plate was abandoned after being partially welded. The supervisor of welding research for the National Research Council was consulted since his office has sponsored a large amount of development welding with this electrode. Mr. H. J. Zoog of the N.R.C. Welding Research Staff was appointed to supervise welding of plates WA7 and WA8. The two plates were welded with a joint design and welding procedure (see Chart 4 and extract from WAS-2 Form - Appendix A) selected by Mr. Zoog. A preheat of 300° F. and an interpass temperature of 350° - 400° F. were maintained during this welding. Results of firing tests at Aberdeen Proving Ground indicated very excellent ballistic shock resistance for both of the plates (see Chart 4 - Appendix A). A photograph of one of the plates after ballistic testing is shown in Figure 10. Photographs of a macroetched section, and nick-break and bend-fracture specimens are shown in Figure 11. The bend-fracture showed weld metal failure after considerable deformation. The nick-break test was made to see if the relatively high preheat and interpass temperatures had caused loss of toughness in the heat-affected zone (as a result of slow cooling after being heated above the critical hardening temperature during the welding operation). However, comparison with the nick-break fracture specimen for the austenitic weld (Figure 9) indicates that this very severe test developed no crystalline (slack-quench, shock-deficient) structure in either weld heat-affected zone. The ferritic weld metal itself developed only a very small amount of crystallinity and may therefore be judged as relatively tough.
