March 6, 1936

Preliminary Heat Treatment  
of  
Chromium Plated Steel

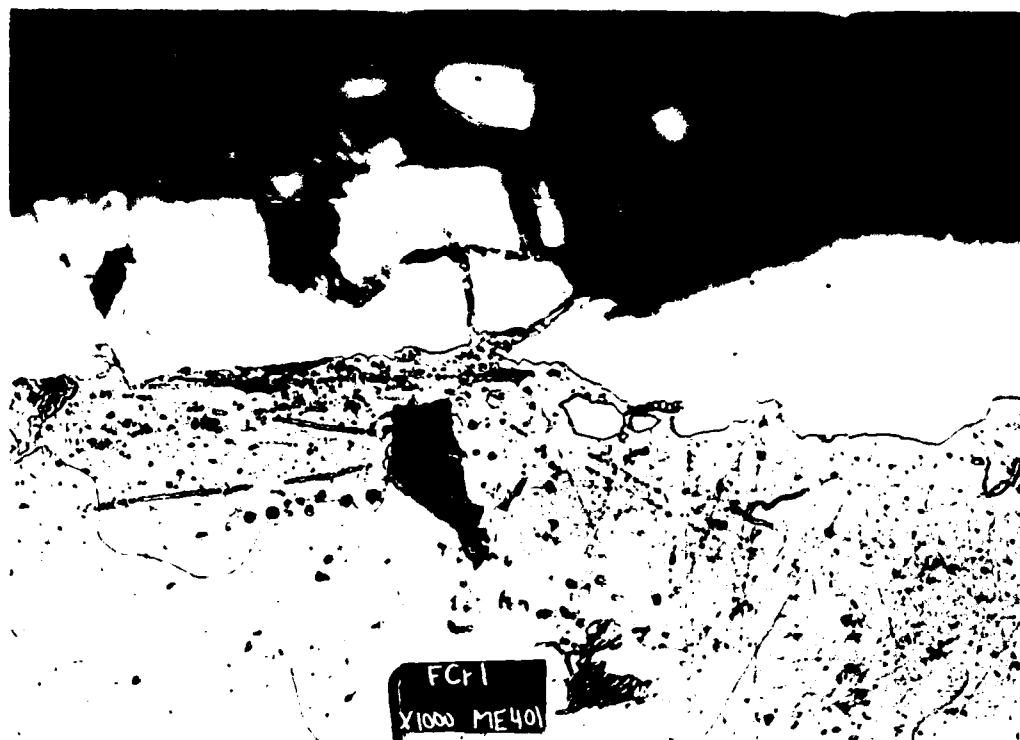
FIG. 2

Figs. 2 & 3 X1000 F Cr 1 Show areas of expoliation of  
the plate. ME 401, 402

1. The thin layer specimens showed many spots where the plating had not adhered. The spots showed up as spongy or porous areas. There were places where the plate showed signs of exfoliation. There were also many more or less radial cracks. Such conditions would afford little corrosion resistance.

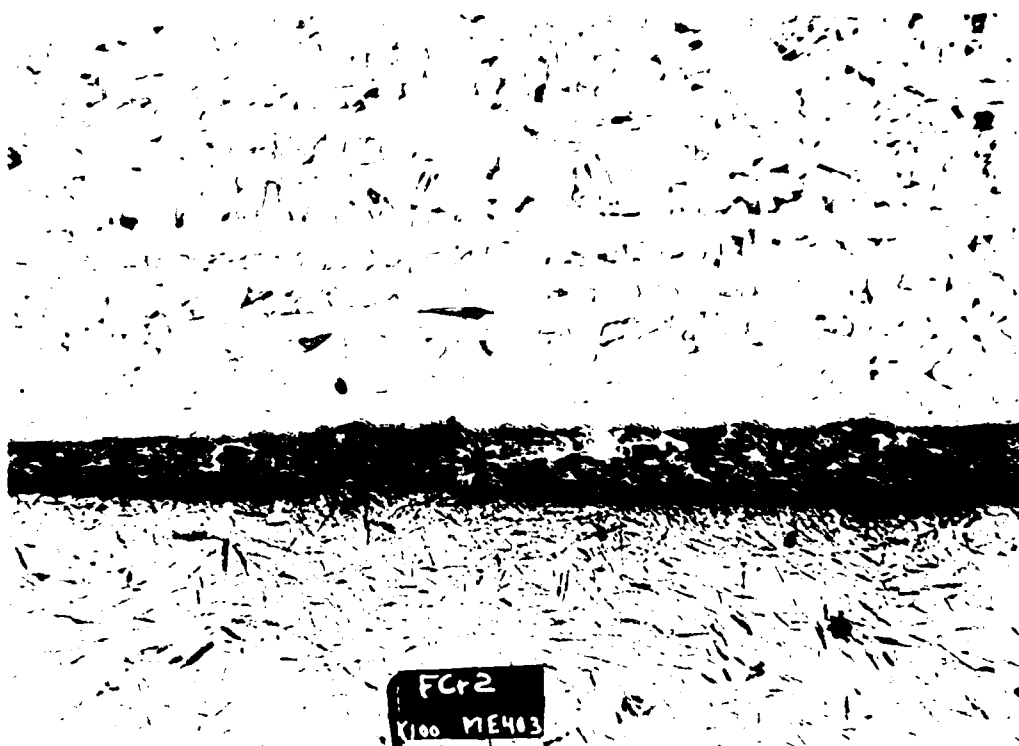
FIG. 4

Fig. 4 X100 F Cr 2 Shows the plating to be discontinuous.  
ME 403
