U.S. EXPERIMENTAL MODEL BASIN  
NAVY YARD, WASHINGTON, D.C.

WELDING TEST NO. 170

INVESTIGATION OF WELDED BUTTS AND SEAMS IN S. T. S.  
SUBJECTED TO BALLISTIC IMPACT - REPORT OF TENSILE  
AND BEND TESTS

Report R-106

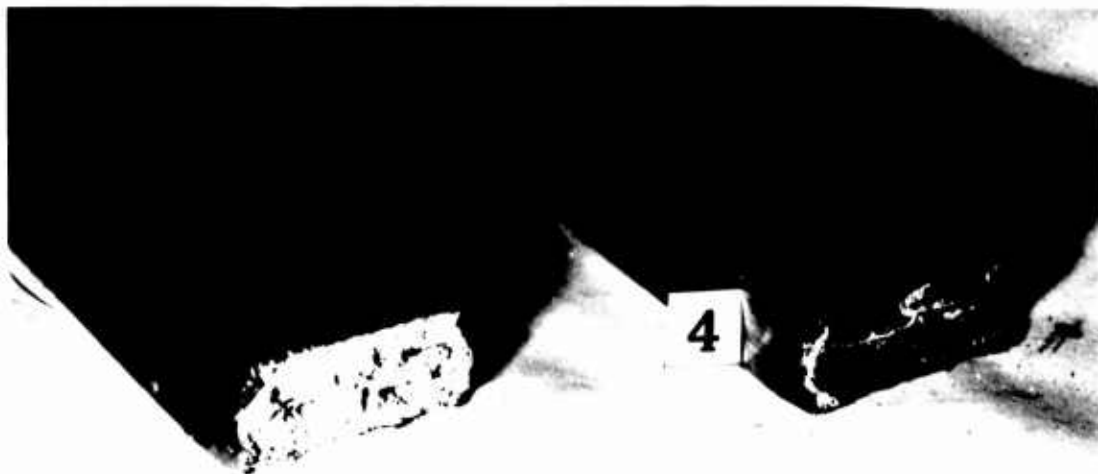
Specimen No. 4 - Machined butt weld.

Tensile strengths are given in Table 1. Fractures are shown in the accompanying photographs, Fig. 1-5. The different specimens arranged in order of decreasing tensile strength are as follows: base metal, "as deposited" scarp weld, machined scarp weld, "as deposited" butt weld, machined butt weld. Results were quite consistent. The base metal ultimate strength averaged 114,400 lbs. per sq. in. The welded specimens developed 75 per cent to 88 per cent of the strength of the plate.

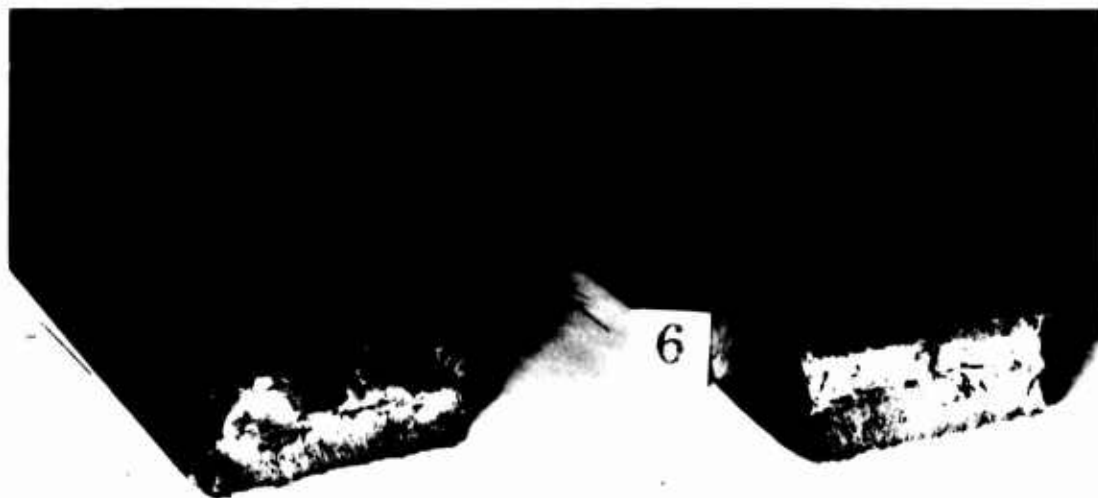
Specimen No. 6 - Machined butt weld.

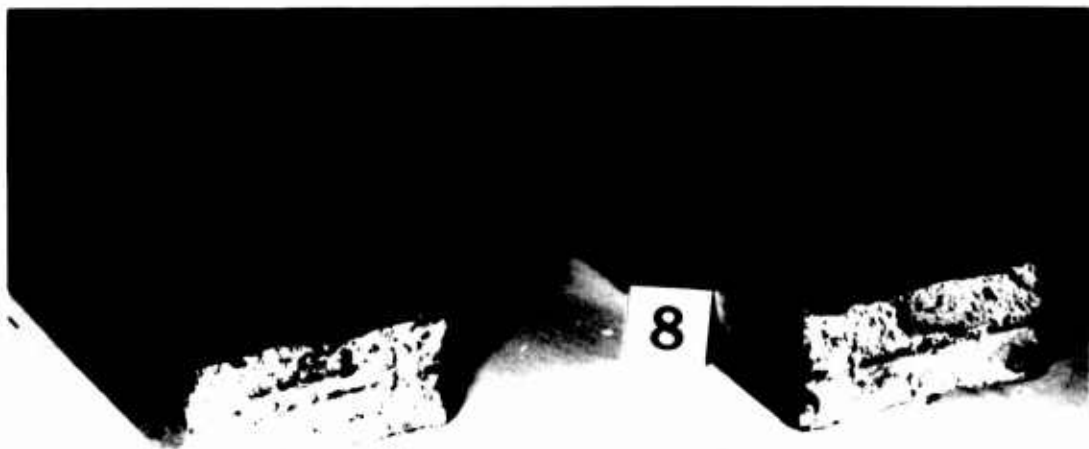
Specimen No. 8 - "As deposited" butt weld.

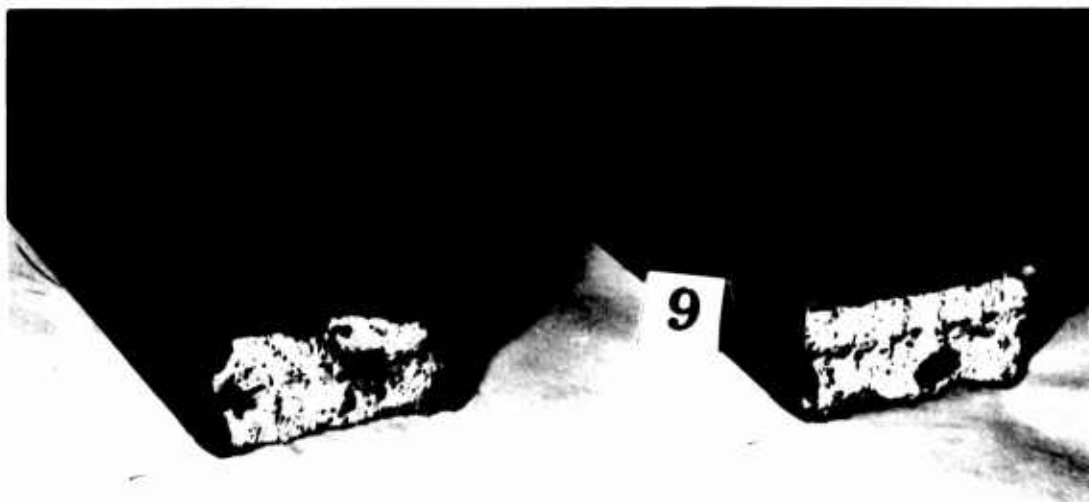
Specimen No. 9 - "As deposited" butt weld.

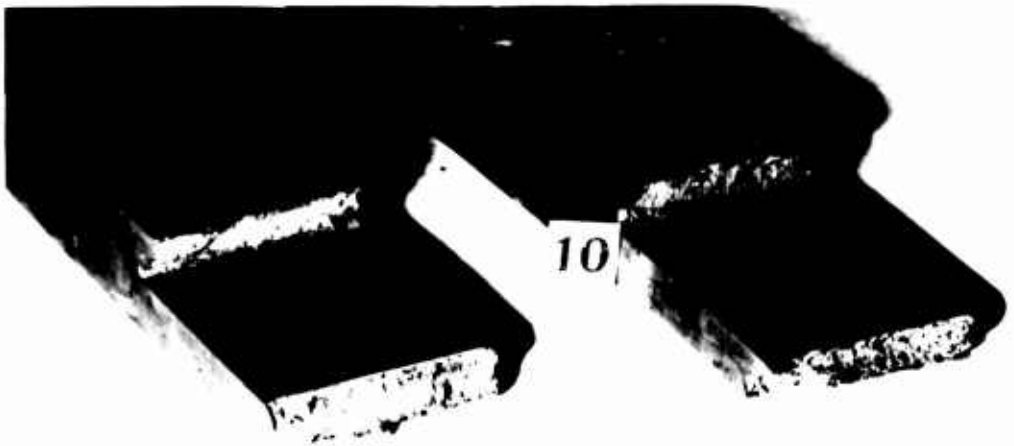
Specimen No. 10 - Scarph, machined weld.

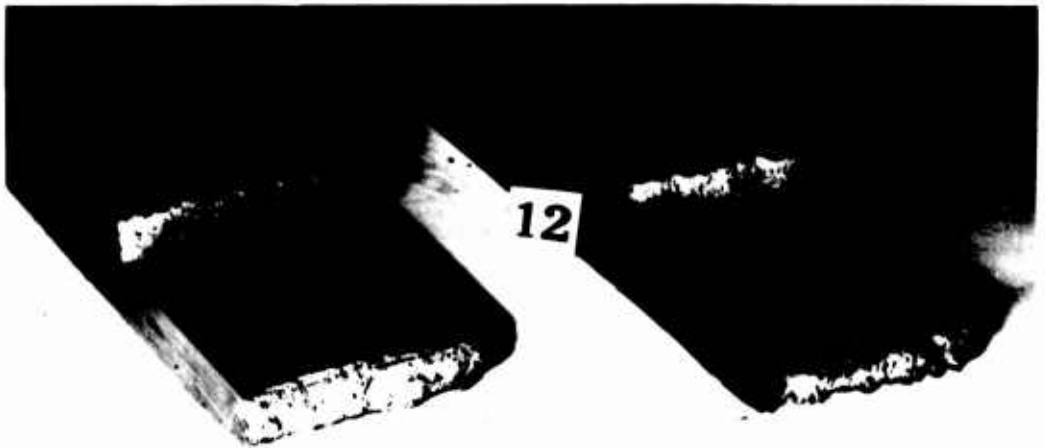
Specimen No. 12 - Scarph, machined weld.

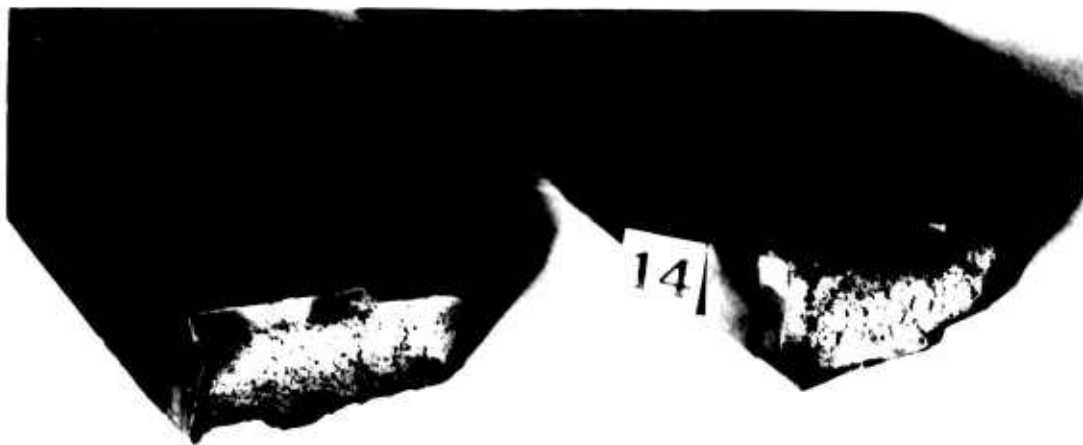
Specimen No. 14 - Scarph, as deposited weld.

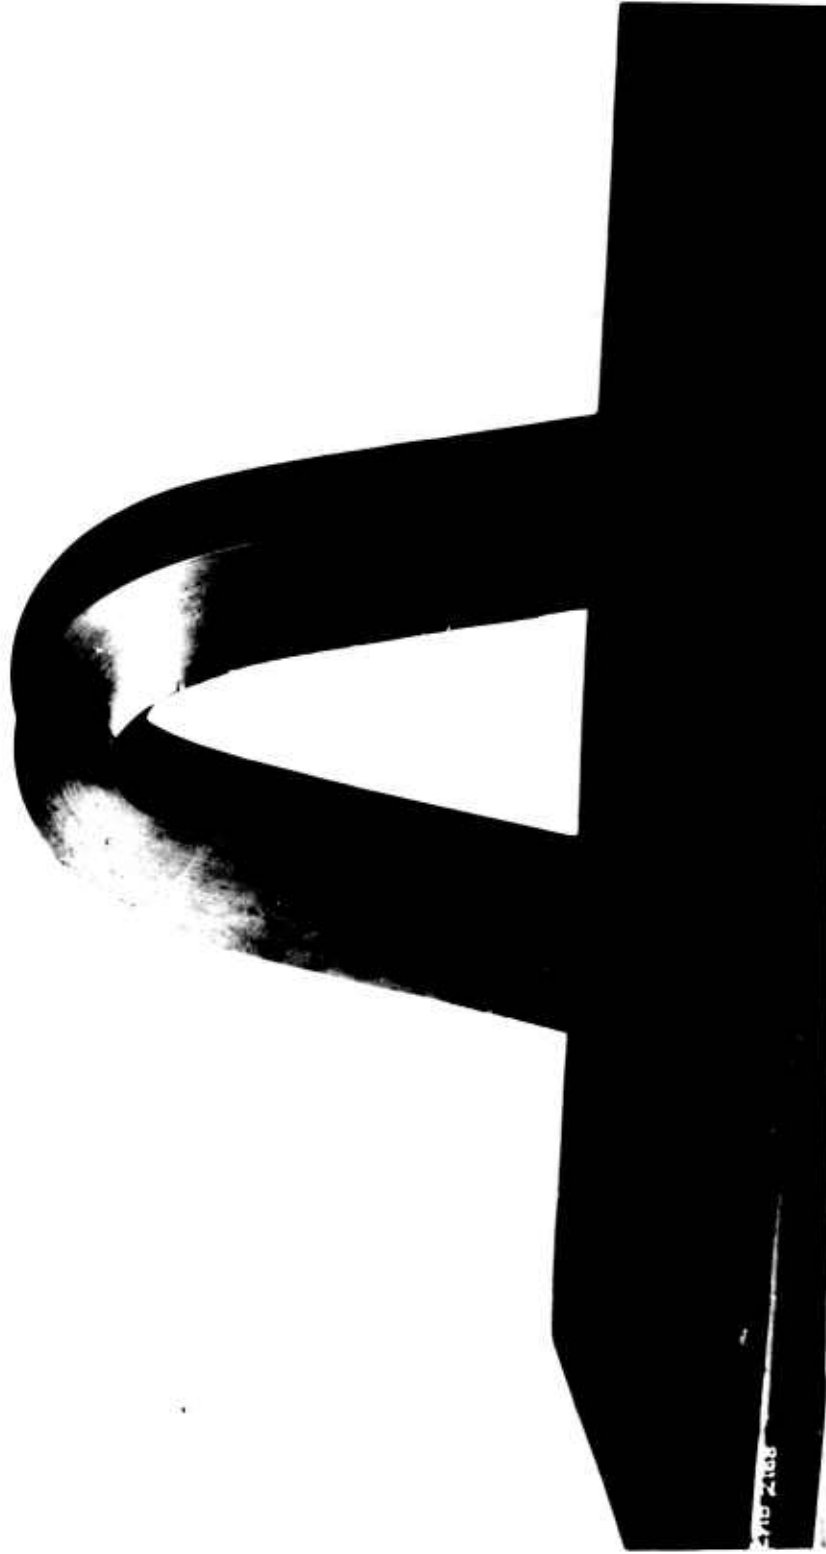
Specimen No. 3 - Base Metal.

Bend test results are given in Table 2. The photographs, Fig. 6-10 show the specimens after test. The base metal specimen was bent to an angle of 180° without failure. The failure of the butt welded specimens was gradual, the machined butt being a little more ductile than the "as deposited". However, it is to be noted that the machined specimen failed through the weld while the "as deposited" failed in the bend. (Fig. 7 and 8). The scarp joints failed with a sharp fracture, the "as deposited" joint being considerably more ductile than the machined joint. This apparently increased ductility of the scarped joints is probably due to the method of testing whereby the maximum curvature came at the center of the weld for the butt welded specimens and between the welds for the scarped specimens.

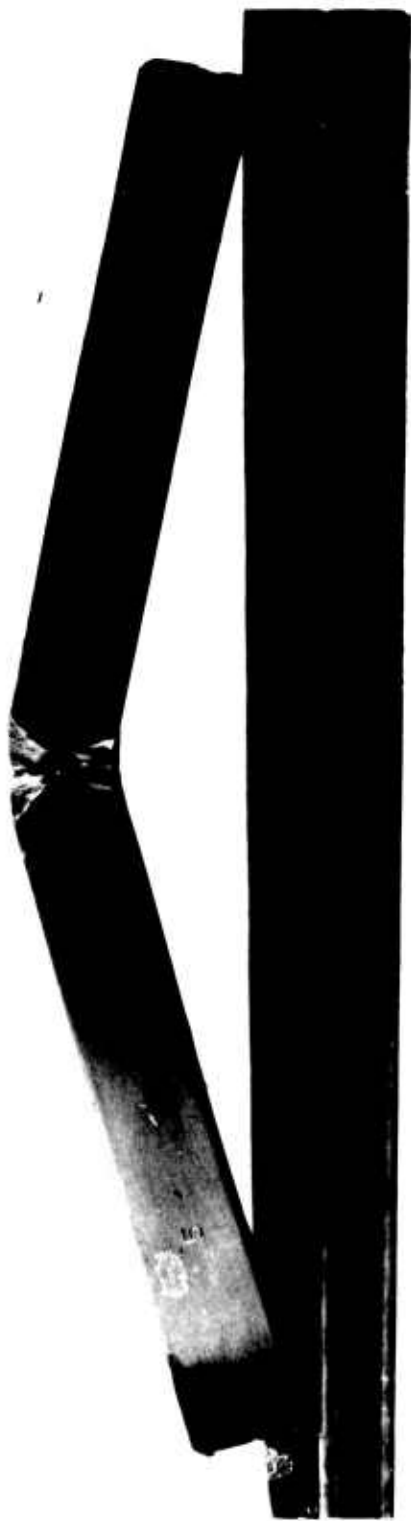
**Specimen No. 5 -- Machined butt weld.**
