REPORT NO. 710/375

METALLURGICAL EXAMINATION OF  
TWO HEAVE CAST ARMOR PLATES

June 12, 1941

WATERTOWN ARSENAL  
WATERTOWN, MASS.

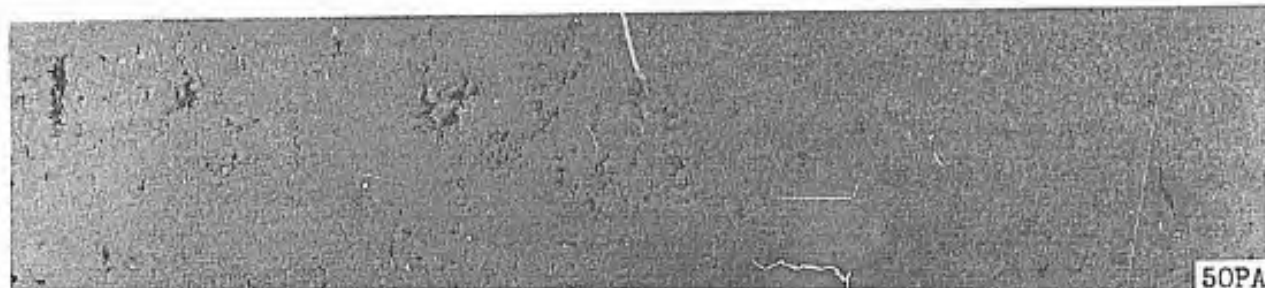
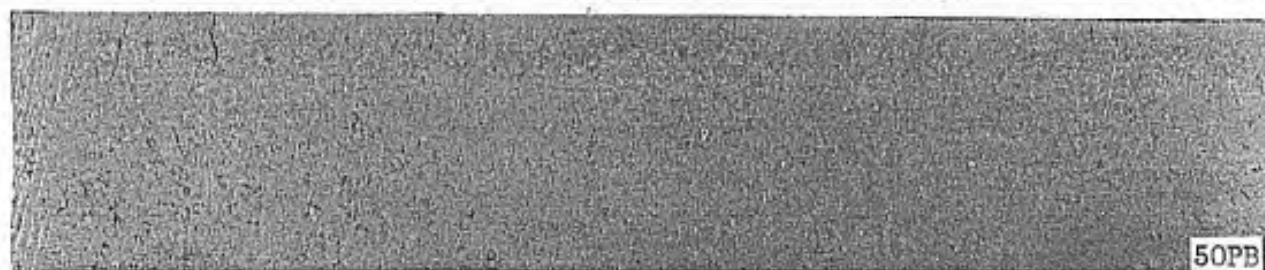
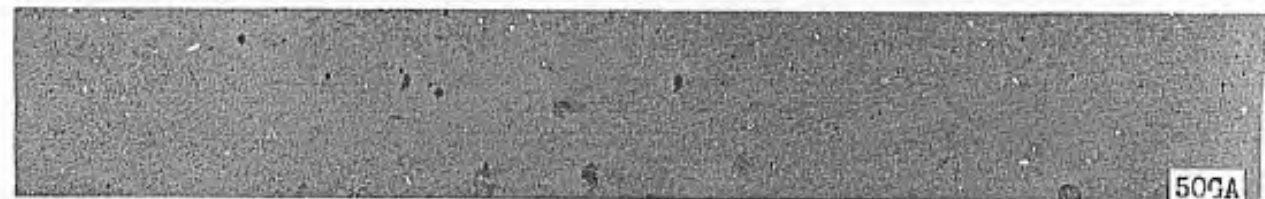
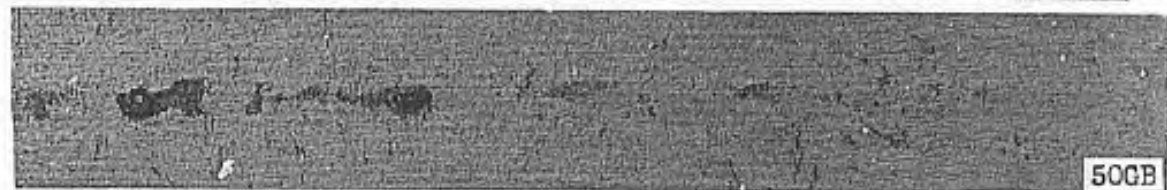
FIG. I

Area "A" - The metal shows a quite coarse dendritic structure throughout with prominent interdendritic segregates and occasional small cracks.

Area "B" - The macrostructure and the dendrites in this section are as coarse as those described for Area "A", but the interdendritic segregates are not as extensive.

Area "1." - A reasonably fine dendritic structure is seen throughout this section. The segregations noted are similar to sulphide-rich impurities.

Area "2" - This metal shows very heavy segregations in the mid-wall portion, and short quite prominent cracks.

1. Unsound metal due to casting defects, see Figure #1.
2. Extremely large grain size, see Figure #5.

- 3. Short prominent cracks, see Figure #1.
- 4. Carbon content on the high side. See Table below.

Generally speaking the 3 inch cast plate had quite a coarse dendritic structure with prominent interdendritic segregates and occasional cracks. In the case of the 15 inch grate casting rather heavy segregations associated with quite prominent cracks were present in the mid-wall portion, see Figure #1. The size and distribution of the dendritic segregation in both plates is shown in Figure #2.

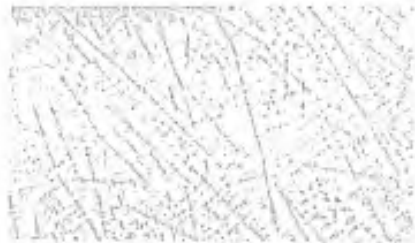
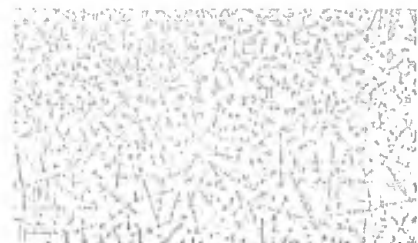
Figure 2

Dendritic Structure of 3" Plate

Area "A" - Specimen 50-P-A

A coarse dendritic structure.

Area "B" - Specimen 50-P-B

A mixture of fine and coarse dendrites.

Area "A" - The metal shows a coarse dendritic structure.

Area "B" - The metal shows a mixture of fine and coarse dendritic structure.

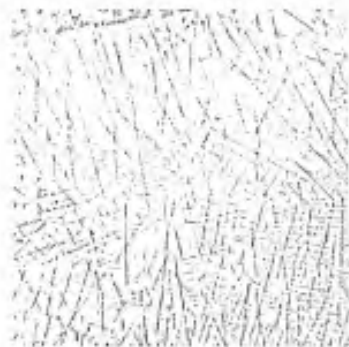
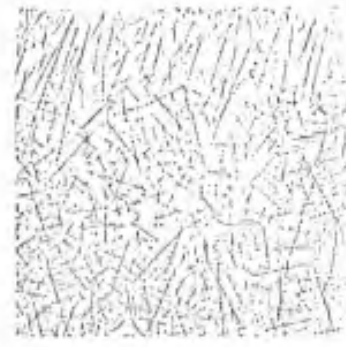
Dendritic Structure of 15" Grate Casting

Area "A" - Specimen 50-G-A

A medium coarse dendritic structure.

Area "B" - Specimen 50-G-B

A fairly coarse structure.

Area "A" - A medium coarse dendritic structure is present.

Area "B" - A fairly coarse dendritic structure is evident.

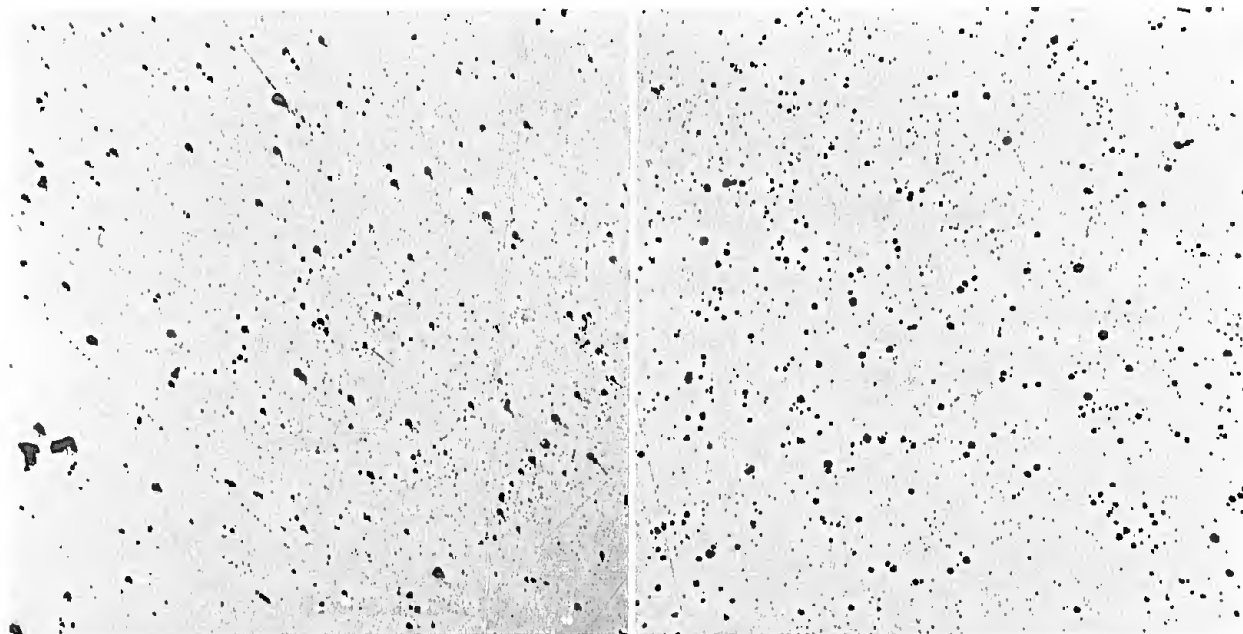
Figure 3

Non-Metallics in 3" Plate

Area "A" - Specimen 50-P-A

Large, round inclusions in a background of numerous fine non-metallics.

Area "B" - Specimen 50-P-B

Same type and distribution of the non-metallics as in Area "A", but slightly dirtier.

Microscopic examination of samples cut from the 3 inch plate and the 15 inch grate casting showed in each case fairly well distributed nonmetallic inclusions. The amount of nonmetallics evident was considerable; and although no information is available to indicate a detrimental effect, it is believed desirable to reduce the amount of nonmetallics as much as possible.

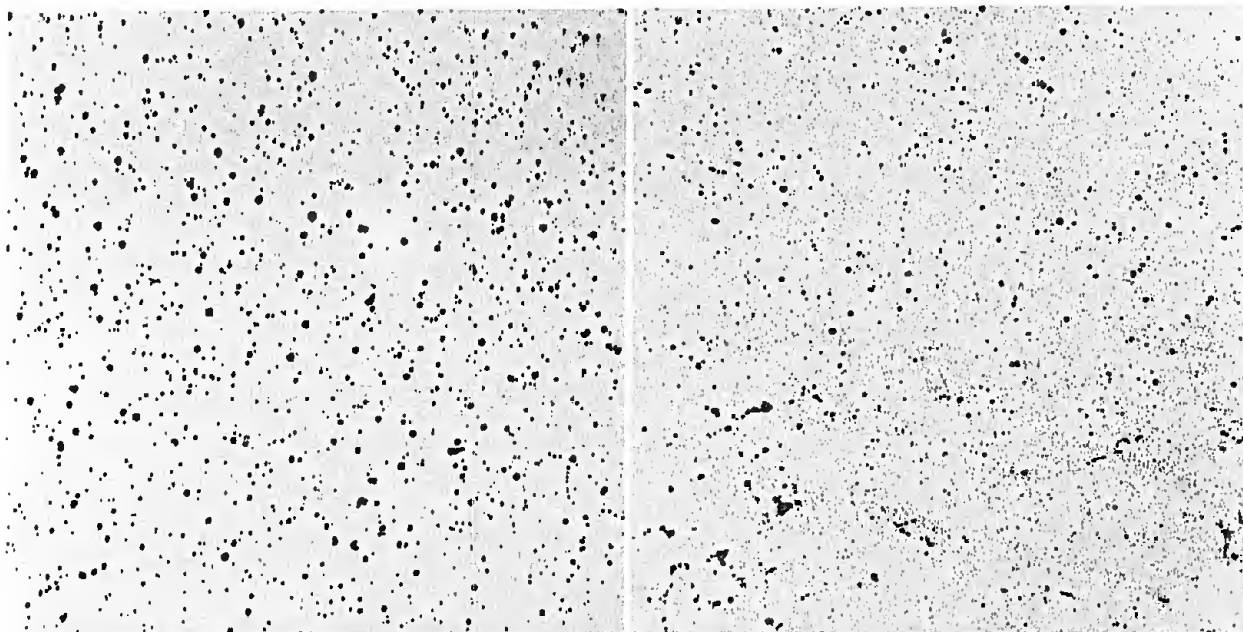
Non-Metallics in 15" Grate Casting

Area "A" - Specimen 50-O-A

A great many large, round inclusions, with a small amount of fine non-metallics present.

Area "B" - Specimen 50-O-B

Large, round inclusions in an extremely dirty background of fine non-metallics.

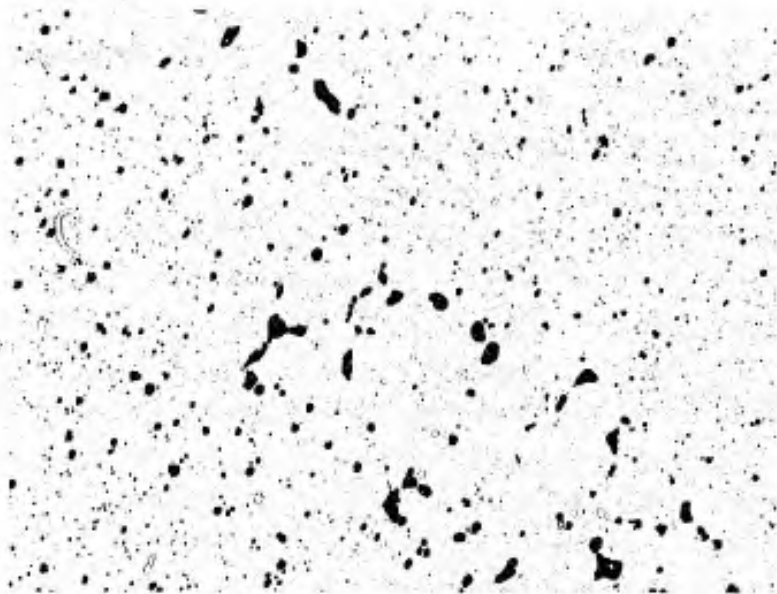
Figure 4

Porosity in 3" Plate

Area "A" - Specimen 50-P-A

Porosity in Specimen 50-P-A. The large black irregular areas are gas holes. This is the worst field found. There are in addition a few scattered gas holes in the specimen. Specimen 50-P-B has no field comparable to this, there being only a few gas holes in the specimen.

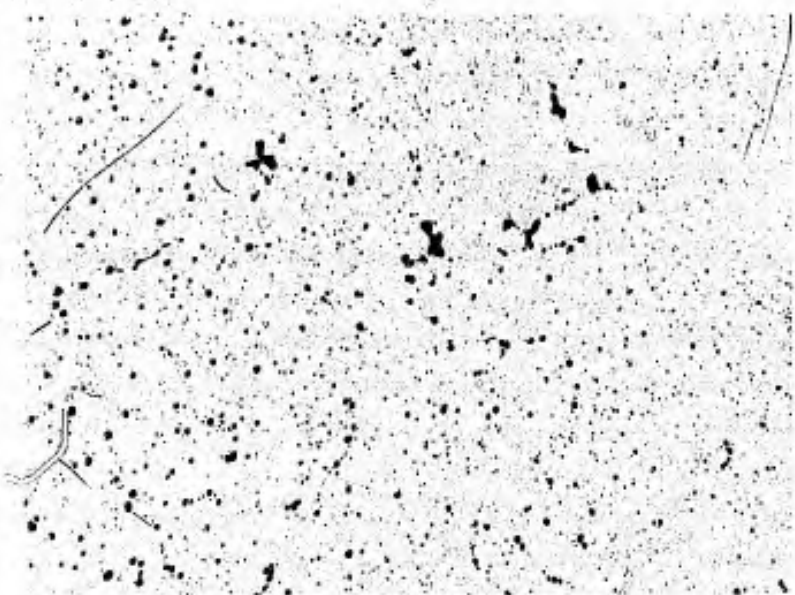
Porosity in 15" Orate Casting

Area "B" - Specimen 50-G-B

Porosity in Specimen 50-G-B. The large black irregular areas are gas holes. There are only a few fields as bad as this. In addition there are several scattered gas holes in the specimen and also in Specimen 50-G-A.

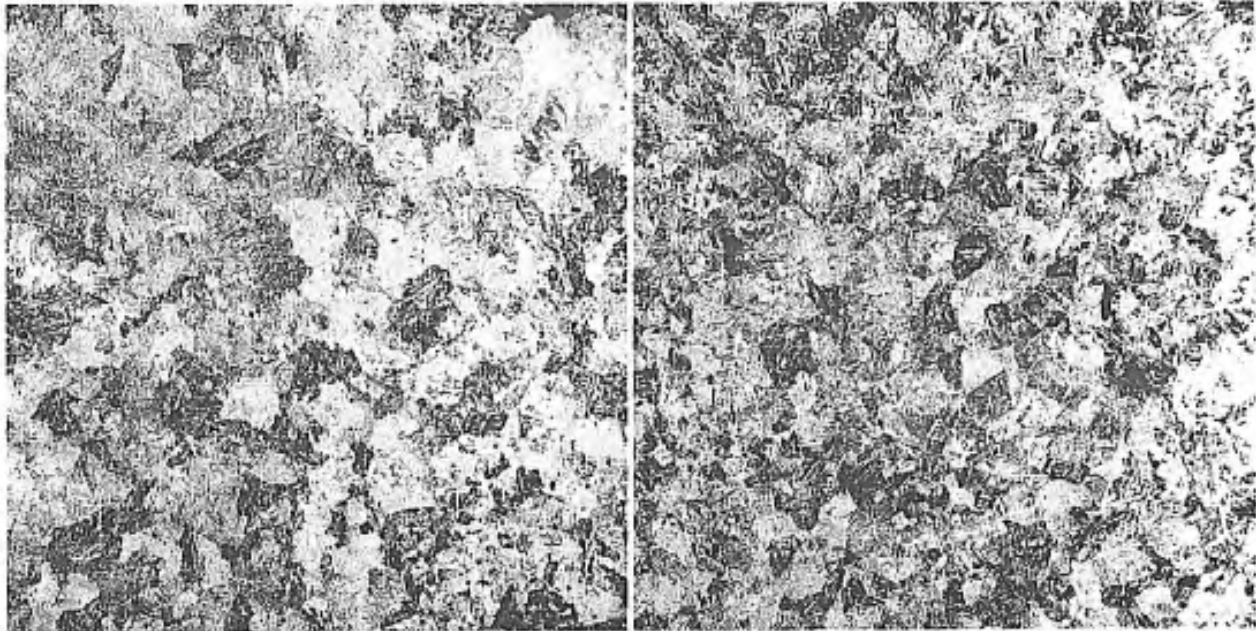
Figure 5

Grain Size of 3" Plate

Area "A" - Specimen 50-P-A

Grain size index number 1.

Area "B" - Specimen 50-P-B

Grain size index number 1-2.

The general structure was sorbitic and the materials possessed a very coarse grain size of Number 1 rated on the A.S.F.M. grain size scale. Only traces of net work grain boundary carbides were evident.

Figures #3 to #7 illustrate the microstructure of the 3" plate and the 15" grate casting. Both castings had an A.S.T.M. grain size No. 1. Recent investigations made at Rock Island Arsenal and this Arsenal indicate that a very large grain size such as reported in this material is correlated with poor ballistic properties. It has been determined to date that good quality cast armor should possess a grain size not larger than No. 6 A.S.T.M. grain size. The variation in the ductility values of the two castings, especially that of the 15 inch grate casting

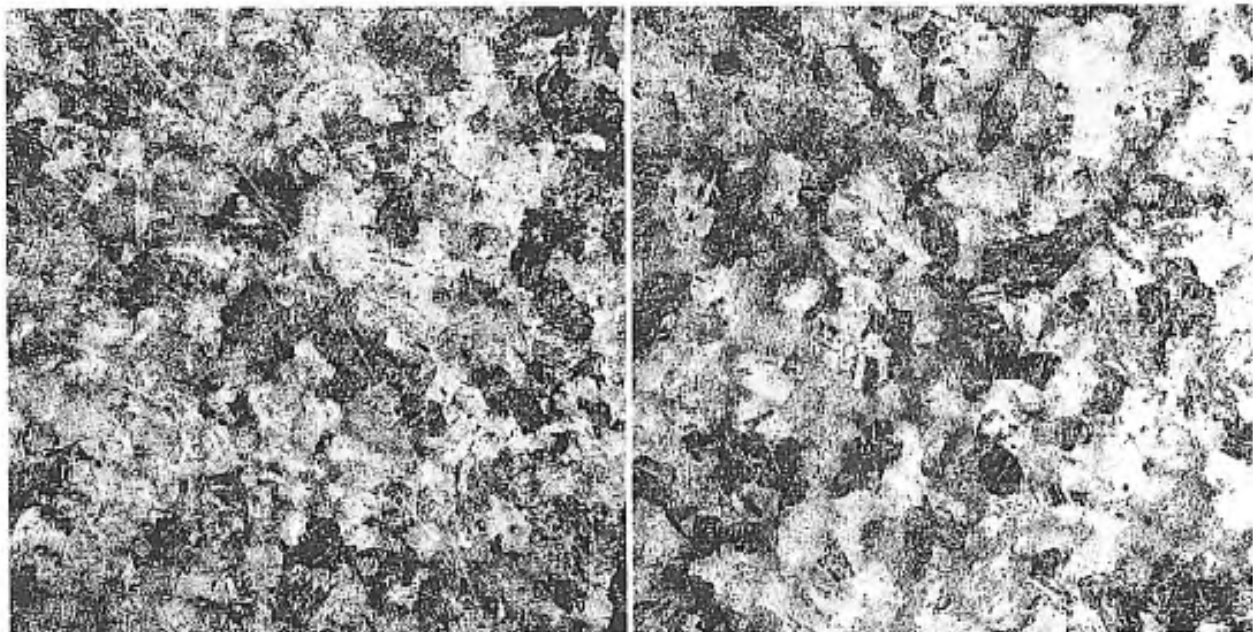
Grain Size of 15" Grate Casting

Area "A" - Specimen 50-G-A

Grain size index number 1.

Area "B" - Specimen 50-G-B

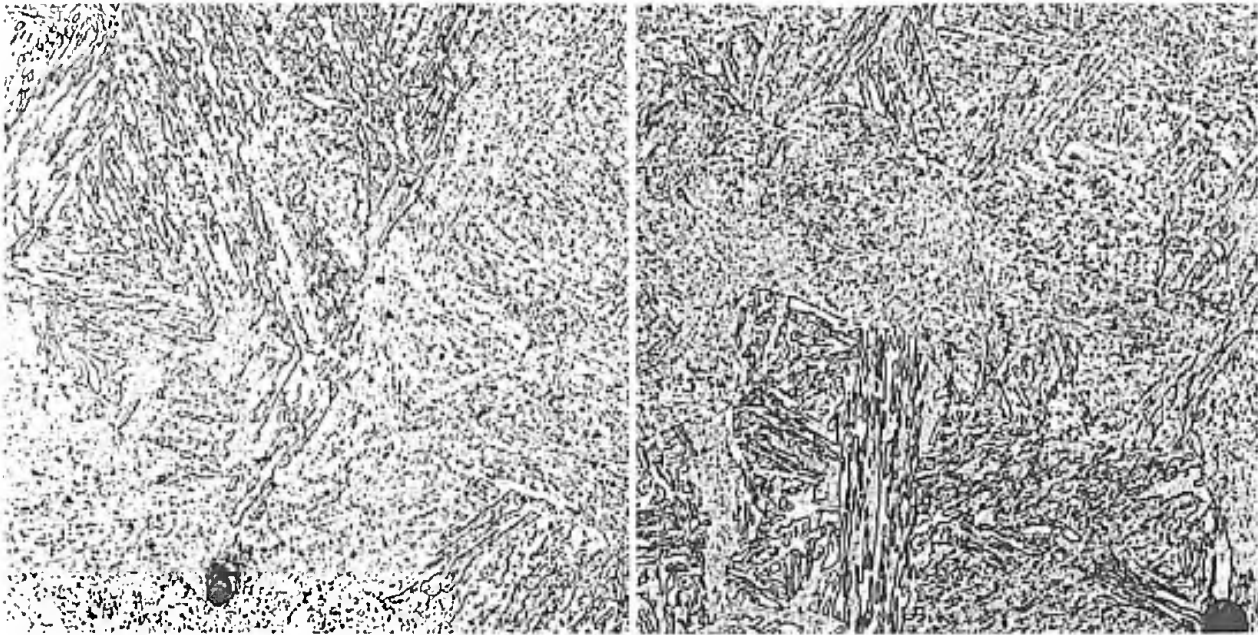
Figure 6

#### Microstructure of 3" Plate

Area "A" - Specimen 50-P-A Brinell 217

A coarse pseudo-martensitic sorbite having pronounced but fairly uniformly distributed micro-segregation. The triangular formation is most prominent in the dark grains (see Figure 5) which are of different chemical composition than the light grains.

Area "B" - Specimen 50-P-B Brinell 217

Exactly the same as above.

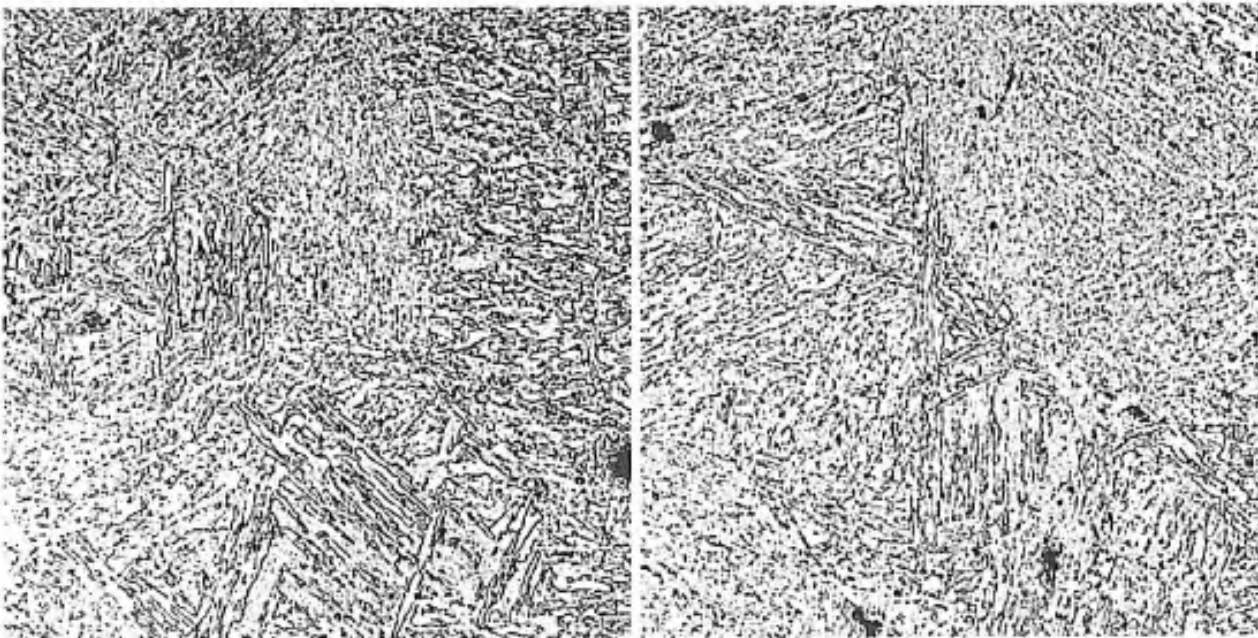
#### Microstructure of 15" Grate Casting

Area "A" - Specimen 50-G-A Brinell 228

The same as 50-P-A and 50-P-B.

Area "B" - Specimen 50-G-B Brinell 228

The same.

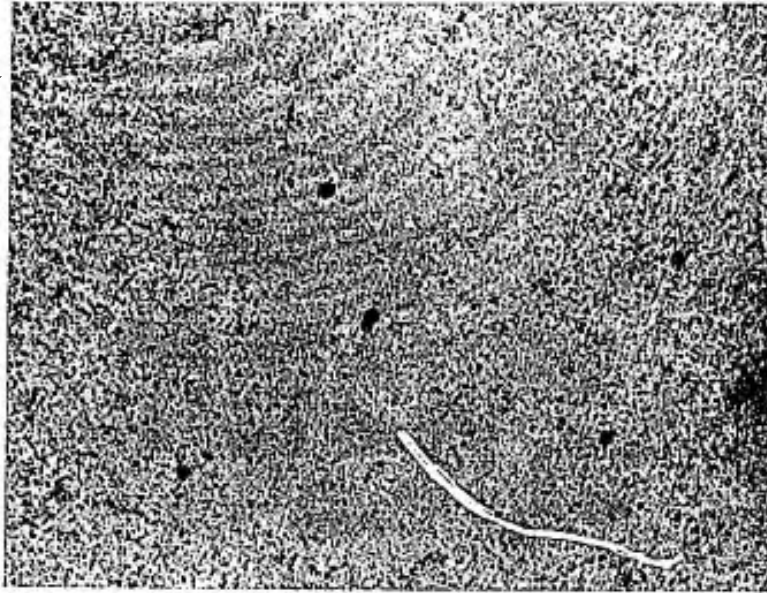
Figure 7

General Carbide Condition in Both Castings

Uniformly distributed carbides. The carbides were revealed by a ten minute etch in Kurakami's Reagent, which stains carbides black.

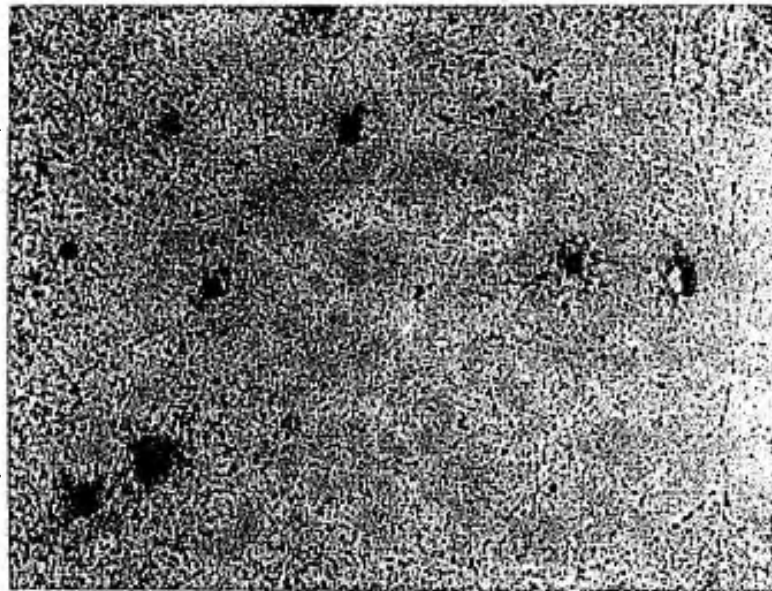
Evidence of Grain Boundary Carbides in Both Castings

Grain boundary carbide chains. Chains exist in only about 5% of each specimen.
