U. S. NAVAL PROVING GROUND  
DAHLGREN, VA.

EXAMINATION OF JAPANESE EQUIPMENT  
37mm ANTI-TANK AMMUNITION  
3-INCH A.A. AMMUNITION  
75mm HOWITZER AMMUNITION  
50mm MORTAR PROJECTILE  
50mm MORTAR GRENADE

REPORT NO. 5-43.

(9) CAPTURED ENEMY EQUIPMENT  
REPORT NO. 57

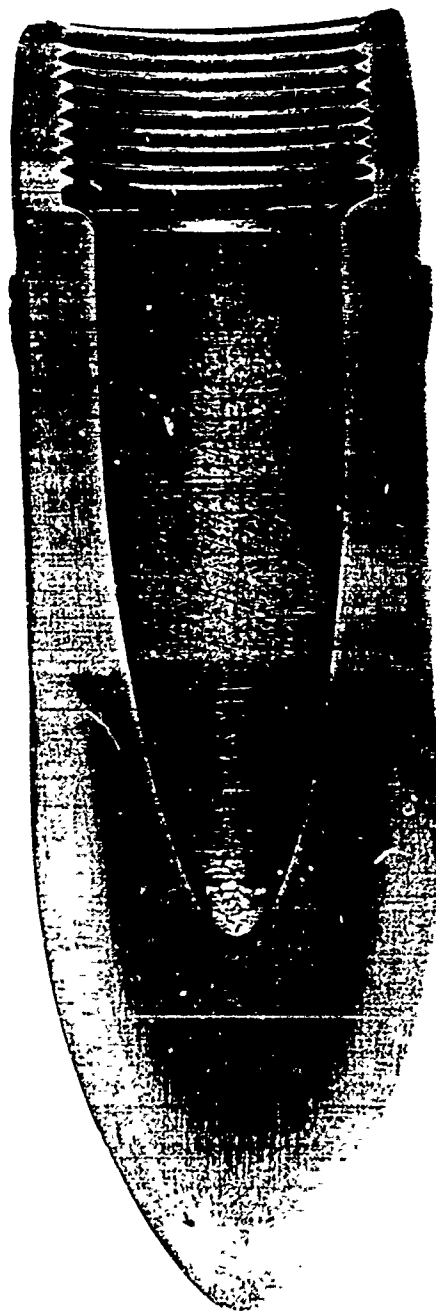
NP7 PHOTO NO. 610 (APL) - Examination of Enemy weapons.  
Report No. 57. Cross section of Japanese 57 mm. anti-tank projectile;  
lightly etched to show nature of heat treatments.

Etch: 5 minutes in floral.

A deep etch of the cross section of the projectile showed that it was machined from bar stock. NFG Photo. No. 610 (APL) shows a lightly etched cross section of this projectile; the nature of the heat treatments are clearly indicated. A study of the microstructure and hardness of the zones delineated by the light etch indicated that:

1. The lightly etched region on the nose surface represents a tempered martensitic structure of high hardness, 62 R.C. (80 Shore).
2. The deeply etched region in the center of the nose and extending to the cavity represents a structure arising from a partial reaction of the austenitized matrix to pearlite and martensite. The hardness varies from 55 R.C. (73 Shore) at the interface of the wholly martensitic region to 25 R.C. (40 Shore) at the cavity; at this point the structure is entirely pearlitic.
3. The remainder of the body and base, which show

even etching, represents a zone having a uniform hardness of 25 R.C. (40 Shore) and a normalized structure. The interface of this zone and the darkly etched zone shows almost complete spheroidization of this normalized structure. It would appear that the projectiles were heat treated as follows:

- (1) Normalized by holding at approximately 1400° F and air cooling.
- (2) Nose hardened by dipping 2-1/8 inches of the nose into a lead alloy pot held at approximately 1500° F for a definite time, followed by a timed oil quench.
- (3) Tempered at approximately 300° F.

On the basis of the distribution of the hardness and microstructure found in this projectile, it is believed that a serious weakness exists at a point immediately behind the bourrelet. (The hardness falls abruptly from 62 R.C. (80 Shore) to 25 R.C. (40 Shore)) which should cause this projectile to fail at this point on impacts involving appreciable obliquities.

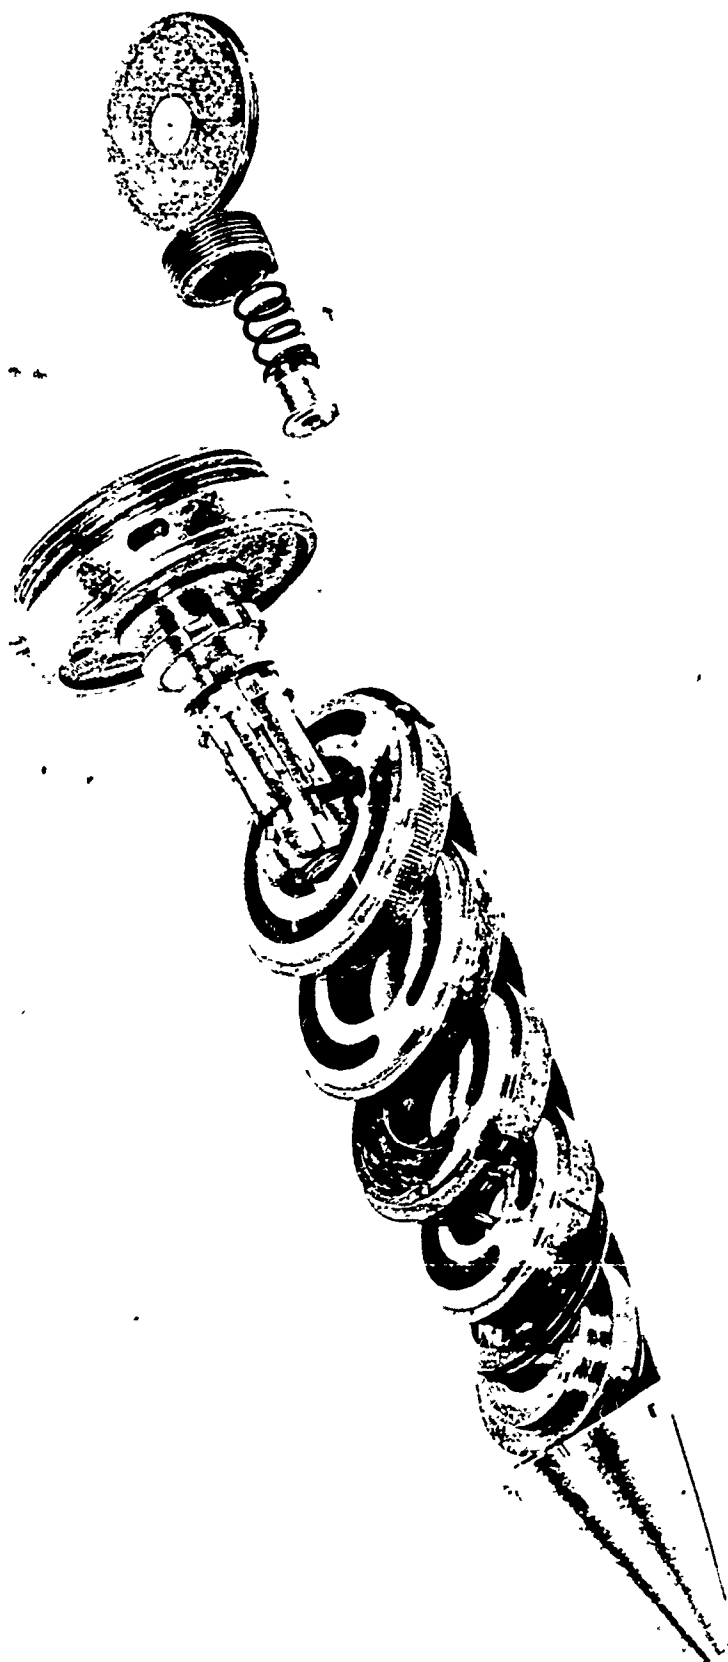
NPQ PHOTO NO. 629 (APL) - Examination of Metals from Enemy Weapons.  
Report No. 57. Component parts of Japanese 3 inch AA fuze.  
4 February, 1943.

NPG Photo. No. 548 (APL) shows the cartridge case and decoppering foil, NPG Photo. No. 629 (APL) shows the fuze components, NPG Photo. No. 251 (APL) shows a cross section of the projectile, and NPG Photo. No. 6030 (APL) shows a cross section of the cartridge case.

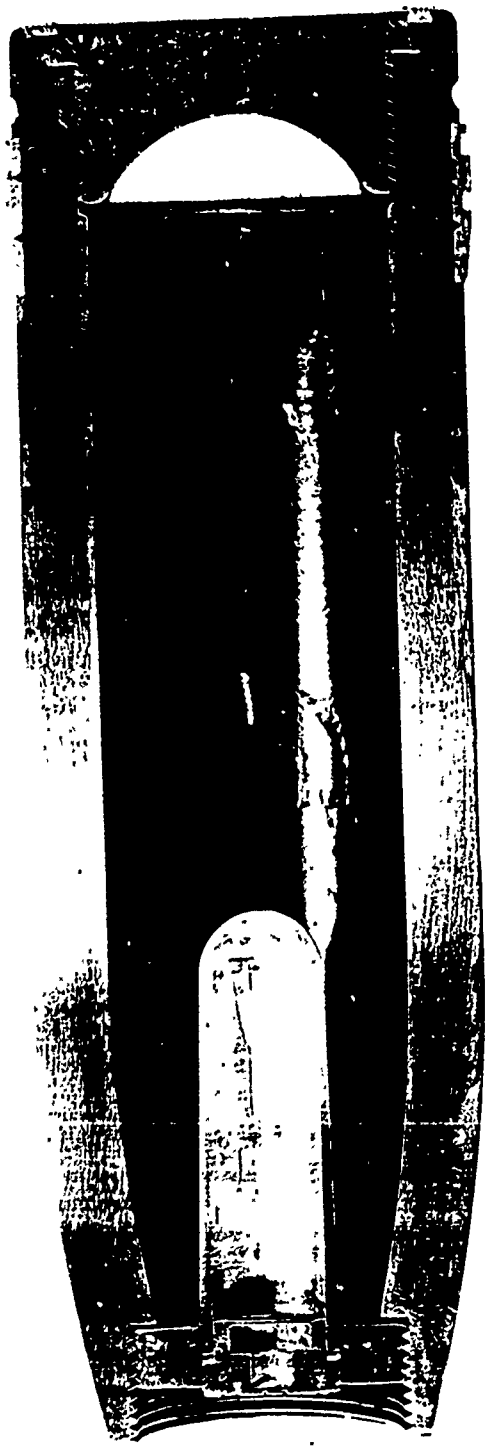
WFO PHOTO N. 251 (AFL) - Examination of pellets from enemy weapons.  
Report No. 47. Cross section of Japanese 3 1/2 in. projectile.  
Note wood section in base plus to prevent premature detonation

The projectile body contains a spherical section of wood, which is recessed into a conjugate depression in the base plug. This wood plug serves as a cushion for the filler on set-back.

The deep etched macrostructure indicated this steel to be sound and free from segregation of non-metallics; the flow figures were found to be parallel to the contour of the projectile in such a fashion as to indicate that it was formed by a draw forging operation.

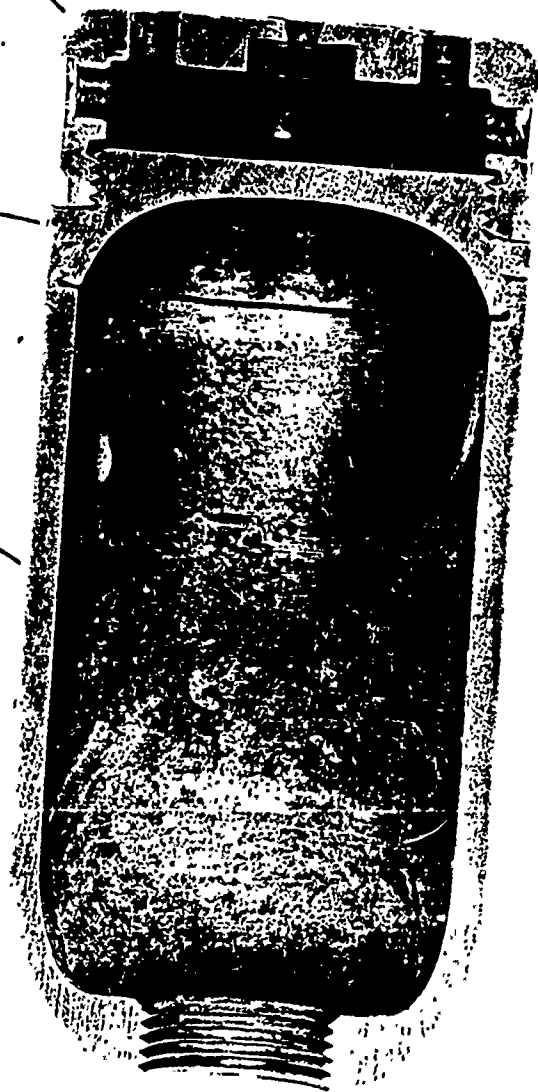
1 G PRO-10, 602 (1943) - Examination of Metals from Enemy Weapons.  
Report No. 57. Cross section of Japanese 50 mm. mortar projectile.  
4 February, 1943.

DISCHARGER

BASE

BODY

EXPANSION BAND

NPG Photo. No. 545 (APL) shows the component parts of this ammunition; the projectile body, base and discharger. A cross sectional view of the projectile is shown in NPG Photo. No. 602 (APL).

The design is that of a conventional mortar projectile with the exception of an attempt to secure increased forcing of the projectile by the use of a copper expansion band, which encircles the discharger. When the propellant charge is set off the resulting gas pressure which is built up in the discharger body, and subsequently against the base of the projectile, also acts to expand the copper band against the rifled bore of the mortar. Small copper pins are inserted between the expansible rotating band and the discharger body to prevent stripping. To prevent possible slapping, the forward part of the projectile has been machined to have a bourrelet.

The deep etched macrostructure of all three projectile components shows only longitudinal flow figures, indicating that these components were made by machining from bar stock.
