MTMC REPORT OA 7T-16

**AN ANALYSIS  
OF MTMC PARTICIPATION  
IN THE  
REFORGER 76 EXERCISE**

MARCH 1977

**MILITARY TRAFFIC MANAGEMENT COMMAND  
TRANSPORTATION ENGINEERING AGENCY  
NEWPORT NEWS, VIRGINIA 23606**

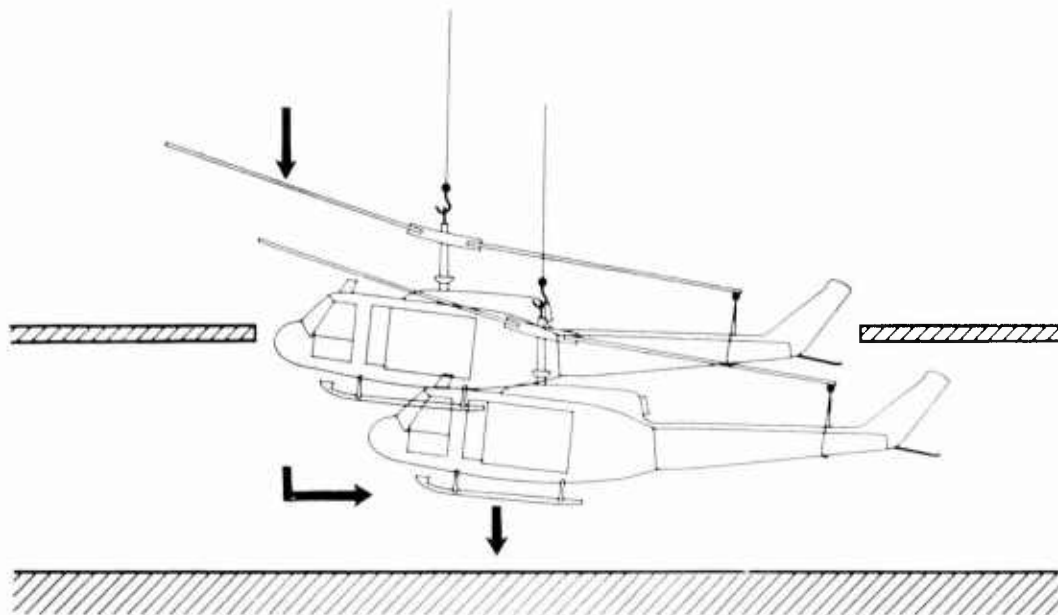
Figure 4-9. Concept for Lowering Helicopters With Main Rotor Blades Through the Vessel's Hatch.

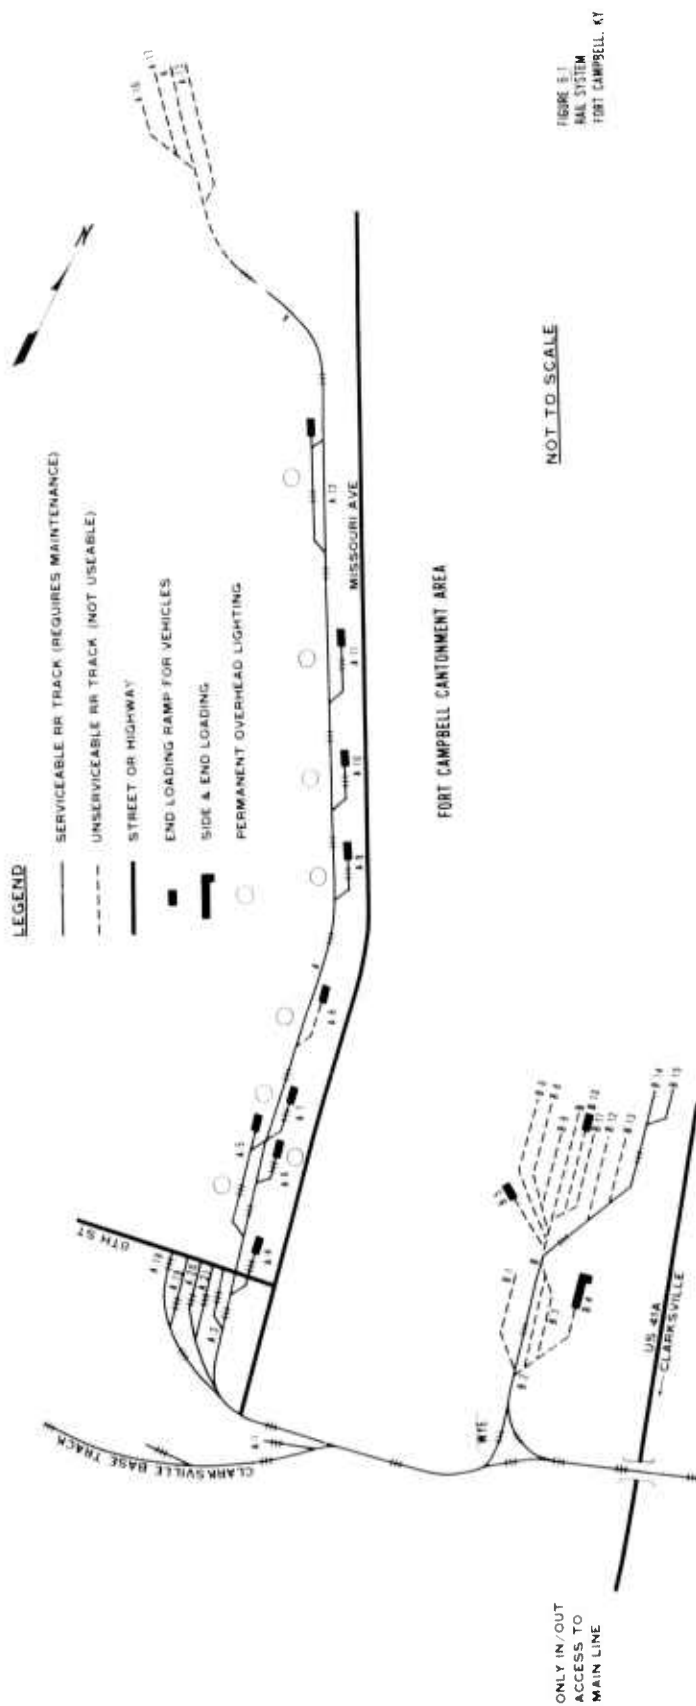
Figure 6-1. Installation Rail Network.

(5) The survey of the system revealed that some maintenance was required on many tracks and spurs to upgrade them to an acceptable standard. The most prevalent deficiency was rotted ties. Other defects in order of descending magnitude were: unserviceable switch mechanism, loose or missing spikes, poor track gauge and surface conditions, and broken joint bars and rails. The survey indicated that Clarksville Base track and spurs were serviceable. However, the only spurs in the "A" track that were usable for vehicle outloading were A-1, A-4 thru A-7, A-9 thru A-12, and A-18 thru A-21. Track "A" from a point 2500 feet north of the ramp at A-12 to the airfield was unserviceable except as shown in Figure 6-1. The unserviceable track amounted to some 30 to 40 percent of the total trackage at Fort Campbell.

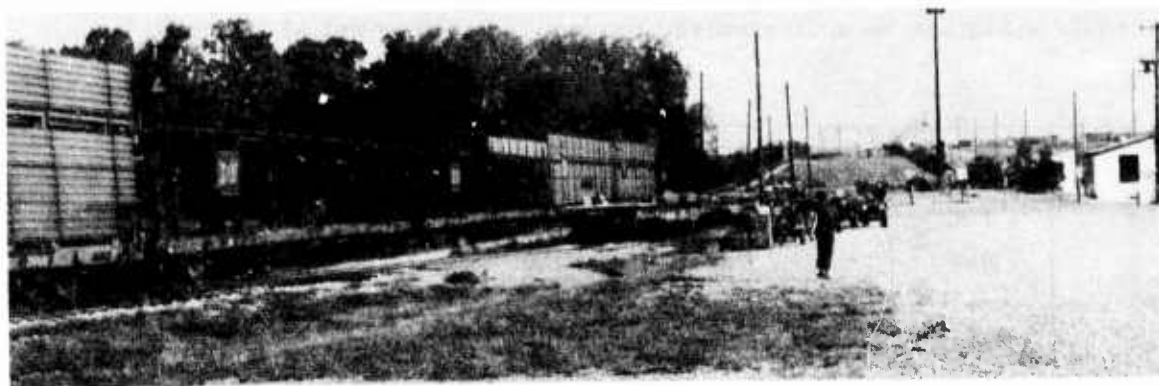
Figure 6-12. Rail Congestion due to Locomotive Failure.

(6) Blocking and bracing activities required continual supervision and assistance from MTMC representatives during the first day of outloading operations. Each loading site was visited on a rotational basis, questions were answered, procedures were explained, and modifications were made, as necessary. The supervisors and the unit crews appeared to be completely inexperienced in blocking and bracing techniques. The loading, blocking and bracing, and load inspections on the first day consumed so much time that the cars could not be switched from sites before the next day's activities began. This was coupled with the fact that the two organic locomotives of the post (estimated to have the capacity of pulling approximately 60 railcars in tandem) actually could pull only 20 to 25 railcars. To improve the switching operations a 130-ton locomotive was leased from the Illinois Central & Gulf Railroad, and Fort Eustis rail detachment personnel were obtained to supplement the Fort Campbell rail crew. Long site work times, railcar congestion, and inadequate locomotive capabilities jointly caused operational delays during the first 3 days of outloading (Figure 6-12).

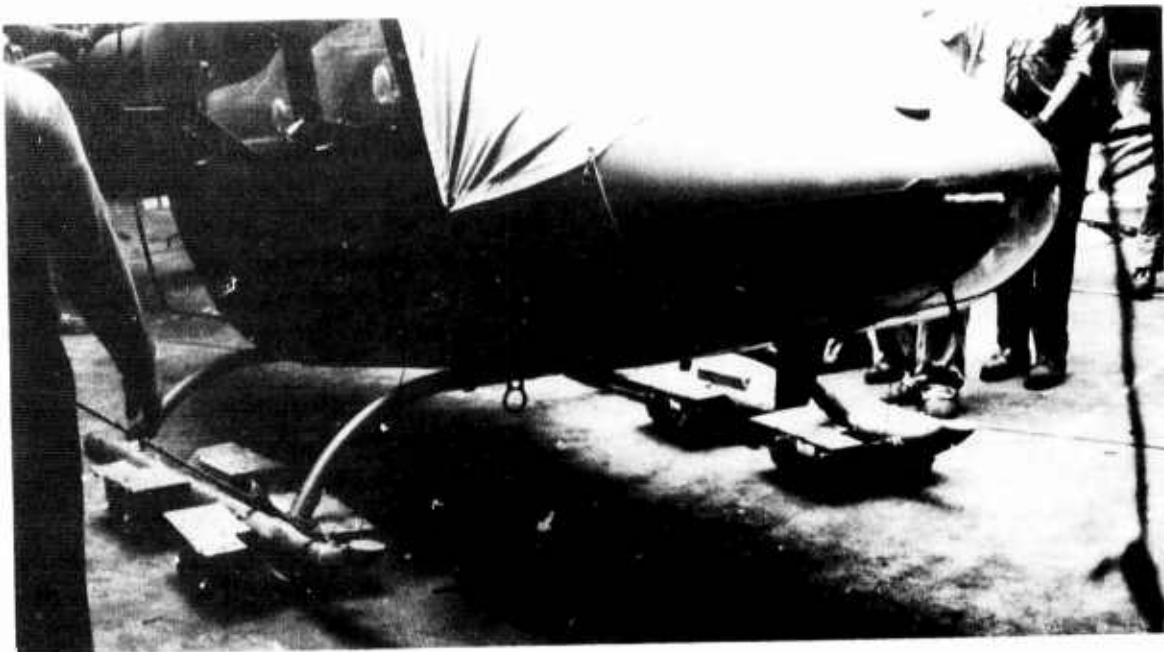
Figure 8-5. Helicopter Positioning Device (Caster Wheels).

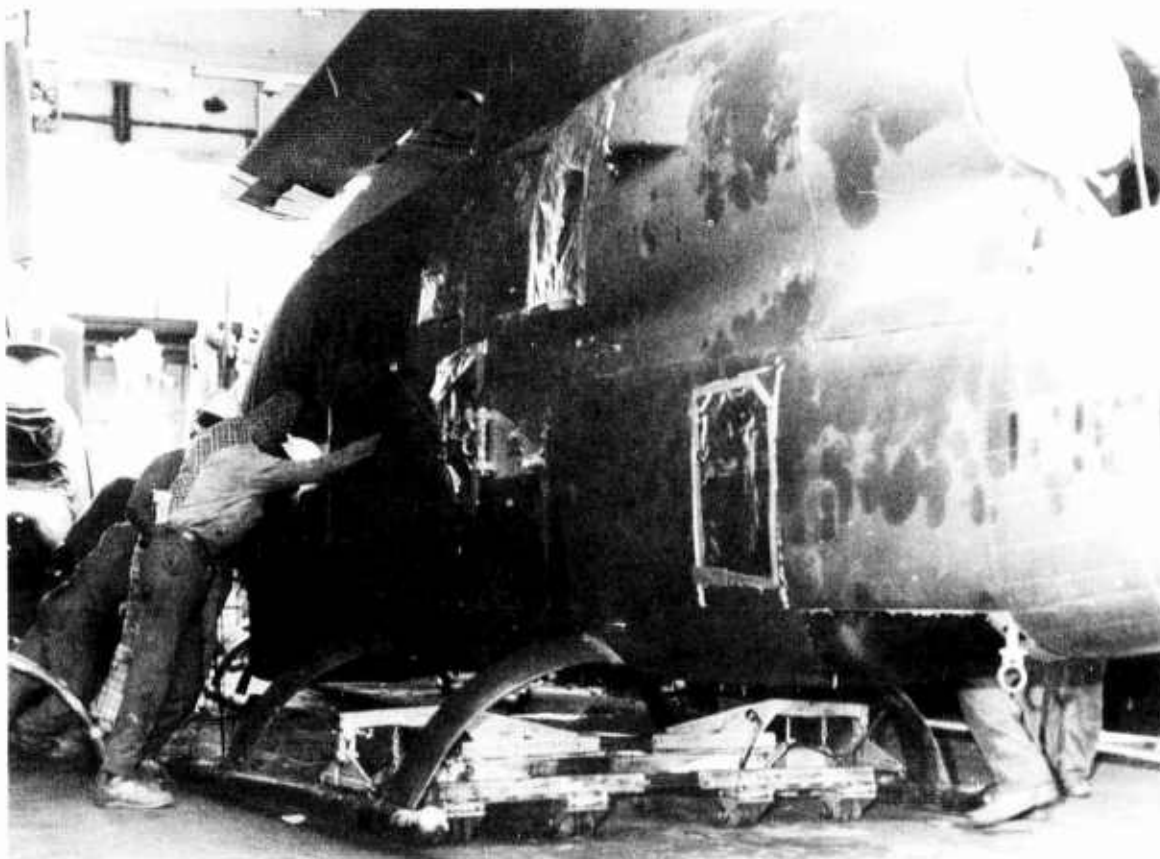
Figure 8-8. Helicopter Positioning Device (MTMC Device).

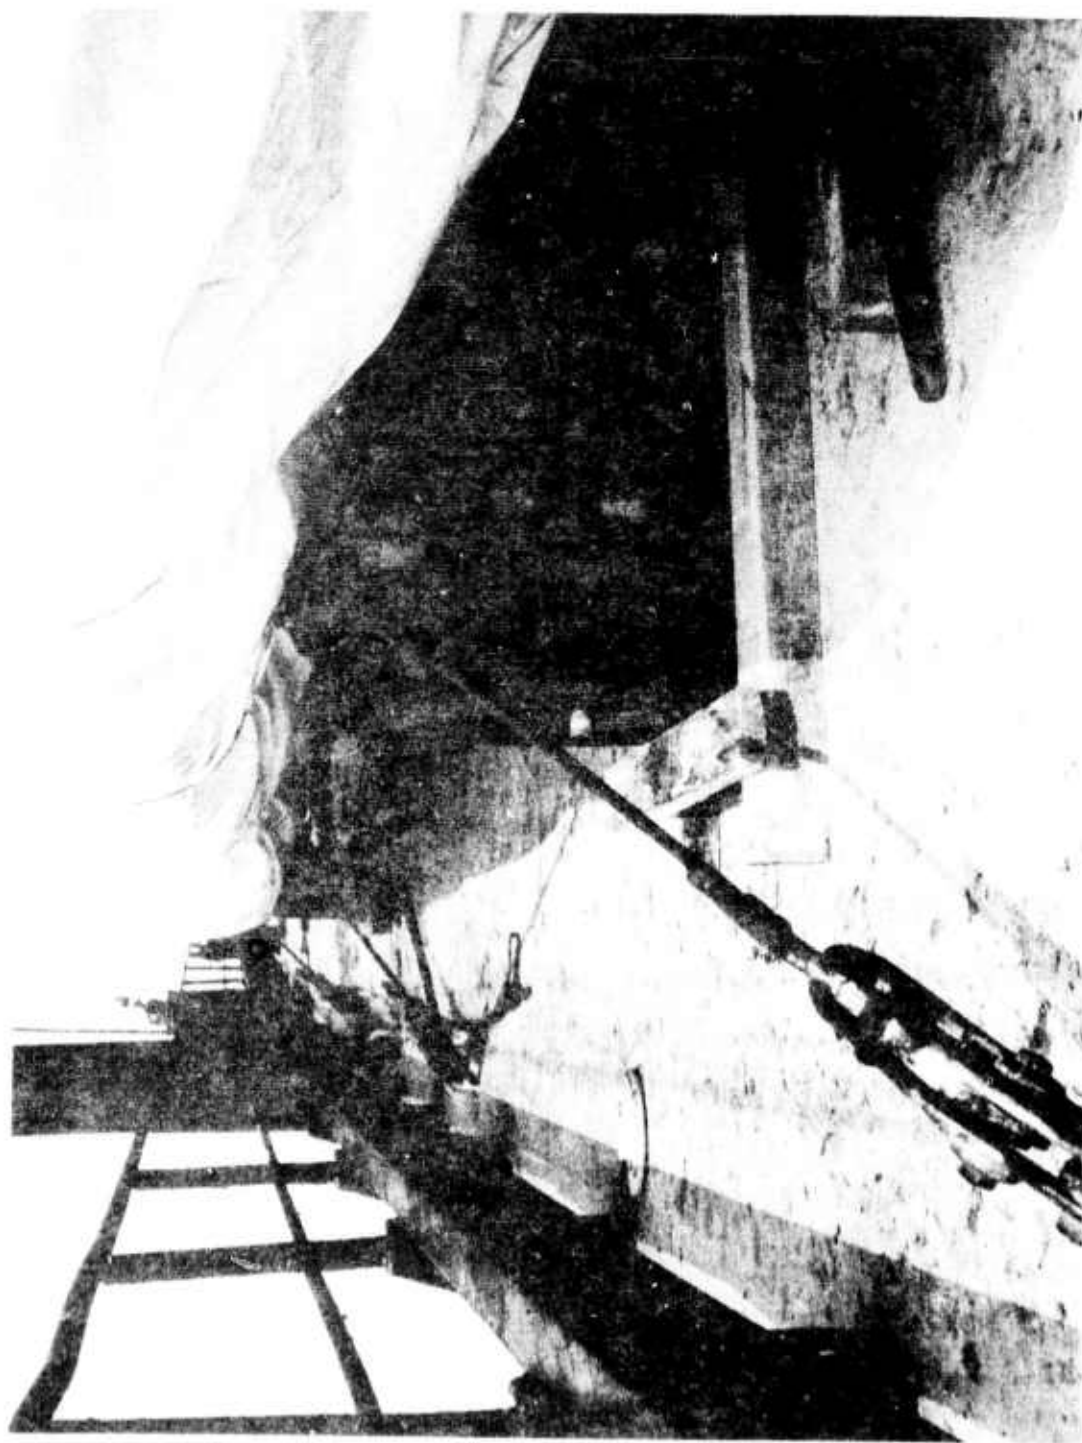
Figure 8-14. CH-47 Tiedown on the Main Deck of the GTS Callaghan, Stabilizers.

(d) All helicopters were restrained using the standard ship-board tiedown devices with Peck and Hale gear (Figures 8-14 and 8-15). The deck toedown points proved adequate for helicopter restraint. Extra "D" rings installed on the Callaghan and Meteor assisted in achieving the tiedown patterns. The tight helicopter stow required caution when tiedown devices were installed to insure that the devices did not chafe delicate surfaces of the helicopters.

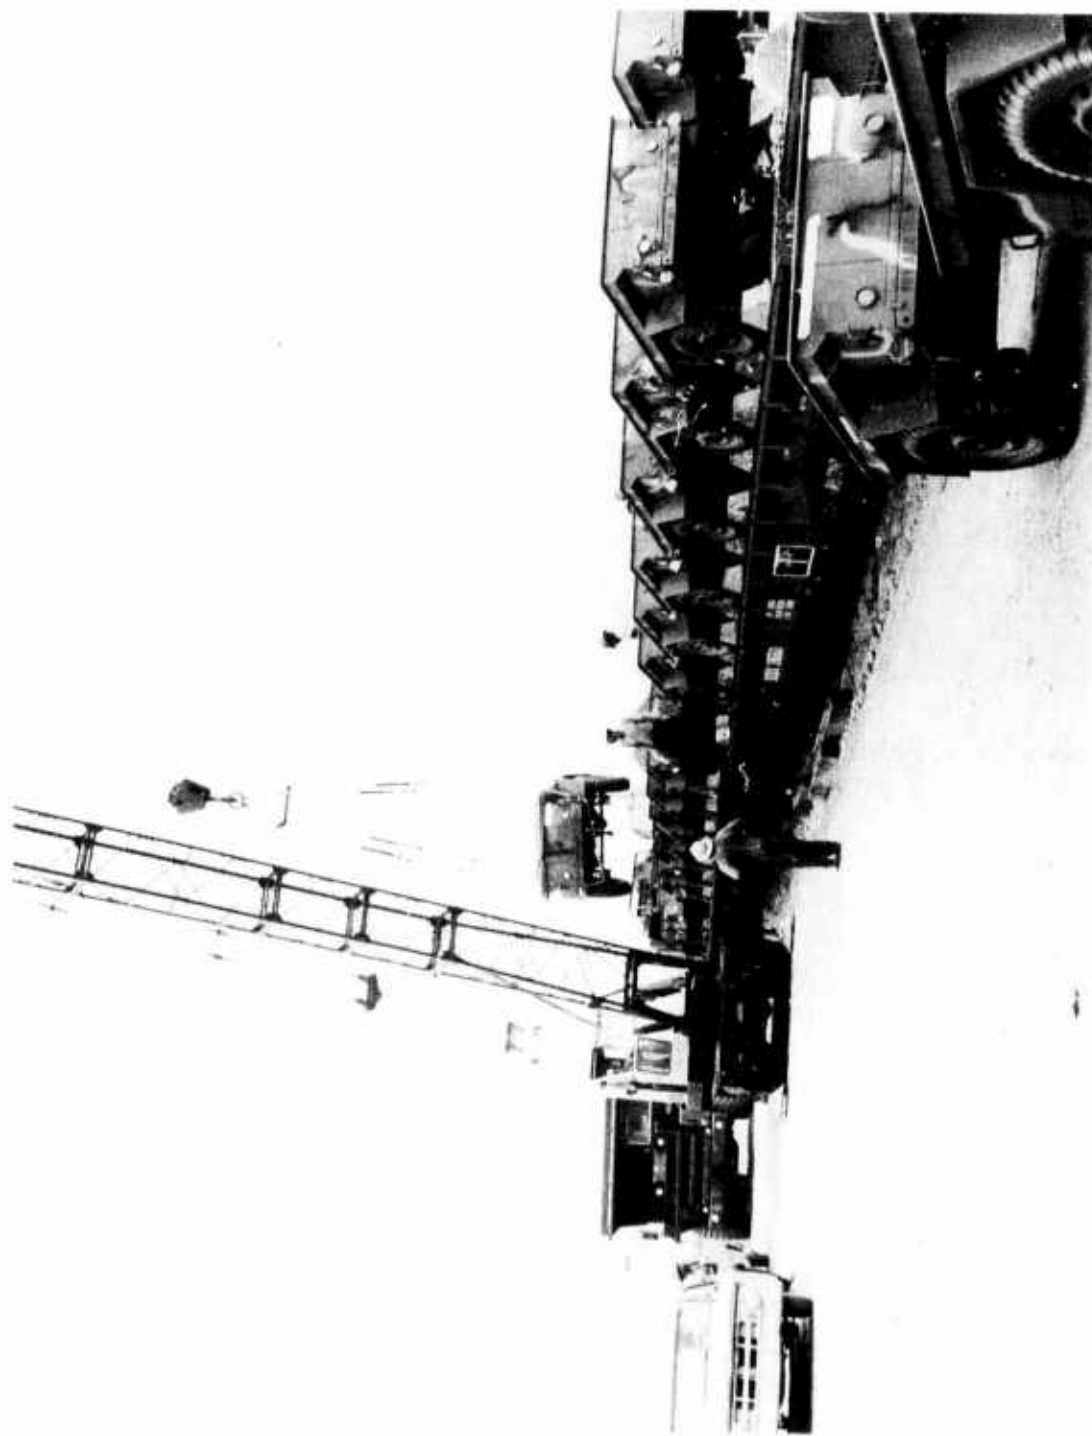
Figure 8-25. Empty Unnested Trailers, Arriving at Norfolk.

2. Approximately 50 percent of the cargo stowage space in vehicles such as cargo trucks, gamma goats, and trailers was not used for storing break-bulk cargo (Figure 8-25). Army regulation 220-10, para 7-6, and FORSCOM Regulation 55-1 require that the moving unit use vehicle cargo space to the maximum for storing miscellaneous organization equipment and supplies. The moving unit's noncompliance with these regulations required substantial manpower at the SPOE to consolidate equipment and make better use of vessel stowage space (Figures 8-26 and 8-27). It also increased the number of MILVANS needed to transport the miscellaneous break-bulk cargo. It is estimated that, if vehicle cargo stowage space had been fully utilized, the number of MILVANS could have been reduced by 25 percent and over \$50,000 of line haul and port handling

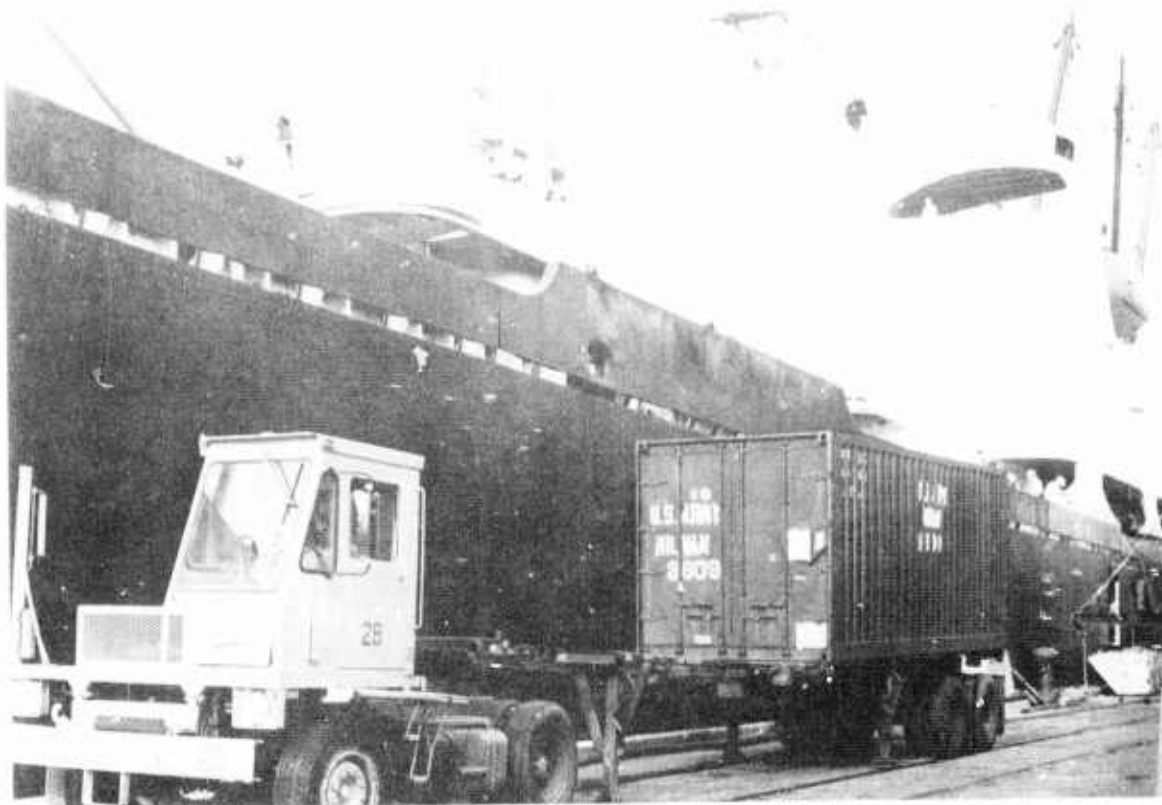
Figure 8-55. To Preclude Damage to the MILVAN Chassis, the Landing Legs on the Second Chassis Must be Installed Prior to Lifting the MILVANS.

When the forward MILVAN was removed from the coupled MILVAN chassis the landing gear on the rear chassis was not lowered, which caused the coupled MILVAN chassis to bow in the middle (Figures 8-54 to 8-56). Subsequently, the landing gear on the MILVAN chassis were lowered to preclude further damage.

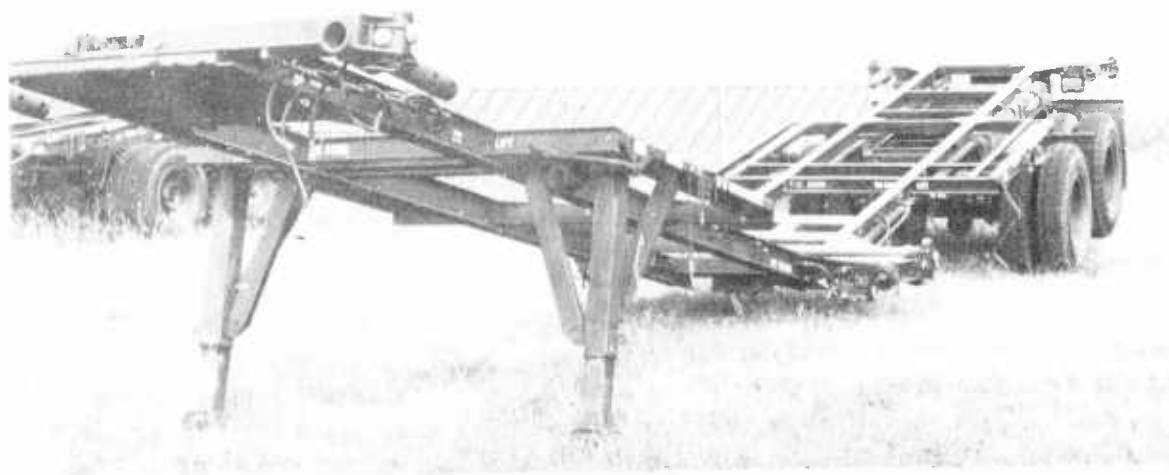
Figure 8-56. MILVAN Chassis Damaged Due to Failure to Install Landing Legs.

(b) Because of improper unloading techniques, eight coupled MILVAN chassis received minor damage during vessel loading operations.

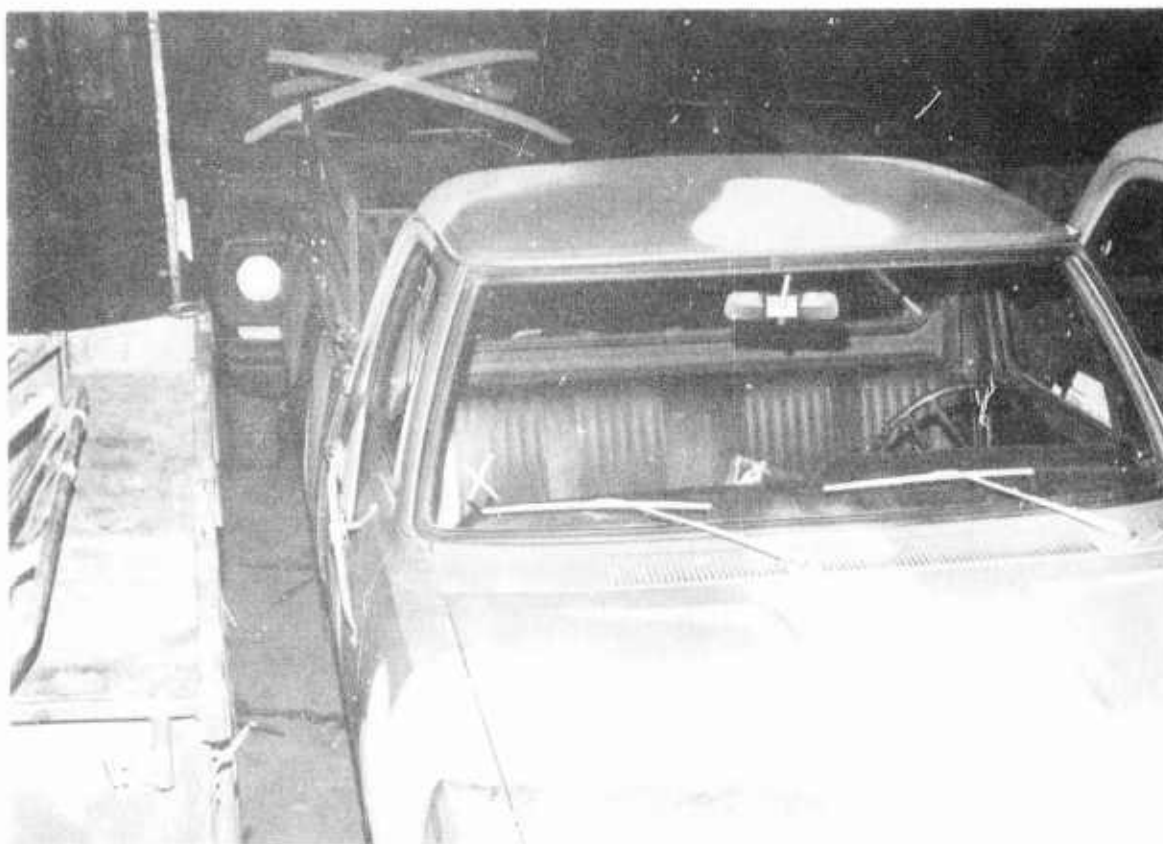
Figure 8-57. Commercial Pickup Trucks (M880) Must Be Stowed With 9-Foot Clearance.

(e) Because of their flexible suspension system (Figure 8-57), the M880s required stowage with at least a 9-inch clearance to avoid in-transit damage to the vehicles. One hatch on the Callaghan was already loaded with M880s when the 9-inch clearance requirement was received by the MTMC REFORGER operations center. An extra labor force was required to effect the proper stow.

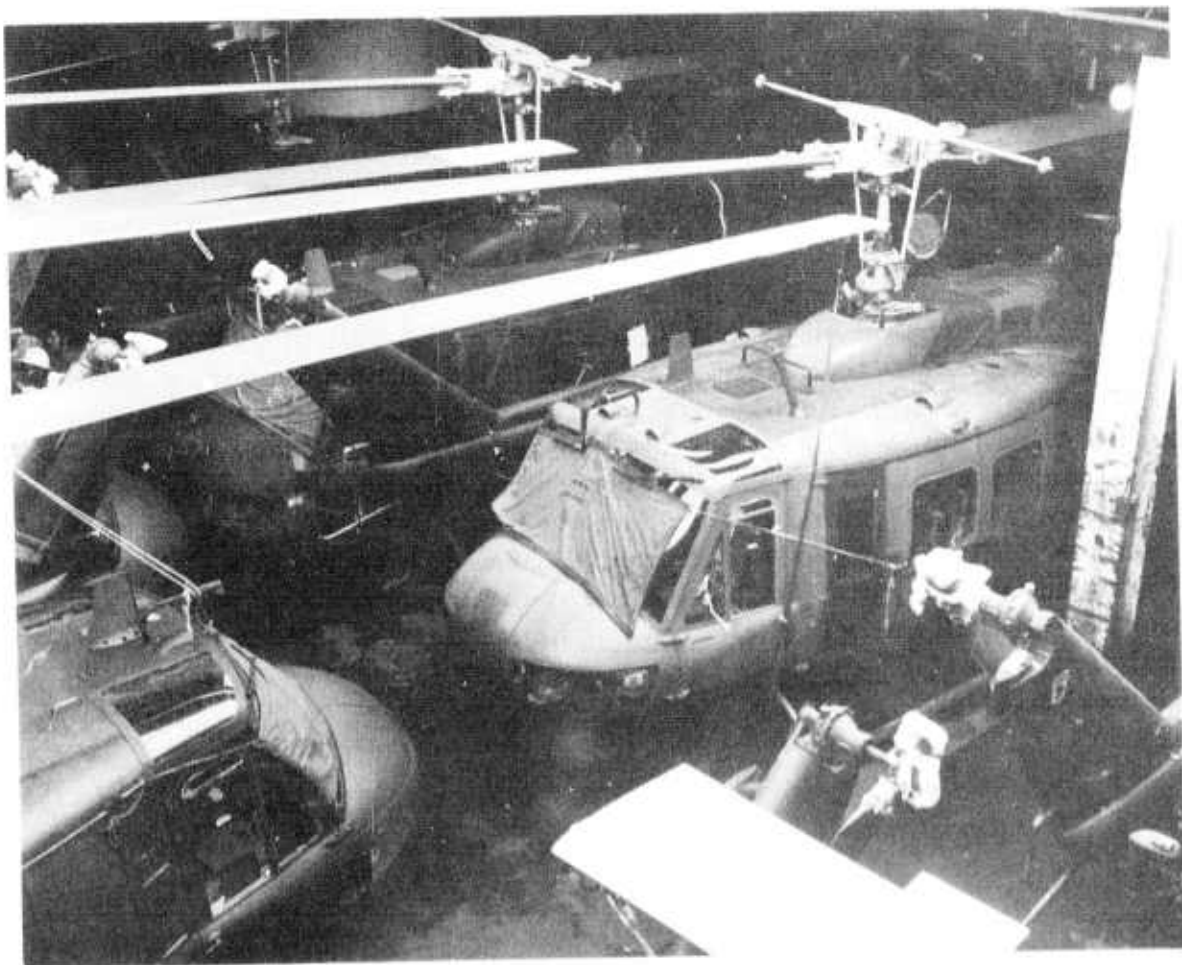
Figure 8-63. UH-1 Helicopter Stowed in Hatch Square (GTS Callaghan).

(l) Stowing UH-1 and AH-1 helicopters with rotor blades in the square of the hatch proved to be time-consuming (Figure 8-63). To facilitate loading and discharge operations, these helicopters had their rotor blades removed during redeployment loading operations.

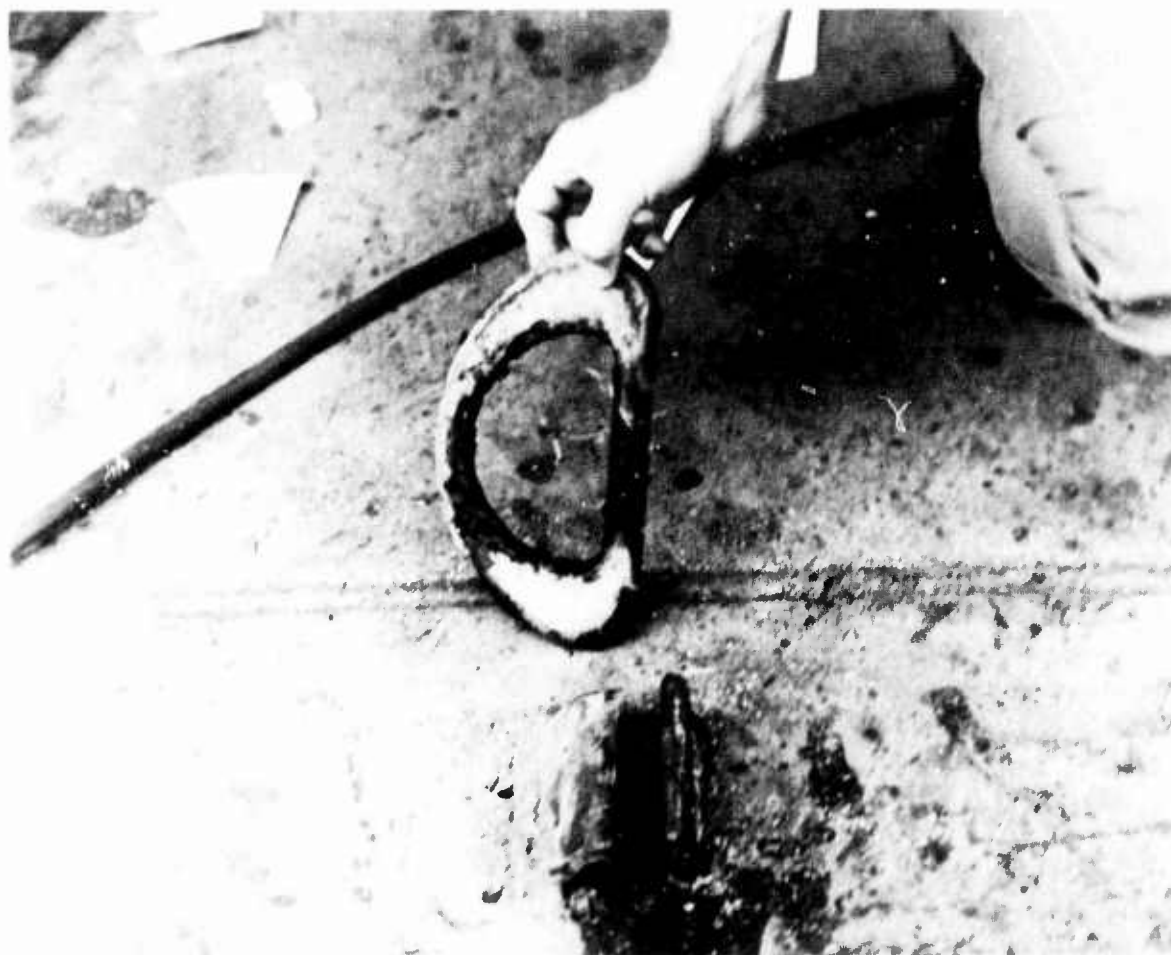
Figure 8-64. Defective "D" Ring on the Main Deck GTS Callaghan.

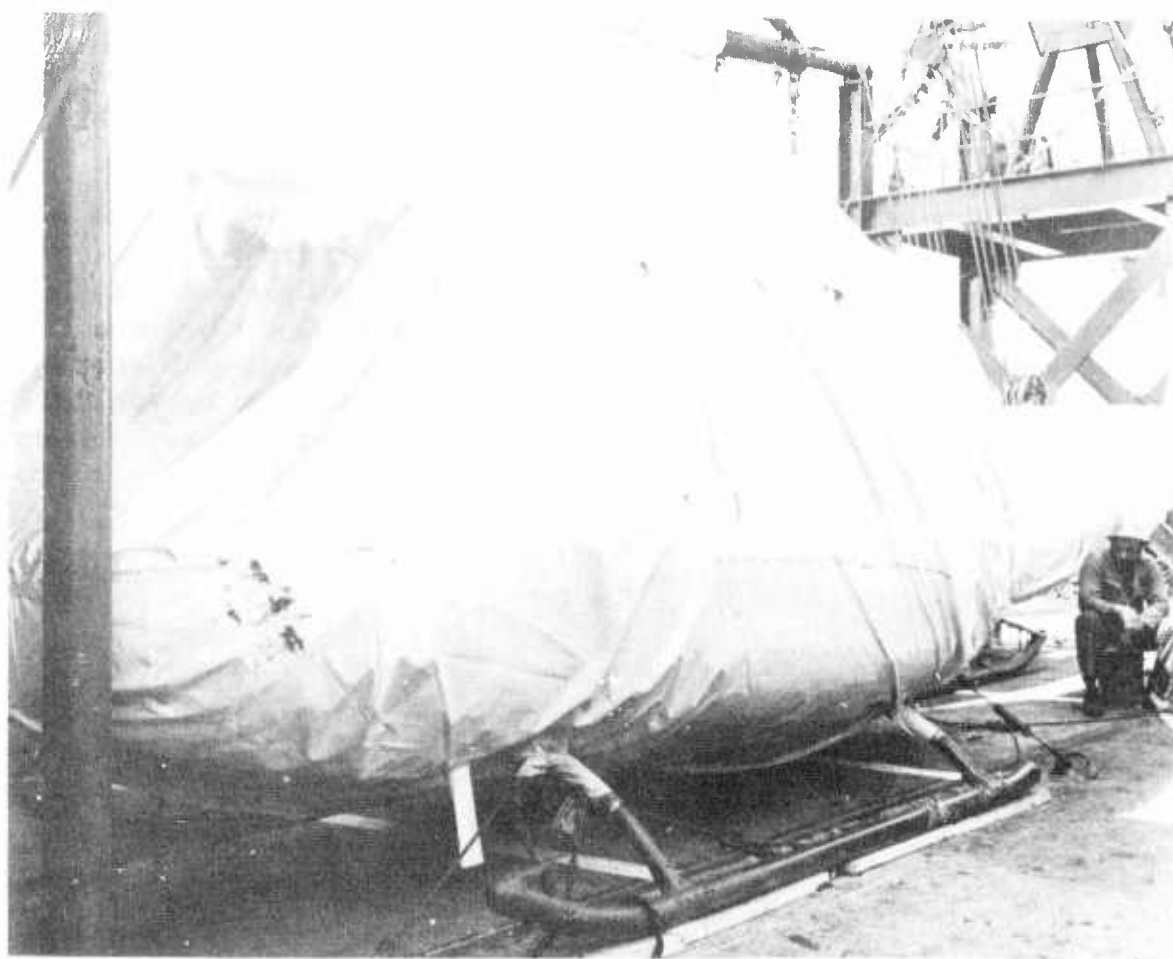
Figure 8-65. UH-1 Helicopter Inadvertently Damaged When Boom Guide Broke Loose From a Defective "D" Ring.

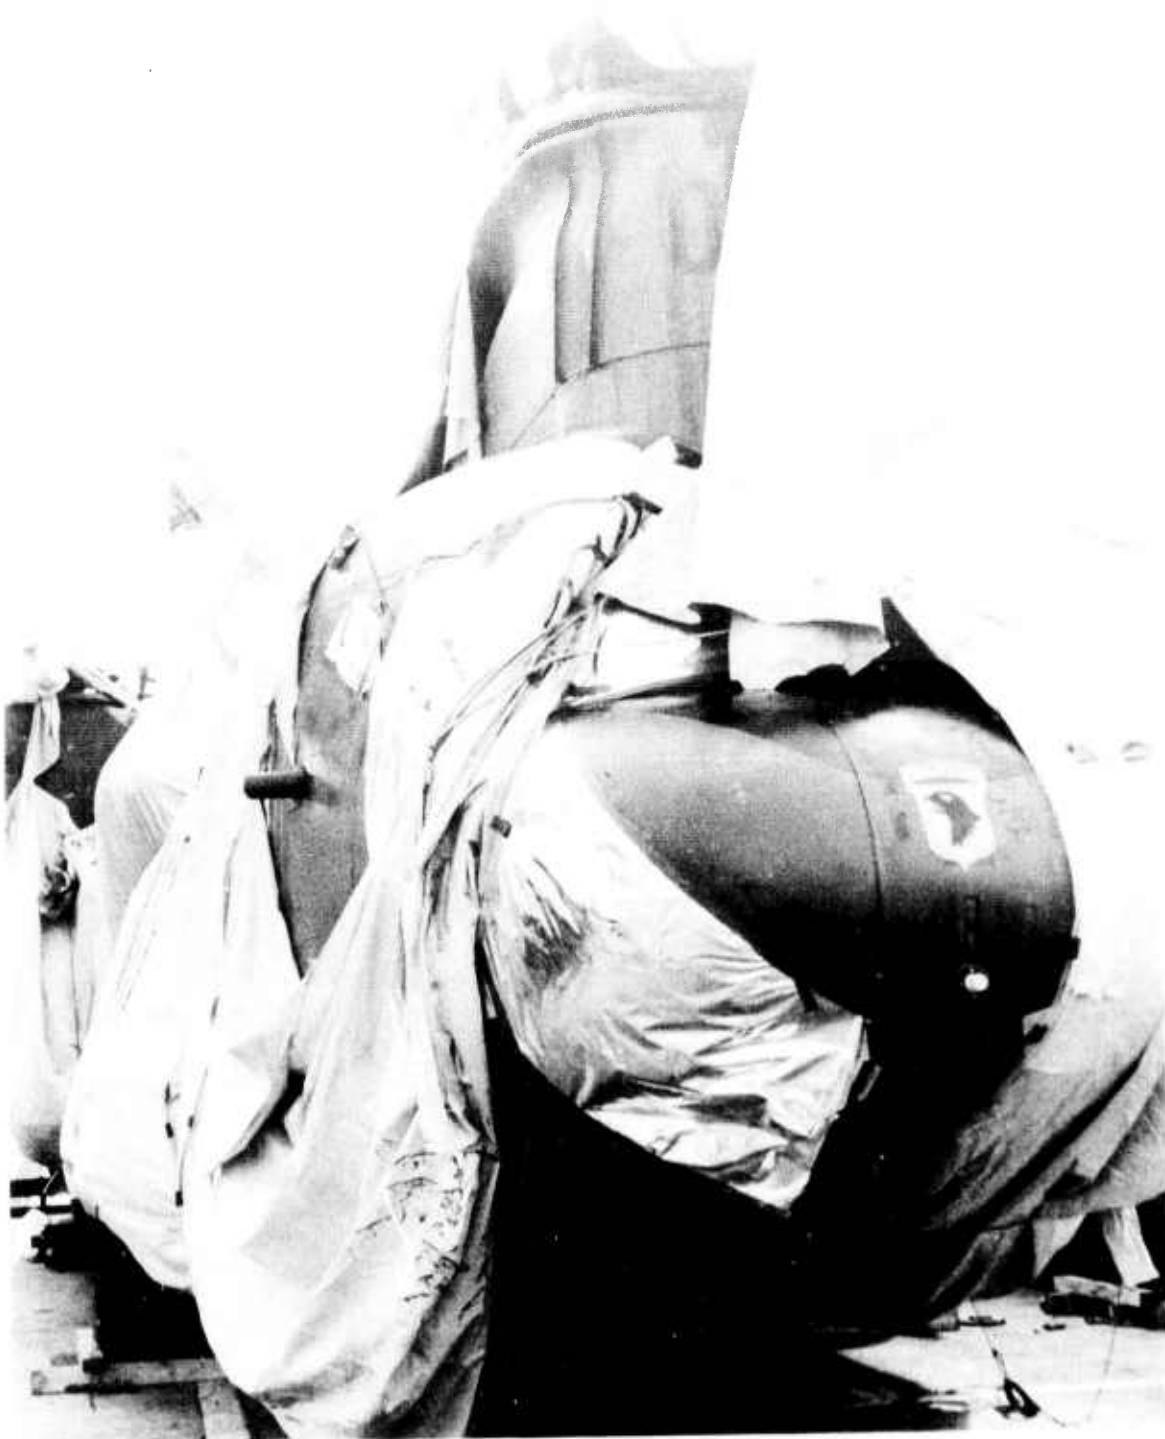
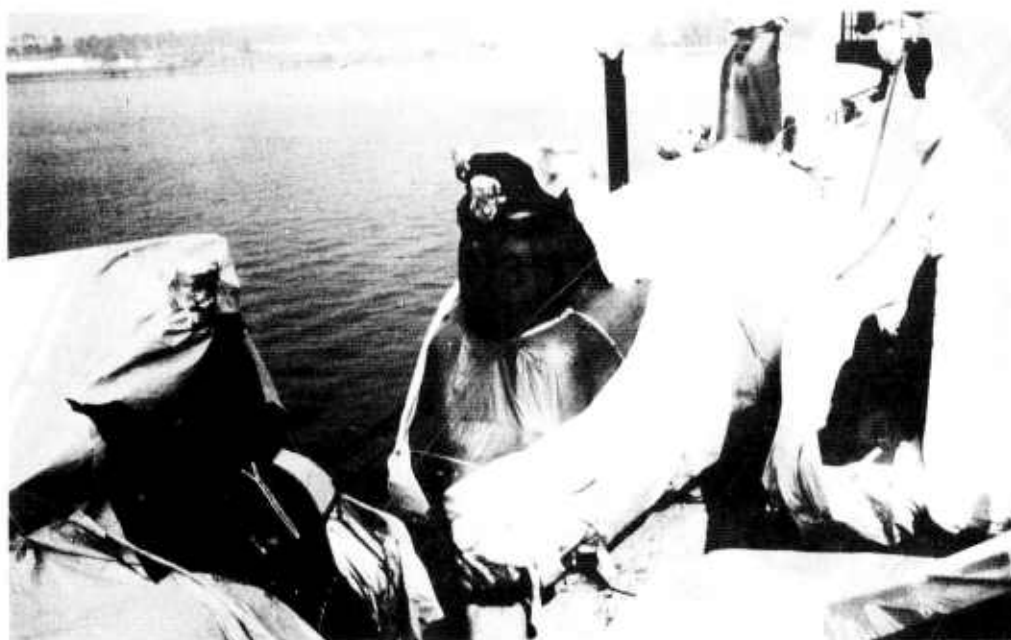
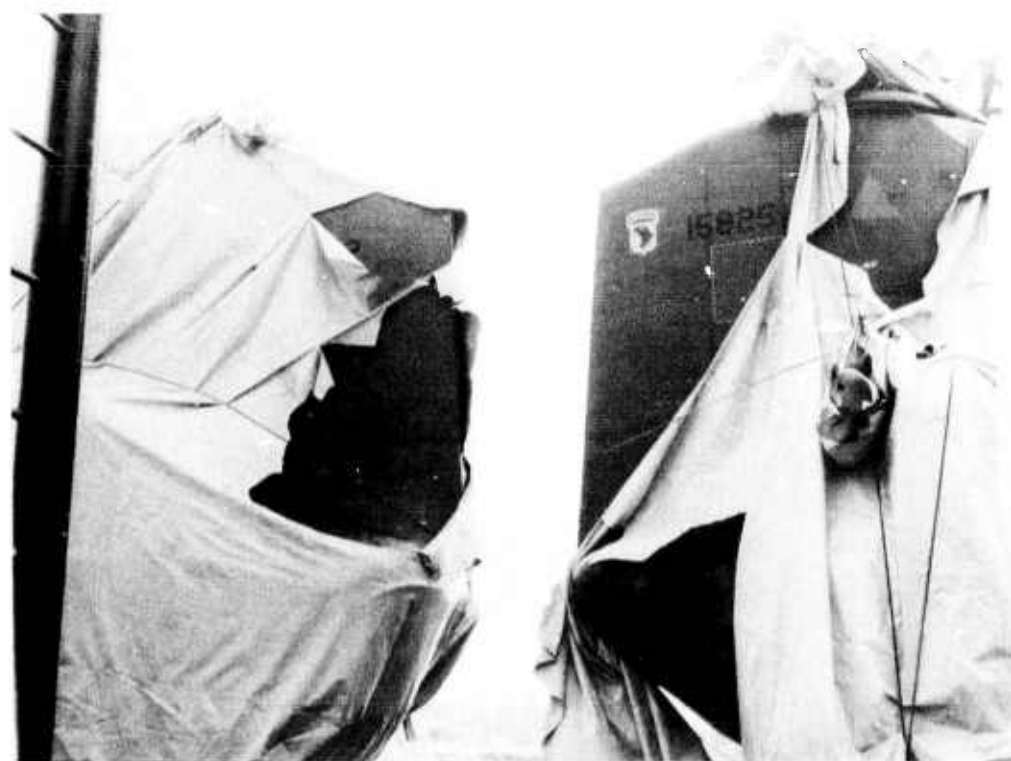
Figure 8-73. Damaged CH-47 Redi-Covers.

(d) The zippers on the helicopter redi-covers provided by AVSCOM came open while subjected to normal winds, and modifications were recommended.
