LOW-COST AIRCRAFT STRUCTURAL REPAIR AND  
MAINTENANCE STUDY

ROCKWELL INTERNATIONAL  
LOS ANGELES AIRCRAFT DIVISION  
LOS ANGELES, CALIFORNIA

MARCH 1977

FINAL REPORT FOR PERIOD AUGUST 1974 - MAY 1976  
TECHNICAL REPORT AFFDL-TR-76-63

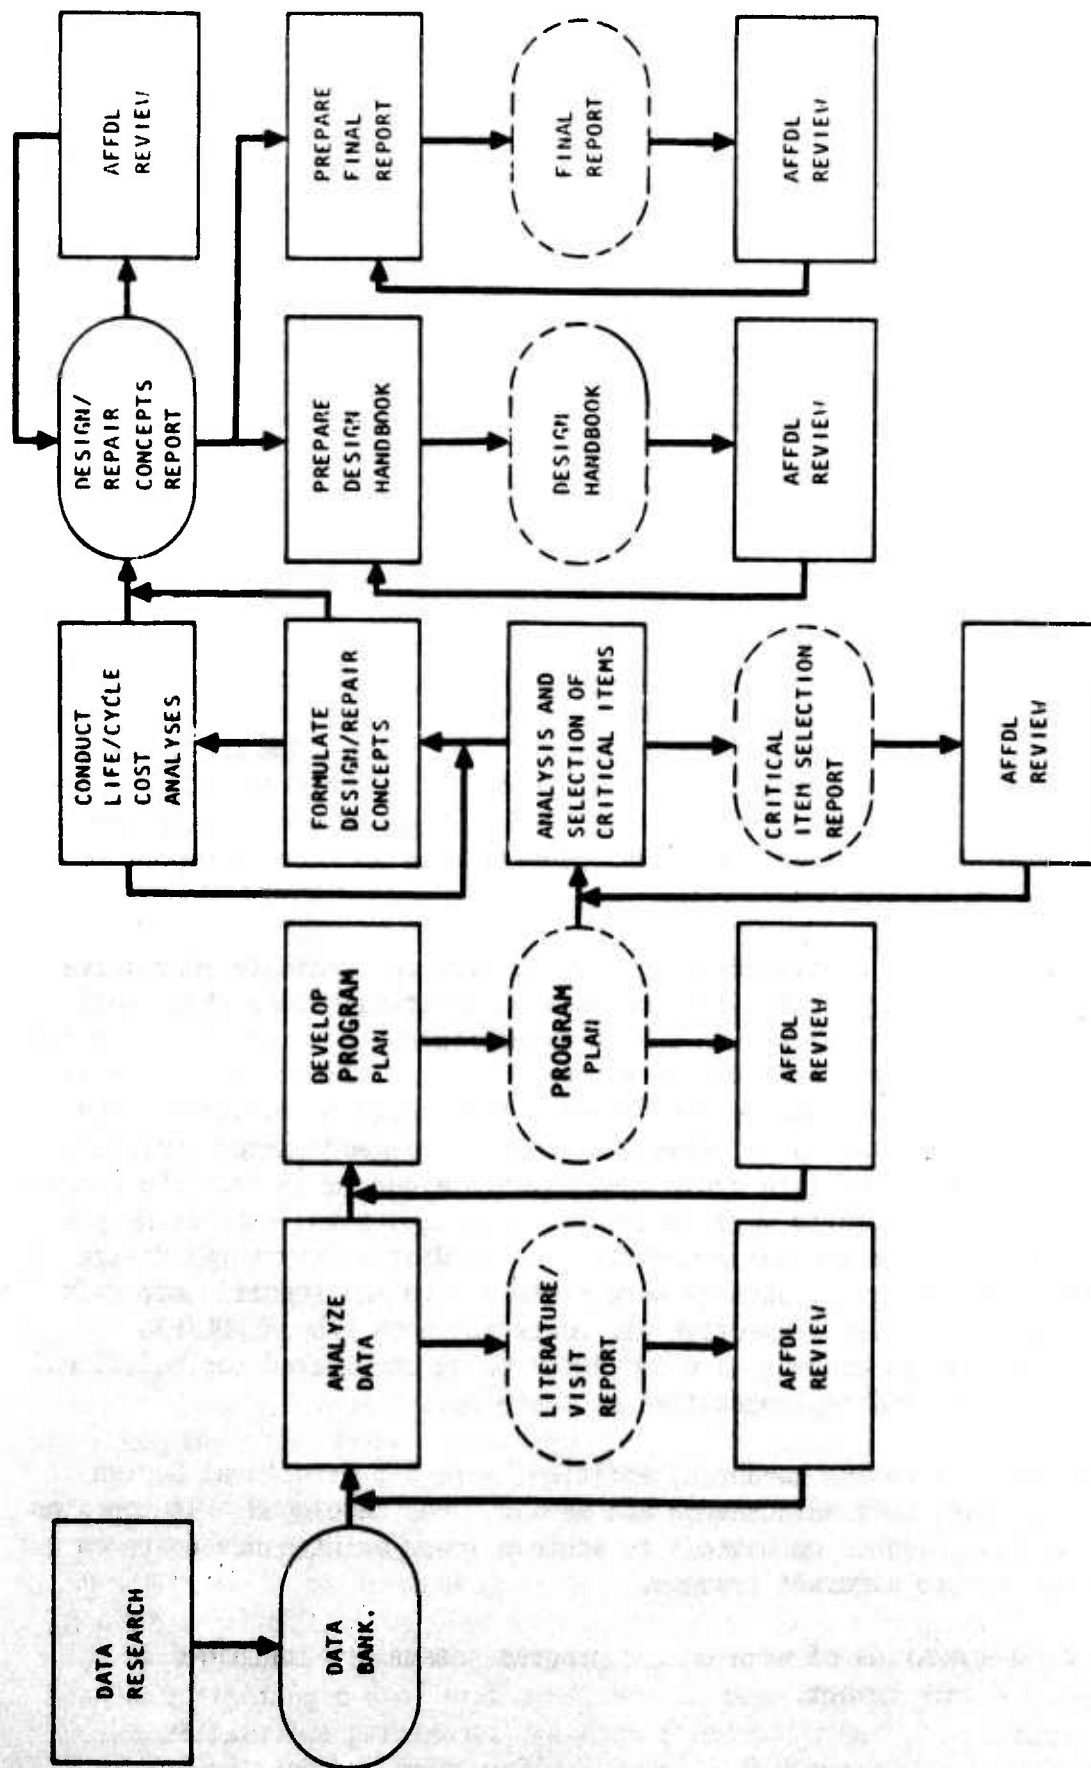
Figure 1. Program task/event flow diagram.

The program was organized and conducted as shown by the task/event flow diagram in Figure 1. It provides an overall view of each of the tasks performed in the program. Phase I consisted of a data research and acquisition effort where information on current military aircraft structure maintenance and repair problems were obtained through visitations to Government and industry activities, use of Air Force and Navy maintenance reporting systems, and literature searches. The information obtained was then organized, and specific elements were selected for analysis. The information was also placed in a data bank for future use in the program. A briefing and an interim report were then prepared by the contractor and reviewed by AFFDL/FBS. Concurrently with this activity, a detailed program plan was prepared for the conduct of the subsequent program phases.

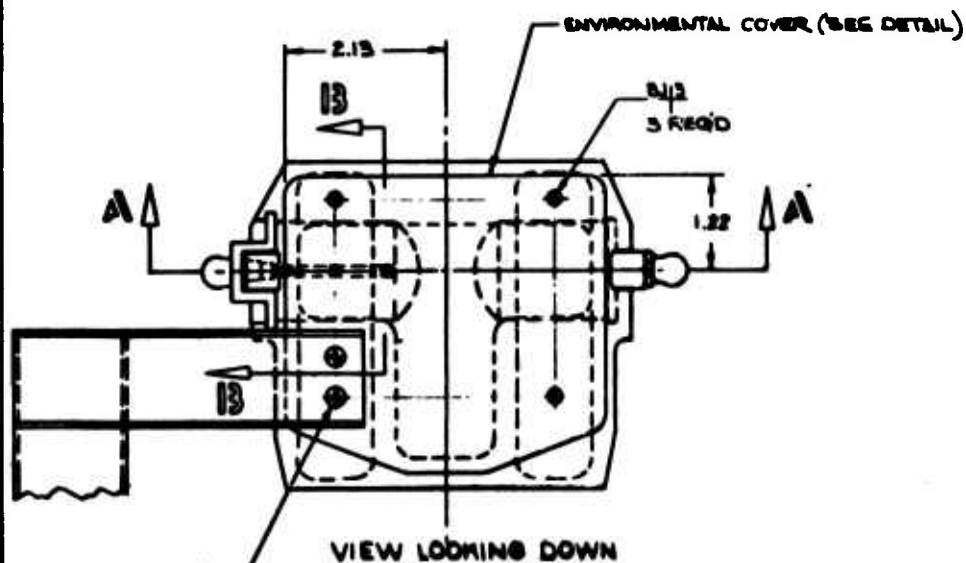
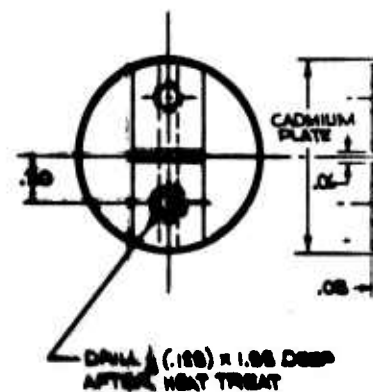
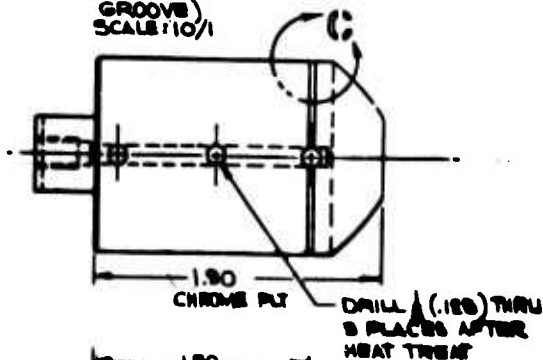
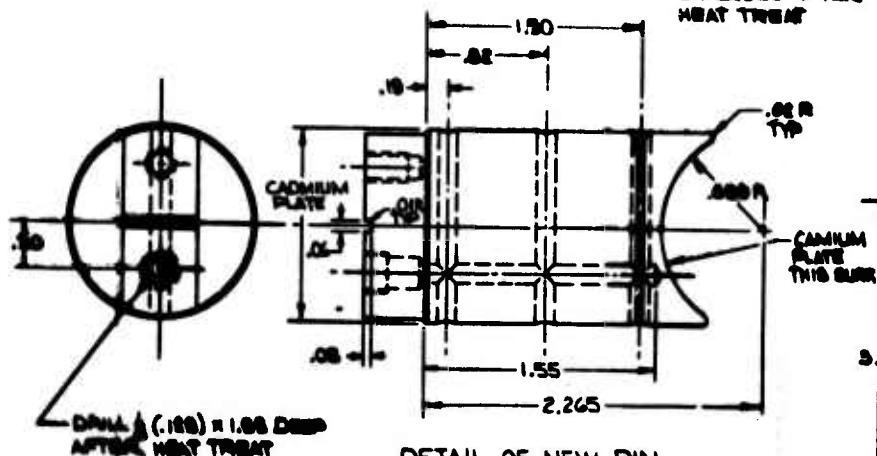
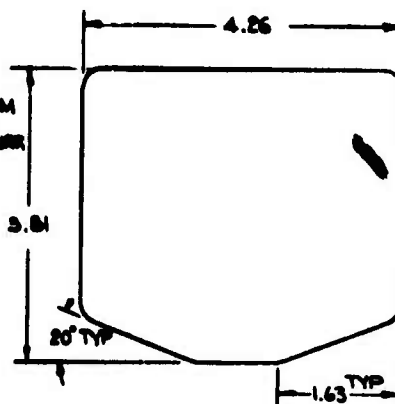
DRILL OUT EXIST  
FASTENERS TO  
INSTALL NEW  
COVER

TRUNNION  
215-24016 (REF)  
STRUT  
215-24020 (REF)

DETAIL (C)  
(LUBRICATION  
GROOVE)  
SCALE: 10/1

DRILL (.188) THRU  
3 PLACES AFTER  
HEAT TREAT

DETAIL OF NEW PIN  
SCALE: 2/1 ~ MATL: 4340 STL  
(SEE CV21-564502 FOR  
DIMENSIONS & HOLE  
SIZES NOT SHOWN)

DETAIL OF ENVIRON.  
COVER ~ .030 THK ALUM SMT  
SCALE: 1/1

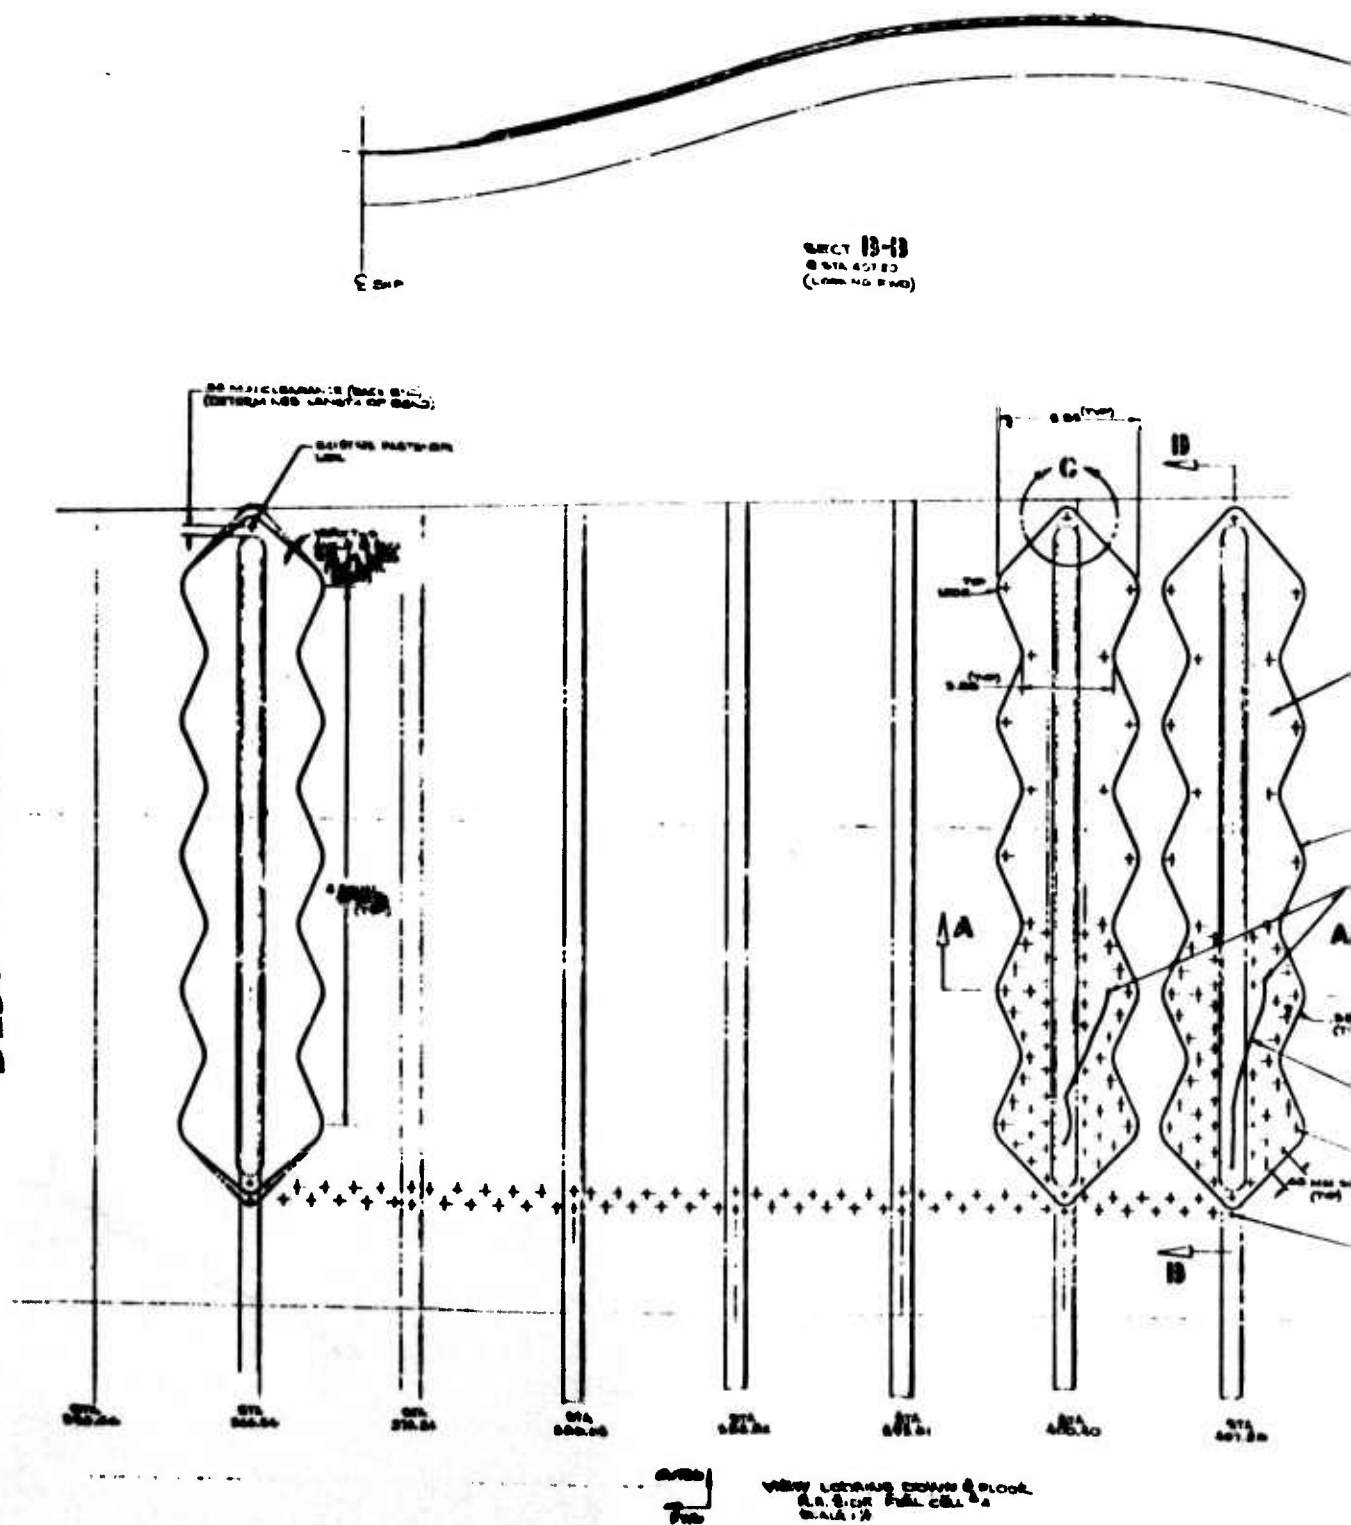
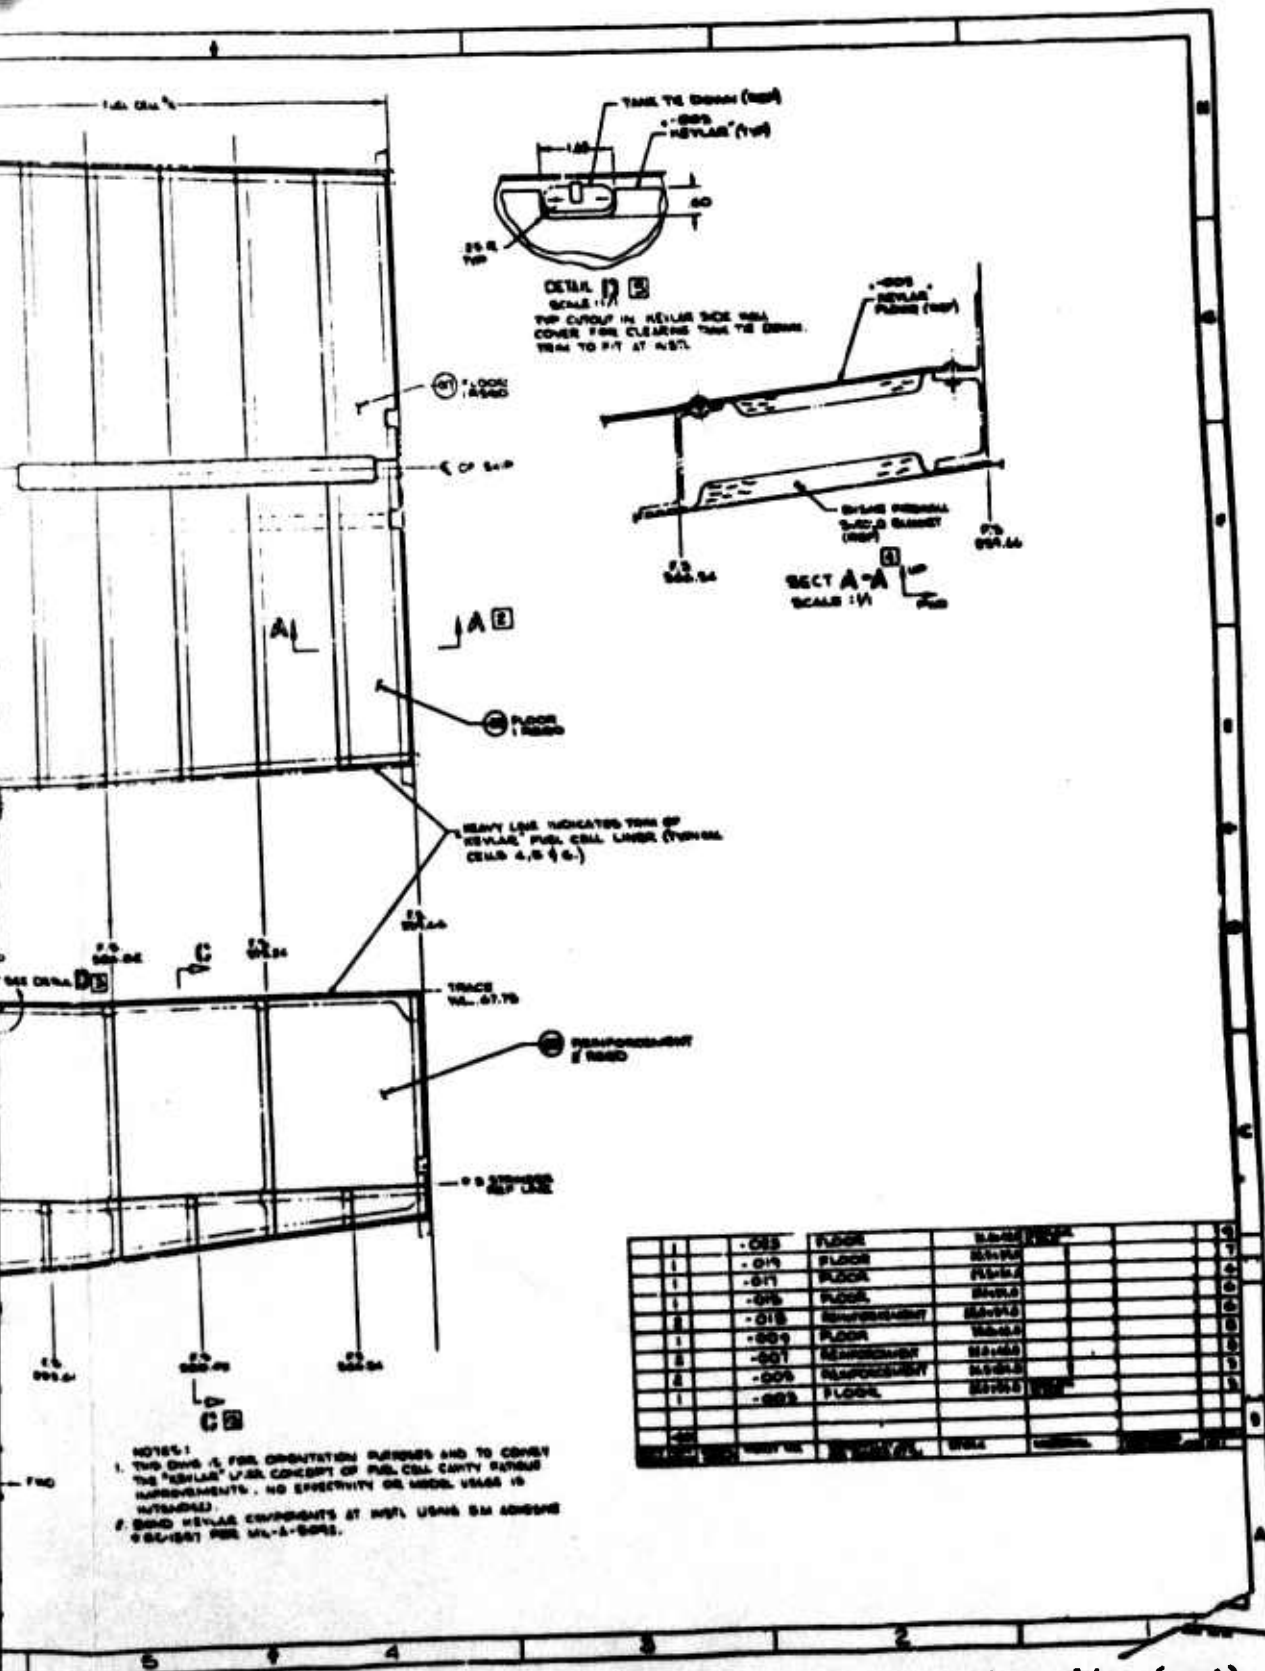
Figure 14. Item No. 4 - F-4 fuselage fuel tank reinforcement liner skins (cont).

Merit of this repair is its ease of fabrication and installation. Roll-formed straps could be utilized, and a universal size selected for each fuel bay needing repair. The beaded section is used to "bridge" over existing fasteners. All work would be accomplished from the top side of the tank floor, and no floor would need to be removed to install new straps. Due to the design of the straps, existing load paths will not be changed. Installation will be accomplished per T.O. manual methods currently in use regarding bonding, stop drilling of cracks, sealing, finishing, and chafing tape application. Total weight of repair is 2.41 pounds for cell No. 4.

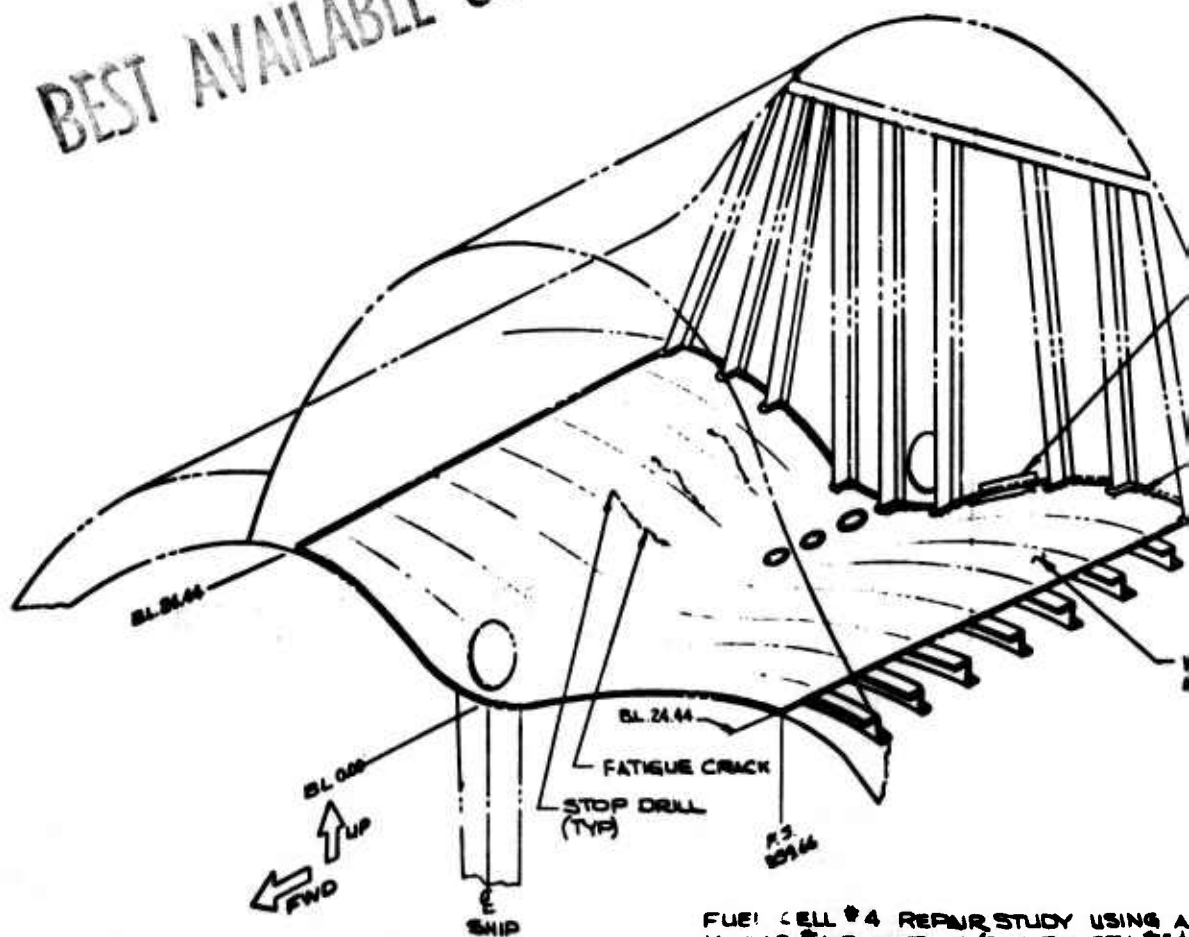
FUEL CELL #4 REPAIR STUDY USING A KEVLAR #143 OVERLAY. (TYP FOR CELL #5) EXISTING FATIGUE CRACKS ARE TO BE STOP DRILLED (SEE ILLUSTRATION) AND STANDARD PATCHING METHODS USED AS REQD. KEVLAR #143 MAY THEN BE APPLIED (SEE VENDOR INSTRUCTIONS) IN A 2 PLY LAMINATE.

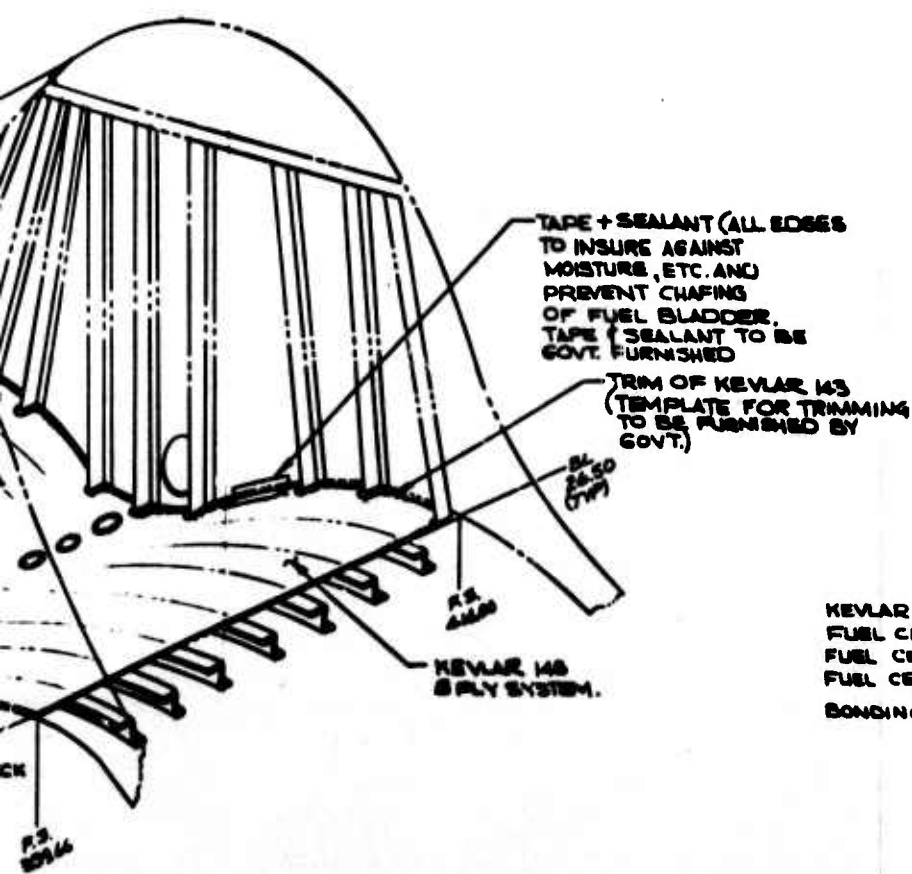
KEVLAR SIZES: (8 PLY LAMINATE)  
 FUEL CELL #4 62" WIDE X 95" LONG. (WEIGHT OF KEVLAR 4.88)  
 FUEL CELL #5 62" WIDE X 40" LONG. (WEIGHT OF KEVLAR 2.0)  
 FUEL CELL #6 62" WIDE X 40" LONG. (WEIGHT OF KEVLAR 2.0)  
 BONDING MATL WEIGHT: 3 POUNDS/SHIP

FUEL CELL #4 REPAIR STUDY USING A  
 KEVLAR #143 OVERLAY. (TYP FOR CELL #5 (#6))  
 EXISTING FATIGUE CRACKS ARE TO BE STOP-  
 PLED (SEE ILLUSTRATION) AND STANDARD  
 PATCHING METHODS USED AS REQD.  
 KEVLAR #143 MAY THEN BE APPLIED (PER  
 INDOOR INSTRUCTIONS) IN A 8 PLY LAMINATE.

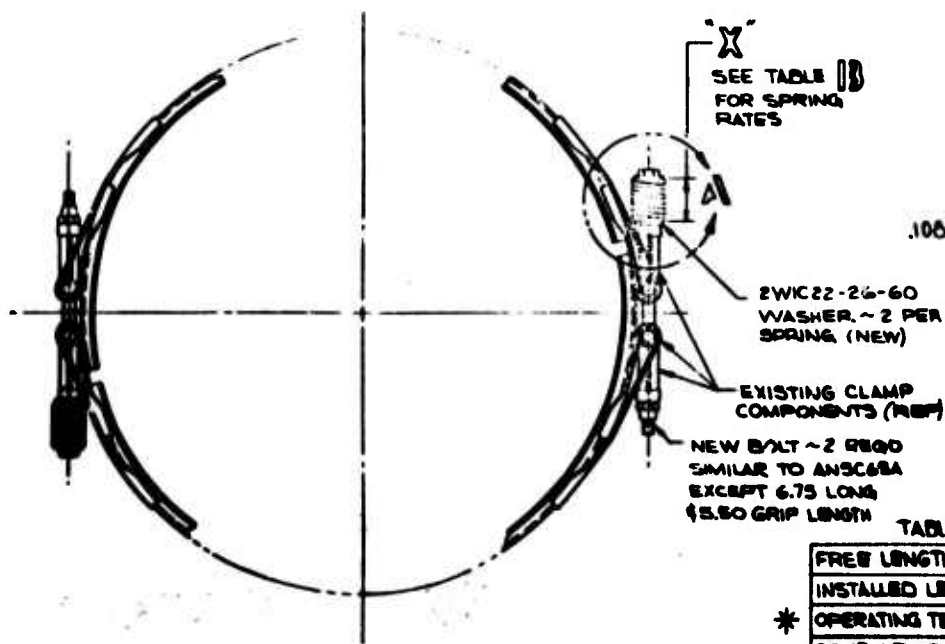
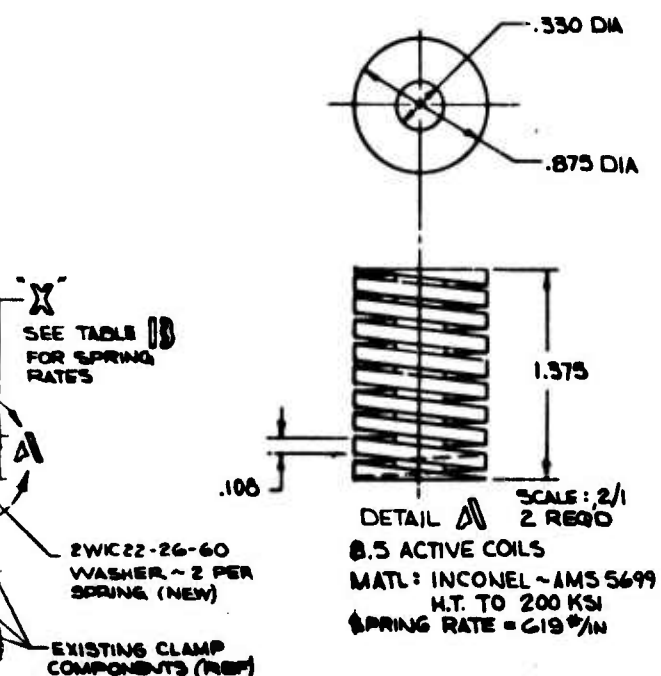
COUPLING \* NH1000850  
(AEROGUIP) WITH ADDITIONAL  
TEMPERATURE COMPENSATOR  
SPRING INSTALLED  
SCALE: 1/2

\* BASED ON 500°F TEMP.  
BETWEEN CLAMP AND TAIL

TABLE 18 X BOLT TENSION

FREE LENGTH	1.375	◆
INSTALLED LENGTH	1.117	160*
* OPERATING TEMP LENGTH	.987	240*
SOLID LENGTH	.872	249.5*

##### LOW-COST DESIGN (See Figure 15):

A spring of suitable strength and deflection may be incorporated into the clamping bolt assembly to prevent overstress of the clamp band when differential heating occurs. A rectangular section compression spring has been designed to serve this function. From existing test data, it has been estimated that a temperature differential as high as 500° F between the engine and clamp can be experienced. This requires 0.11-inch spring deflection in addition to the initial installation deflection. Inconel was selected as the spring material to withstand the maximum operating temperatures and stresses without loss of spring characteristics.

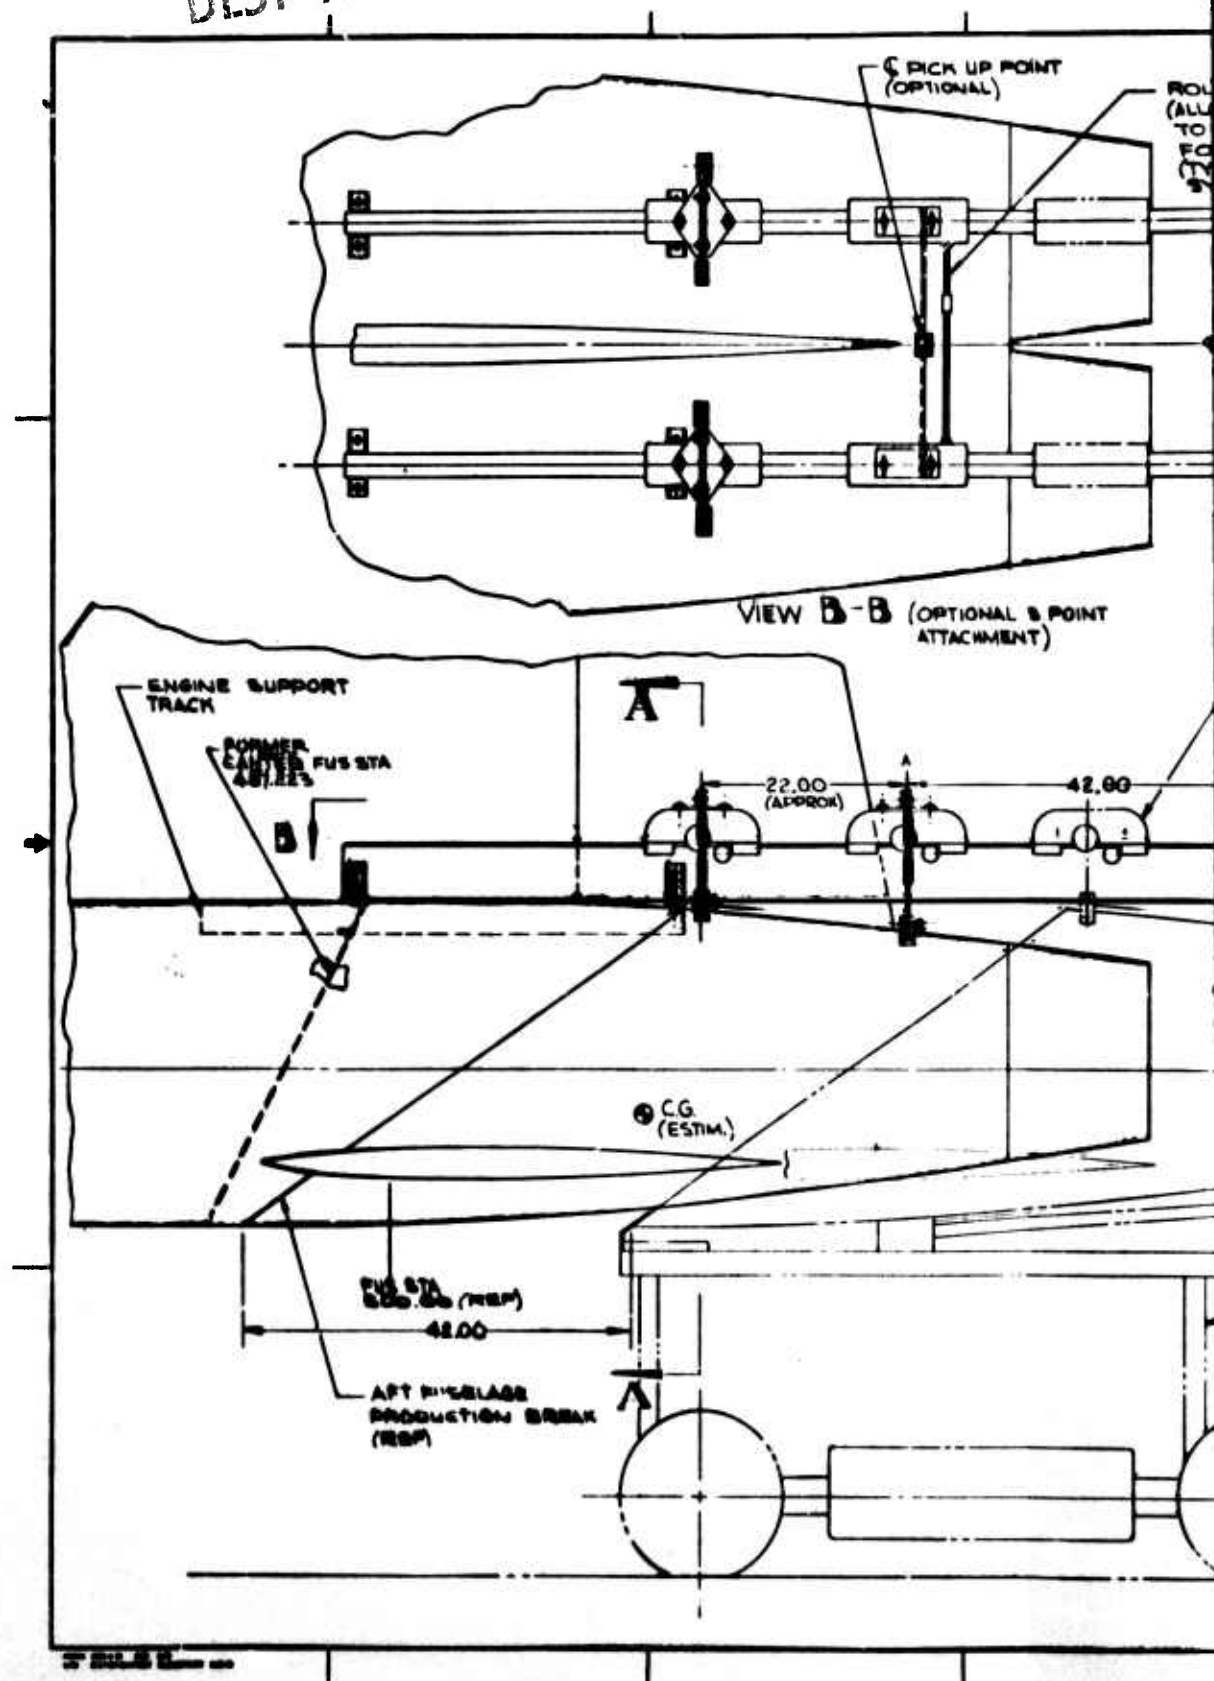
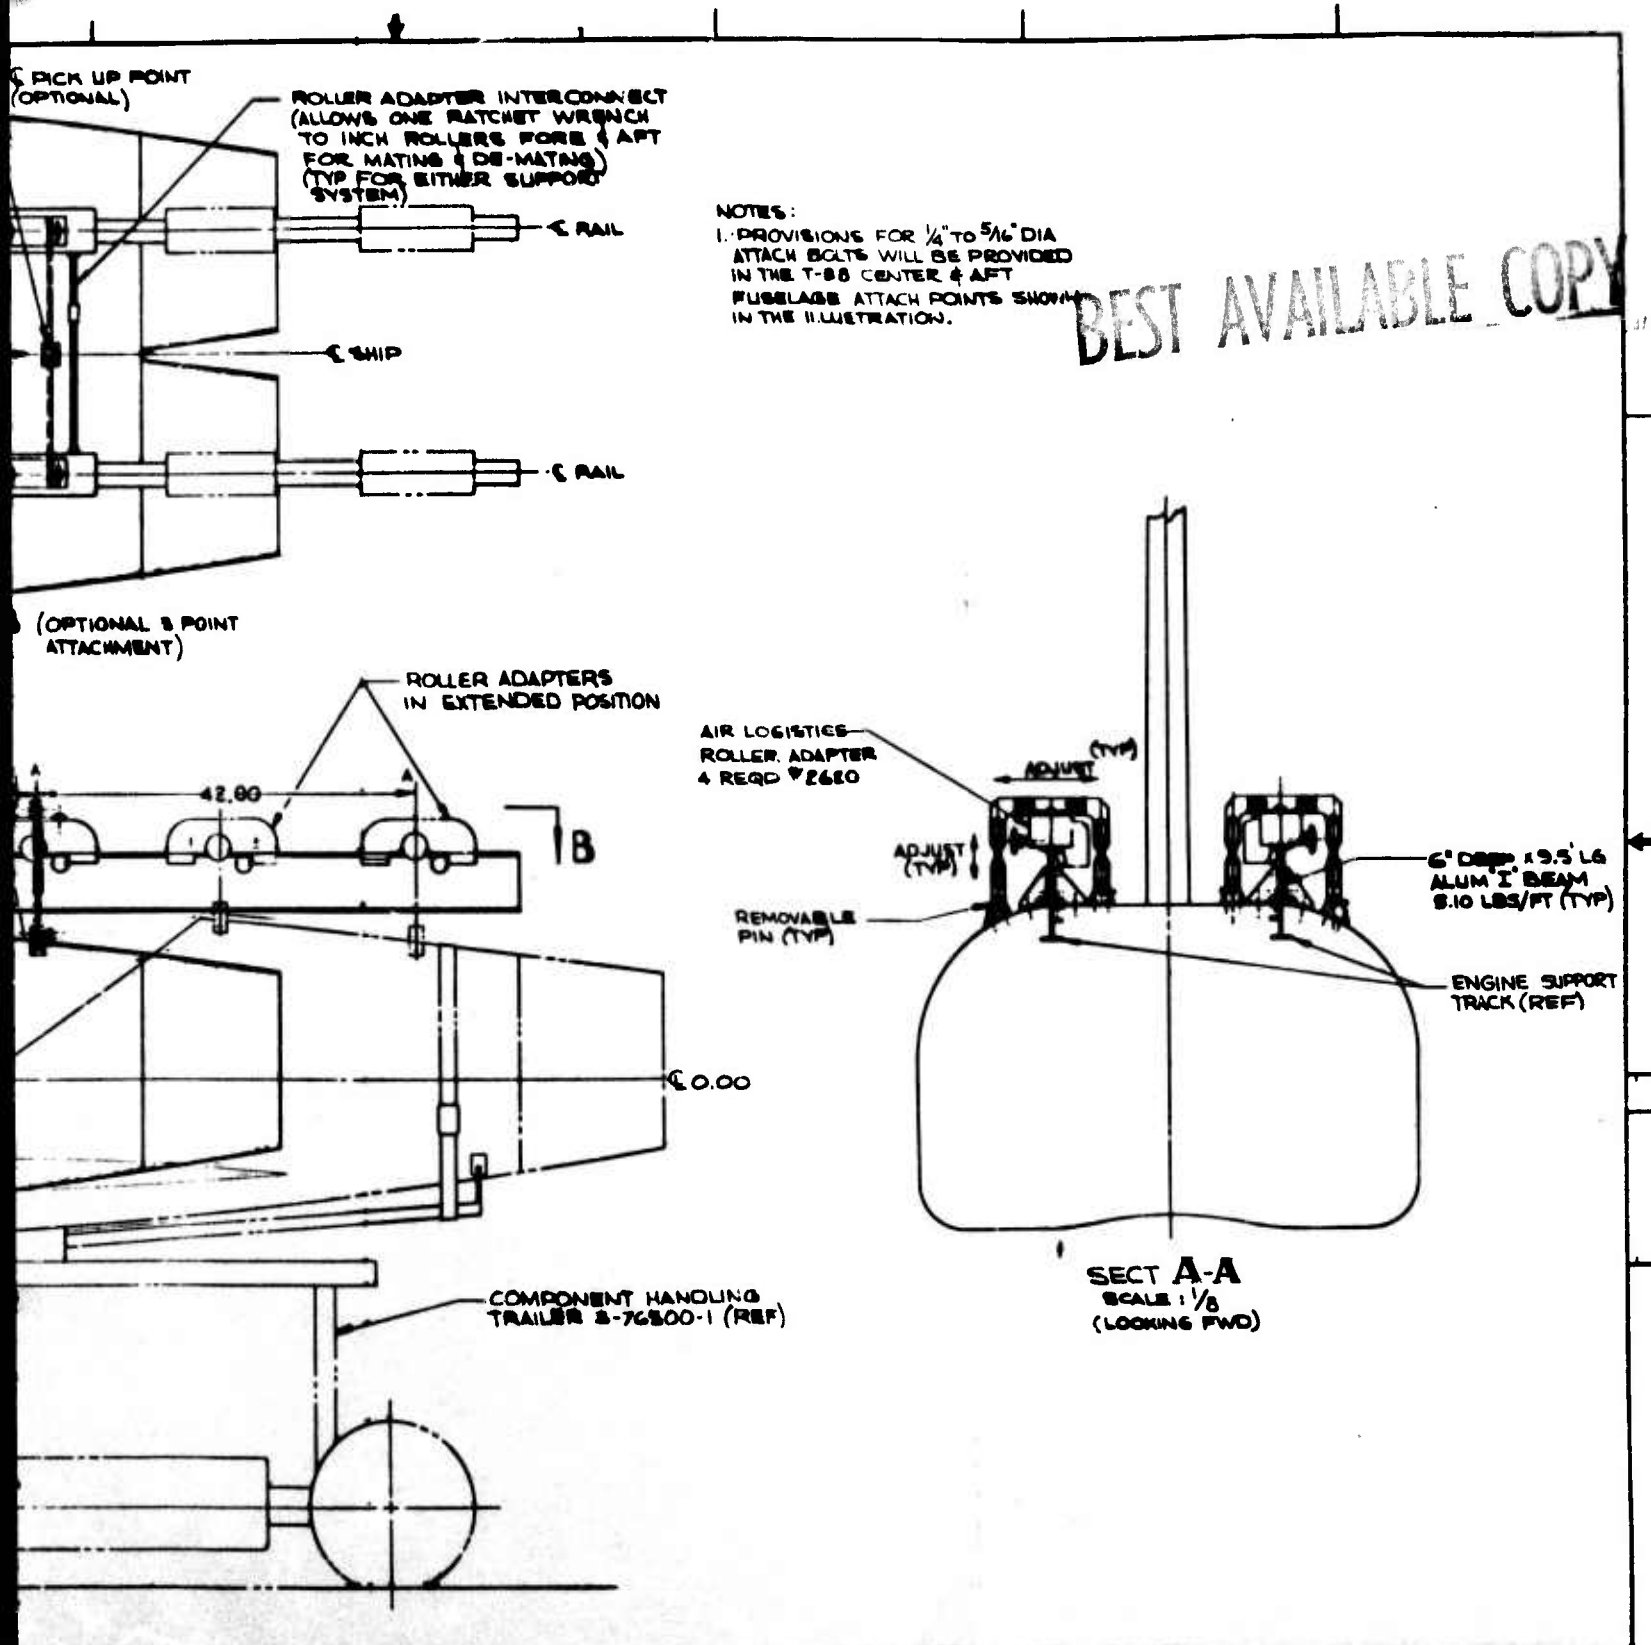
Figure 16. Item No. 6 - T-38 removable aft fuselage firewall assembly.

Reversal of the foregoing procedure would be utilized for remating the two fuselage sections. The guide system has the additional merit of a built-in capability that may be utilized to make incremental forward movements during the final mating operation.

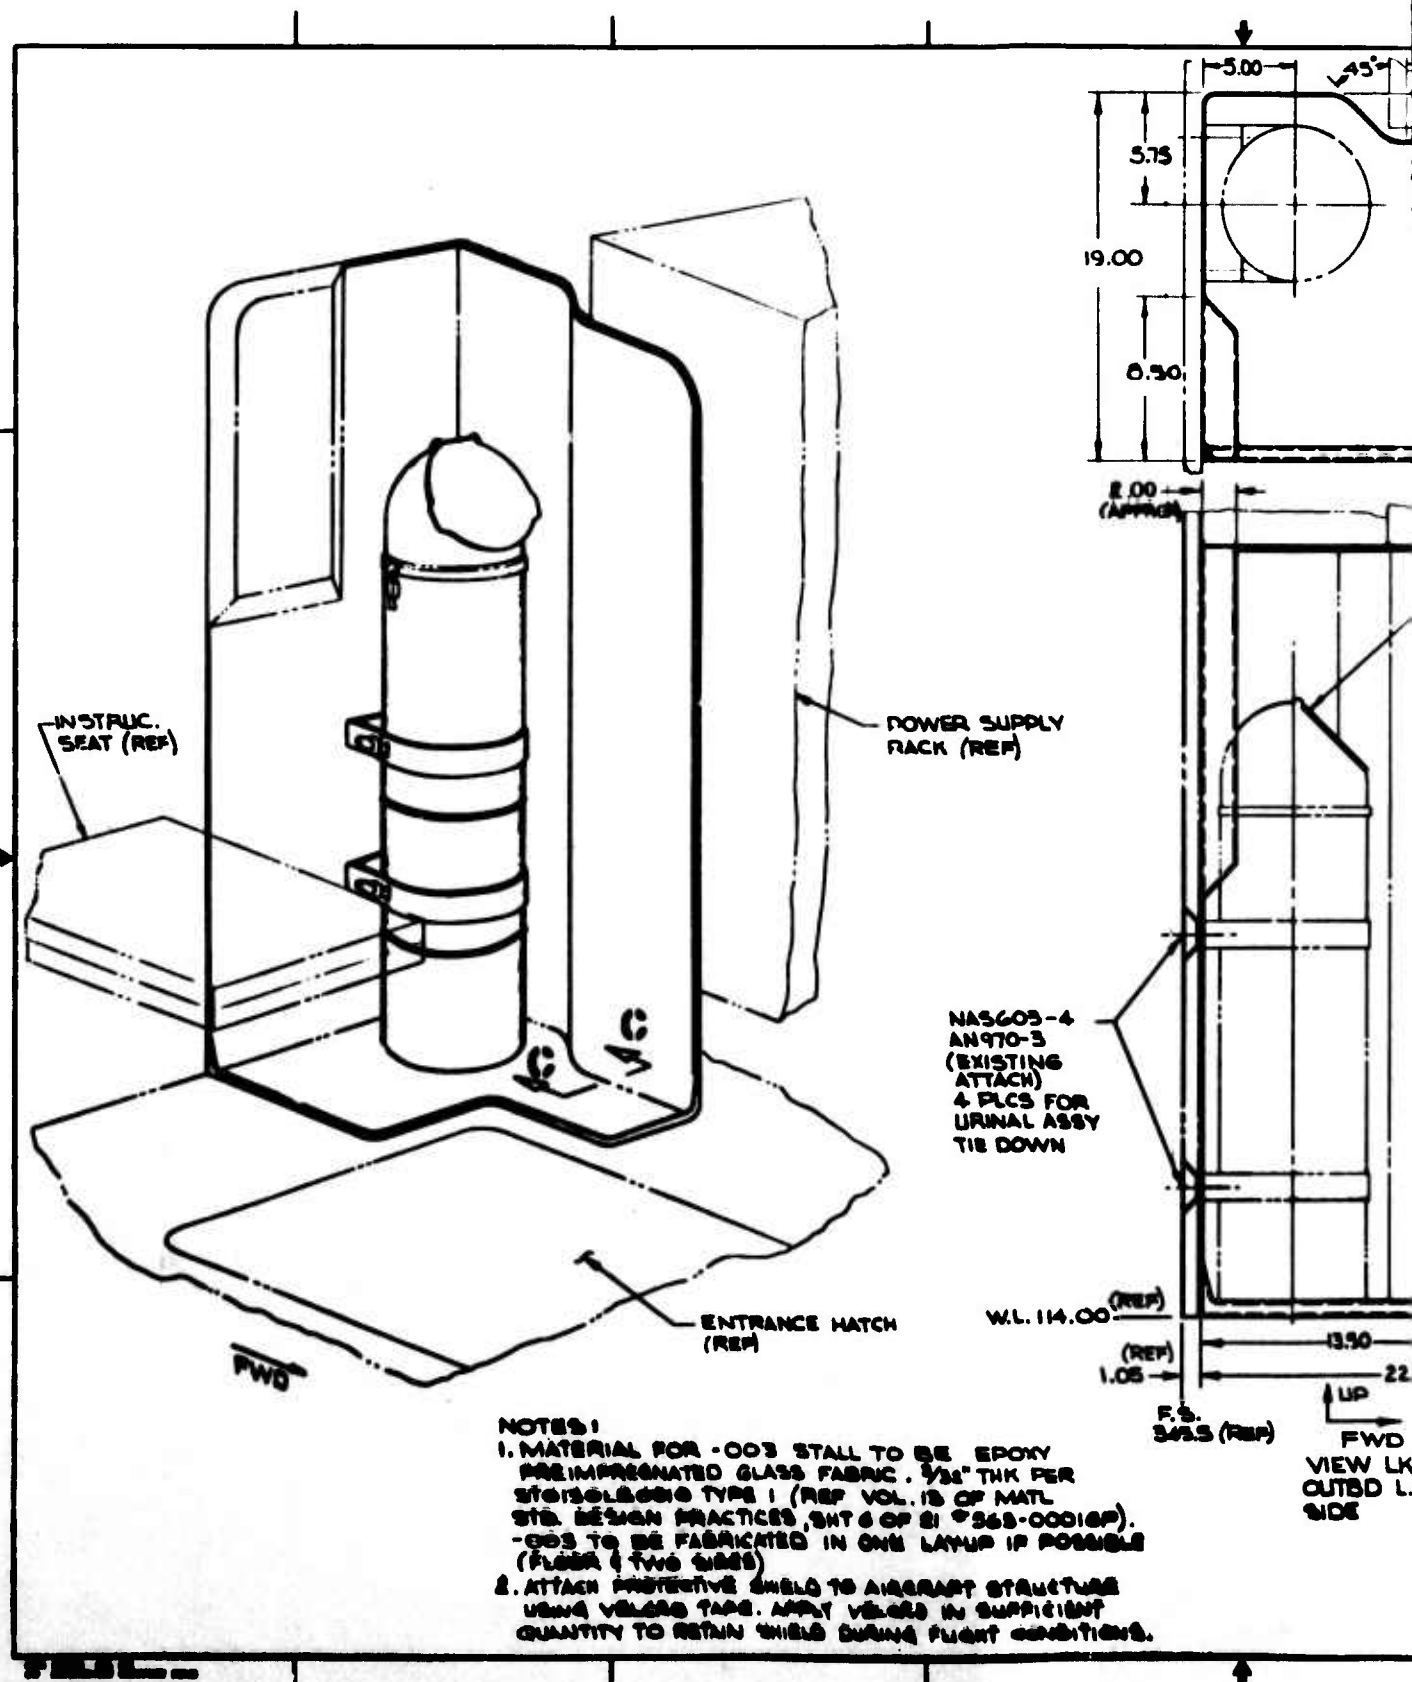
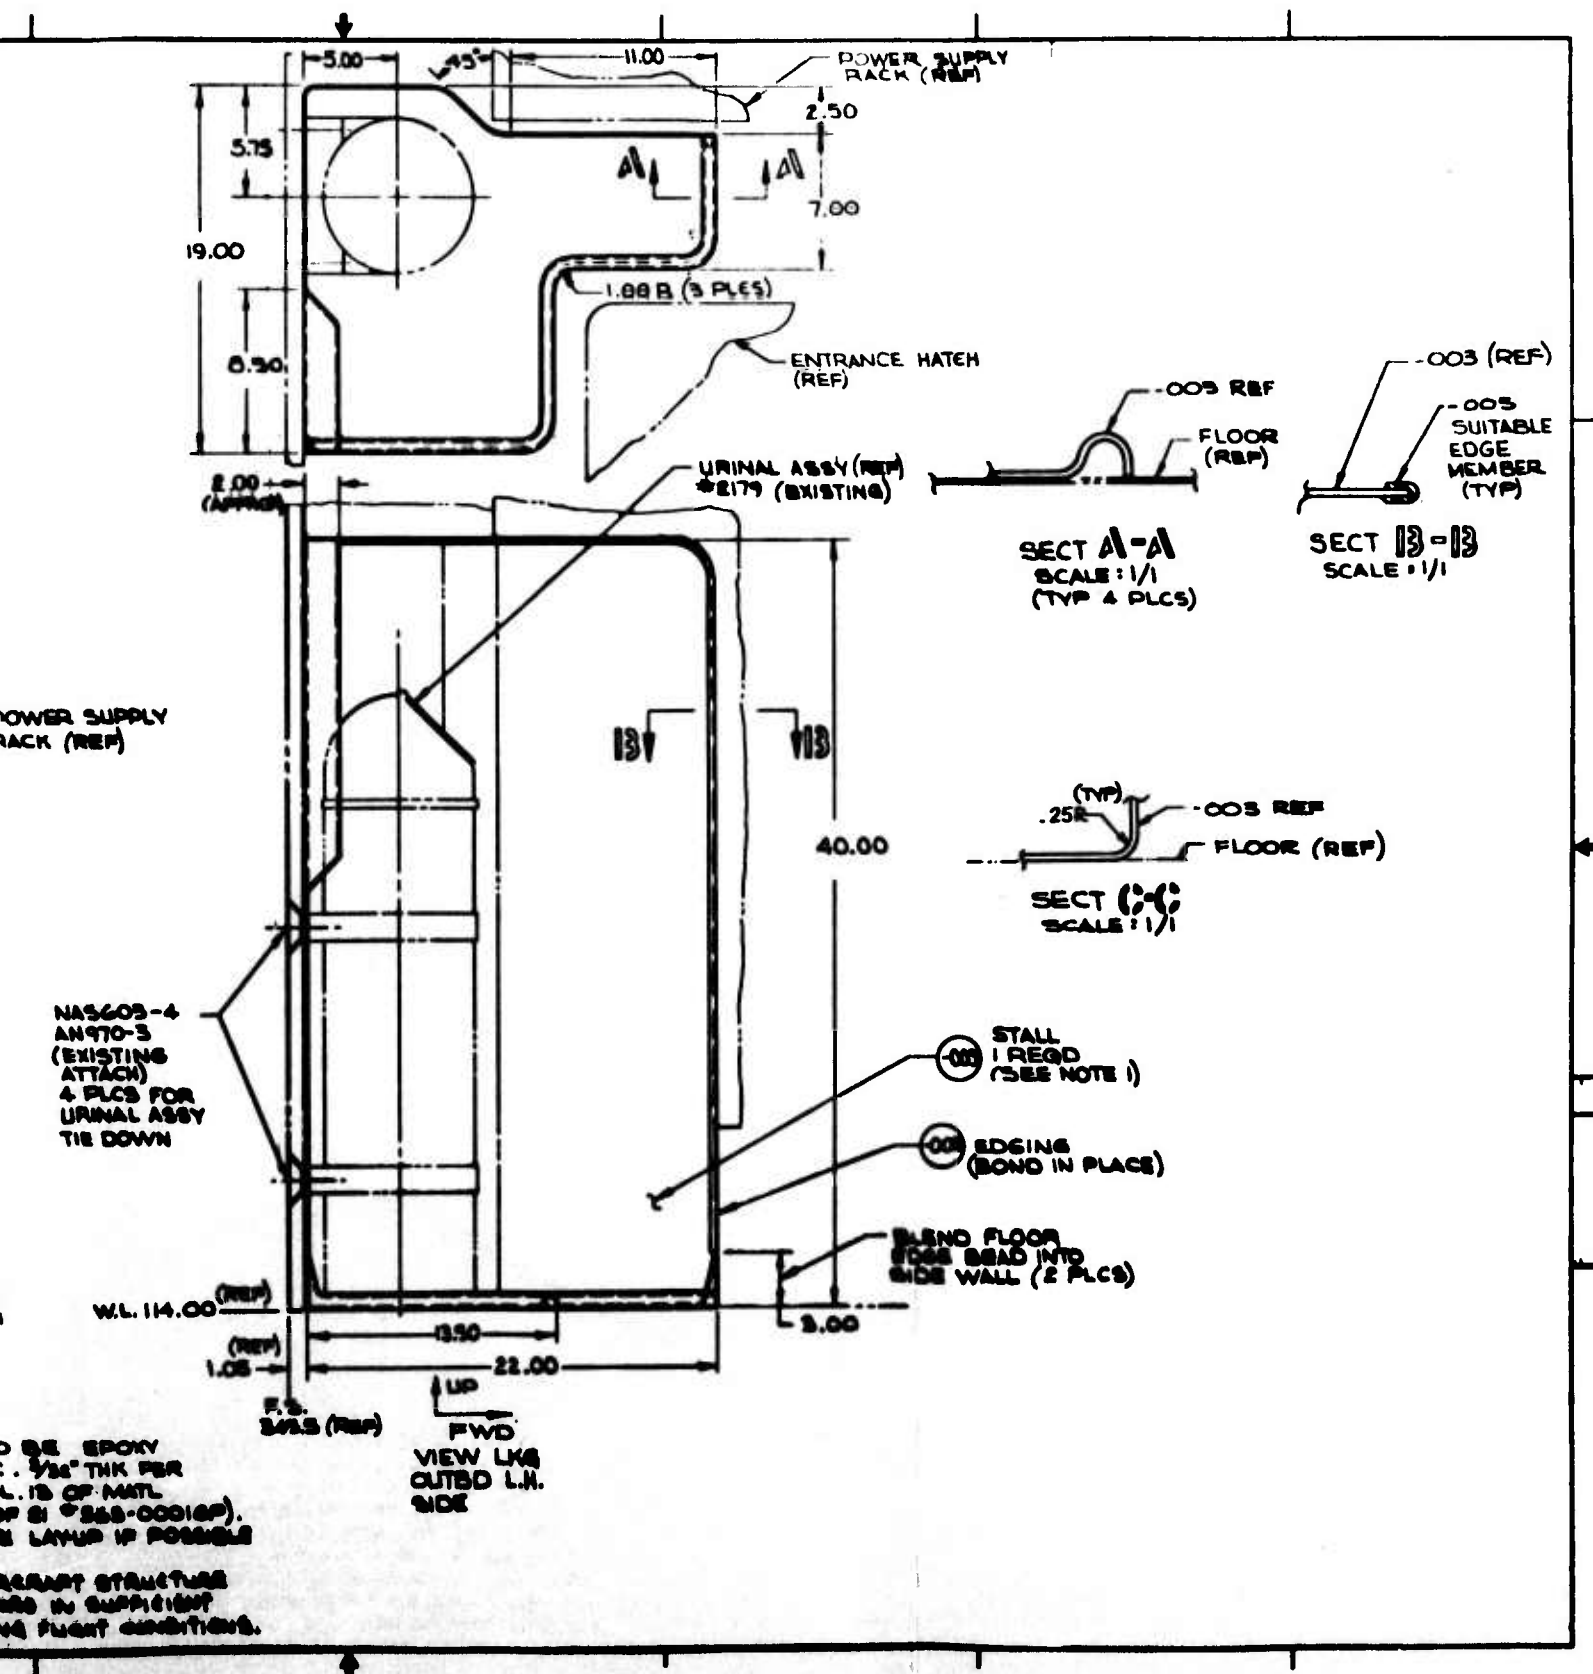
Figure 17. Item No. 8B - B-52G and H forward fuselage urinal area.

The floor pan would have a beaded section along its free edge high enough to retain excess moisture and would be shaped to allow clearance around the main entry hatch opening.

The urinal tank assembly would be restrained against the rear wall, using the existing brackets. These attachments would be sealed with a leakproof corrosion material.

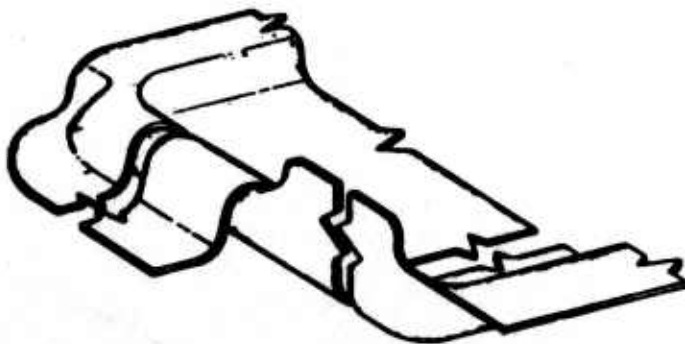
**DETAIL F**  
 (FLOOR PAN DETAIL ONLY)  
 (-1 REF)

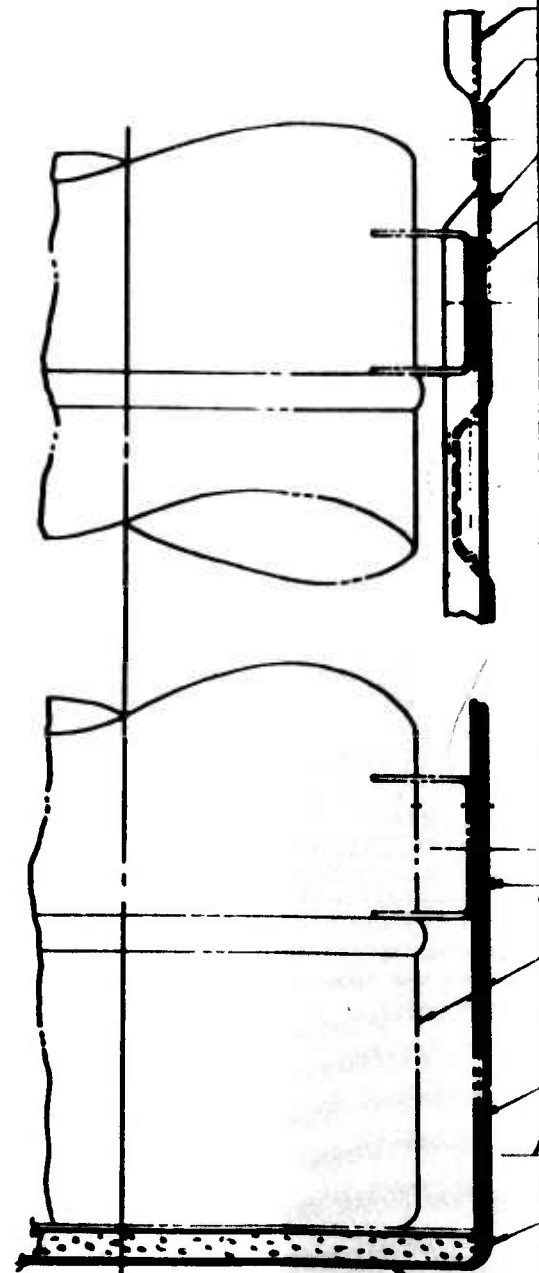
**SECT D-D**  
 SCALE 1/1
