LOW-COST AIRCRAFT STRUCTURAL REPAIR AND  
MAINTENANCE STUDY

ROCKWELL INTERNATIONAL  
LOS ANGELES AIRCRAFT DIVISION  
LOS ANGELES, CALIFORNIA

MARCH 1977

FINAL REPORT FOR PERIOD AUGUST 1974 - MAY 1976  
TECHNICAL REPORT AFFDL-TR-76-63

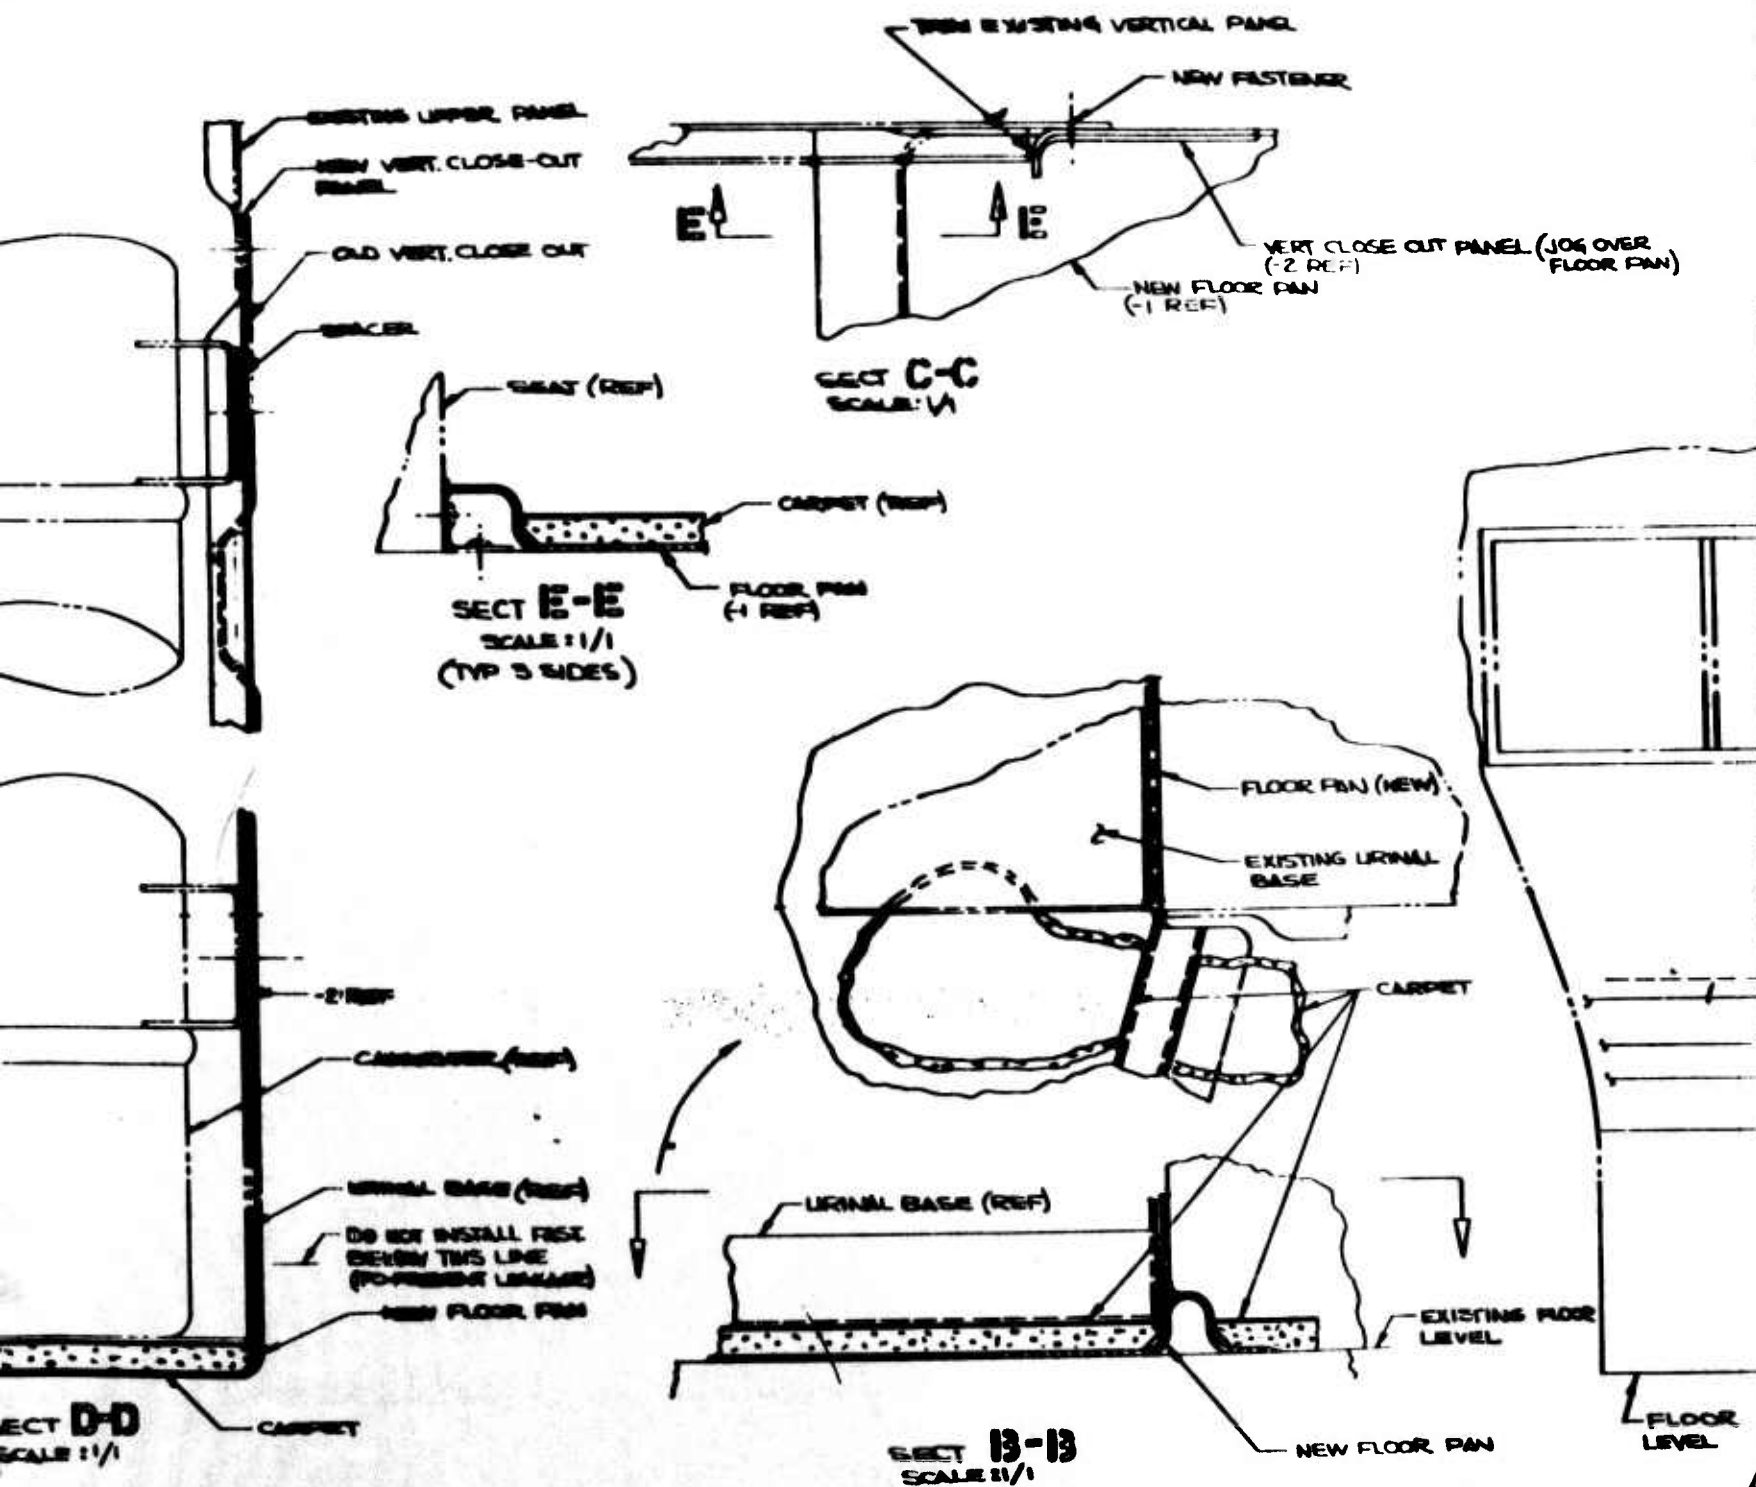
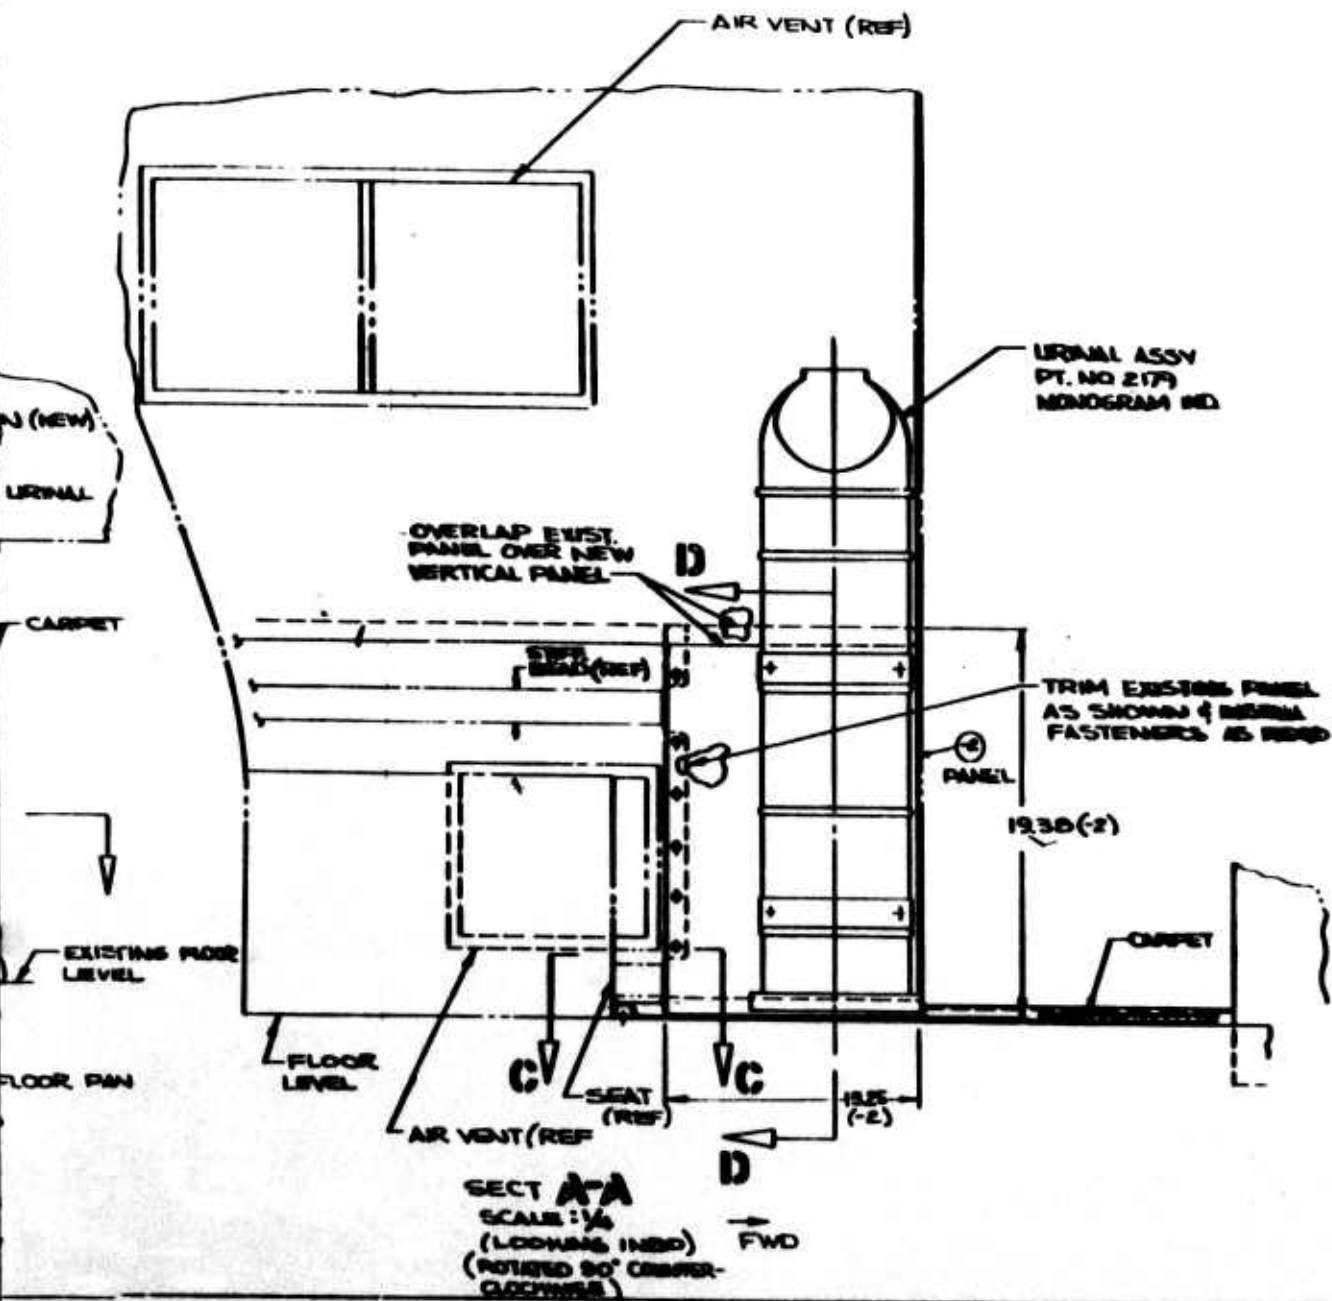
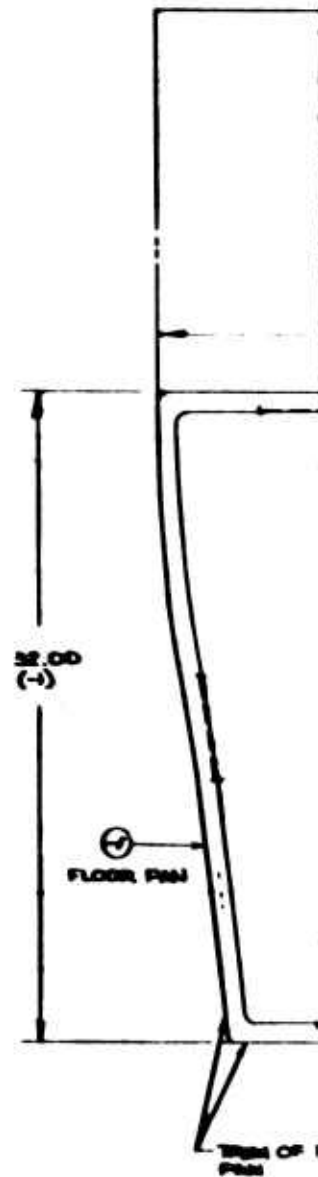
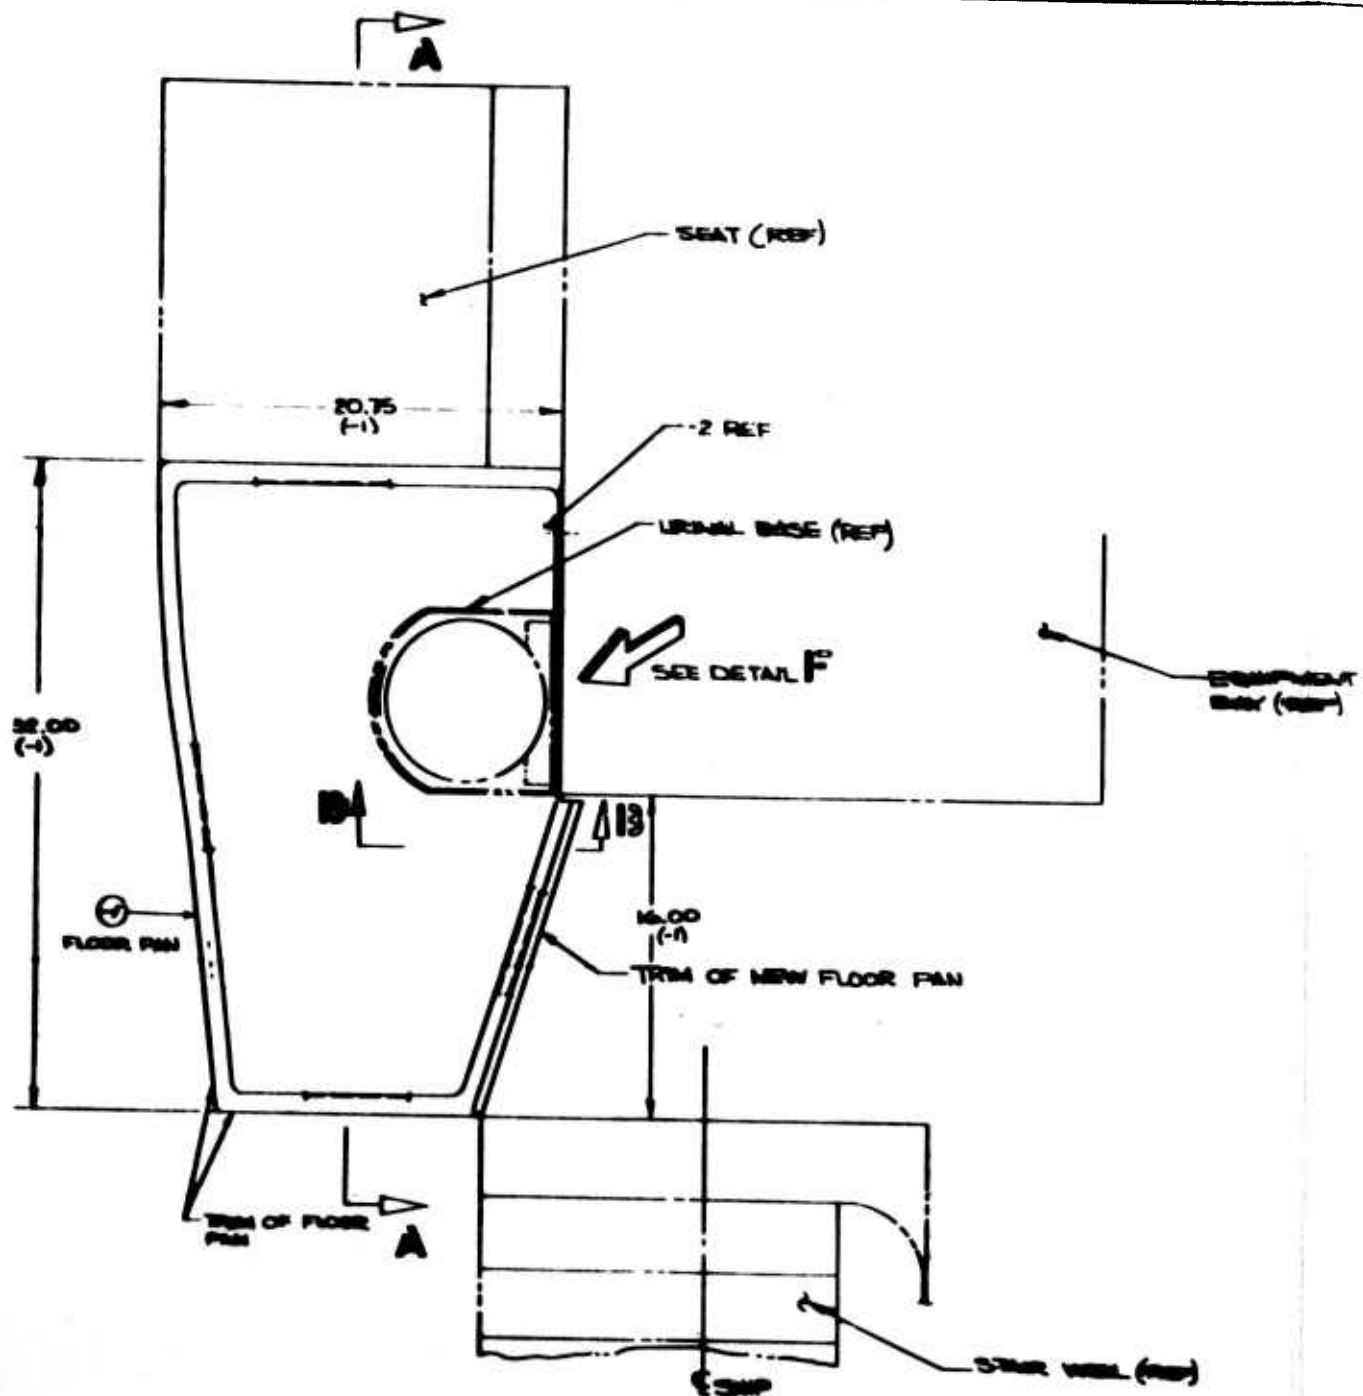
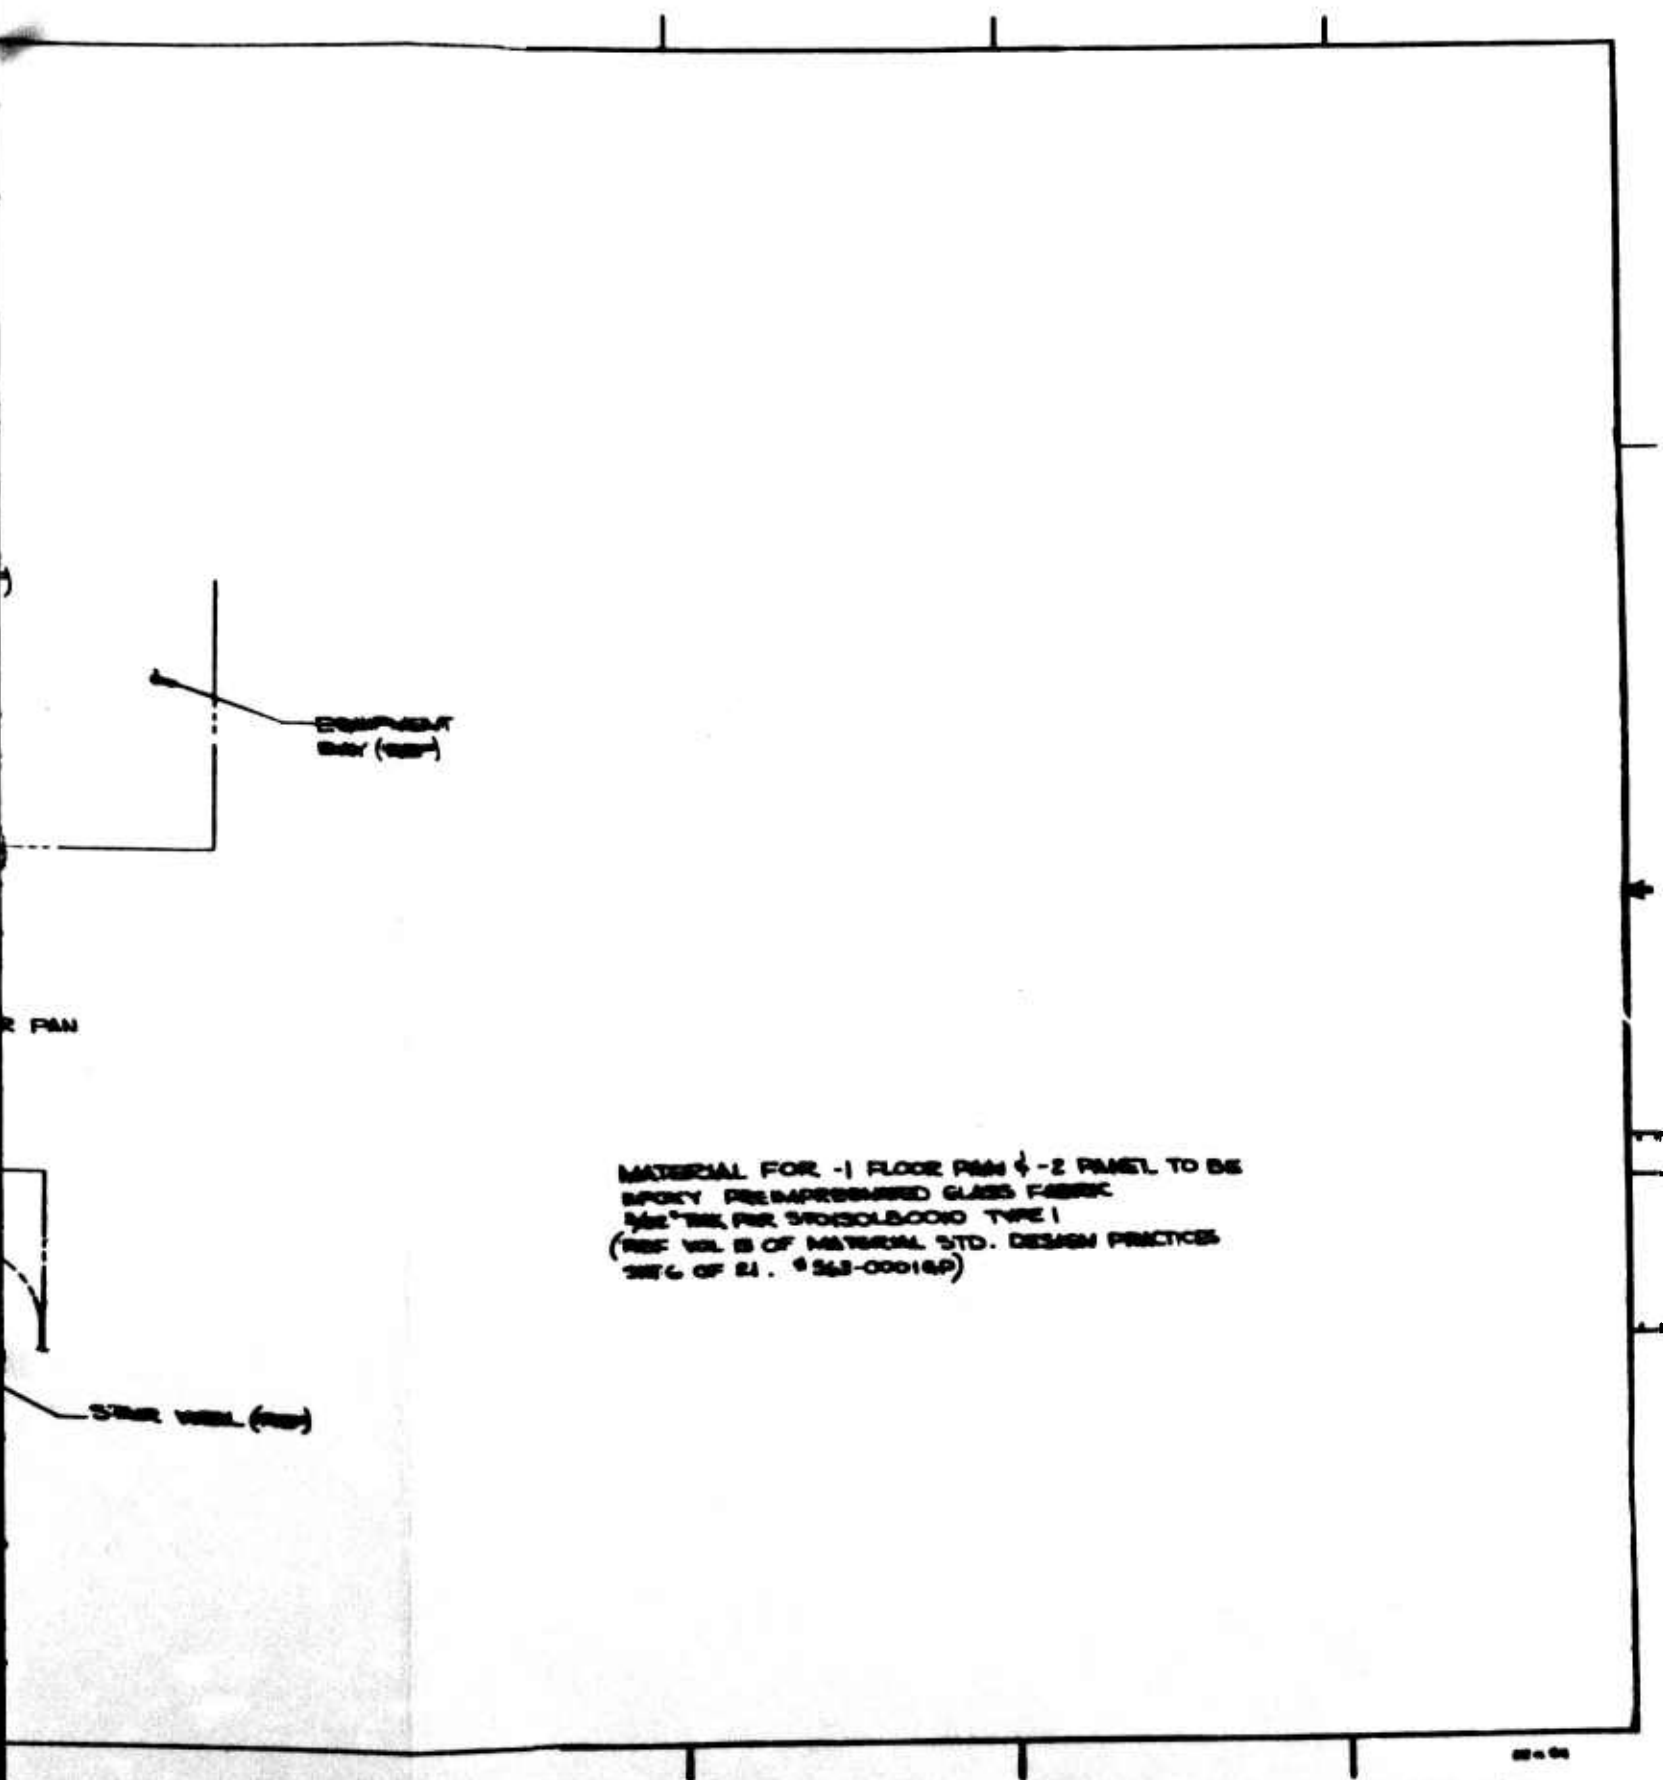
Figure 18. Item No. 8A - B-52D forward fuselage urinal area.

LOSE OUT PANEL (JOG OVER FLOOR PAN)

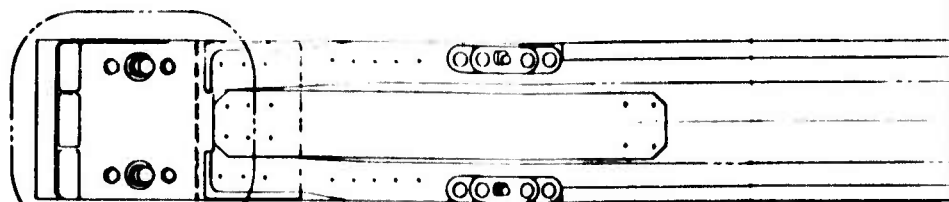
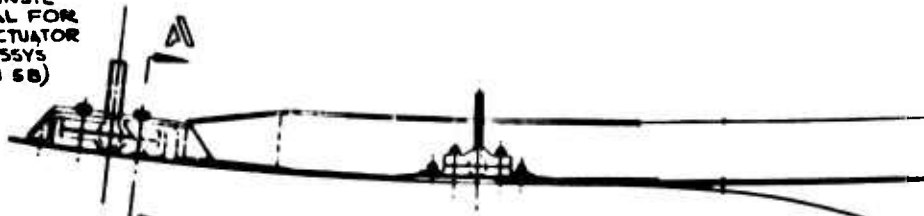
SEE DETAIL  
FOR NEW DOOR  
GUIDE INSTL  
(TYPICAL FOR  
SLAT ACTUATOR  
DOOR ASSYS  
1A THRU 5B)

DOOR ASSY-SLAT ACTUATOR, TRACK 1A  
VIEW LOOKING INBD PARALLEL TO  
THE INNER WING SLAT HINGE LINE

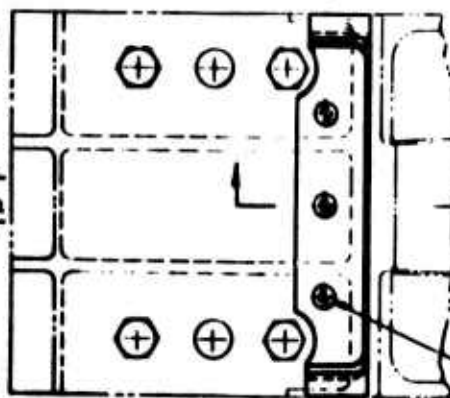
DETAIL (C)  
SCALE 11/1  
INBD  
OUT

BLIND RIVETS  
IF NEEDED FOR  
INSTL WITHOUT  
DOOR REMOVAL  
& REGRIND

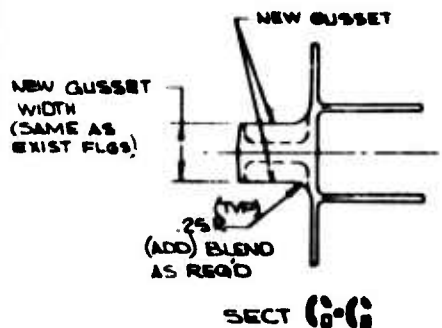
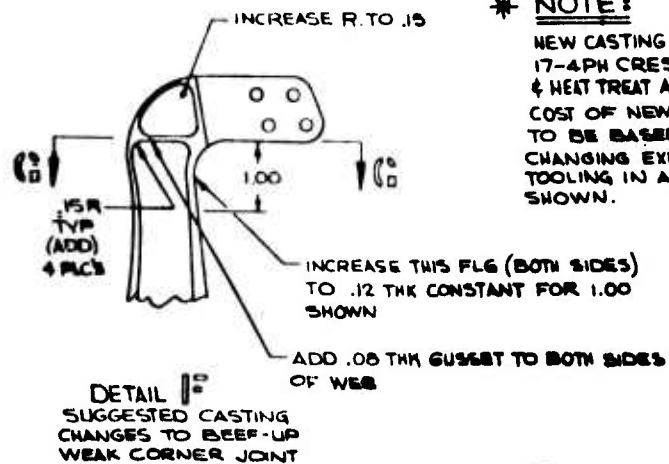
**\* NOTE:**

NEW CASTING TO BE 17-4PH CRES (SAME MAT'LTY & HEAT TREAT AS ORIG. PART). COST OF NEW CASTING TO BE BASED ON CHANGING EXISTING TOOLING IN AREA SHOWN.

Two approaches to the cracked fitting were considered. The first was a new fitting with an adequate beefup of the flange area. The increased thickness of the flanges and the addition of gussets would insure adequate load paths for momentary high stress loads the fitting may experience.

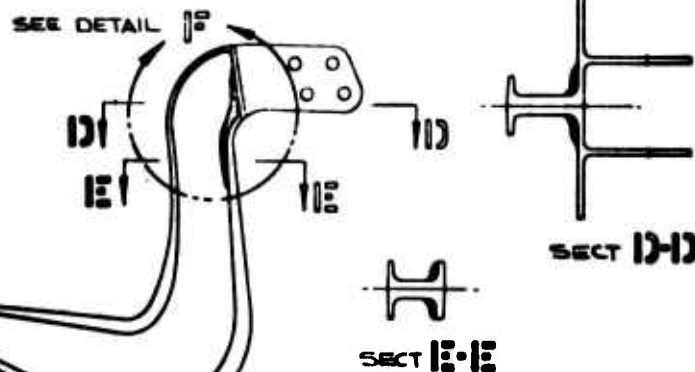
- PREPARATION OF HINGE FTS. PRIOR TO WELDING & WELDING PROC.
1. CLEAN FTS. USING SOLVENT & EMULSION CLEANING METHODS.
  2. ANNEAL FTS. AT A TEMP OF 1900 ± 25°F FOR MAX OF 45 MIN. USING A ARGON, HELIUM OR DRY HYDROGEN ATMOSPHERE OR VACUUM FURNACE.

3. APPLY SCALE INHIBITING COMP. .0005 THK TO PREVENT OXIDATION DURING ANNEALING.
  4. BLEND OUT CRACKS INSURING NO PART OF CRACK REMAINS. USE 60° VEE GROOVE IF POSSIBLE.

7. REPEAT STEP #1 (CLEANING)
  8. RADIOGRAPHIC INSPECT HINGE
  9. REPEAT ANNEAL STEP #2
  10. PRECIPITATION HARDEN FTS TO COND H925, SPEC STPS4-G13 (LOCKWED)

11. PASSIVATE FTS BY IMMERSION FOR 30 TO 60 MIN IN SOLUTION OF 60 TO 70 GSS. OF FES. SPEC G-N-50 NITRIC ACID IN ONE GAL OF H2O AT A TEMP OF 150°F. & DRY.

An alternate approach considered was reinforcement of the crack-prone area by welding. The flanges on either side of the critical area could be built up with weld until the cross-sectional area is large enough to withstand higher stress loads. This method may also be used to repair cracked fittings.

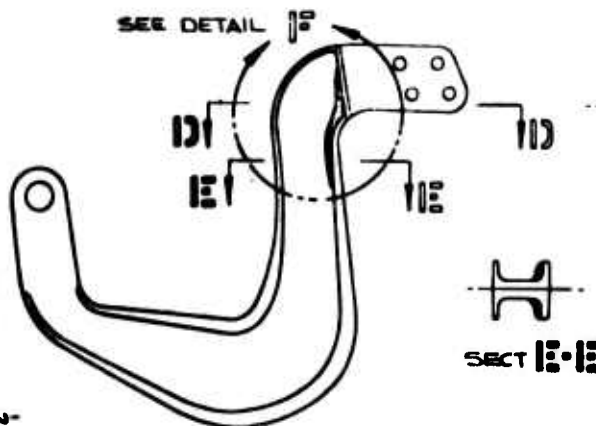
**VIEW C**  
SCALE: 1/1

SUGGESTED METHOD OF SALVAGING EXISTING COWL HINGE BY INCREASING CROSS SECTIONAL AREA USING WELD BUILD-UP. (SEE DARKENED AREA IN ILLUSTRATION)

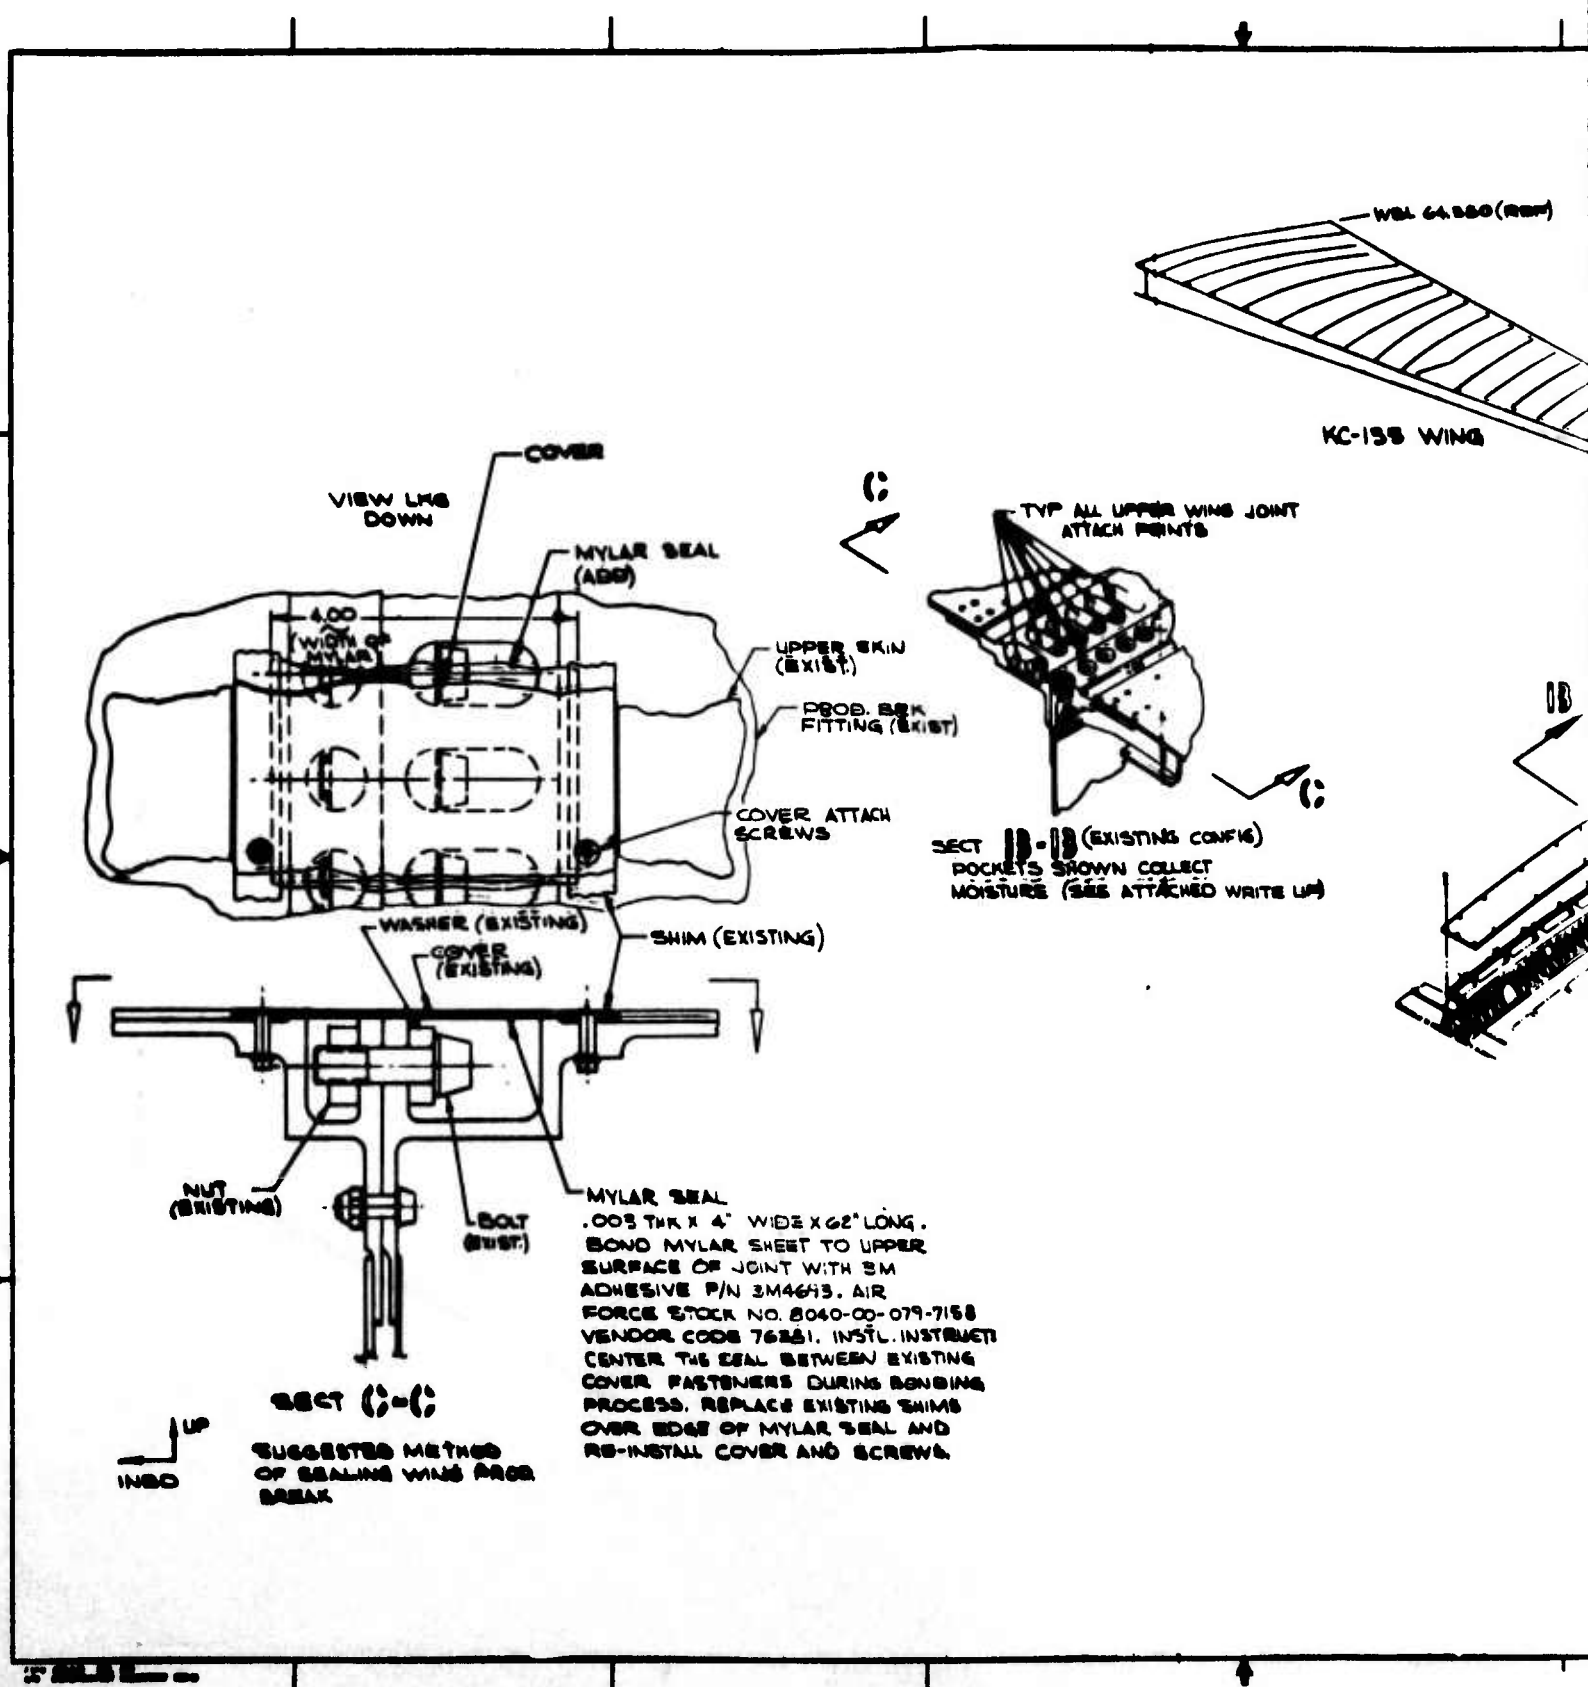
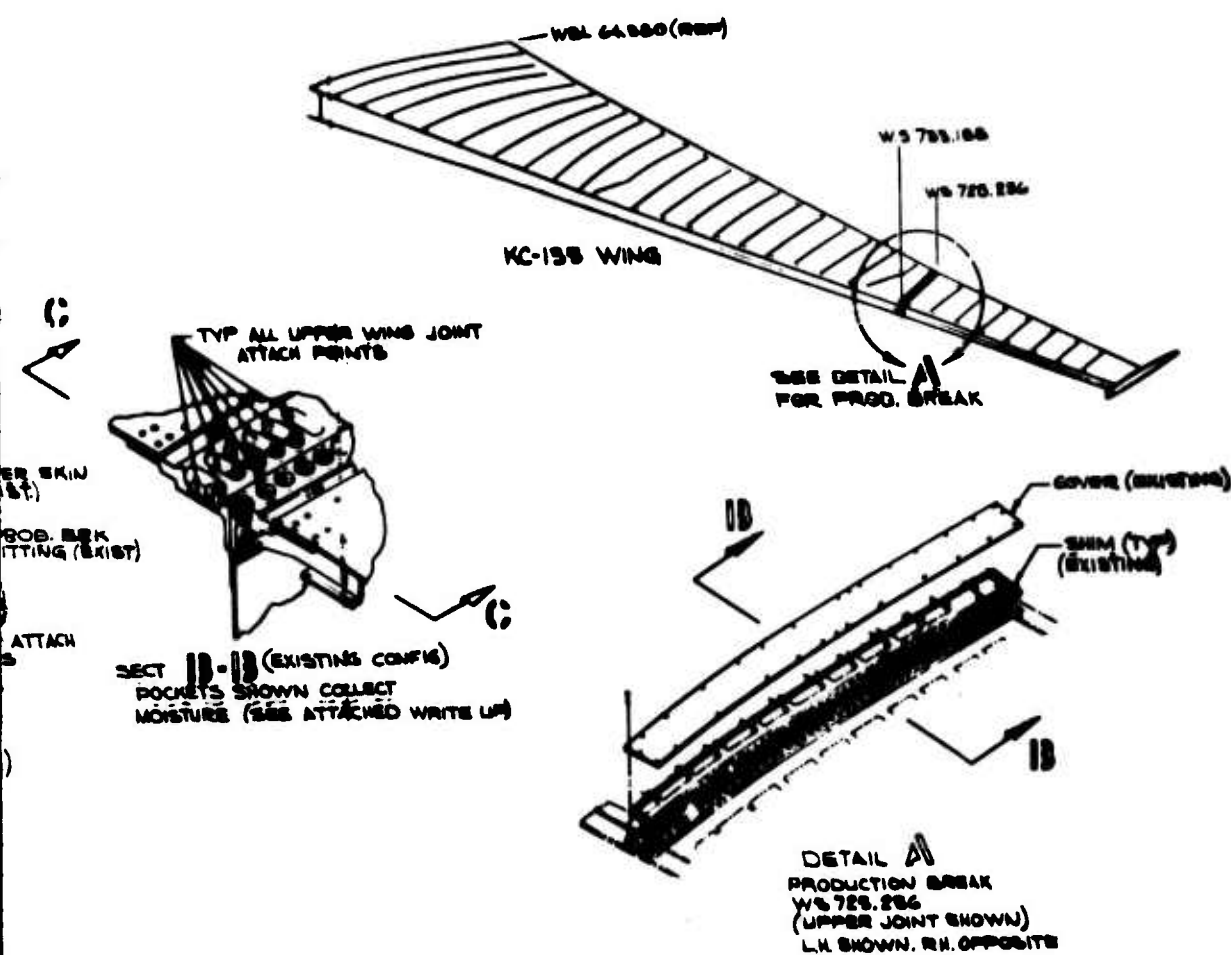
Figure 22. Item No. 13 - C/KC-135 inner to outer wing joint ribs.

The fairing cover has been designed to provide an adequate seal. A Mylar-type gasket would be cemented to the fittings covering the bathtub recesses so that moisture would be prevented from entering the cavities.

62" LONG.  
TO UPPER  
WITH SM  
3. AIR  
40-00-079-7158  
1. INSTL. INSTRUCT  
BETWEEN EXISTING  
DURING BONDING  
EXISTING SHIMS  
R SEAL AND  
NO SCREWS.

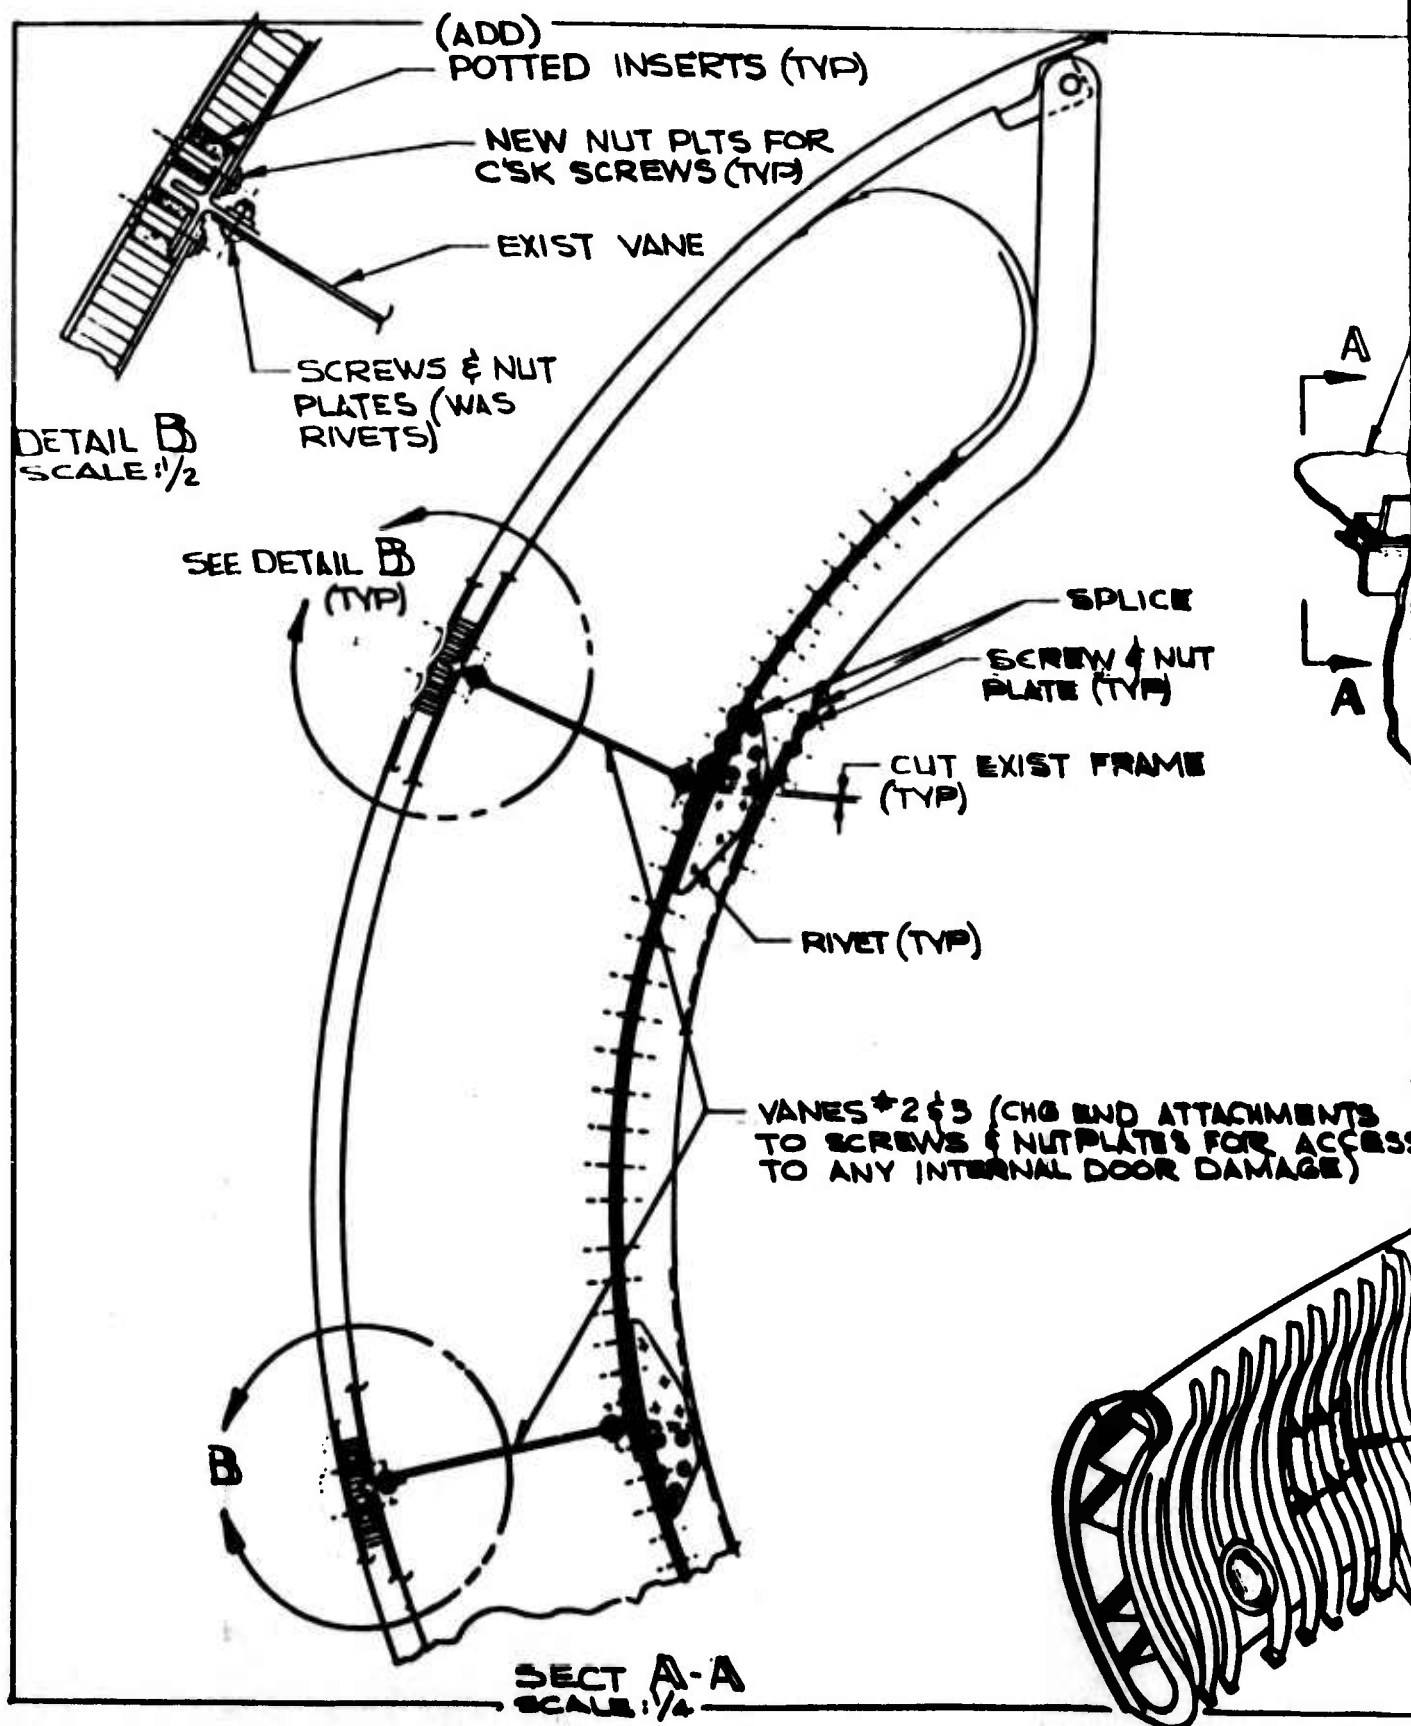
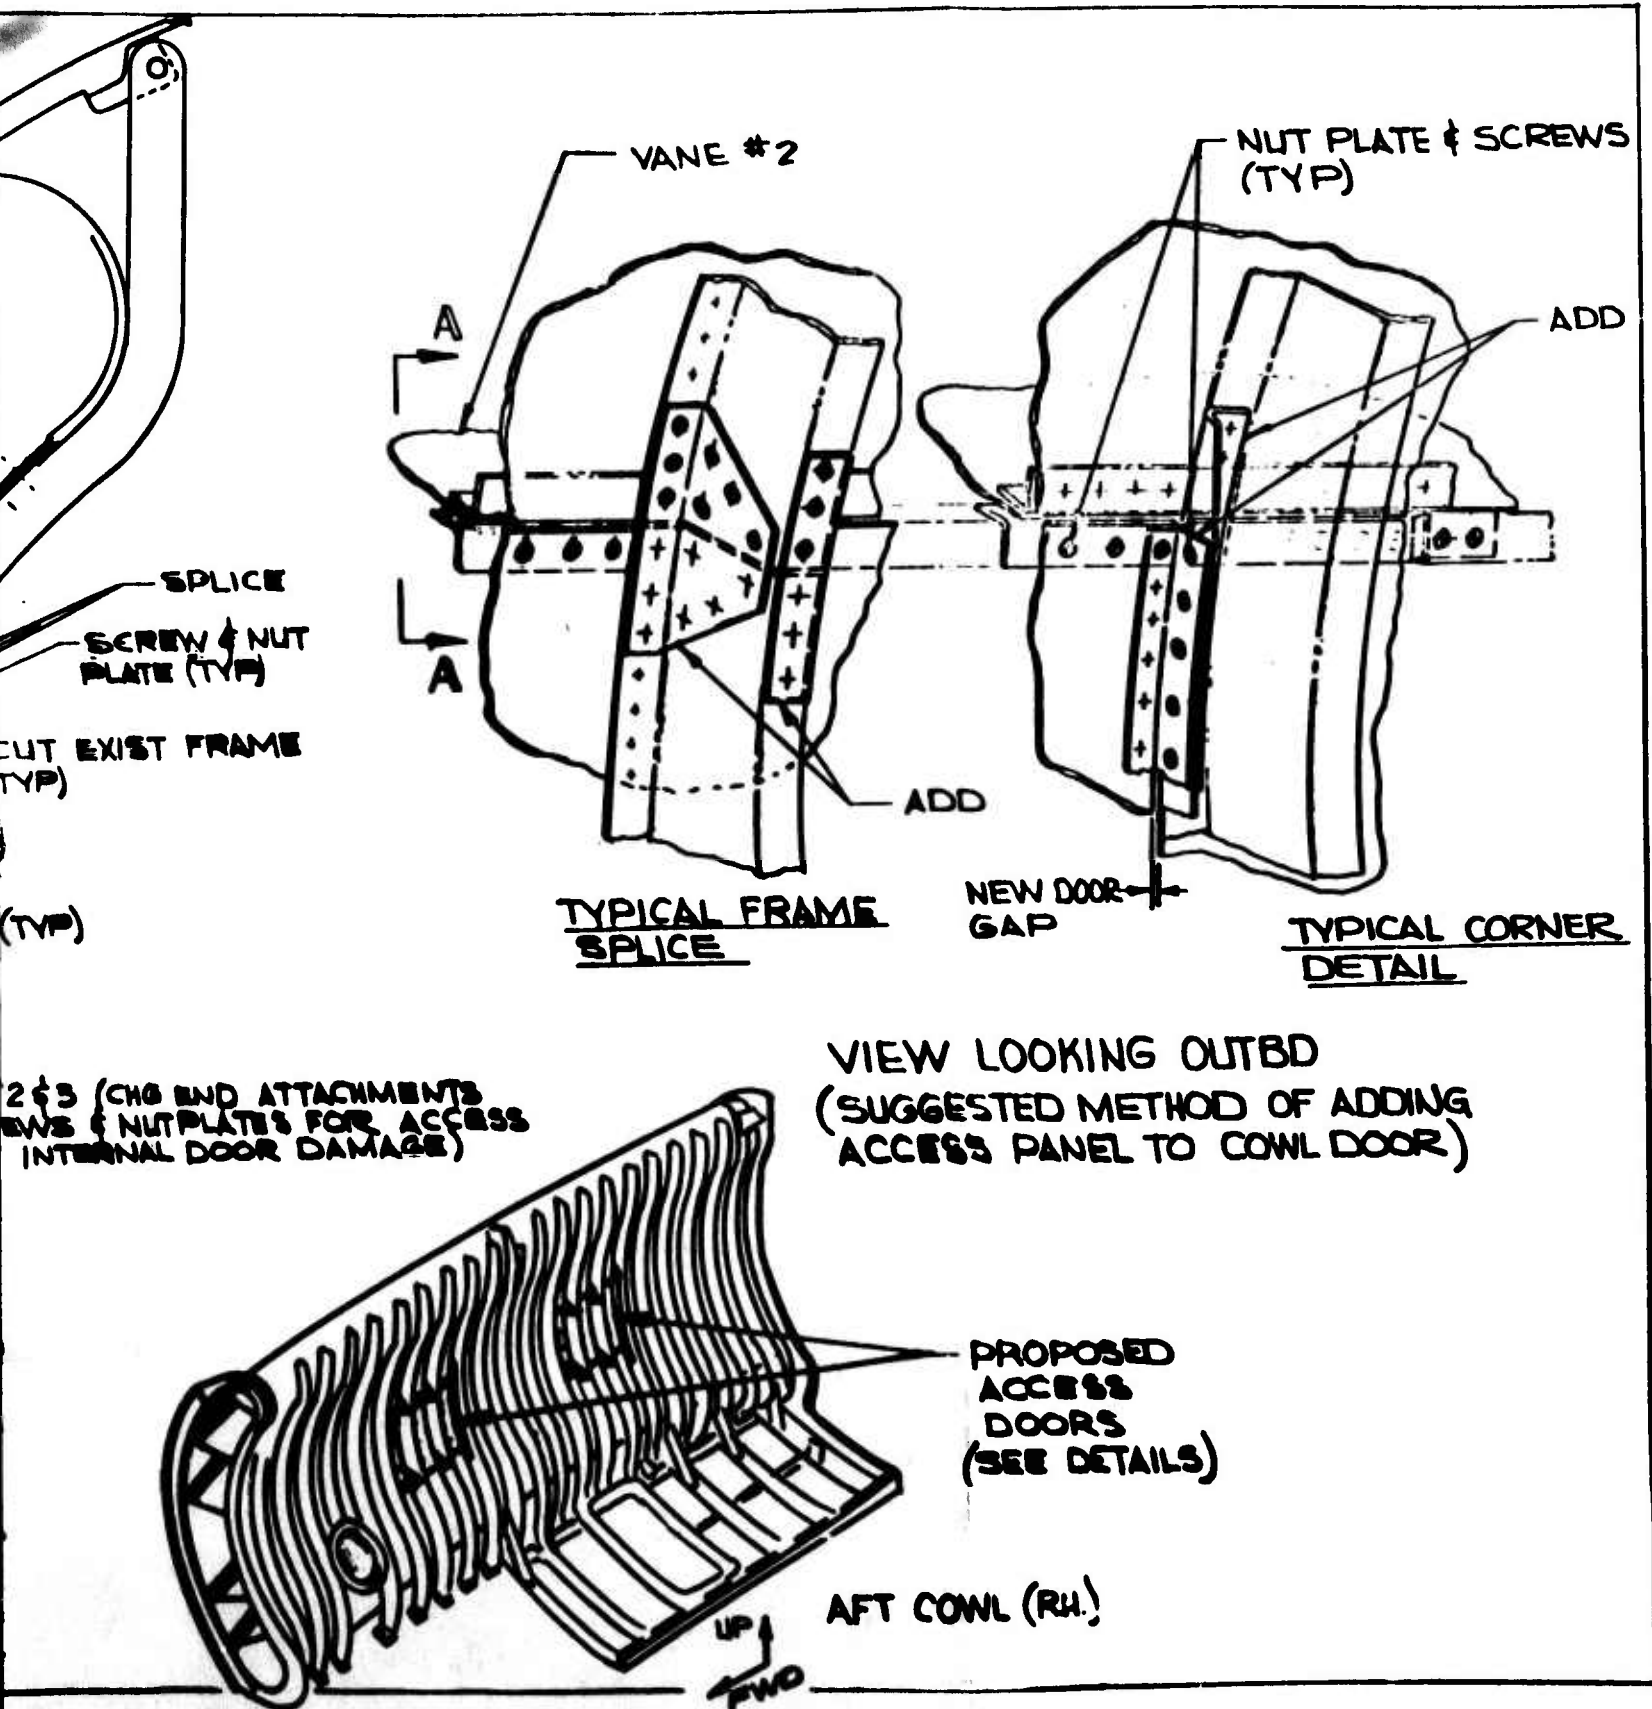
Figure 23. Item No. 14 - C-141 nacelle aft cowl door.

Access to areas of the duct, unreachable from either end, is mandatory for repair of the vanes and their attachments. Provisions for two small removable doors in the inboard duct wall structure can be made. These doors would be between the two main vanes and between stations 120.130 and 132.320 for the forward door, and between stations 147.950 and 159.950 for the aft door. The two intermediate frames in each case would require removable splice joints at the upper and lower edges of each door. Sections of each vane in the proximity of each door must also be made movable for access into the upper and lower sections of the duct.

A mechanical attachment of the outboard vane attach member to supplement the integral bonding attachment as shown will also prevent disbonds in the honeycomb.

LOW-COST DESIGN (See Figure 23)
