USAAVSCOM TR-84-D-6

**SMALL PORTABLE ANALYZER DIAGNOSTIC EQUIPMENT (SPADE)  
PROGRAM — DIAGNOSTIC SOFTWARE VALIDATION**

**P. Berrett and J. M. Laskey  
RCA AUTOMATED SYSTEMS  
Burlington, Mass. 01803**

**Final Report**

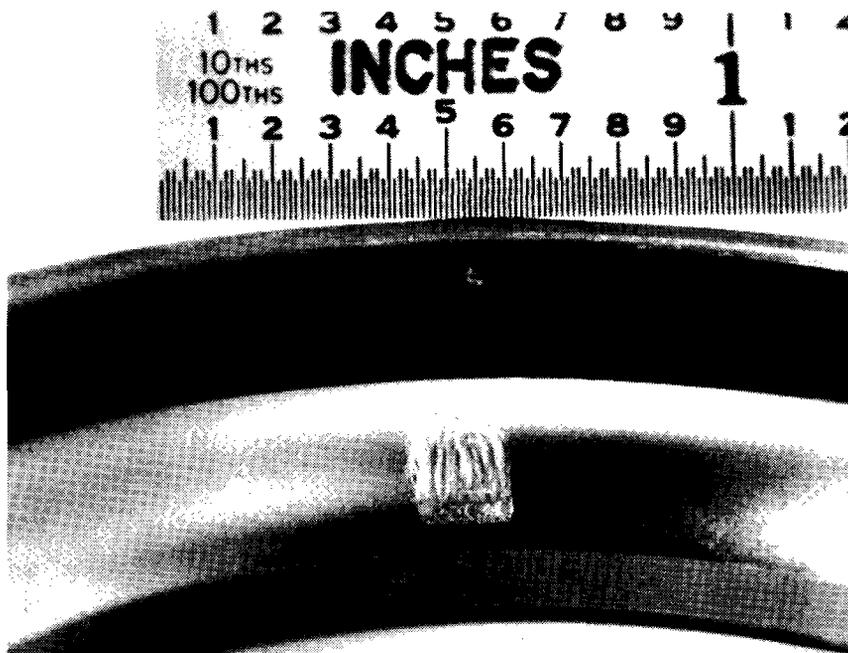
Figure C-34. 42-Degree Gearbox -143 Bearing Outer Race C/D,  
S/N J0629, Runs 2A + 2B and 8A + 8B

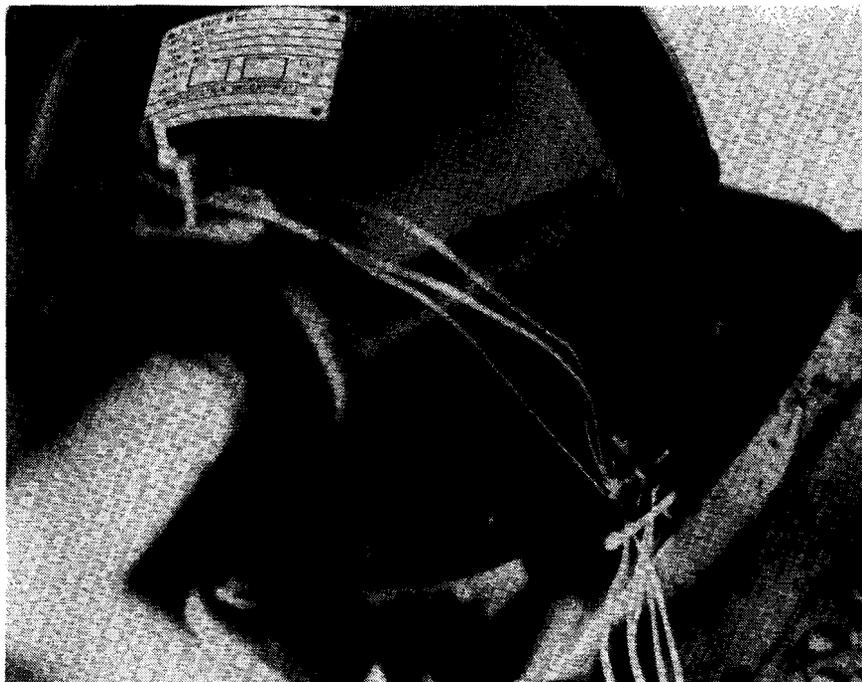
Figure C-62. Typical AH-1S 90-Degree Gearbox with Bolted and Bonded Triaxial Accelerometers for Data Recording
