**THERMIONIC SYSTEM EVALUATION TEST: YA-21U.
SYSTEM TOPAZ INTERNATIONAL PROGRAM****Glen Schmidt, Ph.D.****TOPAZ International Program
901 University Blvd SE
Albuquerque, NM 87106-4339****July 1996****Final Report**

**PHILLIPS LABORATORY
Space Technology Directorate
AIR FORCE MATERIEL COMMAND
KIRTLAND AIR FORCE BASE, NM 87117-5776**

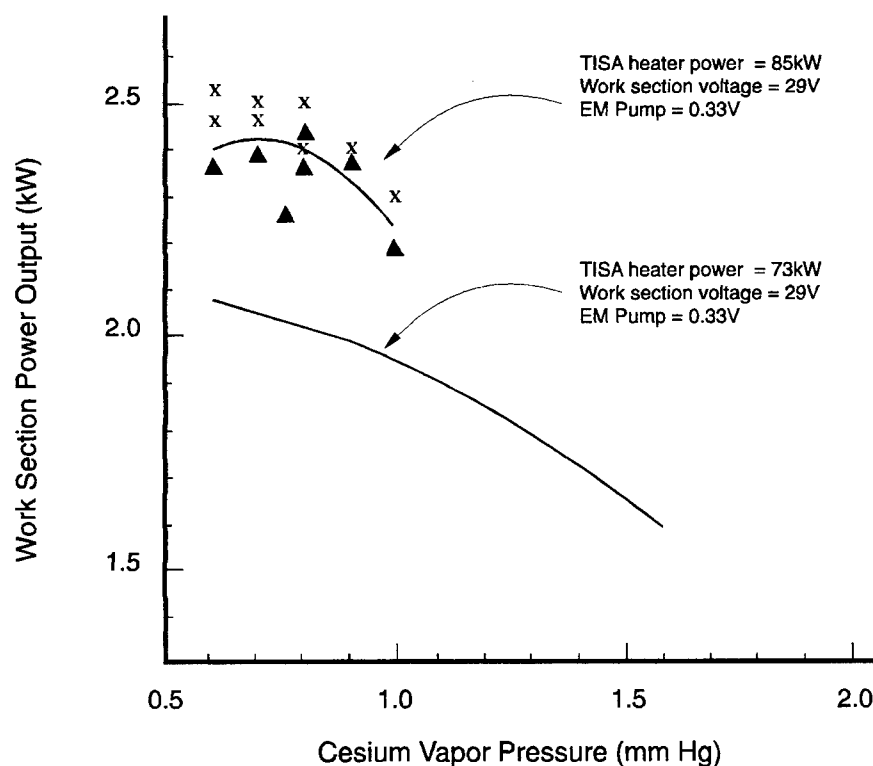
Figure 24. Ya-21U working section power versus cesium vapor pressure.

Acceptance tests of Ya-21U were performed during the period from August 8 to 14, 1989. The acceptance tests included a normal heatup rate and operation at the established mode for non-nuclear tests and a rapid startup from a TISA heater power level of 2.5 kW to a TISA power of 83.5 kW within a 23-min period, as illustrated by Figure 25. Ya-21U system parameters at conclusion of the rapid startup are listed in Table 10.
