**CREEP OF HAFNIUM DIBORIDE -20 VOL% SILICON CARBIDE AT 1500 °C
IN AIR**

THESIS

Glen E. Pry, Captain, USAF
AFIT-ENY-MS-18-M-286

AIR FORCE INSTITUTE OF TECHNOLOGY

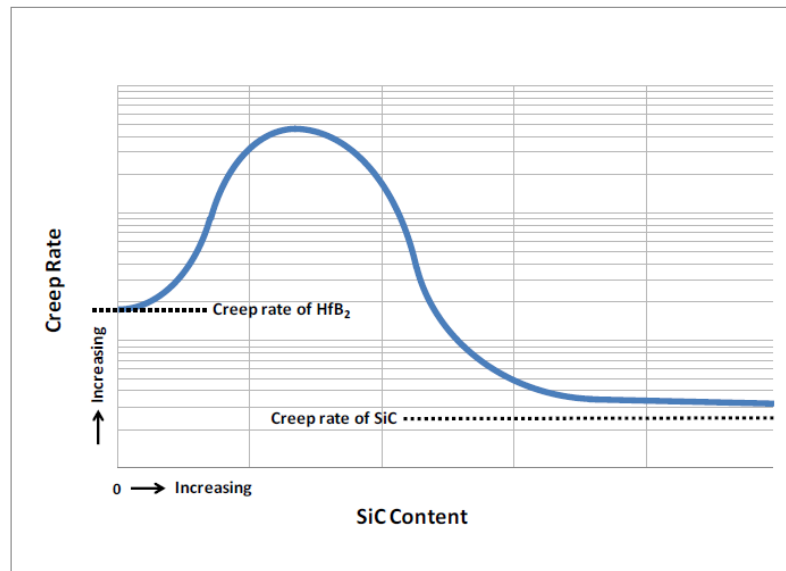
illustrates how the creep rates of pure HfB_2 , and SiC are significantly lower than those of HfB_2 - SiC composite with certain amounts of SiC . The rise in creep rate is due to the reduction in HfB_2 grain size caused by the introduction of SiC into the HfB_2 matrix. The subsequent decrease in creep rate is explained through percolation theory. Percolation theory postulates that additives create networks of point-to-point contacts within the parent material. When enough contacts occur, generally due to increased volume fraction of the additive, networks form which can greatly increase creep resistance of the composite [24]. The curve in Figure 2 provides a visual representation of percolation theory through the creep rate of a HfB_2 ceramic with increased SiC content. Creep rate starts off at a value for pure HfB_2 then increases as grain size decreases due to the initial introduction of the SiC additive. As the volume fraction of SiC increases, a network of SiC contacts forms within HfB_2 - SiC and drives down the composite's creep rate, eventually reaching a value exhibited by SiC .

Figure 2. Creep rate of HfB_2 vs. SiC content, reproduced from DeGregoria [23].

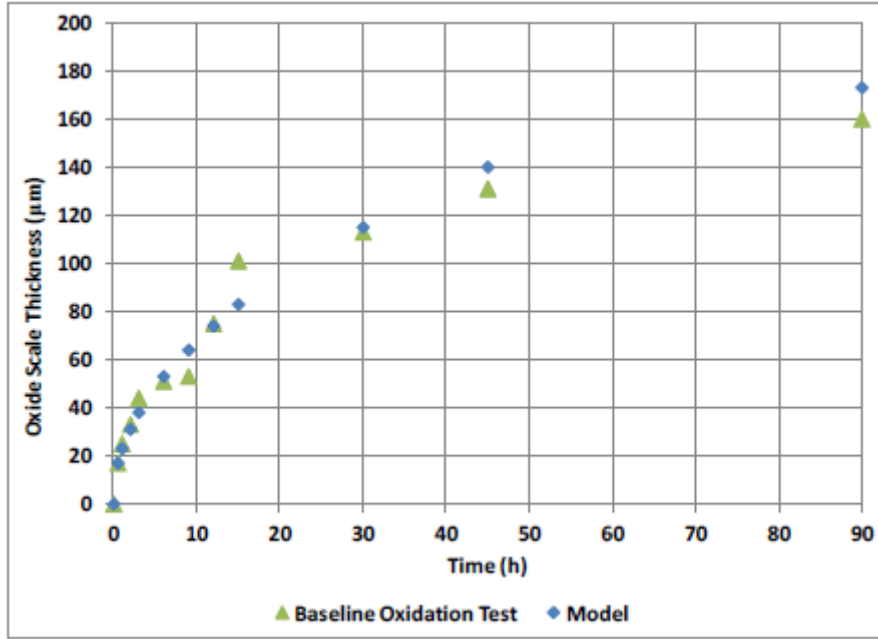
Figure 5. Oxide scale thickness vs time for HfB₂-20% SiC at 1500°C in air, experimental data from DeGregoria [23], model data from Parthasarathy et al. [30]

Experimental results obtained by DeGregoria [23] were compared with the predictions of the oxidation model proposed by Parthasarathy et al [30]. As shown in Figure 5, model predictions agreed well with the experimental data. DeGregoria also designed an experiment to assess effects of compressive stress on oxidation of HfB₂-based UHTCs at 1500°C. He investigated the oxidation behavior of HfB₂-20% SiC under compressive stress of 50 MPa at 1500°C in air. Sustained compressive stress of 50 MPa was found to have no significant effect on oxidation of HfB₂-20% SiC compared to experimental results for the baseline, unstressed specimen. However, the question remained whether oxidation behavior of HfB₂-20% SiC would be affected by sustained compressive stresses exceeding 50 MPa.

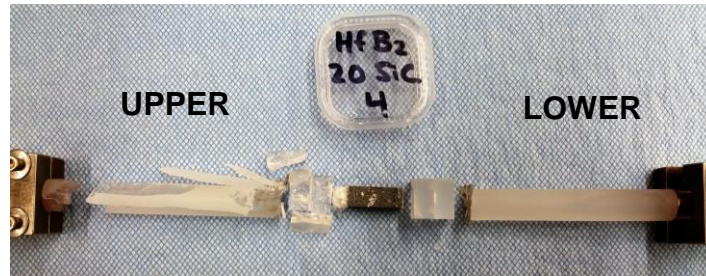
Figure 11. Failed YAG rods and sapphire spacers used in a creep test of specimen HfB₂-20SiC-4 performed at 150 MPa for 8.05 hours.

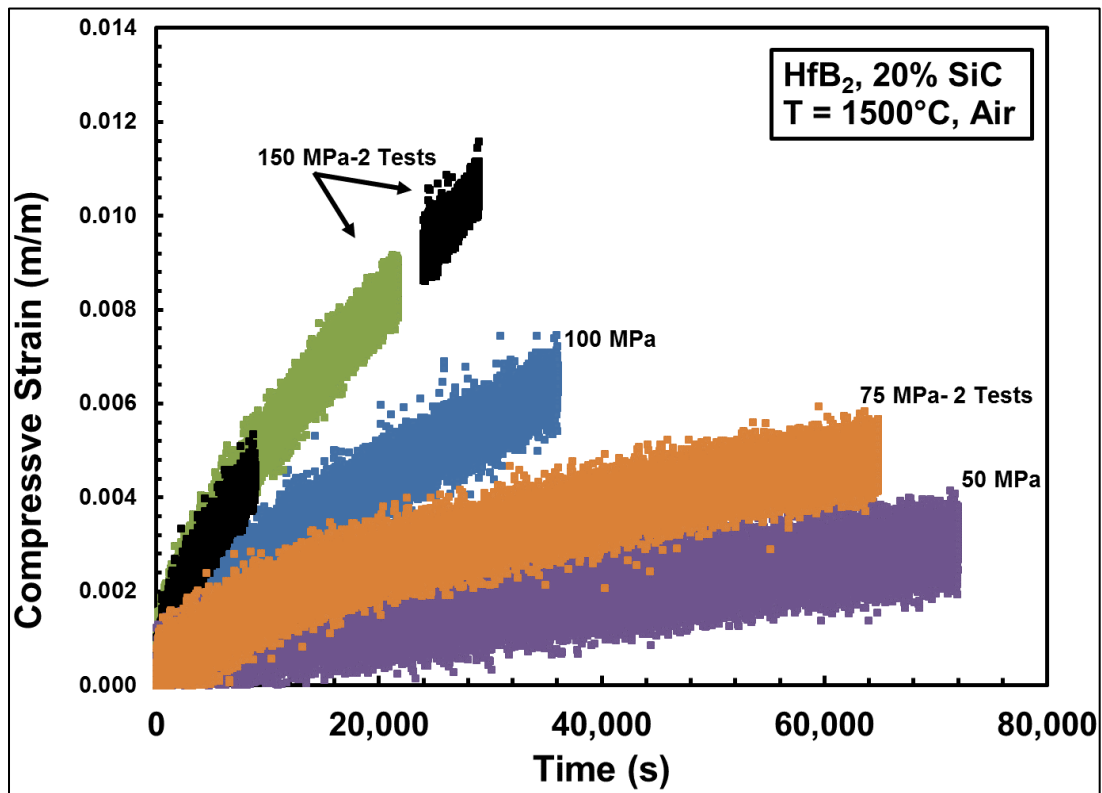
Figure 13. Compressive creep strain vs. time curves obtained for HfB₂- 20% SiC specimens at 1500°C in air.

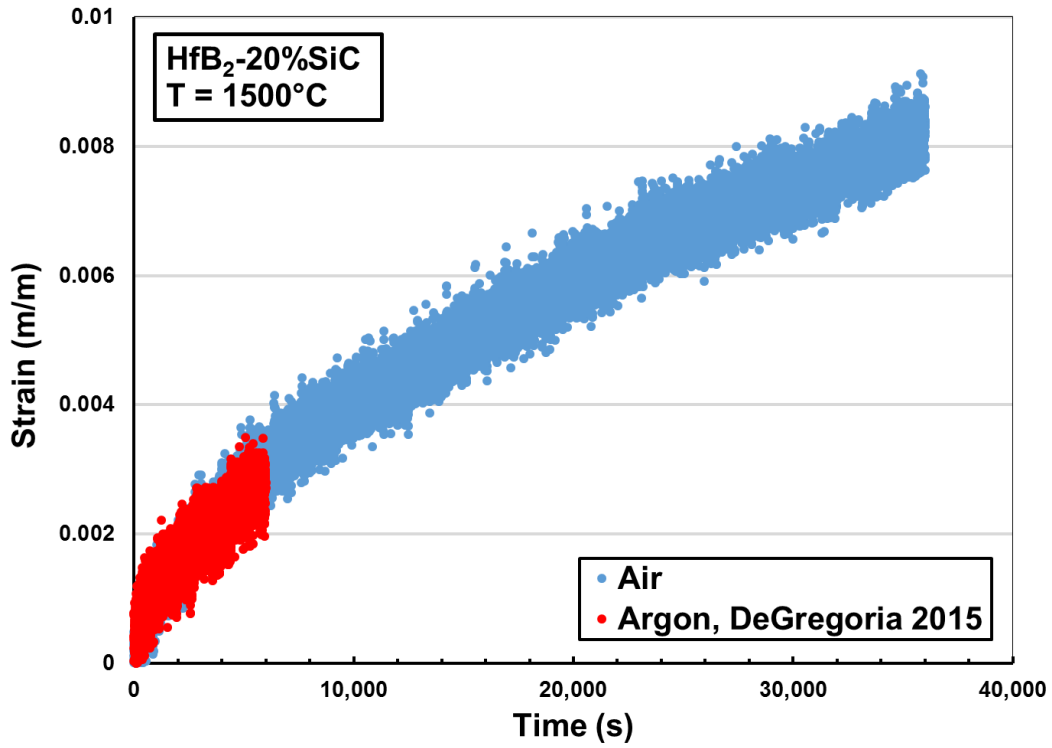
Figure 14. Creep curves obtained for HfB₂-20% SiC at 75 MPa in air and in argon. Data in argon from DeGregoria [23]. Note the importance of test duration for ensuring that steady-state creep has been reached.

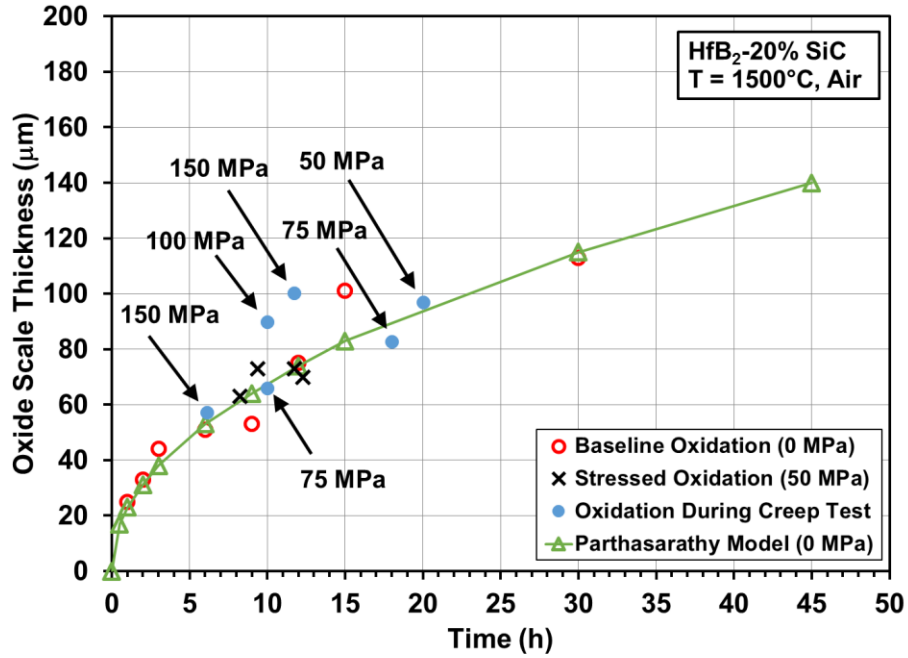
Figure 18. Average oxide scale thickness vs. time for HfB_2 -20% SiC at 1500°C in air. Results at 0 MPa (baseline oxidation) and at 50 MPa (stressed oxidation) from DeGregoria [23]. Experimental results are compared with predictions of the oxidation model by Parthasarathy et al [30].

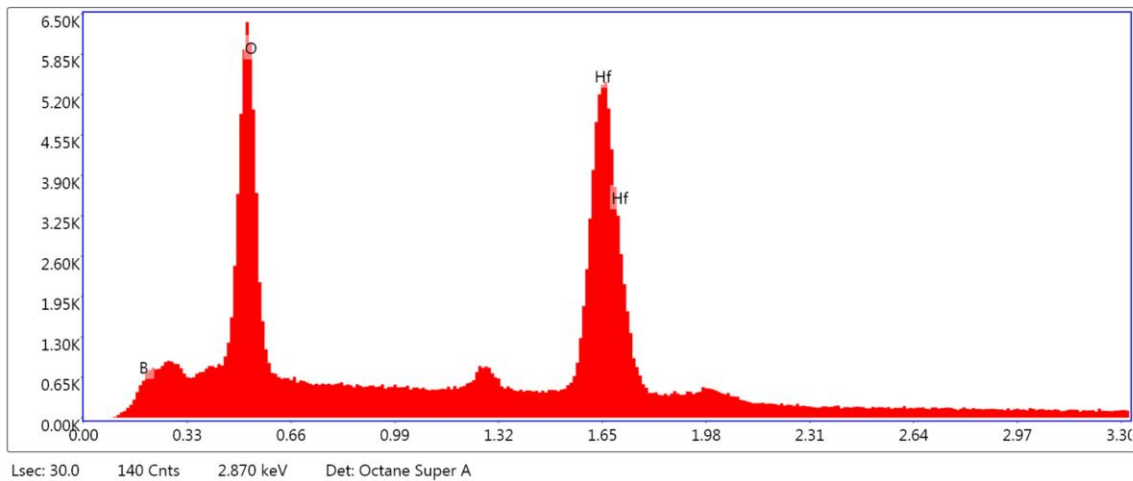
Figure 22. Area 1 EDS analysis indicating that hafnium and oxygen are the most prominent elements present in this region. Note that silicon was not detected in this region.
