A Snow Runway for Supporting Wheeled Aircraft

Phoenix Airfield, McMurdo, Antarctica

Final Report

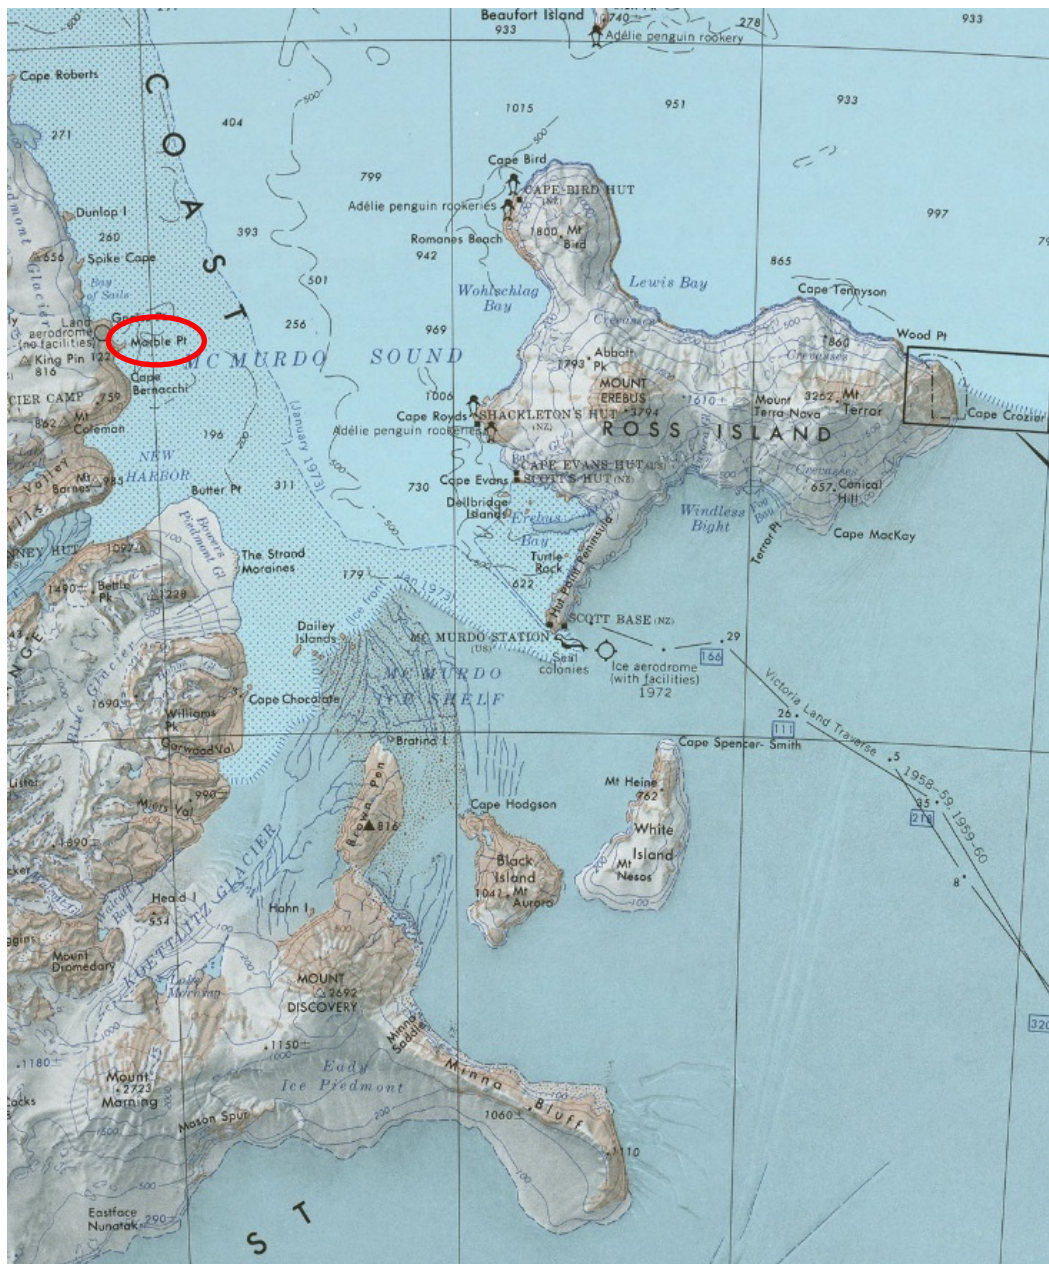
Figure 2. U.S. Geological Survey (1970) map of the McMurdo Sound Area. Marble Point is in the *upper left* quadrant indicated by the *red ellipse*.

Since about the early 1980s, the requirements for aircraft operators and modern aircraft make the Marble Point site totally unacceptable because of nearby terrain elevations and available length and clear zone requirements. Further, with Marble Point being located 90 km (50 miles) from McMurdo with ephemeral sea ice spanning much of that distance, the logistics associated with this site being a primary air logistics hub are prohibitive.

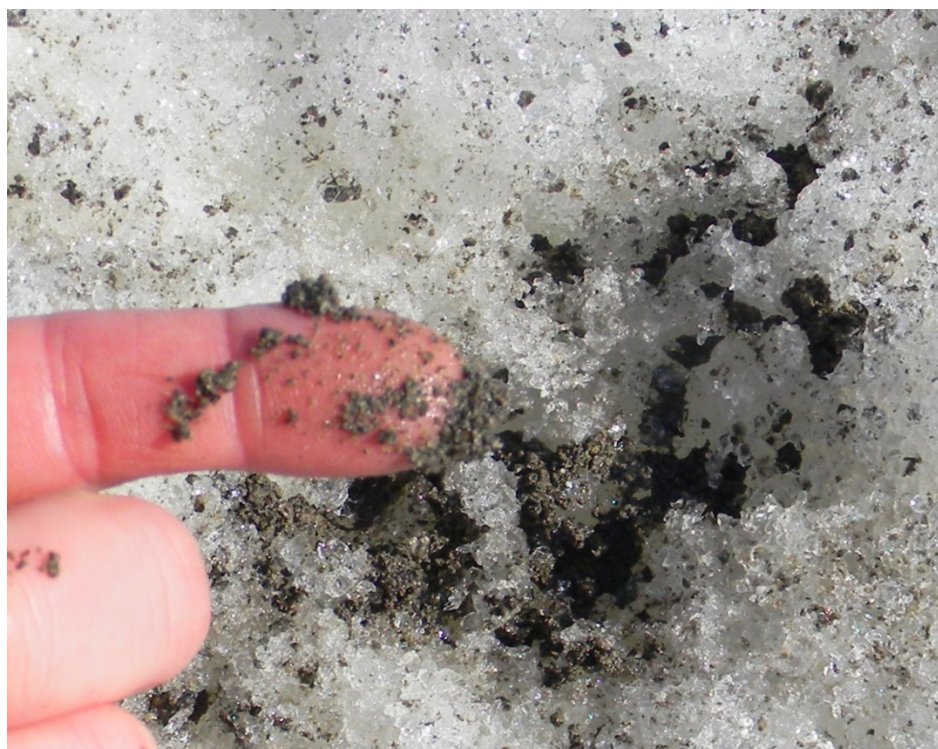
Figure 9. Pocket of “rotted” snow where mineral dust and cyanobacteria have made a foothold, creating a small, wind-protected, microenvironment conducive to melt.

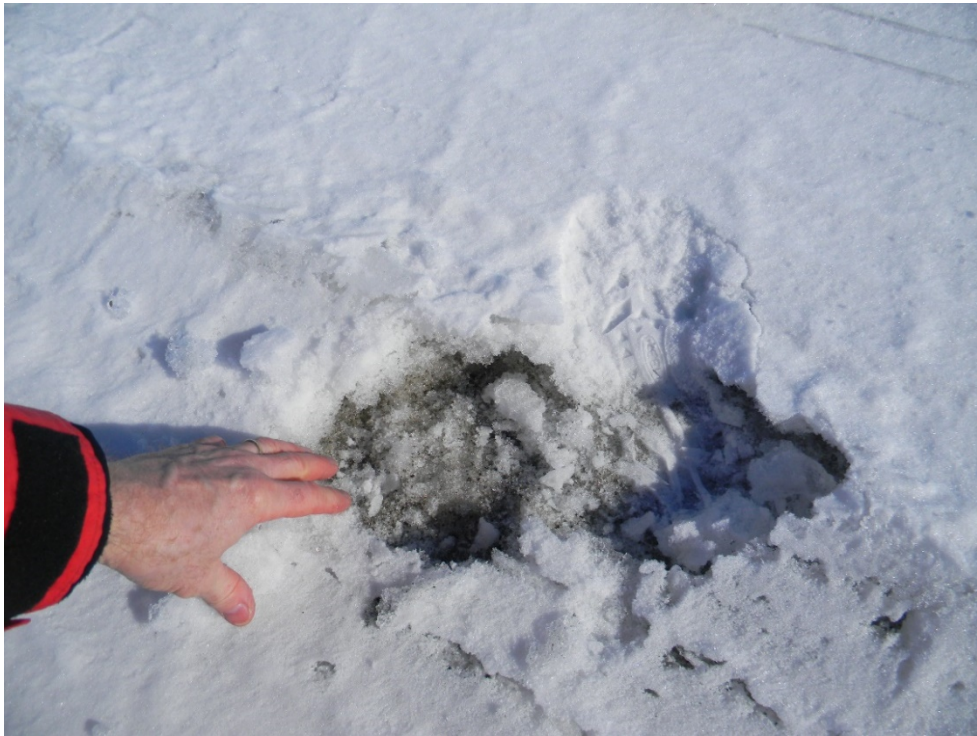
Figure 10. Area of snowpack “rotted out” by localized melting and ablation caused by the microclimate induced by a concentration of contaminants.

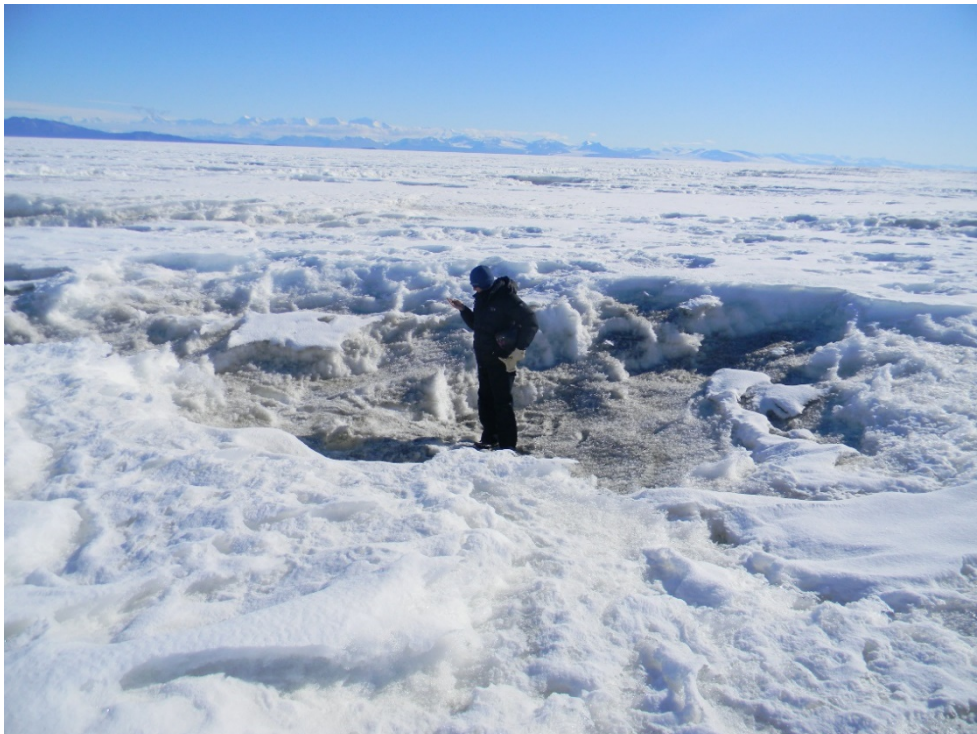
Figure 11. A several-centimeter-thick mat of cyanobacteria in the base of a “rotted” snow pit just to the east of Pegasus airstrip. This area was untouched throughout the austral summer, allowing the cyanobacteria to flourish (image taken 26 January 2016).

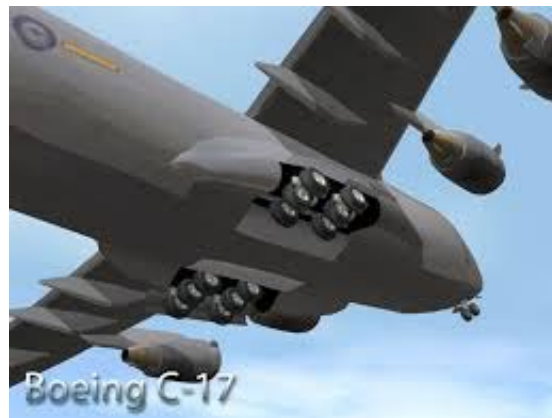
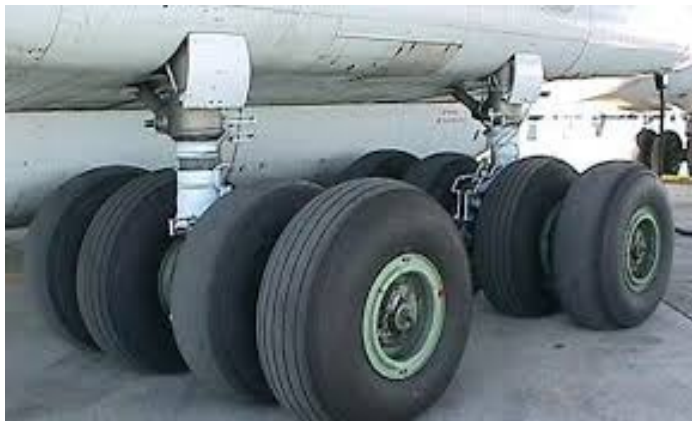
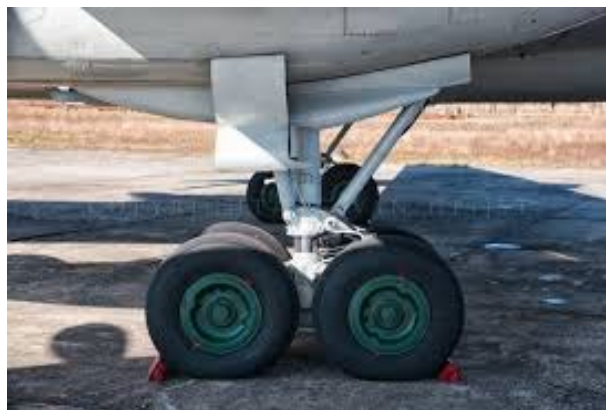
Figure 27. BAKFAA model results for the C-17, assuming elastic modulus based on target snow density from Table 6 (for a range of E based on density) and IL-76 and IL-18 for the same snow conditions. Compressive stress is positive.

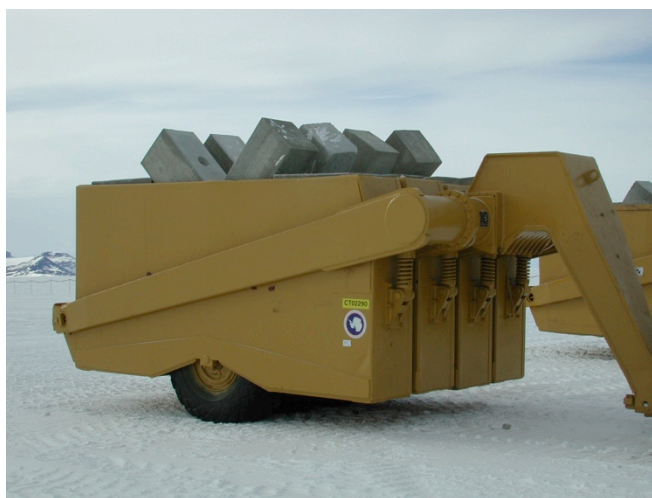
Figure 35. SW weight cart used for compaction on the roads and runways at McMurdo.

At the design load, each tire of the C-17 main landing gear carries 17,700 kg (38,800 lb); this is the load per tire needed to proof the runway. Each tire on the SW cart (Figure 35) can be independently loaded to as little as approximately 6800 kg (15,000 lb) and as much as 18,500 kg (40,750 lb). The SW cart tires could be loaded to a little more than the equivalent wheel load of a C-17. We performed an analysis using BAKFAA with the SW cart fully loaded to 74,000 kg (163,00 lb). Because of the limitations of BAKFAA discussed previously, we could not simulate a case where adjacent wheel loads differed, so our initial evaluation of using the SW cart for proofing the runway was done simulating the cart fully loaded.

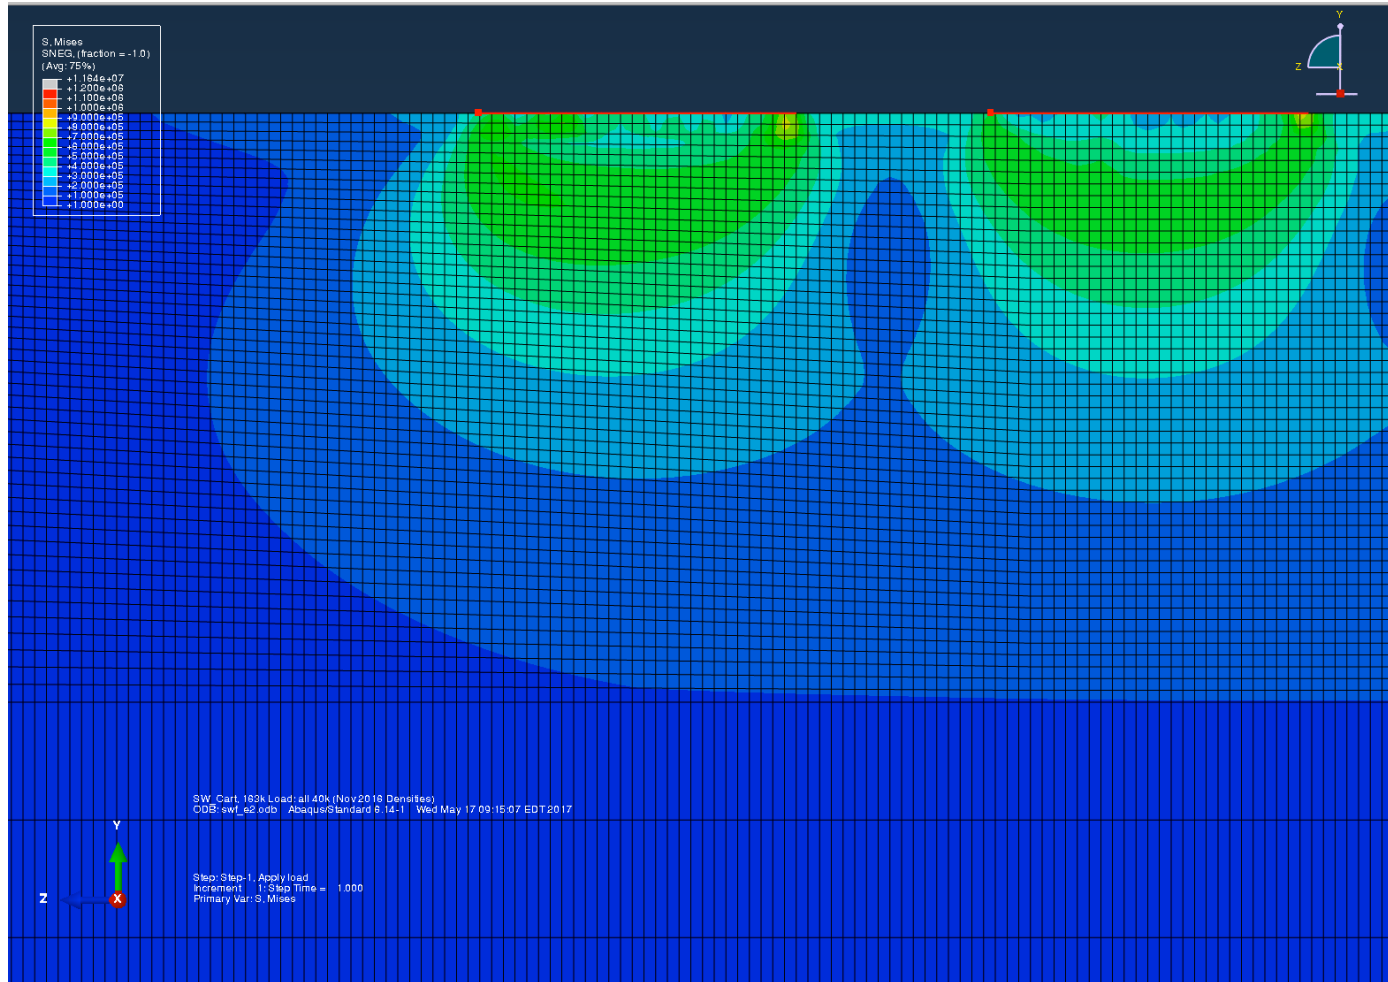
Figure 37 (cont.). Finite element simulations of the SW cart (a) fully loaded, (b) with the outside tires fully loaded 18,000 kg (40,000 lb) and inside tires loaded to 6800 kg (15,000 lb), and (c) alternating tires fully loaded. For (a) and (b), the right edge of the model is a symmetry plane; therefore, the cart is effectively mirrored about that side. Contours of von Mises stress are shown. The scale for the stresses is the same for (a) through (c).

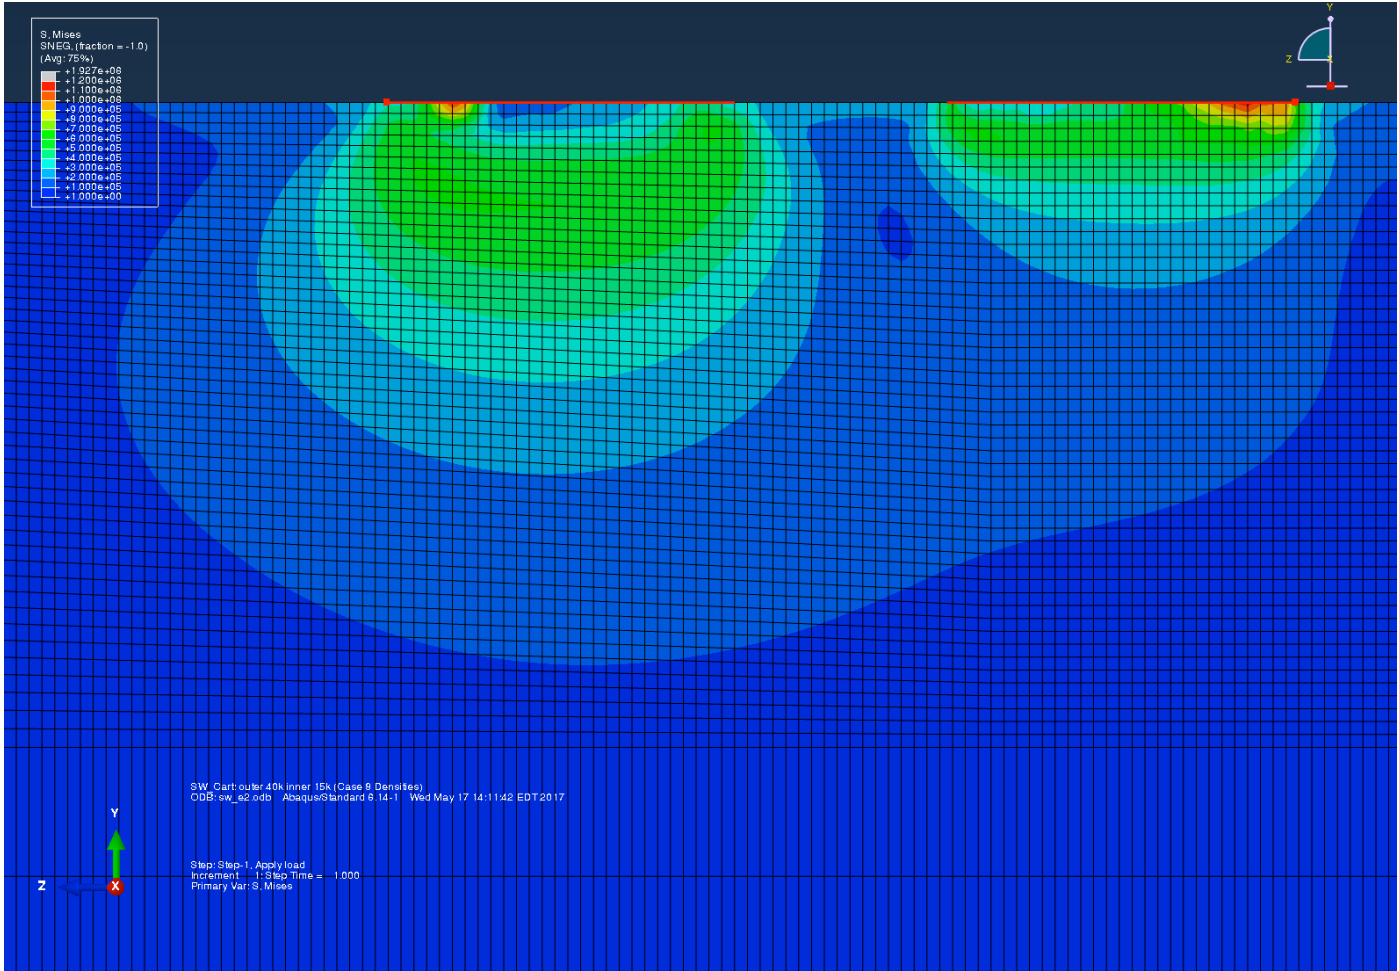
Figure 37 (cont.). Finite element simulations of the SW cart (a) fully loaded, (b) with the outside tires fully loaded 18,000 kg (40,000 lb) and inside tires loaded to 6800 kg (15,000 lb), and (c) alternating tires fully loaded. For (a) and (b), the right edge of the model is a symmetry plane; therefore, the cart is effectively mirrored about that side. Contours of von Mises stress are shown. The scale for the stresses is the same for (a) through (c).

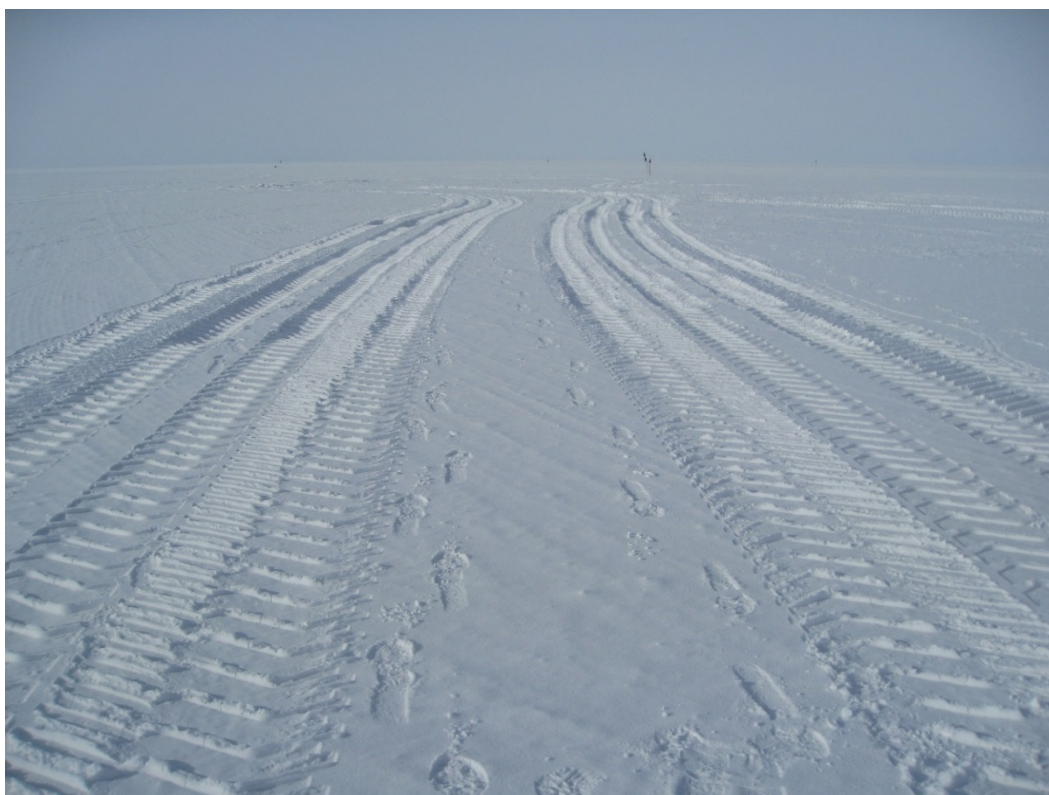
Figure 41. Parallel 50,800 kg (112,000 lb) compaction-roller tracks generated when moving from a very strong airfield apron (out of sight in the foreground) into a modestly compacted town site showing alignment of areas that supported the tire load (near-field tire tracks) and areas that suffered rutting (depressions further out).

Dispensing with concerns about getting the tractor and roller stuck, we drove the 50,800 kg (112,000 lb) SW cart with unequally loaded tires forward into the town site parallel to but 2 m (6 ft) offset from the backing-in path. The roller failed the pavement only in areas that were aligned adjacent to failures in the first path. This provided us with areas for RSP testing of untracked pavement that could reliably be assumed to have inadequate strength. Likewise, there were ample untracked areas that clearly would have supported the roller (Figure 41).

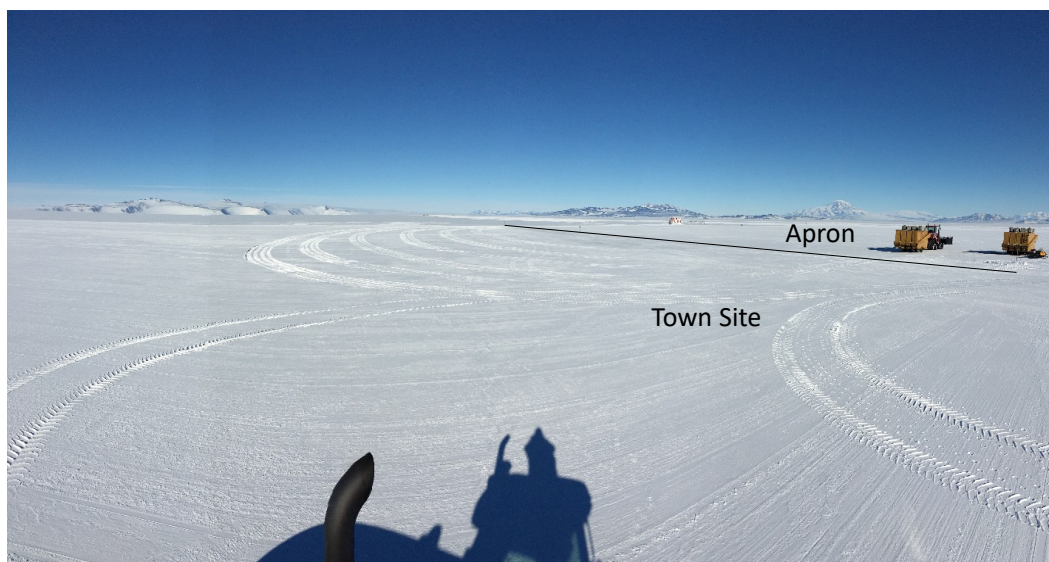
Figure 43. Arced paths of the 74,000 kg compaction roller traveling from the very strong airfield apron (in the *background* and to the *right*) into the modestly compacted town site (*foreground* and to the *left*).

from the apron for the initial 75 m (250 ft) and then became more or less uniform beyond that. We ultimately drove six arcing paths into the town site (Figure 43). The two deepest incursions generated sections where the roller tires penetrated the surface. Only the final track caused an immobilization of the tractor when the roller tires sank between 120 and 150 mm (5 and 6 in.) below the pavement surface. (A second tractor was hooked in tandem, and the roller was handily moved along the rest of its designated track back into the apron.)

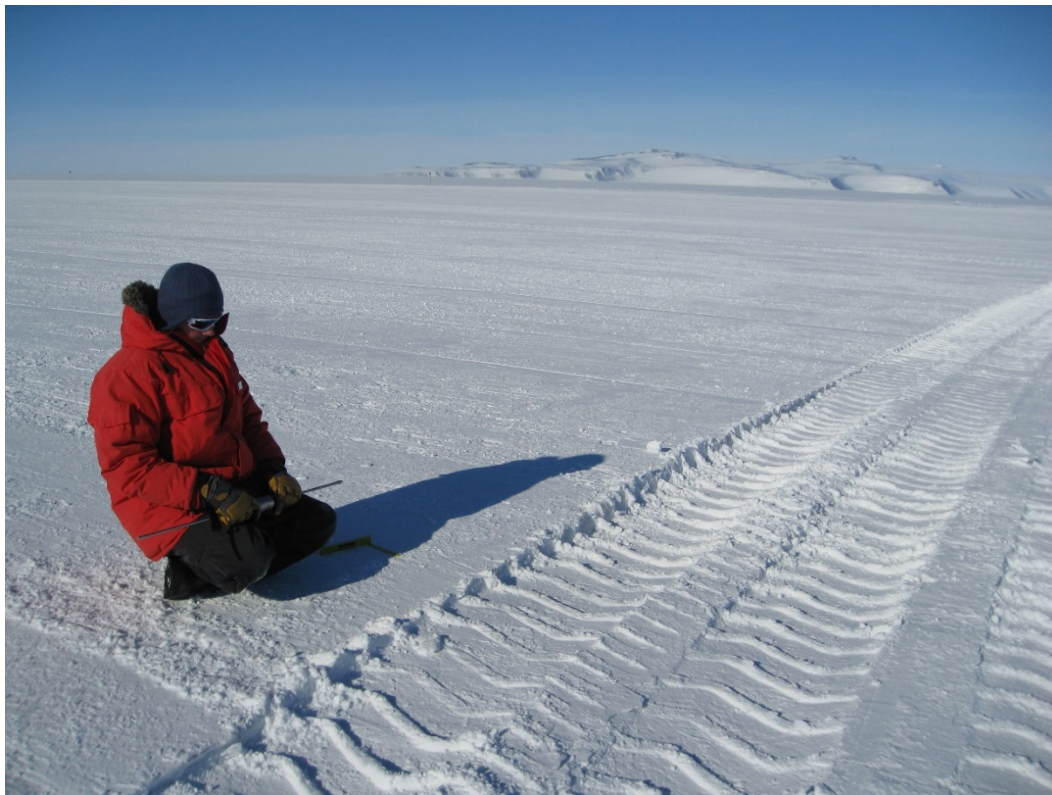
Figure 44. Area of snow pavement showing a Surface Disturbance.

We observed that not only could the roller tracks be divided into Fail/No-Fail categories but also there seemed to be two types of failed surfaces. In the more benign case, the snow surface compressed enough to cause surface cracking along the edges of the roller tire's tread, but there was little or no spalling (lateral displacement and upheaval) of snow from below the surface. We defined this type of failure as a *Surface Disturbance* and set the limit of vertical displacement as between 25 and 130 mm (1 and 5 in.). A Surface Disturbance (Figure 44) is characterized by the subsurface compacting (volume reduction) rather than disaggregation and displacement of snow. This type of pavement compromise is very unlikely to be noticed by a flight crew when it occurs during flight operations. However, like all compaction activities, the newly densified subsurface snow will have lower strength until it has had a period of time to “heal” (sinter, or form and grow new intergranular bonds). Adequate healing time is a function of the snow and air temperatures but is typically 24–48 hours. Thus, a Surface

Disturbance should not be loaded by an aircraft (or other vehicle, including compaction roller) until the required healing time has passed. This would not preclude use of the runway, but aircraft should avoid traveling over the area displaying a Surface Disturbance. Additionally, adequate repair can be achieved by dragging fresh snow over the area and “packing” it into the depression with the tractor tracks and allowing the repair to heal for 24–48 hours.

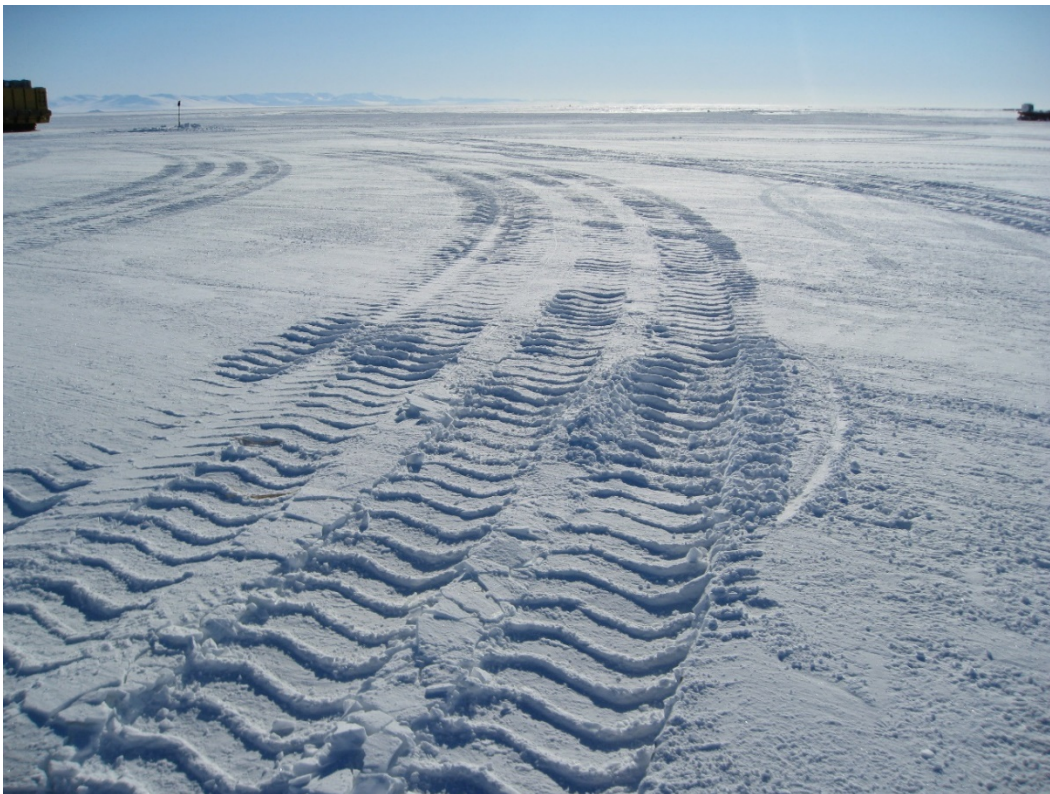
Figure 45. Compaction-roller tracks (movement in the direction from foreground to background) showing an area of Pavement Failure on the rightmost tire in an isolated region with the other tracks displaying only a Surface Disturbance response. Note the definitive difference between these two types of deformation where Pavement Failure displays disaggregation of the snow surface under the tire and “squeezing out” of this loose subsurface snow along the side of the tire.

A more dramatic and concerning type of compromised surface is *Pavement Failure*, which results from a lack of bearing strength in the subsurface, allowing the pavement surface to crack and disaggregate and some of the subsurface snow to be dislodged up onto the surface along the sides of the tire (Figure 45). While these two features characterize distress of the pavement, we also believe that any area showing a tire penetration or rut depth greater than 120 mm (5 in.) has subsurface weakness that leads to disaggregation and dilatation of the snow by the passage of the heavy load rather than the compaction and consolidation of the snow, which is more indicative of a Surface Disturbance. Thus, a Pavement Failure should not be loaded by an aircraft (or other vehicle, including compaction roller) un-

til a repair has been effected and the area retested (section 7.4 of this report provides repair procedures). If the quantity and distribution of Pavement Failure areas allow, such surface compromises need not automatically close the runway. It is critical, though, that the damaged area of the runway is not traversed by any aircraft until repaired.

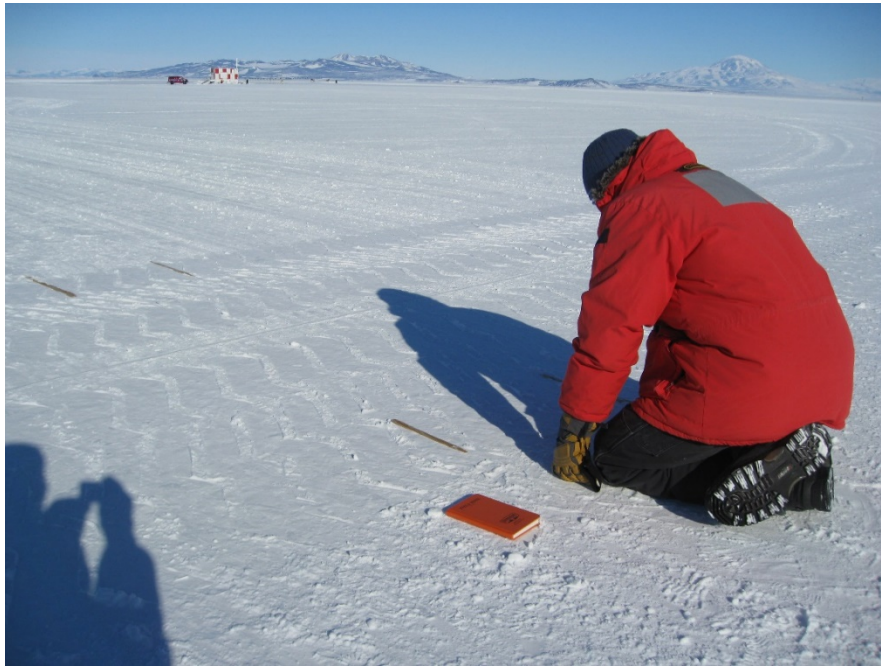
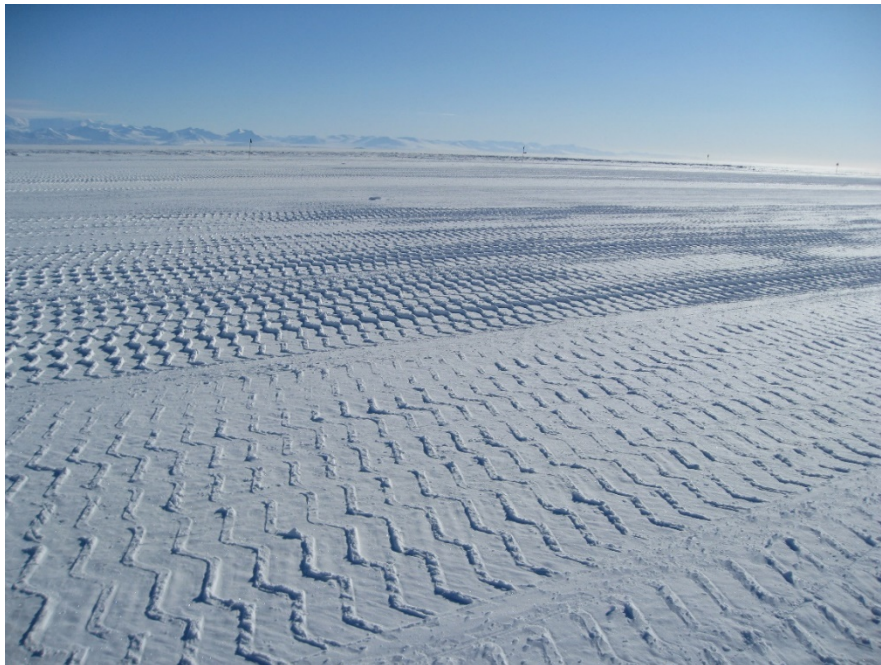
Figure 46. Two examples of pavement areas fitting the Fully Supporting performance level: (*top*) faint tire tread and (*bottom*) obvious tread and imprints.

Fully Supporting is the term we used to describe all areas of the surface that did not exhibit Surface Disturbance or Pavement Failure. In the best case, only a faint impression of the tire tread can be seen (Figure 46a), but any imprint less than about 25 mm (1 in.) deep suggests a loose covering of snow on the pavement itself rather than a lack of strength in the pavement system (Figure 46b) and is also classified as Fully Supporting.

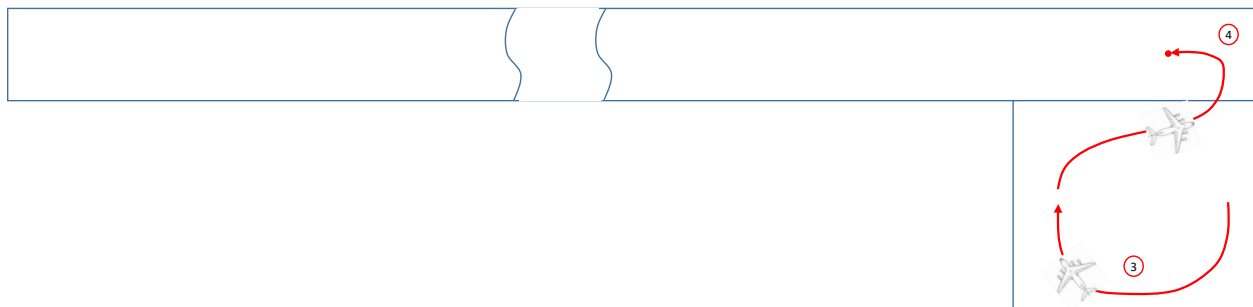
Figure 54. Push turn (4) to slide nose-gear tires on snow pavement.

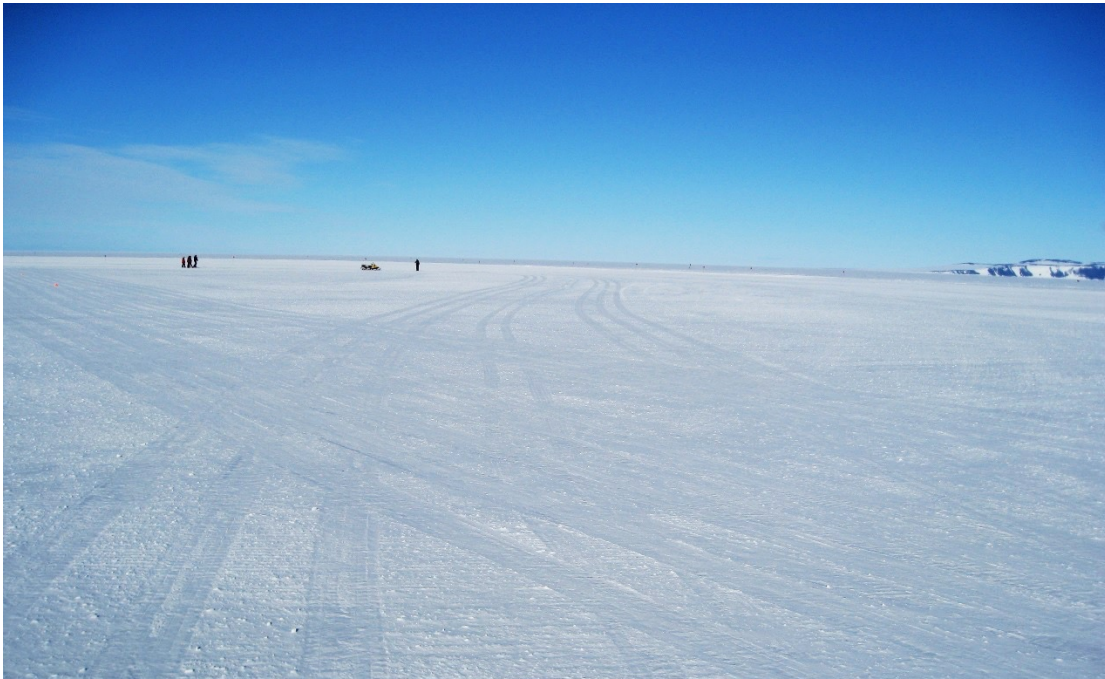
Figure 65. Close-up view of C-17 taxi tracks at the north end of the airstrip.

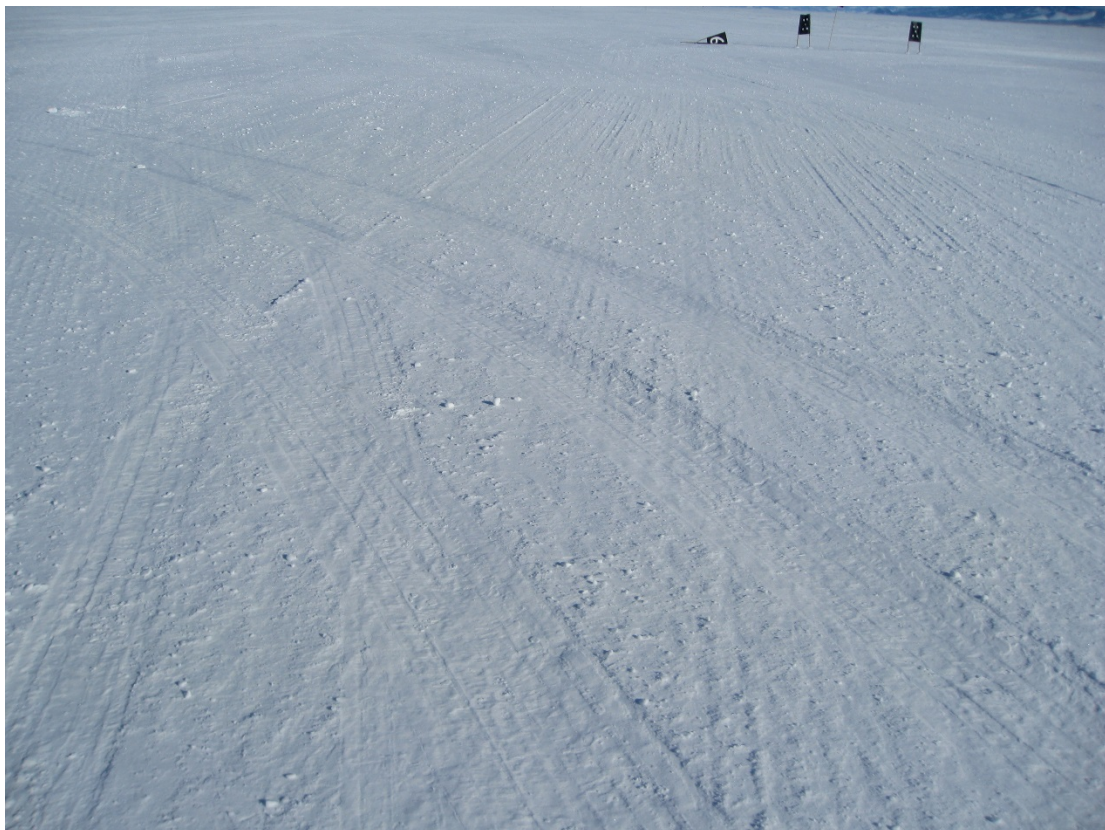
Figure 66. Tracks of eroded rubber from a C-17 landing.

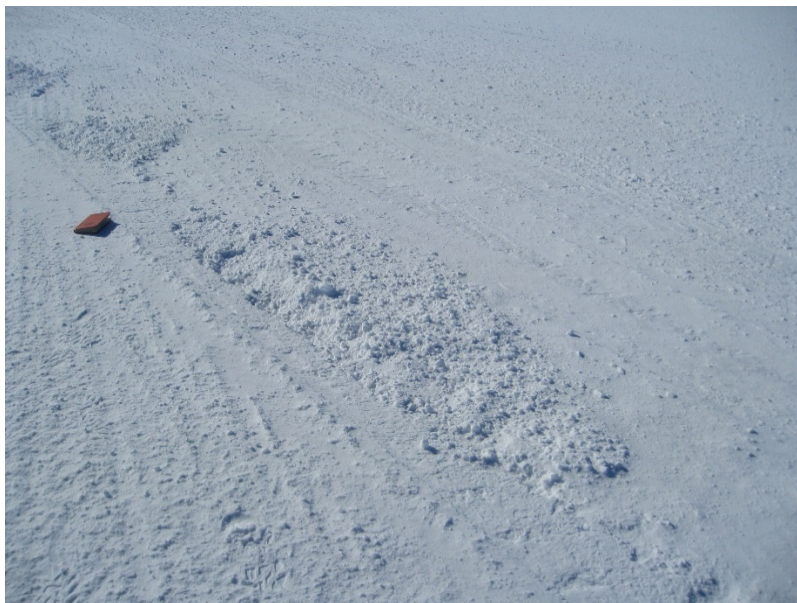
Figure 68. One of a handful of areas showing rutting of the runway surface with the passing of aircraft tires.

Secondly, several areas showed some degradation of the pavement surface. These took the form of slight “unravelling” of the surface (Figure 67) to outright rutting (Figure 68). Both types of surface disturbances represented a tiny percentage of the area touched by the aircraft tires, and neither was detectable by the aircrew when they occurred. Nonetheless, these areas were of keen interest to the project team since they represent strength levels that perhaps were on the margin of adequate.

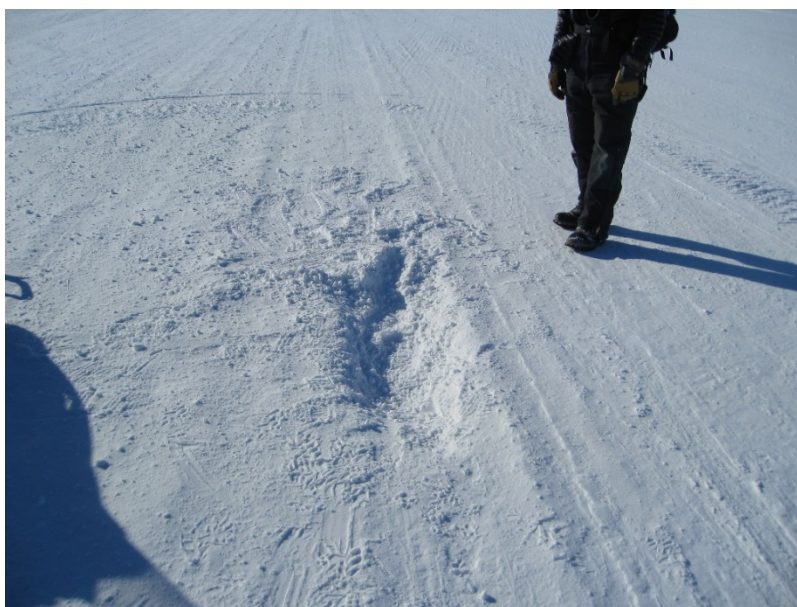
Figure 69. Tracks of the C-17's nose gear when "skidded" on the snow-pavement surface.

The validation event continued as planned with routine turning to maneuver around and off the apron and a tight turn on the runway end to prepare for takeoff. During the later, the front tires were “skidded” on the runway surface (Figure 69) to demonstrate that the pavement strength was adequate for the level of runway surface friction present to avoid having the tires dig in and put unacceptable levels of stress on the nose landing gear.

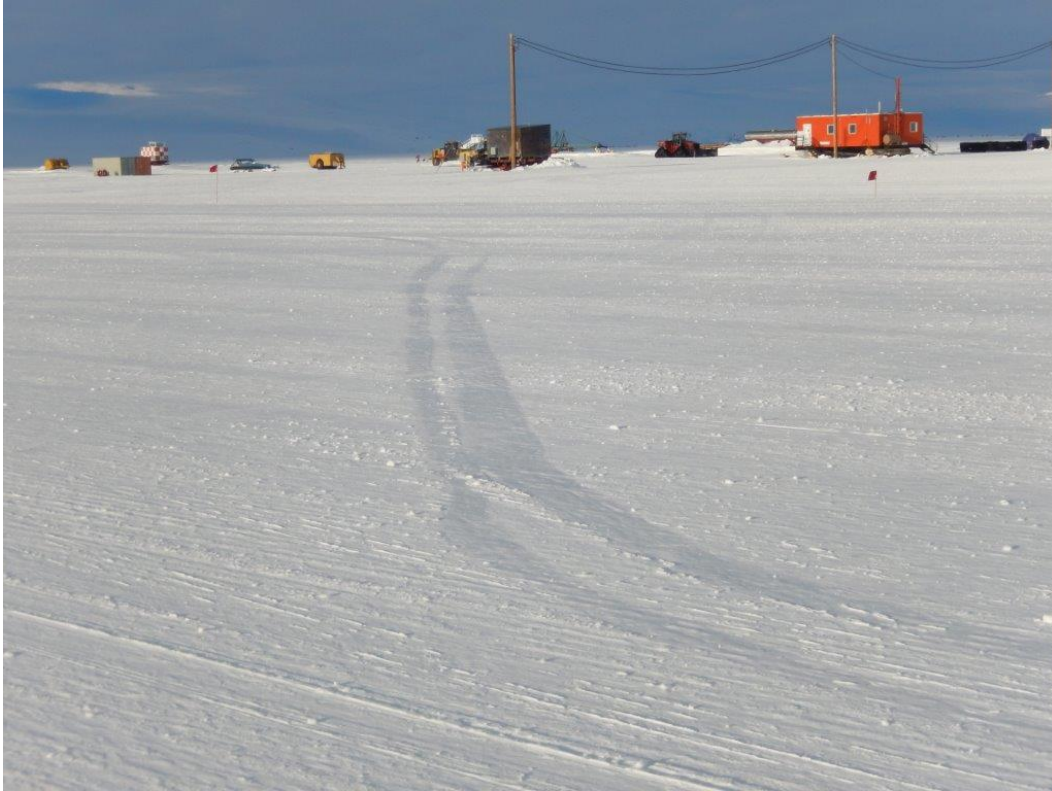
Figure 70. Isolated but deep ruts associated with one tire path of the main landing gear at the point of C-17 rotation at takeoff.

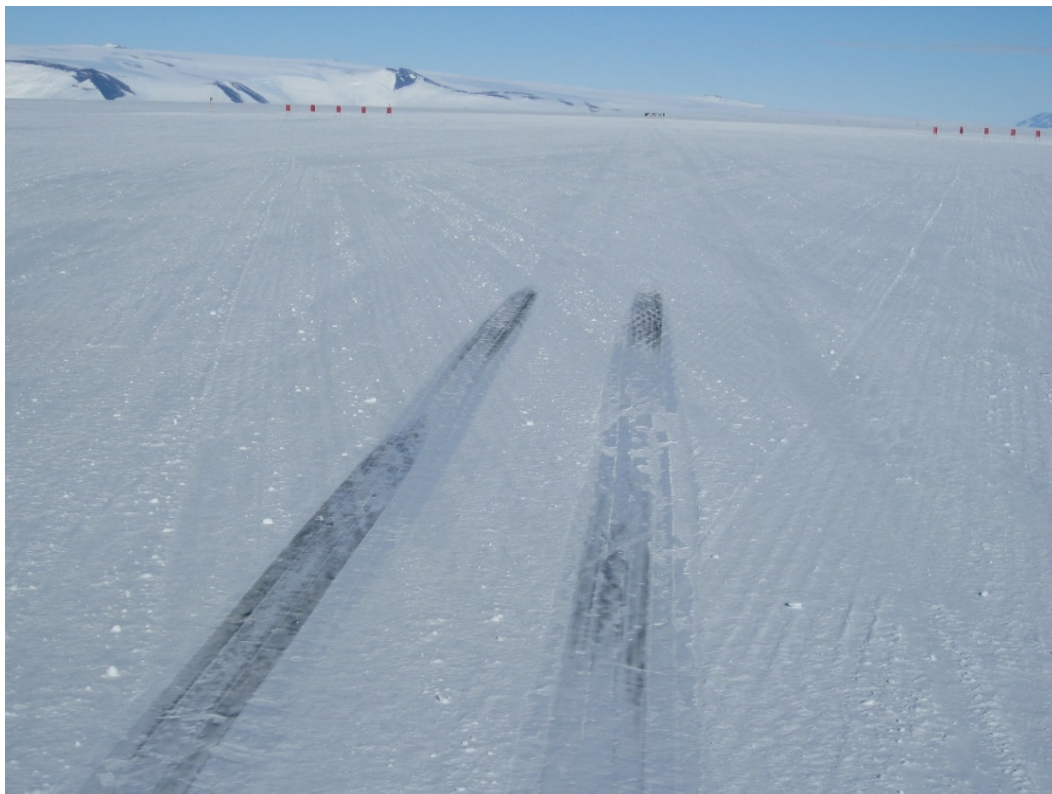
Figure 72. Segments of the main landing-gear tire tracks showing snow-pavement polishing where the main landing gear's antilock braking system created tire slip and segments where tires were rotating without slip in between antilock braking system pulses.

Eroded rubber tracks and both types of frictional melt-refreeze features represent areas of the runway that will be susceptible to accelerated deterioration if left untreated. Maintenance activities to disaggregate and disperse all of the ice and rubber must be completed as soon as possible after each aircraft mission.

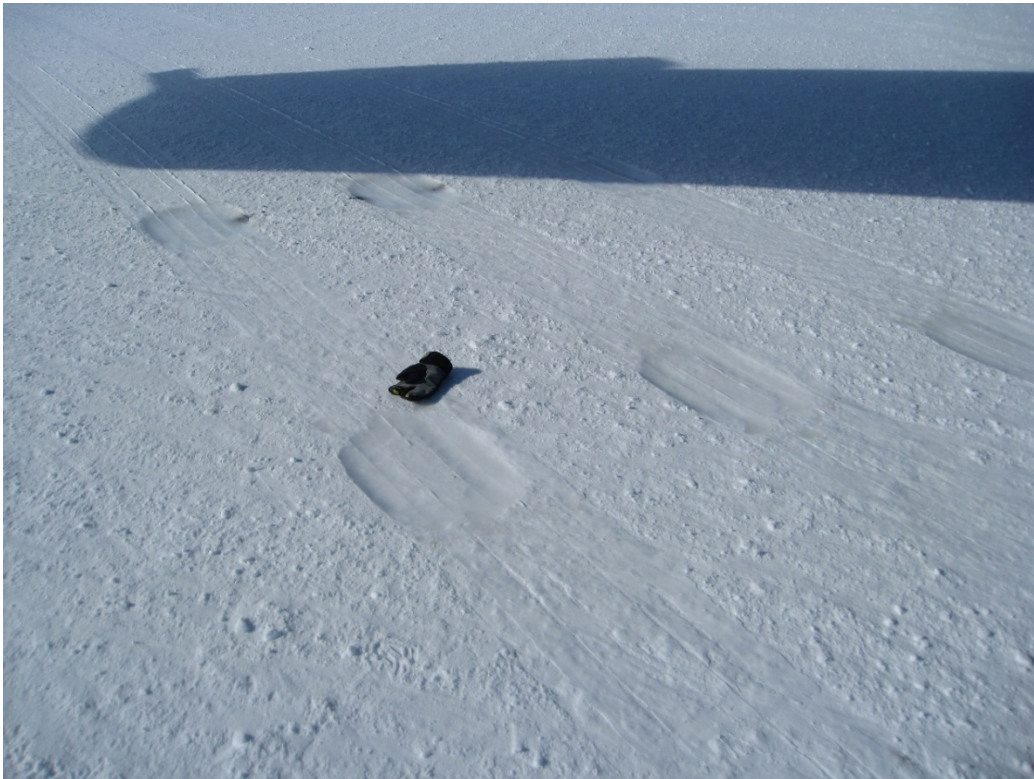
Figure 74. Thin melt-refreeze ice layer at the tire-ice interface of the parking depression.

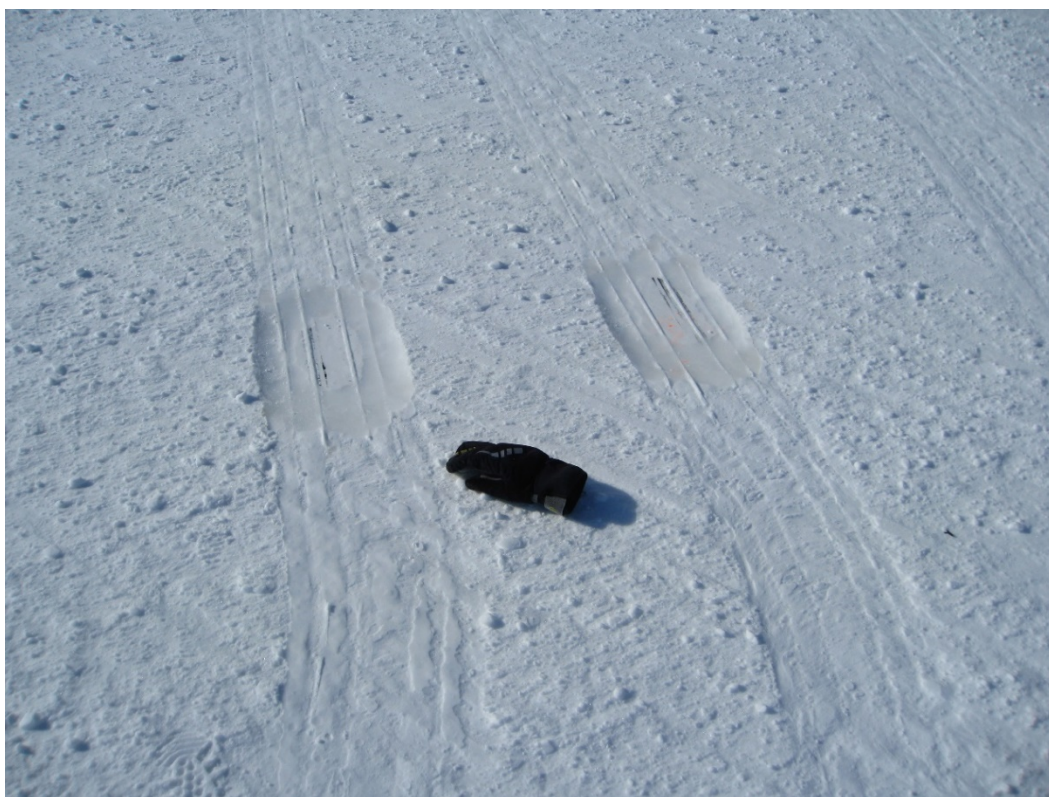
Figure 75. Depressions left in the snow by the nose gear during parking. The black glove in the picture is shown for scale.

The depressions were observed to be slightly deeper under the main landing gear (Figure 73) than under the nose gear (Figure 75), which is related to the greater tire loading of the main landing gear. The maximum depression we measured was less than 40 mm (1.6 in.). It was also apparent, as expected, that the longer parking time associated with the second landing created deeper depressions than the first, shorter, parking event.

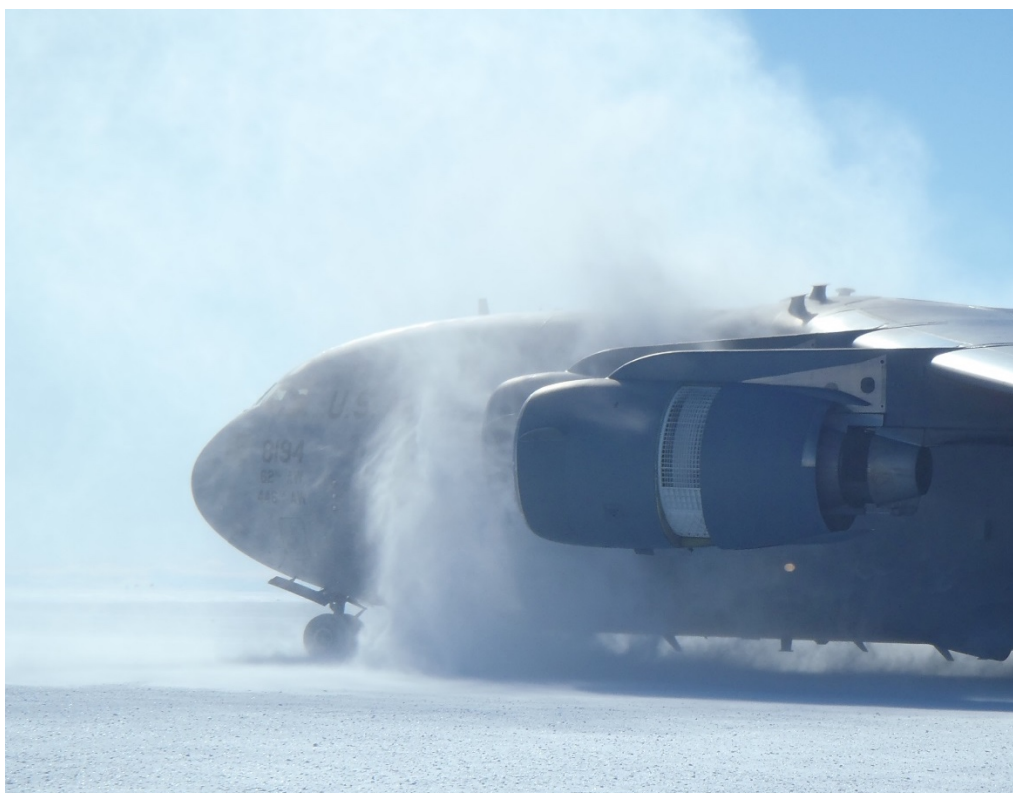
Figure 76. Snow whirlwinds forming in front of the jet engines during high reverse-throttle settings when attempting to back out of parking depressions.

After the parking event, the C-17 configured for backing. The flight crew gradually increased reverse thrust in an attempt to roll free of the depressions. After reaching typical reverse thrust levels, the aircraft still had not moved, but snow whirlwinds (similar to a dust devil, a strong, well-formed vertical-axis cylinder of rotating wind) formed in front of the engines on both sides of the aircraft (Figure 76). These whirlwinds alternated randomly between being wide (a 3.5 m [12 ft] diameter) to being very tightly formed (less than 1 m [3 ft] in diameter). The tightly formed whirlwinds “danced” and “snaked” along their vertical axis from the snow surface until they were approximately at the height of the center of the jet engine. There, they sharply bent horizontal and were sucked directly into the engine. To add to the artificial snowstorm, the jet engine exhaust, being deflected toward the front of the aircraft, generated a white-out condition around the cockpit area of the aircraft.

During its planned final short-field takeoff, two of the C-17's engines shut down shortly after being placed at full throttle settings. After taxiing back to the apron and troubleshooting, the flight crew determined that the engines had ingested so much snow during the backing event that they were still too saturated to perform at full load. By running the engines at moderate throttle settings while parked for a few minutes, the flight crew deemed them to be dry and fully functional. The final takeoff took place without incident (Figure 77), and the aircraft returned to the Pegasus Airfield for cargo and passenger upload and the return flight to Christchurch.
