A Snow Runway for Supporting Wheeled Aircraft

Phoenix Airfield, McMurdo, Antarctica

Final Report

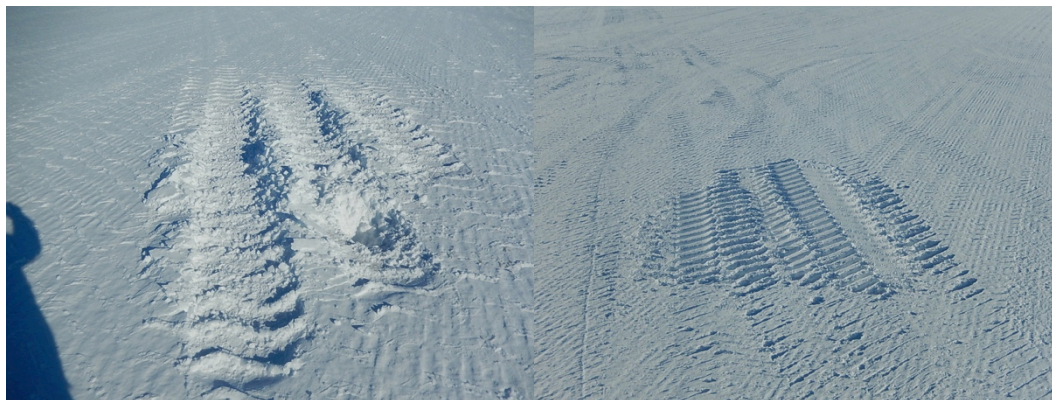
Figure 78. (a) Rutting caused by the fully loaded (74 tonnes [163 kips]) weight cart during runway compaction on 22–23 January 2017 on the Phoenix Airfield at the 2200 m (7100 ft) distance mark, 12–15 m (40–48 ft) west of centerline. (b) The same area following repairs. (Photos by Jonathan Green, Antarctic Support Contract.)

a. Before repair

b. After repair

The length of these ruts was typically less than 2.4 m (8 ft) long. The most severe rut was 3.7 m (12 ft) long and about 75 mm (3 in.) deep (Figure 78a). This level of rutting is a minor surface disturbance and, as discussed in section 4.1, is classified as “low risk” (AFCEA/CES 1997) and therefore within the operating parameters of the C-17. These ruts were repaired following the protocol described in section 7.4; Figure 78b shows the surface

after repair of the ruts at the 2200 m (7100 ft) distance from the north end of the runway.

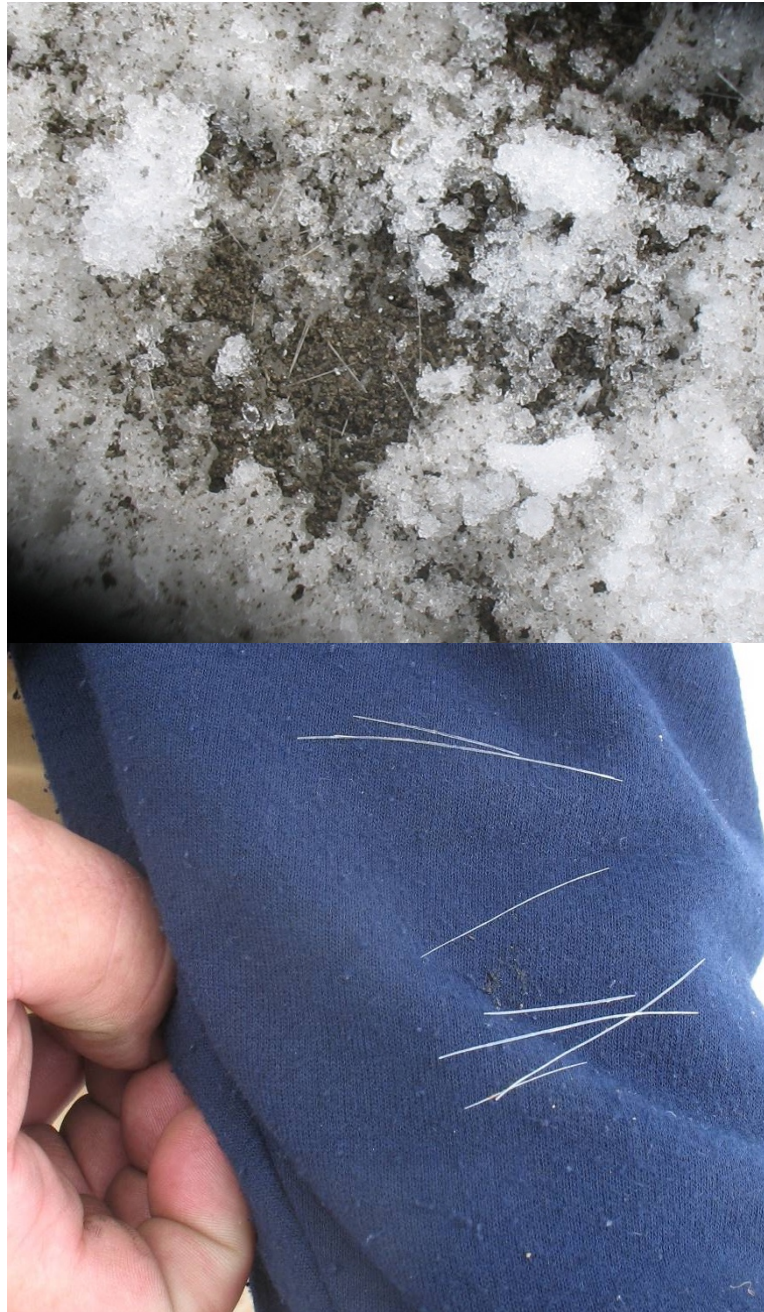
Figure 80. Mineral and organic-matter deposits with sponge spicules deposited on the surface of the McMurdo Ice Shelf (*top*); sponge spicules photographed on the sleeve of a site worker (*bottom*) for contrast/visibility.

Recent and on-going observations of the organic material that appears to be symbiotic with mineral dust deposits on the MIS suggest that it becomes active and propagates rapidly, forming dark mats or colonies (top of Figure 80) in the peak of the austral summer, owing to melt water generated initially by solar heating of the mineral particle and later by heating of the dark organic matter itself. This understanding of the likely propagation process led us to experiment with interruption of the growth cycle through grooming (dragging or planing) of the runway surfaces as soon as a mineral deposit was apparent or organic growth was detected on any operating surface of the runway. This action spread out any dark material—inorganic or organic—that was concentrated on the surface and thereby interrupted the warming and water-generation cycle and stunted or prohibited organic growth. This proved successful but clearly requires immediate action by the runway maintenance crew. This maintenance activity needs to be instigated early and repeated as soon as reactivation of growth appears and until a fresh snow cover or dropping temperatures no longer allow water formation.

Other natural contaminants have been observed on the MIS, specifically sponge spicules. Speculation still exists on how these slender, fragile “hairs” (Figure 80) get deposited on the ice shelf; but as they are clear in color, we have seen no evidence that they present a hazard to creating and sustaining a snow runway facility.
