ARL-TR-8886 • JAN 2020

# Defect Characterization in Silicon Carbide by Cathodoluminescence

by Harun Gopal Ganesan, Robin Karhu, and Brenda VanMil

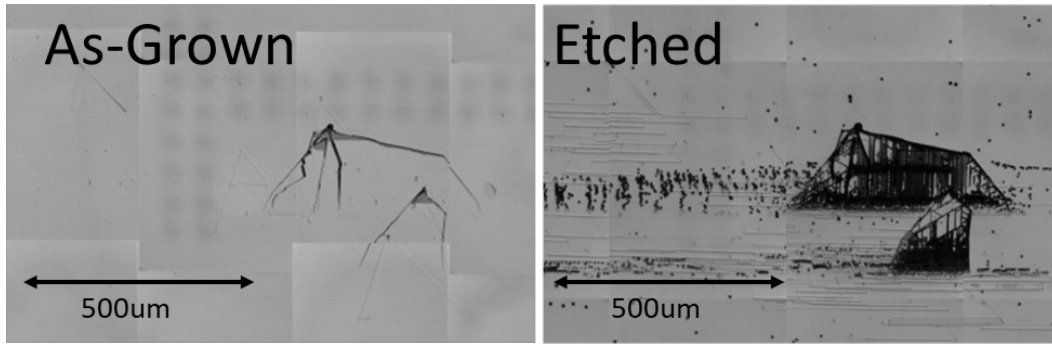
**Fig. 1** Comparison of the as-grown and etched sample of SiC demonstrating how the TDs were used for image alignment

CL images were taken using a CamScan SEM operating with a 20-keV accelerating voltage and a nominal 100- $\mu$ A electron beam emission current with an attached Applied Beams (Beaverton, Oregon) CL system. The CL signal is gathered from a parabolic mirror, which is then either separated by wavelength using a diffraction grating for monochromatic measurements or reflected by a mirror for panchromatic measurements over a wavelength range of 190 to 850 nm. The photons are measured using a charge-coupled device (CCD) camera. CL images were taken near unique in-grown SFs to ensure that the area on the sample could be found again after defect etching, as demonstrated by a comparison of an as-grown and post-etch image shown in Fig. 1. After the etch condition was finalized, the imaged sample was etched at the optimal condition to reveal surface defects. Multiple optical images were taken of the sample at the same locations where the CL was previously taken. Then, the CL images were compared to the respective optical image of the etched sample.

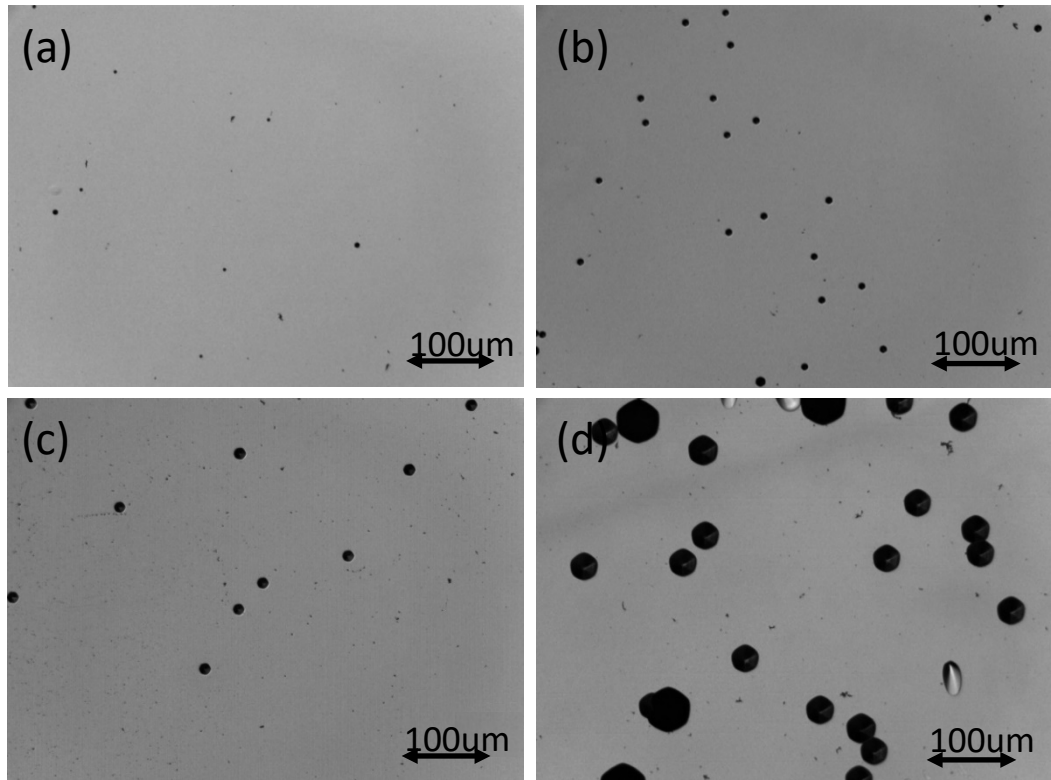
**Fig. 2** Microscope images after KOH etching for a) 5 min 450 °C, b) 10 min 450 °C, c) 5 min 500 °C, and d) 10 min 500 °C

The KOH etching conditions were optimized for our experimental setup. Samples were etched in a nickel wire basket. Molten KOH was contained within a nickel crucible. Four different test samples, all from the same wafer, were etched at different temperatures and durations. The different samples were etched for 5 min at 450 °C, 10 min at 450 °C, 5 min at 500 °C, and 10 min at 500 °C (Fig. 2, left to right, respectively). After etching, samples cooled in air and were then rinsed in flowing deionized (DI) water. Each etch condition produced different sized etch pits, as seen in Fig. 2. For this experiment, it was determined that etching for 5 min at 500 °C was optimal because it clearly revealed the four main types of defects shown in Fig. 3, while also not over-etching the sample. These defects shown are consistent with those shown by Kimoto and Cooper.<sup>10</sup> Over-etching can lose definition, making it difficult to differentiate between the types of defects.

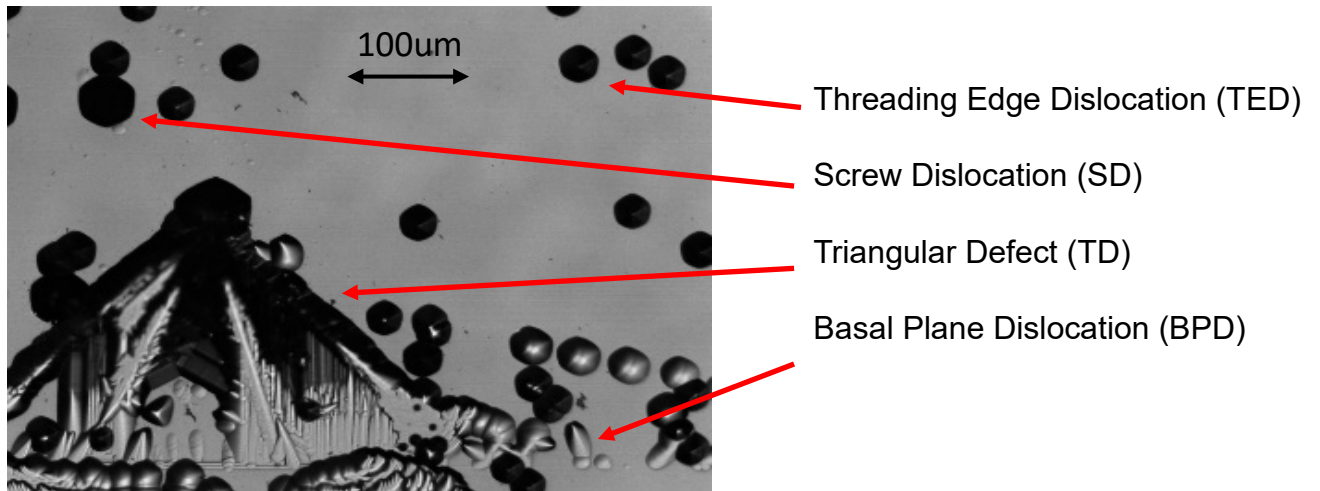
**Fig. 3** The 4° off-axis 4H-SiC epitaxial layer etched for 10 min at 500 °C. Examples of a TED, SD BPD, and TD are all seen in this micrograph.

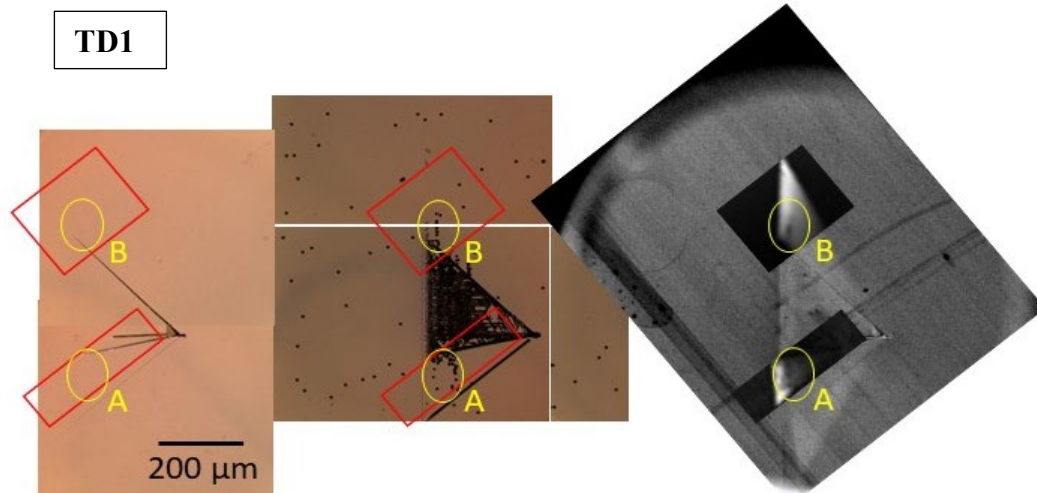
In Fig. 4, the CL image for TD1 indicated by the yellow oval and labeled A is within the TD. The area, labeled B, is outside of the TD, but inside of a SF. The pre-etch CL has contrast in the areas that contain TEDs within the SF.

**Fig. 4** Comparison of the optical microscopy, post-etch optical microscopy, SEM imaging, and CL imaging, for the sample area denoted as TD1. The circled areas show contrast in the CL intensity within the SF where TEDs are located.

SF. Monochromatic post-etch CL was performed on both TD1A and TD2B post-etch indicating the emission centered at 505 nm for area A and 465 nm for area B was responsible for revealing contrast at areas containing TEDs. The monochromatic post-etch CL emission for TD2 is broad around 530 nm. The monochromatic post-etch CL emission for TD7 had peaks near 460 and 505 nm depending on the underlying SF.

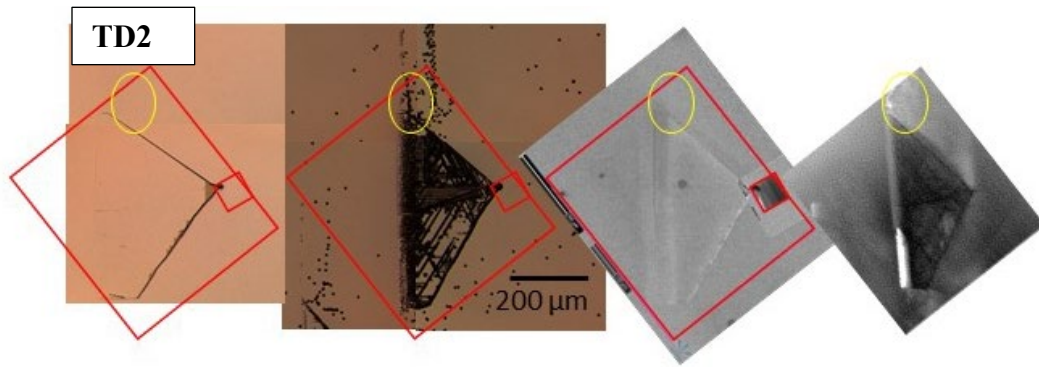
The small-area CL image for TD2, shown in Fig. 5, centered at the point of the TD does not have any contrast differentiation and the etch pit microscope image corresponding to that area does not include any etch pits. The large-area CL image does contain some contrast in the area within the oval inside the SF, outside the TD. There is no contrast observed for the TEDs outside of the SF.

**Fig. 5** Comparison of the optical microscopy, post-etch optical microscopy, SEM imaging, and CL imaging for the sample area denoted as TD2. The circled area shows contrast in the CL intensity within the SF where TEDs are located.

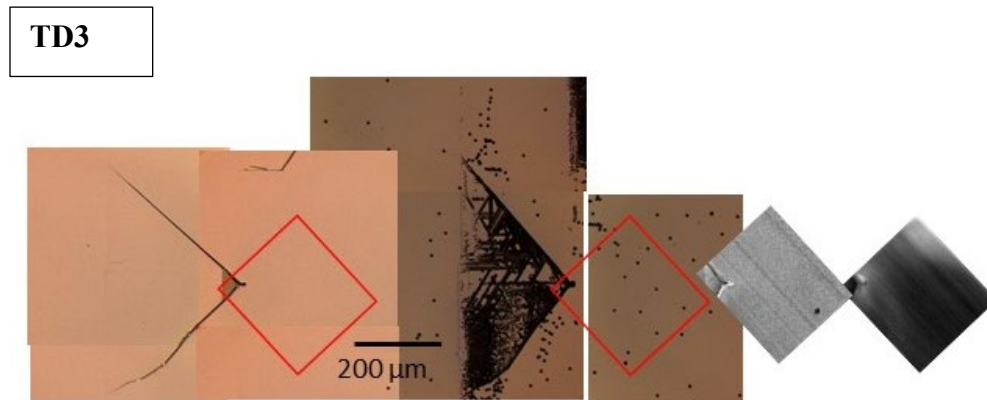
The CL images for TD3, TD4, and TD5, in Figs. 6 and 7, show the nucleating defect for the TD. However, there is no contrast for the numerous TEDs that are observed within the area on the etch pit microscope image.

**Fig. 6** Comparison of the optical microscopy, post-etch optical microscopy, SEM imaging, and CL imaging for the sample denoted as TD3

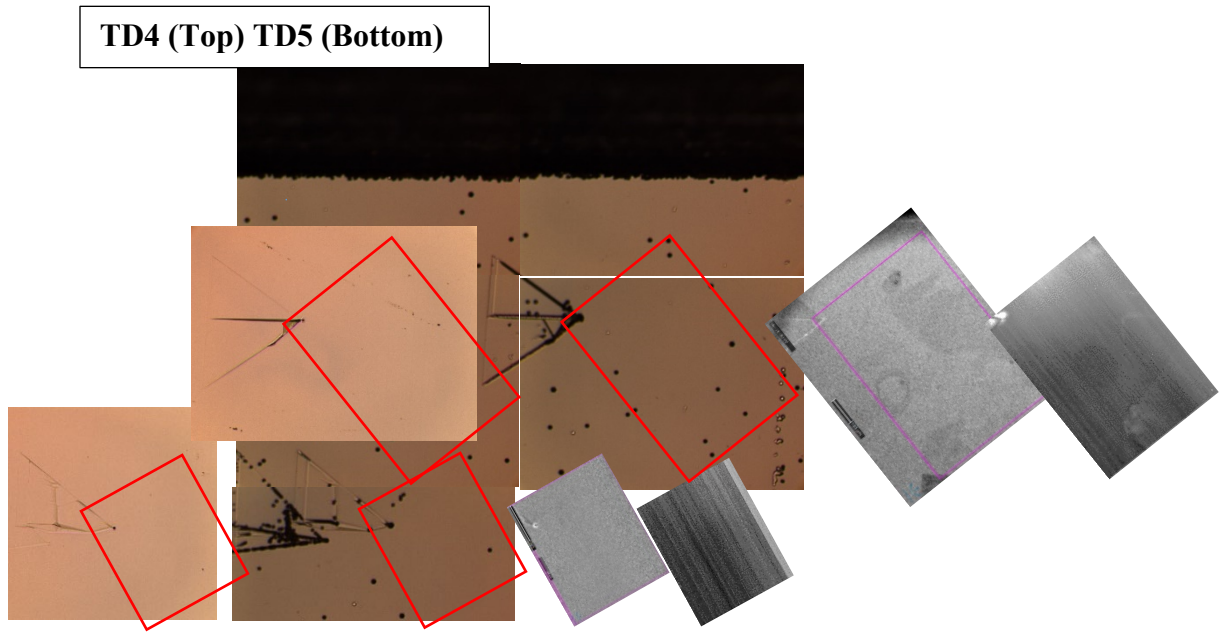
**Fig. 7** Comparisons of the optical microscopy, post-etch optical microscopy, SEM imaging, and CL imaging for the sample areas denoted as TD4 and TD5

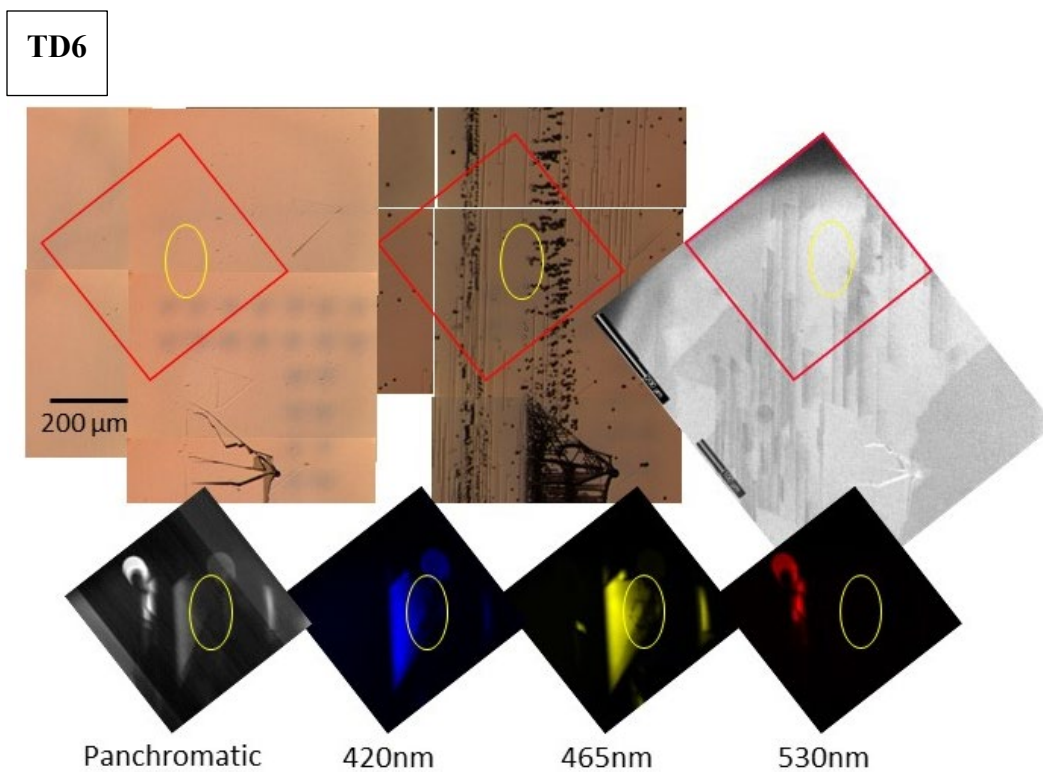
The CL image for TD6, in Fig. 8, was taken in area with a high density of in-grown SFs. There are also a large quantity of defects that are associated with the SFs that nucleated from the TD at the bottom of the image. These TEDs are apparent in the 420- and 465-nm monochromatic CL images.

**Fig. 8** Comparison of the optical microscopy, post-etch optical microscopy, SEM imaging, and CL imaging for the area on the sample denoted as TD6

Two of the areas (TD6 and TD8) also include a comparison of the panchromatic CL image to monochromatic CL imaging at three peak wavelengths of 420, 465, and 530 nm. These wavelengths were chosen by finding peaks in a spectral plot taken within TD6. These wavelengths are all reported with discussion of the types of SFs in Maximenko et al.<sup>7</sup> Different wavelengths of CL imaging can reveal multiple types of SFs. Different types of SFs emit different wavelengths of light, as seen in TD6 and TD8. This indicates there are multiple SFs in the same area existing on different planes.

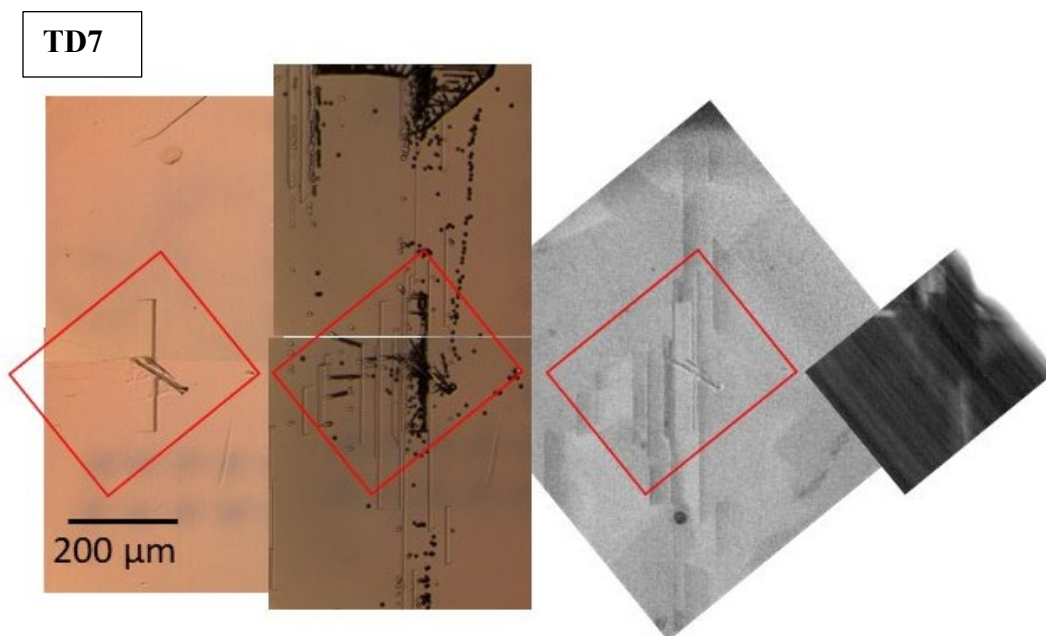
The CL image for TD7, in Fig. 9, is also taken in an area with a TD and a high density of in-grown SFs.

**Fig. 9** Comparison of the optical microscopy, post-etch optical microscopy, SEM imaging, and CL imaging for the area on the sample denoted as TD7

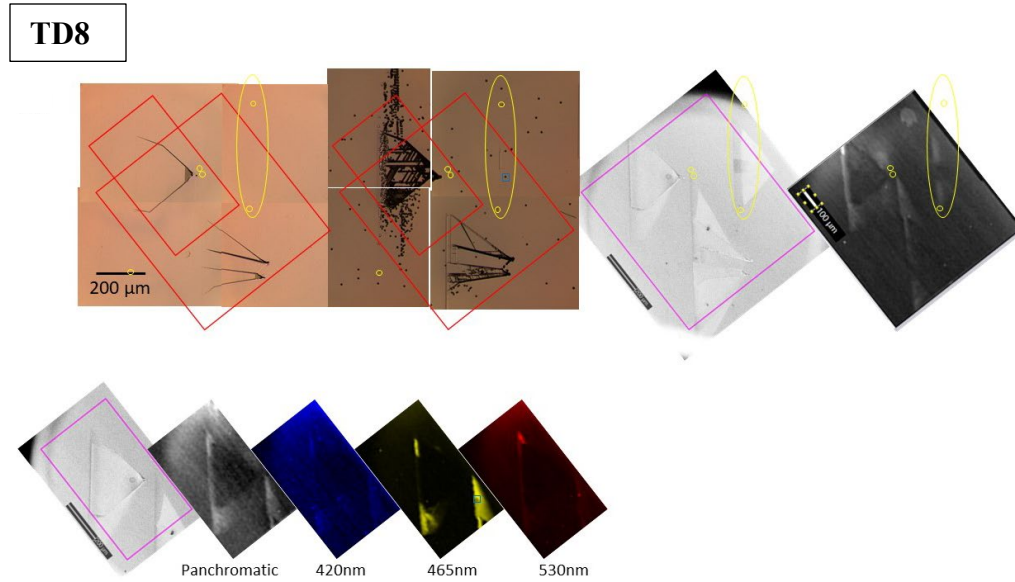
**Fig. 10 Comparison of the optical microscopy, post-etch optical microscopy, SEM imaging, and CL imaging for the area on the sample denoted as TD8**

There are observations where the CL also indicates planar defects not revealed by defect etching. These cases are the same as the SFs in SiC imaged by Maximenko et al.<sup>7</sup> Etching only reveals defects where they intersect with the surface, while CL can also reveal planar defects within the material. In the image for TD8, in Fig. 10, the CL clearly indicates a SF in the yellow oval location; however, the SF is not fully observed in the etched sample. This is because the SF is below the surface of the sample and, therefore, not visible in the etched sample. Note that the SF observed in the CL but not the optical microscope are also observed in the SEM image. The smaller circles in TD8 indicate the presence of BPDs. These BPDs demarcate the edges of partial dislocations, which coincide with the boundaries of in-grown SFs. CL imaging and SEM are methods to determine the location and size of in-grown SFs. In-grown SFs are also observed in TD1, TD2, TD6, and TD7.

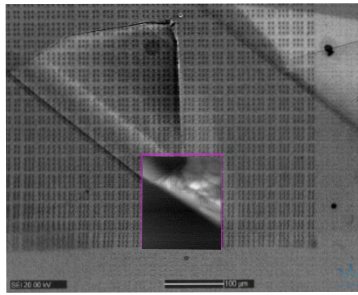
For this study, the highest-resolution CL was not selected because of the time needed to acquire the images. The resolution of the CL scans is likely not sufficient to observe some defects in the SEM scans. This was learned when an SEM image was acquired in the same location after a CL image was taken and the spot scans left a pattern in the sample (possibly due to charging or carbon deposition). This is seen in Fig. 11. Optimization of the SEM spot size and the resolution need to be performed to ensure all areas of the sample are imaged by the CL. The time issue limiting the resolution can be addressed by upgrading the detector from a CCD to a photo multiplier tube (PMT) detector.

**Fig. 11** The position of each spot can be observed in an SEM image taken of an area that had a CL image taken previously
