SBIR Phase II Sub-award Report Phase 2B

Performance of Active Porcelain Enamel Coated Fibers for Fiber-Reinforced Concrete

The Performance of Active Porcelain Enamel Coatings for Fiber-Reinforced Concrete
and Fiber Tests at the University of Louisville

May 2021

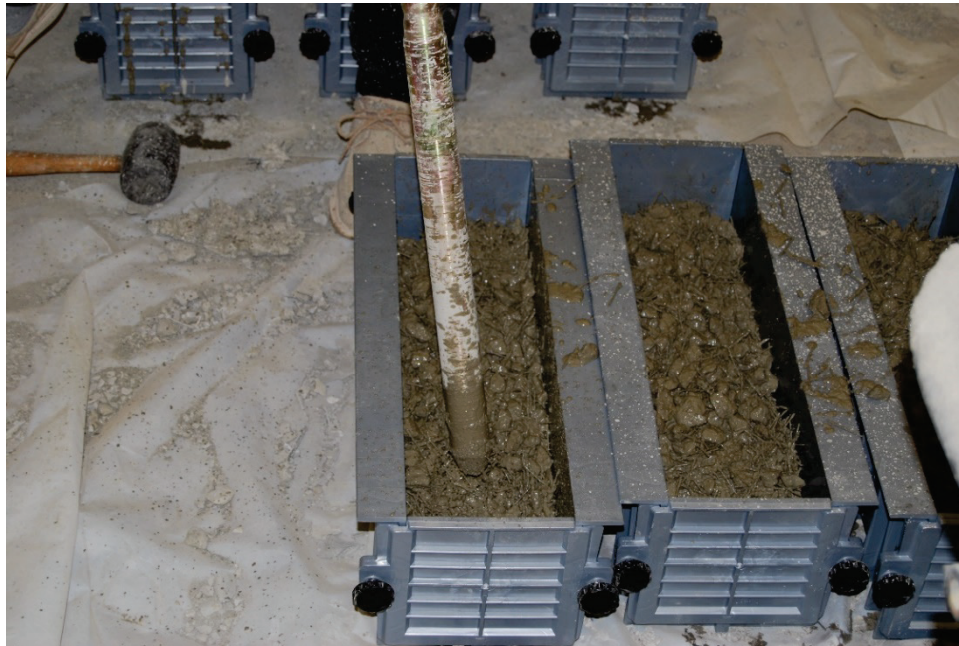
Figure 3. Fiber-reinforced concrete added to the beam mold and vibrated (3% loading).

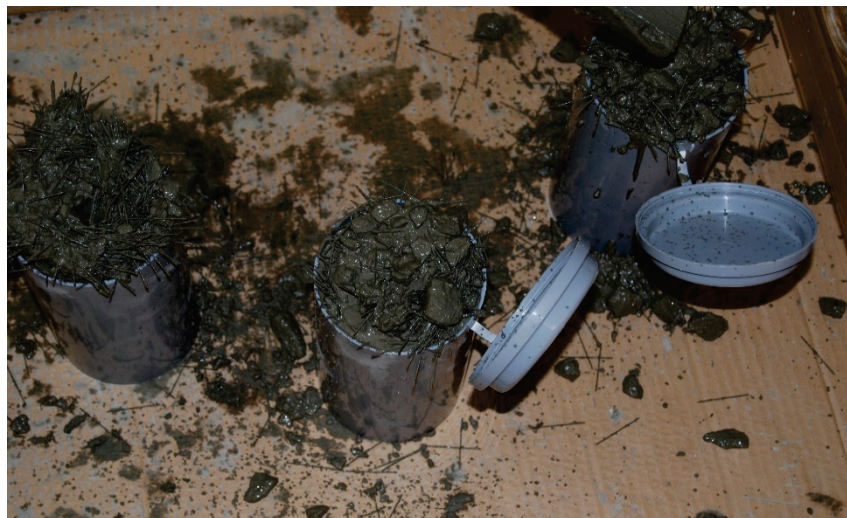
Figure 8. Rough cylinder finishing (0.029-in.-diam, uncoated fibers at 3% by volume).

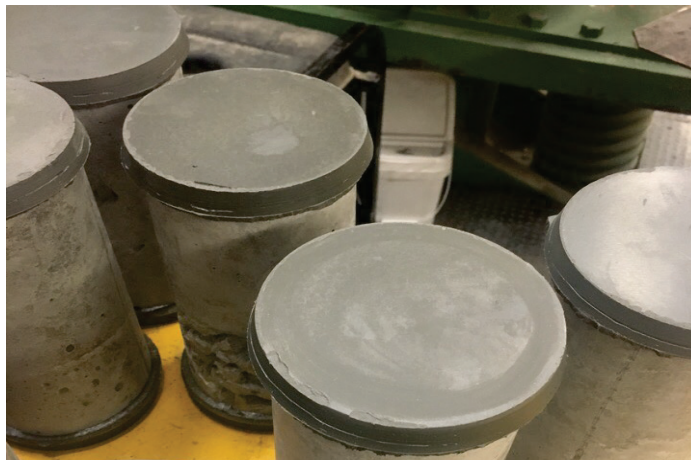
Figure 9. Capped cylinders.

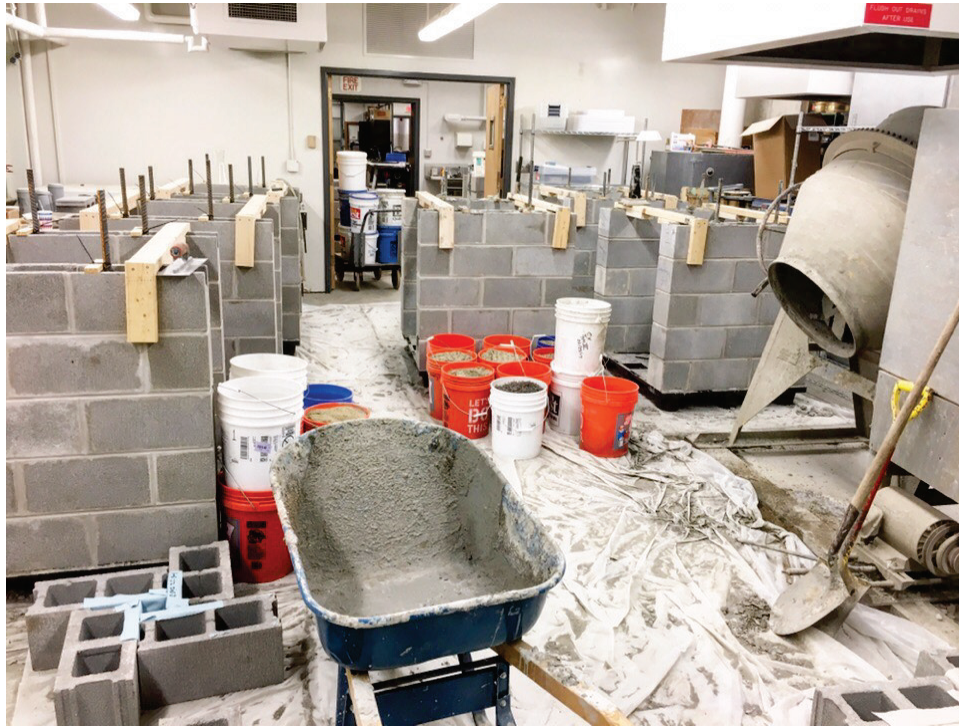
Figure 12. Masonry wallets prior to grouting.

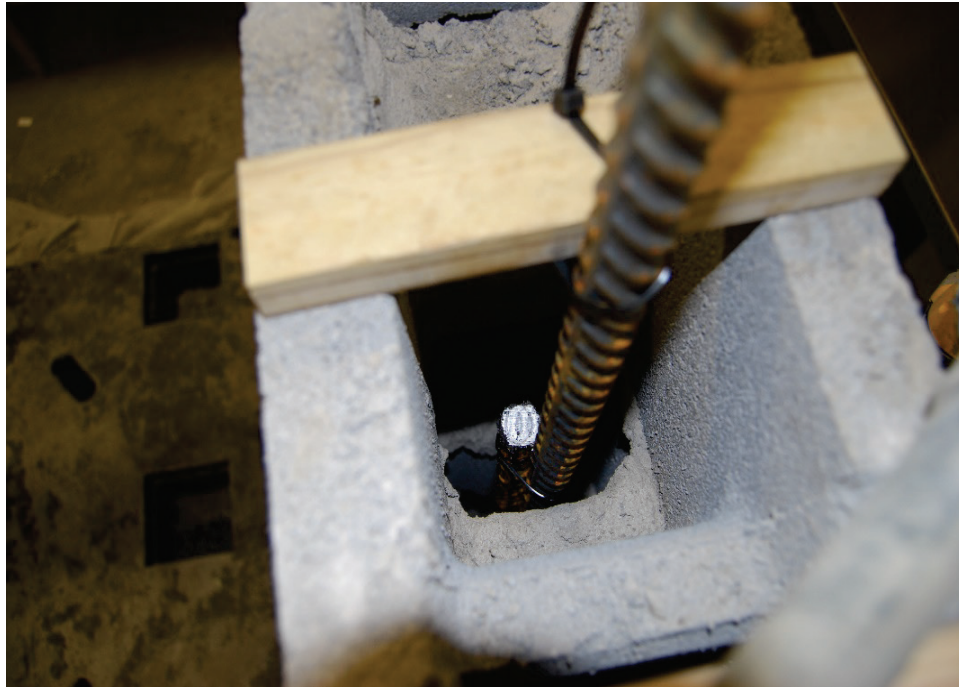
Figure 14. Wallet specimens about to receive grout.

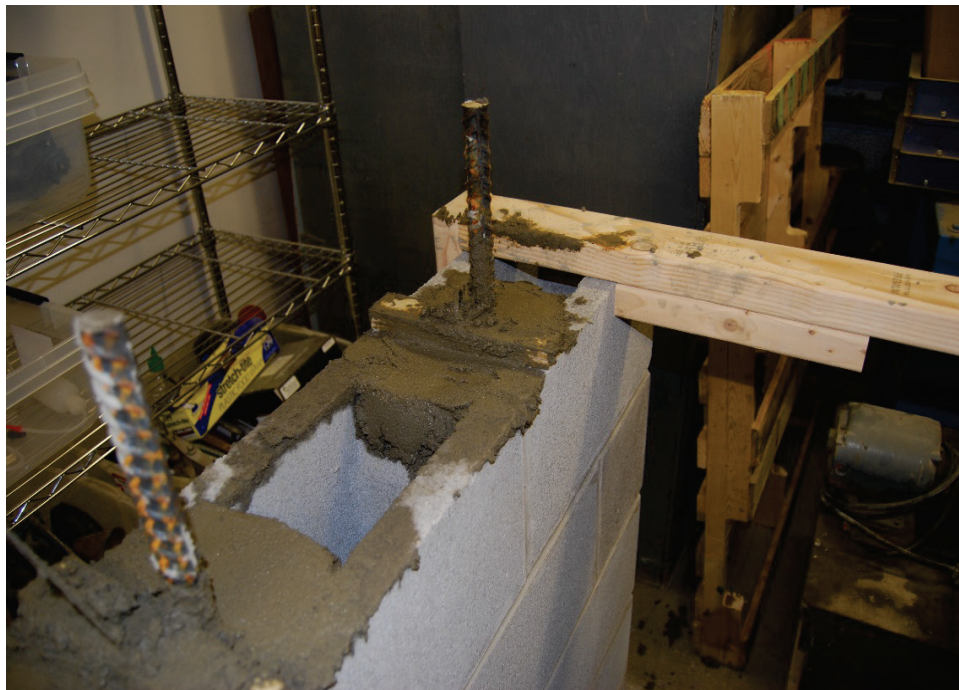
Figure 15. Wallet specimens after grouting.

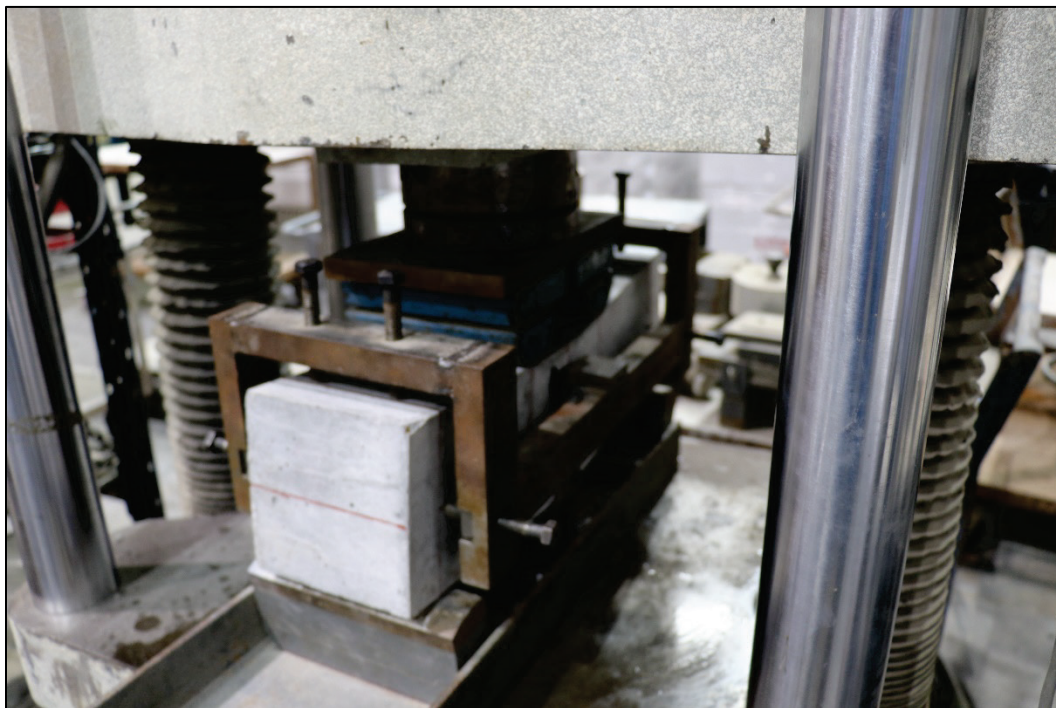
Figure 19. ASTM 1609 (2019b) test setup.

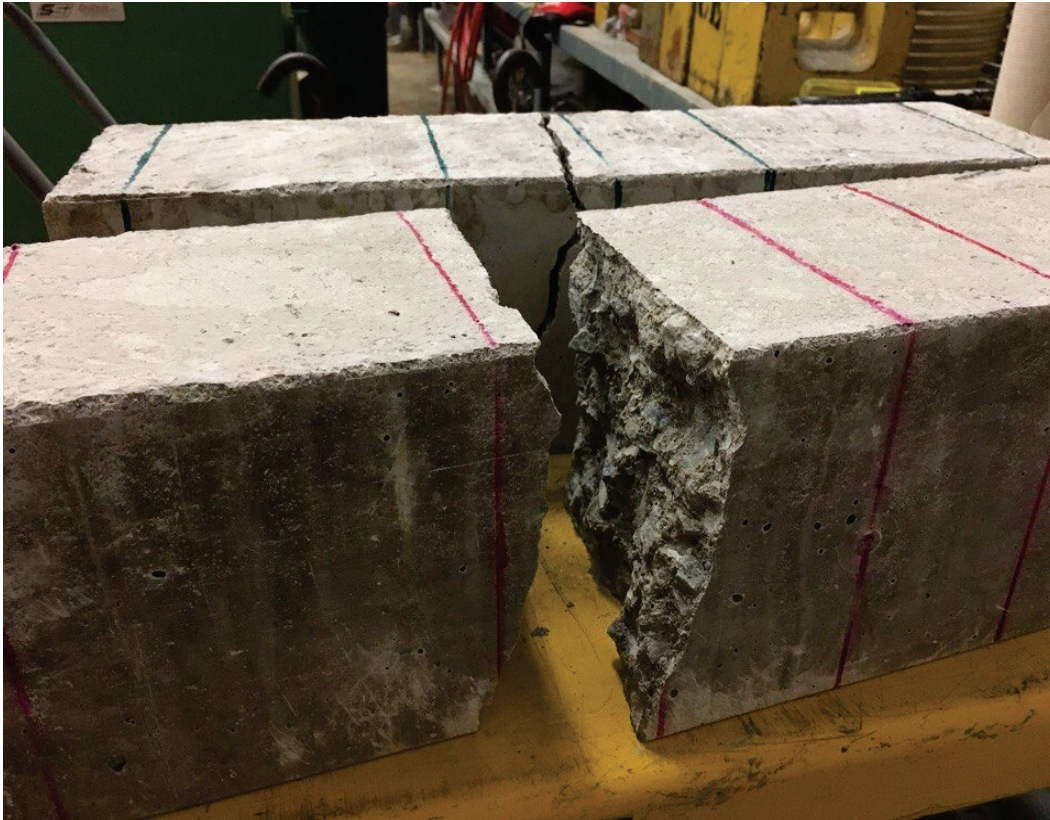
The three plain (control) concrete beam specimens -- S1, S2, and S3 -- deformed little under third-point loading until snapping through at peak cracking loads of 7,561 lb, 5,849 lb, and 6,234 lb, respectively. This produced an average peak load of 6,548 lb. The plain concrete beam

cracked in the central peak moment region, as shown in Figure 22. All beams were loaded initially with steel plates.

Figure 22. Plain concrete beams after cracking.

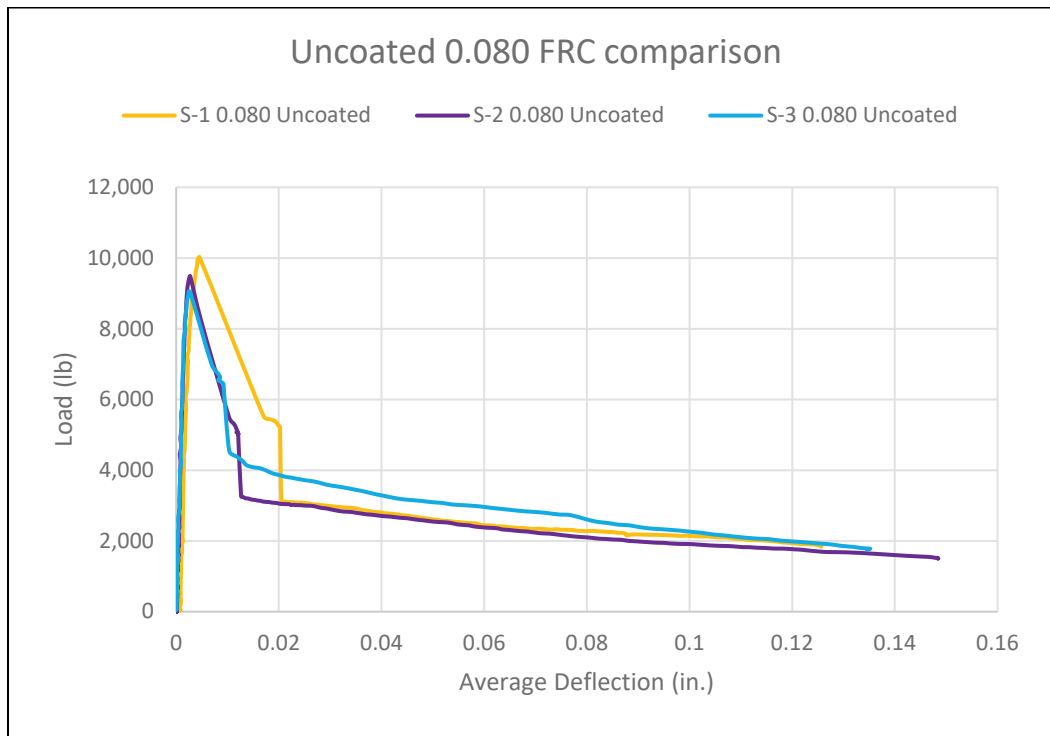
The load-deflection response of the beams reinforced with uncoated 0.080-in.-diam fiber (3% loading) is shown in Figure 23. All beams were loaded initially with steel plates underneath the beams. For these beams, deflection increased with load in a linear manner until near peak, where nonlinear deformation occurred. This nonlinear response was followed quickly with a load peak and a gradual falloff in load capacity with relatively large deflection. Near peak load, a large vertical crack was observed in the maximum moment region of the beam (Figure 24). Upon removal of the plate and reloading, the post-cracking responses of all three beams were similar, but there was a higher second peak load shown for Specimen 3 before a gradual falloff of load. Loading was stopped at about 0.15 in. due to travel limits on the sensors.

Figure 23. Load-deflection responses of uncoated 0.080-in.-diam fiber (3% loading) concrete beams.

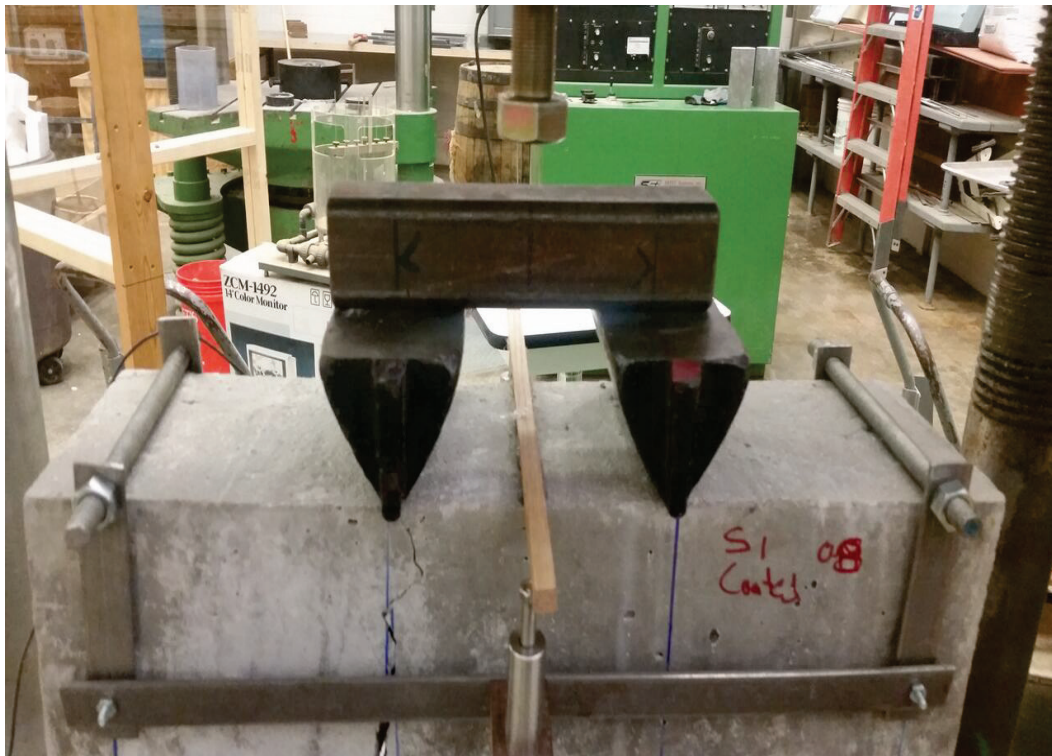
Figure 26. Coated 0.080-in.-diam fiber (3% loading) beam cracked configuration after peak loading.

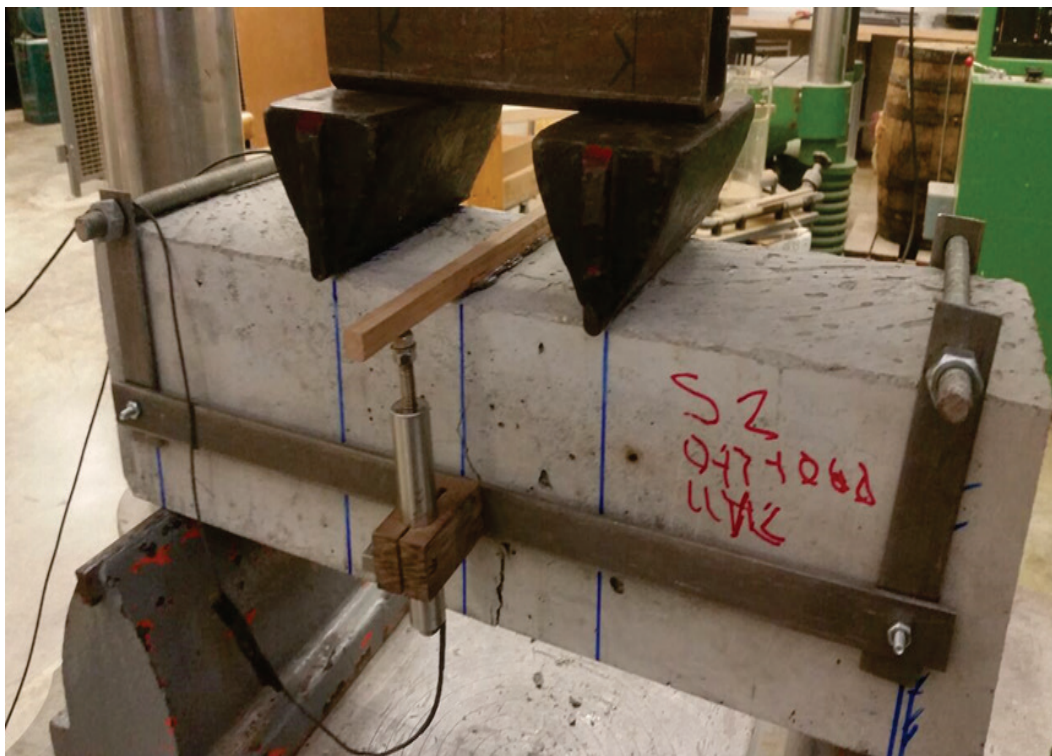
Figure 28. Uncoated 0.080-in.-diam fiber (1.5% loading) + 0.047-in.-diam fiber (1.5% loading) mix beam cracked configuration after peak loading.

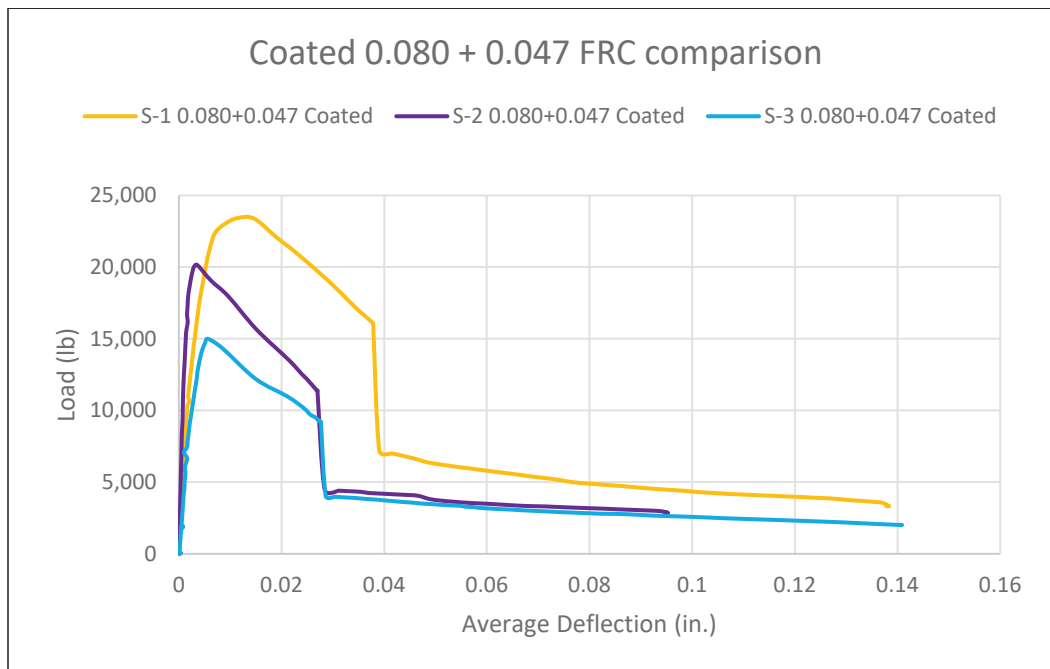
The load-deflection responses of the beams with a coated 0.080-in.-diam (1.5% loading) and 0.047-in.-diam fiber (1.5% loading) mix are shown in

Figure 29. All three beams in this configuration deflected in a linear manner until near peak, where nonlinear deformation occurred. This nonlinear response was followed quickly with a load peak and a gradual falloff in load capacity with relatively large deflection. Near peak load, vertical cracks were observed in the maximum moment region of the beam (Figure 30). Upon removal of the plate and reloading, the post-cracking responses of all three beams were similar, but there was a much higher second peak shown for Specimen 1. This was most likely the result of variability of fiber orientation and loading in the area of maximum tensile stresses. Loading was stopped near 0.1 in. due to travel limits on the sensors. Both cracking loads and post-cracking loads were significantly higher for the coated 0.080+0.047 fiber mix-loading configuration compared to the uncoated one. Moreover, the coated 0.080+0.047 fiber mix showed the best results among all fiber configurations tested.

Figure 29. Load-deflection response of coated 0.080-in.-diam fiber (1.5% loading) + 0.047-in.-diam fiber (1.5% loading) mix concrete beams.

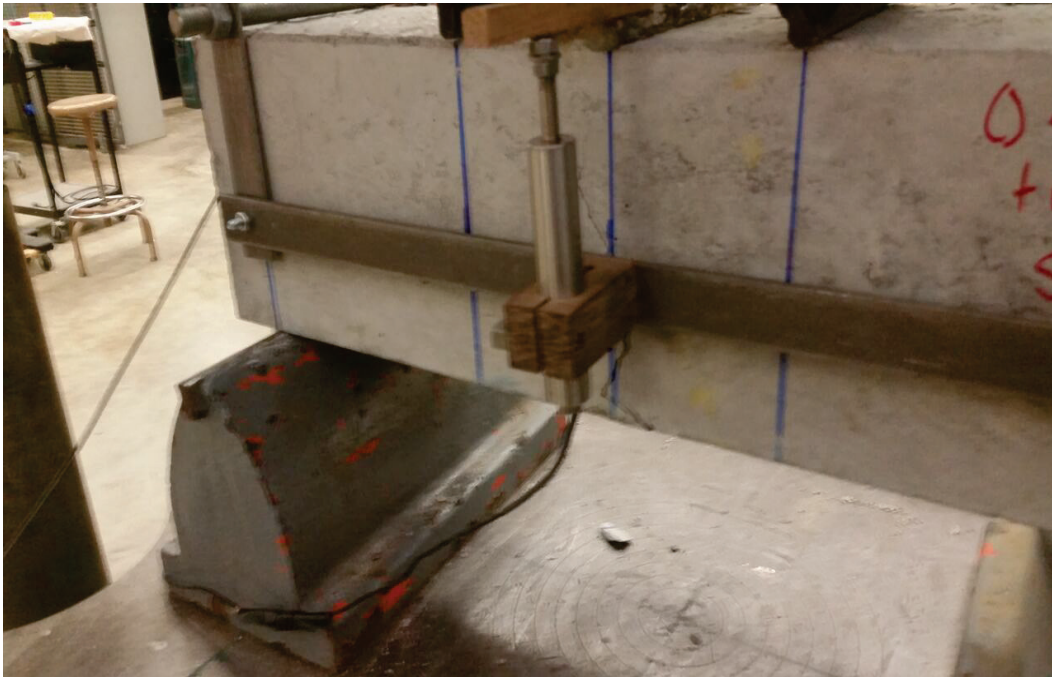
Figure 30. Coated 0.080-in.-diam + 0.047-in.-diam fiber mix beam cracked configuration after peak loading.

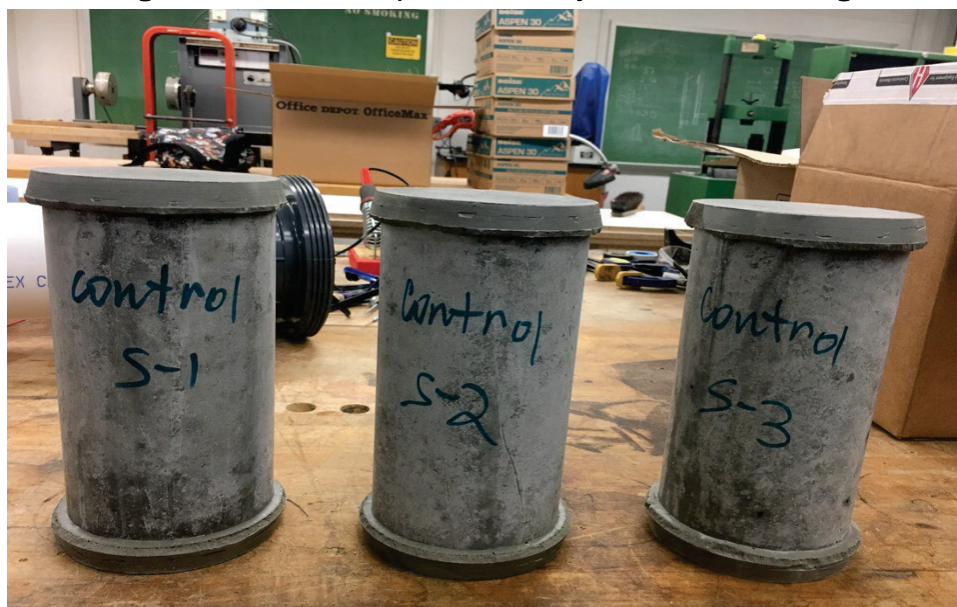
The control (no fibers) cylinders demonstrated typical behavior for unreinforced concrete under compression. Figure 31 shows the cylinders after stripping of the forms. There were no significant voids. The cylinder prior to testing with the extensometer attached is shown in Figure 32. The evenly distributed vertical cracks the cylinders experienced right after failure are shown in Figure 33. The compression stress-strain response of the control cylinders is shown in Figure 34. There is little ductility in post-cracking behavior.

Figure 31. Control compression test cylinders before testing.

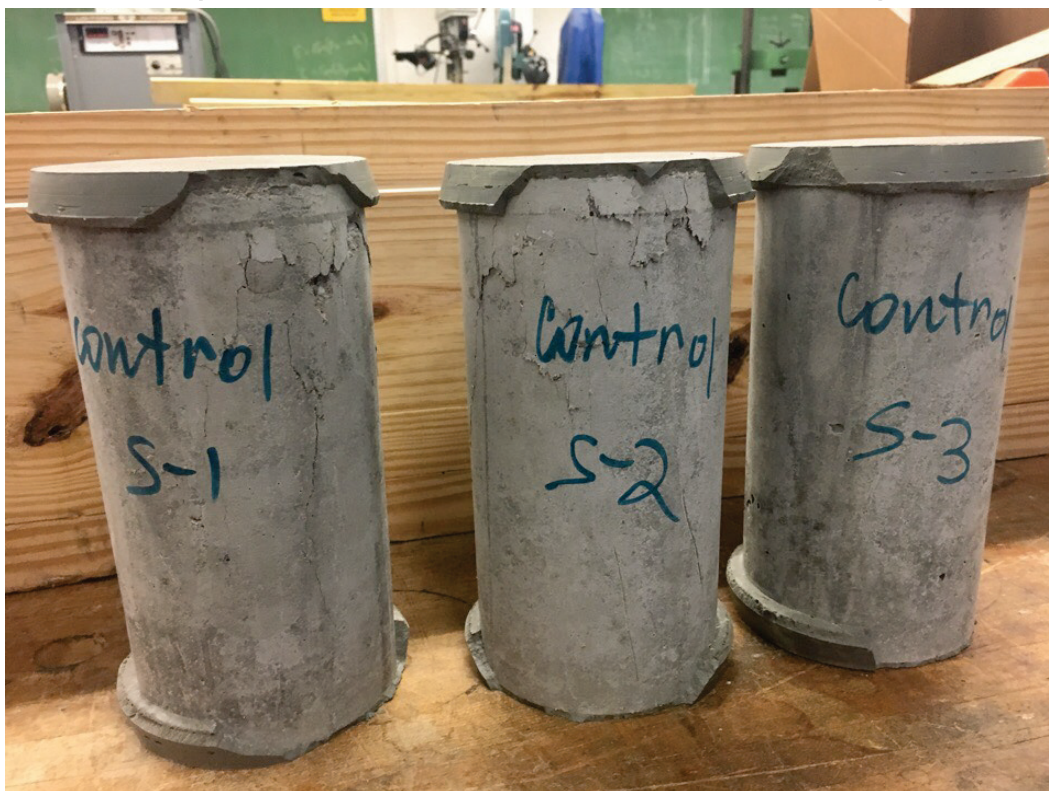
Figure 33. Control compression test cylinders after testing.

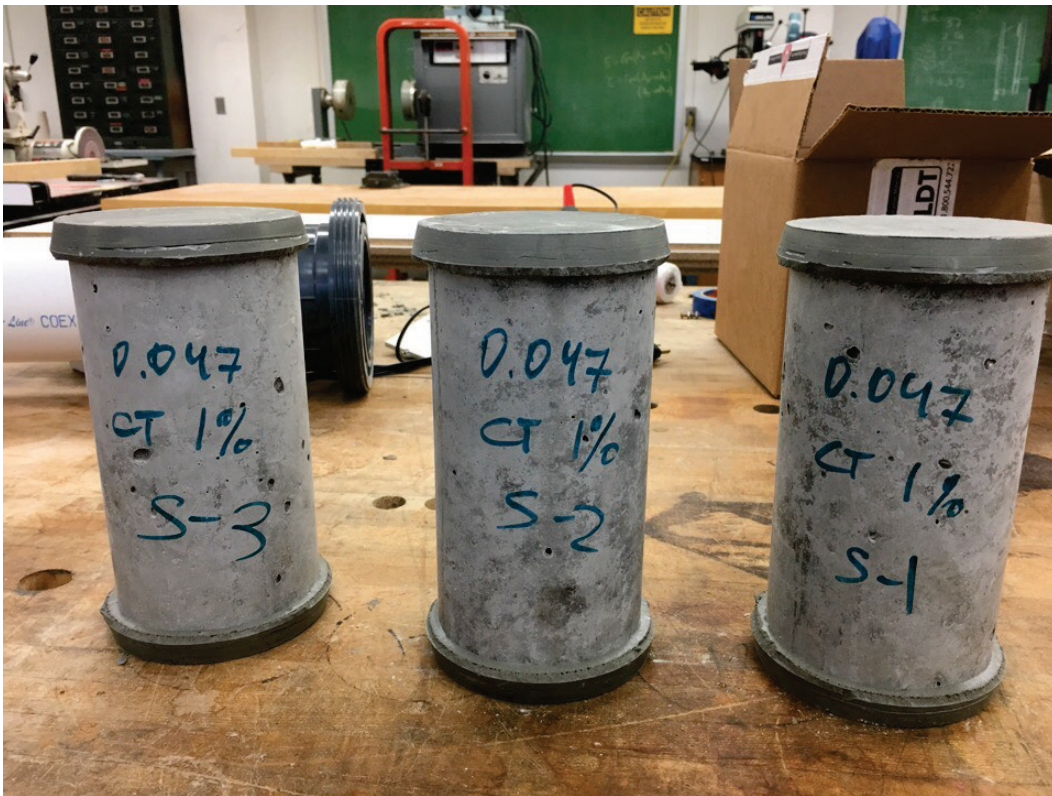
The compression cylinders with coated 0.047-in.-diam fibers (1% loading) before and after compression tests are shown in Figures 35 and 36, respectively. The compression stress-strain response for this fiber-reinforced concrete is shown in Figure 37. During loading, strain of the concrete initially increased with load in a linear manner, showing elastic behavior, which was then followed by a non-elastic curve until it reached its peak stress. All three cylinders had a similar pre-crack behavior, with an average compressive strength of 5,968 psi and CV of 7.4% (Table 7).

Figure 35. Cylinders made with coated 0.047-in.-diam fiber (1% loading) before testing.

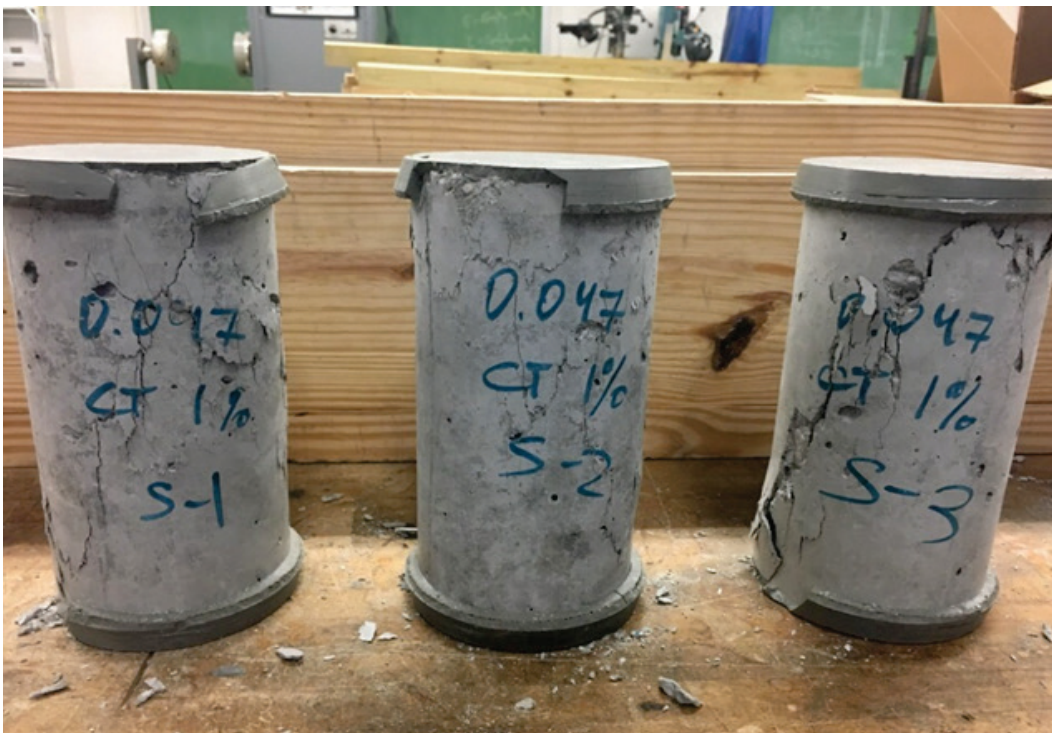
Figure 36. Cylinders made with coated 0.047-in.-diam fiber (1% loading) after testing.

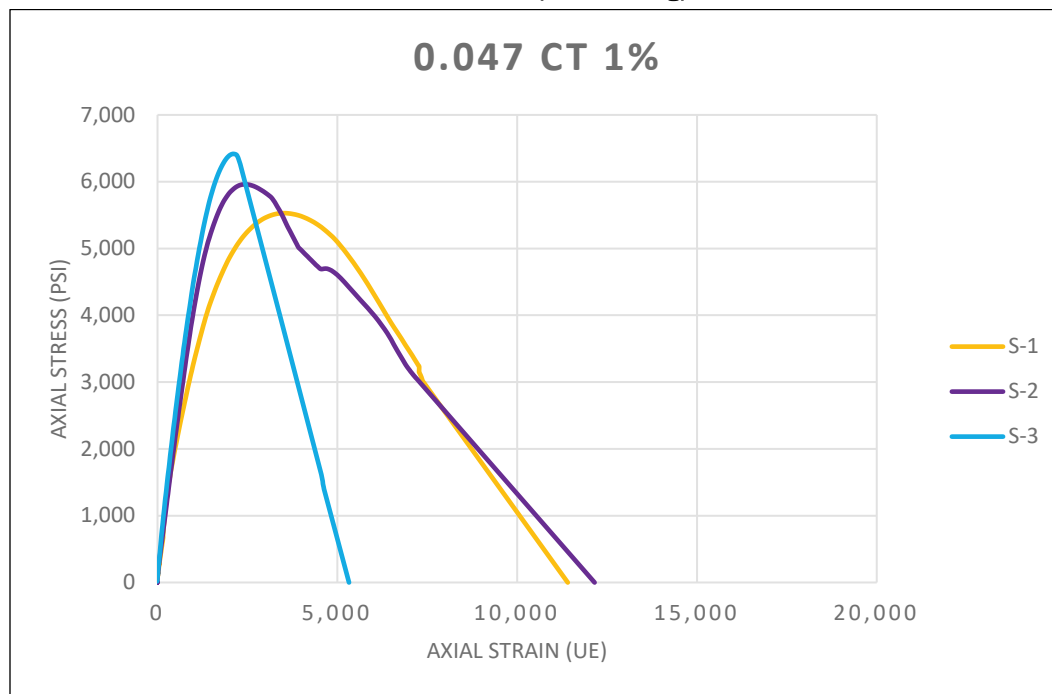
Figure 37. Compression stress-strain response of cylinder with coated 0.047-in.-diam coated fiber (1% loading).

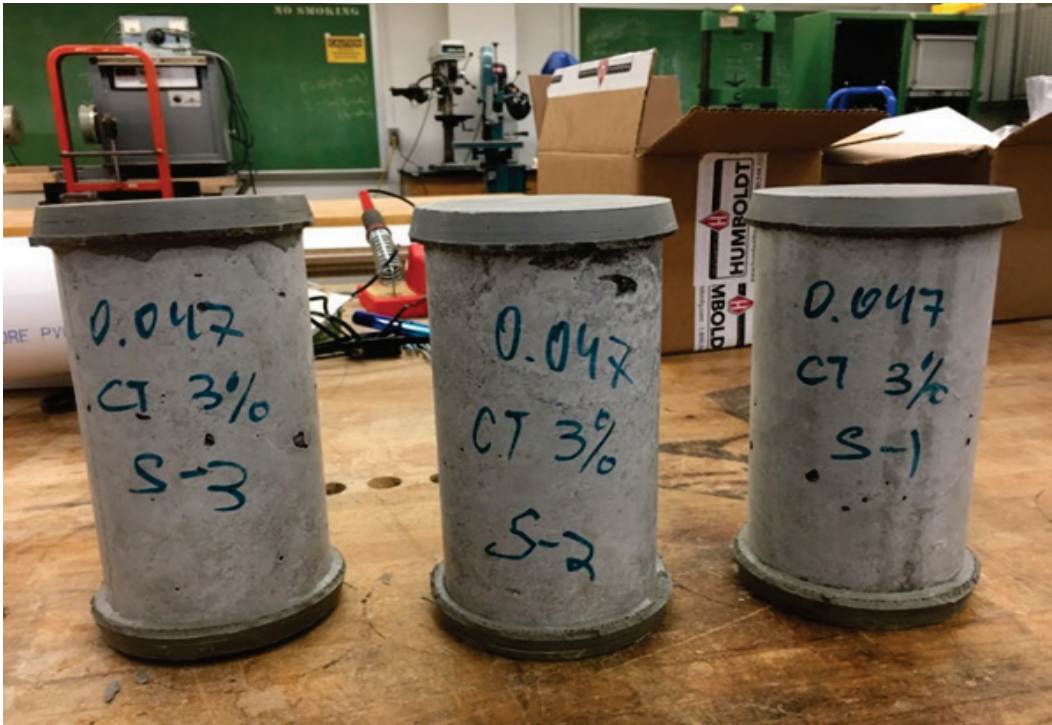
Cylinders of concrete formed with coated 0.047-in.-diam fibers (3% loading) before and after the compression tests are shown in Figures 38 and 39, respectively. The compression stress-strain responses for this fiber-reinforced concrete are shown in Figure 40. During loading, strain of the concrete initially increased with load in a linear manner showing elastic behavior, which was then followed by a non-elastic curve until it reached its peak stress. All three cylinders exhibited similar pre-crack behavior, with an average compressive strength of 5,540 psi and a CV of 11.0%.

Figure 38. Cylinders made with coated 0.047-in.-diam fiber (3% loading) before test.

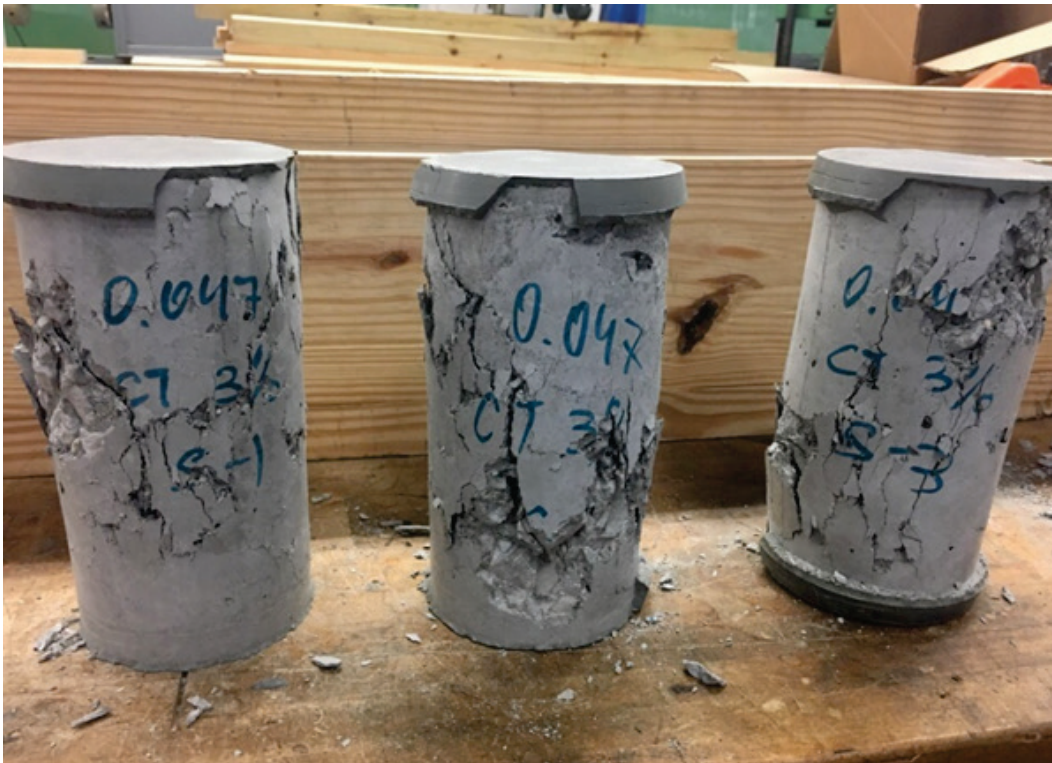
All the cylinders after testing had vertical cracks evenly distributed over their surfaces. Figure 40 shows the compression stress-strain behavior of these cylinders. Specimen 3 shows the lowest peak load and the most ductile post-peak behavior. This may have occurred because the cap on the cylinder was not perfectly straight, causing an uneven loading and, thus, non-uniform stresses. All the cylinders from this set had a relatively gradual falloff in load capacity and reached a large strain value relative to the control set.

Figure 39. Cylinders made with coated 0.047-in.-diam fiber (3% loading) after test.

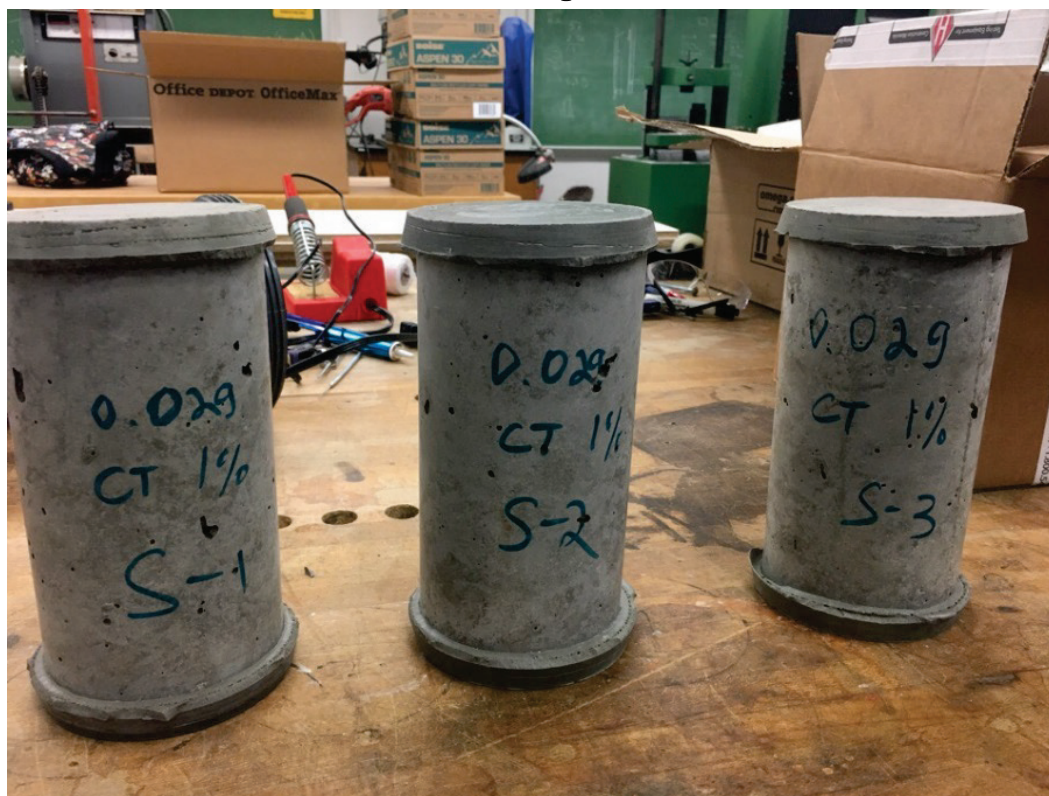
Figure 41. Cylinders made with coated 0.029-in.-diam fiber (1% loading) before testing.

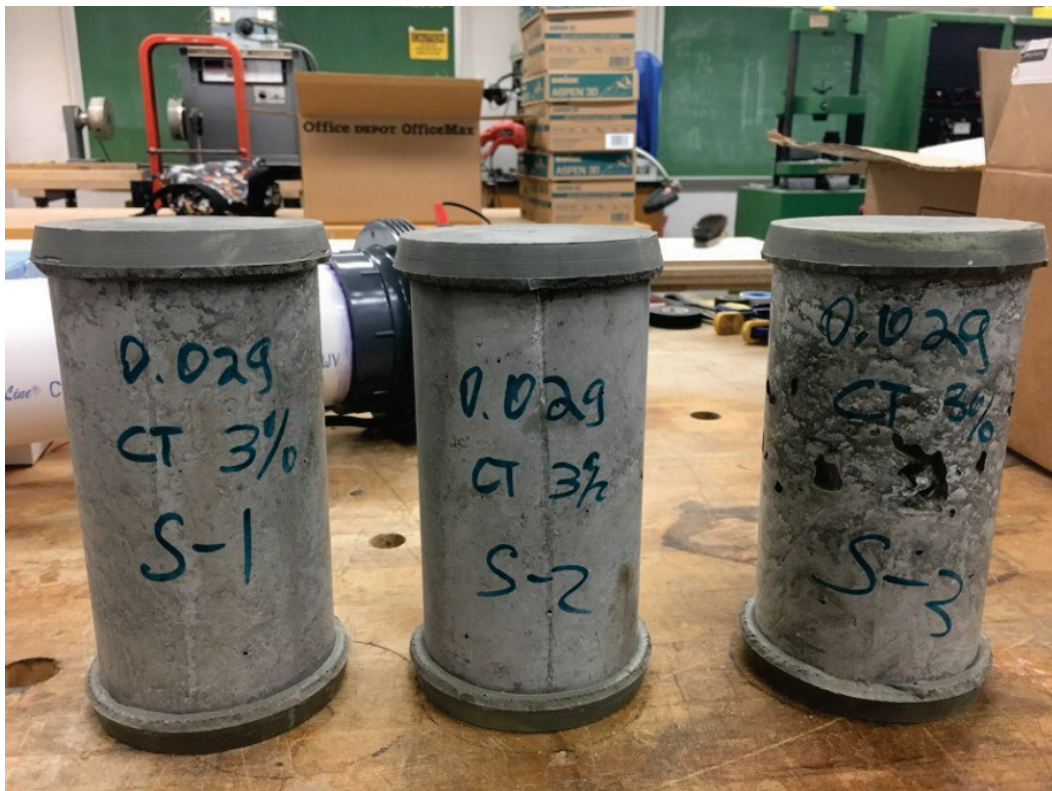
Cylinders with coated 0.029-in.-diam fibers (3% loading) before and after compression testing are shown in Figures 44 and 45, respectively. The compression stress-strain responses of the specimens are shown in Figure 46. During initial loading, the strain of the concrete increased with load in a linear manner, followed by a nonlinear response until the peak load was reached. All three cylinders demonstrated a similar pre-crack behavior. However, one of the three specimens had a consolidation problem (voids) that caused a significantly lower compressive strength than the other two (3,222 psi vs. 4,780 psi and 4,808 psi). Thus, the average strength was 4,270 psi, and a large CV of 21.3% was observed.

Figure 44. Cylinders made with coated 0.029-in.-diam fiber (3% loading) before testing.

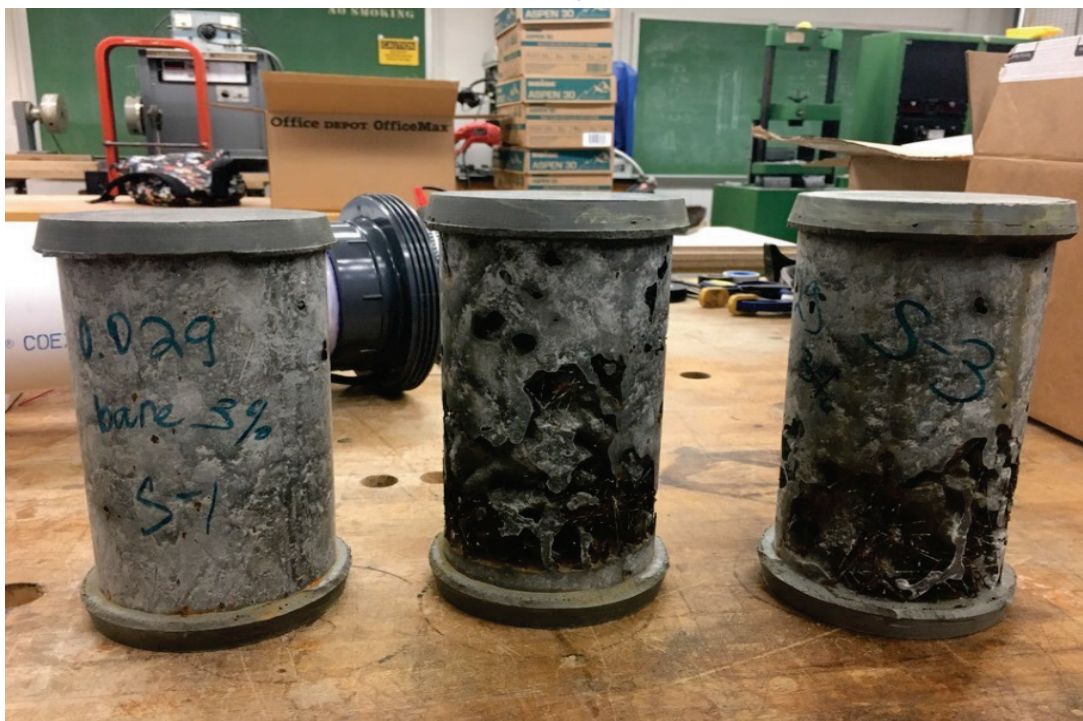
Figure 50. Cylinders made with uncoated 0.029-in.-diam fiber (3% loading) before testing.

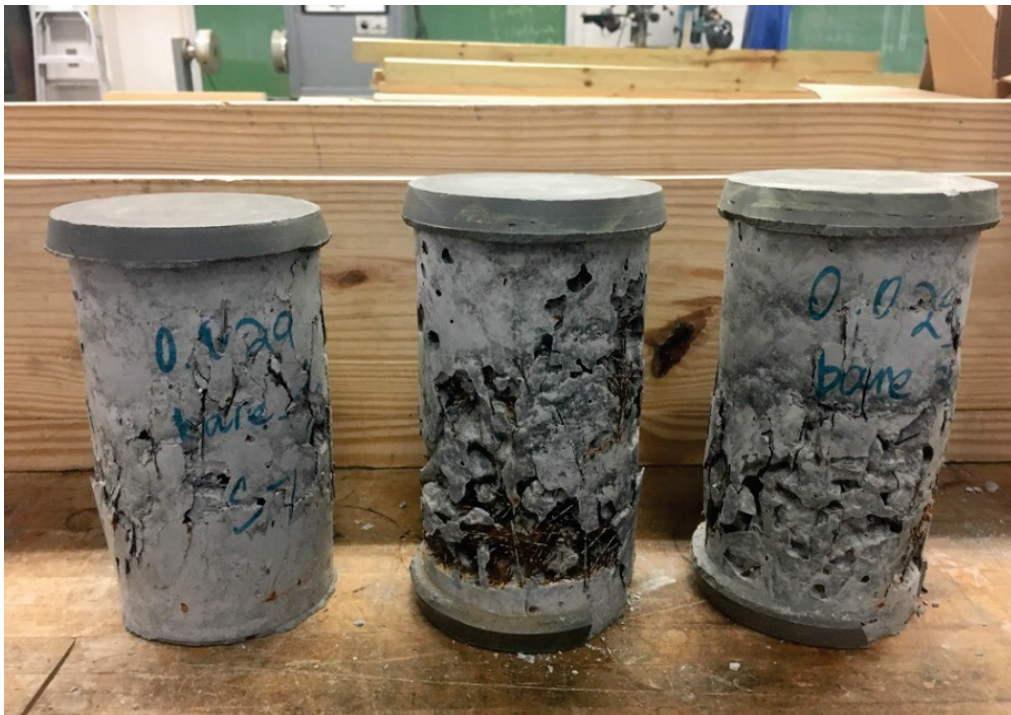
All three cylinders demonstrated a similar pre-crack behavior with a significant reduction in compressive strength relative to the control set. Only one of three specimens reached a compressive strength of 3,410 psi, while the other two showed strengths in the 1,300-psi range, resulting in a mean value of 2,039 psi and a very large CV of 58.3%.

Figure 51. Cylinders made with uncoated 0.029-in.-diam fiber (3% loading) after testing.

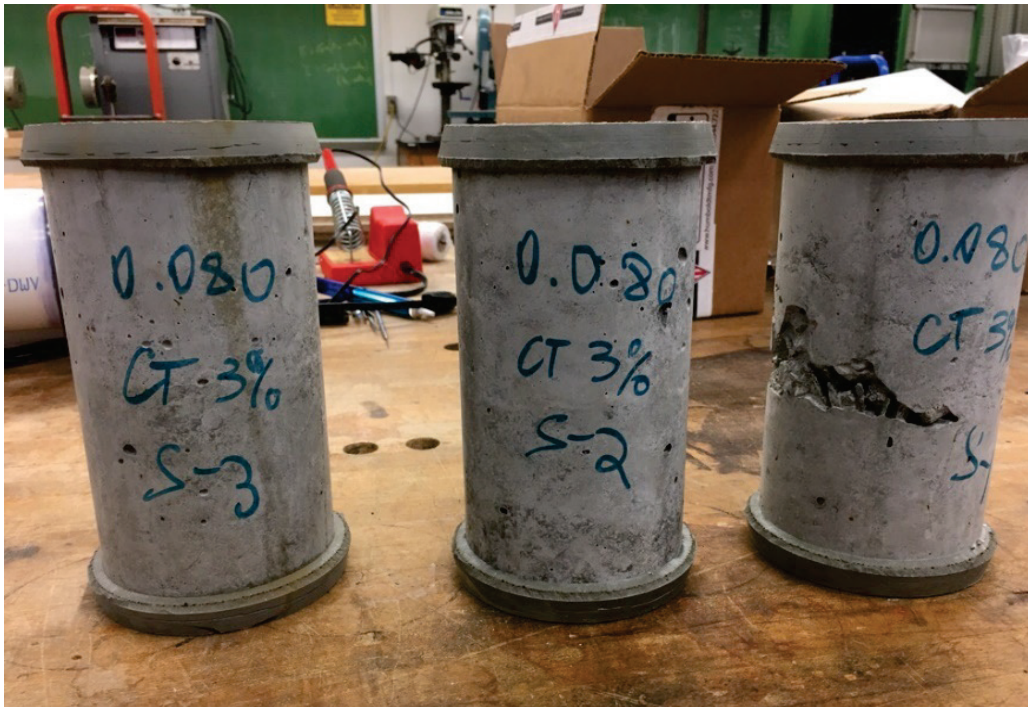
Figure 53. Cylinders made with coated 0.080-in.-diam fiber (3% loading) before testing.

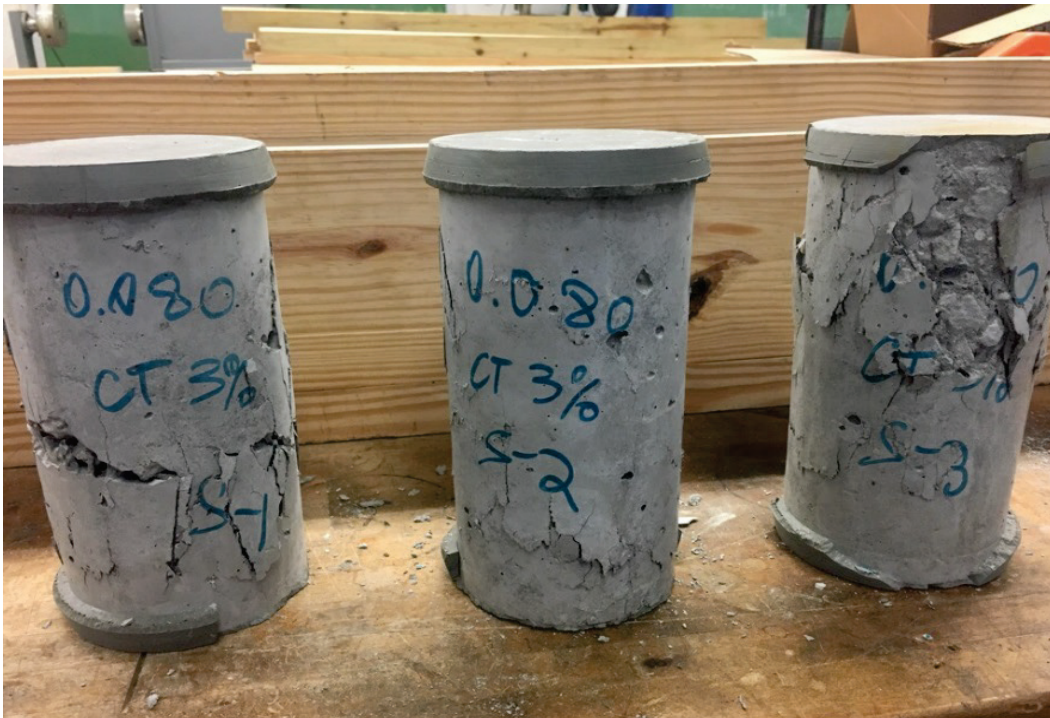
Figure 54. Cylinders made with coated 0.080-in.-diam fiber (3% loading) after testing.

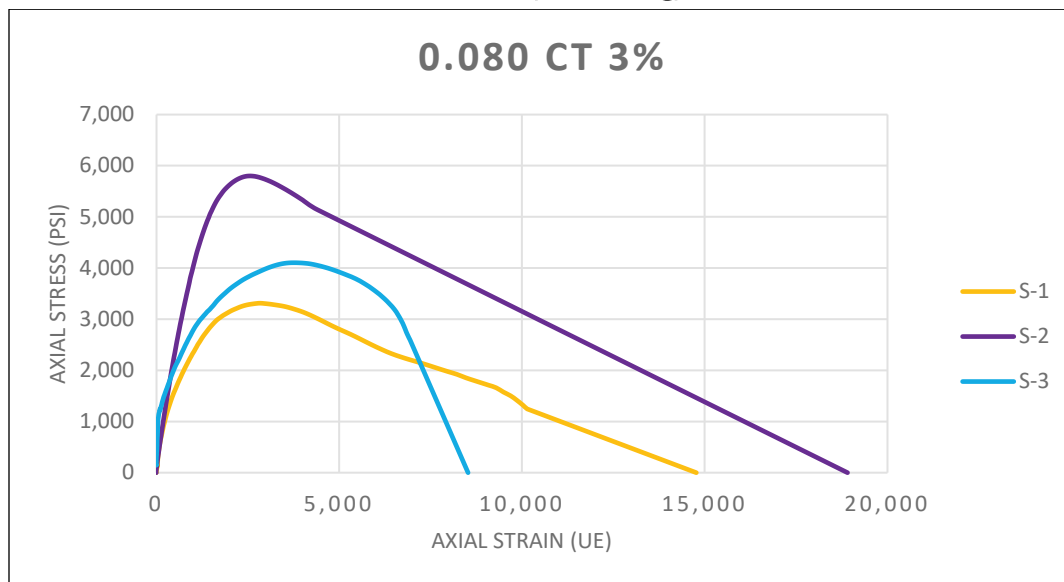
All three cylinders showed similar pre-crack behavior, but with a large variability in compressive strength values. Specimen 1 has the lowest strength, because the cylinder had consolidation issues, with a portion of its area showing exposed aggregate with concrete missing on the sides. The average compressive strength value for this set was 4,406 psi with a CV of 28.8%.

Figure 55. Compression stress-strain behavior of cylinders with coated 0.080-in.-diam fiber (3% loading).

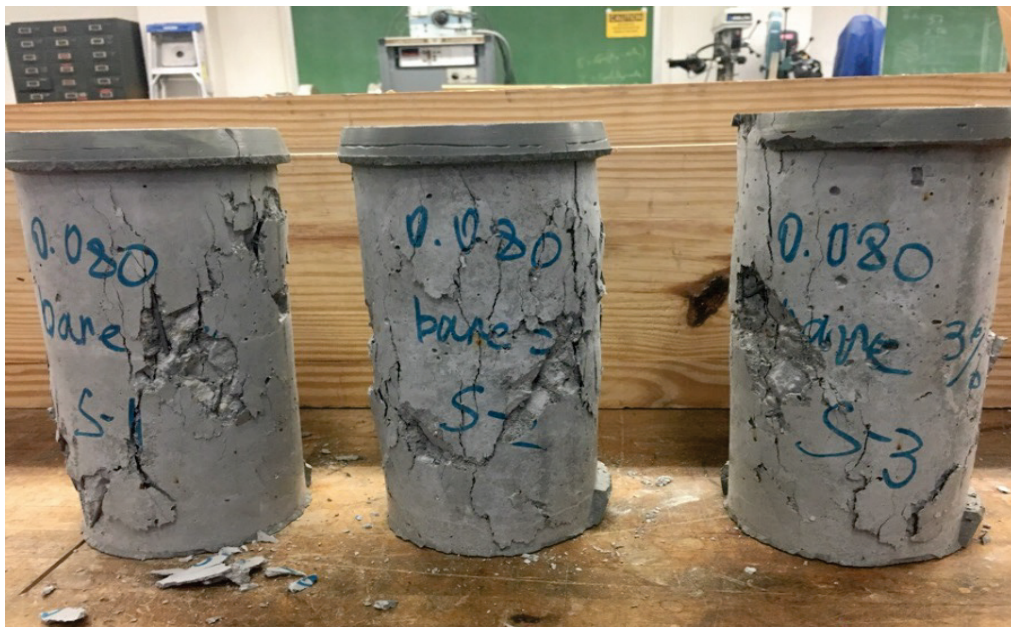
Figure 56. Cylinders made with uncoated 0.080-in.-diam fiber (3% loading) after testing.

All three cylinders show relatively similar pre-crack behavior but with a large variability of compressive strength values. Specimen 3 has the lowest strength because the cylinder had consolidation issues, with a portion of its area showing exposed aggregate with concrete missing on the sides. The average compressive strength value for this set was 4,212 psi with a CV of 21.0%.
