SBIR Phase II Sub-award Report Phase 2B

Performance of Active Porcelain Enamel Coated Fibers for Fiber-Reinforced Concrete

The Performance of Active Porcelain Enamel Coatings for Fiber-Reinforced Concrete
and Fiber Tests at the University of Louisville

May 2021

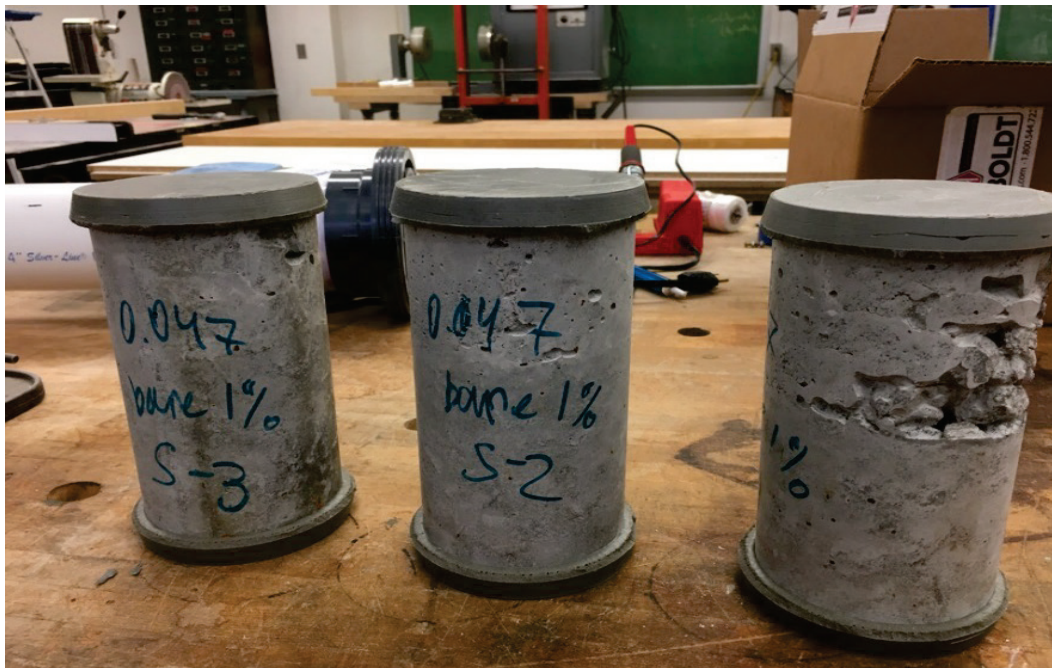
All three cylinders show a relatively similar pre-crack behavior, with Specimen 2 having a slightly higher compressive strength than the other two specimens. Specimen 1 had consolidation problems, and some of its area had concrete missing on the sides, which could possibly reduce the strength of the cylinder. The average compressive strength value for this set was 4,308 psi with a CV of 5.7%.

Figure 58. Cylinders made with uncoated 0.047-in.-diam fiber (1% loading) before testing.

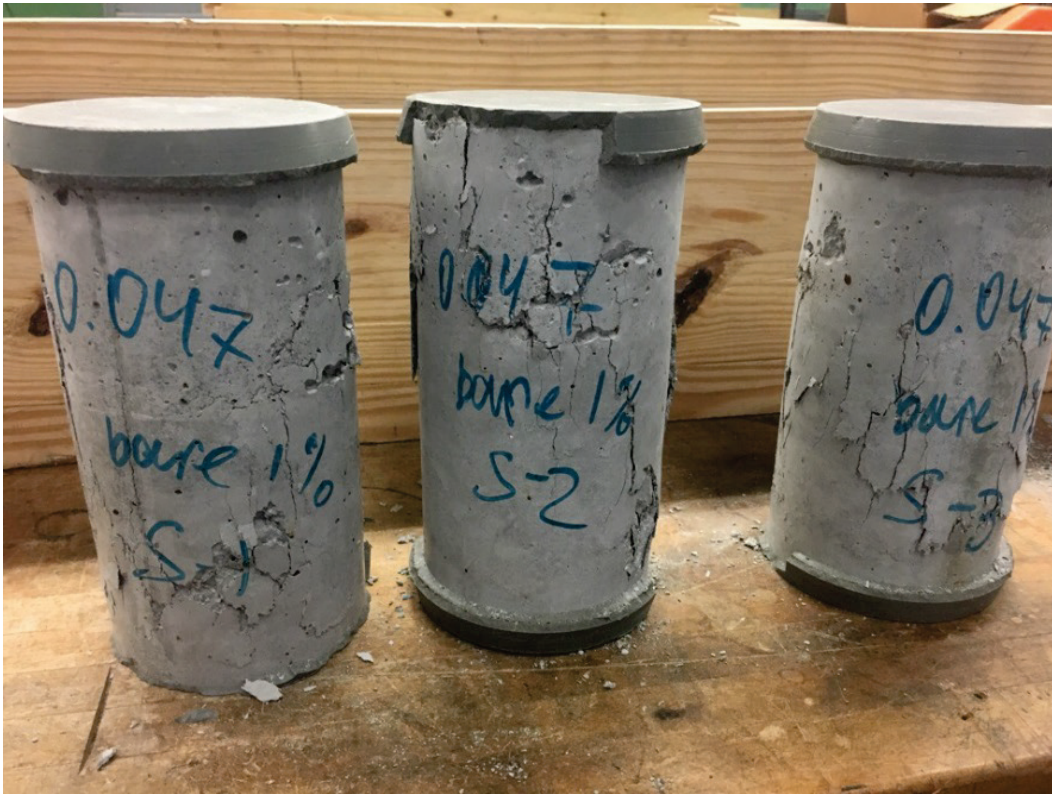
All three cylinders showed vertical cracks over their surfaces after testing. The post-peak behavior of the cylinders had some variability in ultimate strain values. Overall, this set had a relatively low ductility (Figure 60).

Figure 59. Cylinders made with uncoated 0.047-in.-diam fiber (1% loading) after testing.

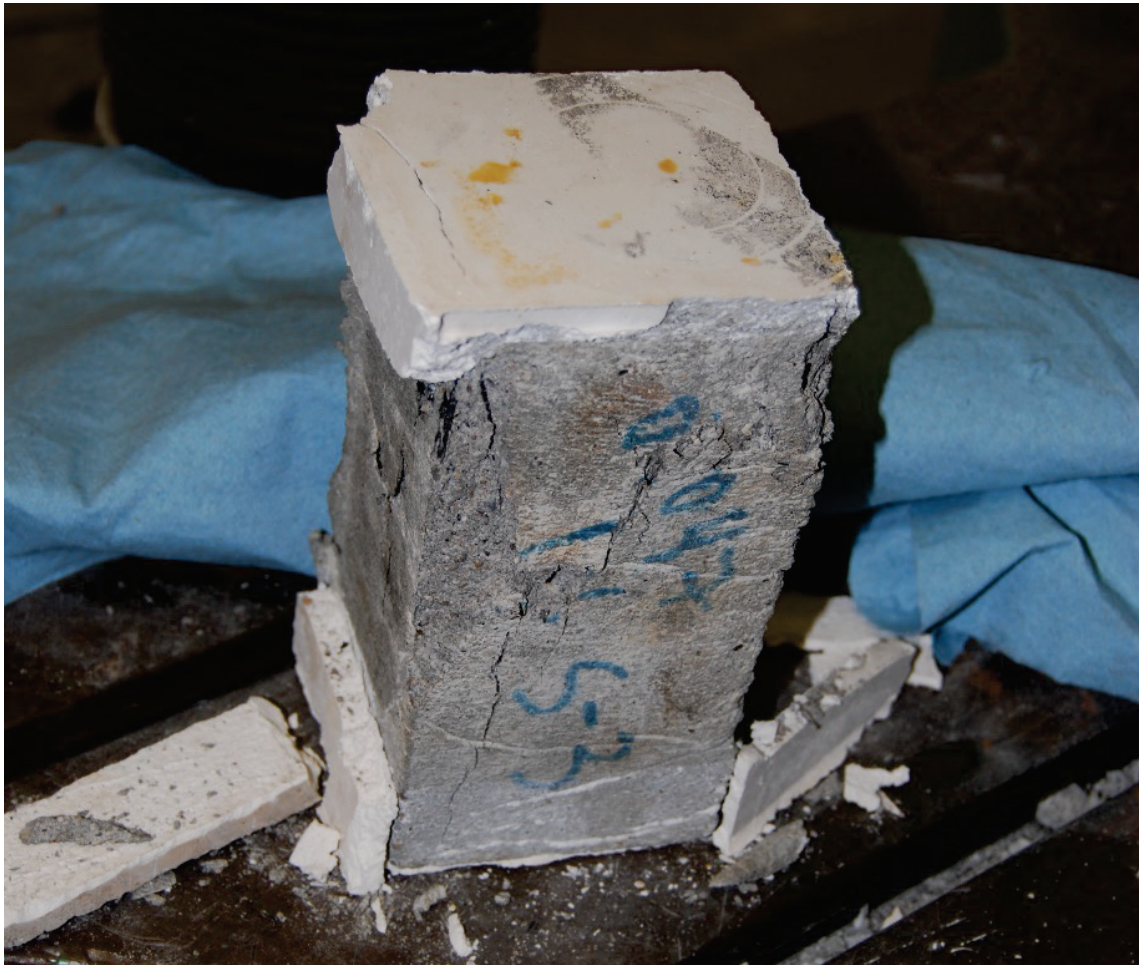
The typical grout prism failure, with significant vertical cracking shown on the surfaces, is shown in Figure 61.

Figure 61. Rectangular prism with coated 0.047-in.-diam fibers (1% loading) after testing.

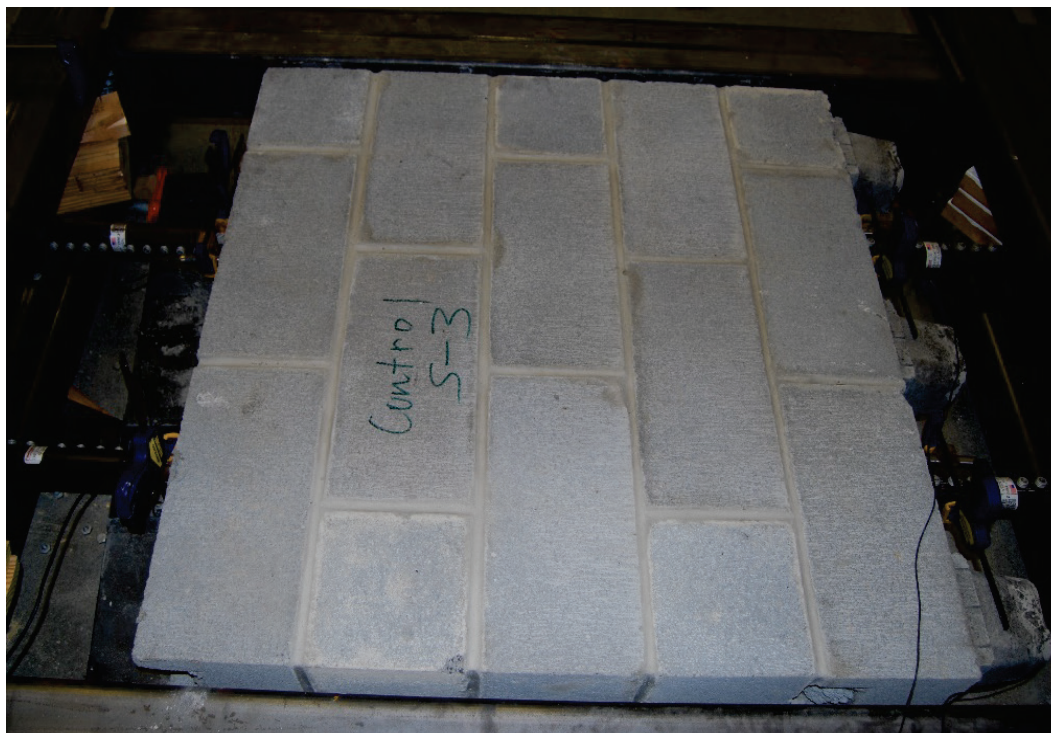
Figure 62. Plain (control) masonry wallet before testing.

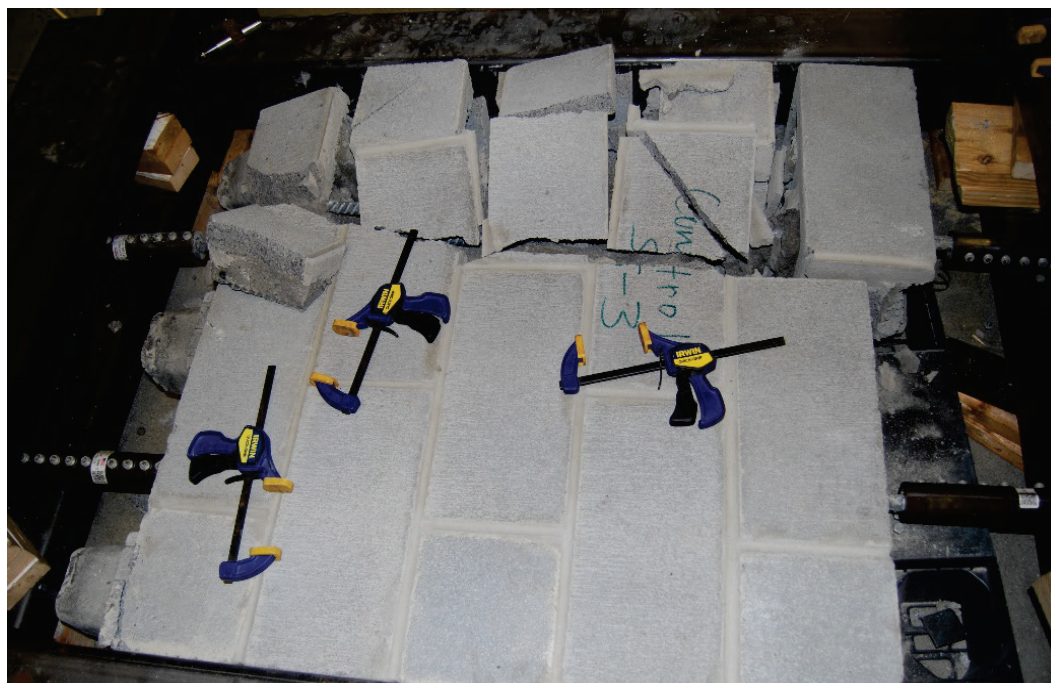
Masonry wallet specimens with non-reinforced grout exhibited brittle failures. Control specimen 3 was tested by loading only one of the rebars, since the exposed rebar on one side of the right-hand bar splice was not long enough to provide sufficient load transfer through the rebar coupler. A control wallet specimen prior to testing is shown in Figure 62. All specimens were loaded beyond 36,000 lb (the specified yield load of the rebar) per rebar when the masonry surrounding one of the splices split suddenly. The typical wallet specimen after failure is shown in Figure 63. The load-deflection responses of all three control specimens are presented in Figure 64.

Figure 63. Plain (control) masonry wallet after failure.

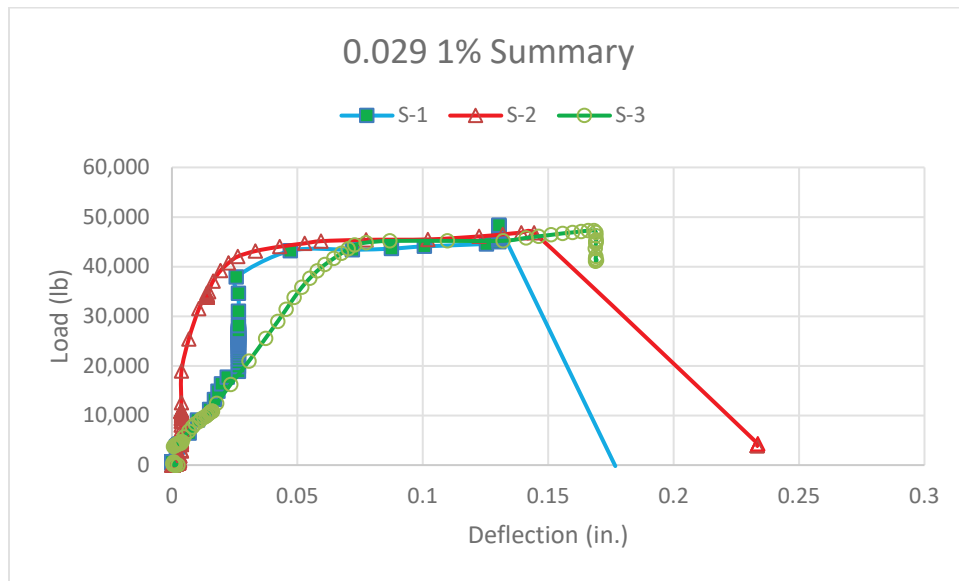
Figure 65. Coated 0.029-in.-diam fiber (1% loading) masonry wallets bar load deflection response.

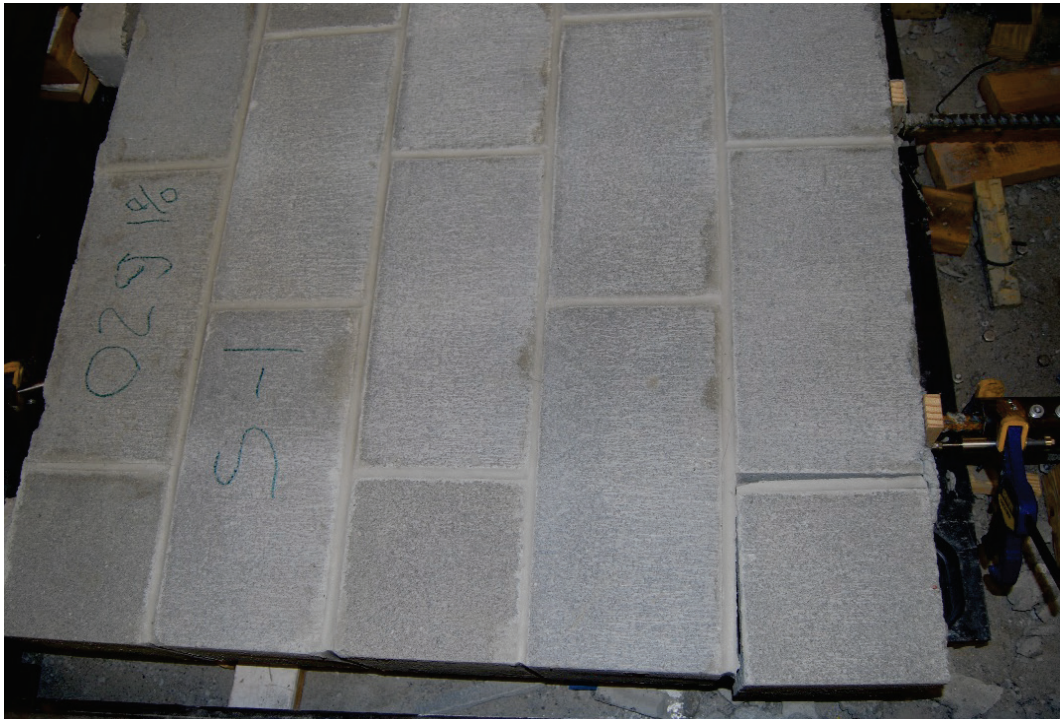
The masonry wallet specimens' conditions after the tests are shown in Figure 66, Figure 67, and Figure 68. Both Specimens 1 and 3 showed very little sign of external cracking (only minor bed joint cracking), while Specimen 2 showed significant damage (probably caused by the obvious void exposed at midsplICE in Figure 68). However, the capacity and ductility of all three specimens remained high.

Figure 66. Coated 0.029-in.-diam fiber (1% loading) specimen S-1 after failure.

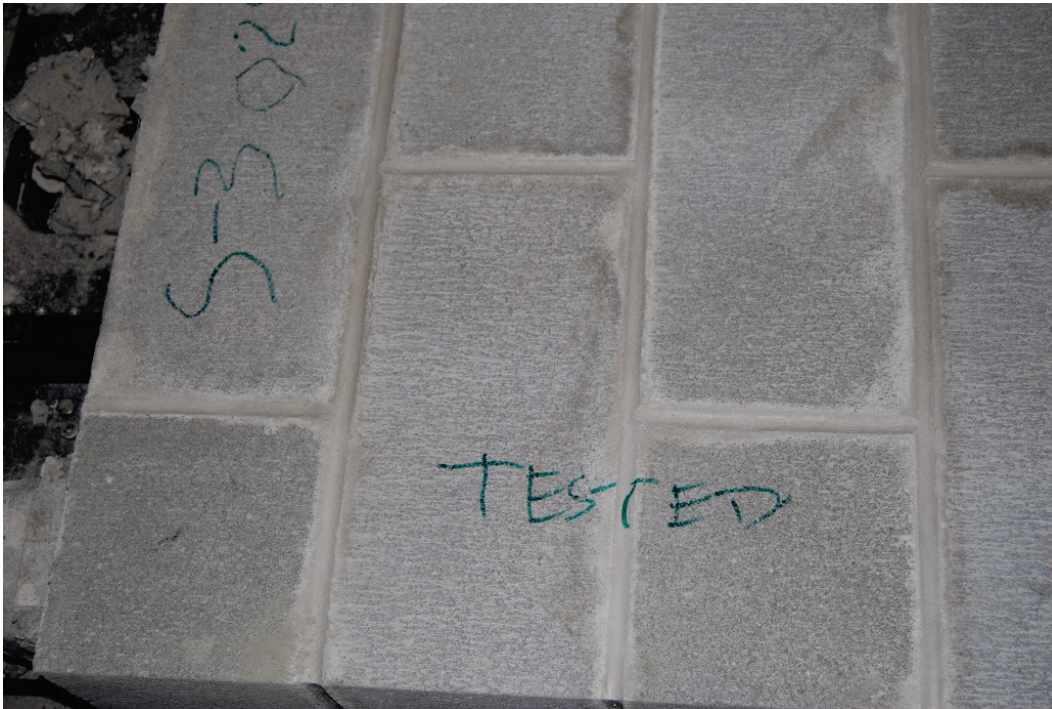
Figure 67. Coated 0.029-in.-diam fiber (1% loading) specimen S-3 after failure - no cracking.

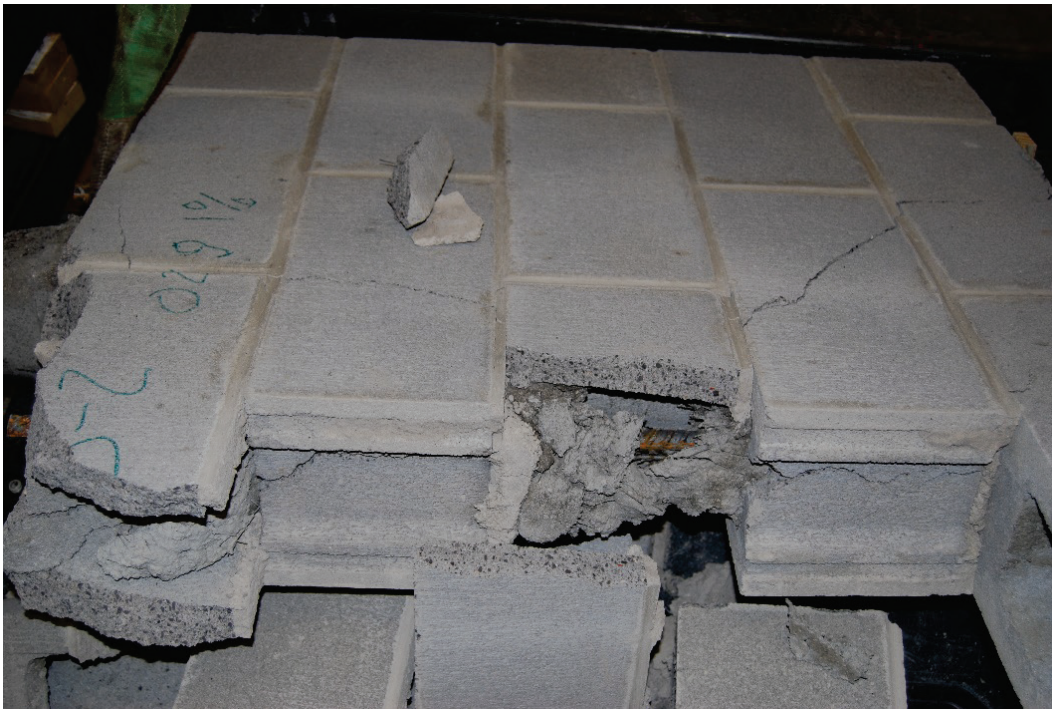
Figure 68. Coated 0.029-in.-diam fiber (1% loading) specimen S-2 after failure, with an obvious void in the grouted cell.

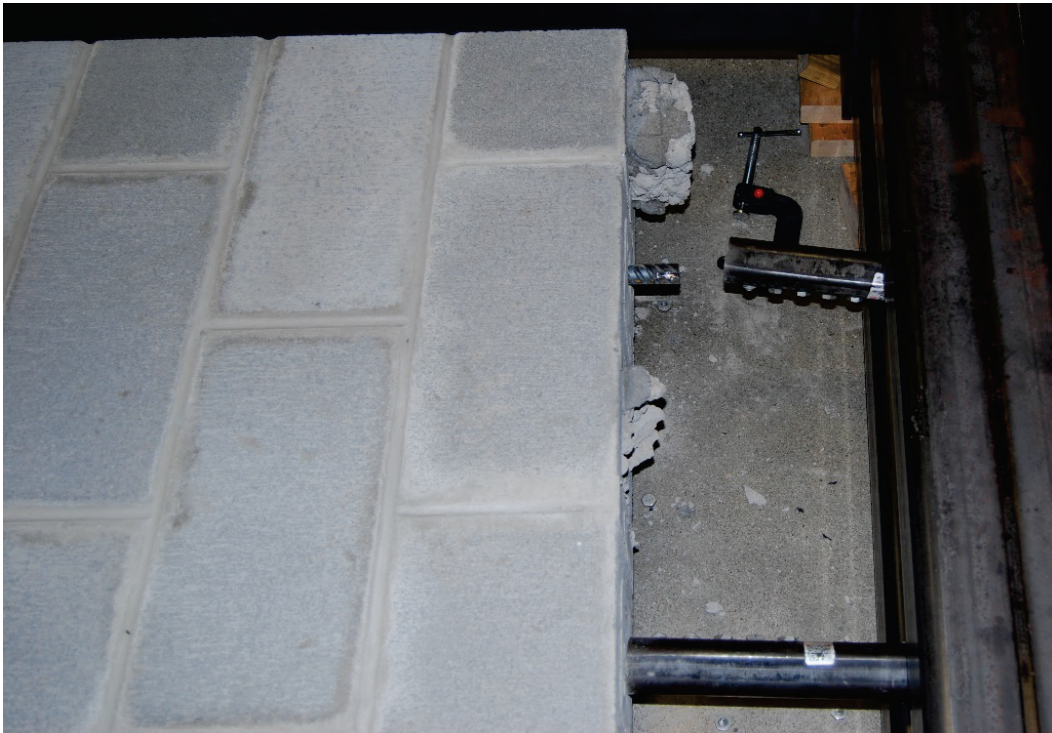
Figure 70. Short rebar end.

The rebar load-deflection responses of masonry wallets reinforced with 1% of 0.047-in. coated fibers are shown in Figure 69. These specimens generally showed relatively high ductility, but lower peak bar loads compared to the control set. For Specimens 1 and 3, only one bar splice was tested, as the length of the exposed rebar on one of the specimen splices was not sufficient to allow the couplers to achieve full bar yielding (Figure 70). Specimen 3 failed prematurely due to this deficiency on the tested splice (rebar pulled out of the coupler). The average tested stress to the specified rebar yield stress (60 ksi) ratio was 1.10, and all three specimens appeared to indicate some yielding of the rebars. The minor cracking after failure of Specimen 1 is shown on Figure 71.

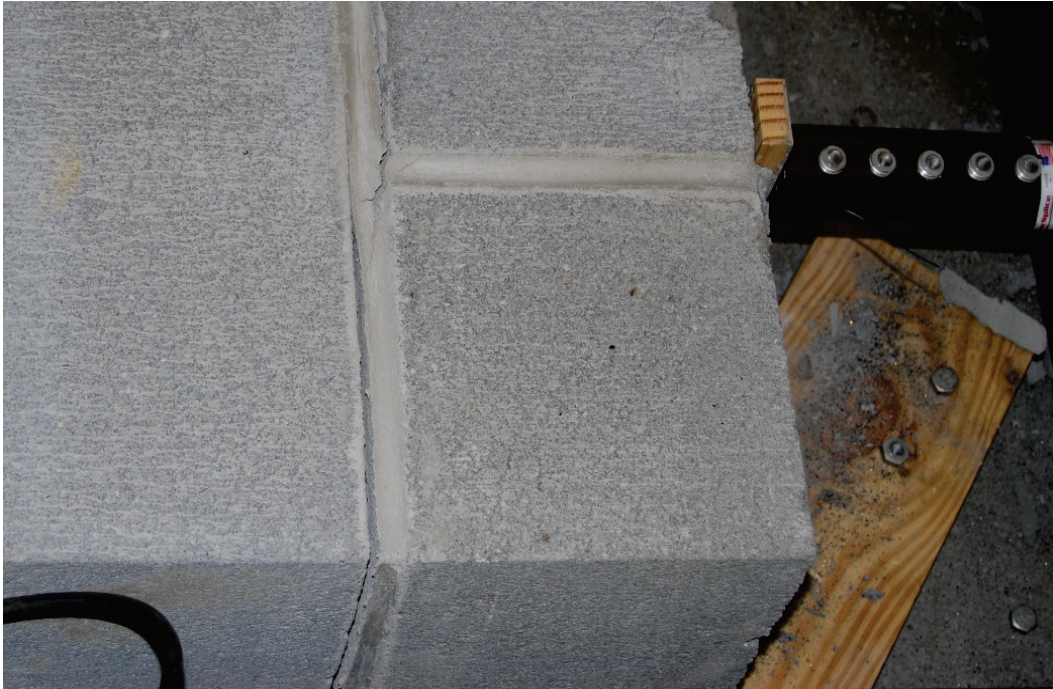
Figure 73. Coated 0.047-in.-diam fiber (2% loading) specimen S-3 after failure.

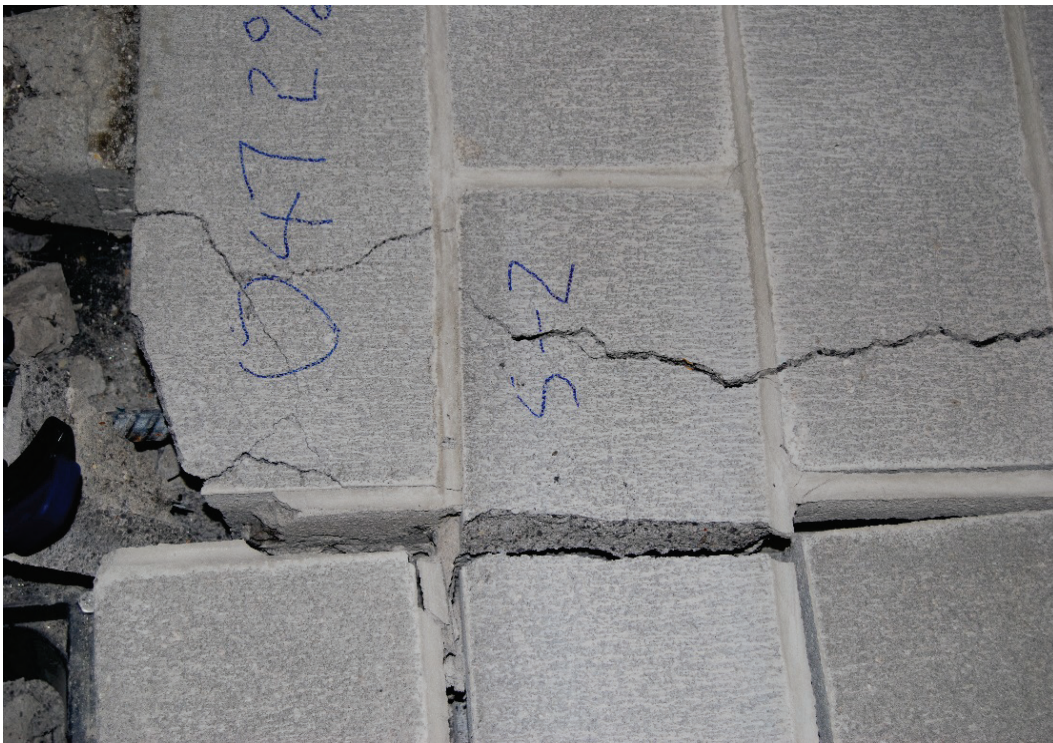
Figure 74. Coated 0.047-in.-diam fiber (2% loading) specimen S-2 after cracking.
