# **Environmentally-Preferred and Improved (Rapid) Laser Coating Removal Process for the Safe Removal of Coatings from Composite Substrates**

**ESTCP Project WP-201709**

**Final Debrief**

**24 SEPTEMBER 2020**

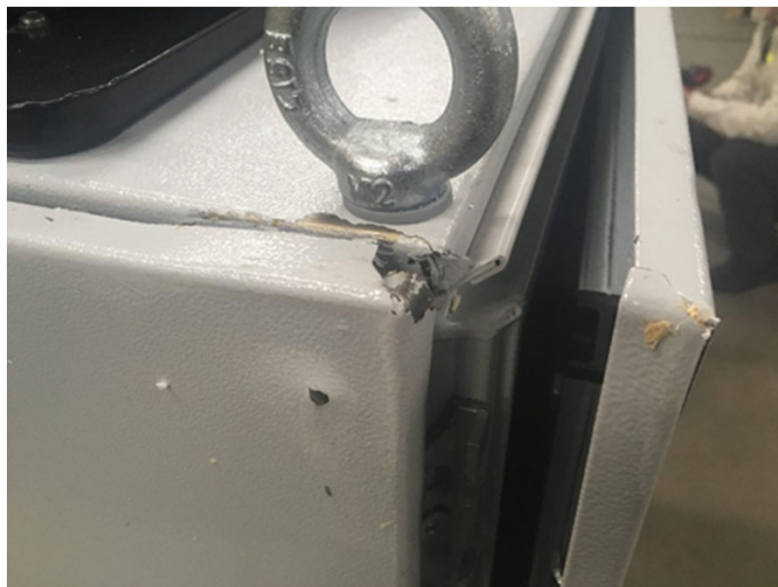
Shipping damages

- Equipment shipped through UDRI, repairs made
- Equipment set up at Titan Robotics Laboratory style
- Selected scanner: ScanLab IntelliWELD galvanometer

- Laser was shipped from SwRI to UDRI (Spring 2018)
  - ◆ Cosmetic damage to laser housing
  - ◆ Corrosion was found inside chiller line fittings
- Repairs were conducted at UDRI

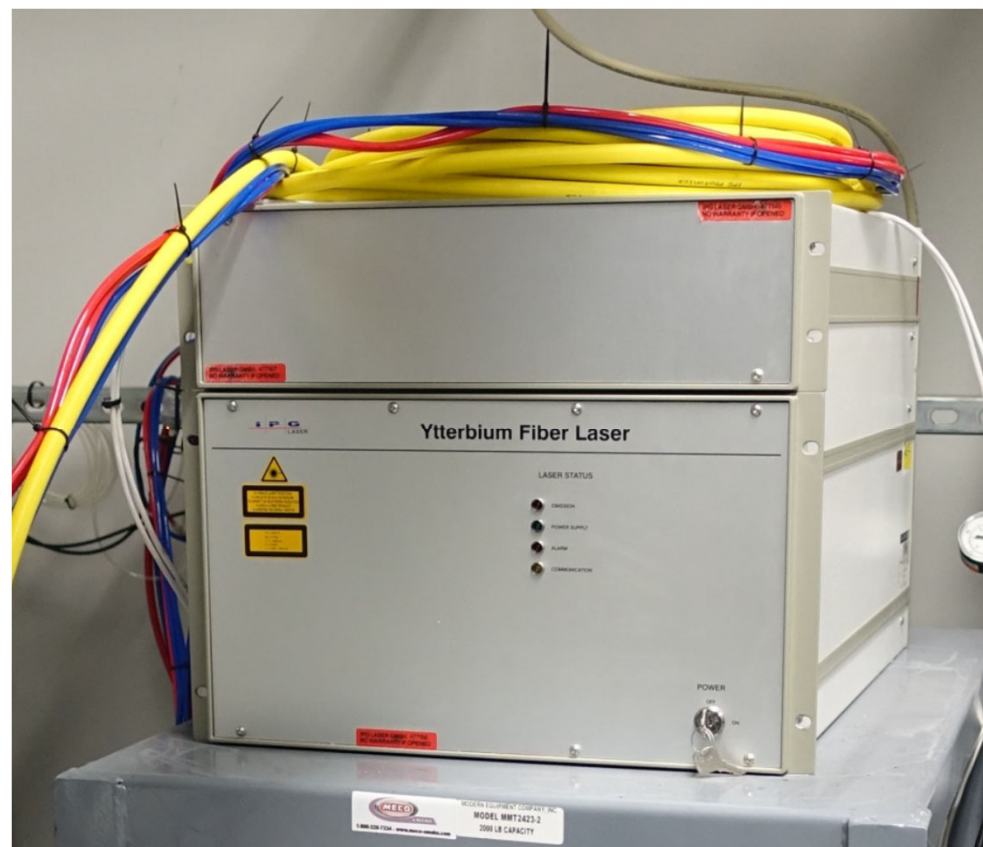
- ◆ 1 kW NPF Laser: IPG Model YLPN-100-30X100-1000
- ◆ 60 mm square process fiber
