Waterborne Geophysical Investigation to Assess Condition of Grouted Foundation

Old River Control Complex – Low Sill Structure, Concordia Parish, Louisiana

Final report

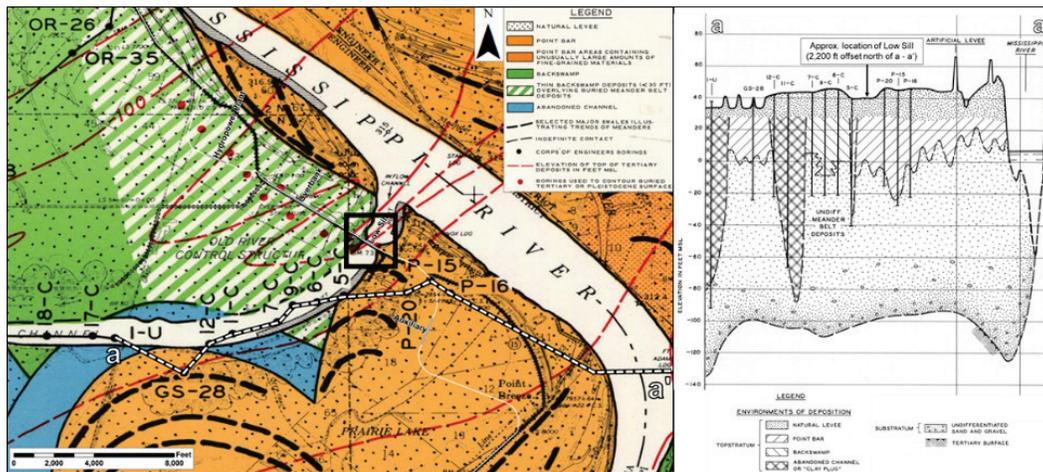
al. 2021*) The study area is located along the east-central border of Louisiana (Figure 2). The surficial geology of the ORCC area consists mainly of four depositional environments common to the Lower Mississippi River Valley, backswamp, natural levee, point bar, and abandoned channel deposits as identified by Fisk (1947) and Saucier (1969, 1994), which comprise the topstratum. Backswamp and abandoned channel deposits are primarily composed of plastic clay with a higher moisture content, while point bar and natural levee deposits are composed of a mixture of sand, silt, and clay. The shallow, subsurface materials of the right abutment, which are 6.1 m (20.0 ft) thick, consist mostly of clay, associated with a backswamp deposit, while the left abutment consists of a heterogeneous mixture of silt, silty sand, clay, and sand strata associated with point bar deposits.

Figure 2. General geologic settings (Saucier 1969).

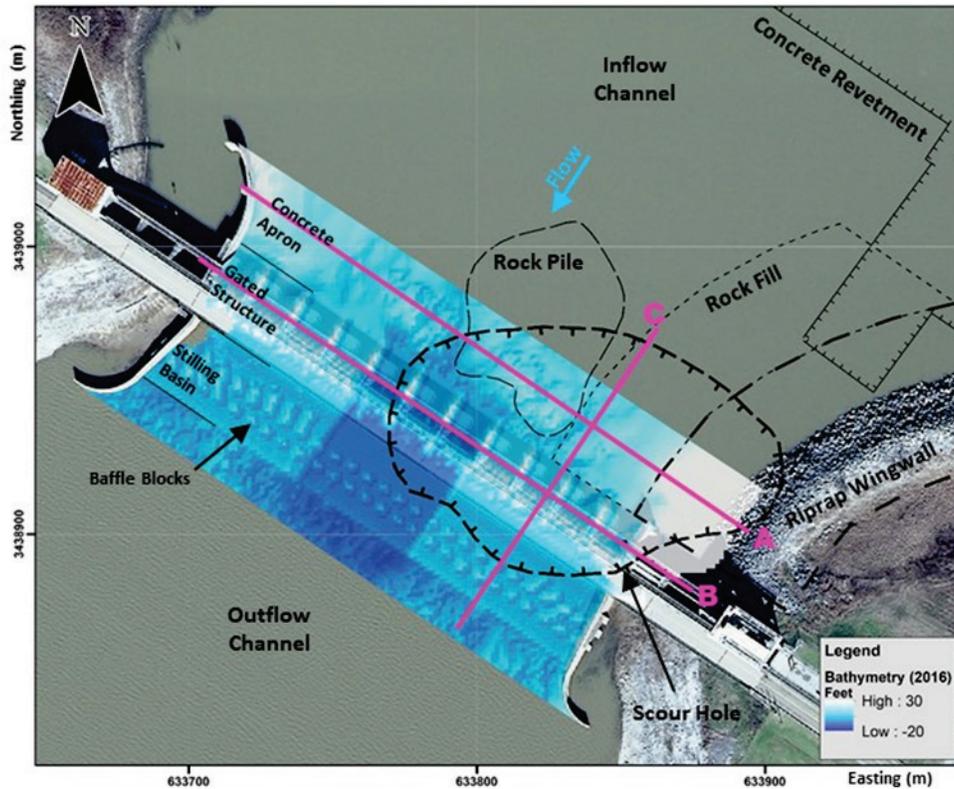
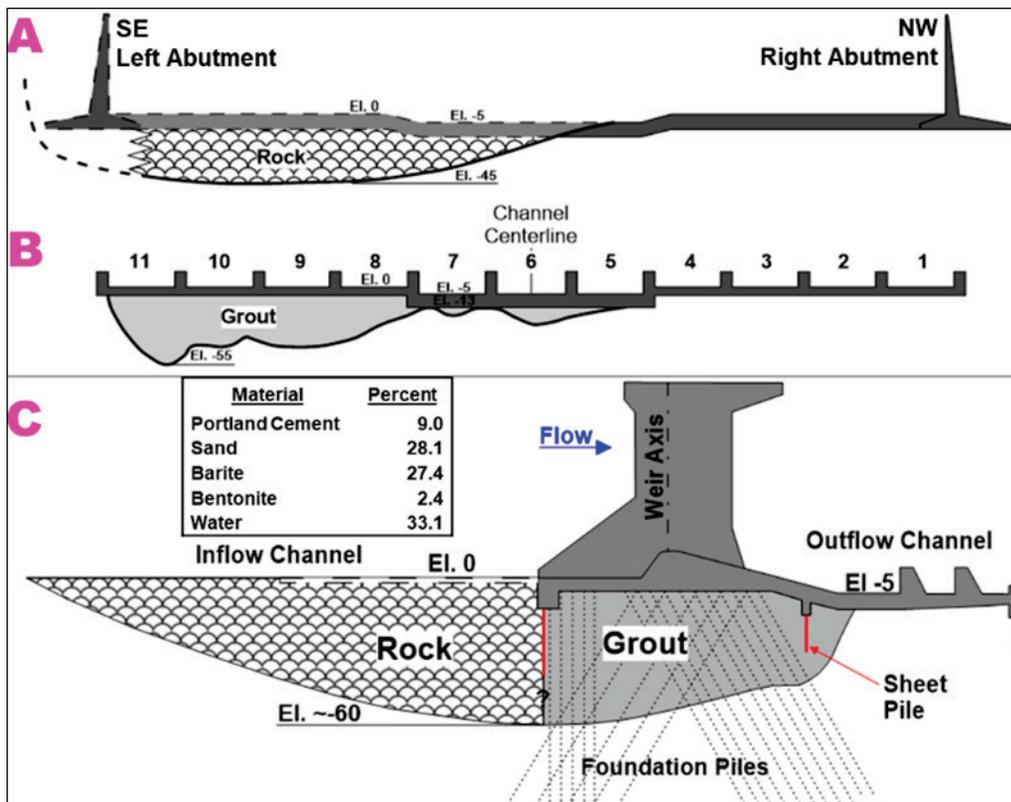
ORLSS is a steel pile-founded, reinforced-concrete structure with eleven 13.4-m (44-ft)-wide, steel-gated bays separated by reinforced-concrete monoliths. Gates 5-7 are low-flow bays while gates 1-4 and 8-11 are high-flow bays. Both inflow and outflow channels at ORLSS were constructed to convey water from the Mississippi River through ORLSS at a design flow capacity of 8,495 m³/s (300,000 ft³/s). The inflow channel is 305 m (1,000 ft) wide and includes a 0.5-m (1.5-ft)-thick concrete apron, which extends 30.5 m (100 ft) upstream of the weir axis, and a large, stone riprap wingwall on the left abutment. The outflow channel is 180.5 m (592 ft) wide and includes a stilling basin, which consists of derrick stone, riprap, and a drainage blanket. Revetment, comprised of an articulated concrete mattress, is present along the banks of both inflow and outflow channels. There are three rows of sheet piles located along different areas of the structure. One row is located at the upstream edge of the gate bays down to an elevation of -11 m (-36 ft). Another row is at the upstream edge of the stilling basin down to an elevation of -12.2 m (-40 ft) in the low-flow bays and -8.2 m (-27 ft) in the high-flow bays. The last is at the downstream edge of the stilling basin down to an elevation of -12.8 m (-42 ft) in the low-flow bays and -7.6 m (-25 ft) in the high-flow bays.

The scour hole that developed during the flood of 1973 resulted in collapse of the left abutment wingwall, partial collapse of the concrete apron, and significant removal of foundation material. Borehole data, range-line measurement, and scaled drawings were used to approximate both the horizontal and vertical extents of the grouted scour hole (information courtesy of MVN; Wilson 1978). The dimensions of the scour hole were estimated to be 91.5 m (300 ft) in diameter and extended vertically down to around -18.3 m (-60 ft) in elevation. These approximations were used to determine the survey geometry for the waterborne geophysical data collection conducted by ERDC. Figure 3 provides an illustrative view of the features of ORLSS described previously, including the area of the scoured foundation.

Figure 3. Schematic drawings of ORLSS (courtesy of MVN). Elevations are in feet.

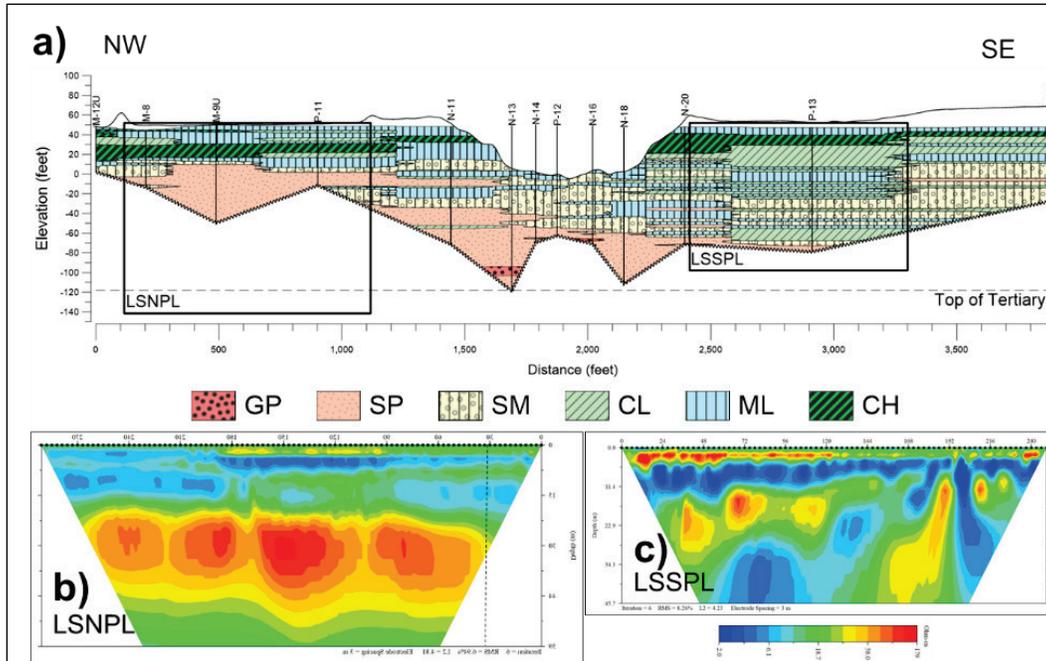
Land-based geophysical surveys using ERT and seismic refraction were previously conducted proximal to both the left and right abutments of ORLSS. Figure 4a illustrates a section view of the horizontal and vertical extents of the land-based resistivity survey measurements along with their relationship with the subsurface geology. These surveys found a subsurface geology that resembles a layered geometry on the right abutment side. The geological layers are clay-rich from backswamp deposits. Conversely,

Results of the seismic land surveys conducted in 2018 were complex because of the occurrence of low-velocity layers underlying higher velocity layers and strong lateral velocity contrasts that are presumably associated with transitions in soil type between different depositional environments. It is anticipated that the lateral velocity transitions associated with point bar deposits on the left abutment continued into the pre-scour channel and, at some point in the sediments beneath the pre-scour channel, transitioned into a layered structure typical of the backswamp deposits observed on the right abutment of the channel. Because the structure indicated by the land seismic surveys on the left abutment side is so complex, the interpretation of both seismic and resistivity features in the marine data becomes more difficult to distinguish pre-scour from post-scour effects where both can involve sharp lateral transitions in geophysical properties.

Figure 4. Interpreted ERT sections from land surveys: (a) geologic cross section of ORLSS with outline of ERT profiles, (b) ERT line LSNPL parallel to levee embankment on the upstream side near the right abutment, and (c) LSSPL parallel to levee embankment on upstream side near the left abutment.

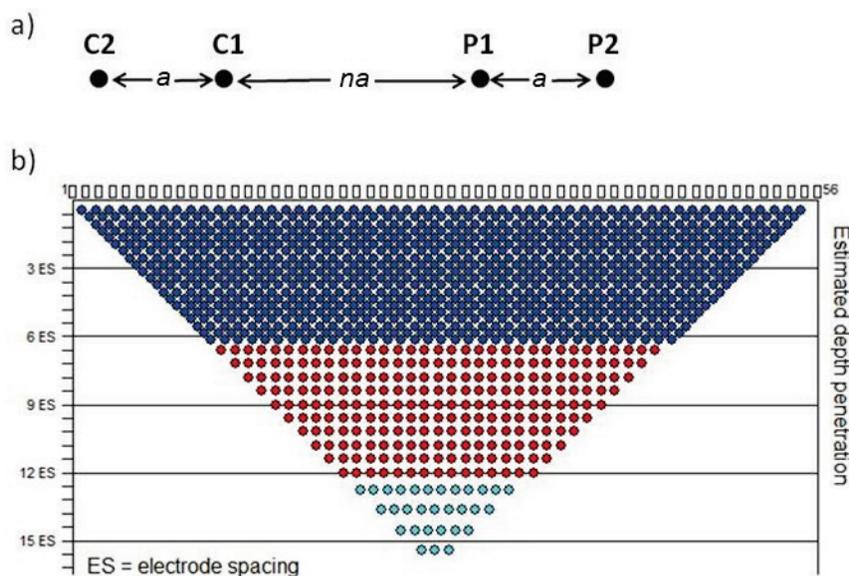
Figure 5. Idealized diagram of a dipole-dipole electrical resistivity configuration. (a) By using different values for a and n , 2-D coverage of the subsurface is obtained (b). In (b), the rectangles along the surface represent electrodes (in this example there are 56), and the dots in the subsurface represent the pseudo-location of a measurement. For a given number of electrodes, and as the electrode spacing increases, the number of measurements at depth decreases.

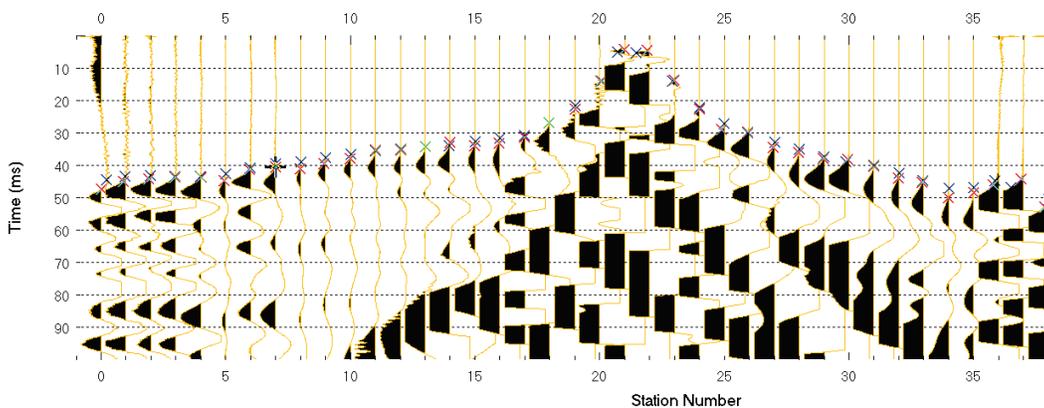
Figure 6. Idealized diagram of travel times of first-arriving seismic waves indicated by “x” in the top portion of the figure that can be compiled for all shot points.

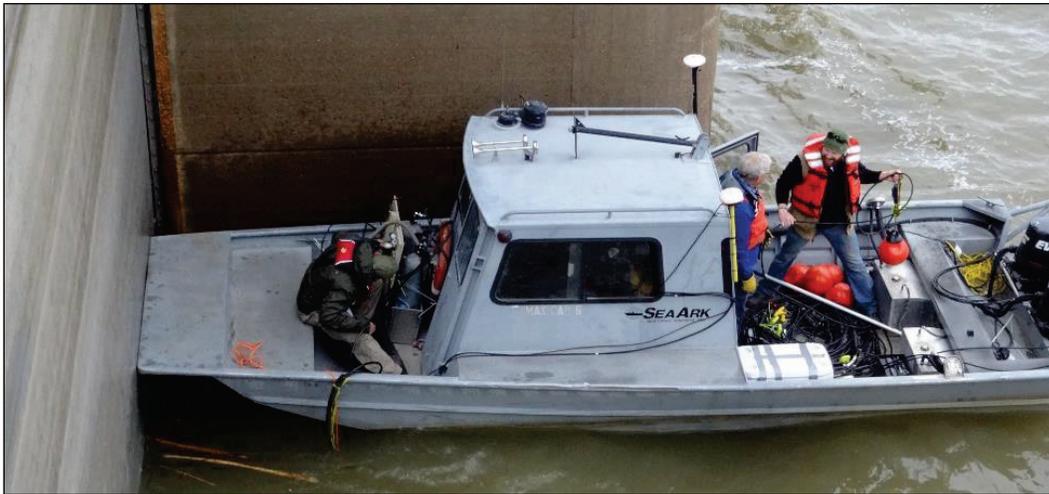
Figure 7. SeaArk boat used for data acquisition at ORLSS.

Waterborne geophysical data were collected on both the inflow and outflow channels of ORLSS between 2 and 11 December 2019. The resistivity data were acquired 2-6 December, and the seismic data were acquired 9-11 December. Data were acquired using two 18-ft SeaArk boats (Figure 7) operated by ORCC personnel. The primary boat housed the geophysical equipment and geophysical crew, and the secondary boat was used to assist in positioning and aligning the cables. Both boats were used to position each resistivity survey line as stationary as possible during the data collection (approximately 10 min per line). The seismic survey was conducted by using one boat to tow the hydrophone array in a predetermined grid.

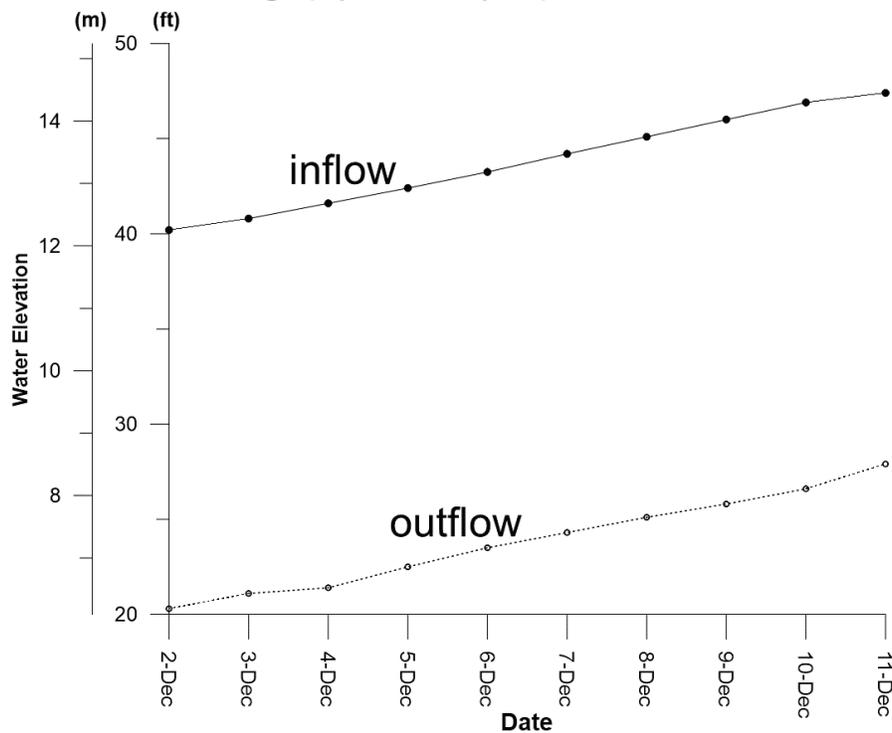
Figure 8. Plot of river elevation, in meters and feet, during the waterborne geophysical survey acquisition.

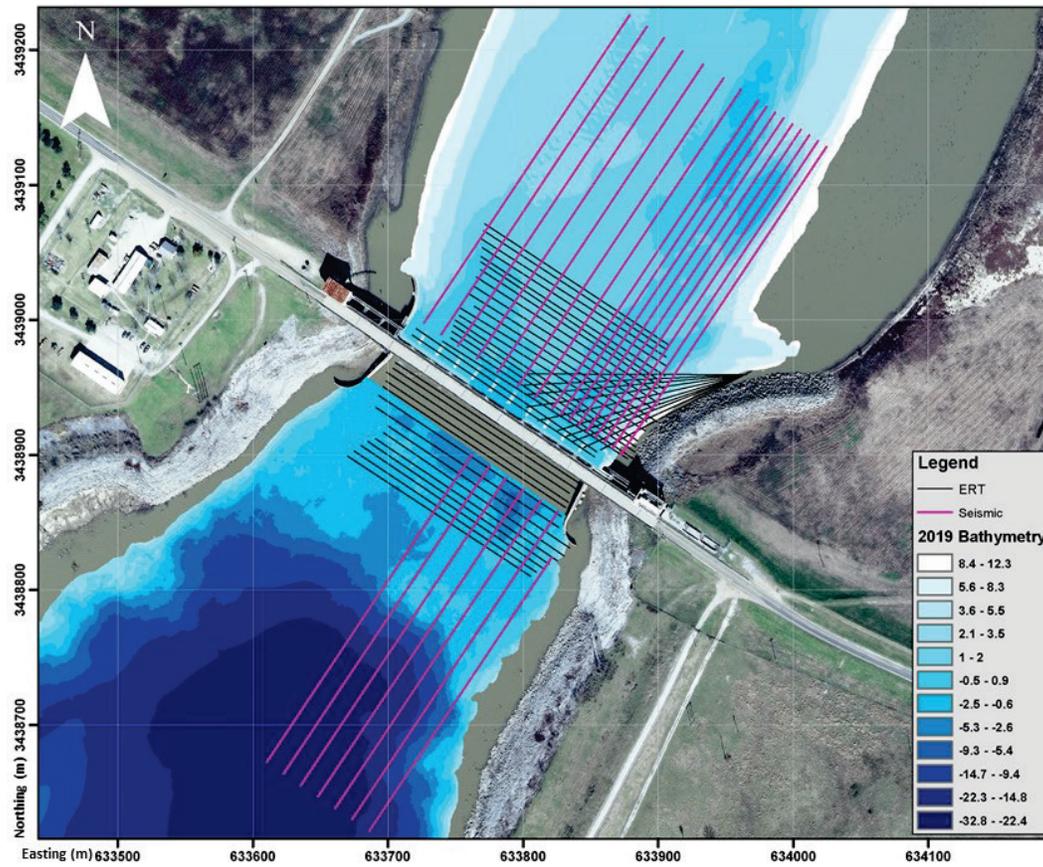
A bathymetry survey conducted in December 2019 (Figure 9) shows that the inflow channel gradually deepens from a bathymetric elevation of about +12.2 m (+40 ft) along the shore to about 0 to +2 m (0 to +6.6 ft) near the center of the channel and adjacent to the structure. The bathymetry of the outflow channel shows steeper slopes along the shoreline that deepen to about 2 to 5 m (6.6 to 16.4 ft) in elevation proximal to the stilling basin. About 152.4 m (500 ft) downstream from the structure, the outflow channel deepens sharply to about -30 m (-100 ft) below MSL. The bathymetric data on both the inflow and outflow channels of ORLSS were used to determine the depth of the water column during the data collection with respect to the corresponding channel gage readings (Figure 8).

Figure 9. Bathymetry of the site, in meters with respect to MSL, from December 2019 (provided by MVN) and location of geophysical survey lines. Seismic lines are shown in red, and resistivity lines are in black.

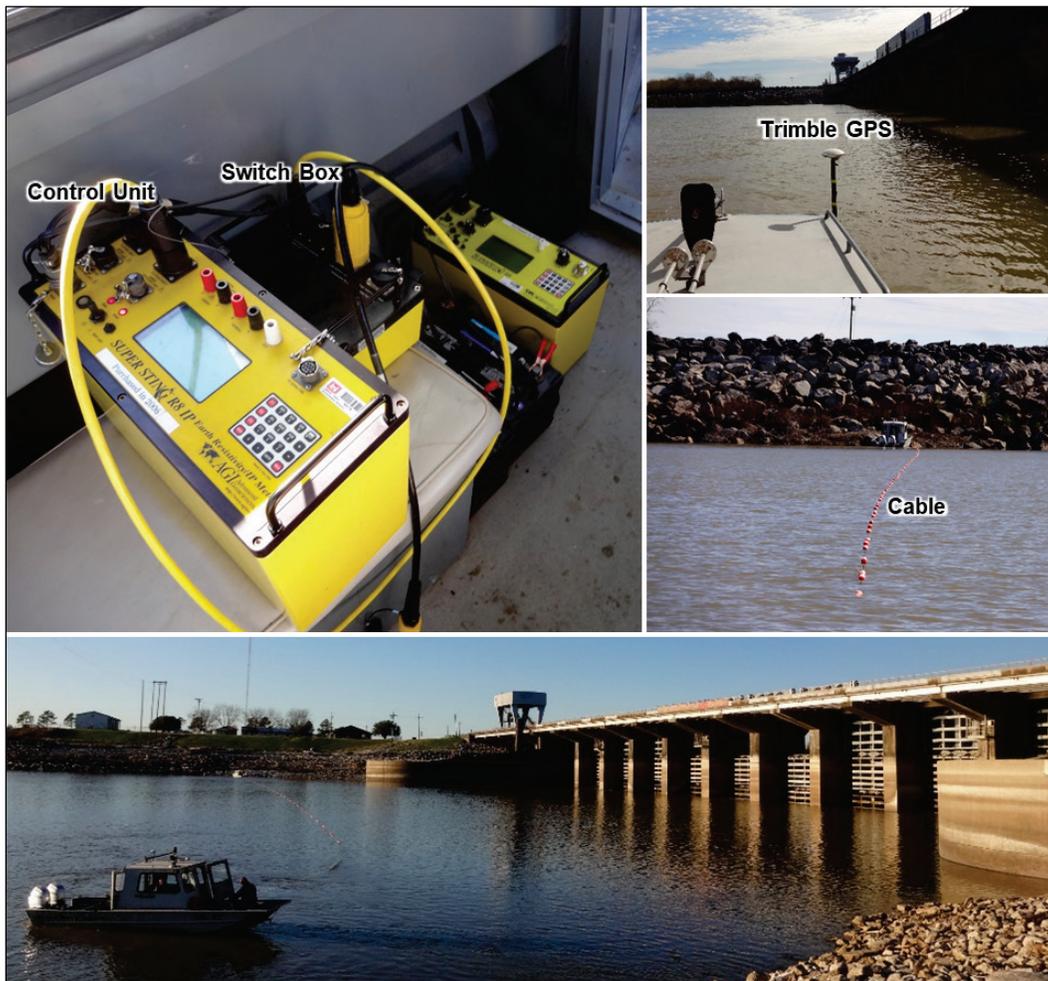
Figure 10. SuperSting R8/IP system, GPS, and cable used in ERT data acquisition.

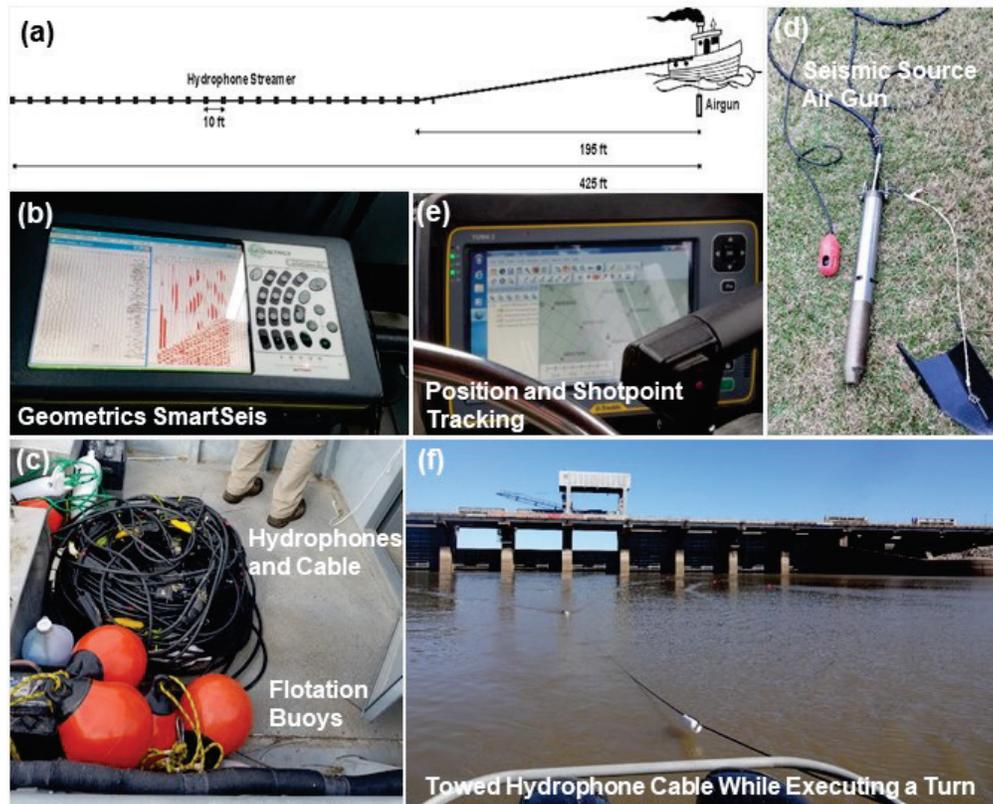
The hydrophone streamer consisted of 24 Geospace MP-25 10-Hz hydrophones spaced 3 m (10 ft) apart. Seismic data were acquired using a

Figure 11. Equipment used for seismic survey acquisition: (a) seismic data acquisition configuration, (b) Geometrics SmartSeis used for data recording, (c) hydrophones and cable attached to flotation buoys, (d) airgun used as the seismic source with a control fin and hydrophone, (e) tracking system used to maintain acquisition geometry of prescribed survey layout, and (f) hydrophone cable being towed behind the boat (white floats) after making a turn near the structure. Orange floats on the cable that have not yet turned and are still moving toward the structure can be seen closer to the structure.

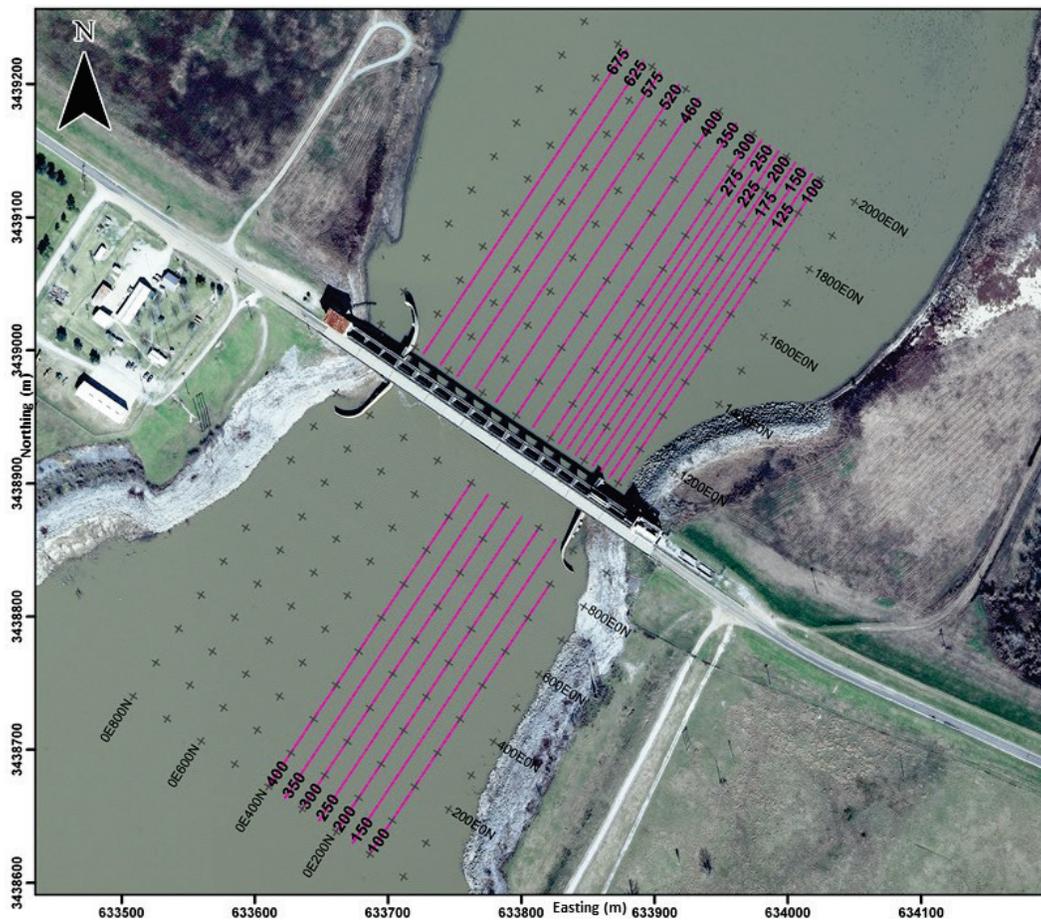
Shots were acquired at 30.5-m (100-ft) intervals along prescribed survey lines (Figure 12) as the boat moved down the survey lines at a speed of approximately 3.7 to 5.6 km/h (2.3 to 3.5 mph). The data were sampled at a rate of 0.125 ms with a maximum range of 200 ms.

Figure 12. Marine seismic refraction survey navigation plan and acquired survey lines (magenta).

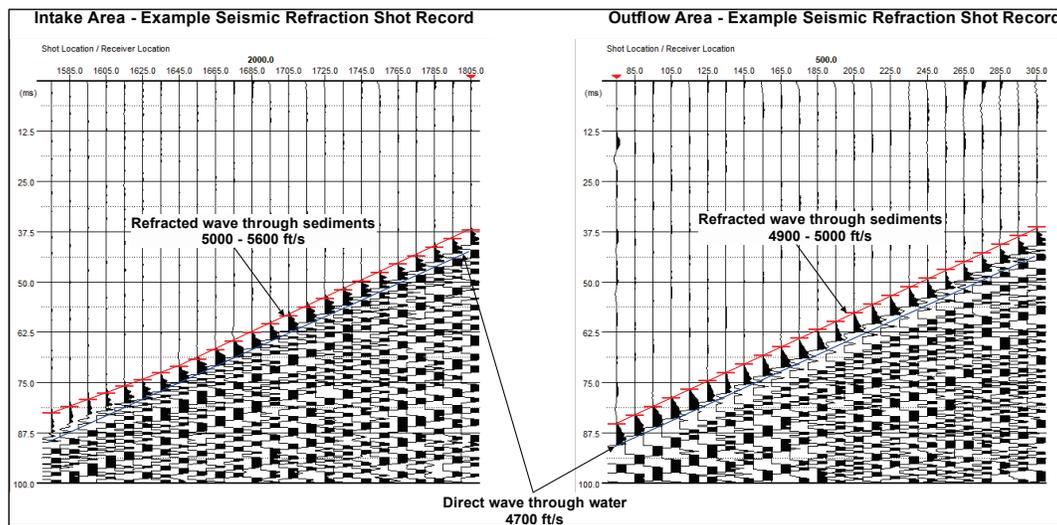
The seismic data files were organized by line number into separate directories for seismic refraction analysis. The files were imported into Geogiga DWTOMO v9.15 software. The shot and hydrophone geometries were entered for each line, and the shot records were individually analyzed for first arriving energy (direct or refracted). A frequency bandpass filter of 100-800 Hz was applied to the data. Seismic data quality exhibited coherent first arrivals in each shot record, as indicated by the examples

Figure 13. Example seismic shot records and travel-time picks for both inflow and outflow channels.

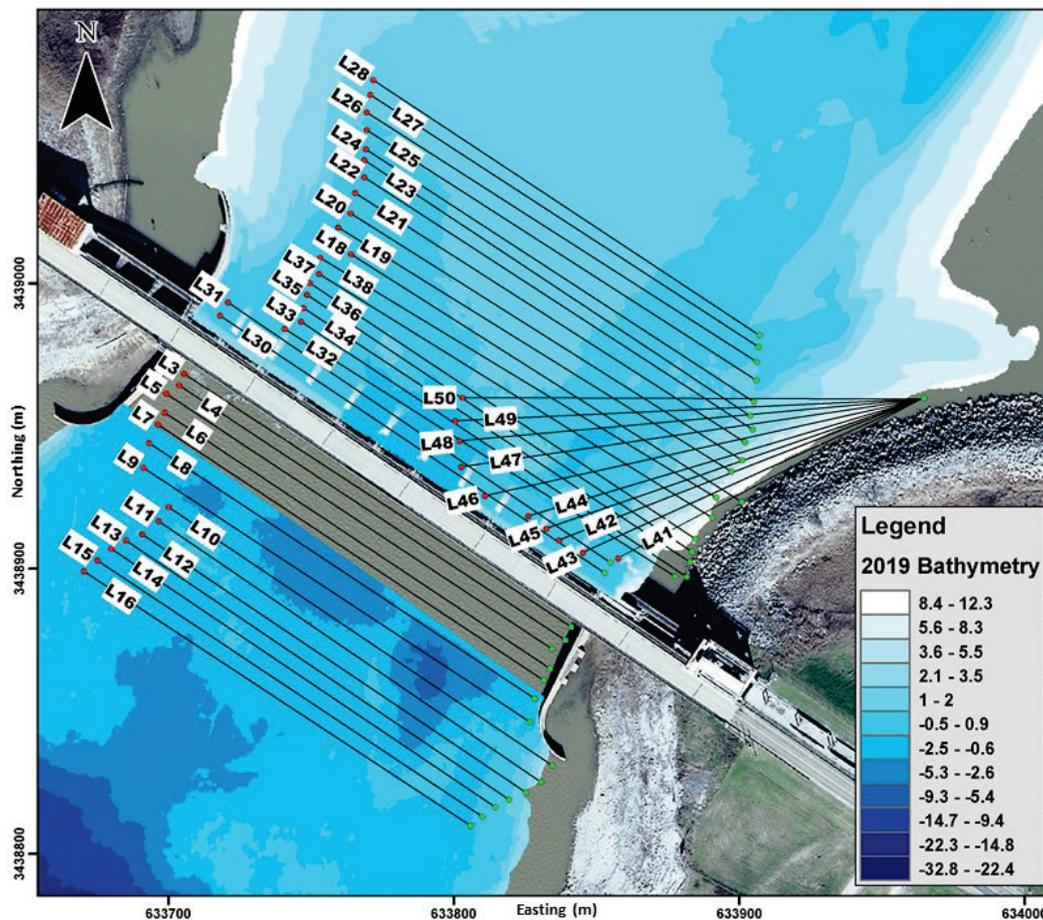
Figure 14. Resistivity lines with bathymetric map (m, MSL). Green and red points indicate the start and end electrodes, respectively, for each line.

Additional ERT profiles from the inflow channel were collected in a “fan” layout to acquire ERT data more nearly perpendicular to ORLSS (Figure 14). Resistivity values from the inverted profiles are represented by a blue-green-yellow-red linear color scale, in order from lower to higher resistivity. From left to right, each line is orientated relatively northeast to southwest, or the edge of the riprap wingwall to a gate bay. Line numbers progress from L41, L43, L42, L45, L44, L46, L47, L48, L49, and L50 starting at gate 11 and proceeding to gate 7. Figure 16 provides ERT lines L41, L42, L44, and L49. Inflow water elevation at

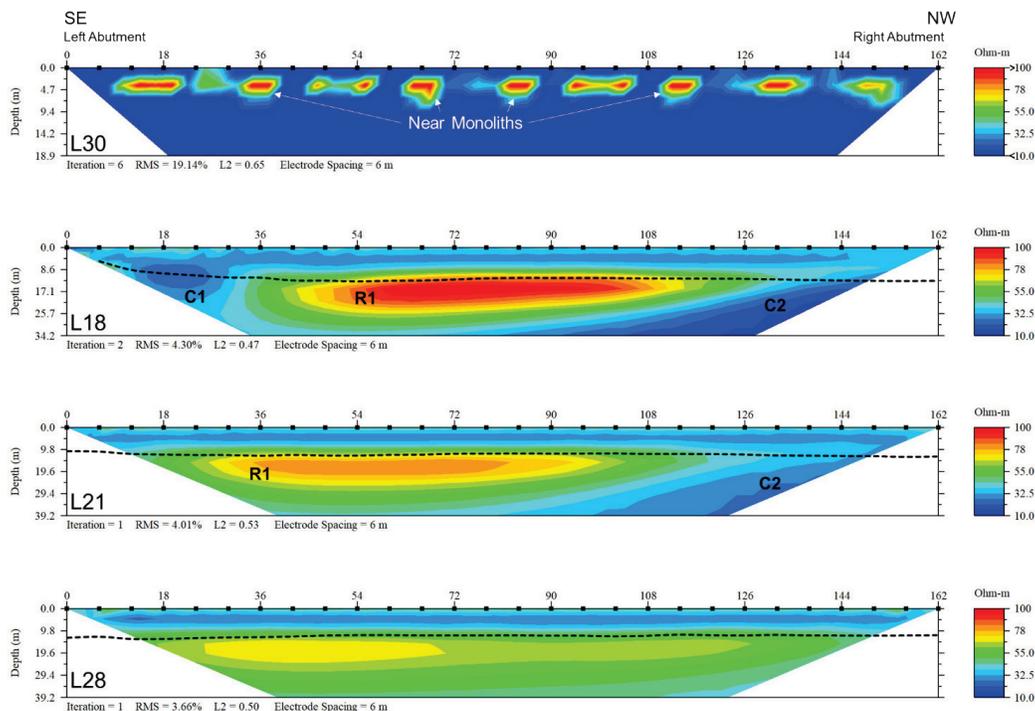
L30, which was acquired closest to ORLSS, shows areas of high resistivity (200 to >1,000 Ω -m) with a lobate geometry that is coincident with the concrete monoliths. These lobate, resistive features do not persist in sections farther from the structure. The resistivity decreases rapidly to less than 5 Ω -m at a depth of 7 m (23 ft), which is likely caused by the steel in the structure.

An anomalous area of higher resistivity (feature R1) is observed in L18 (Figure 15) beneath the channel bottom between positions 54 and 108 m. ERT profiles near L18 toward ORLSS (L36 to L38, Appendix A) show a progressive increase in resistivity from 75 Ω -m to around 100 Ω -m that is coincident with the position of R1 in L18. This area of higher resistivity persists up channel through lines L36 to L21 and varies in lateral extent across each line between positions 36 to 108 m. This feature exhibits a decrease in resistivity and size at L21 and continues to decrease in resistivity and size with distance from the structure progressing towards L28.

An area of lower resistivity is observed at the eastern flank of the feature R1. This feature, annotated as C1, is most apparent on L18 between positions 12 and 30 m (Figure 15). It can also partially be seen on profiles L37, L38, and L19 (Appendix A).

Figure 15. ERT profiles acquired in the inflow channel parallel to the weir axis. Dashed line represents the channel bottom.

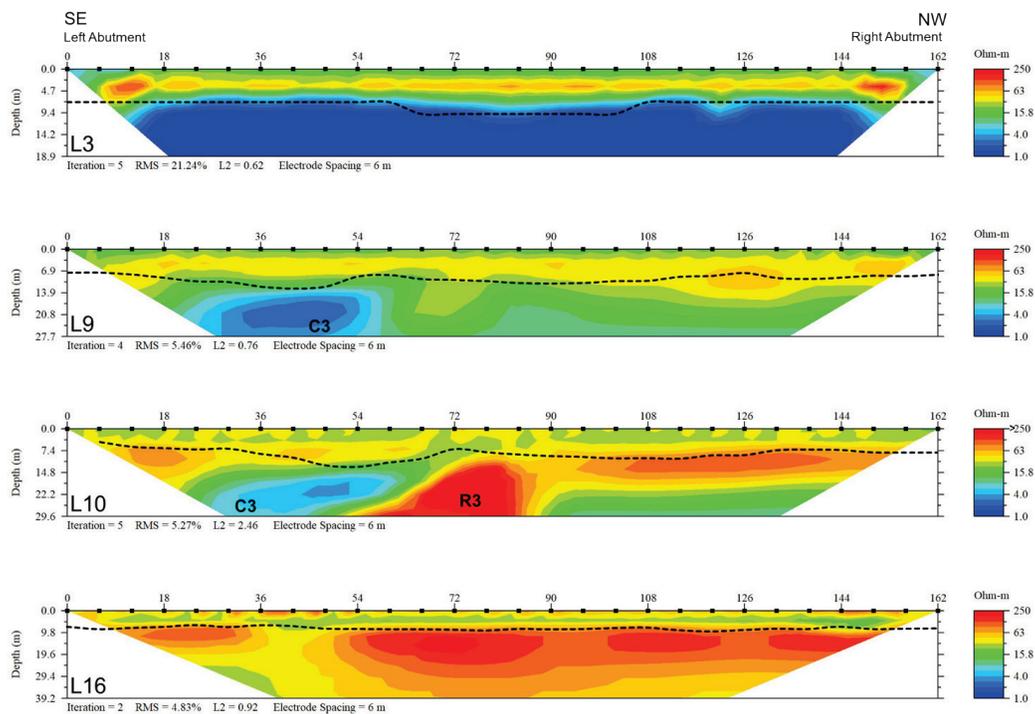
The character of the ERT lines changes beyond Line L8. Lines 9-16 exhibit a more heterogeneous resistivity character. The subsurface resistivity in L9 shows an area of low resistivity (less than 10 Ω -m), labeled C3 in Figure 18, between positions 24 and 60 m at a top depth of about 13 m. C3 is observed in an area having a slightly deeper water column. Bathymetric changes can influence the resistivity readings. However, this effect typically occurs when the vertical bathymetry changes are greater than the horizontal electrode spacing of the ERT survey. In this case, the change in the bathymetry of the channel bottom is less than the 6-m (19.7-ft) electrode spacing. Therefore, C3 does not appear to be an artifact caused by a change in the channel bottom. This low-resistivity feature is laterally persistent in the outflow lines past the flank of the stilling basin. The contrasting resistivity and geometry of feature C3 gradually dissipates with distance from the structure. C3 has similar resistive character to C1 in the inflow channel, but at this point we are unable to explain its cause/origin or any possible relationship to feature C1.

Figure 18. ERT profiles from the outflow channel. Dashed line represents the channel bottom.

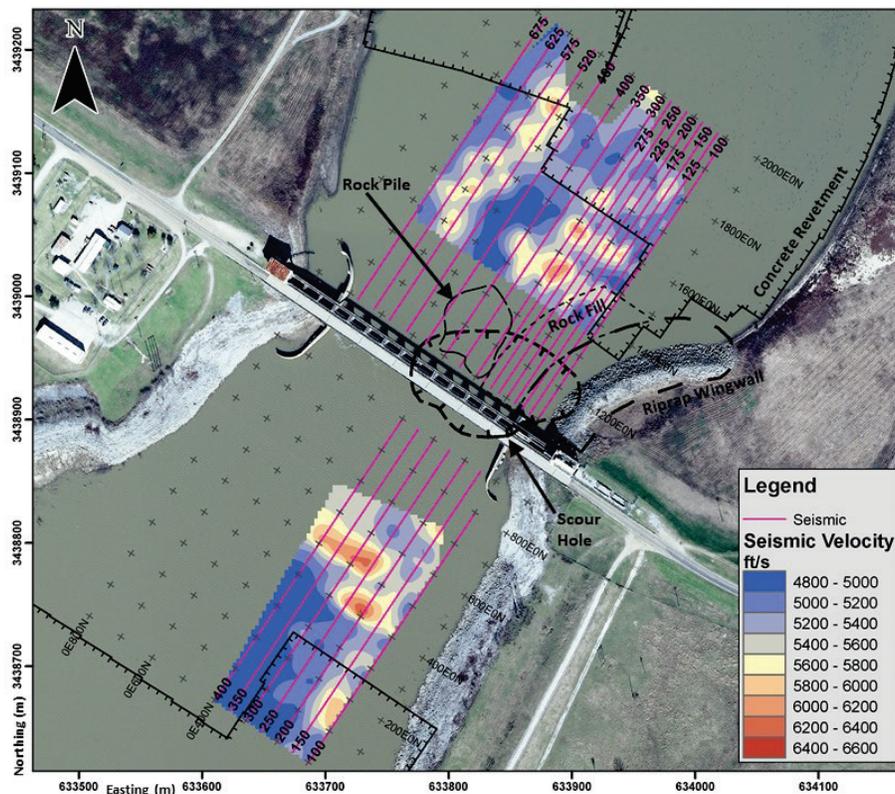
Figure 19. Apparent P-wave velocity of shallow sediment.

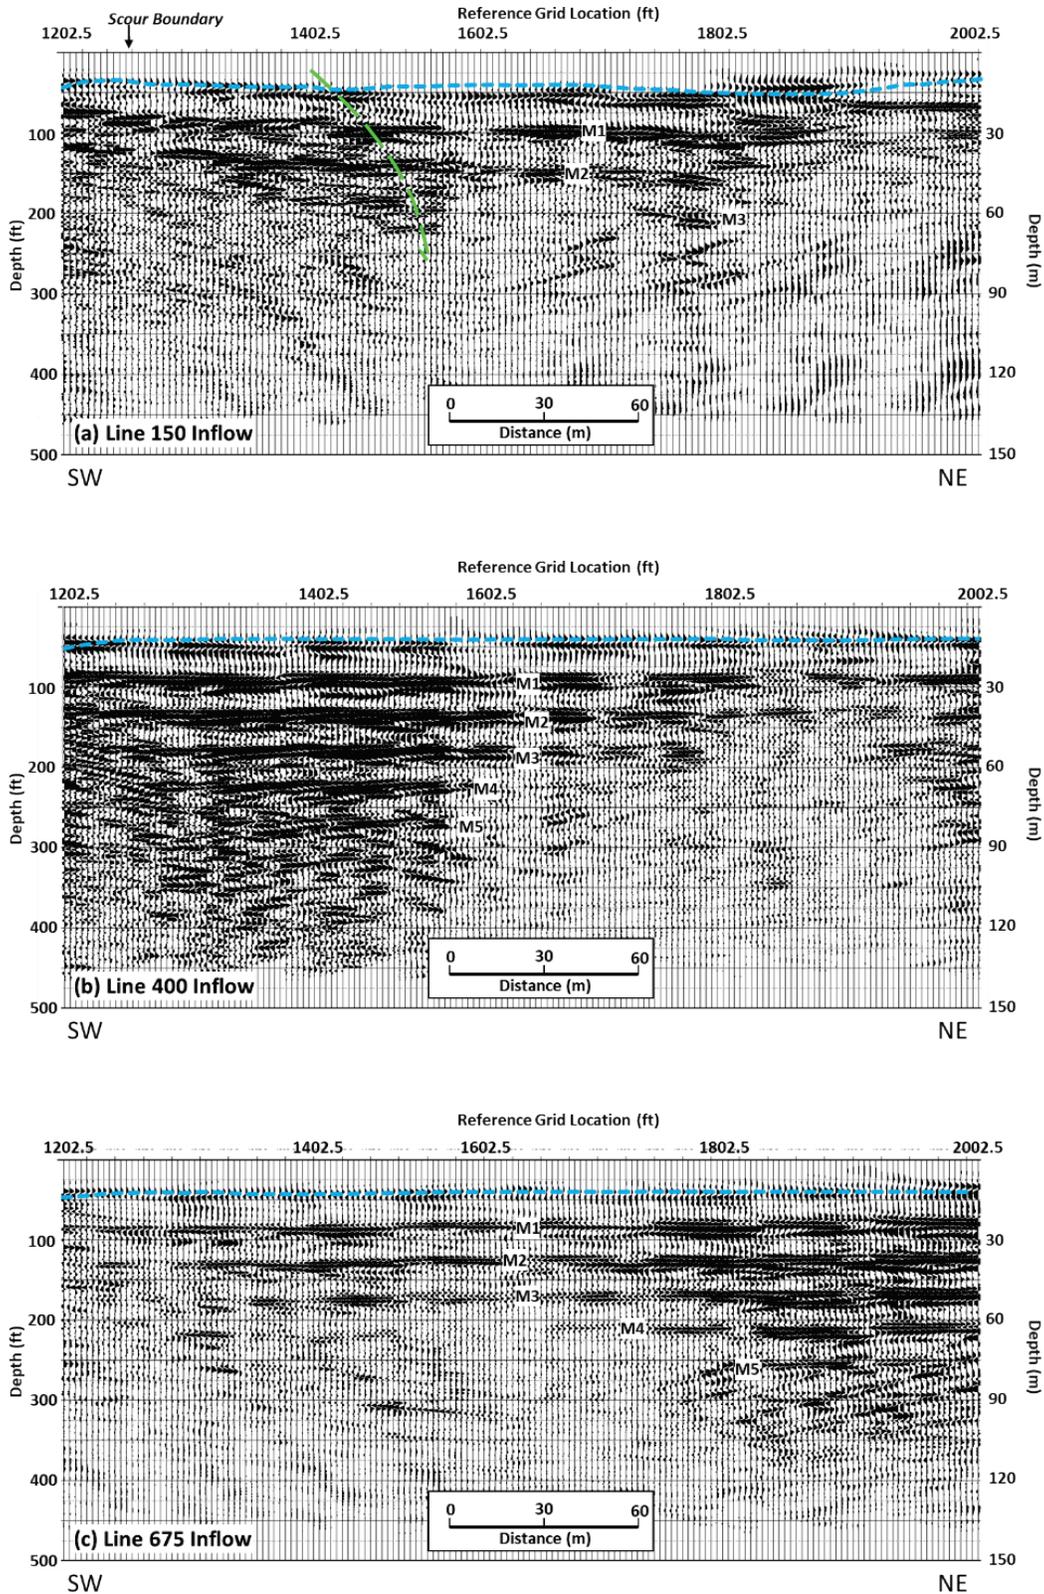
Three selected seismic reflection profiles from the inflow channel side (Lines 150, 400, and 675) are provided in Figure 20. Reflections from the channel bottom (annotated by a dashed blue line on each seismic profile) exhibited consistent results with the bathymetry. Repeating groups of sub-horizontal reflections (M1, M2, M3, M4, and M5), each with an apparent group thickness of about 6 m (20 ft), occur at depth increments of about 15 m (50 ft). These sub-horizontal reflections are observed in all three sections. These are multiples of reflections from the bottom of the channel, as described in Appendix B. In some of the stacked sections, as many as five multiple reflections (M1, M2, M3, M4, and M5) can be seen.

Figure 20. Stacked sections for three lines on the inflow side of ORLSS: (a) line 150 (green dashed line of approximate disturbed area), (b) line 400, and (c) line 675. The blue dashed line represents the channel bottom.

For the stacked seismic reflection sections in the inflow channel (Figure 20) and outflow channel (Figure 21), it is evident that multiple reflections dominate the deeper response and mask reflections that might otherwise be observed from deeper sediment interfaces. While this is unfortunate, it was important to analyze the reflected waves in the seismic data to assess possible information that might be important in understanding the site.

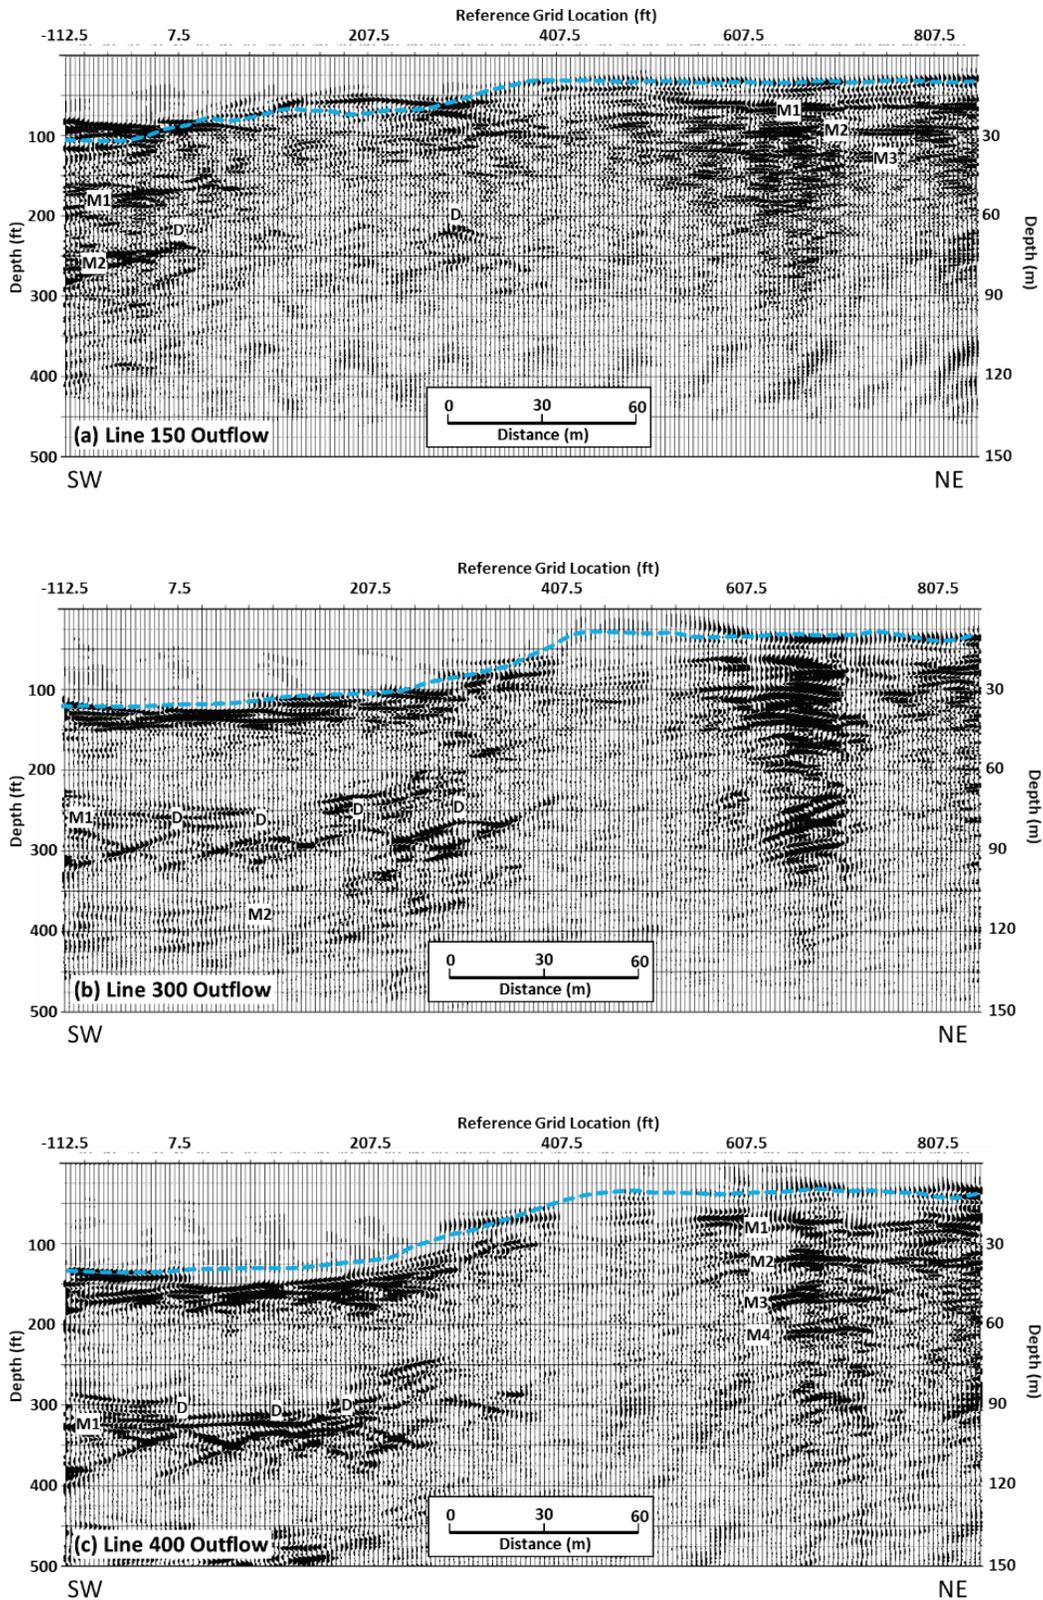
To remove the artifacts at these points, the depth section can be “migrated,” a procedure that should collapse the diffractions to a point at the apex. Examples of migrated profiles for Lines 300 and 400 (Figure 21b and Figure 21c) are provided in Appendix B (Figure B9).

Figure 21. Stacked depth sections for three lines from the outflow channel of ORLSS: (a) line 150, (b) line 300, and (c) line 400. Blue dashed line represents the channel bottom.

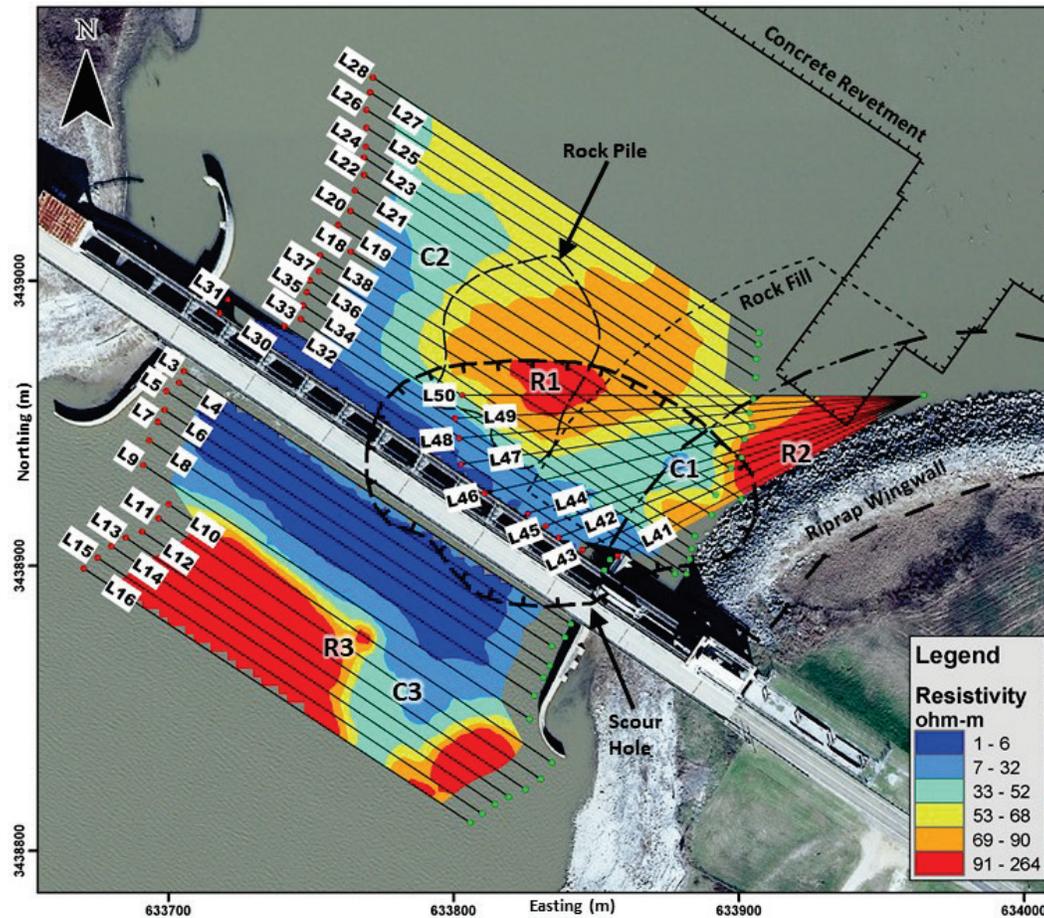
Figure 22 provides a synopsis of features observed in the ERT data from both inflow and outflow channels, in addition to the diagrammatic outlines of components of ORLSS presented earlier in Figure 3. The contour map overlain with the features, represented by the blue-green-yellow-red color scale, is an average of the resistivity values between the channel-bottom surface and 6 m (19.7 ft) below. Key features in this figure are the following.

5. A low-resistivity feature in the outflow channel (C3) observed at the edge of the stilling basin that appears to dissipate with distance from the stilling basin.

6. A high-resistivity feature in the outflow channel (R3) observed at the edge of the stilling basin and adjacent to C3.

Figure 22. Plan view of interpreted ERT results overlain with feature boundaries. Resistivity values are an average of the resistivity values between the channel-bottom surface and 6 m below.

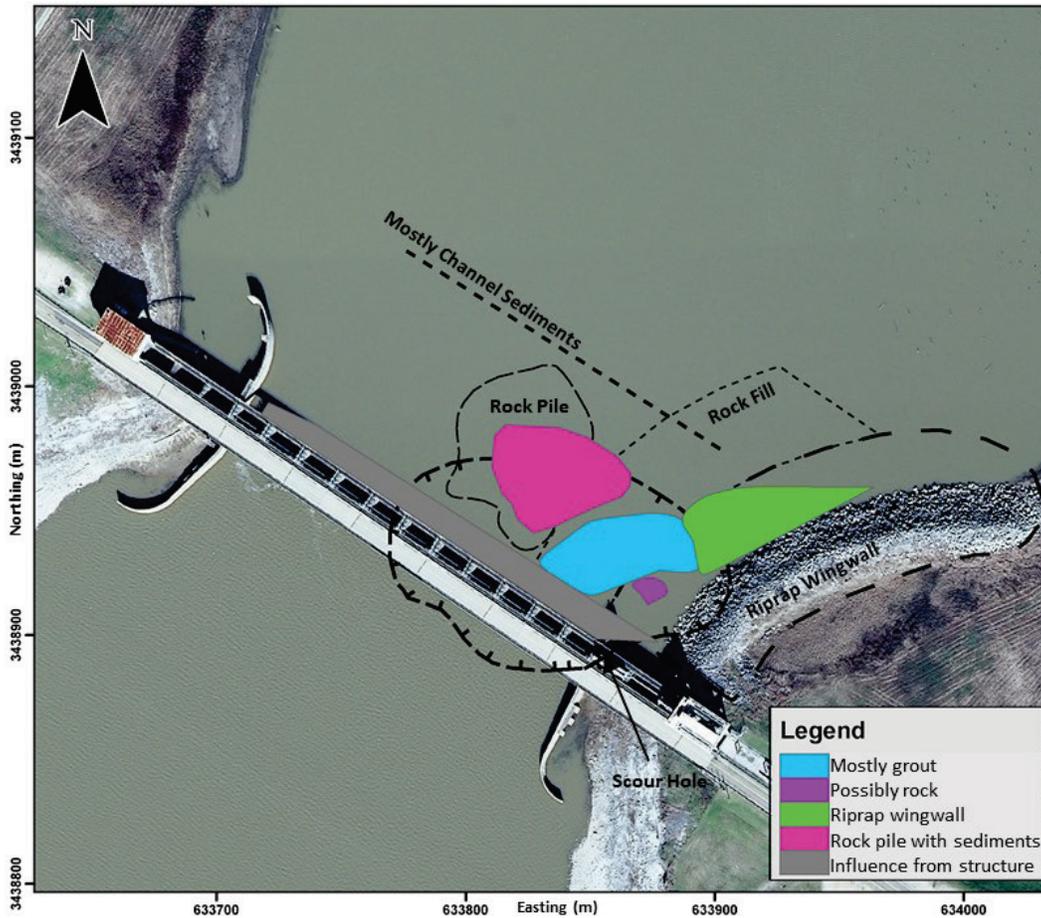
Figure 23. Interpreted areas derived from the geophysical survey.

7. The electrical resistivity data provide a basis for selecting locations where cored samples could be collected to better understand the current condition of the filled scour hole. By selecting locations within the low-resistivity and high-resistivity portions of the scour hole, an

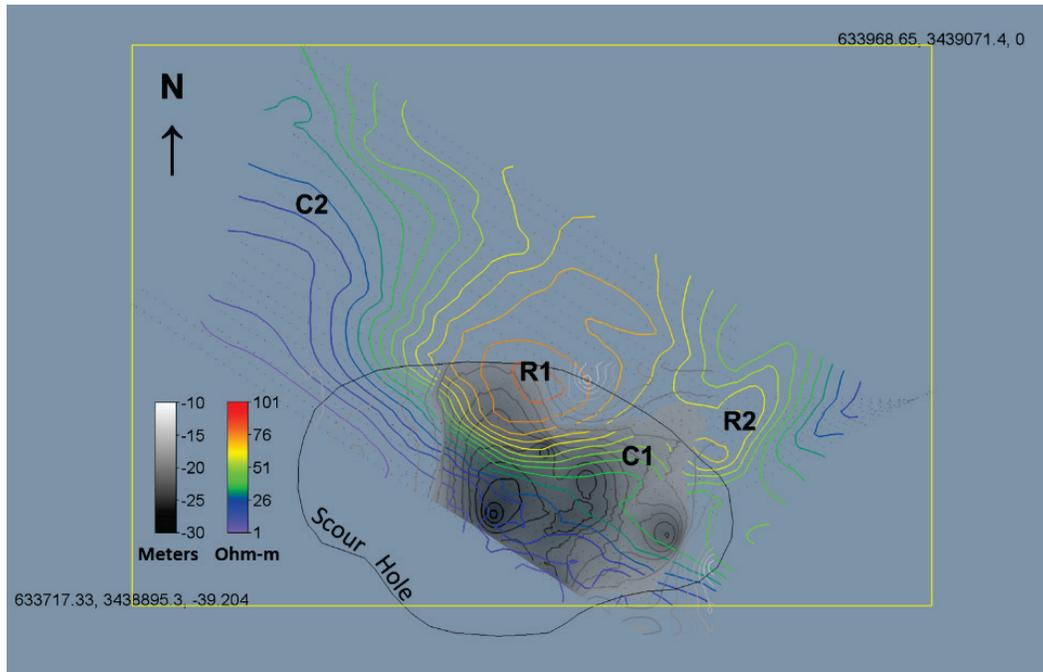
Figure 24. Contours of resistivity in a horizontal plane at 9m below sea level, 21.7m below water surface, shown in color. Gray-scale contours show estimated depth for the deeper part of the scour in meters relative to water surface. The boundary of the estimated scour is shown, and the four resistivity features R1, R2, C1, and C2 are labeled.
