Waterborne Geophysical Investigation to Assess Condition of Grouted Foundation

Old River Control Complex – Low Sill Structure, Concordia Parish, Louisiana

Final report

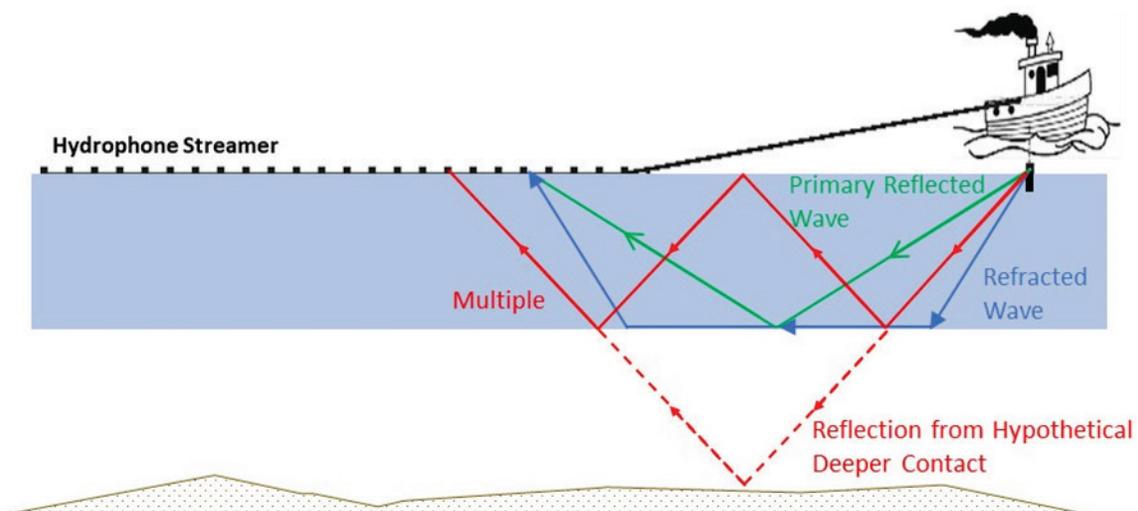
Figure B1. Idealized diagram of raypaths for types of waves produced at ORLSS. The refracted wave is blue, the primary reflected wave is green, and a multiple reflected wave is solid red. The travel time for the multiple is the same as that for a primary reflection from greater depth with the brown representing a deeper geologic contact. A reflection from a hypothetical deeper contact is shown as a dashed red line, with the interface at twice the depth for simplicity; this assumes the same velocity in the water and the first geologic layers.

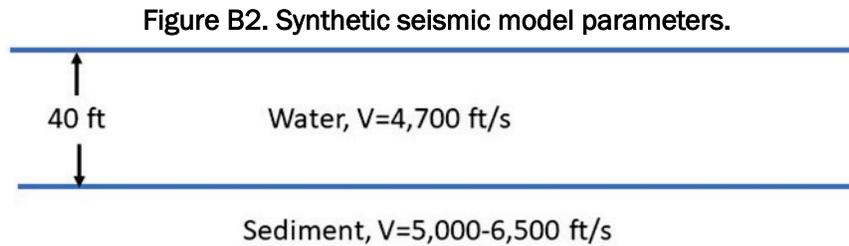
Synthetic seismic modeling was conducted to enhance understanding of the seismic data limitations. The modeling assumed a water layer, 40-ft thick, overlying a sediment layer of constant velocity. The water layer velocity was set at 4,700 ft/s, and the sediment layer velocity ranged from 5,000 ft/s to 6,500 ft/s (Figure B2). These values were selected after data acquisition was completed and represent actual conditions at ORLSS.

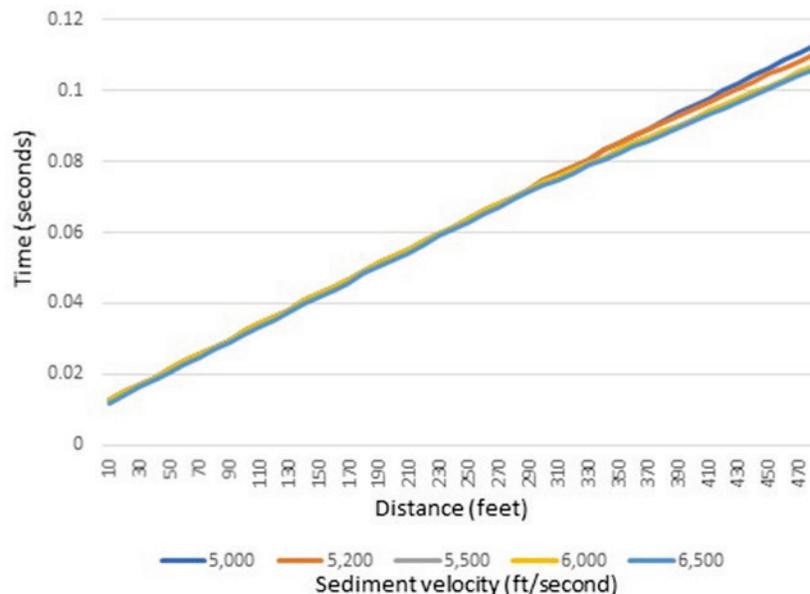
From this model, synthetic seismograms were computed by using the Geogiga software package. First arrival times were picked from these synthetic seismograms by using the same procedure described in the main text of this report. The first arrival times were tabulated for hydrophone offsets ranging from 0 to 480 ft and for sediment velocities of 5,000, 5,200, 5,500, 6,000, and 6,500 ft/s. Figure B3 shows the first arrival plots for all five selected sediment velocities on a single plot. This shows arrival times that would be observed if 48 hydrophones were deployed at distances of 0 to 480 ft from the seismic source.

Figure B3. Time-distance plot showing arrival times of seismic waves for five hypothetical bottom sediment velocities, based on the model in Figure B2.

For distances out to at least 290 ft from the seismic source, the travel times for all five sediment velocities are identical. This is because it is faster for the seismic energy to pass through the upper portion of the water than to travel down to the sediment, along the sediment interface, and back up through the water column. There is little difference between the water velocity and sediment velocities and because of this, the first arriving wave will be through the water until reaching a large distance from the source. It is apparent from Figure B3 that the waves traveling through higher velocity sediments can arrive earlier than the water wave, beginning at about 300 ft from the seismic source.

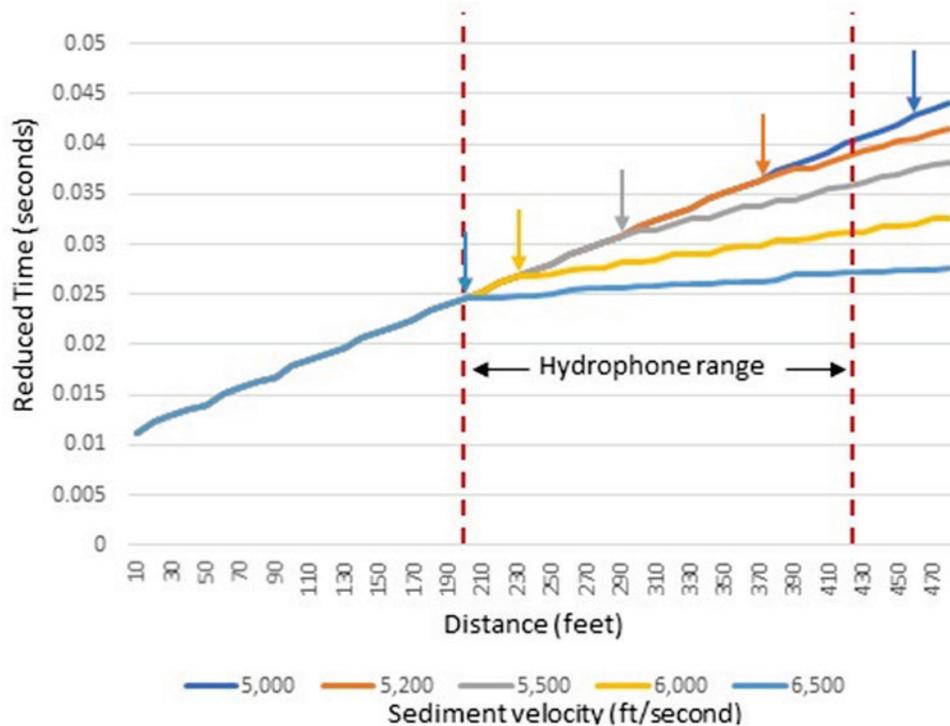
Figure B4. Reduced time-distance plot for the synthetic seismic refraction data.

This figure enhances the synthetic seismic data and shows several important features. Color-coded arrows are used to show the times at which the seismic waves that pass through the sediment layer arrive before the wave traveling through the water column for each of the five sediment velocities. This distance is known as the “crossover distance.” The range of distances, 59.4-129.5 m (195-425 ft), at which hydrophones were located relative to the seismic source is indicated within red dashed lines.

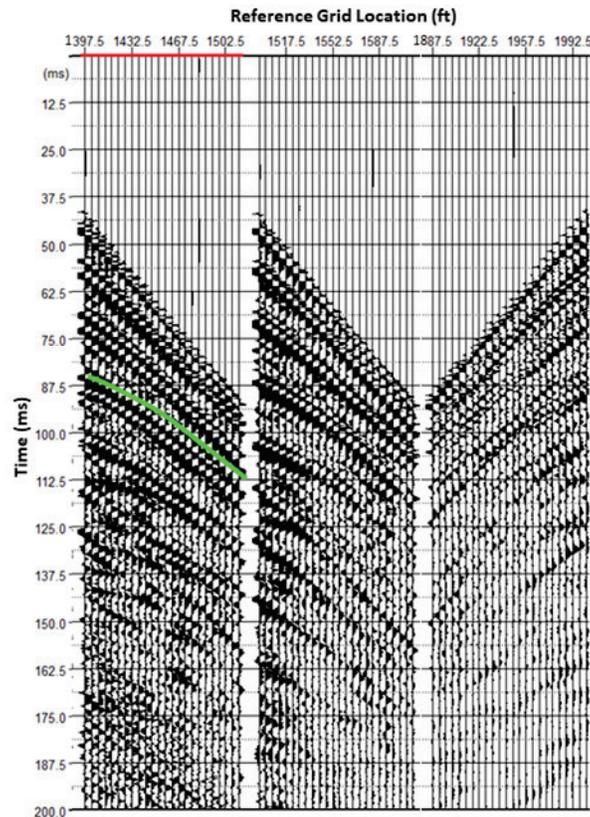
Figure B5. Reflected seismic waves observed in three “shot gathers” during fieldwork on line 400N on the inflow side of ORLSS. One of the many reflections is highlighted in green on the left shot gather.

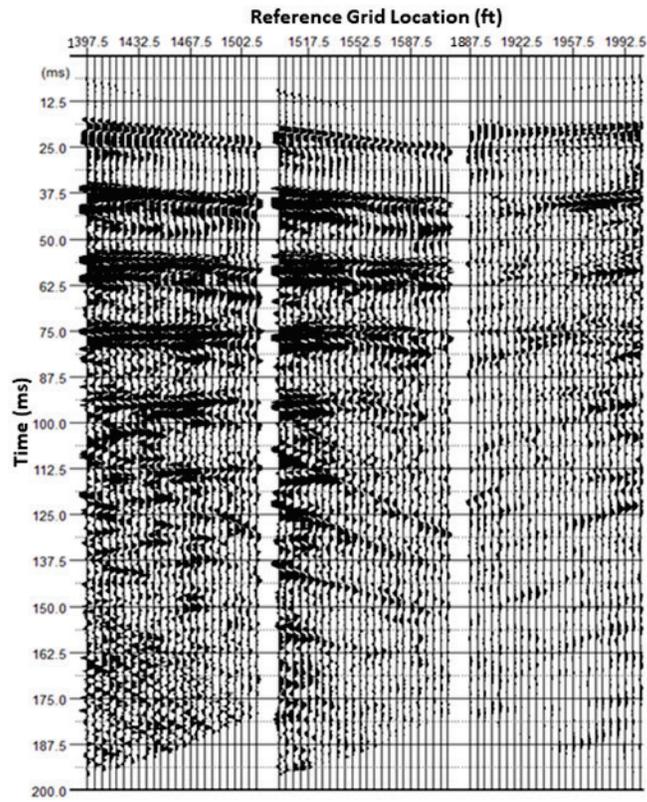
Figure B6. The shot gathers from Figure B5 after applying the NMO correction.

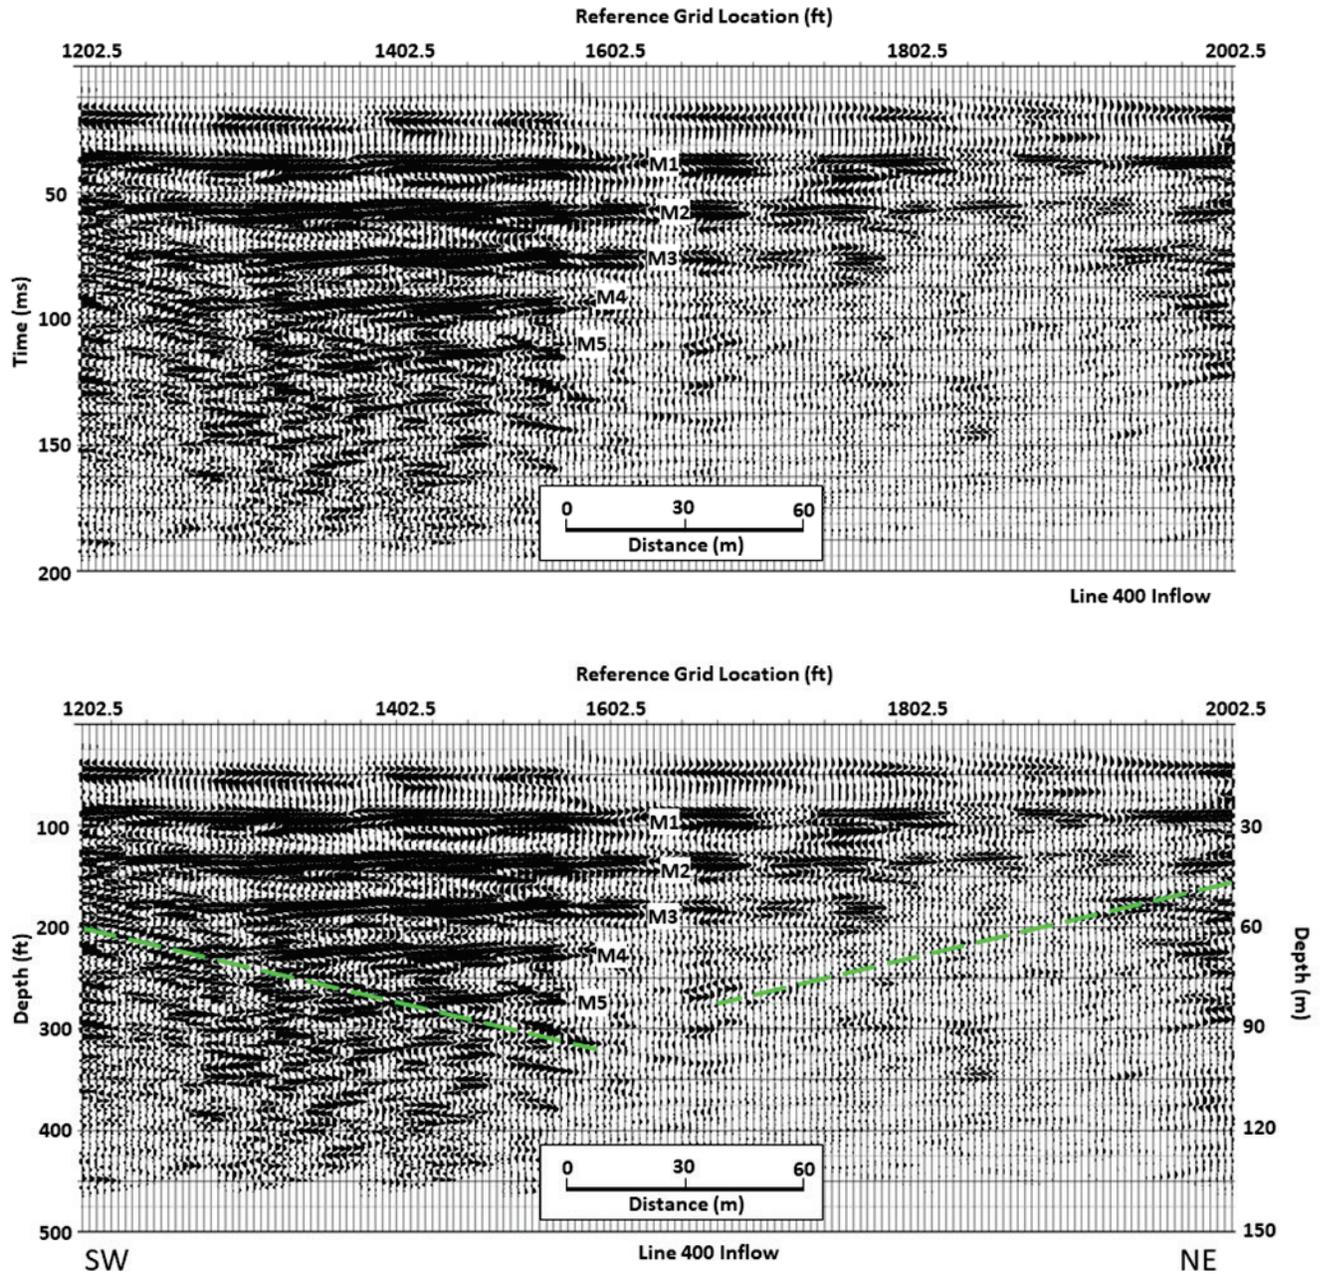
Figure B7. Stacked reflection section for Line 400 from the inflow channel of ORLSS, (top) in travel time and (bottom) in depth feet.

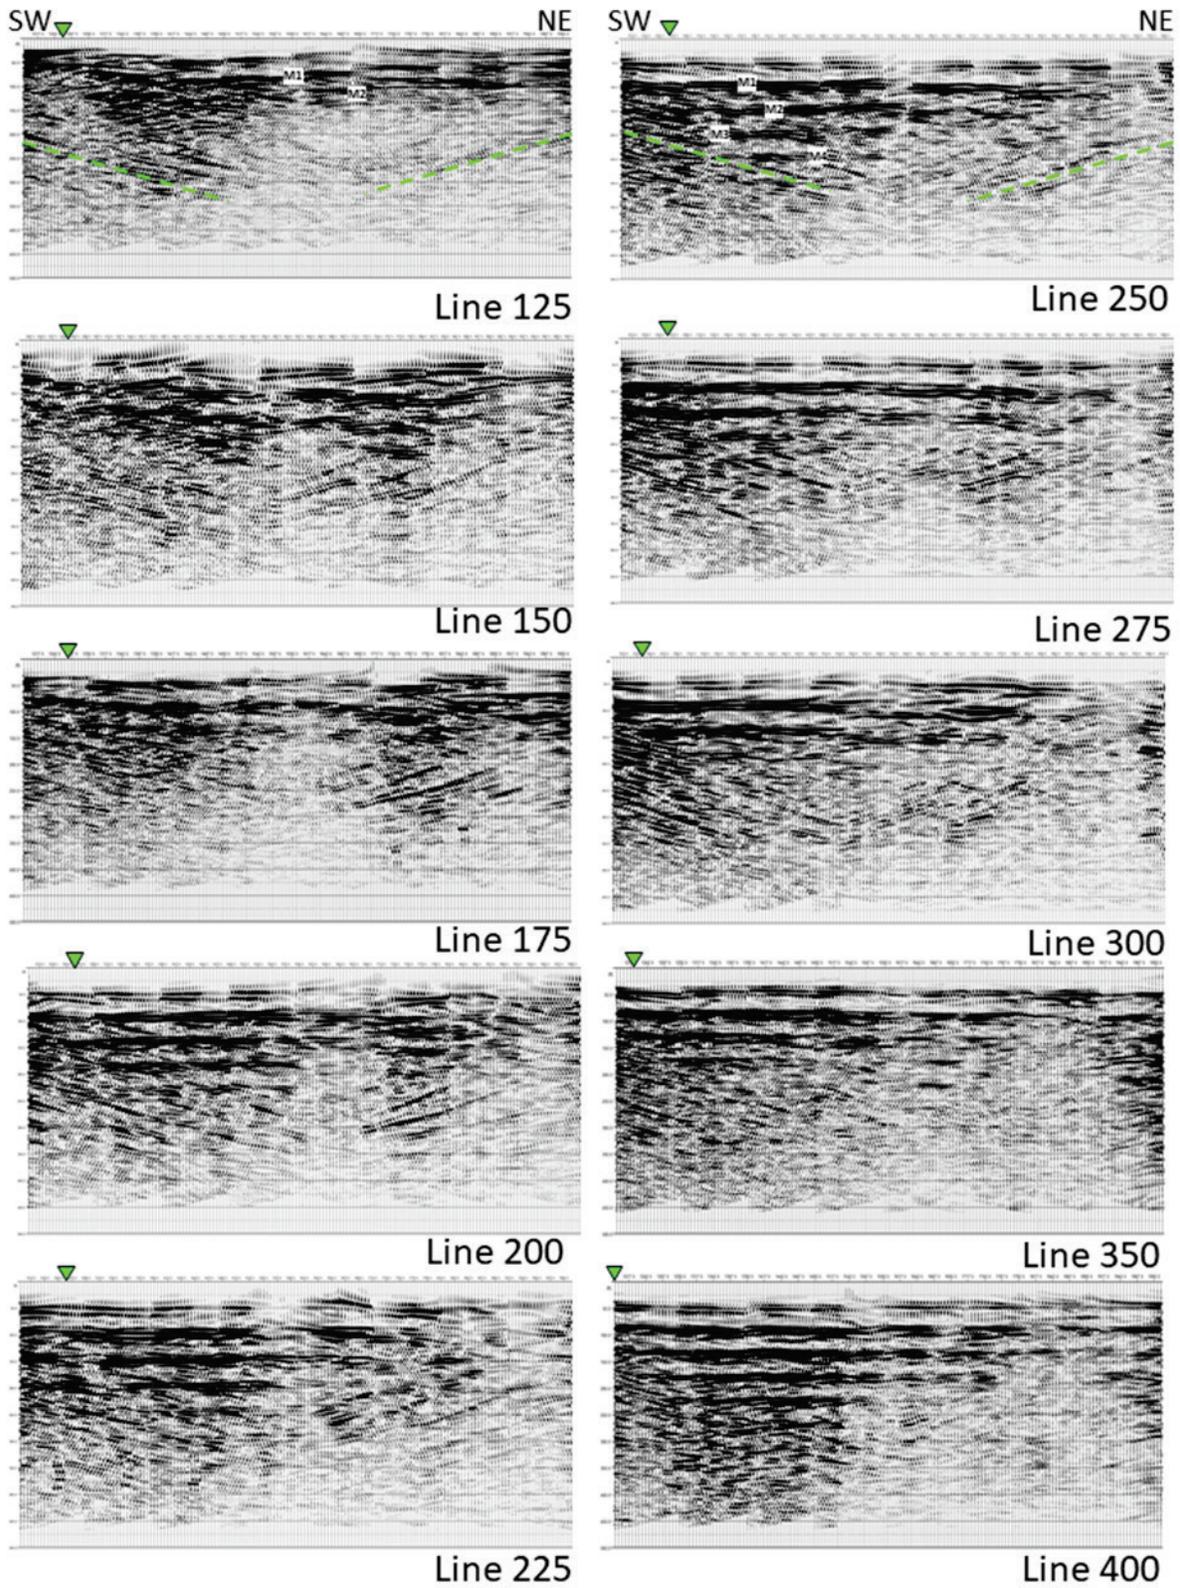
Figure B8. Stacked reflection sections for ten lines on the inflow side of ORLSS. Edge of the scour is indicated by the green triangle at the top of each profile.

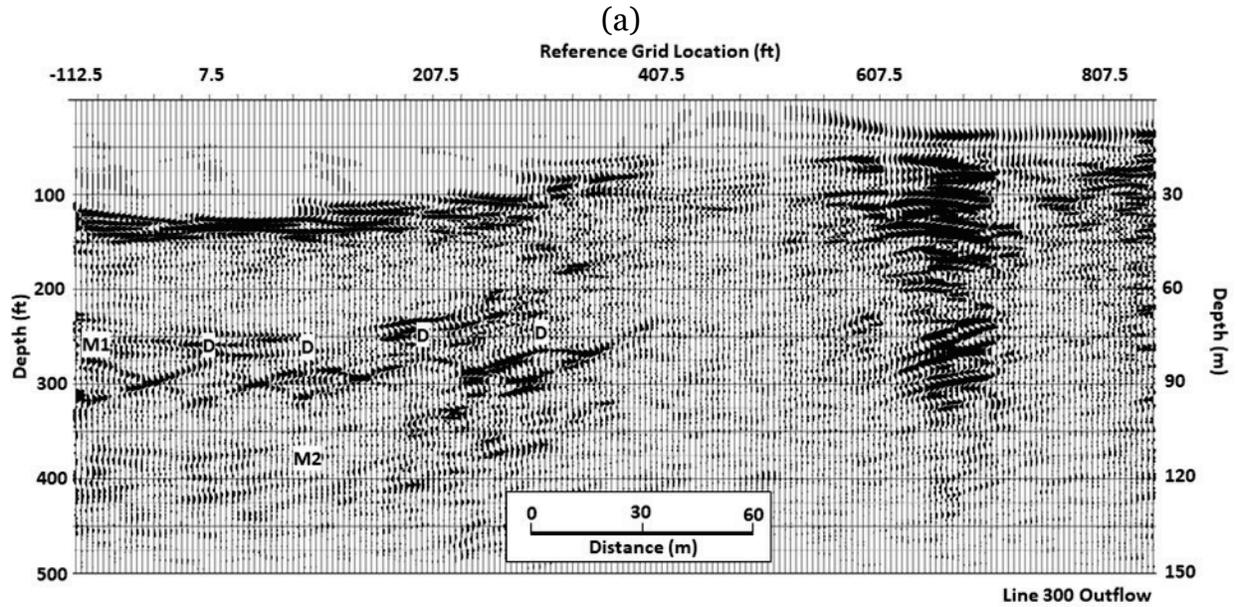
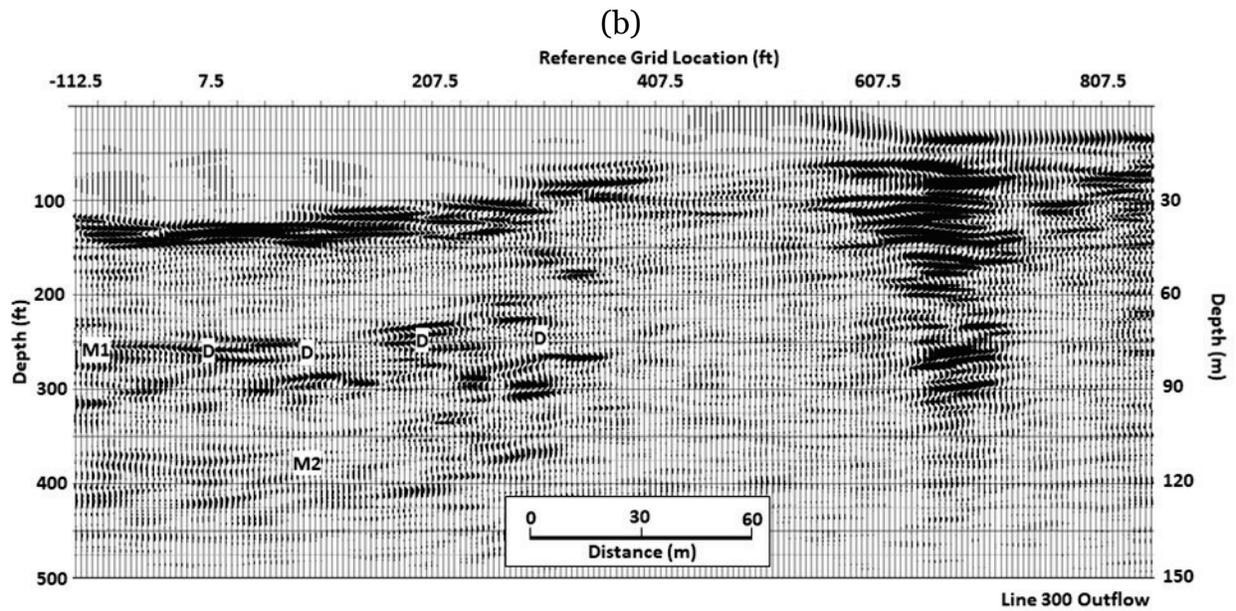
The reflection sections from the outflow side are more interesting than those on the inflow side because the bottom topography deepens substantially moving downstream from ORLSS. In addition, there are features indicative of a rough or irregular bottom, called diffraction hyperbolae. The features appear in the depth section shown in Figure B9a below an apparent depth of 76.2 m (250 ft) on the left half of the figure. They appear as secondary, nearly linear features that trail away in both directions from the diffraction apexes, labeled "D." These artifacts can be remediated through a processing technique known as migration. The migrated section in Figure B9b shows a more representative location for these features once the diffraction hyperbolae have been mostly collapsed to their source location. The absence of diffraction hyperbolae indicated that migration was not needed on most of the ORLSS lines, so it was applied only to selected lines on the outflow side. Similarly, Figures B9c and B9d show both unmigrated and migrated sections for outflow Line 400.

Figure B9. (a) Unmigrated and (b) migrated depth sections for outflow Line 300.

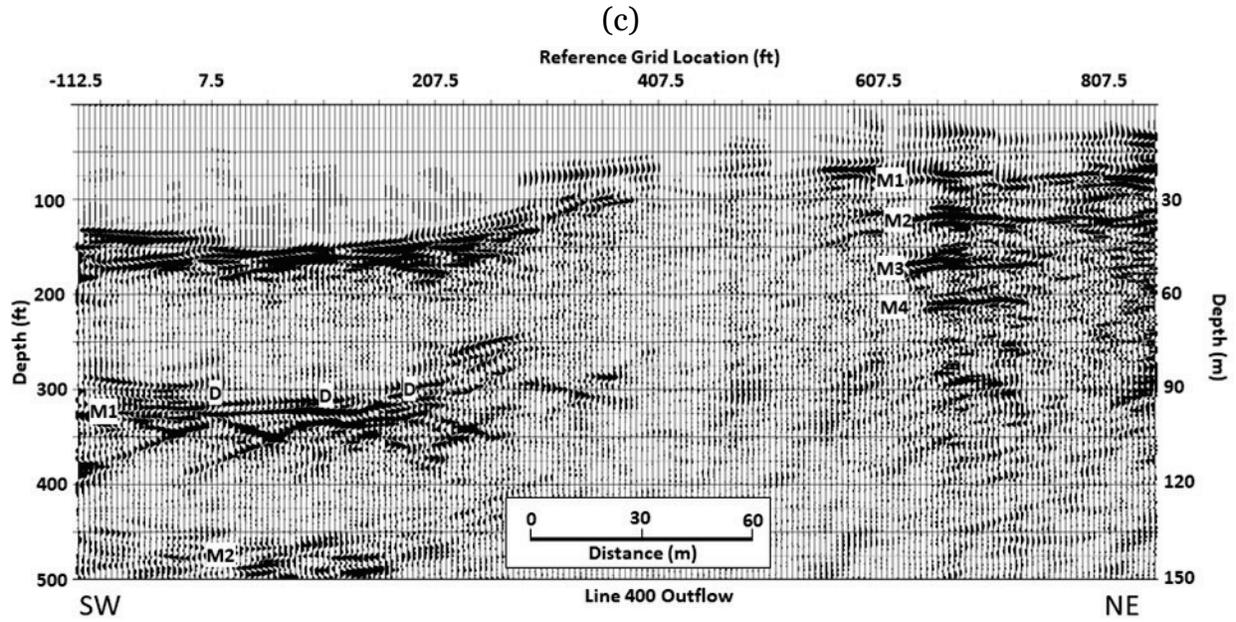
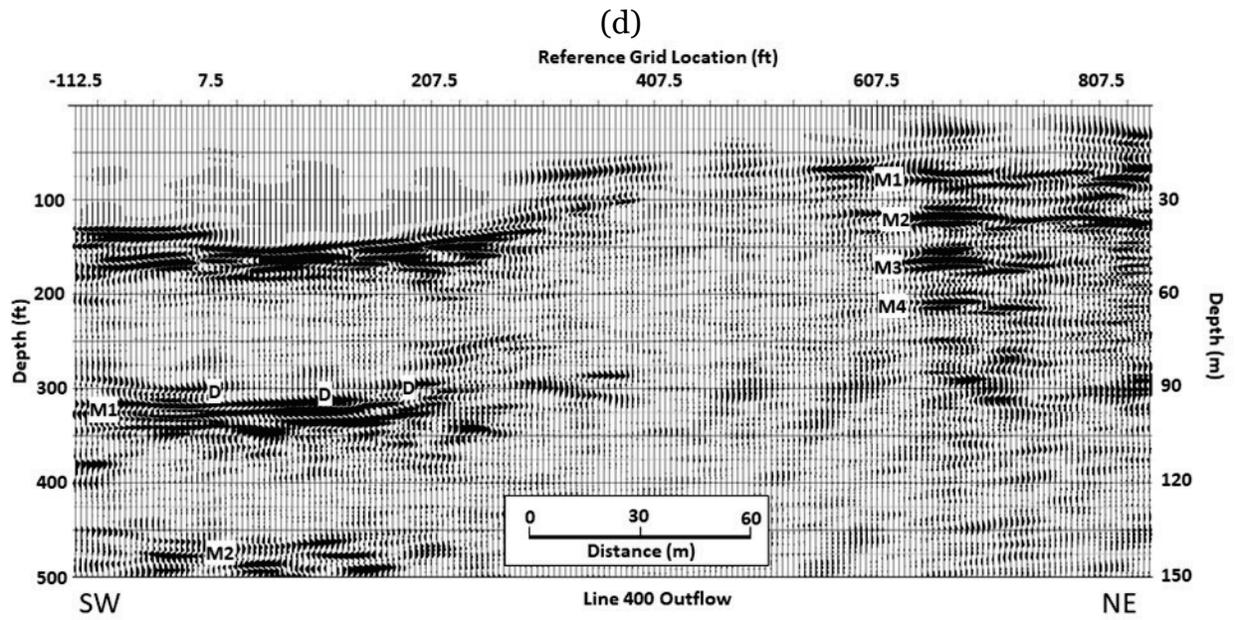
Figure B9. (c) Unmigrated and (d) migrated depth sections for outflow Line 400.
