Waste Management and Landfill Facilities Assessment Using Unmanned Aircraft Systems

March 2023

Technical Report (TR)

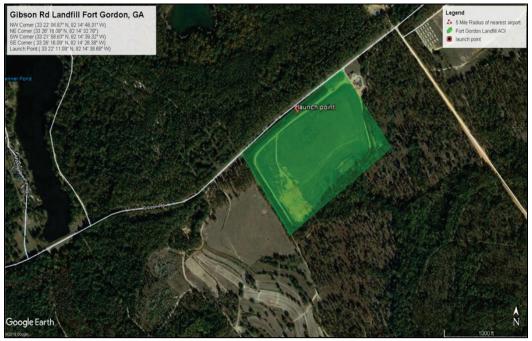
Figure 2. Google Earth image of Gibson Road Landfill site at Fort Gordon. The launch point for the sUAS flight is indicated. (Satellite image from Google Earth 2018.)

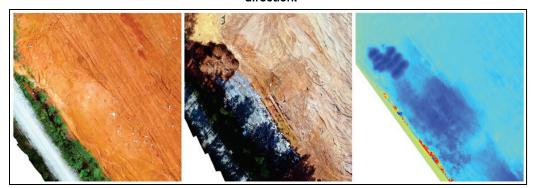
The three sets of images that follow (Figures 6, 7, and 8) are stills taken of the 3D reconstructed point cloud from the active cell and indicate the measurements taken in June (left), the measurements taken in October (middle), and their elevation difference (right). The images on the right

are from a difference map created using the June and October DEMs. The colorization of the difference map reflects changes in elevation, where dark blue indicates an increase in elevation from June to October, dark red indicates a decrease in elevation from June to October, and yellow and light blue indicate little to no change between the images.

Figure 6. The images are from June (*left*), October (*middle*), and elevation difference (*right*) and feature a portion of the active cell at Gibson Road Landfill, as seen from the northern direction.

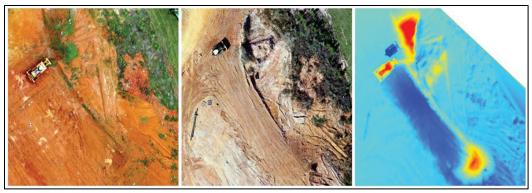
The images in Figure 7 better illustrate the significance of the colors. Two bulldozers were photographed. The first image was taken in June, and the second was taken in October. The June image on the left shows a large dozer, and the October image in the middle shows a smaller dozer. In the difference map on the right, the large dozer is dark red, and the small dozer is dark blue (i.e., the smaller dozer indicates an increase in elevation because there was not a dozer in that specific location in the June image). In addition, two large dirt piles in red can be seen next to the dozers. The dark blue points in between the two piles indicate that they were likely plowed to cover waste in that area. Changes such as these allow base differences to be detected and provide a measure of forensic information on how volumes on the landfill are distributed over time and their likely purpose.

Figure 7. Another portion of the active cell at Gibson Road Landfill, as seen from the northern direction. The image on the *left* was taken in June, the image in the *middle* was taken in October, and the image on the *right* shows the differences in elevation between the first two images.

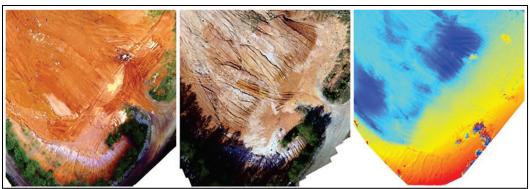
The volume of the active cell was calculated by laying a flat plane over the 3D reconstructed surface and measuring the volume enclosed. The highest elevation in the active dumping area was approximately 154 meters, so that was chosen as the height of the flat plane. The volume of the active cell as measured in the June flights was 89,923.701 cubic meters, and the volume of the active cell as measured in the October flights was 73,568.984 cubic meters. The volume difference was 16,354.717 cubic meters. As noted, the recorded volume was lower on the second collection pass. This is because volume, as measured in this context, is not the volume of the surface contents but, rather, the volume of the air enclosed by the artificial plane height and the surface. In this formulation, a lower volume indicates that less air exists below the plane height, and therefore, it can be surmised that more surface elevation exists. A variety of factors, including added or subtracted waste, soil compaction, and soil erosion, can cause these changes in elevation. While this measure of volume may seem counterintuitive, it allows volume changes to be calculated on areas with an unknown reference surface (i.e., an unknown original elevation). Should a landfill be scanned from its empty state to a future state, then volume changes from the base elevation map can be calculated in a more intuitive manner.

Figure 8. Another portion of the active cell at Gibson Road Landfill, as seen from the northern direction. The image on the *left* was taken in June, the image in the *middle* was taken in October, and the image on the *right* shows the differences in elevation between the first two images.

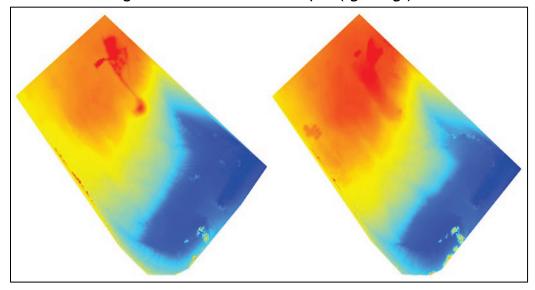
Figure 9 shows two images of the active cell of the Gibson Road Landfill. The dark blue, again representing higher elevation, indicates that the active cell shown in the southwest quadrant reduced in volumetric size.

Figure 9. Images indicate the volumetric data difference. The June pass (*left image*) notes greater volume than the October pass (*right image*).

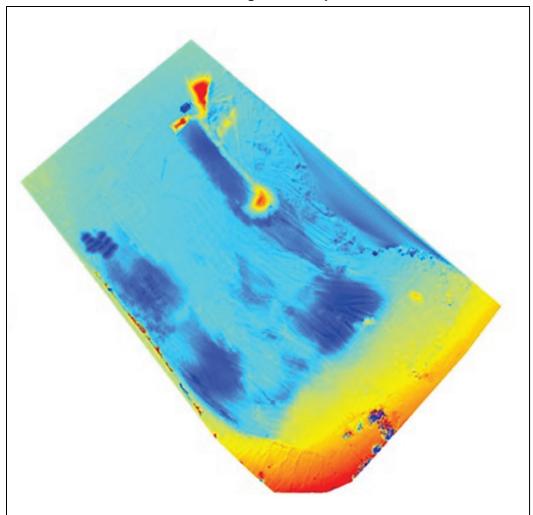
The differential image in Figure 10 is of the active cell at the Gibson Road Landfill. The dark blue indicates all the locations where activity took place after the June pass. Utilizing a data product like this would allow end users to locate hotspots or areas of high or low waste activity and to locate and remediate soil erosion, as seen on the bottom left edge of the difference map in Figure 10.

Figure 10. Difference map generated from the June and October passes in Fig. 9. *Dark blue* reflects greater activity.

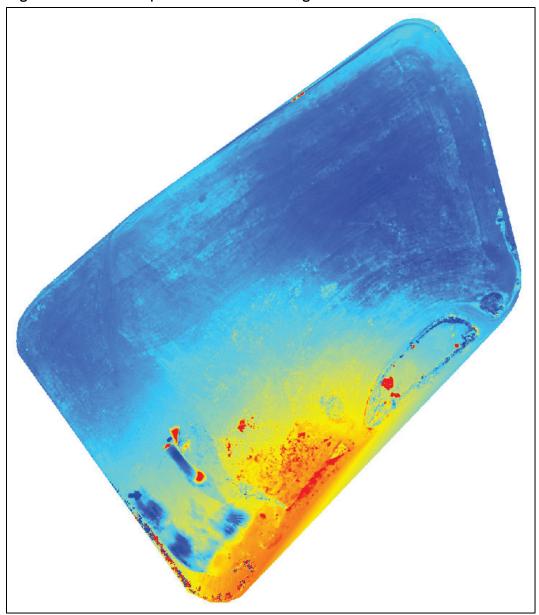
Finally, given sufficient equipment, flight time, and processing time, overflights of entire landfills can be conducted to make broader landfill assessments. Such analyses, while time and cost prohibitive using standard survey techniques, are fundamentally the same as the active landfill analyses referenced in this section, requiring only longer processing times for 3D reconstruction, difference analysis, and flight planning. An example of one such analysis can be seen in Figure 11, where the entire Gibson Road landfill area was scanned and a difference DEM was presented. This difference DEM was derived from June and October flights, from a 200 foot altitude, using the Matrix-E and A6000 with a 19 millimeter lens.

Figure 11. Difference map from June and October flights over the entire Gibson Road landfill.

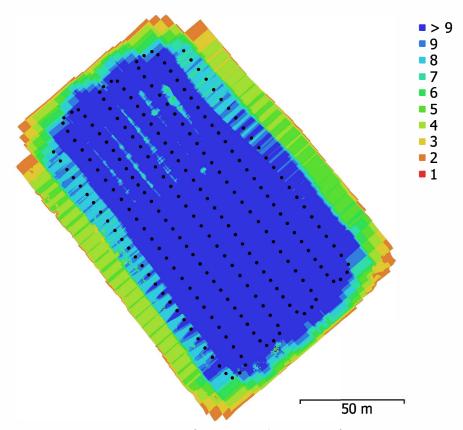
Fig. 1. Camera locations and image overlap.

Number of images: 223 Camera stations: 223 31.9 m Flying altitude: Tie points: 110,554 Projections: 721,403 Ground resolution: 6.12 mm/pix Coverage area: Reprojection error: 0.0196 km² 0.992 pix

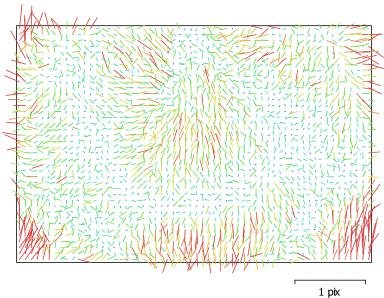
Fig. 2. Image residuals for ILCE-6000 (19 mm).

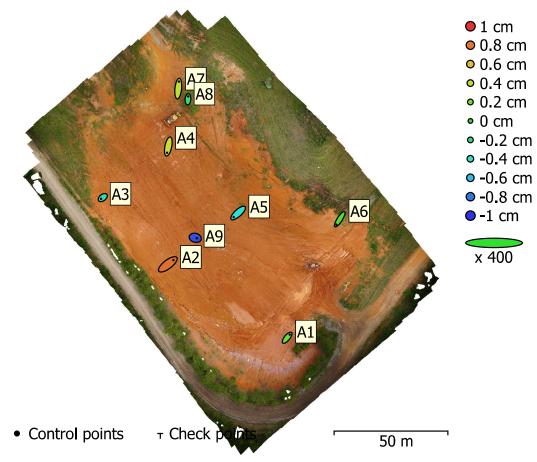
Fig. 3. GCP locations and error estimates.

Z error is represented by ellipse color. X,Y errors are represented by ellipse shape. Estimated GCP locations are marked with a dot or crossing.

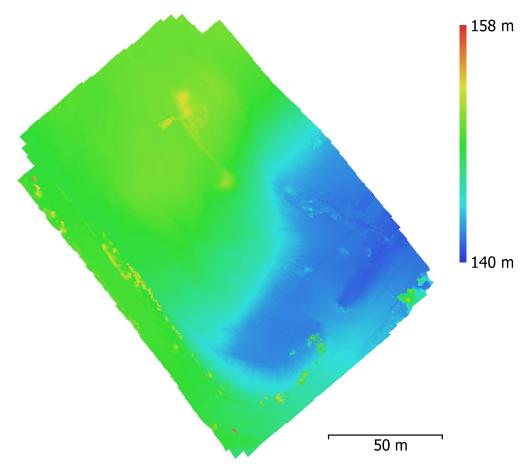
Fig. 4. Reconstructed digital elevation model.

Resolution: 2.45 cm/pix
Point density: 16.7 points/cm²

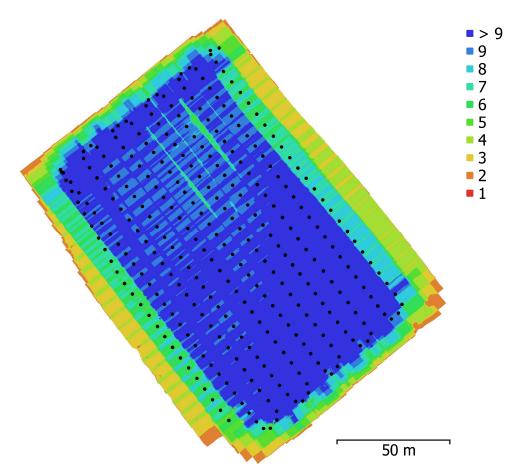
Fig. 1. Camera locations and image overlap.

Number of images: 303 Camera stations: 303 156,183 Flying altitude: Tie points: 44.6 m Ground resolution: 5.02 mm/pix Projections: 1,032,545 Coverage area: 0.02 km² Reprojection error: 0.957 pix

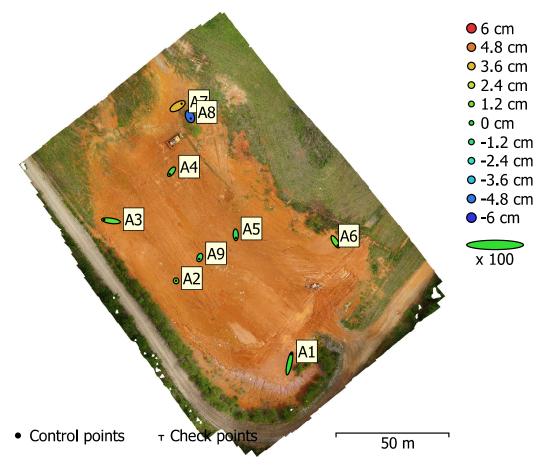
Fig. 3. GCP locations and error estimates.

Z error is represented by ellipse color. X,Y errors are represented by ellipse shape.

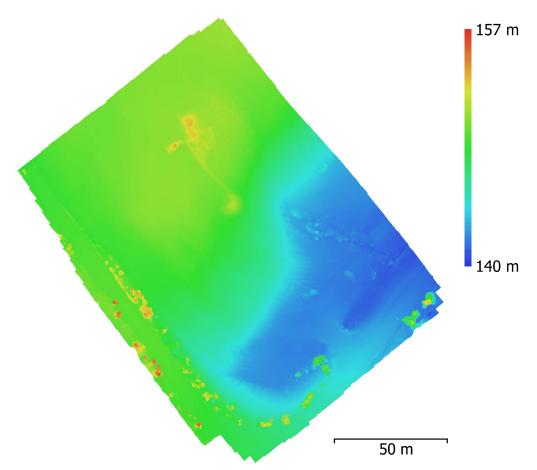
Fig. 4. Reconstructed digital elevation model.

Resolution: 2.01 cm/pix
Point density: 24.8 points/cm²

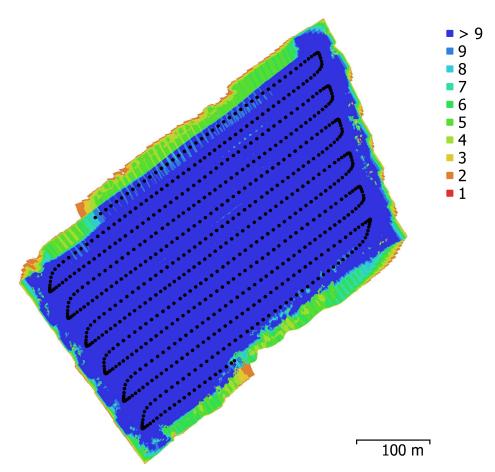
Fig. 1. Camera locations and image overlap.

Number of images: 722 Camera stations: 722 609,279 Flying altitude: Tie points: 60.6 m Ground resolution: 1.14 cm/pix Projections: 2,704,041 Coverage area: 0.164 km² Reprojection error: 1.13 pix

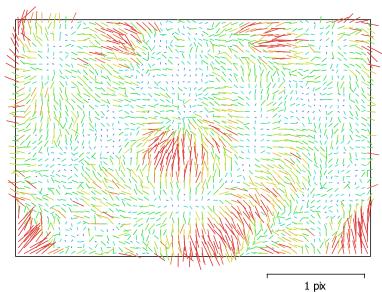
Fig. 2. Image residuals for ILCE-6000 (19mm).

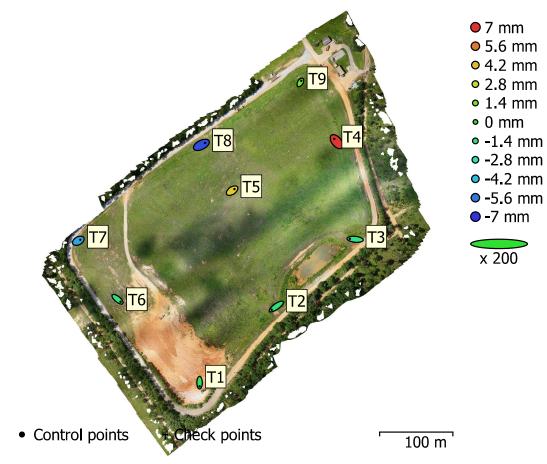
Fig. 3. GCP locations and error estimates.

Z error is represented by ellipse color. X,Y errors are represented by ellipse shape.

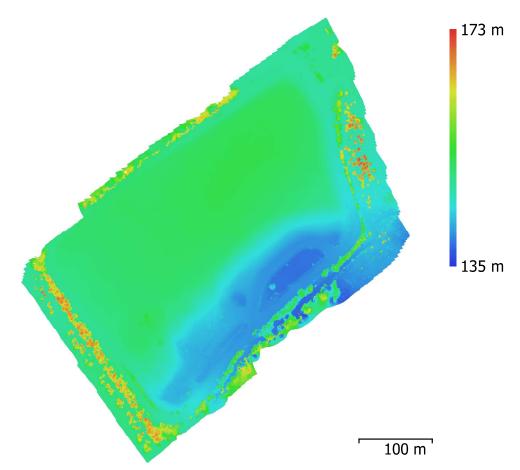
Fig. 4. Reconstructed digital elevation model.

Resolution: 4.56 cm/pix
Point density: 480 points/m²

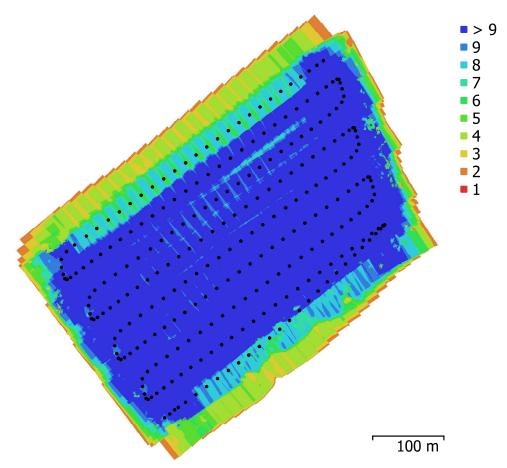
Fig. 1. Camera locations and image overlap.

Number of images: 264 Camera stations: 264 Flying altitude: Tie points: 233,716 91.4 m Ground resolution: 1.75 cm/pix Projections: 1,004,866 Coverage area: 0.199 km² Reprojection error: 1.09 pix

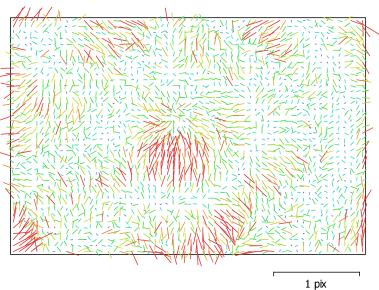
Fig. 2. Image residuals for ILCE-6000 (19mm).

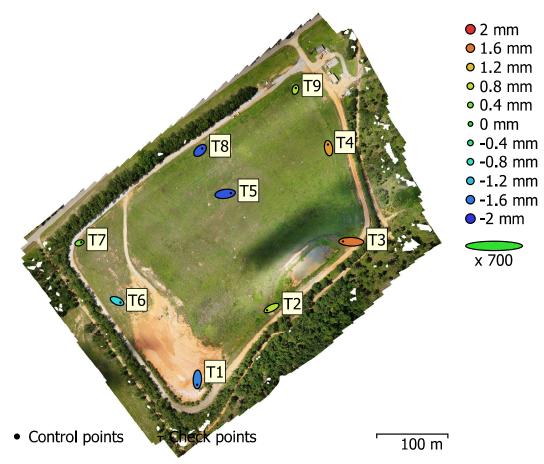
Fig. 3. GCP locations and error estimates.

Z error is represented by ellipse color. X,Y errors are represented by ellipse shape.

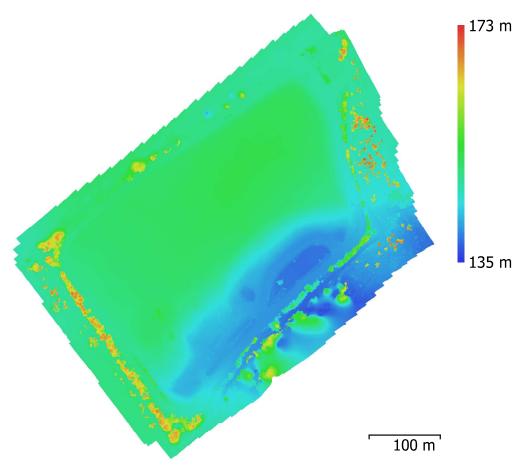
Fig. 4. Reconstructed digital elevation model.

Resolution: 3.51 cm/pix
Point density: 814 points/m²

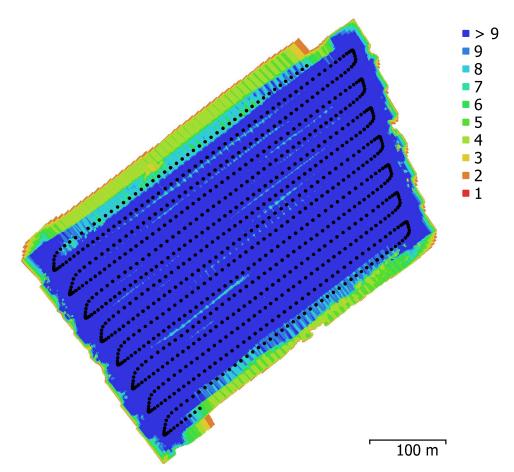
Fig. 1. Camera locations and image overlap.

Number of images: 893 893 Camera stations: Flying altitude: Tie points: 583,005 88.8 m Ground resolution: 9.51 mm/pix Projections: 3,486,653 Coverage area: 0.165 km² Reprojection error: 1.1 pix

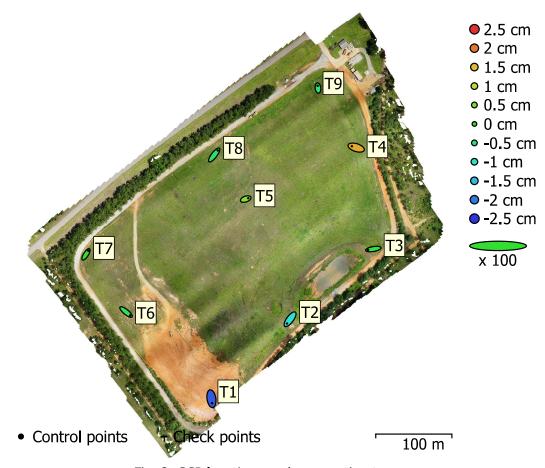
Fig. 3. GCP locations and error estimates.

Z error is represented by ellipse color. X,Y errors are represented by ellipse shape.

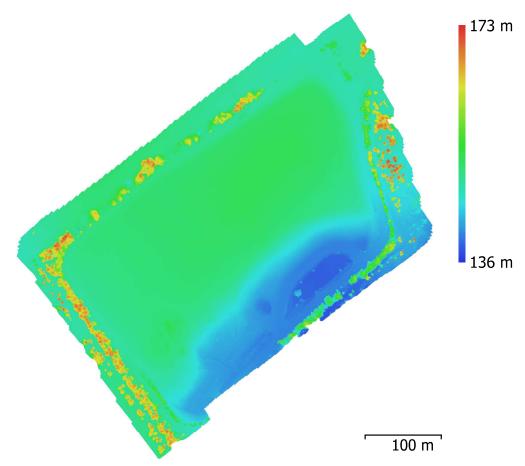
Fig. 4. Reconstructed digital elevation model.

Resolution: 3.8 cm/pix
Point density: 691 points/m²

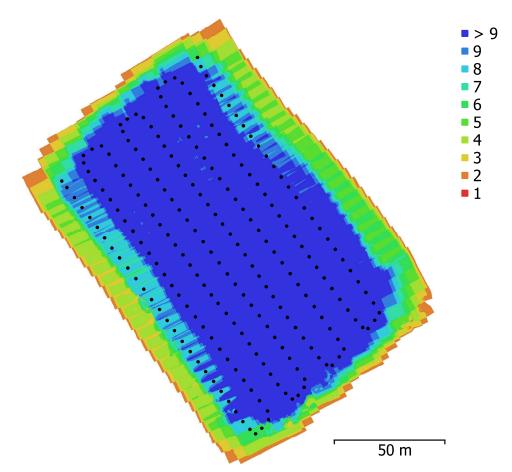
Fig. 1. Camera locations and image overlap.

Number of images: 222 222 Camera stations: Flying altitude: Tie points: 126,534 31.4 m Ground resolution: 6.24 mm/pix Projections: 856,237 Coverage area: 0.0202 km² Reprojection error: 1.15 pix

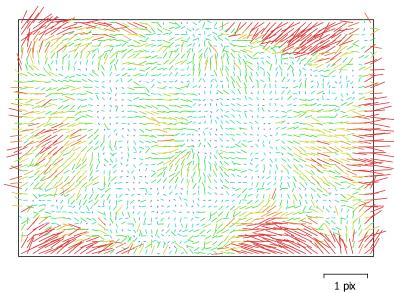
Fig. 2. Image residuals for ILCE-6000 (19mm).

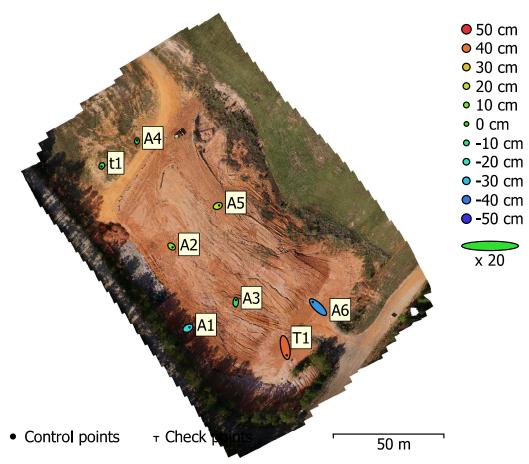
Fig. 3. GCP locations and error estimates.

Z error is represented by ellipse color. X,Y errors are represented by ellipse shape.

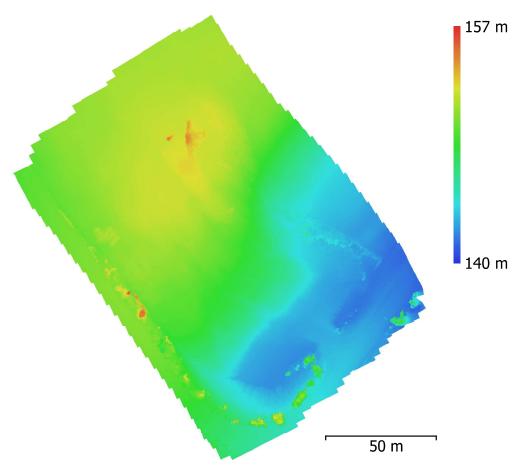
Fig. 4. Reconstructed digital elevation model.

Resolution: 2.5 cm/pix

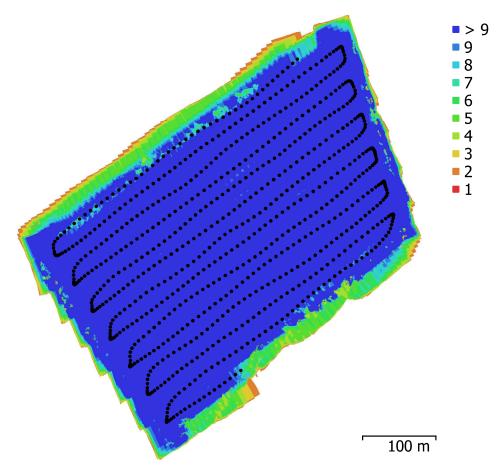
Fig. 1. Camera locations and image overlap.

Number of images: 781 Camera stations: 781 Flying altitude: Tie points: 367,316 63.8 m Ground resolution: 1.18 cm/pix Projections: 3,040,445 Coverage area: 0.181 km² Reprojection error: 1.36 pix

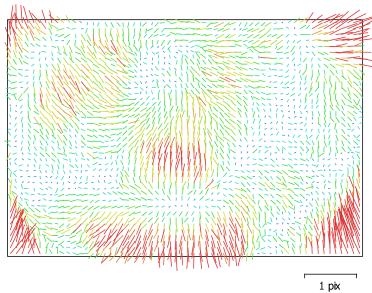
Fig. 2. Image residuals for ILCE-6000 (19mm).

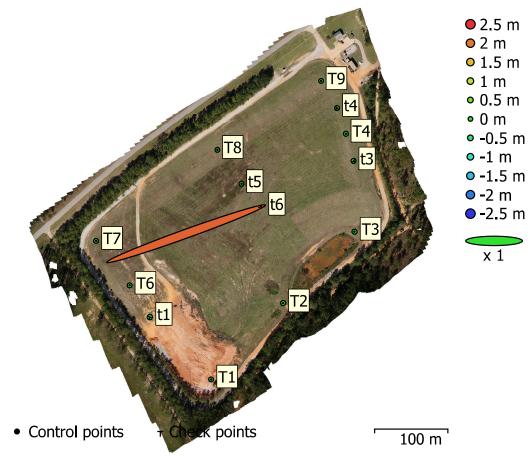
Fig. 3. GCP locations and error estimates.

Z error is represented by ellipse color. X,Y errors are represented by ellipse shape. Estimated GCP locations are marked with a dot or crossing.

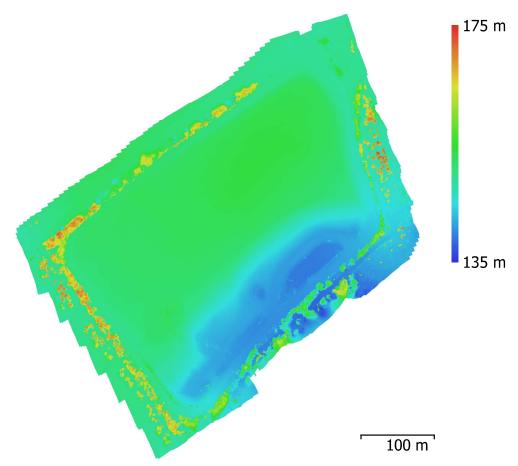
Fig. 4. Reconstructed digital elevation model.

Resolution: 4.71 cm/pix
Point density: 451 points/m²

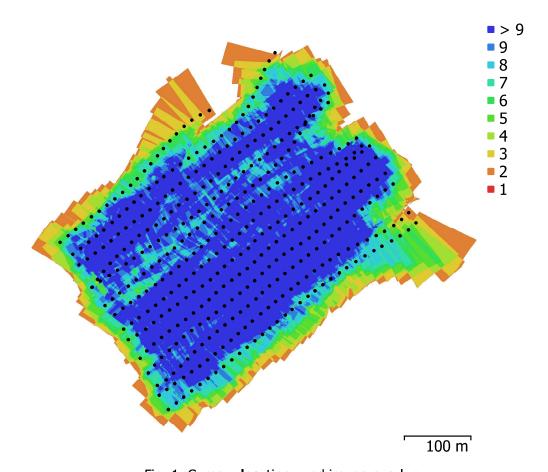
Fig. 1. Camera locations and image overlap.

Number of images: 433 Camera stations: 431 Flying altitude: Tie points: 303,870 74.8 m Ground resolution: 9.43 mm/pix Projections: 1,619,361 Coverage area: 0.199 km² Reprojection error: 0.957 pix

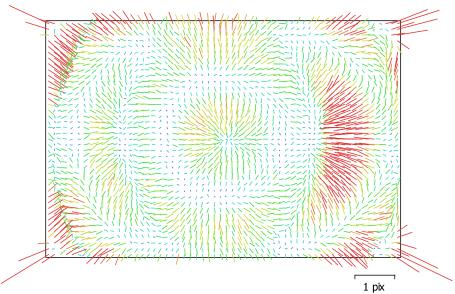
Fig. 2. Image residuals for DSC-RX1RM2 (35mm).

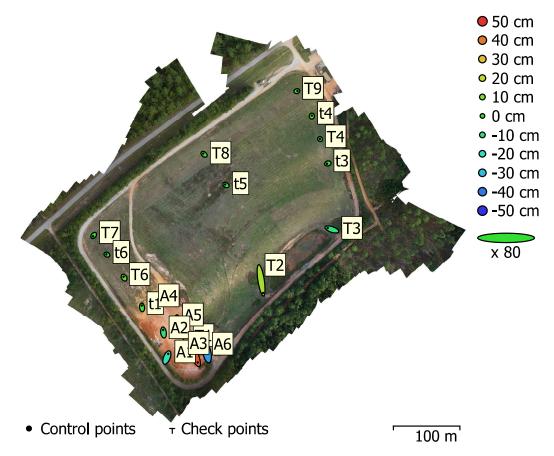
Fig. 3. GCP locations and error estimates.

Z error is represented by ellipse color. X,Y errors are represented by ellipse shape.

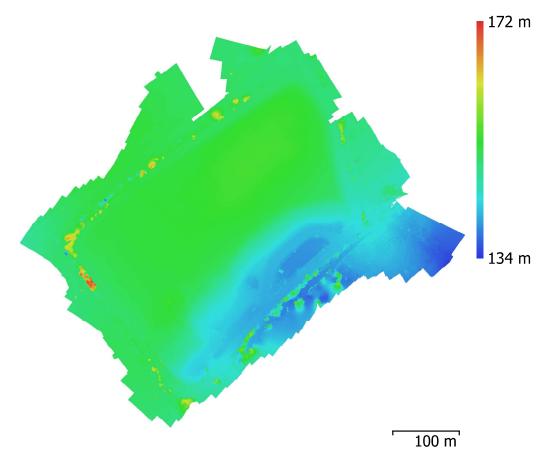
Fig. 4. Reconstructed digital elevation model.

Resolution: 3.77 cm/pix
Point density: 703 points/m²

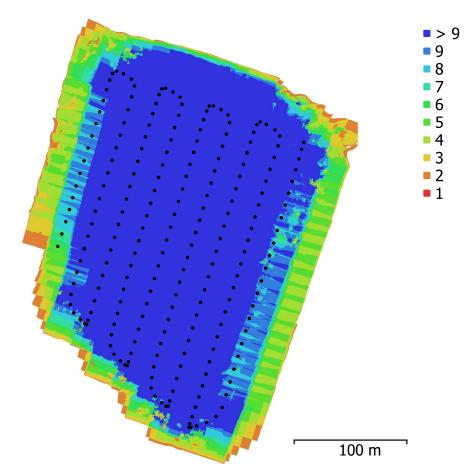
Fig. 1. Camera locations and image overlap.

Number of images: 225 225 Camera stations: Flying altitude: Tie points: 130,311 68.8 m Ground resolution: 1.29 cm/pix Projections: 859,747 Coverage area: 0.0773 km² Reprojection error: 1.1 pix

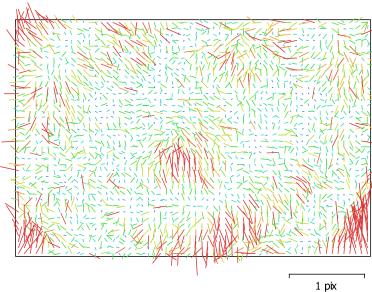
Fig. 2. Image residuals for ILCE-6000 (19mm).

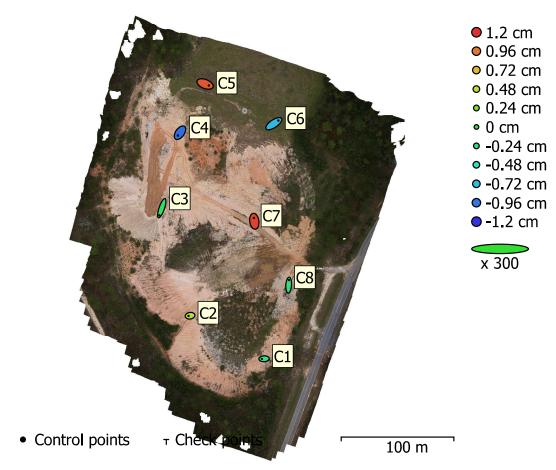
Fig. 3. GCP locations and error estimates.

Z error is represented by ellipse color. X,Y errors are represented by ellipse shape.

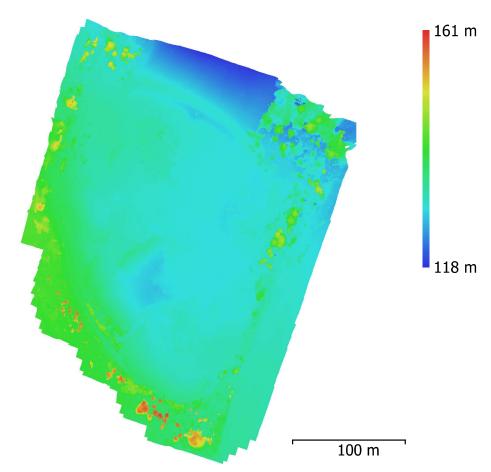
Fig. 4. Reconstructed digital elevation model.

Resolution: 5.16 cm/pix
Point density: 375 points/m²
