## **Evaluation of Non-Destructive Testing (NDT) Methods for Wood Power Poles**

Melisa Nallar, Andrew P. Bernier, and Jamie T. Potter

September 2023

Final Report

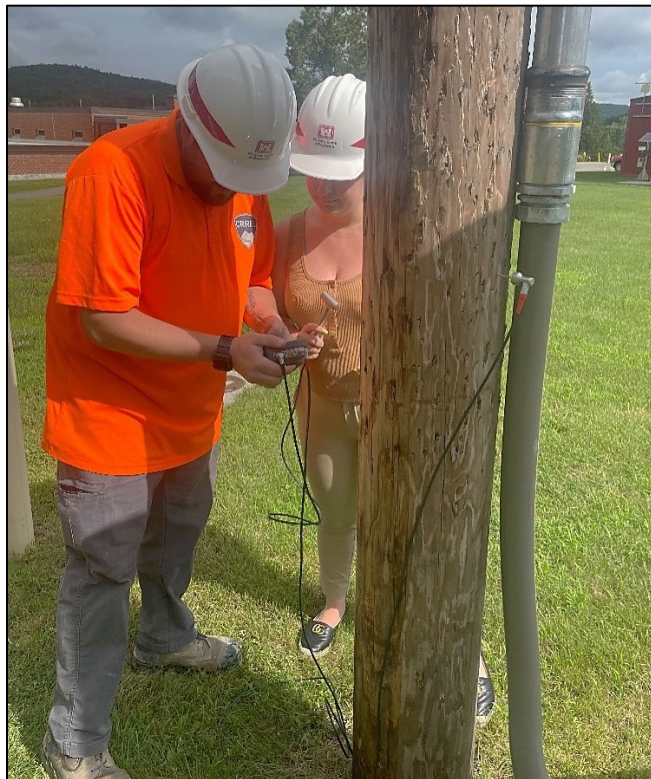
The Micro Hammer method involves the use of a specially designed hammer with a small, hard tip, which is used to strike the surface of the pole. The sound waves generated by the impact are recorded using a microphone, and the resulting data is analyzed to determine the condition of the pole. The hammer is typically struck at multiple locations along the length of the pole, and the resulting sound waves are compared to determine the presence and severity of internal defects. Figure 1 shows the Micro Hammer in use.

Figure 1. Micro Hammer in use.

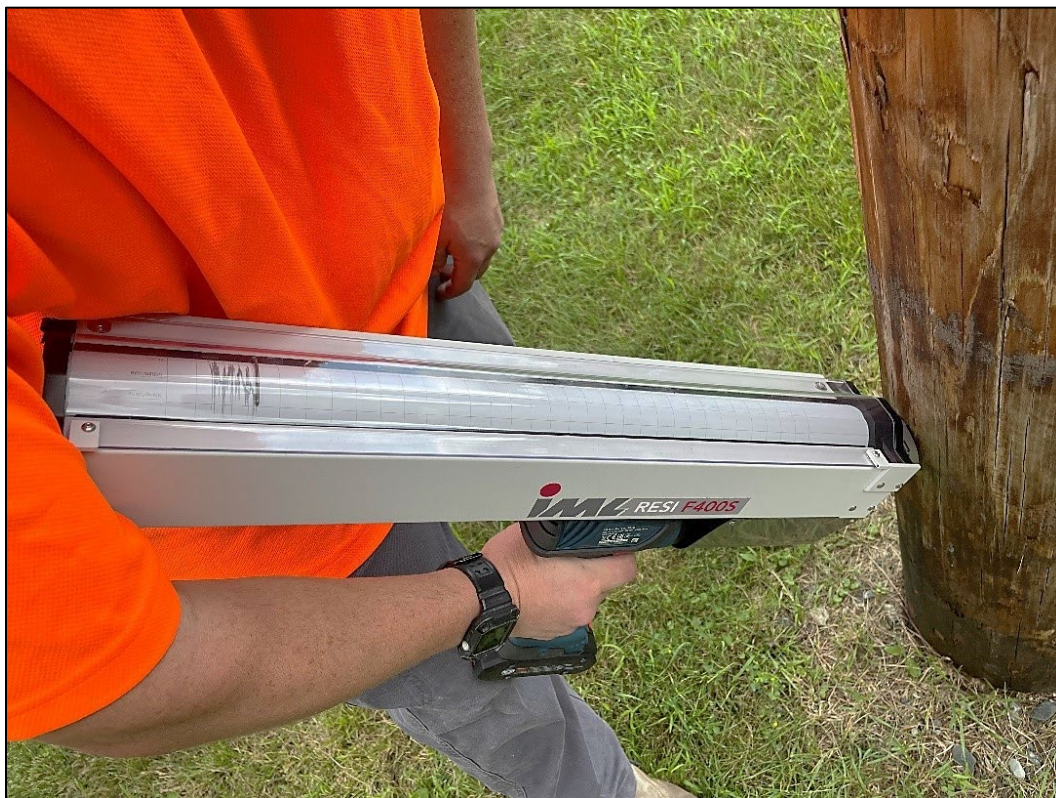
The Resistograph method is an NDT technique that has been widely used in the evaluation of wood utility poles. The method involves the use of a needle-like probe that is drilled into the pole at a constant speed while measuring the resistance encountered by the probe. The measurement of resistance as a function of depth is recorded and analyzed to provide information about the internal structure of the pole. Figure 2 shows the Resistograph in use.

Figure 2. Resistograph in use.

This method proves valuable in detecting and locating internal decay, assessing the overall condition, and estimating the remaining strength. Additionally, it provides insights into the size and location of any defects or anomalies inside the pole. It offers quick results and is relatively user-friendly. However, it's essential to note that the Resistograph method is not a substitute for laboratory testing. To conduct the Resistograph test, a small pilot hole is initially drilled at the desired location. The Resistograph probe is then inserted and driven into the pole at a constant speed. Equipped with a sensor, the probe records resistance encountered during penetration,

generating a graphical representation of resistance as a function of depth. This graph enables the detection of internal decay or anomalies.

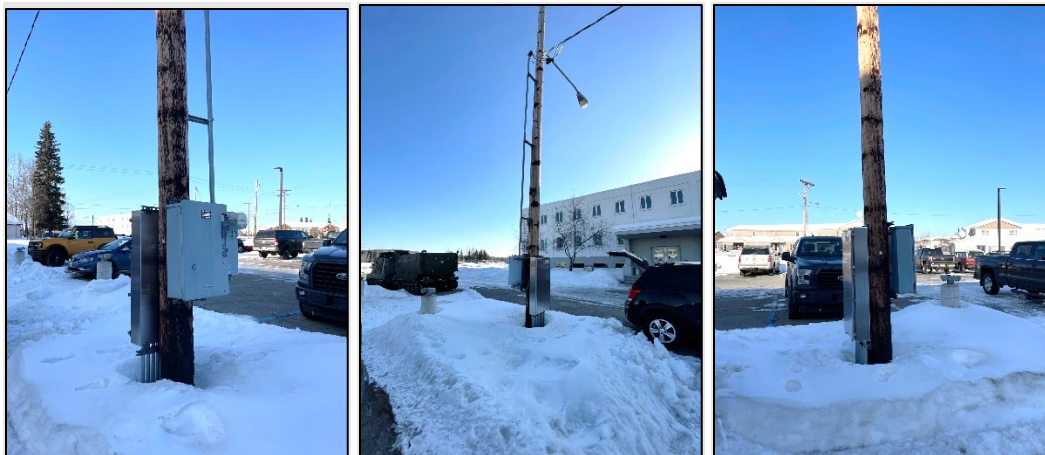
Figure 3. Pole 1 (viewed from multiple angles).

In Figure 3 through Figure 14, snow can be seen on the ground around Alaska poles, but green grass around poles in New Hampshire.

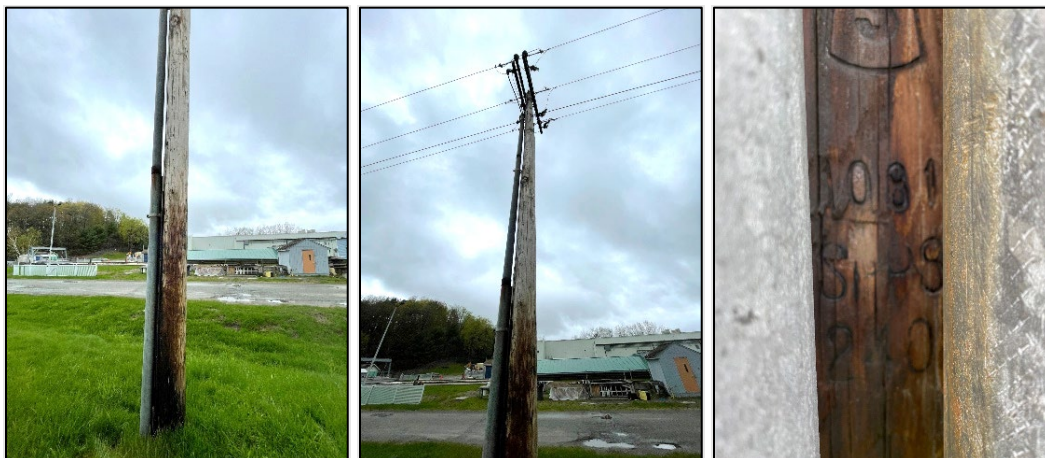
Figure 13. Pole 11 (viewed from multiple angles).

Similarities were noticed between the two NDT methods applied. Pole 11 had both short peaks in the Resistograph and sounded hollow when hit with the Micro Hammer, which both indicate less dense wood. Pole 12 had a notably weak response on Resistograph and had a noticeably different sound with the Micro Hammer.

Visual inspection did not always indicate what the measured values would be. Specifically, pole 11 in New Hampshire had the lowest recorded values compared to other poles with both methods and sounded very hollow when the Micro Hammer was used, however was not visually identified as different. All the poles at CRREL appeared to have voids in the middle of them at about 7 to 8 in into them.
