*Rapid Airfield Damage Recovery and Coalition Warfare Programs*

## **Extreme Cold Weather Airfield Damage Repair Testing at Goose Bay Air Base, Canada**

January 2024

Final Report

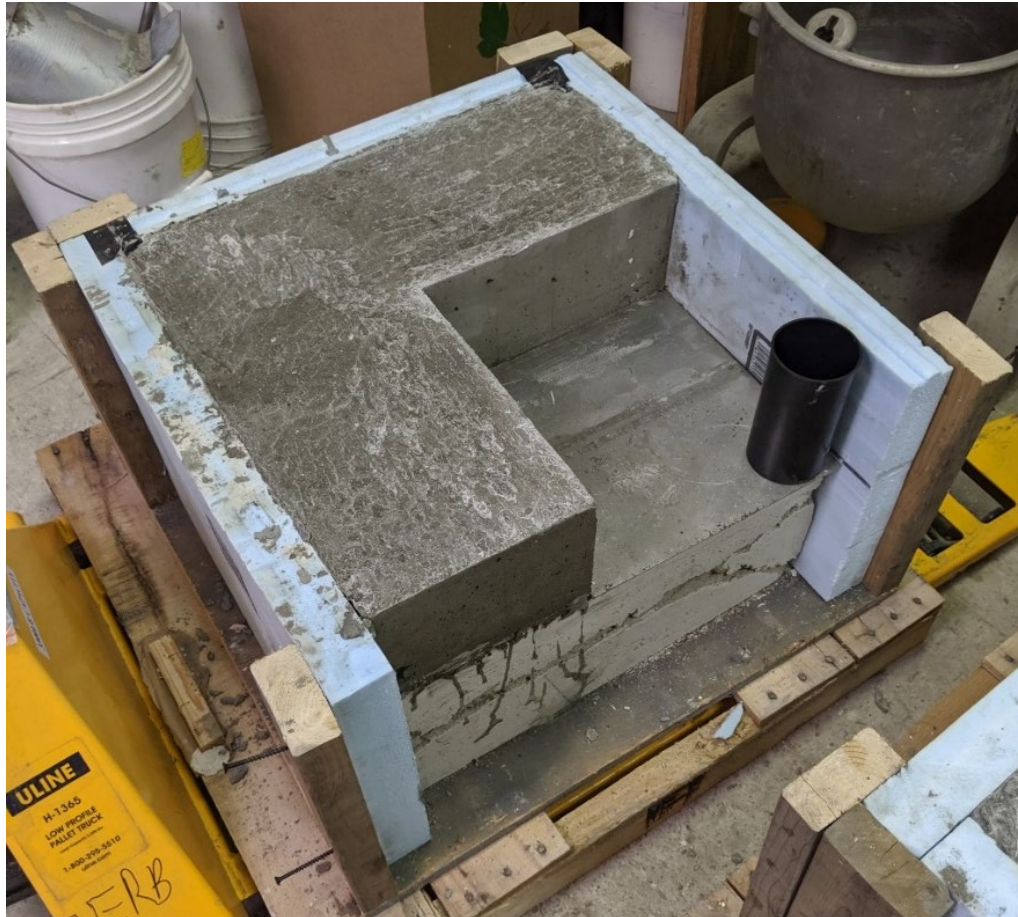
**Figure 1.** Concrete Airfield Repair Thermal Simulator (CARTS) apparatus with one side of the mold removed, showing a simulated patch area, and pallet jack underneath.

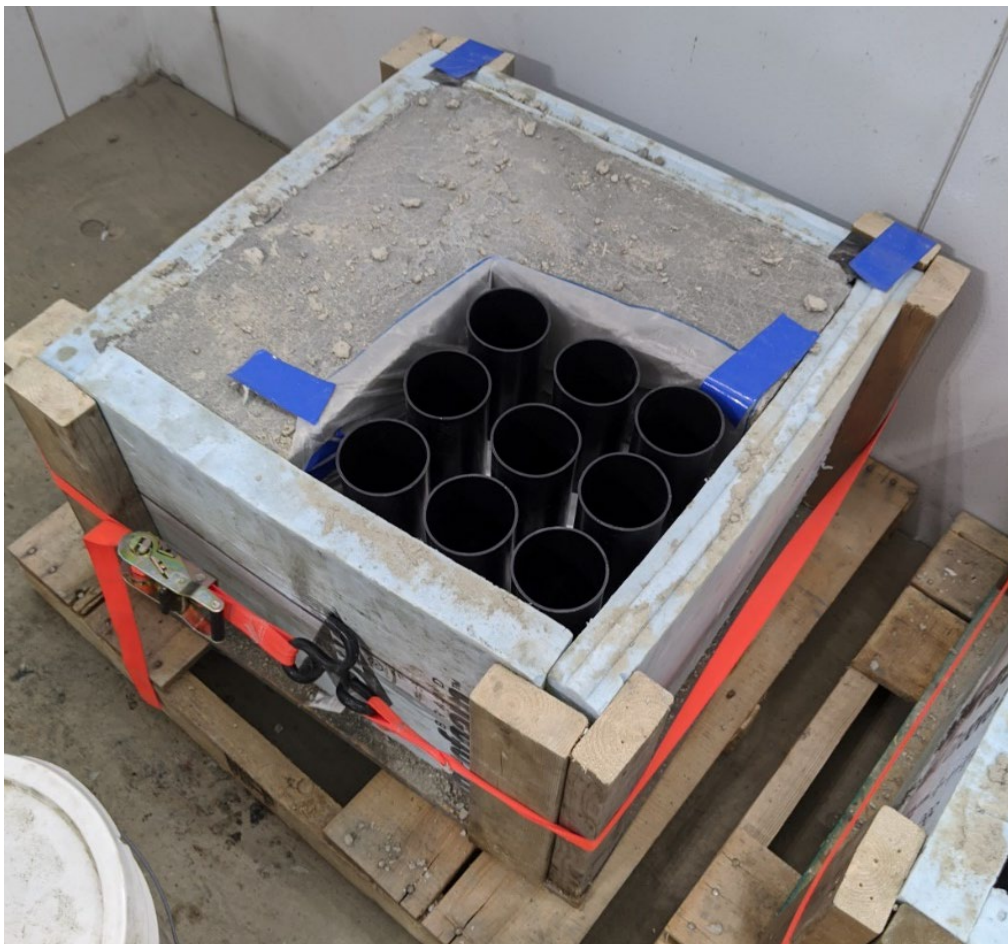
Figure 3. Fully assembled CARTS apparatus in the cold room, ready for testing.

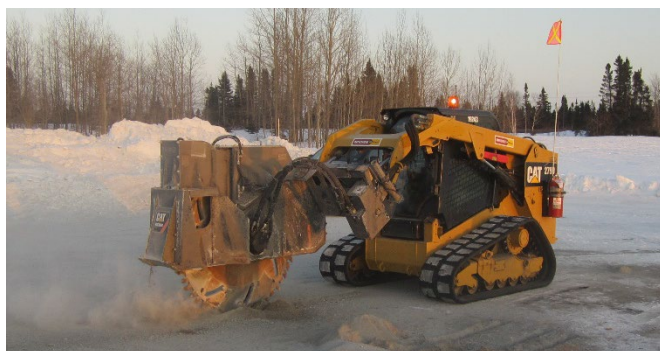
Figure 16. Caterpillar 279D with SW360 wheel saw attachment.

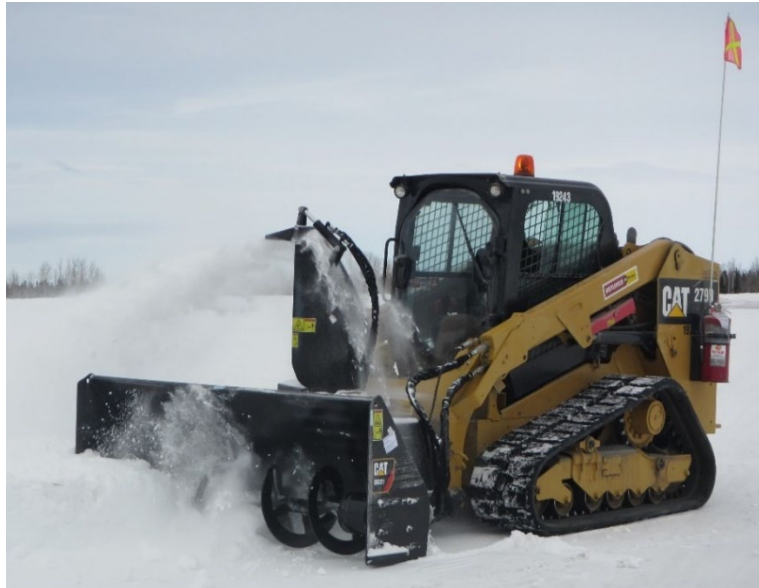
Figure 17. Caterpillar SR321 snowblower attachment.

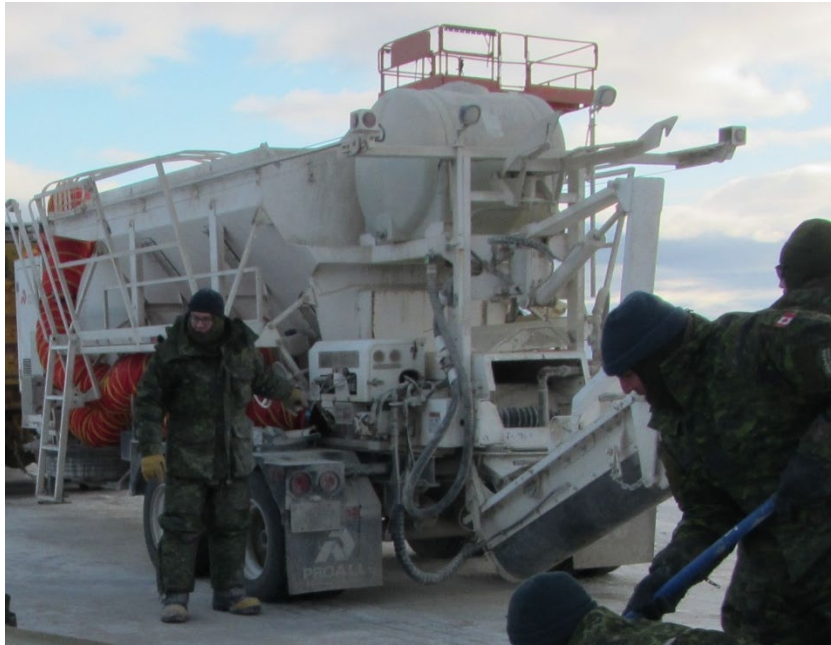
Figure 27. Simplified Volumetric Mixer (SVM).

The mixer consisted of a single dry material hopper with a capacity of approximately 7 yd<sup>3</sup>, a conveyor belt feed system, a positive displacement water pump to meter the mix water according to fixed pump speed, two 200 gal. water containers on each side of the mixer, a washout container with a pressure washer, and a replaceable mixing auger. The machine was outfitted with two retractable catwalk platforms, a bin entry platform, a replacement auger, and two super sack piercing points. A steel grate was located near the bottom of the dry material bin to prevent large pieces of material, from entering the conveyor belt and possibly causing considerable damage.

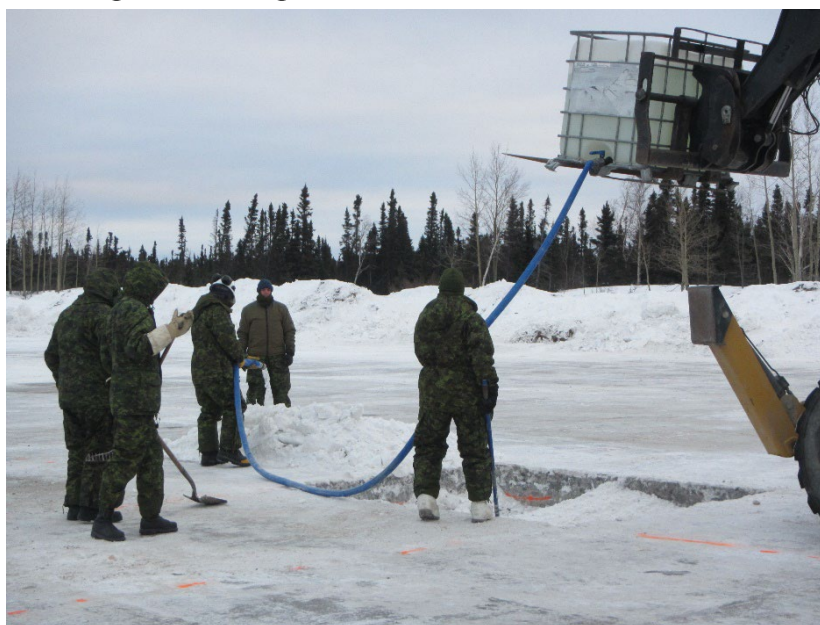
Figure 43. Adding water to snow to achieve ideal moisture.

The processed snow was then spread evenly within the repair before compaction. Preferably, only the quantity of snow needed for one lift was processed each time. The volume of borrow snow required was approximately 1.5 times the volume of the finished lift. Table 10 shows the target lift thickness for repairs backfilled with snow.

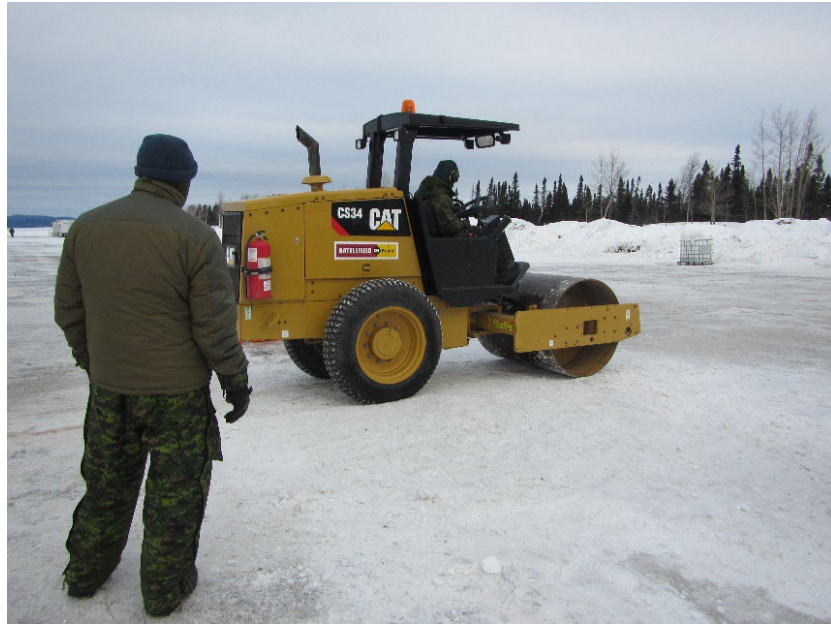
Figure 44. Compaction of final lift of snow-water slurry with vibratory roller compactor.

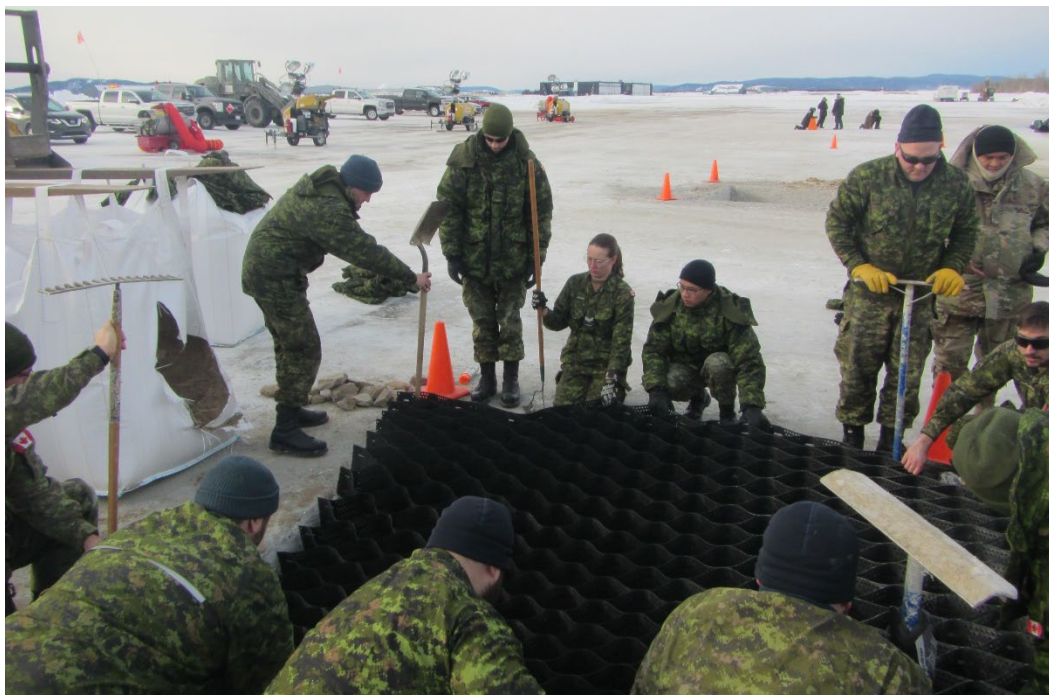
Figure 46. Expanding geocells inside repair.

Once the exact plan dimensions of the repair were determined, the geocells were cut to fit. A proper fit is critical since expansion of the cells is needed for optimal performance. In cases where the repair length was different from the repair width, the dimensions of the first layer of geocells may not be the same size as the sections for the second layer, because the top layer was placed transverse to the bottom layer. The simplest method was to drive a piece of rebar (or similar) in the ground in a square of the same dimensions as the repair, or hold the corners open with a piece of scrap lumber or the handle of a shovel if measuring on a hard surface (Figure 46). Each of the rebar stakes or handles represented the corners of the repair. An additional piece of rebar or a handle was placed between these to prevent the geocell section from collapsing. To cut the first layer of geocells, the corners of a geocell section were placed at two of the corners and then expanded in the direction of traffic (since the first geocell layer is expanded parallel to the direction of traffic.). While fully expanded, the excess length of the geocell section was trimmed using a utility knife (Figure 47). Each cell was cut individually and carefully such that excess material was not cut. The procedure was repeated for the second layer, except the geocells were expanded perpendicular to the first layer.

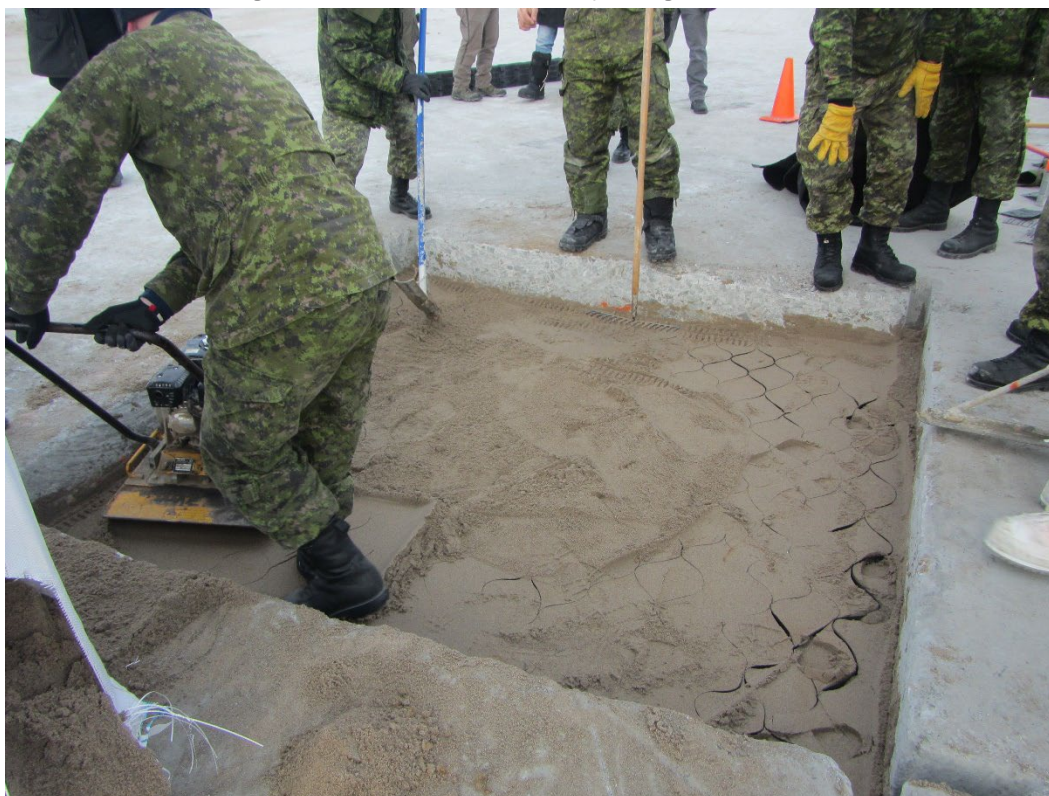
Figure 48. Compaction of first layer of geocell backfill.

Once the geocells were cut to the appropriate size and placed into the repair, super sacks of sand were lifted over the repair with the telehandler, the bottom of the super sack was cut with a utility knife, and the sand was leveled with rakes as it fell into the repair. Sand was placed until a level of approximately 1 in. above the top of the geocells was reached. The plate compactor was used to compact the first layer (Figure 48).

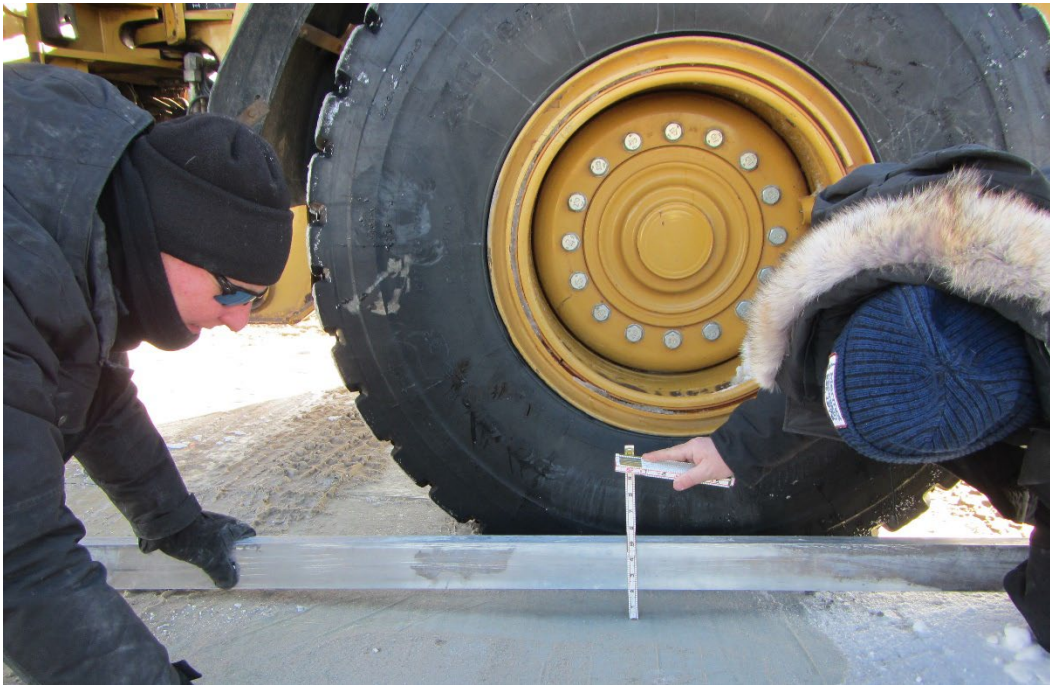
Figure 59. Typical rut depth measurement.

Data collection was performed periodically during trafficking. First, visual observations were conducted, and any damage to the repair surface was noted. Rut depths were measured by placing a 10 ft long straightedge across the repair transverse to the traffic direction in the center and at the two quarter points. The maximum rut depth was recorded in each instance, with a 3 in. deep rut considered as failure. For repairs surfaced with FRP matting, the front tire of a front-end loader was employed to deflect the FRP matting downward along the profile of the rut basin in the underlying material (Figure 59).

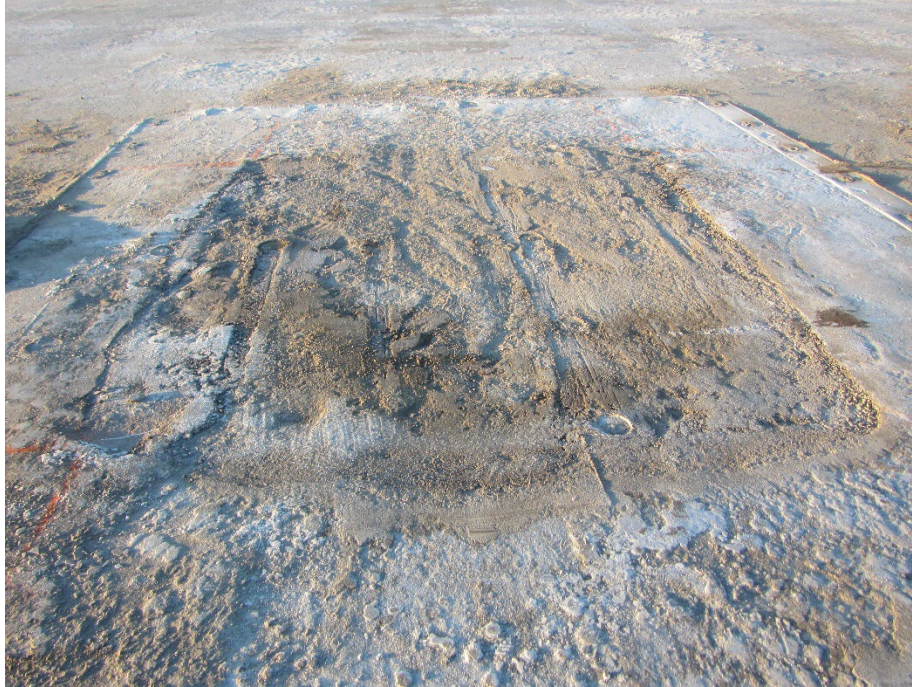
Figure 60. Repair 6, overall surface of RSFF backfill, 500 passes.

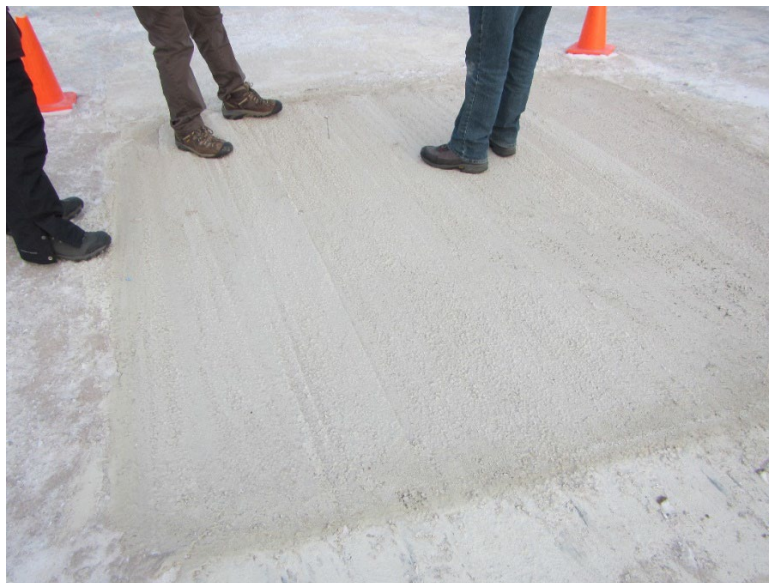
Figure 61. Repair 7, 12 hr cure time, 0 passes.

Repair 7 was backfilled with dry-placed RSFF and capped with RSC. The RSC appeared to reach initial set after approximately 12 hr of curing (Figure 61), and trafficking commenced after 18 hr of curing. Some small shrinkage cracks appeared before trafficking, but they did not propagate during trafficking (Figure 62). Table 20 contains the rut depth data for Repair 7. Trafficking continued until 1,000 passes had been applied with virtually zero deformation observed overall during trafficking.

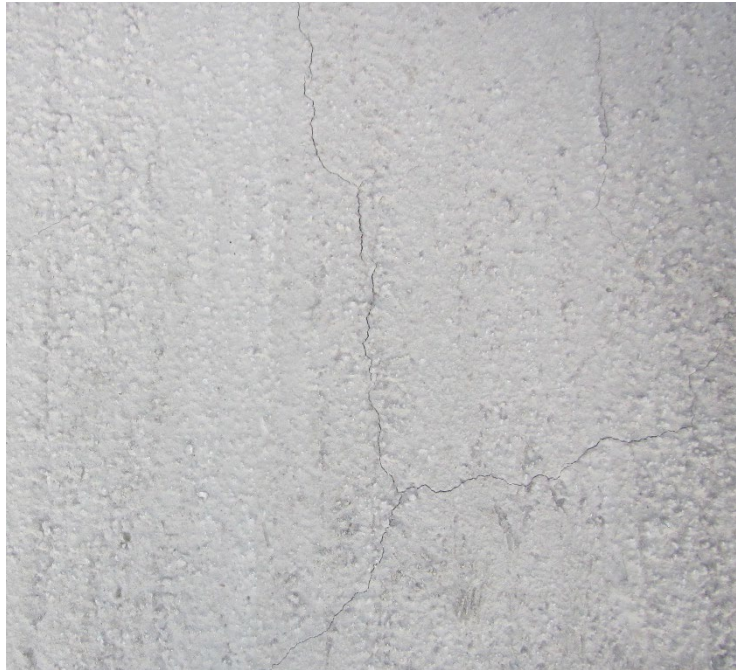
Figure 62. Small shrinkage cracking on Repair 7, 18 hr cure time, 0 passes.

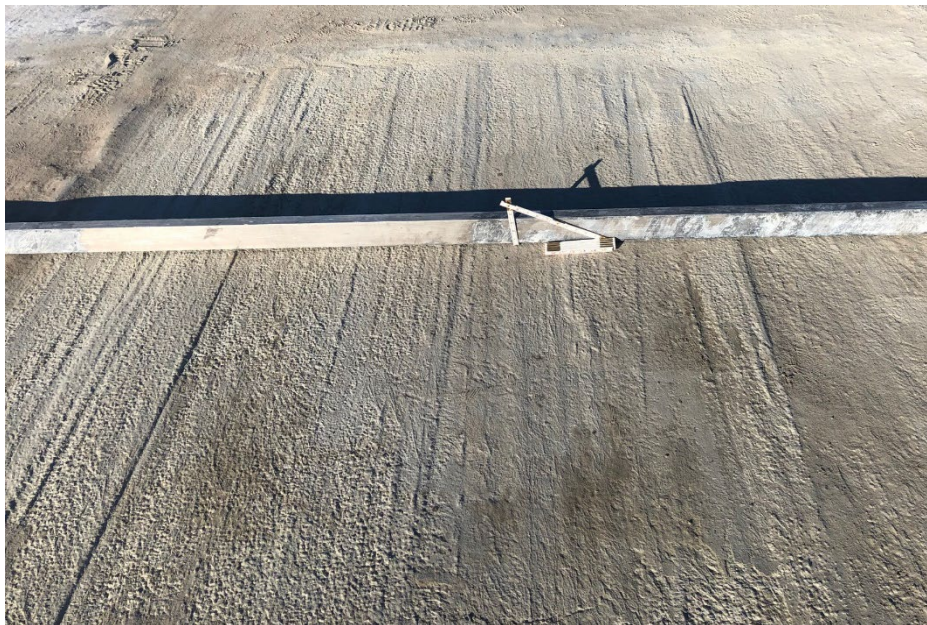
Figure 63. Repair 7, overall, 1,000 passes.

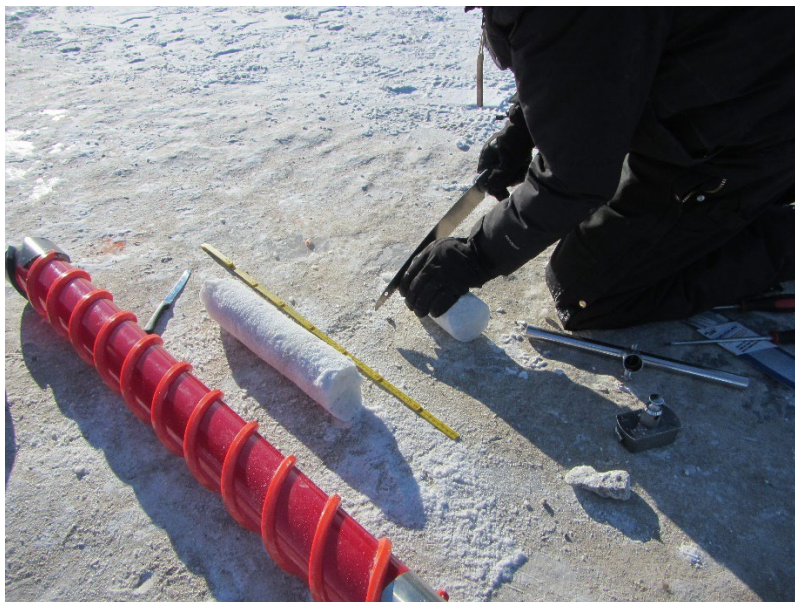
Figure 71. Core sectioning for weight and volume measurement to calculate density.

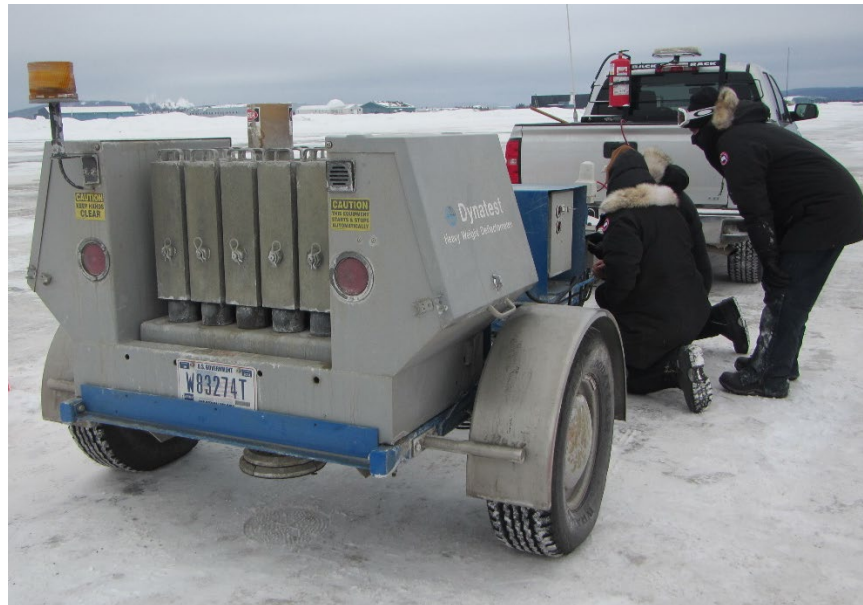
Figure 72. Heavy weight deflectometer (HWD) test device.

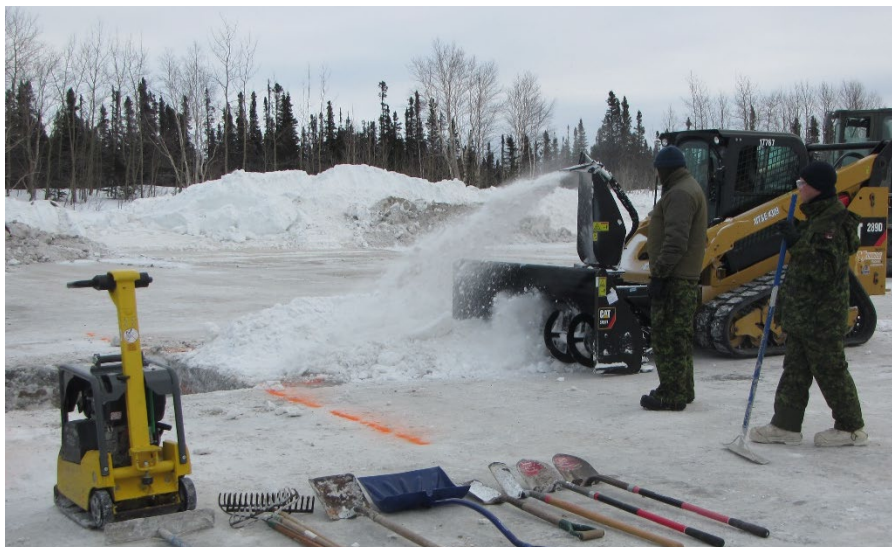
Figure B-2. Snow being blown into crater in lifts in preparation for leveling and compaction.

3. Operate the snowblower along the windrow, parallel to the edge of the crater, directing ejected snow into the crater in as uniform a layer as possible (Figure B-2).

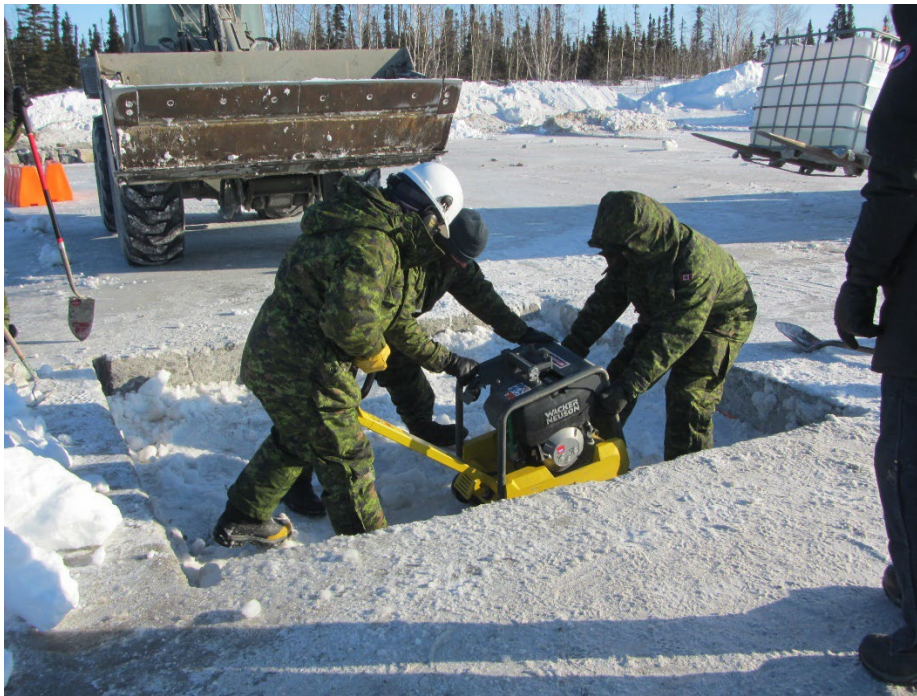
Figure B-4. Vibratory plate compactor consolidating the top of a completed lift.

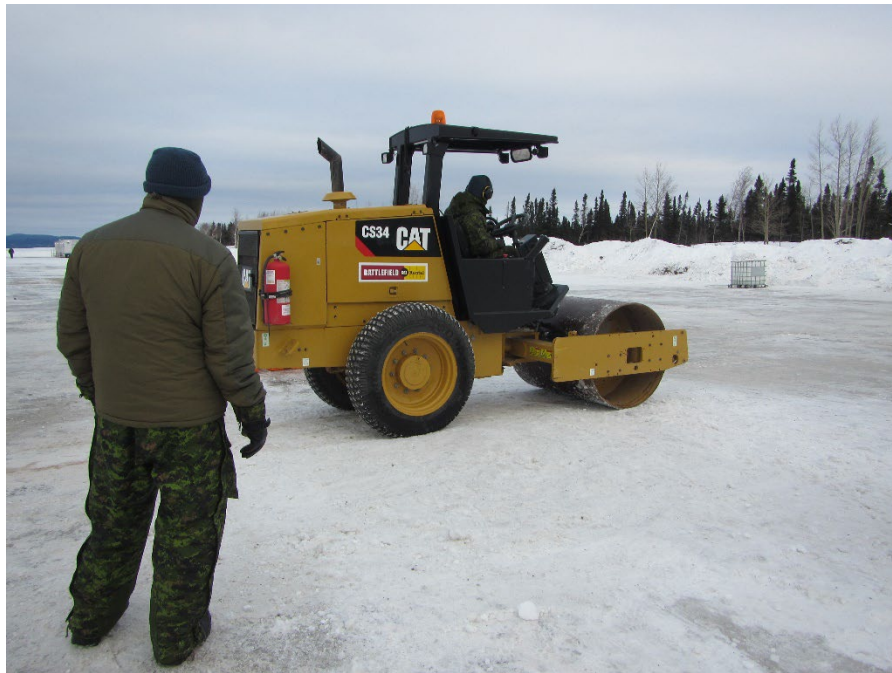
Figure B-5. Vibratory drum roller compacting top of a completed crater patch.

6. Borrow snow for the next lift should be delivered to the crater edges (see step 2 above) while leveling and compaction of the lift is being accomplished.
7. Construct each subsequent lift of the crater patch by repeating steps 3 through 6.
8. The final lift, representing the top of the crater patch, must be approximately two inches above the surrounding (undamaged) pavement.
9. Final compaction is achieved with a moderate-sized vibratory drum roller (10,000–15,000 lb operating weight; Figure B-5) when the finished patch
