WADC TECHNICAL REPORT 53-185

A STUDY OF THE RAIN EROSION OF PLASTICS AND METALS

CORNELL AERONAUTICAL LABORATORY, INC.

FEBRUARY 1954

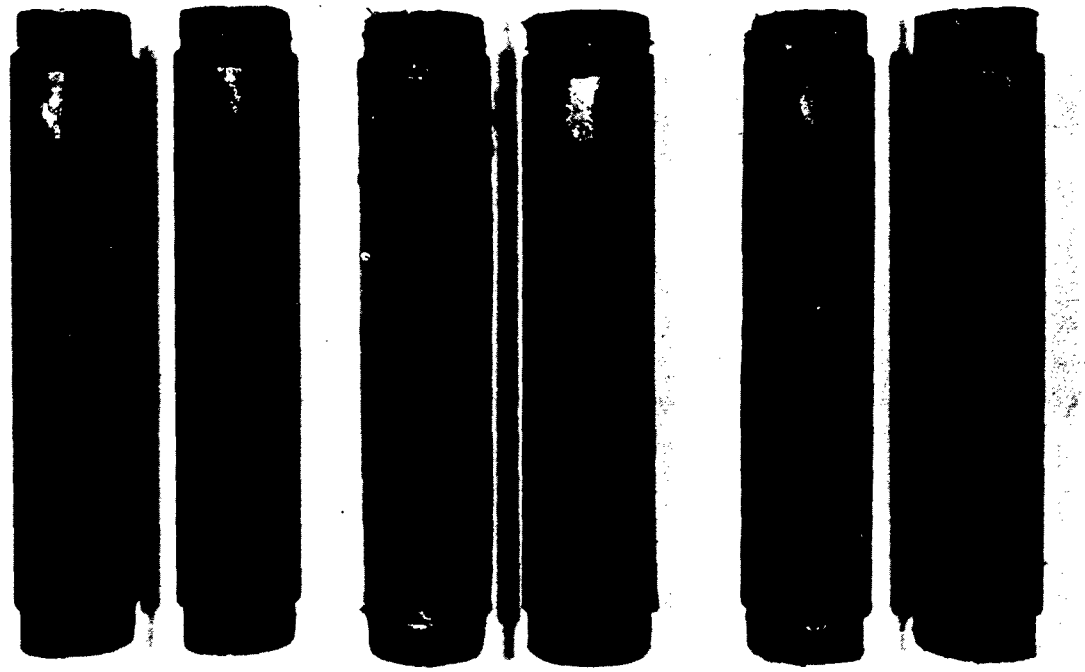
Figure 2 View of Neoprene Coatings After One Year's Outdoor Exposure

Bostik 4764-27 coated specimens #553 with Gaco N-79 and #556 with Goodyear 23-56 top coats, after one year's exposure, are shown in Figure No. 2. Microscopic examination of both top coats indicates alligatoring of the neoprene films. Gaco N-79 showed slightly greater amount compared to Goodyear 23-56. This effect is not visible to the unaided eye.

SPECIMEN #	536 A	536 B	419 A	422 B	556 A	556 B
TOPCOAT	GACO 79		GOODYEAR 23-56		GOODYEAR 23-56	
[illegible] TIME	BRUSH	BRUSH	BRUSH	SPRAY	BRUSH	BRUSH
[illegible]	25 MIN	30 MIN	100 MIN	20 MIN	55 MIN.	60 MIN

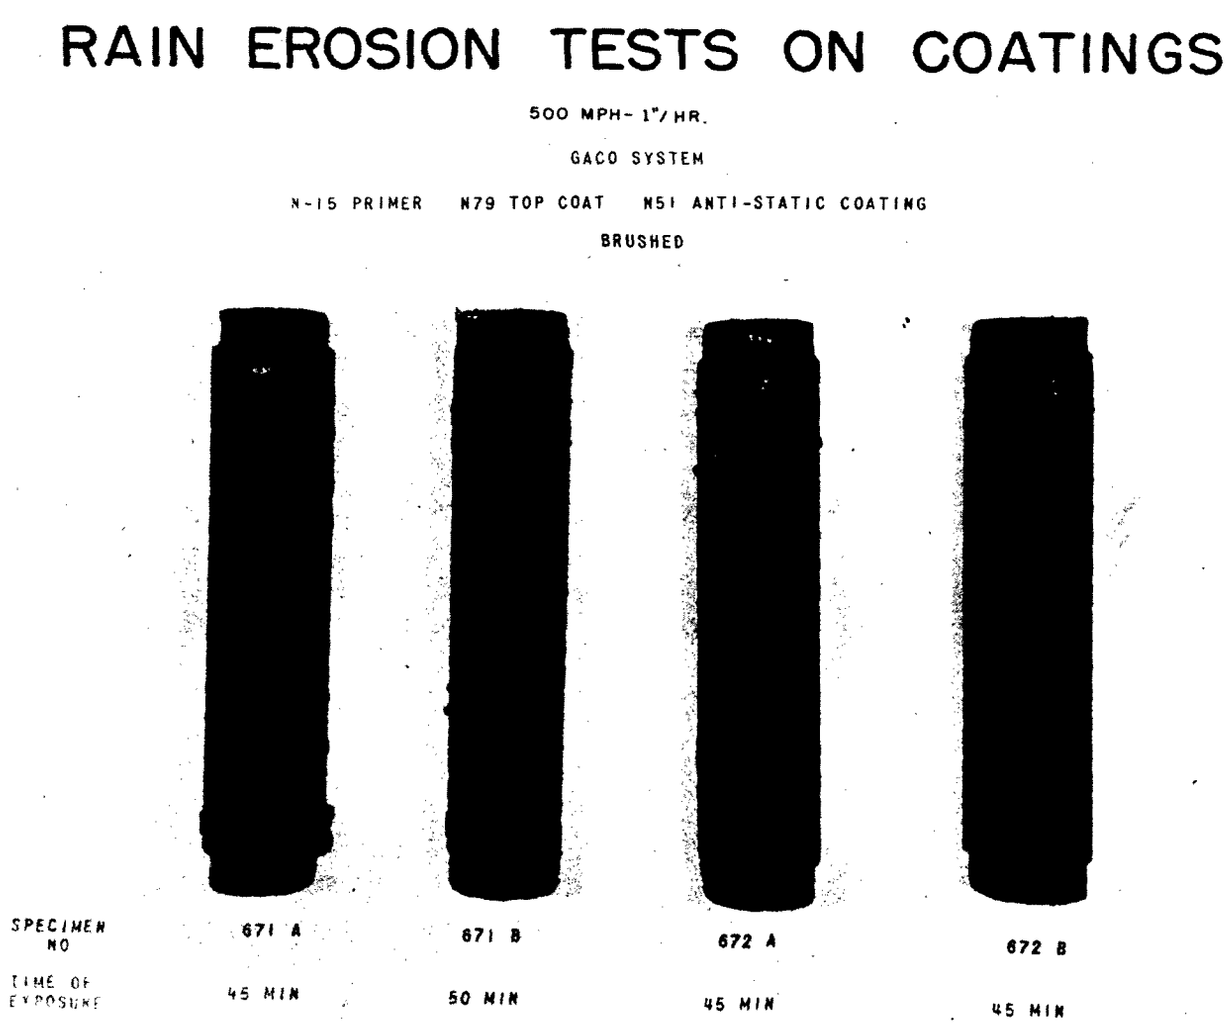
Figure 3 Gaco N-79 Specimens After Test

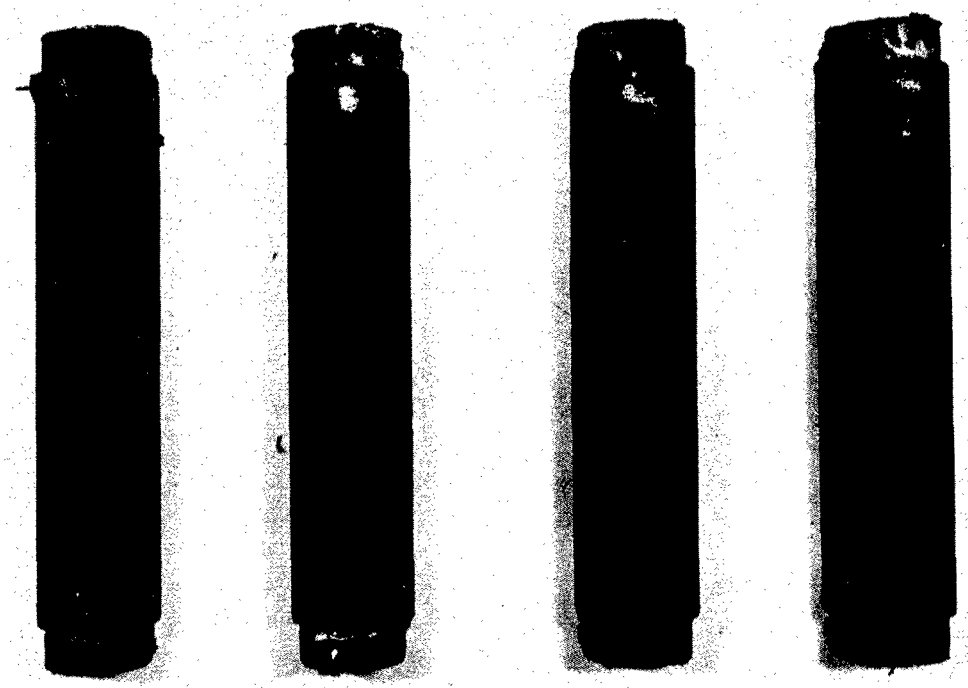
Erosion tests at 500 mph and 1"/hr. rainfall were carried out on specimens #671, 679, and 808 after air drying for 150 hours at room temperature. Specimens #678, 680, and 809 were air dried at room temperature for 150 hours and then exposed to 200°F for 20 hours and evaluated for rain erosion resistance under standard conditions as noted above. The specimens of the Gates air dried coatings after testing are shown in Figure No. 4.

Figure 4 Gaco Anti-static Specimens After Evaluation

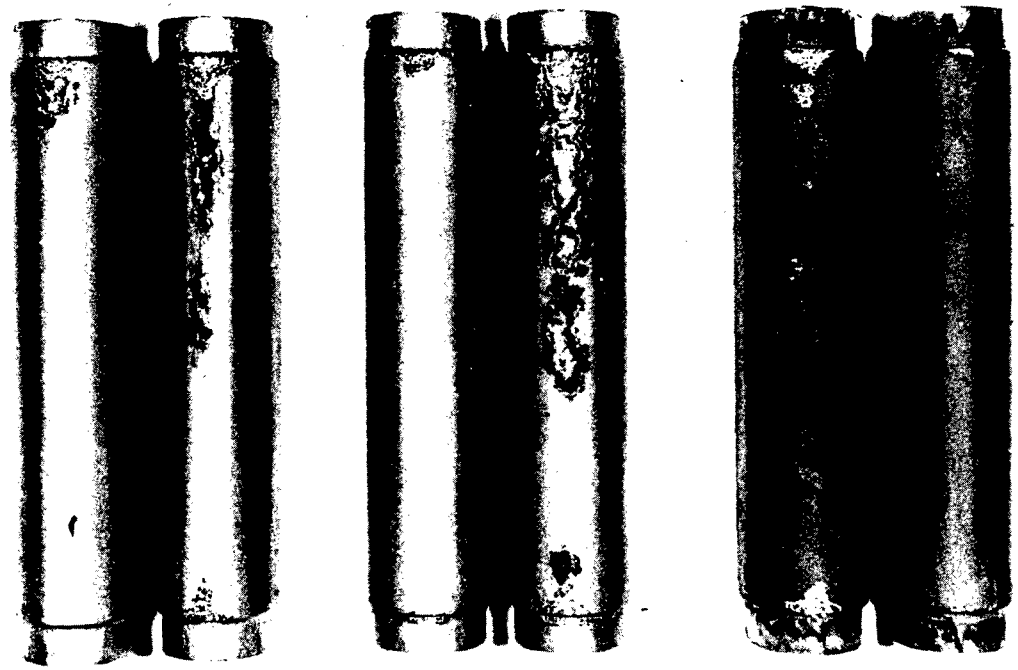
Figure 6 View of 3M Coatings on Fiberglas After Test

SPEC #	366 A&B	367 A&B	368 A&B
TOPCOAT	3M-X33030	3M-X231108	3M-X34932-C
TIME OF EXPOSURE	6 MIN	5 MIN.	9 MIN.

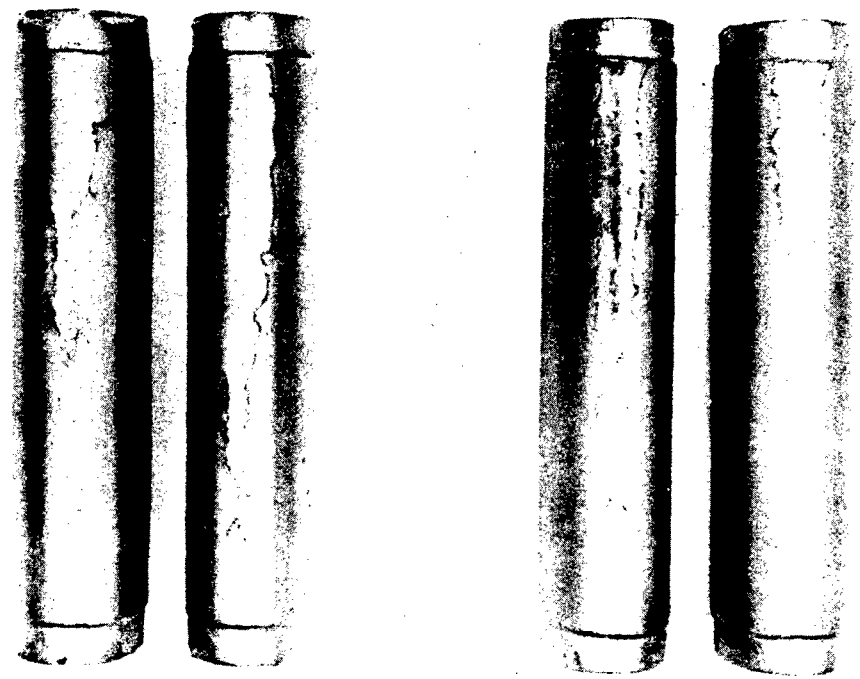
Figure 7 View of 3M Coatings on 24ST Alclad After Test

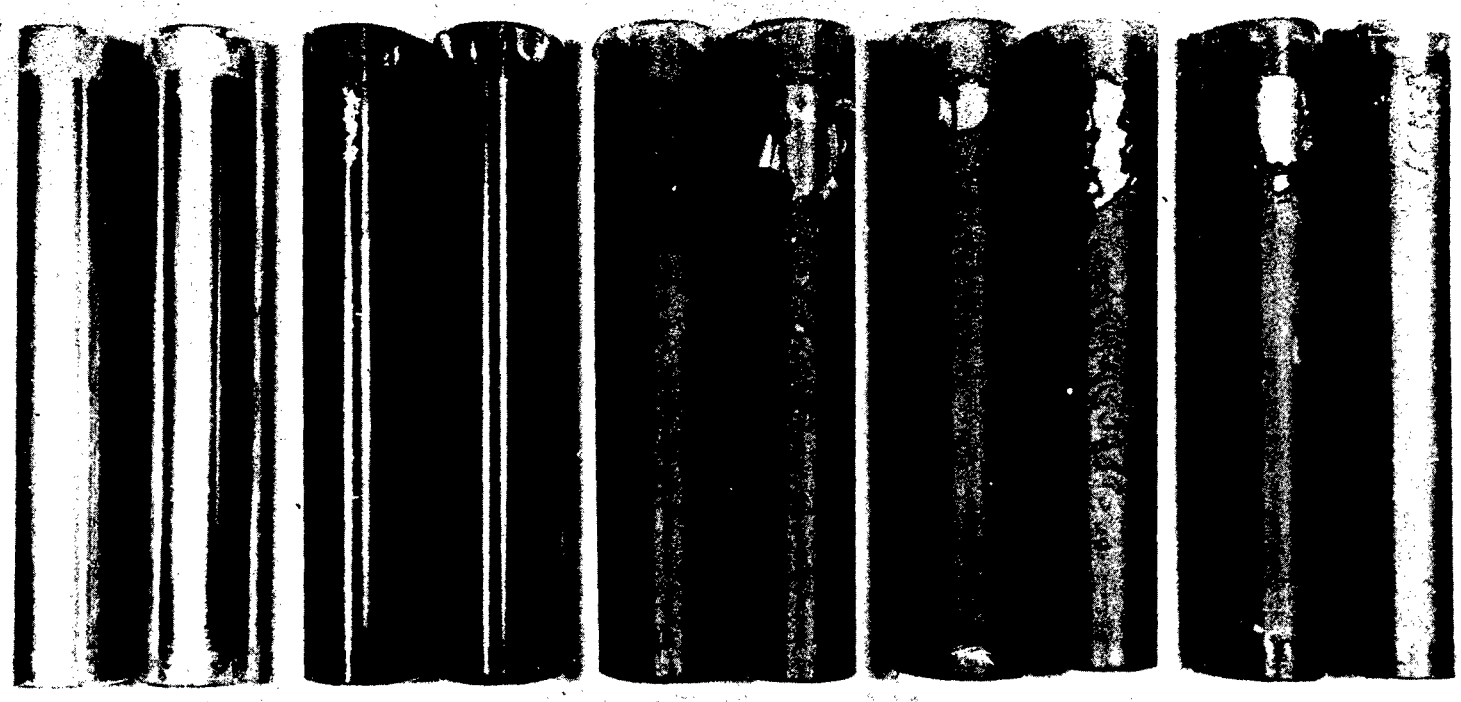
These specimens, #698 A & B and #699 A & B were tested at 500 mph and 1"/hr. rainfall. In general, all four specimens failed through loss of adhesion in ten to fifteen minutes. Due to impact of the rain drops, the film then elongated and because of the inelastic nature of the film, bubbles were formed. These bubbles ruptured in twenty to twenty-five minutes.

Figure 9 View of Douglas Coatings After Test

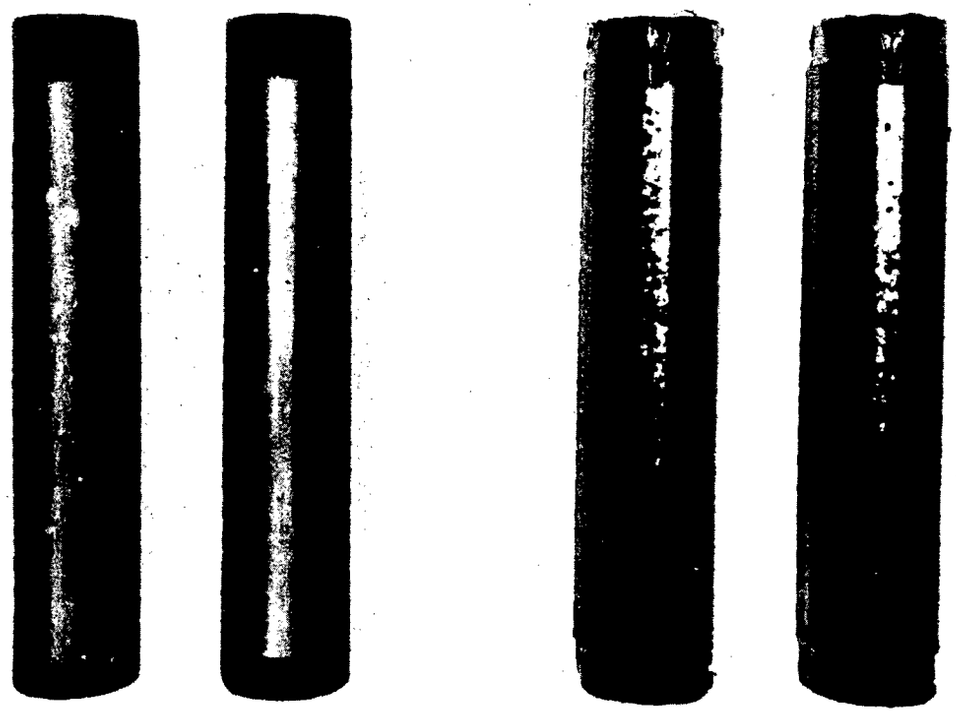
Figure 12 View of Piasecki and Goodyear Specimens, After Testing

On Specimens #629 A & B, which were received at a later date, the following results were obtained. At the end of the first minute of testing, the black lacquer had eroded off the entire leading edge to the primer. At the end of three minutes of testing, the zinc chromate and wash primer were removed from the leading edge. At the end of ten minutes testing the zinc plate showed signs of pitting off in areas fifty mils in diameter. This erosion progressed until the zinc plating was stripped off the entire leading edge at the end of twenty minutes. Figure 12 shows the specimens after twenty minutes of testing.

C A L SPECIMEN NO	629 A	629B		684 A	684 B
PIASECKI CODE NO.	J1	J2			
TOTAL TIME	20 MIN	20 MIN	Figure 12	2 MIN.	2 MIN.

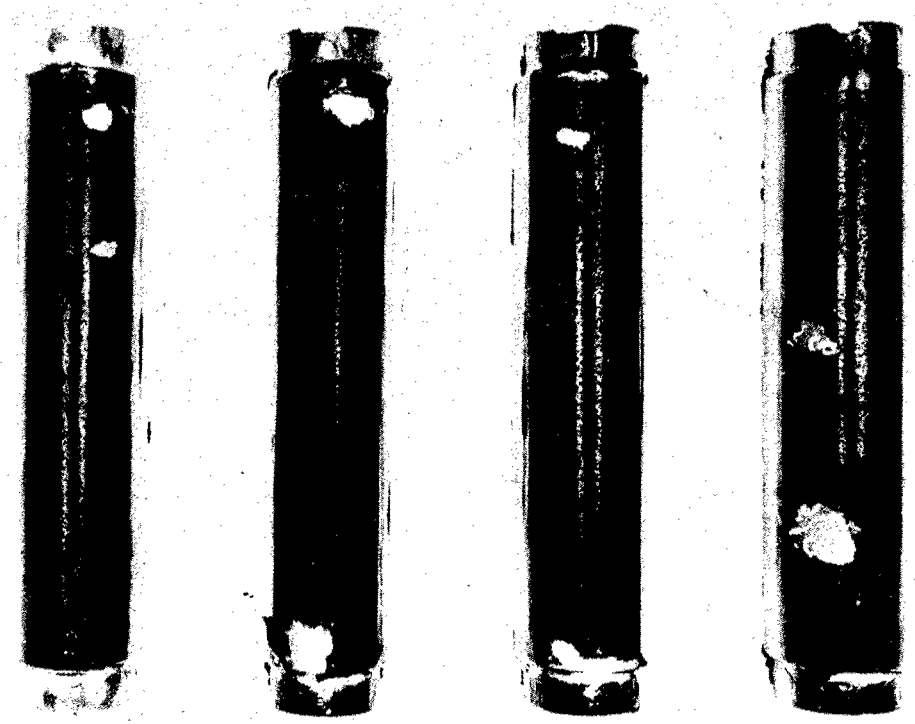
SPECIMEN NO.	634 A	634 B	635 A	635 B
TIME OF EROSION	22 MIN.	17 MIN.	20 MIN.	15 MIN.
