ERDC/GSL TR-18-26

Rapid-Setting Flowable Fill Performance in Cold Weather for Airfield Damage Repair

August 2018

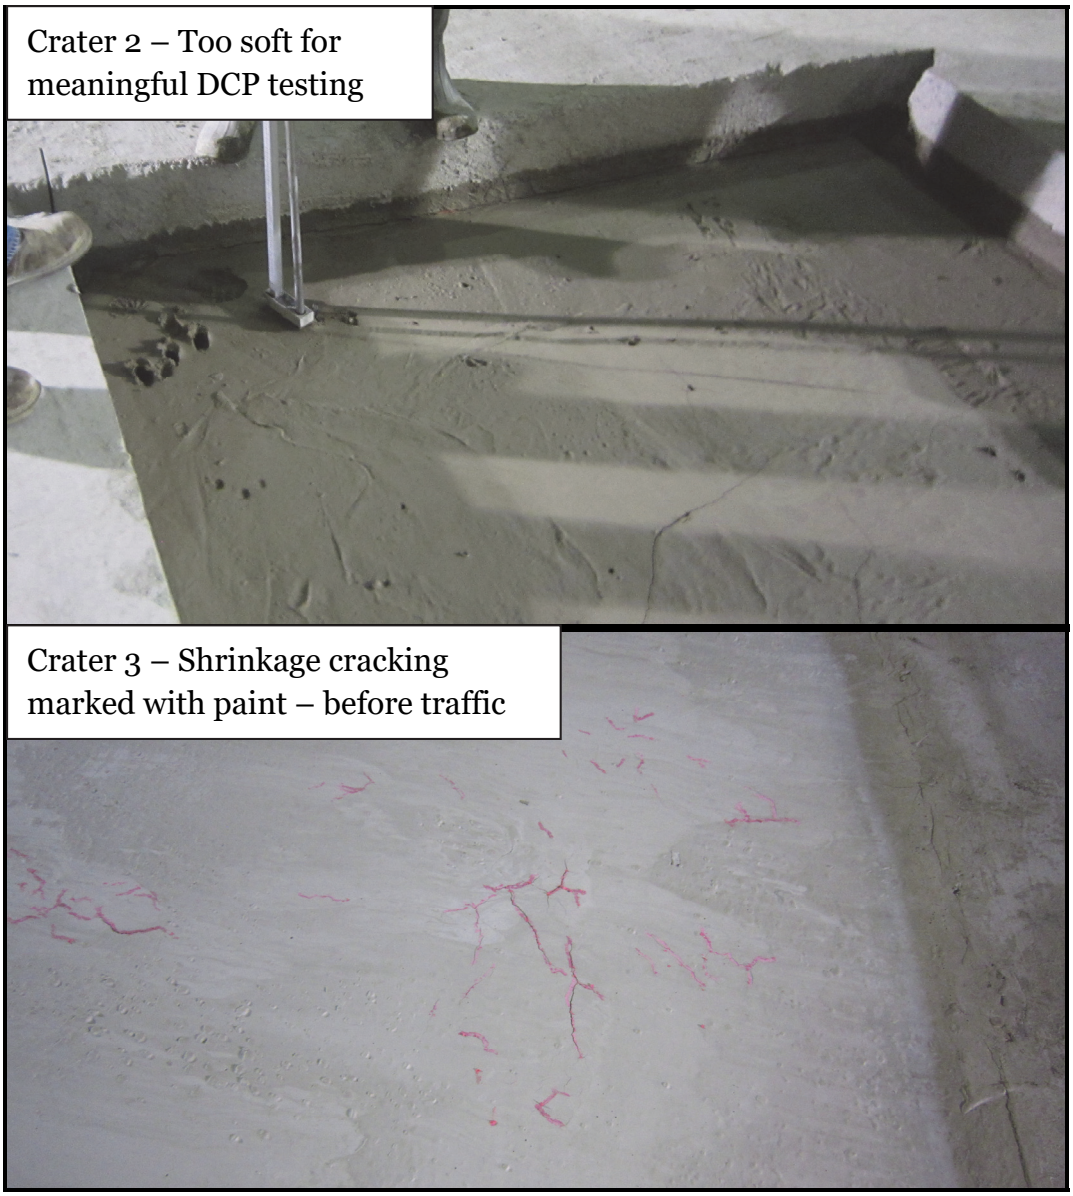
Figure 27. Visual assessments from crater repair testing – Craters 2 and 3.

The $AlSO_4$ additive did not perform well when used by itself to accelerate the chemical reaction of VMFF. Crater 2 did not set up at all, which was considered a failure that led to this material being removed before a cap was placed.

No structural failures occurred for the crater repairs that were trafficked, implying that VMFF capped with RSC was adequate for the as-placed thicknesses. As with other crater repairs, repair edges are the likely failure mode since there is no load transfer at the edge. This is especially true in cold regions as the lower temperature pavement surrounding the crater is going to reduce curing temperatures near the edges, weakening the system in this region at early ages.

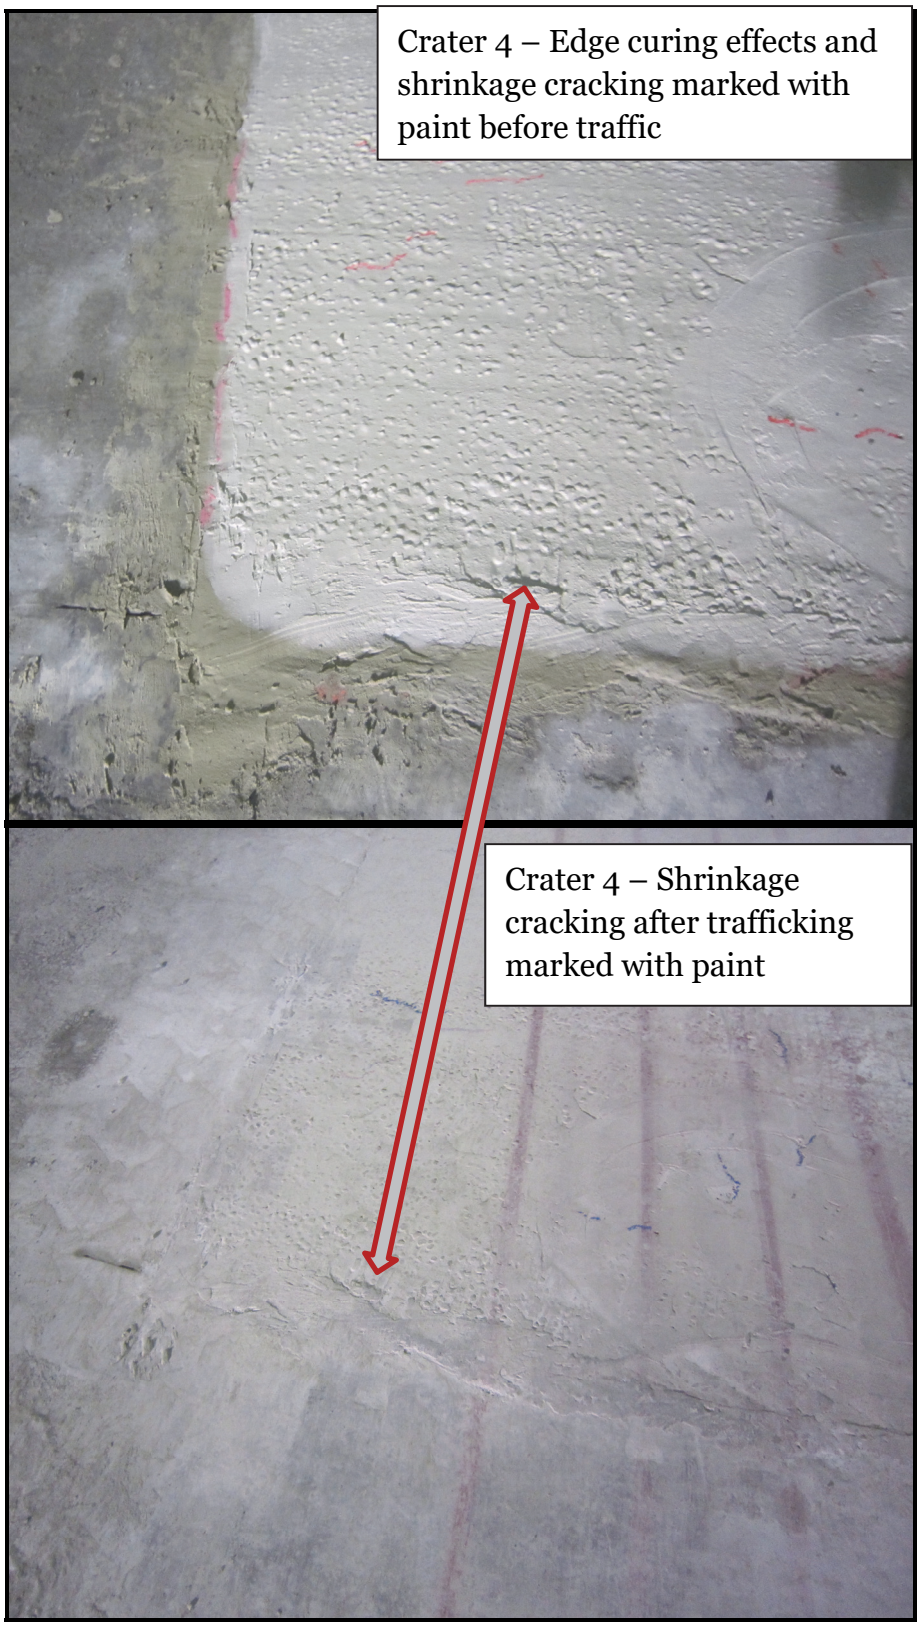
Figure 28. Visual assessments from crater repair testing – Crater 4.

Table 5 provides as-built crater properties with average thicknesses from rod and level survey measurements. Table 6 and Figures 26 to 29 provide visual assessments of all five crater repairs tested with an F-15E aircraft load alongside two examples of newly completed craters. A key observation was that all crater repairs that were trafficked (Craters 1, 3, and 4) were able to withstand 112 passes of the F15-E load cart.

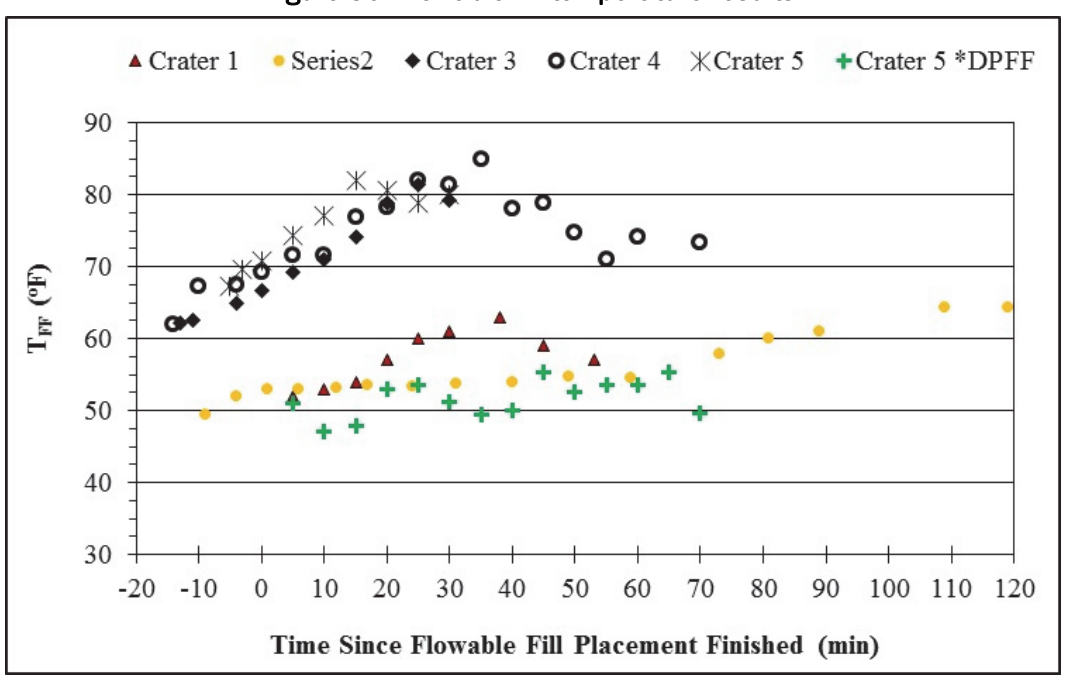
Figure 30. Flowable fill temperature results.

Craters 1 and 2 did not use heated water, and their temperatures were 50 to 64°F (Figure 30). Craters 3 to 5 did use heated water, and their temperatures were 62 to 85°F. When these values are compared to the MEF/FERF temperatures of 20 to 33°F and the small size of the molded cylinders are considered, it is apparent that the temperature condition of the molded cylinders is not representative of the conditions of the larger repairs. The larger repairs benefit from exothermic heat generation from cement hydration. Therefore, measuring properties on small molded specimens in order to represent properties present in the actual repair need to consider exothermic heat generation in the curing protocol for very early-age testing (e.g., 1 to 4 hr). Obtaining core samples directly from the crater repair could be a more effective way of measuring early-age properties of RSFF or RSC in sub-freezing temperatures. When viewing Figure 30, it should be noted that these temperatures were in the upper portion of the crater (a noticeable distance from an edge). Temperatures closer to the middle of the crater would be expected to be higher than those in Figure 30; DCP measurements presented later in this section show CBR values increasing with depth.

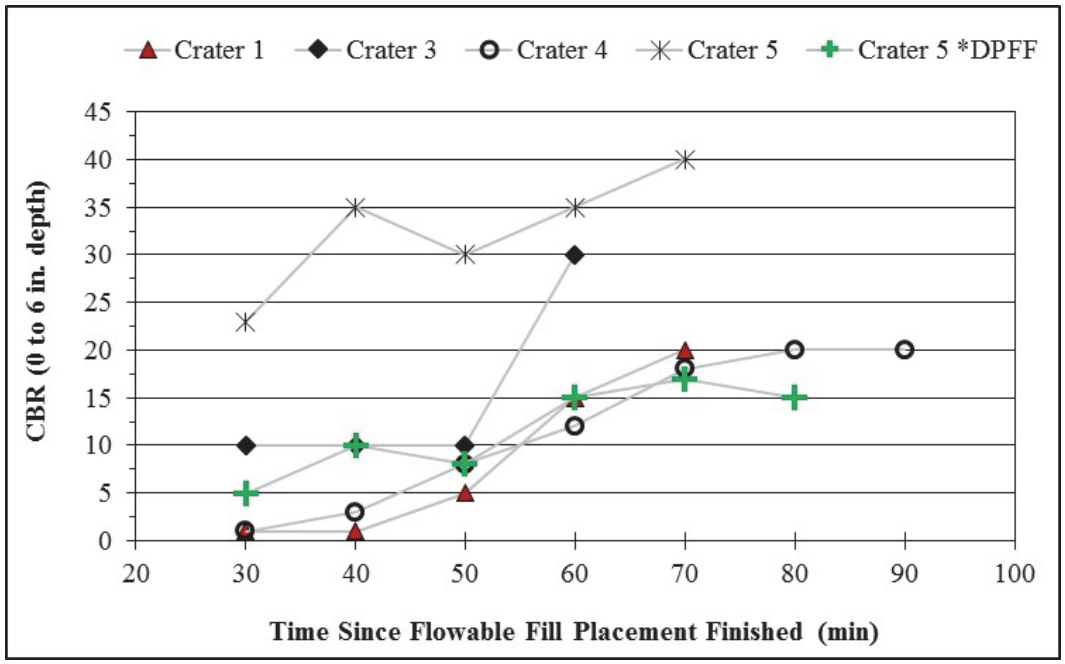
Figure 31. DCP results (0- to 6-in. depth).

The CBR values for all repairs are plotted as a function of time and are shown in Figures 31, 32, and 33 for 0- to 6-in. depth, 6- to 12-in. depth, and 12- to 18-in. depth, respectively. CBR values for Craters 1, 3, and 4 clearly show that heating mix water was more useful than use of $AlSO_4$. All three craters were tested at 30 and 60 min with a DCP, and those readings show that heated mix water made considerable improvements at 30 min, noticeable but lessened improvements at 60 min, and that $AlS0_4$ hindered strength gain even in the presence of heated mix water. Crater 1 was the control section and did not use heated mix water or $AlSO_4$. At 30 min, Crater 3 (heated mix water only) had a composite CBR value over 3 times that of Crater 1, while Crater 4 (heated mix water and $AlSO_4$) had half the CBR value of the control. At 60 min, Crater 3 had a composite CBR roughly 1.4 times the control, while Crater 4 had a composite CBR value roughly one-third of the control. By 90 min of cure time, Crater 4 was comparable to Crater 1 after only 60 min of cure time, i.e., there is evidence that AlSO4 hindered set time. All testing documented in this report showed AlSO4 reducing the performance of crater repairs in cold regions and Crater 3 (heated mix water only) being the best performing option evaluated.
