OPSEC1115

TARDEC Direct Energy Deposition Technical Analysis
Design of Experiments, Part 1, Phase 1

1 May 2017

U.S. Army Tank Automotive Research,
Development, and Engineering Center
Detroit Arsenal
Warren, Michigan 48397-5000

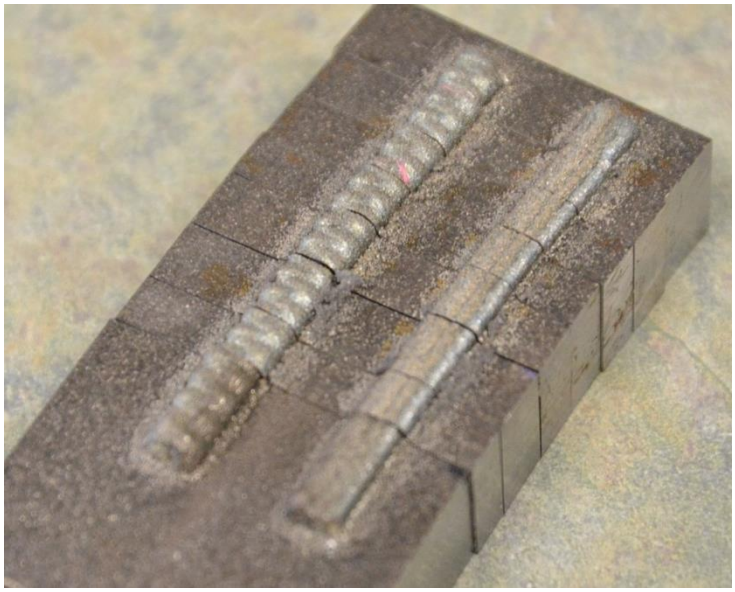
Visual inspection of the deposition can be seen in Figure 1. These depositions were cross sectioned every half inch, from one end to the other, to evaluate the cross sectional layer quality. See Figure 2. The surfaces were polished to a one micron finish, and then etched to evaluate the micro structure and to distinguish between the A514 and Steel interface. It was determined that the Stellite 21 requires a specialty etchant to reveal the microstructure of future depositions. However, this etchant was not available at the time of this report and not required at this point of the evaluations, as only identifying the interface was required.

Figure 1: Sectioned deposition lines. On the left can be seen the Longitudinal/Transverse deposition pattern, and on the right Longitudinal deposition pattern.

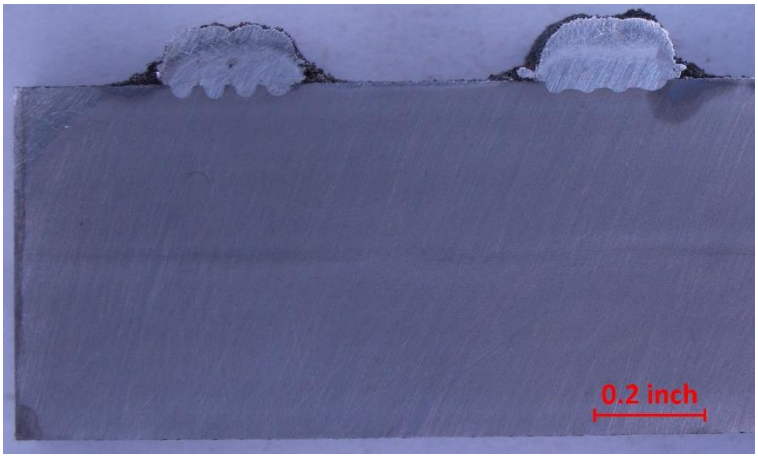
Figure 2: Cross sectioned deposition lines. On the right can be seen the Longitudinal/Transverse deposition pattern, and on the left Longitudinal deposition pattern.

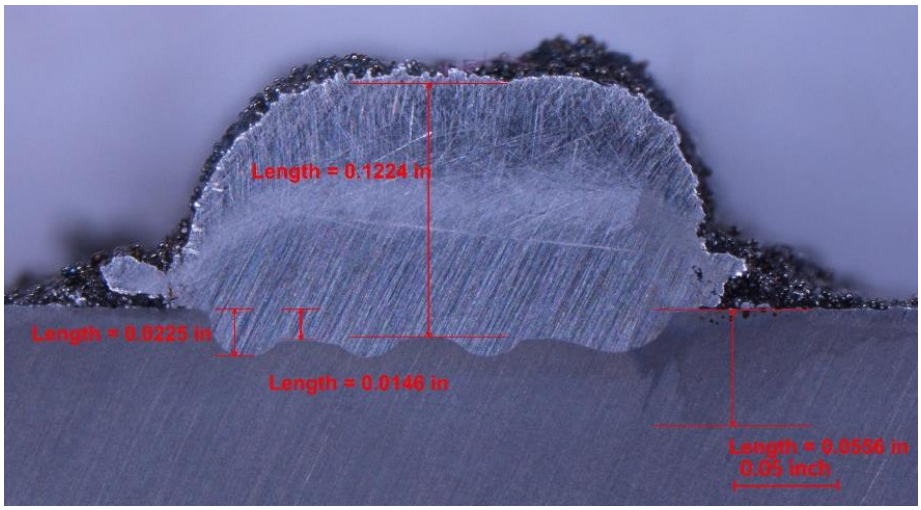
As seen in Figure 3, the deposition had a penetration depth of 0.5715 mm (0.0225 inches) from the surface of the A514 substrate. Total height of the deposition was roughly 3.1090 mm (0.1224 inches), including the overall depth of

penetration. The height of the deposition from the surface of the substrate to the top of the deposition was 2.7635 mm (0.1088 inches). A close inspection of the surfaces indicated one or two pores near the interface on one of the cross sections, as could be seen via microscopic inspection.

Figure 3: Cross sectioned deposition lines. On the right can be seen the Longitudinal/Transverse deposition pattern, and measurements of the deposition penetration depth and height.

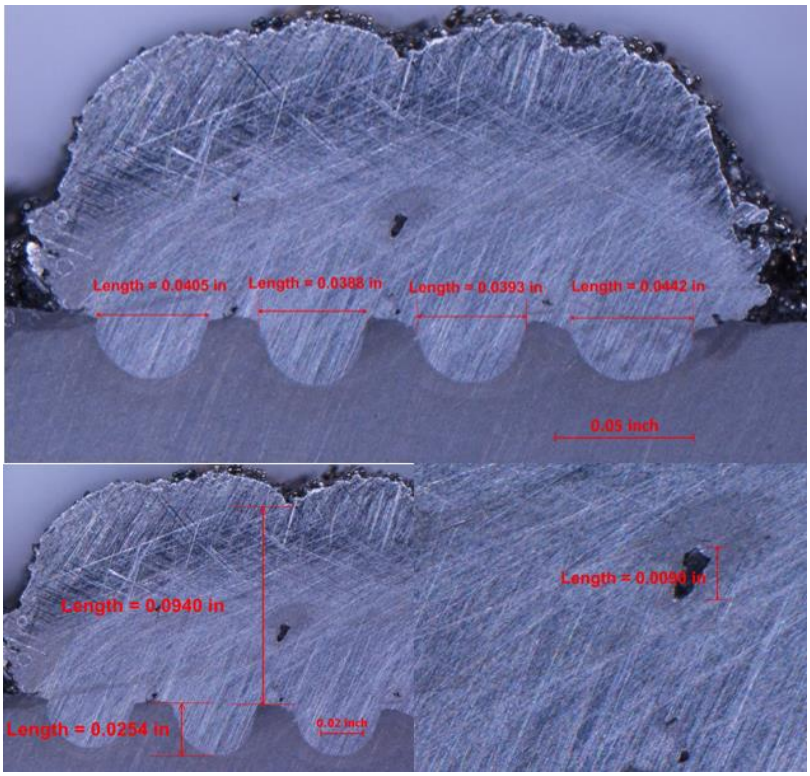
As seen in Figure 4, the deposition had a penetration depth of 0.6452 mm (0.0254 inches) from the surface of the A514 substrate. Total height of the deposition was about 2.3876 mm (0.0940 inches). The surface was further noted to contain porosity between the corners of the deposition passes, as well as within the material between layers. Large pores were documented between the deposition passes.

2. The longitudinal deposition pattern resulted in failure with numerous pores found within the bulk material and at the interface. This indicates most or all parameter settings are too low to achieve a uniform deposition.

Figure 4: Cross sectioned deposition lines. On the right can be seen the Longitudinal deposition pattern, and measurements of the deposition penetration depth and height.

4. TARDEC's Material Characterization & Failure Team recommend:
    a. Moving forward with second phase of depositions by moving the deposition lines close to one another. Reduction of the line spacing within the Longitudinal and longitudinal/transverse layer passes.

b. Adding an additional Longitudinal deposition consisting of an offset layer pattern. Such that the pass lines in a given layer are placed between the deposited pass lines of the preceding layer.

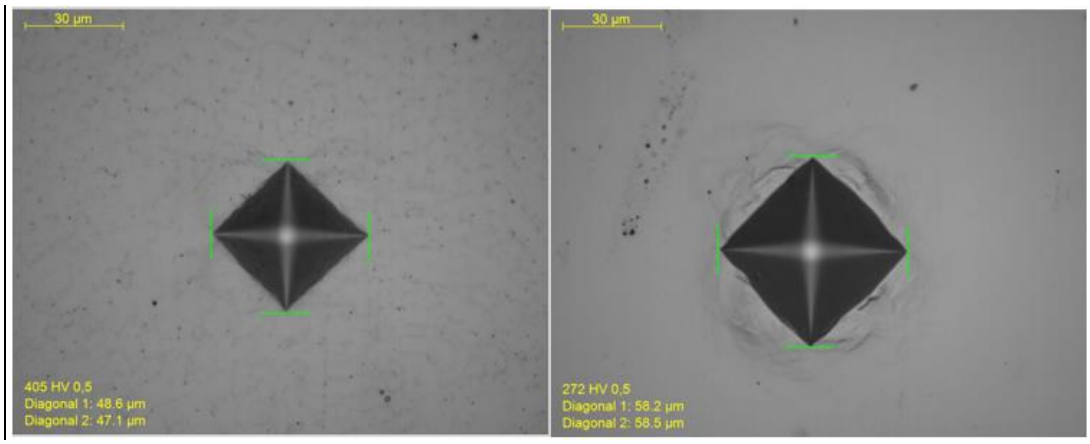
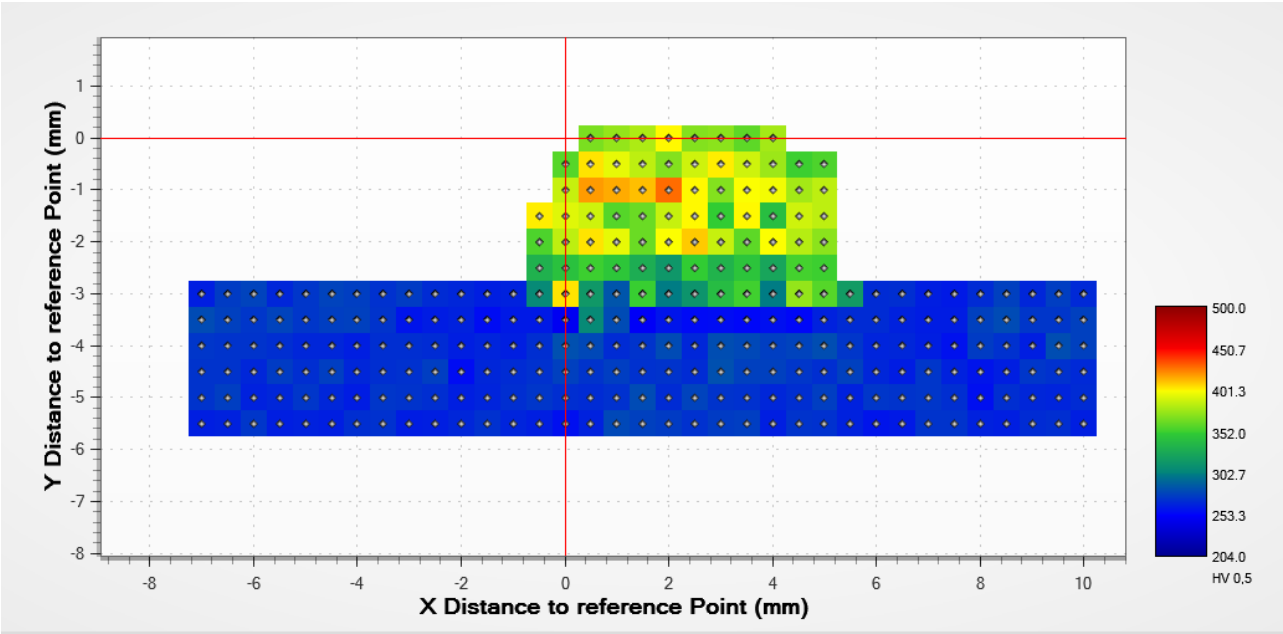
In Figure 5 and 6, Vickers hardness data was collected and analyzed to determine the quality of the deposition. The hardness measurements for the deposition were compiled and the average hardness was determined to be 376 HV. The average hardness of the substrate was determined to be 274 HV.

Figure 5: Longitudinal/Transverse deposition indents. On the left is a Vickers indent into the Stellite 21 deposition and on the right is an indent into the A514 steel. Note the difference in hardness of each material.

Figure 6: Longitudinal/Transverse deposition hardness mapping of the deposition, interface, and substrate.

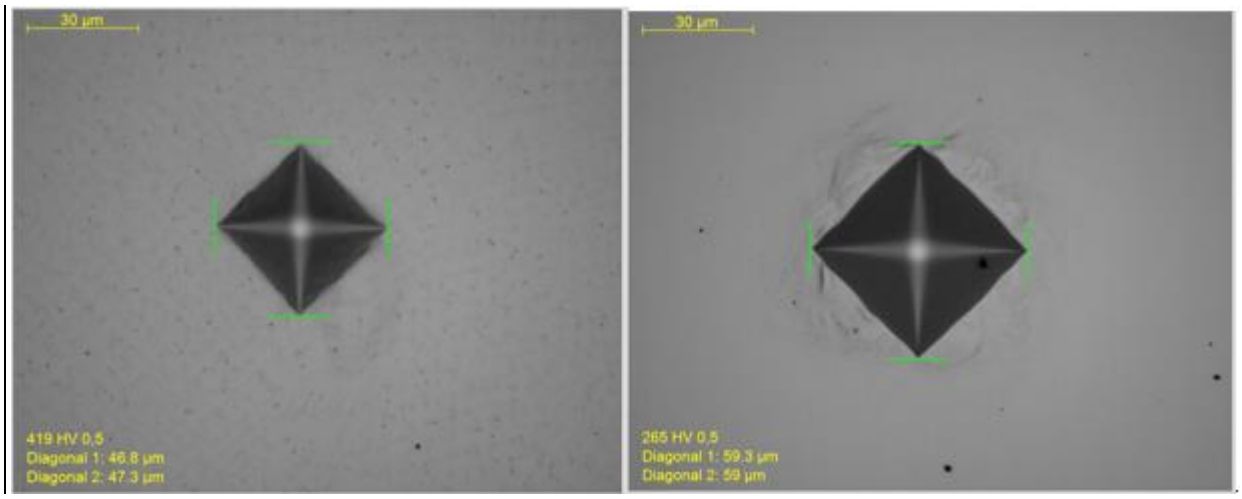
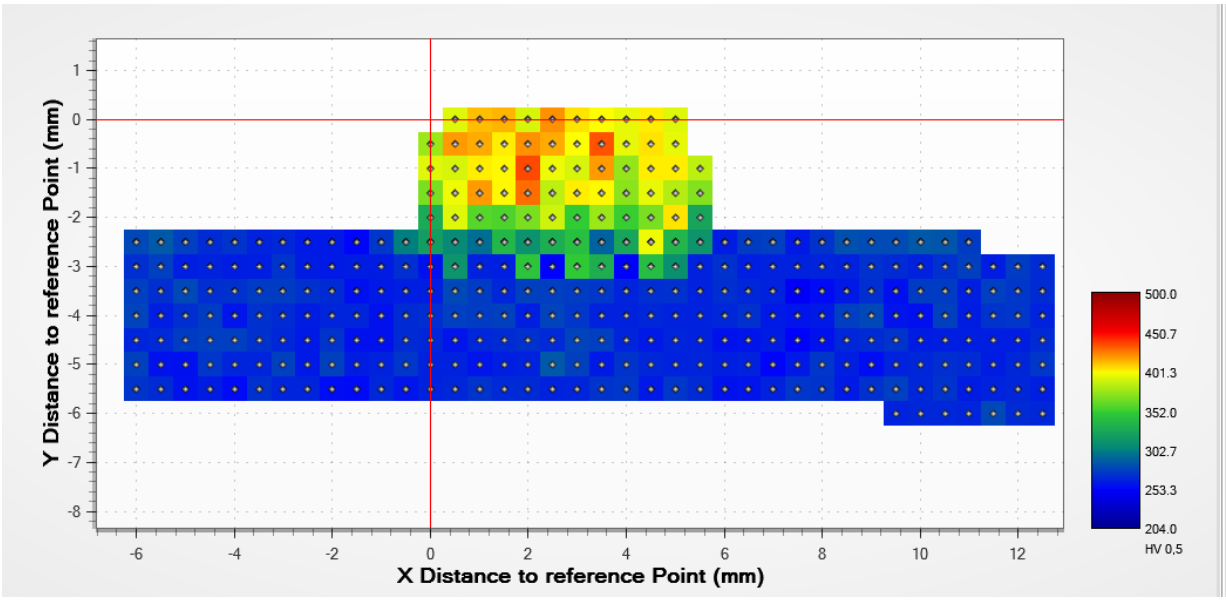
In Figure 7 and 8, Vickers hardness data was collected for the Longitudinal deposition, and the average hardness was determined to be 400 HV. The average hardness of the substrate was determined to be 276 HV.

Figure 7: Longitudinal deposition indents. On the left is a Vickers indent into the Stellite 21 deposition and on the right is an indent into the A514 steel. Note the difference in hardness of each material.

Figure 8: Longitudinal deposition hardness mapping of the deposition, interface, and substrate.

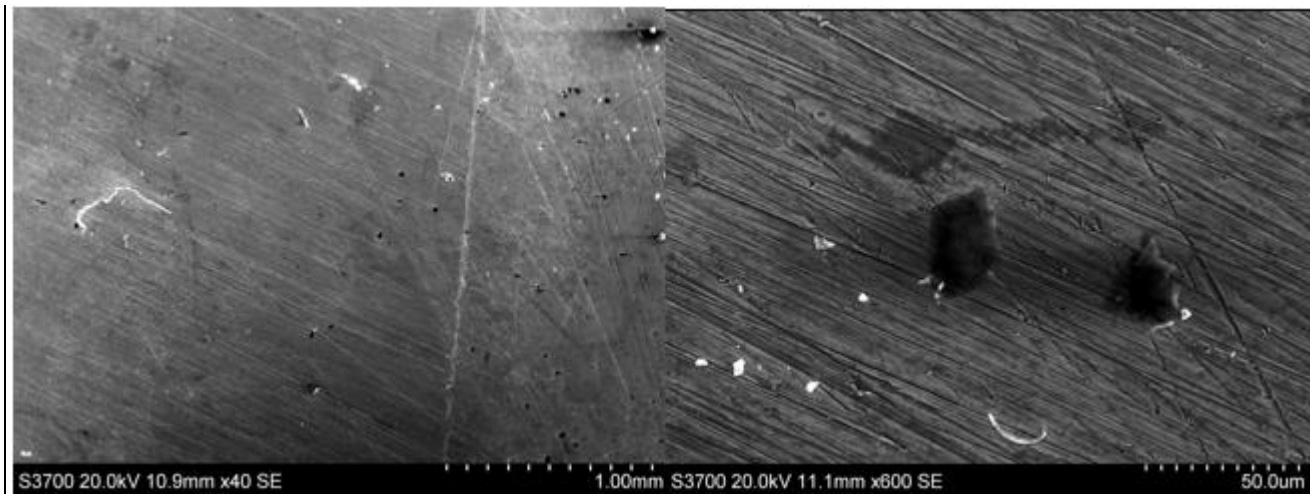
SEM analysis was conducted and found micro pores in both the Longitudinal/Transverse and Longitudinal depositions. These pores were found to be roughly 25 micrometers in diameter. However, the Longitudinal/Transverse deposition had very few pores in the bulk material of the deposition. See Figure 9. The vast majority of pores were located around the deposition surface (away from the bulk material), which would otherwise be removed during CNC finishing operations.

Figure 9: Longitudinal/Transverse deposition SEM imaging of pores and cross sectional surface. The image on the left shows right side of the deposition. The pores located on the right side of the left image are near the surface of the deposition. The image on the right is a close up of two of the pores.

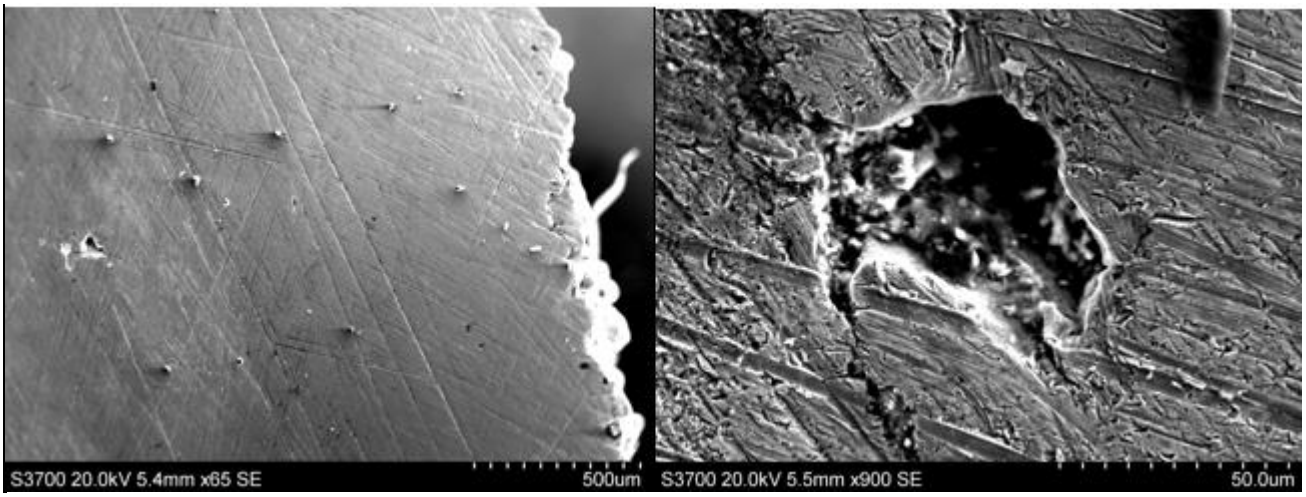
The micro-pores in the Longitudinal deposition appeared to be in less numbers than the Longitudinal/Transverse deposition, but contained more pores and what appeared to be some inclusions within the bulk of the deposited powder. See Figure 10. This was in addition to the visual pores (Figure 4) already identified by microscopic analysis.

Figure 10: Image on the left is of the Stellite 21 Longitudinal deposition upper right edge SEM imaging of pores and cross sectional surface. The image on the right is of a pore in the core material of the Stellite 21 deposition.

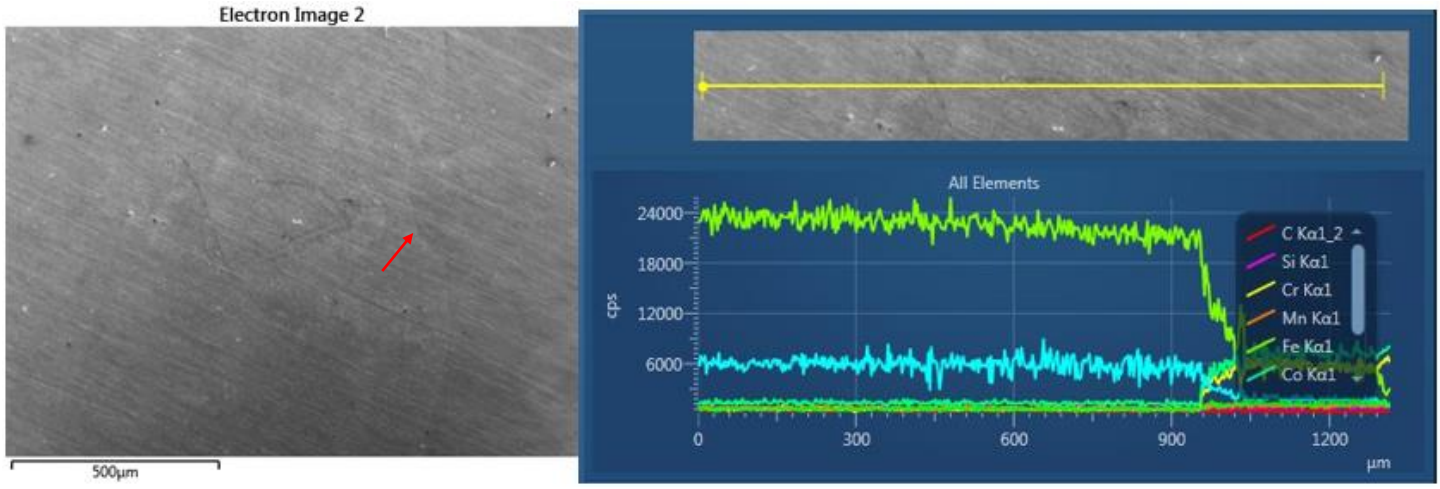
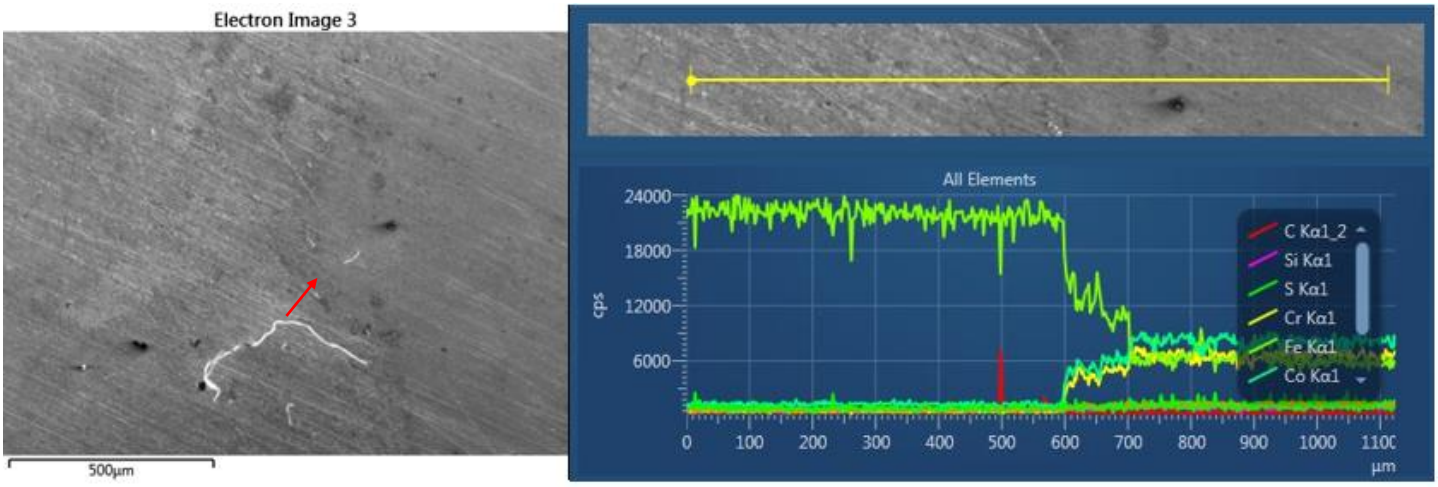
Figures 11 and 12 demonstrated a change in chemical composition as the scanning line crossed the A514/Stellite 21 interface. As can be seen from these images, the surface had little to no defects, and the interface was clearly bonded. Figure 13 shows a line scan of the defects near the deposition surface. Large spikes in carbon are observed, which may be a residual surface coating from polishing medium that was trapped in the pore.

Figure 11: EDS line scans of the Longitudinal/Transverse deposition A514 (on the left)/Stellite 21 (right) chemical analysis.

Figure 12: EDS line scans of the Longitudinal/Transverse deposition A514 (on the left)/Stellite 21 (right) chemical analysis.

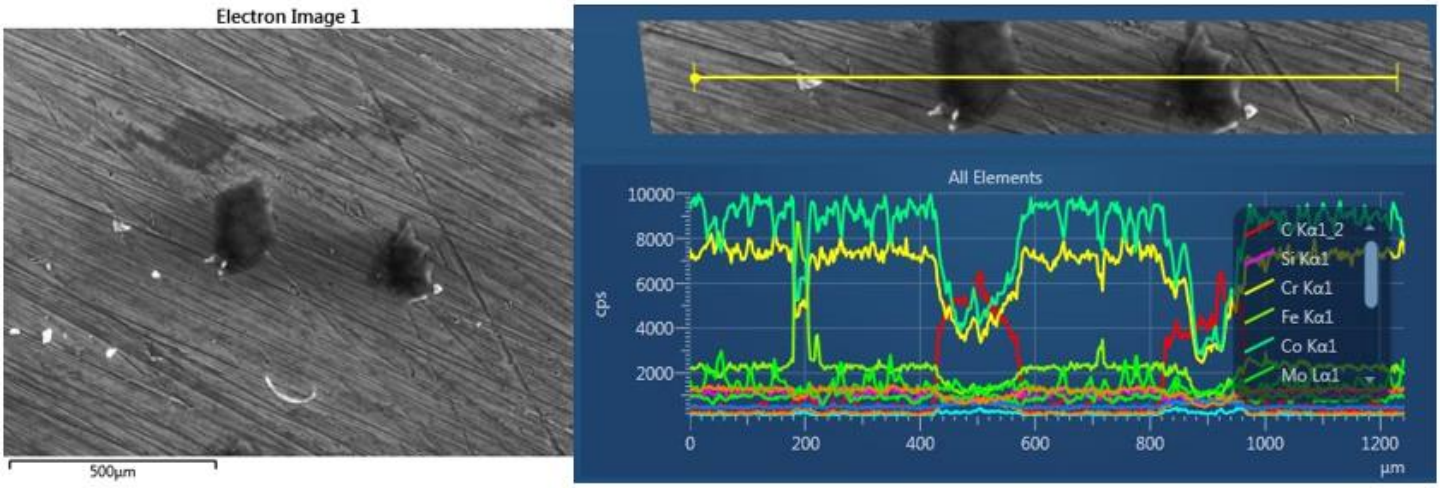
Figure 13: EDS line scans of the Longitudinal/Transverse deposition Stellite 21 (right) chemical analysis near surface pores.

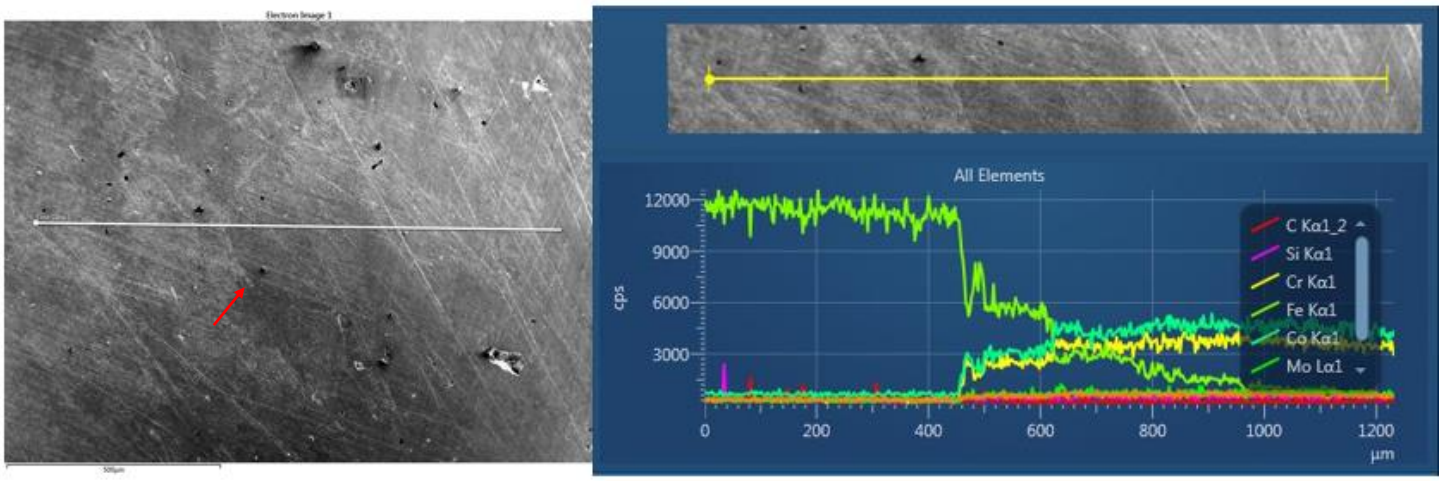
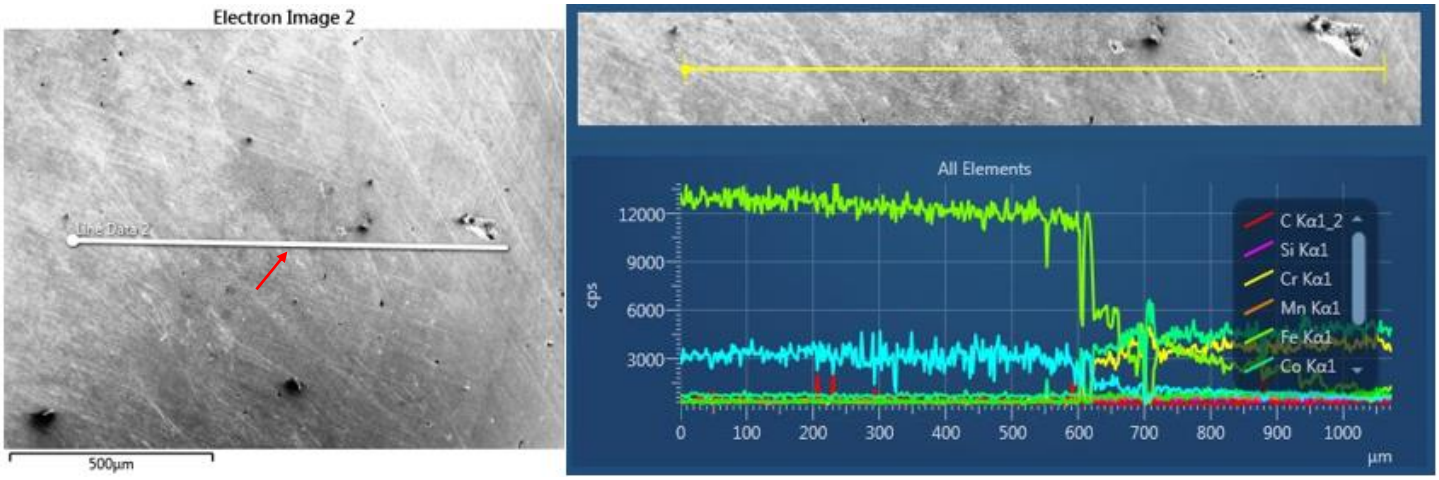
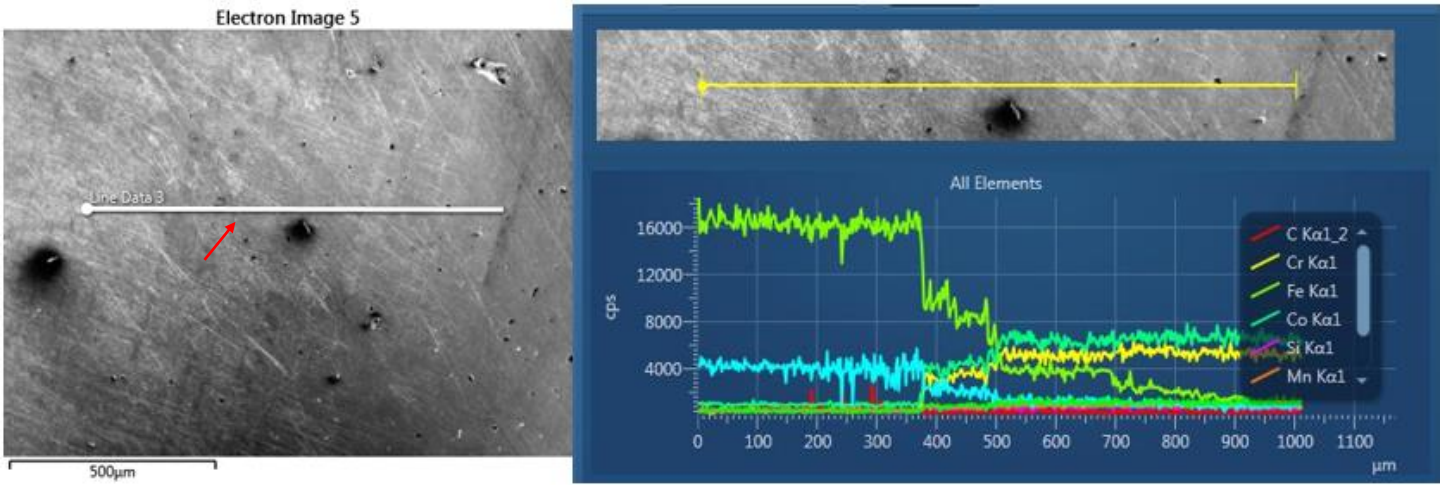
Figures 14, 15, and 16 demonstrate the change in chemical composition as the scanning line crosses the A514/Stellite 21 interface for the Longitudinal deposition. As can be seen from these images, the surface has a large number of defects in the deposition and near the fusion zone of the two materials.

Figure 14: EDS line scans of the Longitudinal deposition A514 (on the left)/Stellite 21 (right) chemical analysis.

Figure 15: EDS line scans of the Longitudinal deposition A514 (on the left)/Stellite 21 (right) chemical analysis.

Figure 16: EDS line scans of the Longitudinal deposition A514 (on the left)/Stellite 21 (right) chemical analysis.
