Final Report

ENERGY REDUCTION USING EPOXY COATINGS FOR SEALING LEAKING COMPRESSED AIR SYSTEMS

Energy and Water Project
EW 201517

September 21, 2018

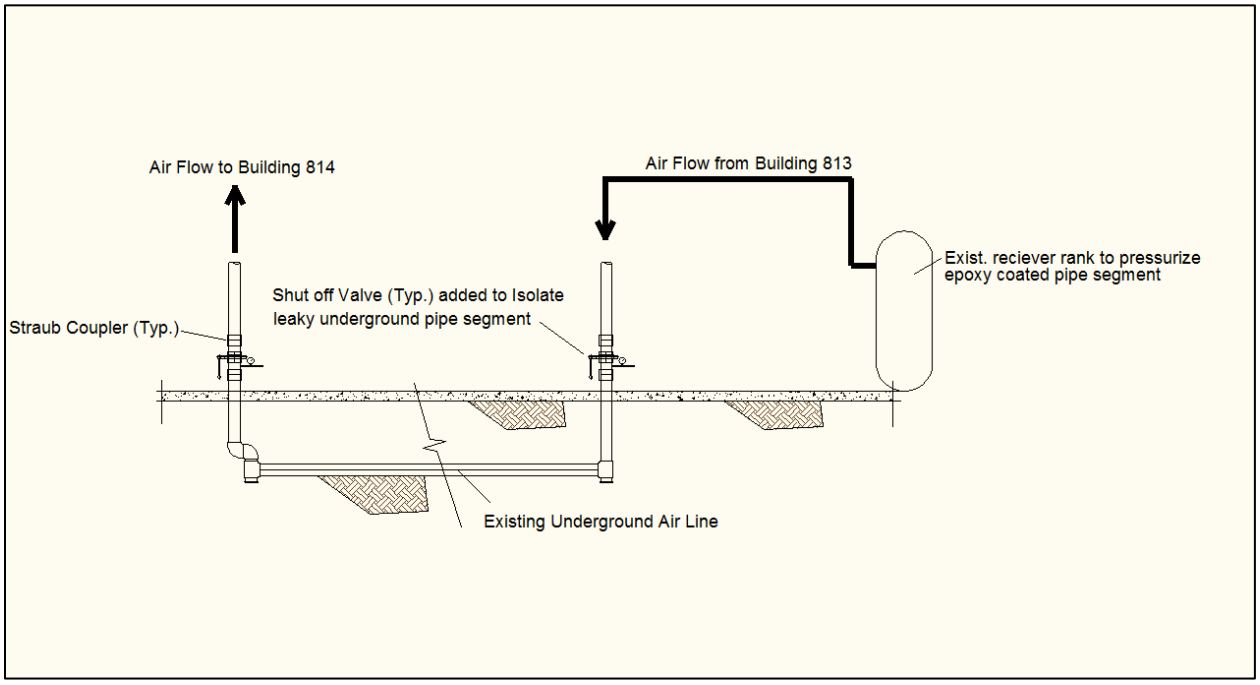
Figure 6. Compressed Air System Schematic for NBVC Port Hueneme

- **Test Design**: Nu Flow technicians were brought to the NBVC CED in Port Hueneme to install the epoxy lining technology. Figure 6 shows a schematic of the 4-inch compressed pipeline that was coated as part of the full-scale field demonstration. The below grade 4-inch-diameter steel pipe mainlines is 420 feet long and 1-1/2-inch-diameter steel pipe is 140 feet long. As part of the demonstration, NAVFAC EXWC performed baseline pressure drop measurements, monitored the technology installation, conducted field and laboratory testing on the lined system, and documented the results in comparison to the established performance objectives. To validate return on investment, cost data was extracted from the epoxy installation contract with Nu Flow. Resources, materials, and man-hours were tracked throughout the demonstration to validate accuracy of the cost proposed during contract negotiations and for use in the cost model in Section 7.0. Qualitative performance objectives were assessed through observations, discussion with base personnel, end user and camera inspections.

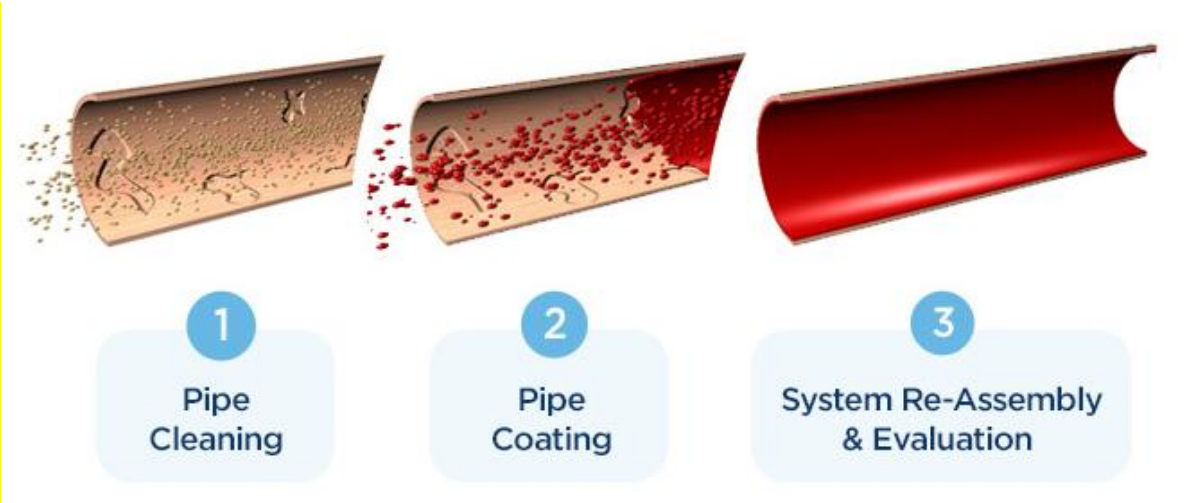
Figure 7. Depiction of the Epoxy Lining Process (Courtesy of Nu Flow)

3) The epoxy lining was applied in one end of the pipe and forced by air pressure through each section (Figure 7, Step 2). Note that the field epoxy application procedure was changed for the 1-1/2-inch pipeline, as epoxy was applied from both pipe ends to compensate for epoxy lost through a pipe breach.

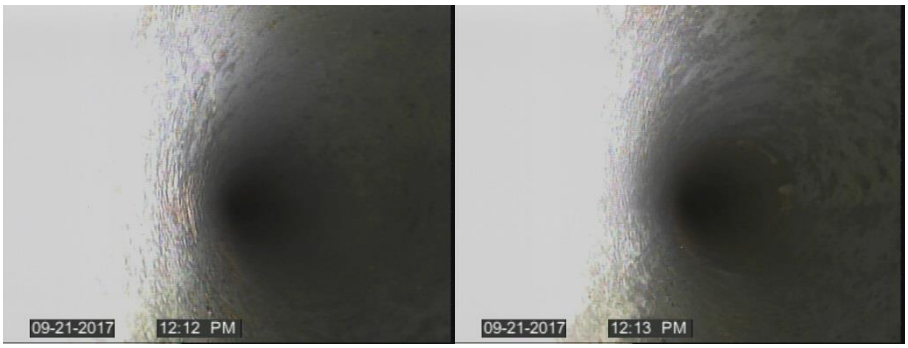
Figure 9. 4-inch Underground Pipeline Inlet and Outlet Ends after Abrasive Garnet

Figures 8 and 9 show pictures of the inlet and outlet ends for the 1-1/2-inch diameter and 4-inch diameter underground pipelines, respectively, post-blasting with the abrasive garnet. The pictures demonstrate that the inlet and outlet ends of the pipelines were mostly clean. In the case of the 1-1/2-inch diameter pipeline there was pipe pigmentation in some of the pictures. This may be due to the removal of heavy scale, rust and possibly corrosion from the inner wall surface. Nonetheless, the images show that the pipe's ends were clean and free of debris. Therefore, both underground pipelines exhibit good general appearance and pass point one of the present performance objective.

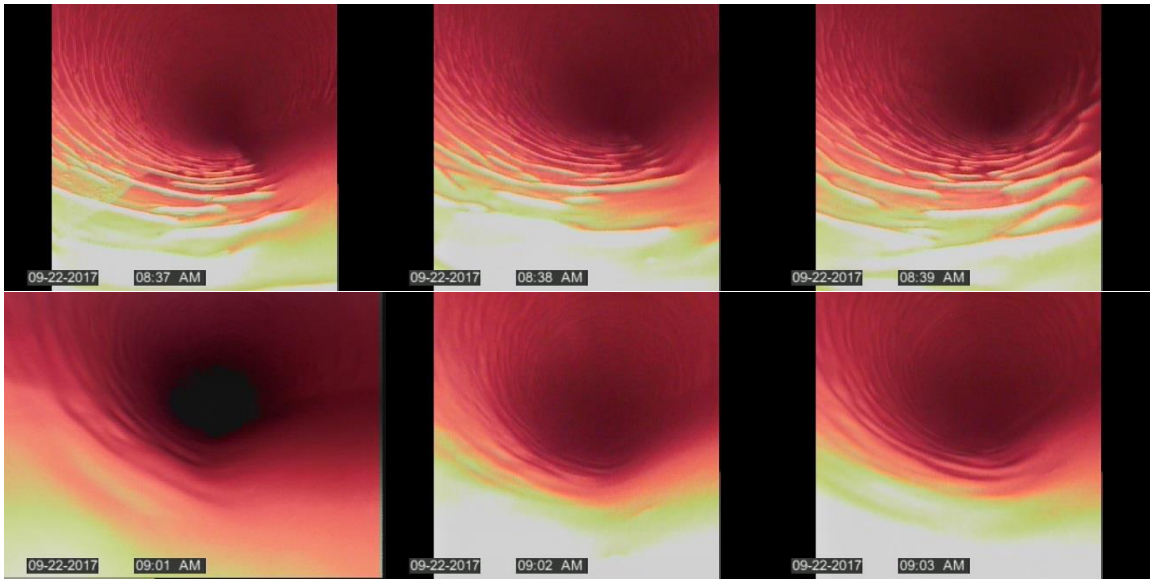
Figure 16. Inside Camera Shots of 4-inch Diameter Pipeline One Day after Epoxy Coating

the thickness and uniformity criteria due to substantial corrosion in the pipe. Camera inspection of the 4" diameter pipeline showed negligible pooling within the pipe.

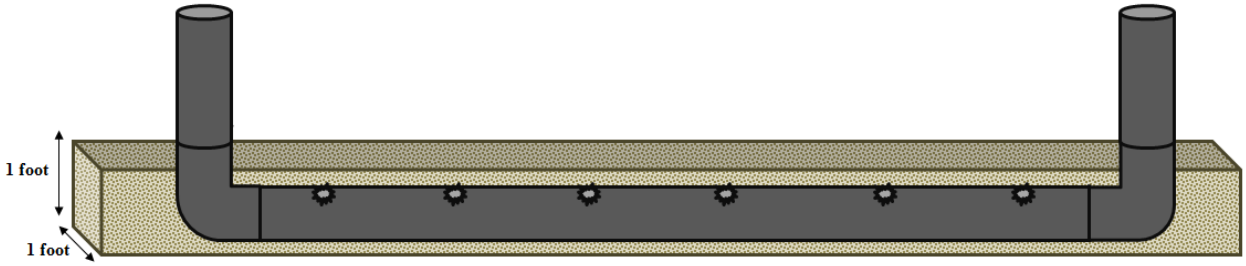
Figure B16. 1" Underground Pipeline with 6 Pin-Holes- 12 o'clock Position (3 of these underground pipelines were built for the 1/4", 1/8" and 1/16" pin-holes).

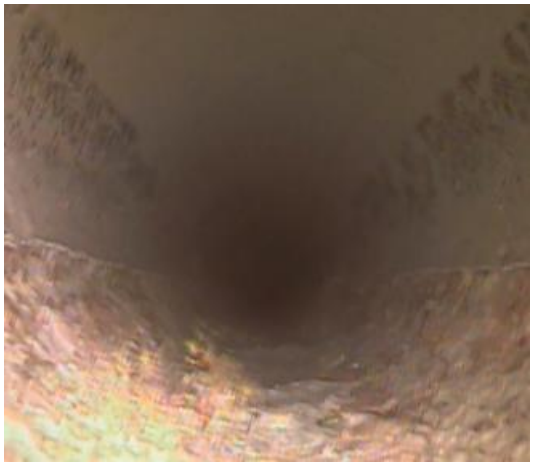
Figure D3. Photo of inner pipe near another leak point and prior to epoxy application (40' from camera's insertion point).
