WATERTOWN ARSENAL LABORATORY

NO. WAL 710/576

Effect of Directional Properties on

Rolled Homogeneous Armor

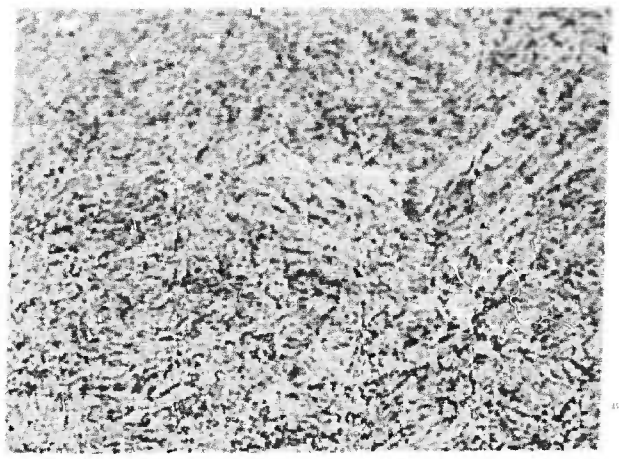
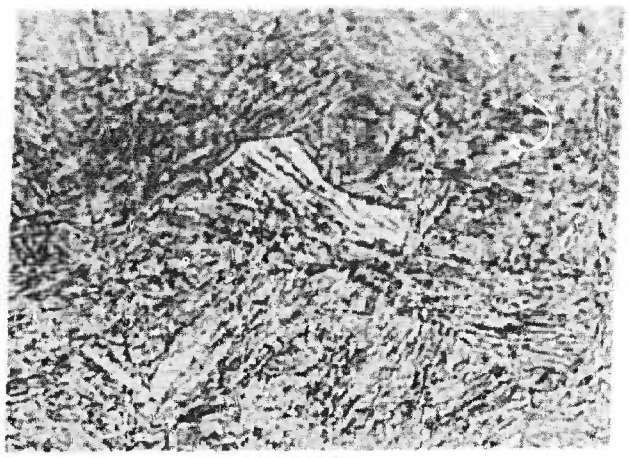
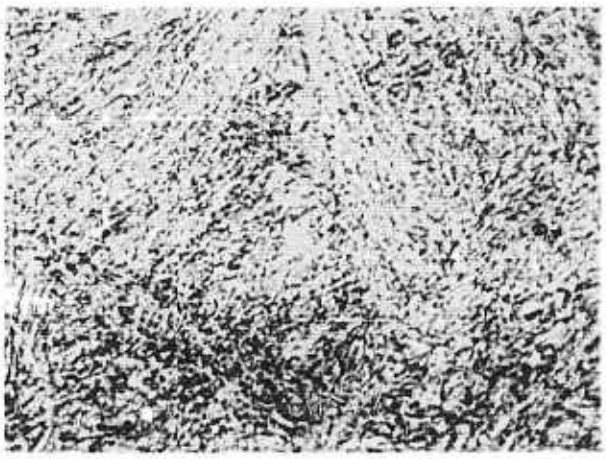
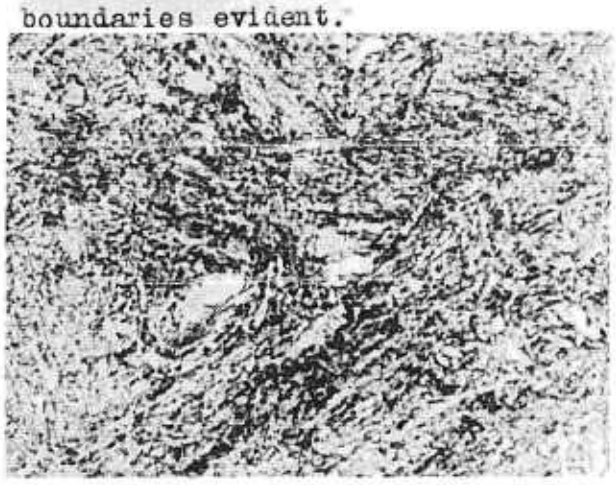
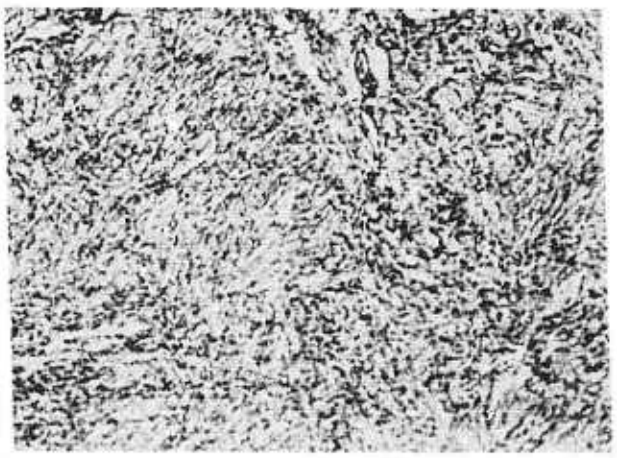
FIG. 4

Figures 4-6 inclusive illustrate the typical microstructure of the samples. With the exception of plate numbers 1 and 1D all plates exhibited a tempered martensitic structure, consisting of sorbite and some traces of ferrite. The microstructure of plate No. 1 consisted of considerable amounts of ferrite and sorbite while plate No. 1D showed evidence of intermediate temperature transformation products.

Typical Microstructure of "Straight Away Rolled"
Great Lakes Armor Plates

No. 3
Fairly uniform spheroidized sorbite and trace of ferrite.

No. XA
Fine sorbite with partially dissolved carbide lamallae. Grain boundaries evident.

No. 1C
Sorbite.

No. 6
Sorbite, trace of ferrite.

No. 5A
Sorbite and trace of ferrite.

No. 2C
Sorbite and trace of ferrite.

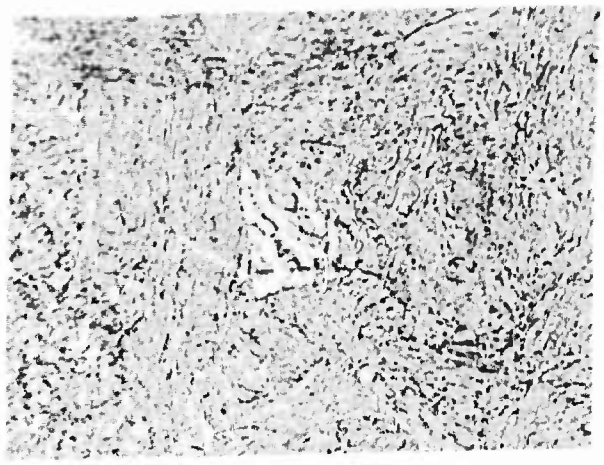
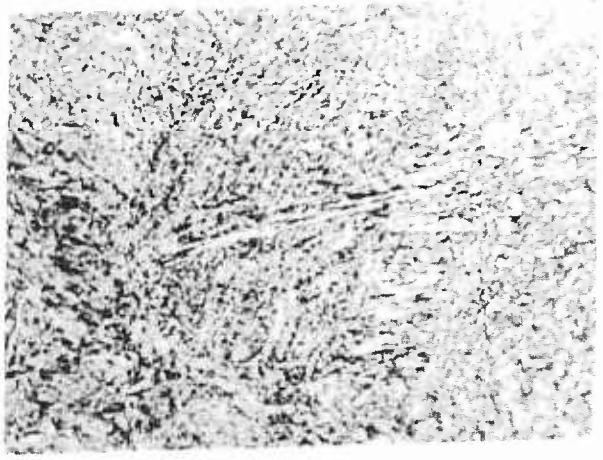
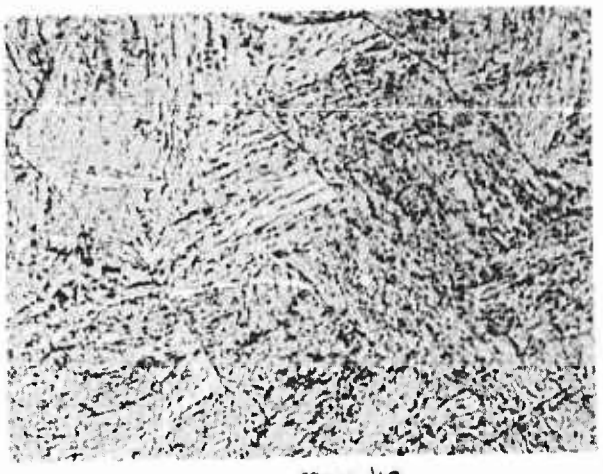
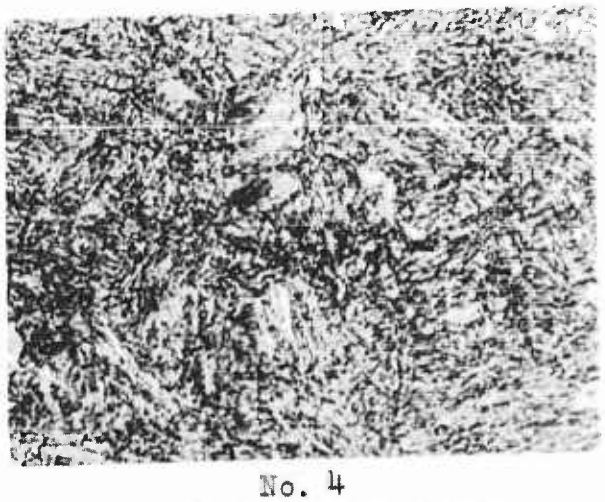
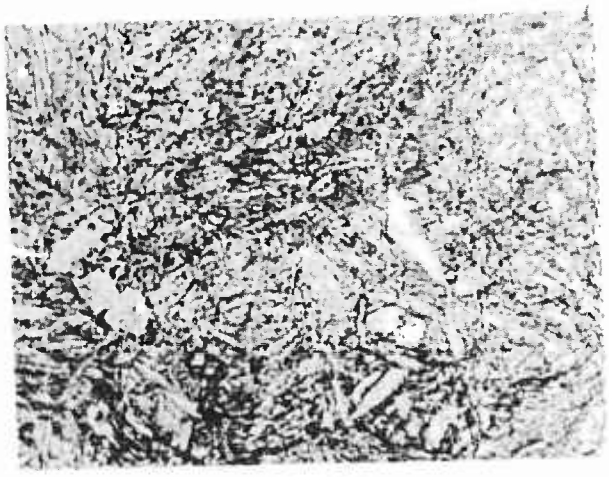
FIG. 5

Typical Microstructure of "Straight Away Rolled"
Great Lakes Armor Plates

No. 5
Sorbite and trace of ferrite.

No. 6A
Sorbite and trace of ferrite.

No. 4C
Sorbite and trace of ferrite.

No. 4
Sorbite and trace of ferrite.

No. 5AX
Sorbite and trace of ferrite.

No. 6C
Sorbite and trace of ferrite.

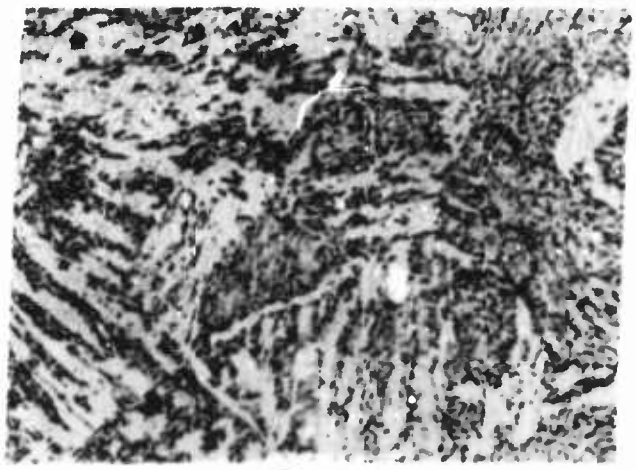
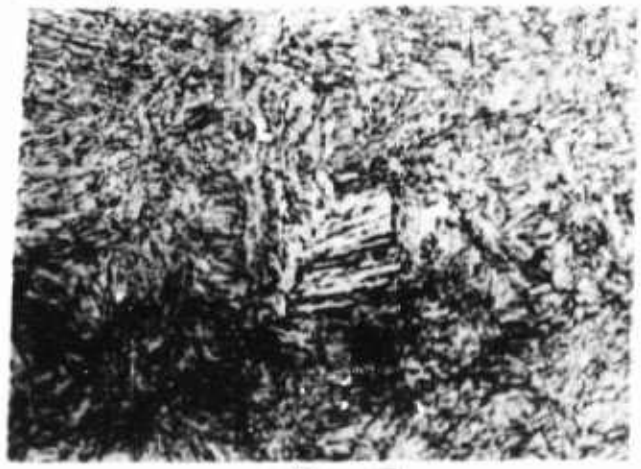
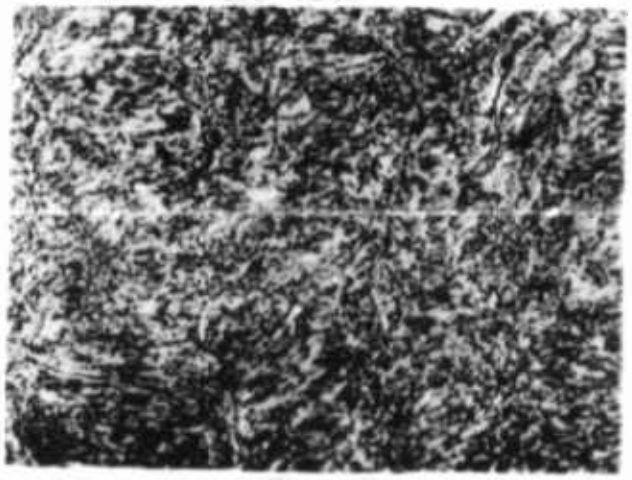
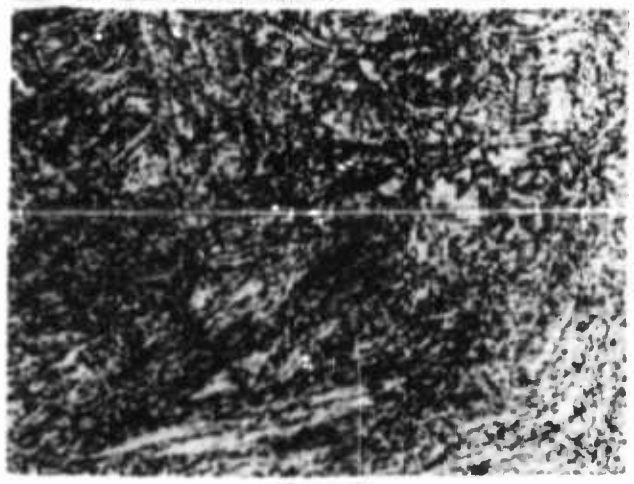
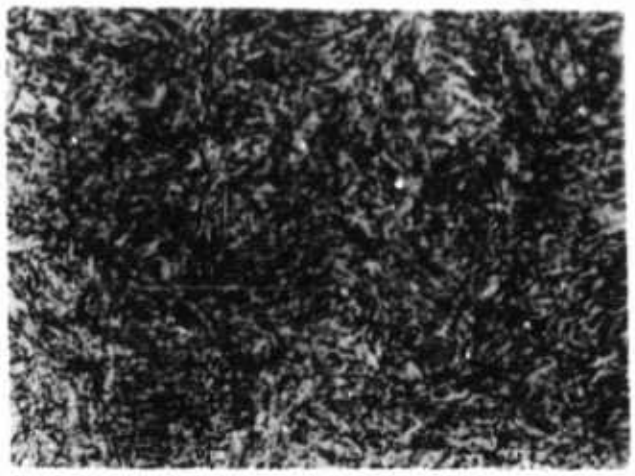
FIG. 6

Typical Microstructure of "Straight Away Rolled"
Great Lakes Armor Plates

Ferrite and sorbite.

Trace of ferrite and sorbite.

Fairly uniform sorbite.

Evidence of intermediate temperature transformation products.

Intermediate temperature transformation products.
