FINAL REPORT

EFFECTS OF CONCENTRATED HYDROGEN PEROXIDE ON MECHANICAL AND CORROSION PROPERTIES OF STRUCTURAL ALUMINUM ALLOYS

BUREAU OF SHIPS
DEPARTMENT OF THE NAVY
Contract No. NObs-72258

16 February 1959 KC-1164-M-11

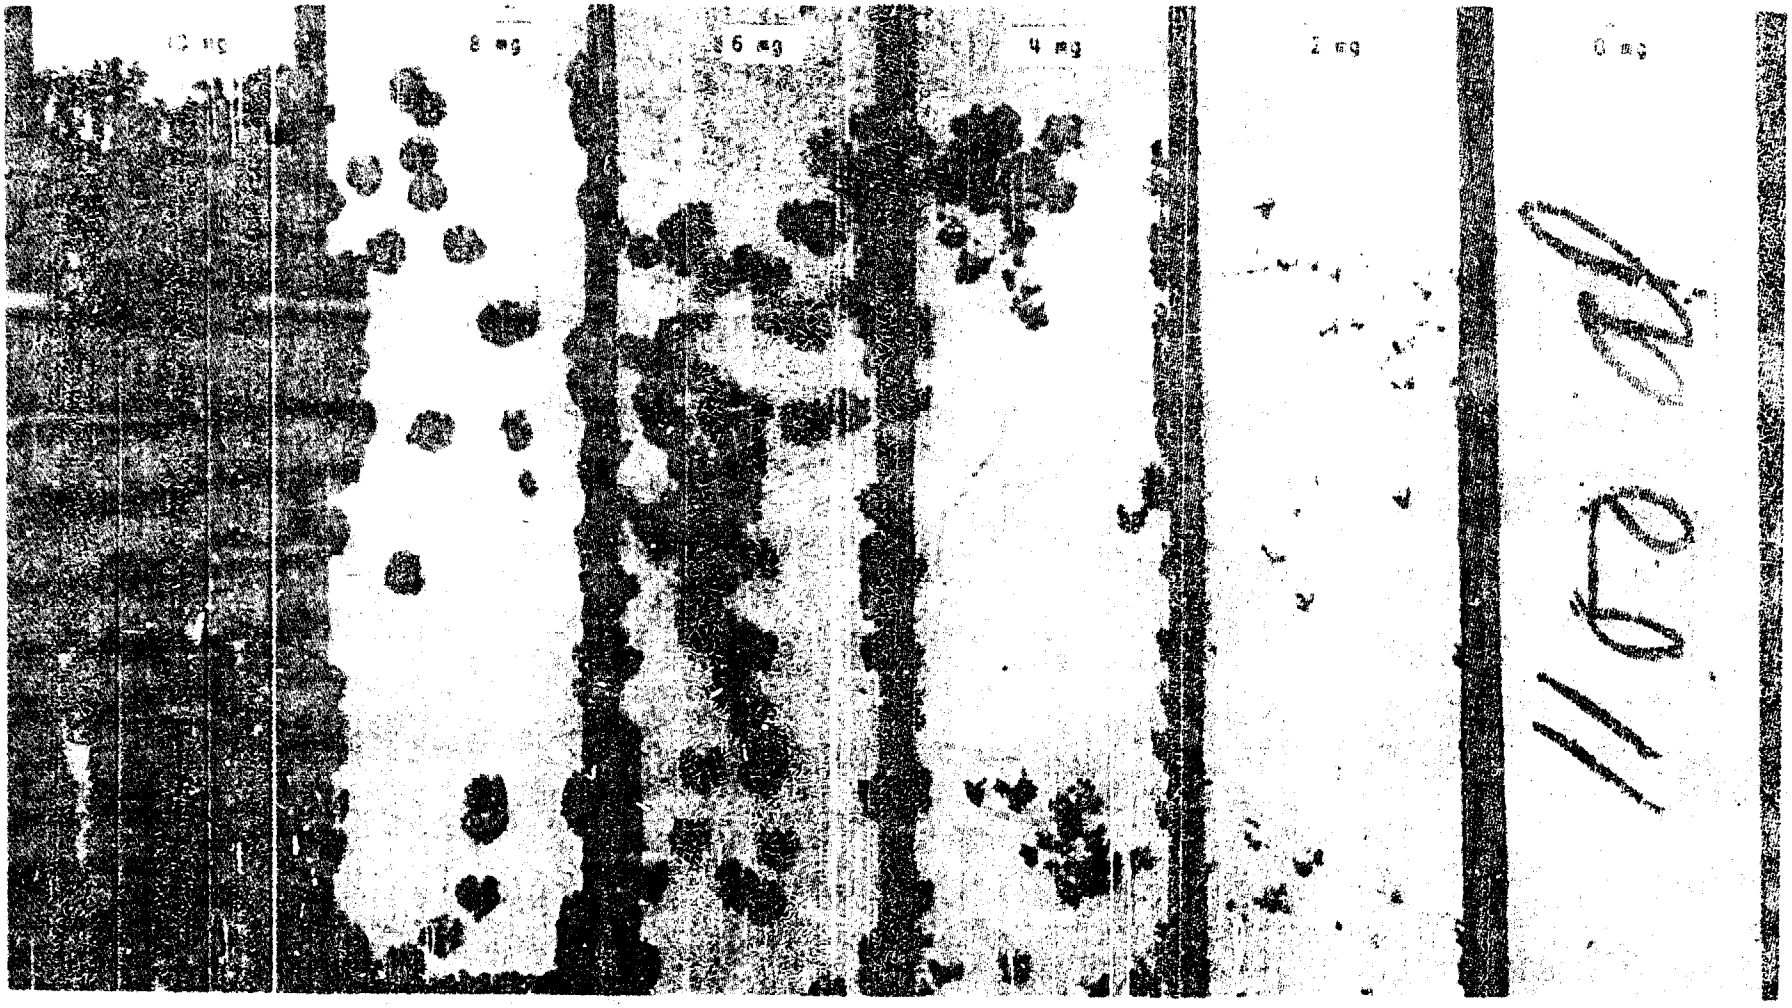
Figure 5 SPECIMENS OF ALLOY 1100 AFTER 7 DAYS EXPOSURE TO 90% H_2O_2 CONTAINING VARIOUS CONCENTRATIONS OF CHLOR DE ION

In order to arrive at a more realistic concentration of the chloride for a six-month exposure test, it was decided to try some immersion tests in 90% H_2O_2 solutions containing various amounts of chloride. Solutions were prepared with 0, 2, 4, 6, 8 and 10 mg of chloride ion per liter (multiplying by 1.39 converts these concentrations to ppm). Specimens of two of the alloys presently in use for peroxide storage, 1100 and 1260, were exposed in these solutions for 7 days. The results of these tests are shown in Figures 5 and 6.
