TECHNICAL INSPECTION REPORT

WELDING

OPERATION CROSSROADS

JOINT TASK FORCE ONE

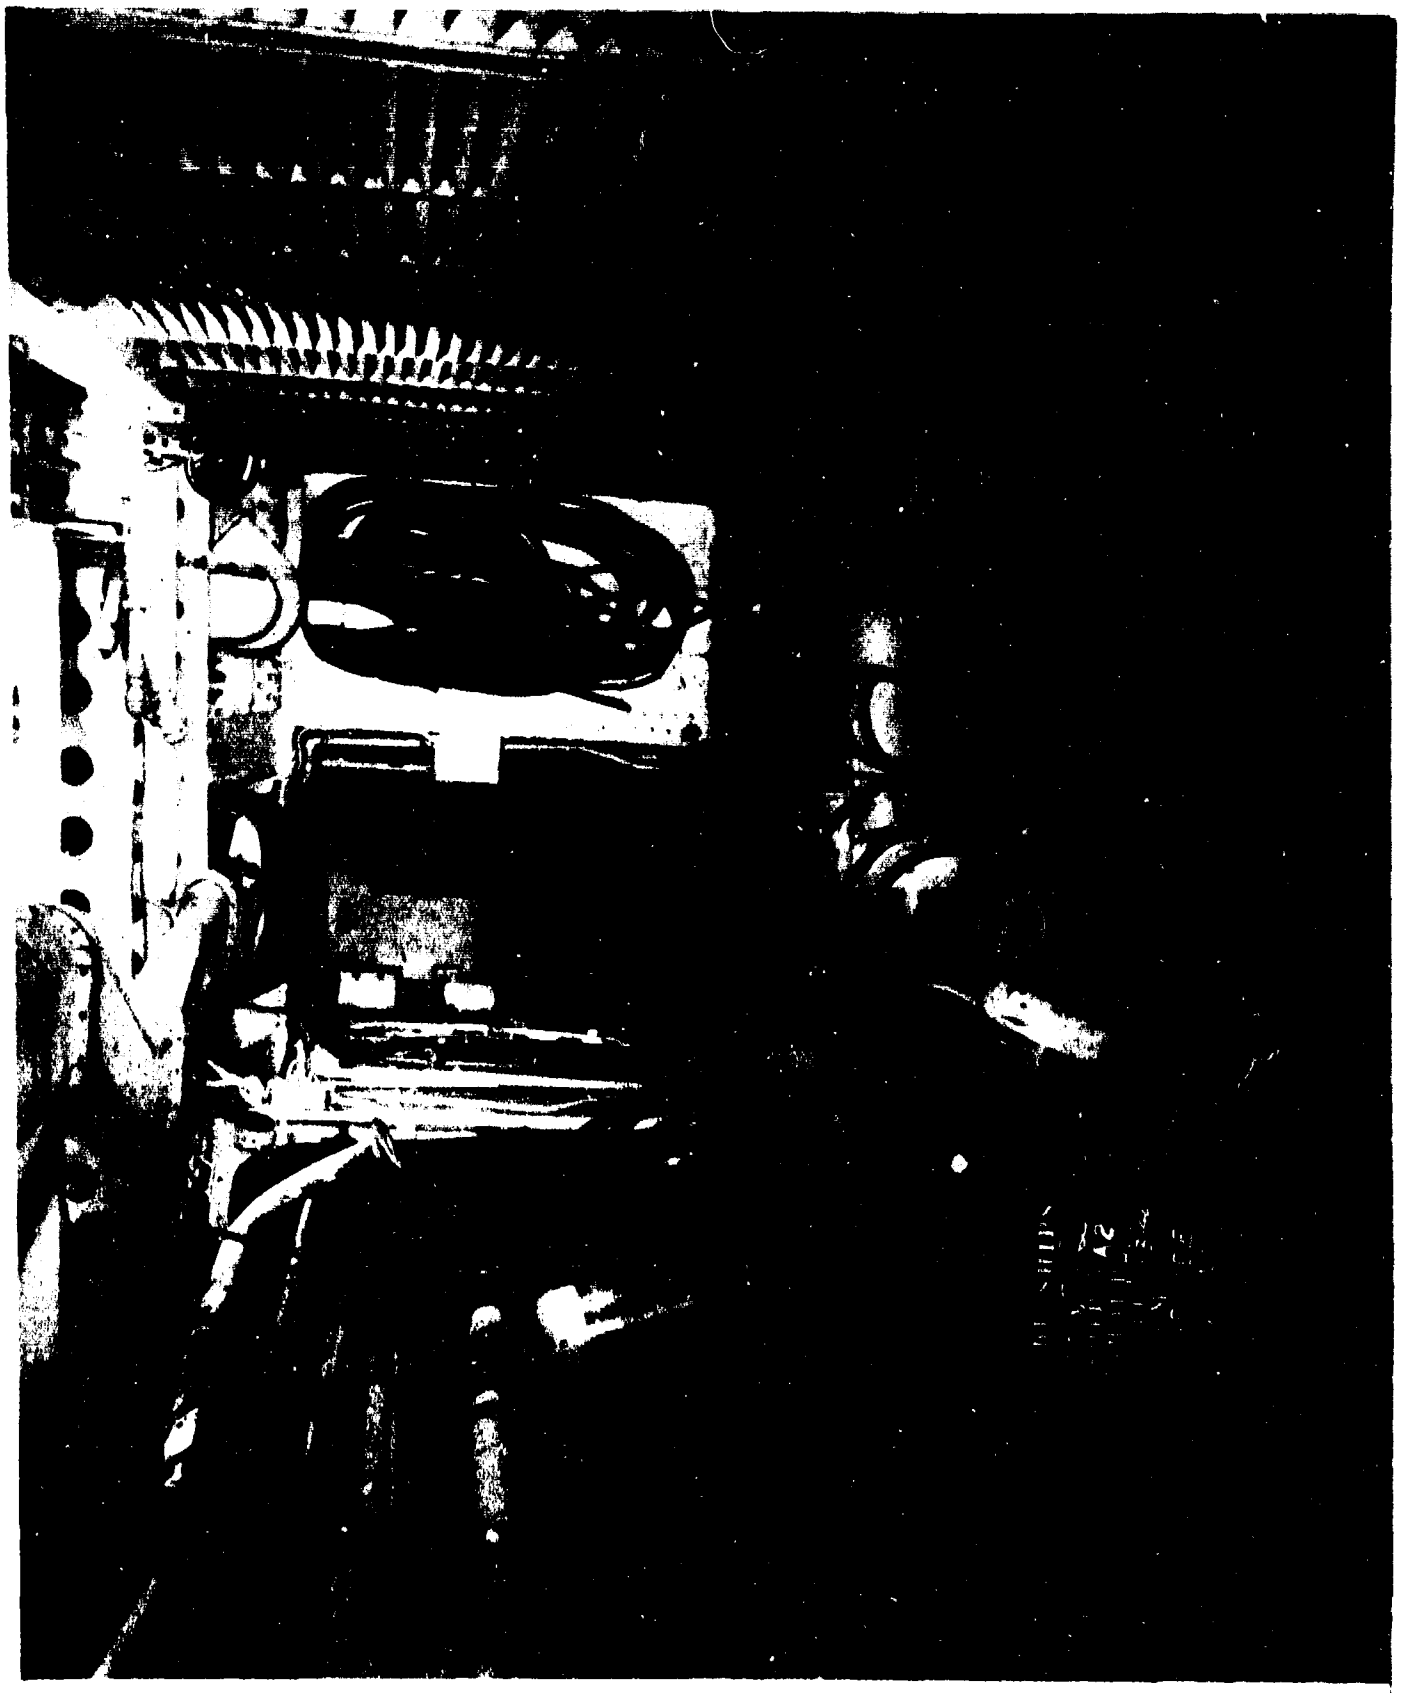
(c) Oxygen, acetylene and other gas cylinders. In most cases gas cylinders were stowed on weather decks. In many instances, such as shown in photographs 1867-2, 1868-3 and 2116-12, pages 22, 23 and 65 , cylinders were displaced from stowage racks by the force of air blast against structures to which they were secured. Similar occurrences were observed on Test B target ships moored close to the bomb. Displacement of cylinders in this test was caused by underwater shock. As far as could be ascertained displaced cylinders were undamaged.

AA-CR-62-1867-2. USS SALT LAKE CITY (CA25). Displaced oxygen and acetylene cylinders. Main deck starboard passage, looking aft from well deck.

AA-CR-62-1868-3. USS SALT LAKE CITY (CA25). Displaced gas cylinders. Main deck, port, looking forward from just aft number 3 main mount.

AA-CR-80-1894-5. USS SALT LAKE CITY (CA25). Damaged fibre glass insulation in forward superstructure.

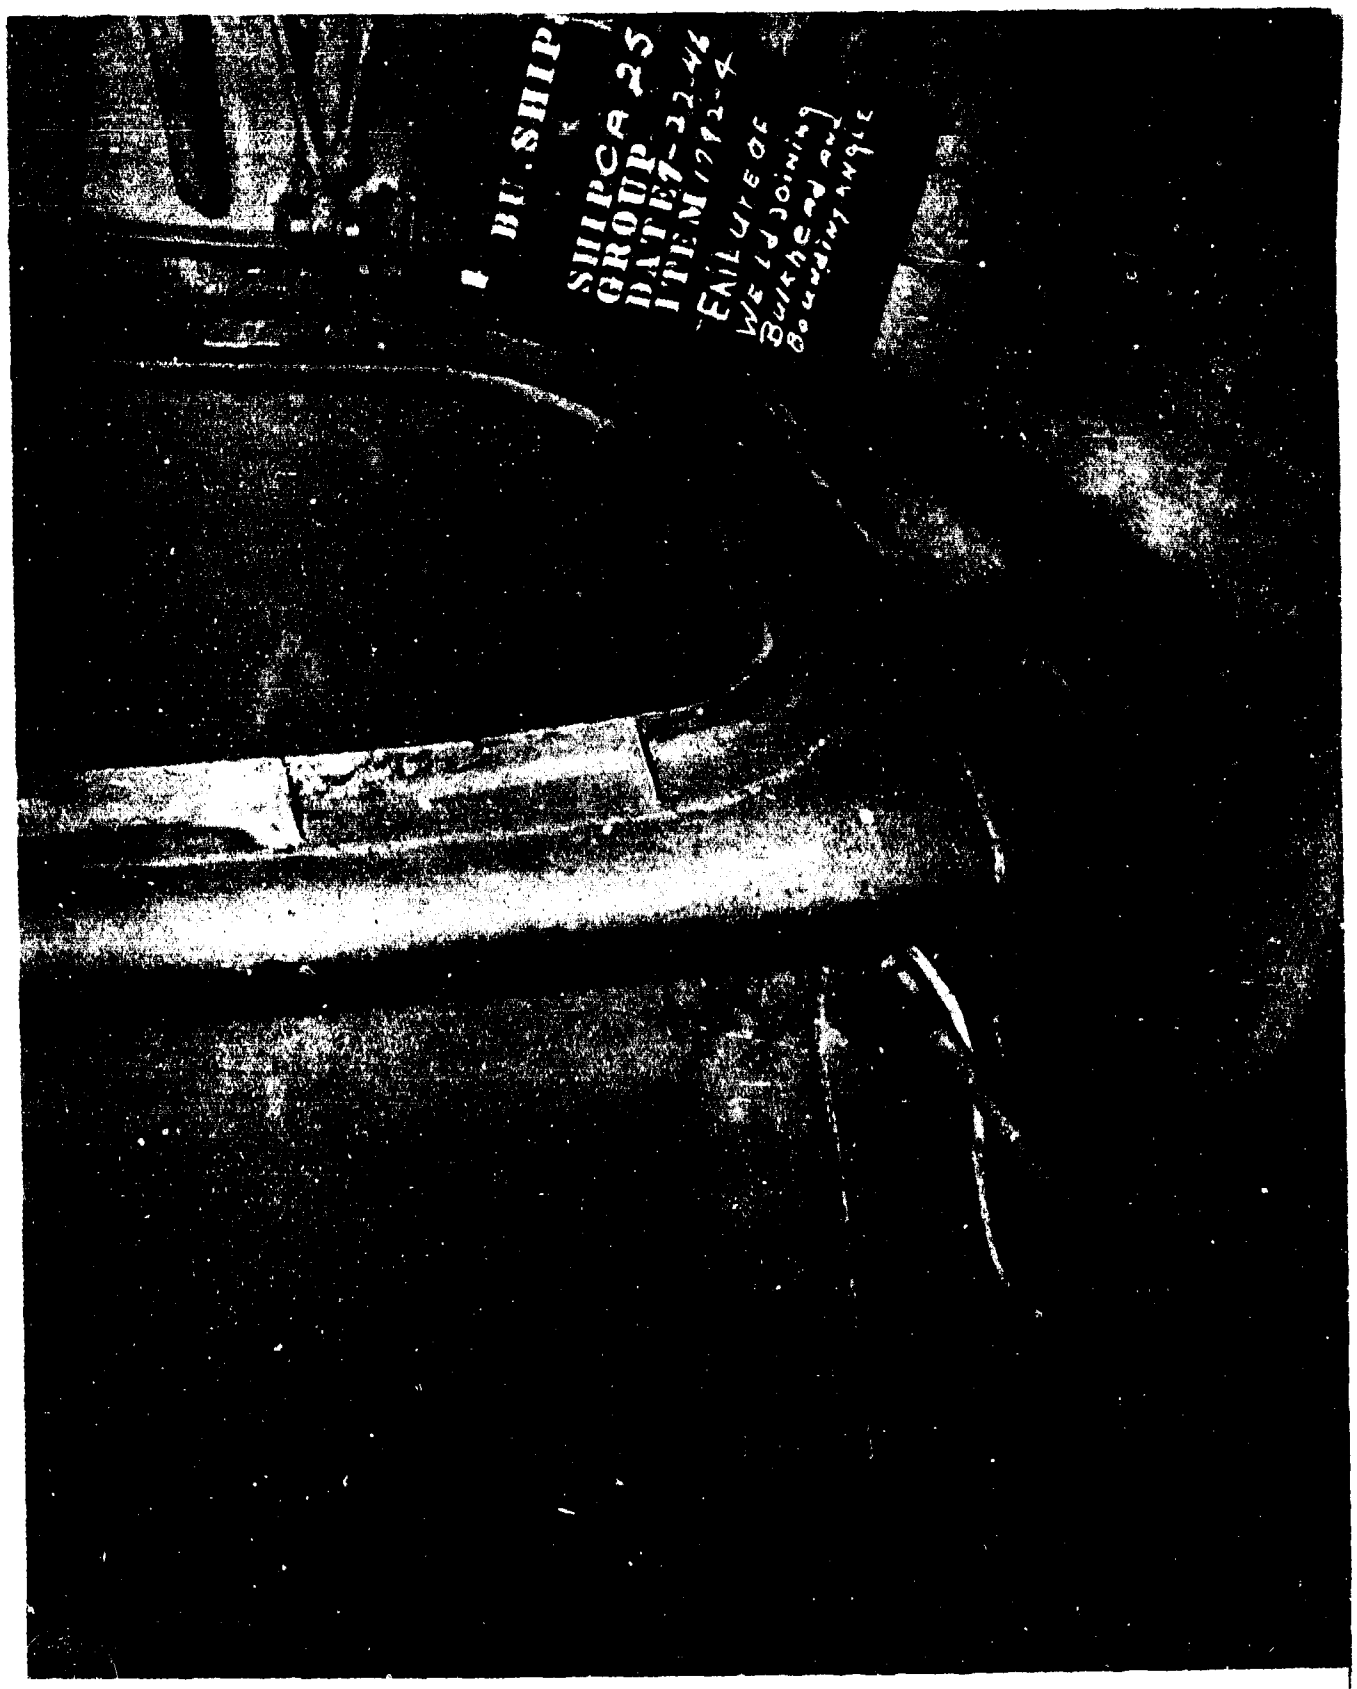
AA-CR-92-1782-4. USS SALT LAKE CITY (CA25). Failure of bulkhead bounding welds at main deck connection, port side, athwartship passage aft of wardroom, looking forward.

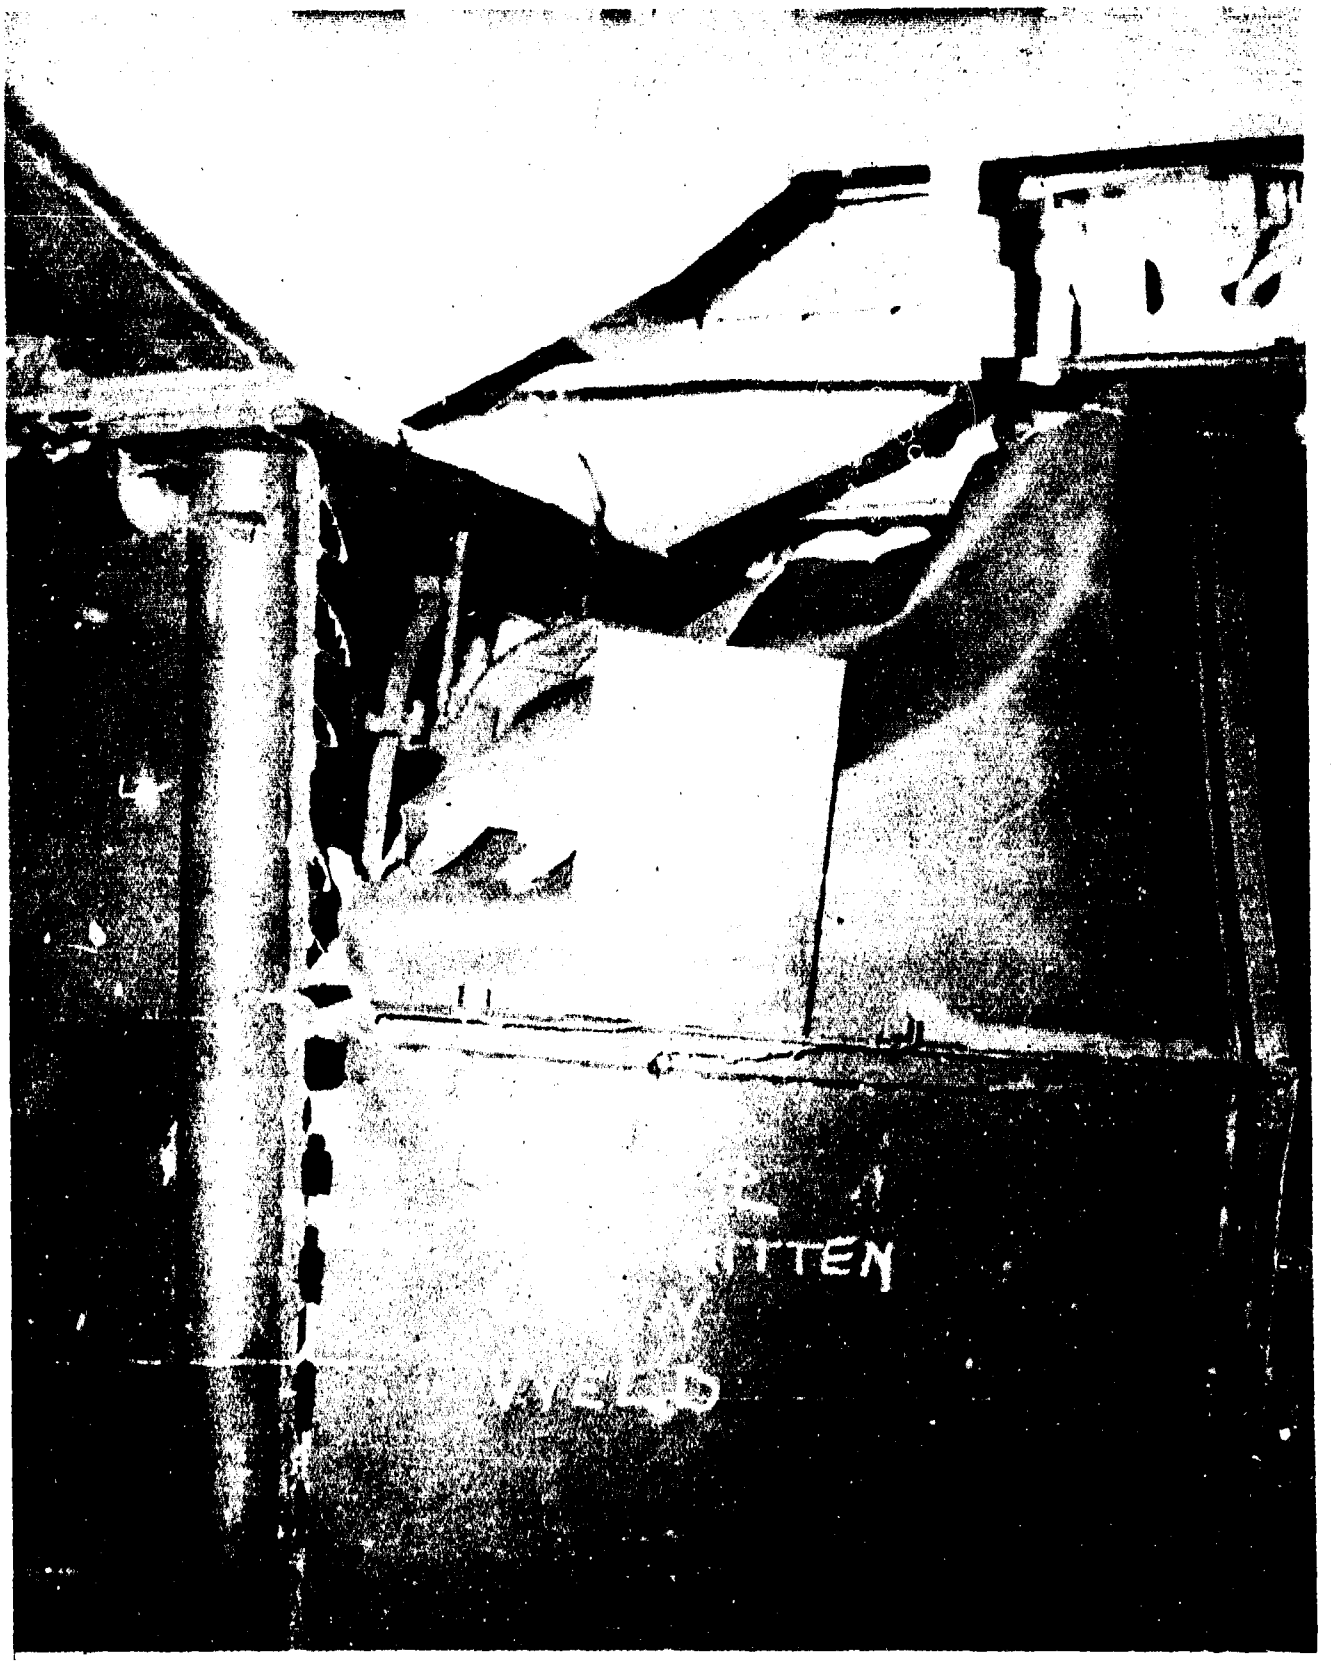
failures in the superstructure on the submarine SKATE as shown in photographs 1753-3 and 1752-12, pages 95 and 98 . On the SALT LAKE CITY welds joining deck house bulkheads to bulkhead bounding aggles failed as shown in photographs 1729-2 and 1782-4, pages 25 and 26 . Examples of failures in way of intermittent weld in deck house bulkheads are shown in photographs 1868-4 and 1782-5, pages 27 and 28.

AA-CR-62-1868-4. USS SALT LAKE CITY (CA25). Failure in way of intermittent welds joining deck house plating to pipe stanchion at after end of port passage. Main deck, looking outboard and forward.

AA-CR-92-1782-5. USS SALT LAKE CITY (CA25). Failure in way of intermittent welds joining deck house plating to pipe stanchion at after end of port passageway. Main deck, looking outboard.

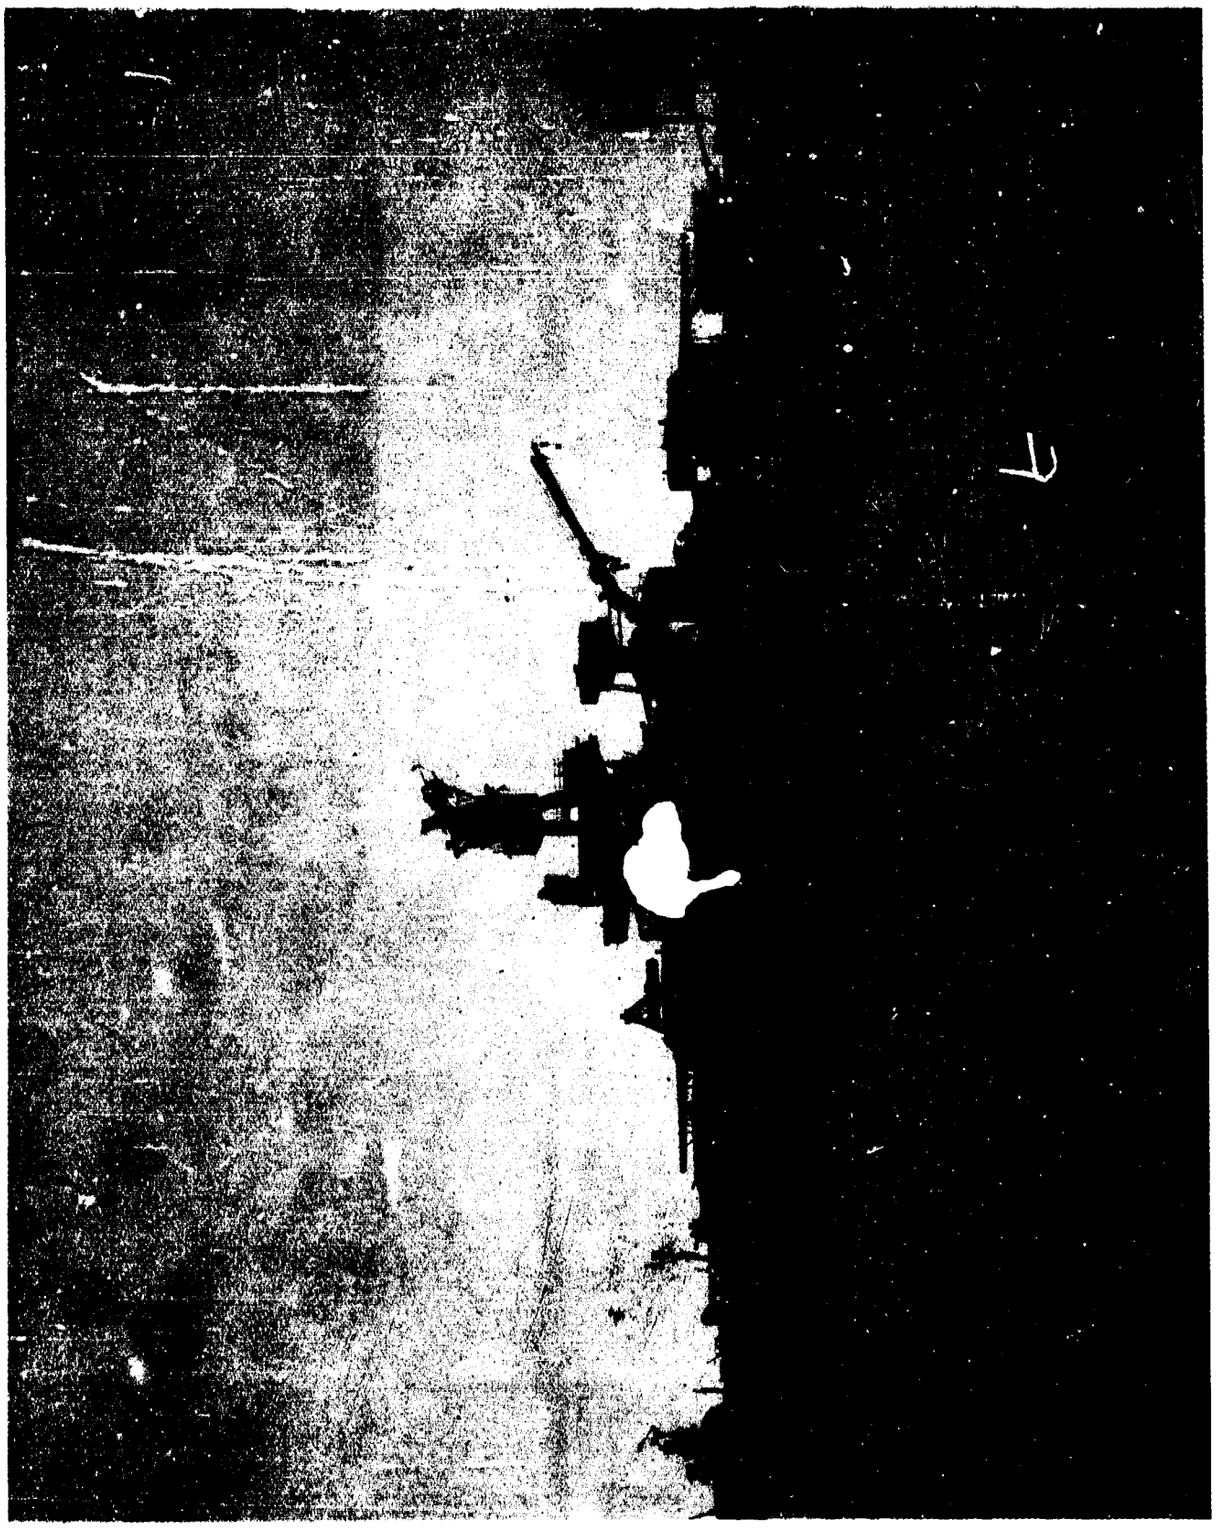
Photograph 1861-1, 1783-2, 1782-12, 2135-3, 1782-11 and 2094-8, pages 29, 30, 31, 32, 33, and 34 show brittle fractures which originated in the weld heat affected zone of the base material of the after tripod legs of the foremast structure. The welds were of austenitic chromium-nickel steel composition. It appears from the nature of the fractures that the tripod leg material is low alloy steel or steel of relatively high carbon content and of questionable weld ability. No thermal cracks were observed. The upward thrust from reflected blast against the bottom of the range finder platform caused the welds joining the cantilever brackets to the tripod legs to be highly stressed.

AA-CR-62-1861-1. USS ARKANSAS (BB33). Port view, showing blast damage to foremast tripod.

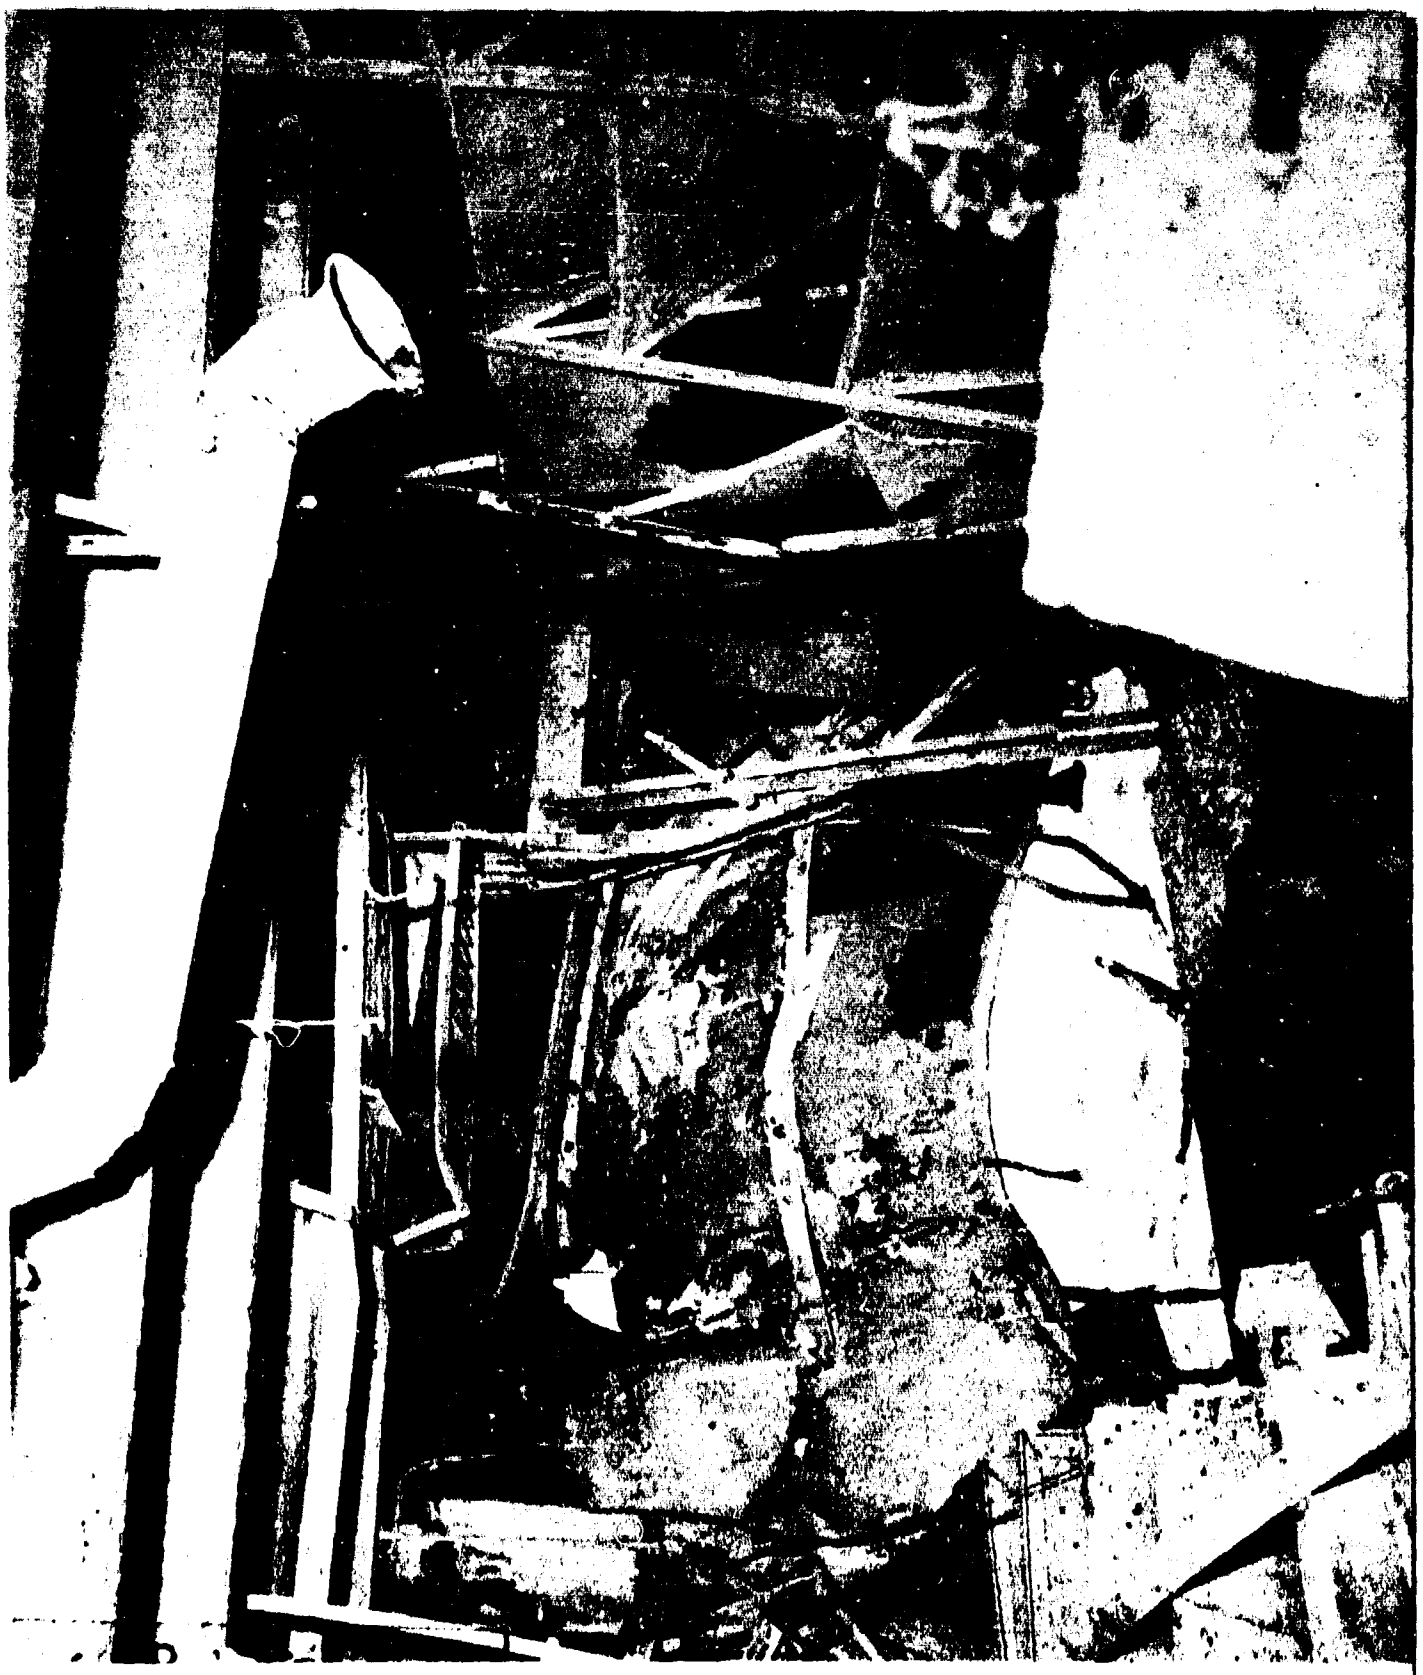
Damage to the superstructure on the INDEPENDENCE aft of the hangar space was severe. As shown in photographs 2216-2, 2216-7, 1734-1 and 2114-1, pages 35, 36, 39, and 40 there were numerous failures in side plating which followed welding seams. Certain of the failures occurred in the welds where incomplete joint penetration was observed. Others followed the seams in the plate material adjacent to the welds, and in certain cases appeared to have been caused by slight undercut at the edges of welds.

AA-CR-17-2114-1. USS INDEPENDENCE (CVL22). Failure of side plating along welded seam at level of poop deck. Port side looking outboard.

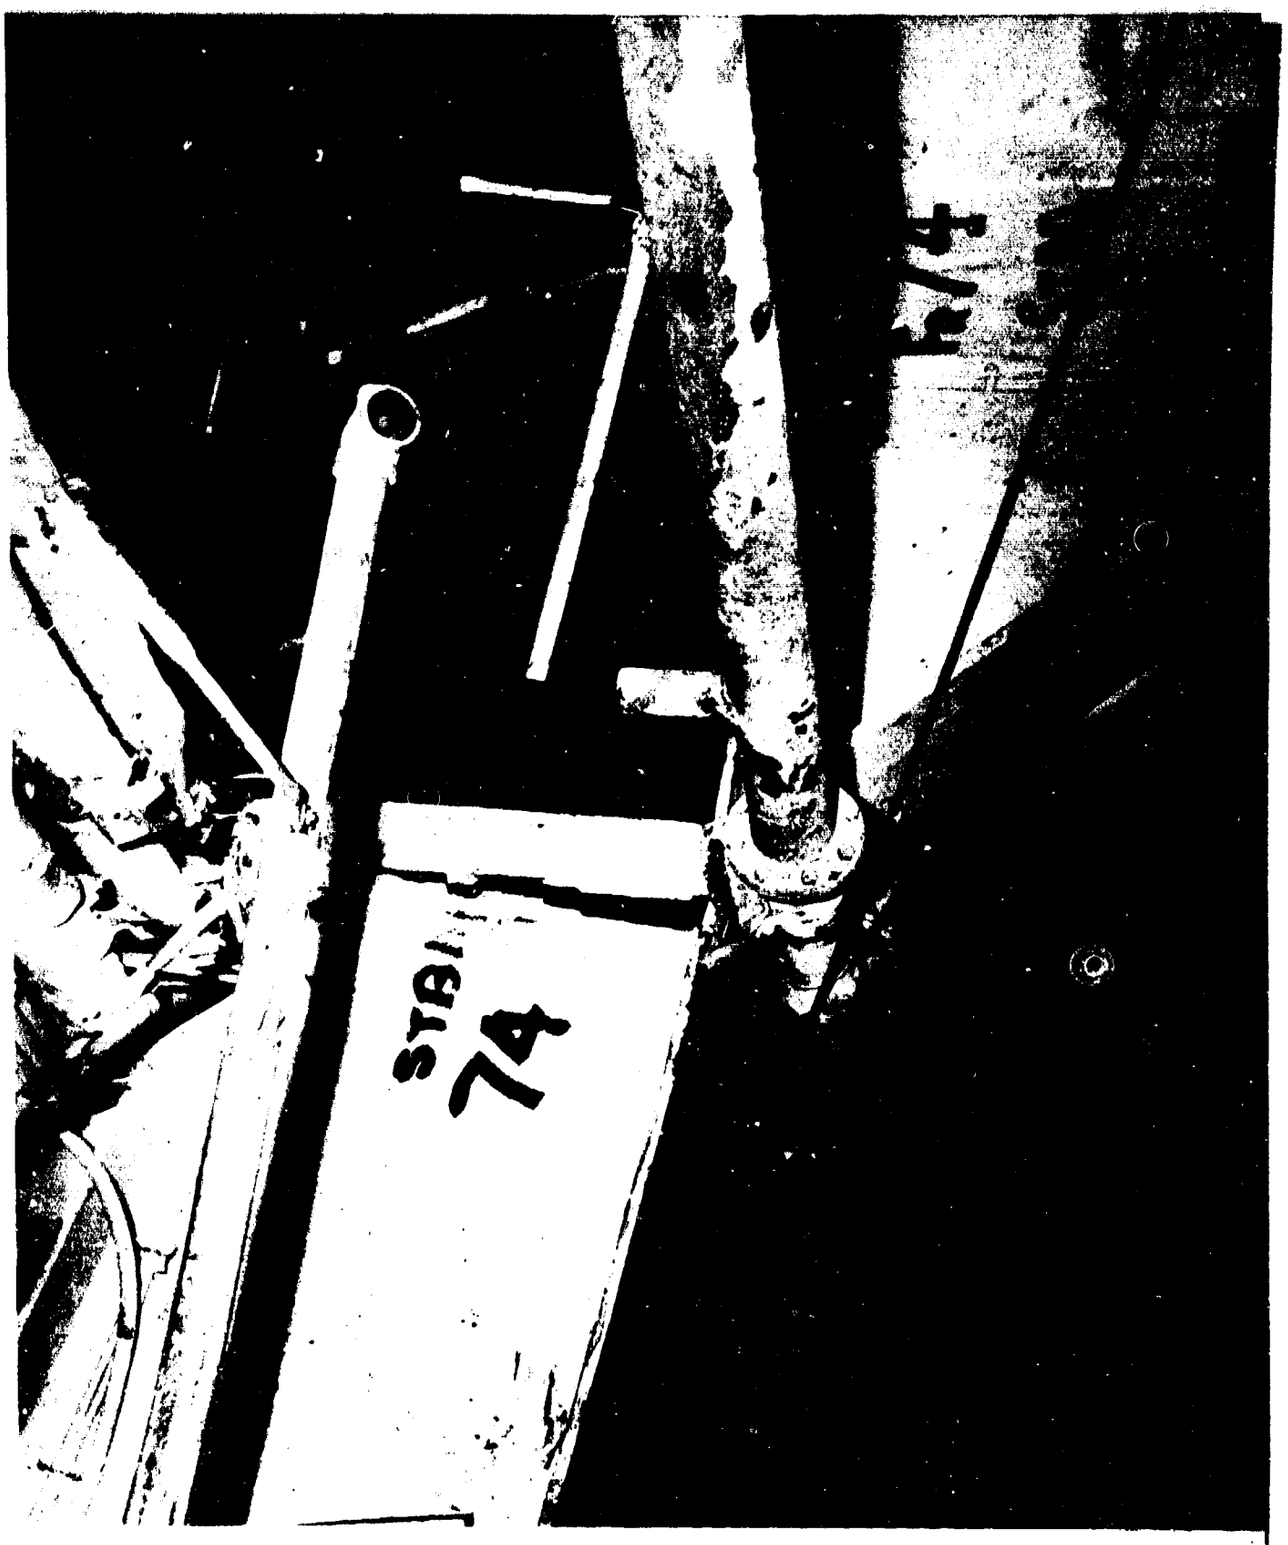
AA-CR-59-4148-11. USS INDEPENDENCE (CVL22). Fracture in flight deck bent overhead connection along inboard edge of vertical weld. Frame 74, looking forward.

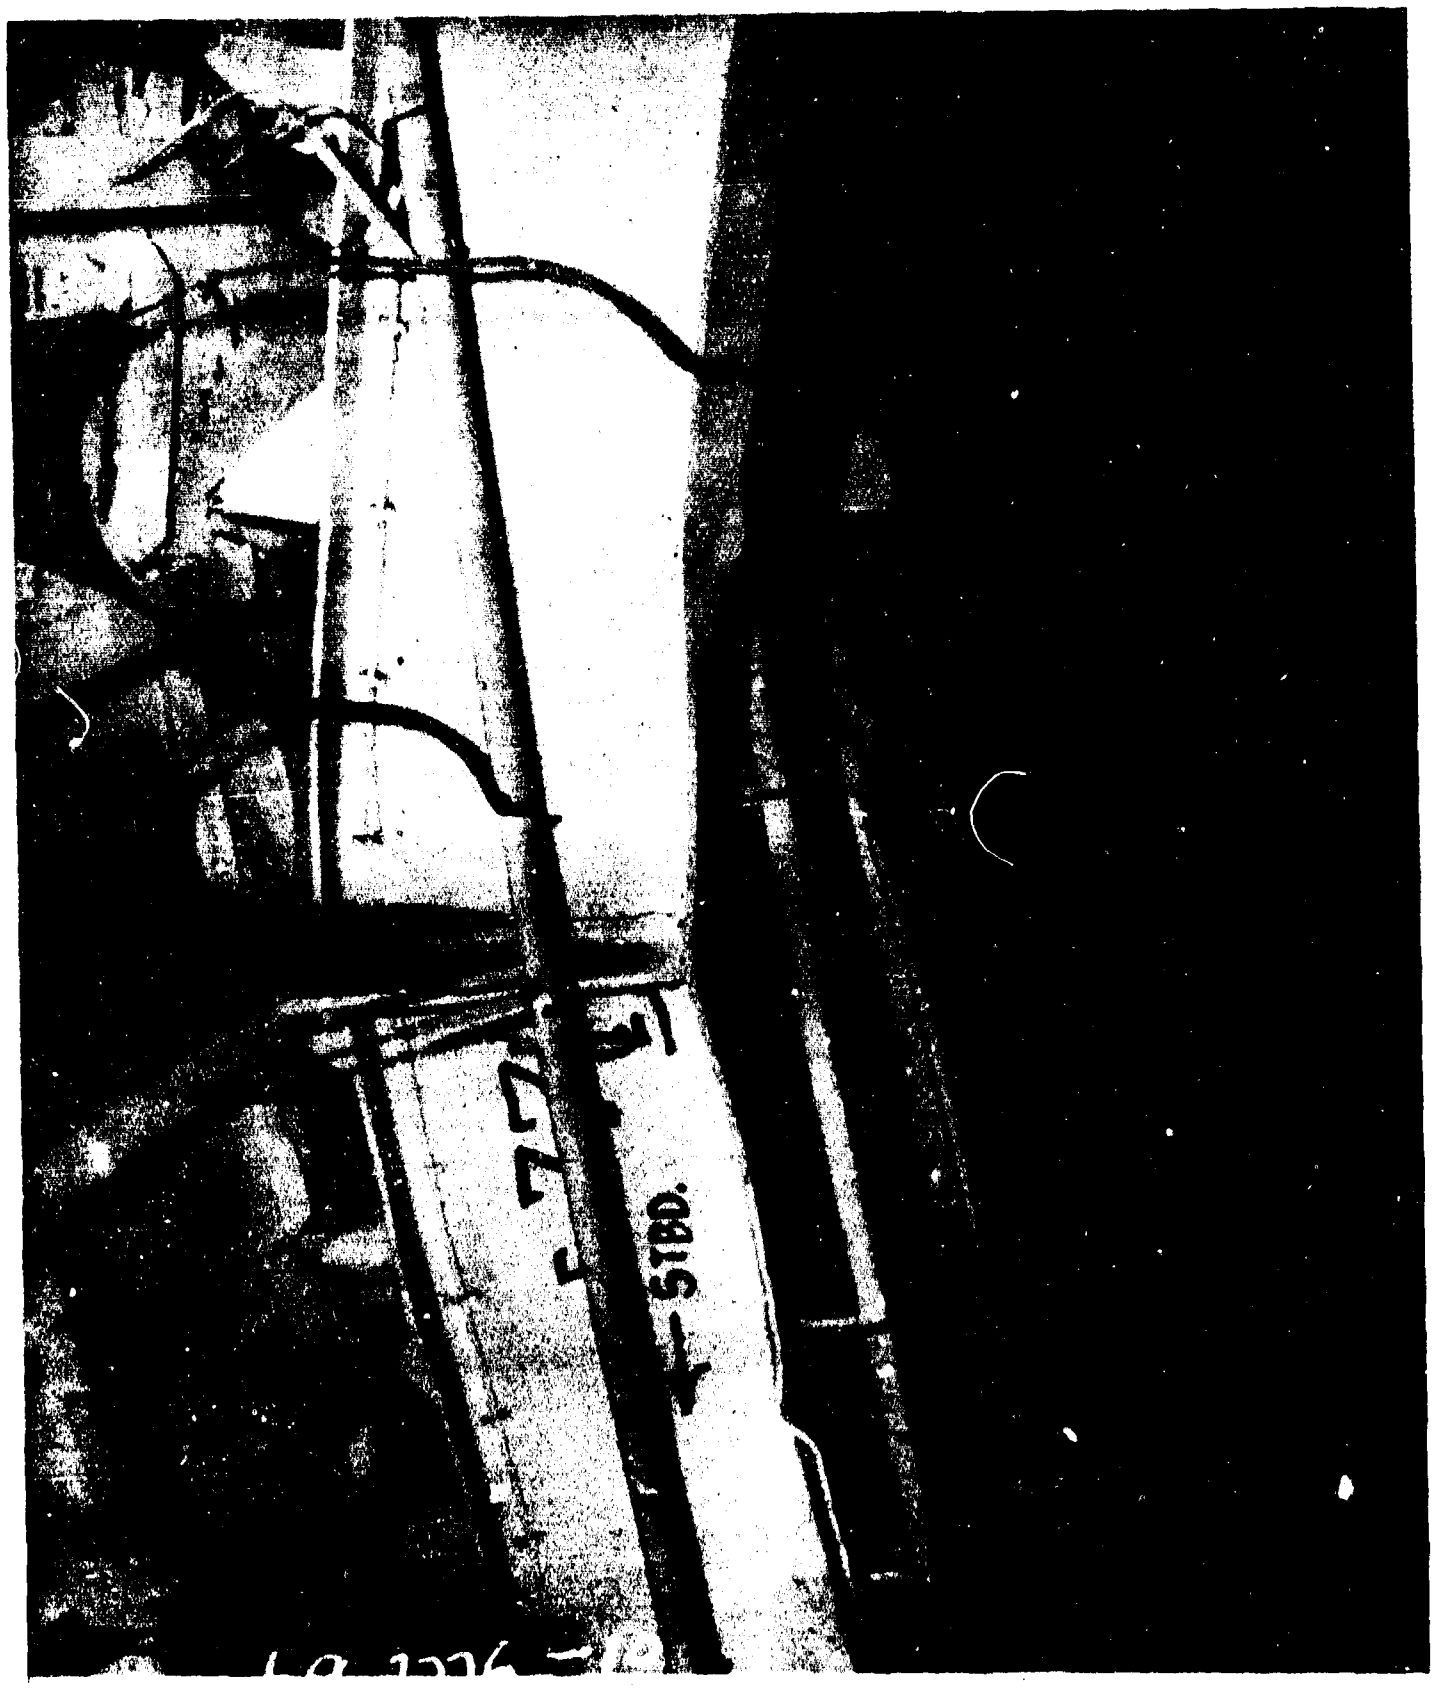
AA-CR-59-2226-10. USS INDEPENDENCE (CVL22). Fracture in center-line butt weld in flight deck bent girder. Fracture originated in weld in upper flange. Looking aft.

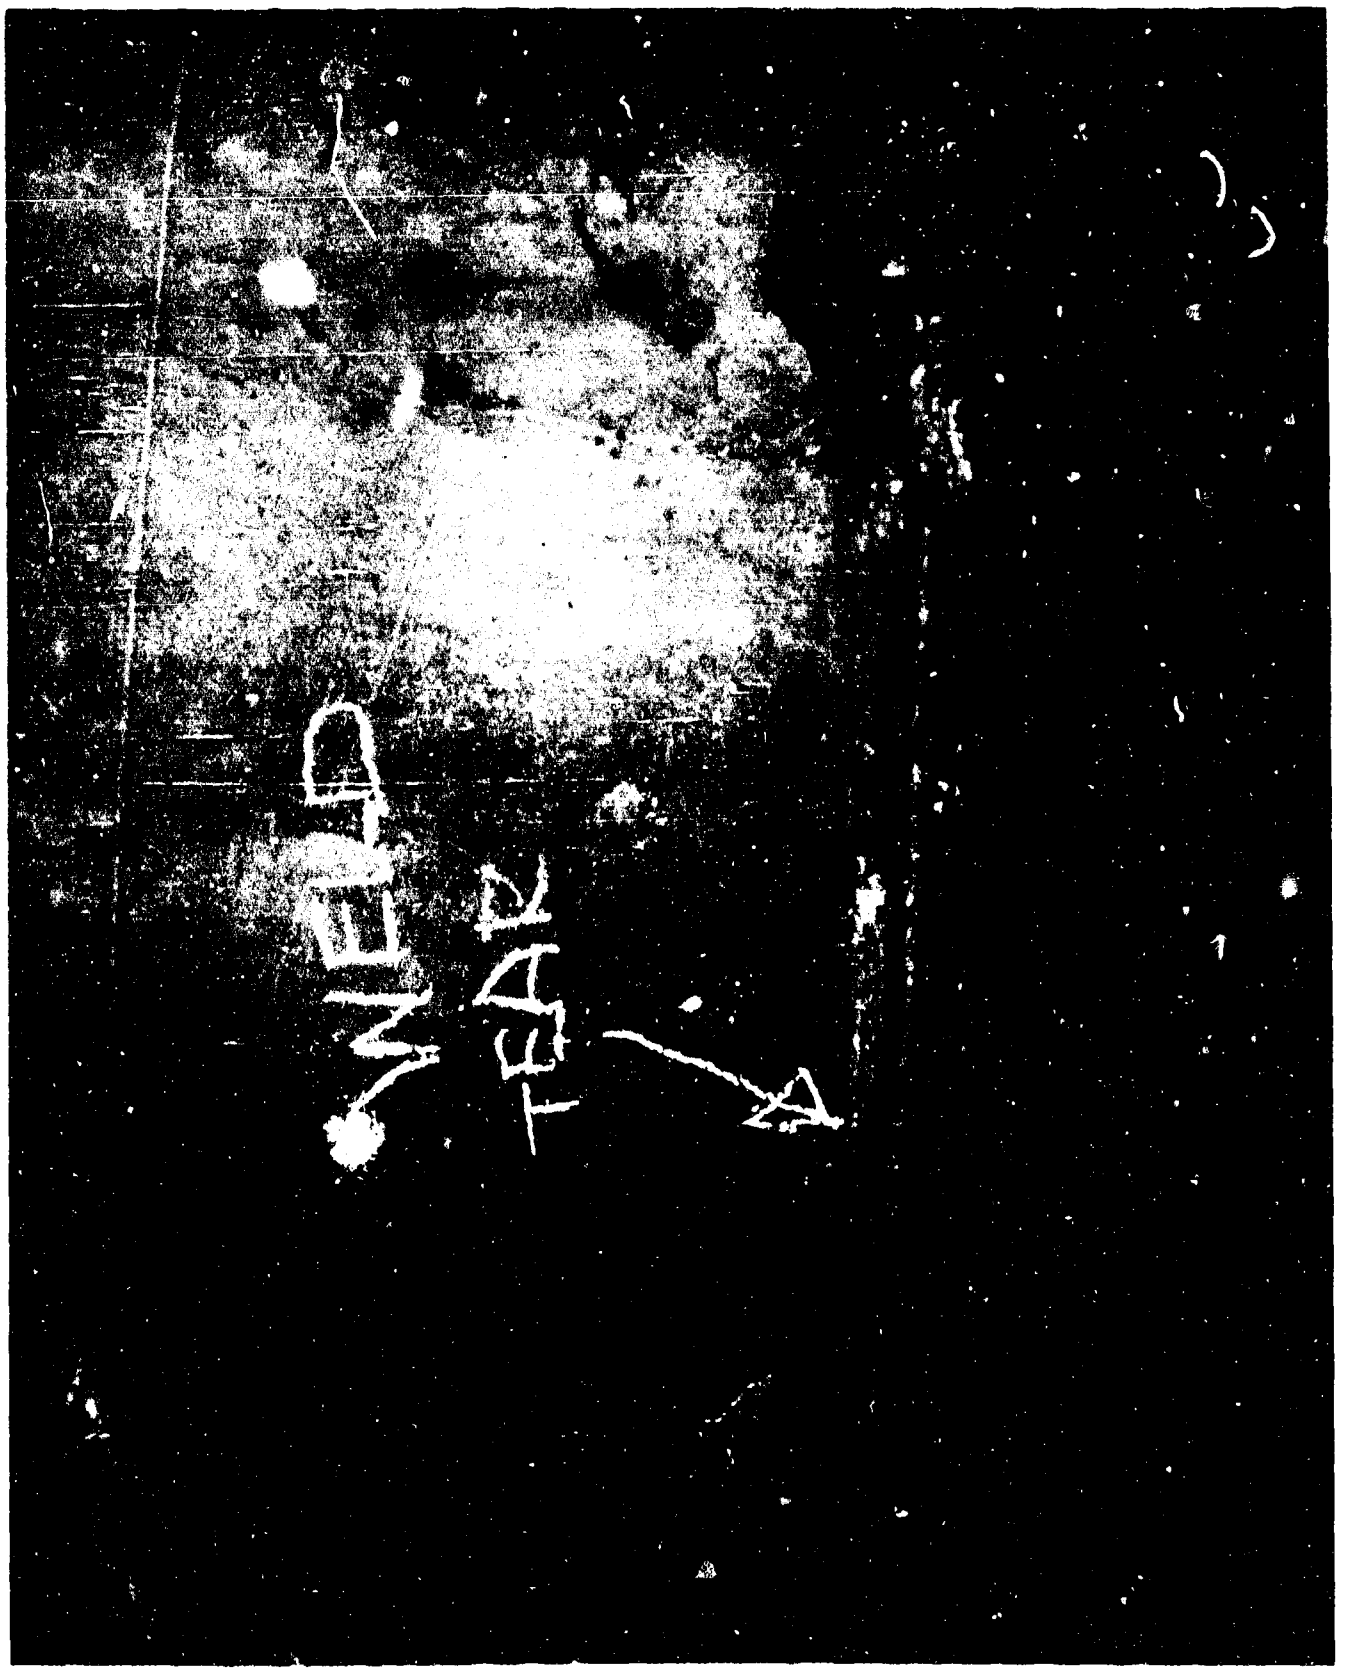
AA-CR-100-4162-2. USS INDEPENDENCE (CVL22). Failire at edge of CRS weld joining flight deck bent column at STS sheer strake at frame 89.

AA-CR-65-959-1. USS INDEPENDENCE (CVL22). Fracture in austenitic welds joining flight deck bent column 89 to STS sheer strake. Port side, looking aft. For outboard view see photograph 4162-2.

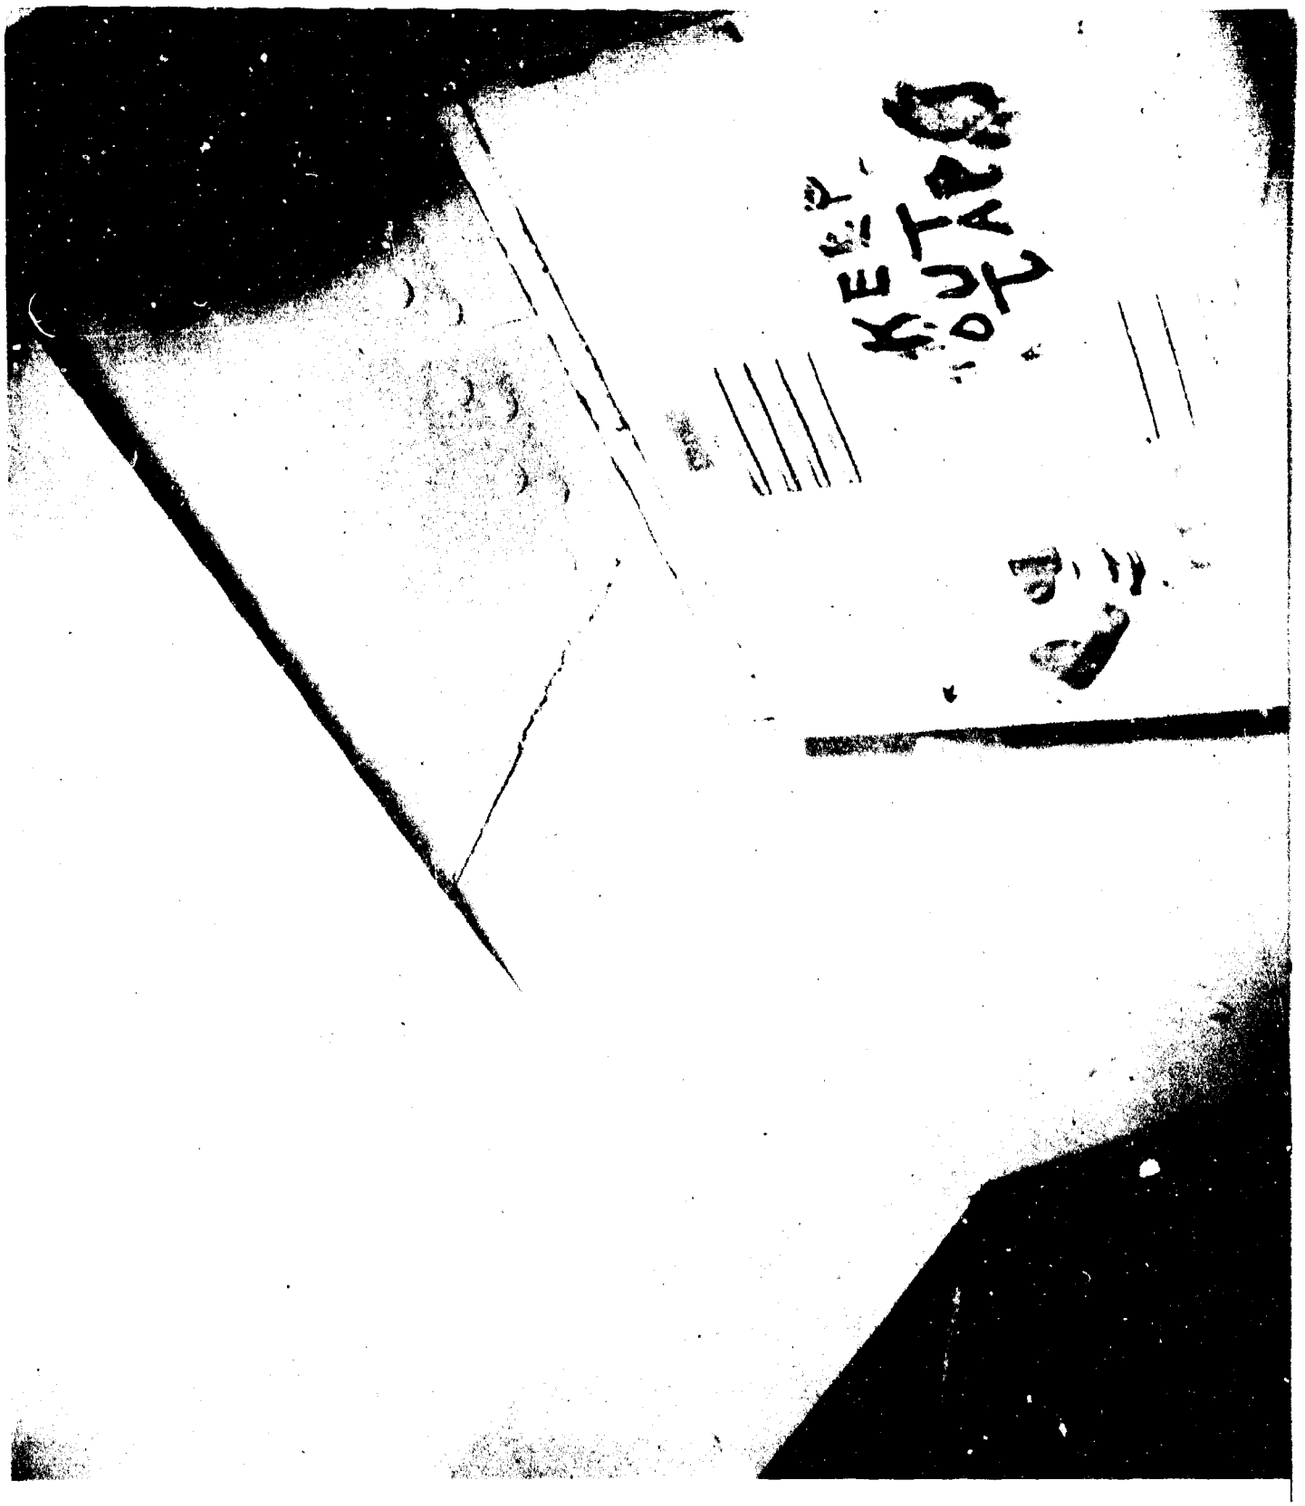
AA-CR-59-2088-7. USS INDEPENDENCE (CVL22). Fracture in web adjacent to weld joining web frame 89, port, to STS stringer strake of main deck. This failure is underneath failure at footing of flight bent 89 shown in photographs 4162-2 and 955-1.

AA-CR-59-2164-2. USS INDEPENDENCE (CVL22). Close-up view of fracture in web at welded connection of web frame 89 to STS stringer strake of main deck. See photograph 2088-7.
