TECHNICAL INSPECTION REPORT

WELDING

OPERATION CROSSROADS

JOINT TASK FORCE ONE

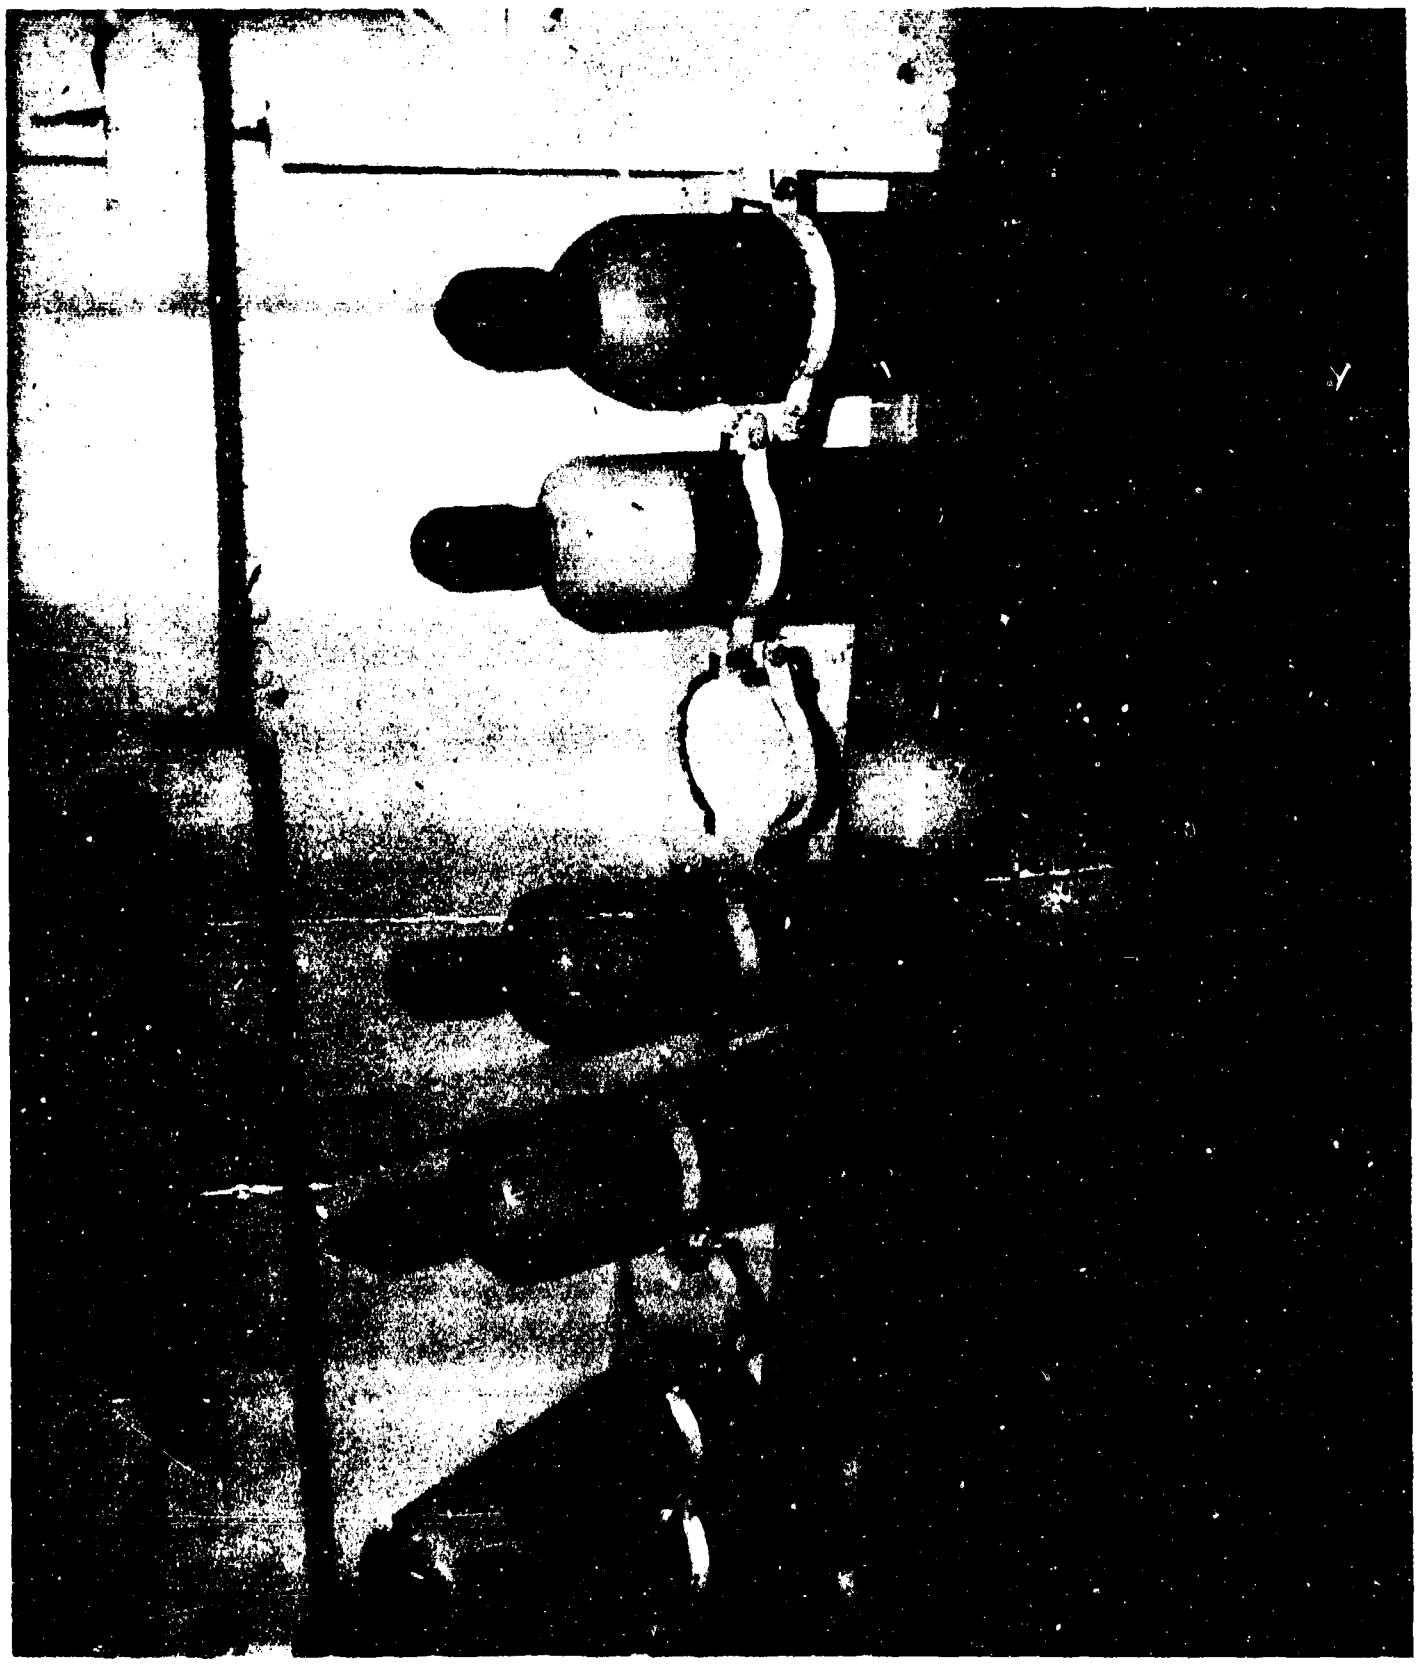
(c) Oxygen, acetylene and other gas cylinders. In most cases gas cylinders were stowed on weather decks. In many instances, such as shown in photographs 1867-2, 1868-3 and 2116-12, pages 22, 23 and 65 , cylinders were displaced from stowage racks by the force of air blast against structures to which they were secured. Similar occurrences were observed on Test B target ships moored close to the bomb. Displacement of cylinders in this test was caused by underwater shock. As far as could be ascertained displaced cylinders were undamaged.

Although the main and second decks aft on the INDEPENDENCE were severely deformed on the port side in way of the severely damaged area, as shown in photographs 2216-2, 2216-7, 2071-1, 2116-12, 2041-7 and 2116-7, pages 35, 36, 64, 65, 68 and 70, no failures were observed in welds. Photographs 2040-2 and 2226-12, pages 48 and 50 show deflection of the all welded hangar deck. No failures were found in welds in this deck. In the forward elevator pit on the INDEPENDENCE a failure occurred in a weld in a make up joint in a flush patch in the main deck. Examination of the fracture revealed that the joint edges of the 20 pound plate had not been beveled for welding with a result that very little of the joint was penetrated by the weld. Photograph 2100-4, page 49 shows the fracture which is approximately 6 1/2 feet long. No failures were observed in welds in STS deck plating.

AA-CR-175-2116-12. USS INDEPENDENCE (CVL22). Weld fractures in mid-height stringer and shell frame in way of bulged port shell. Third deck frames 124 and 125. Note displaced gas bottles.

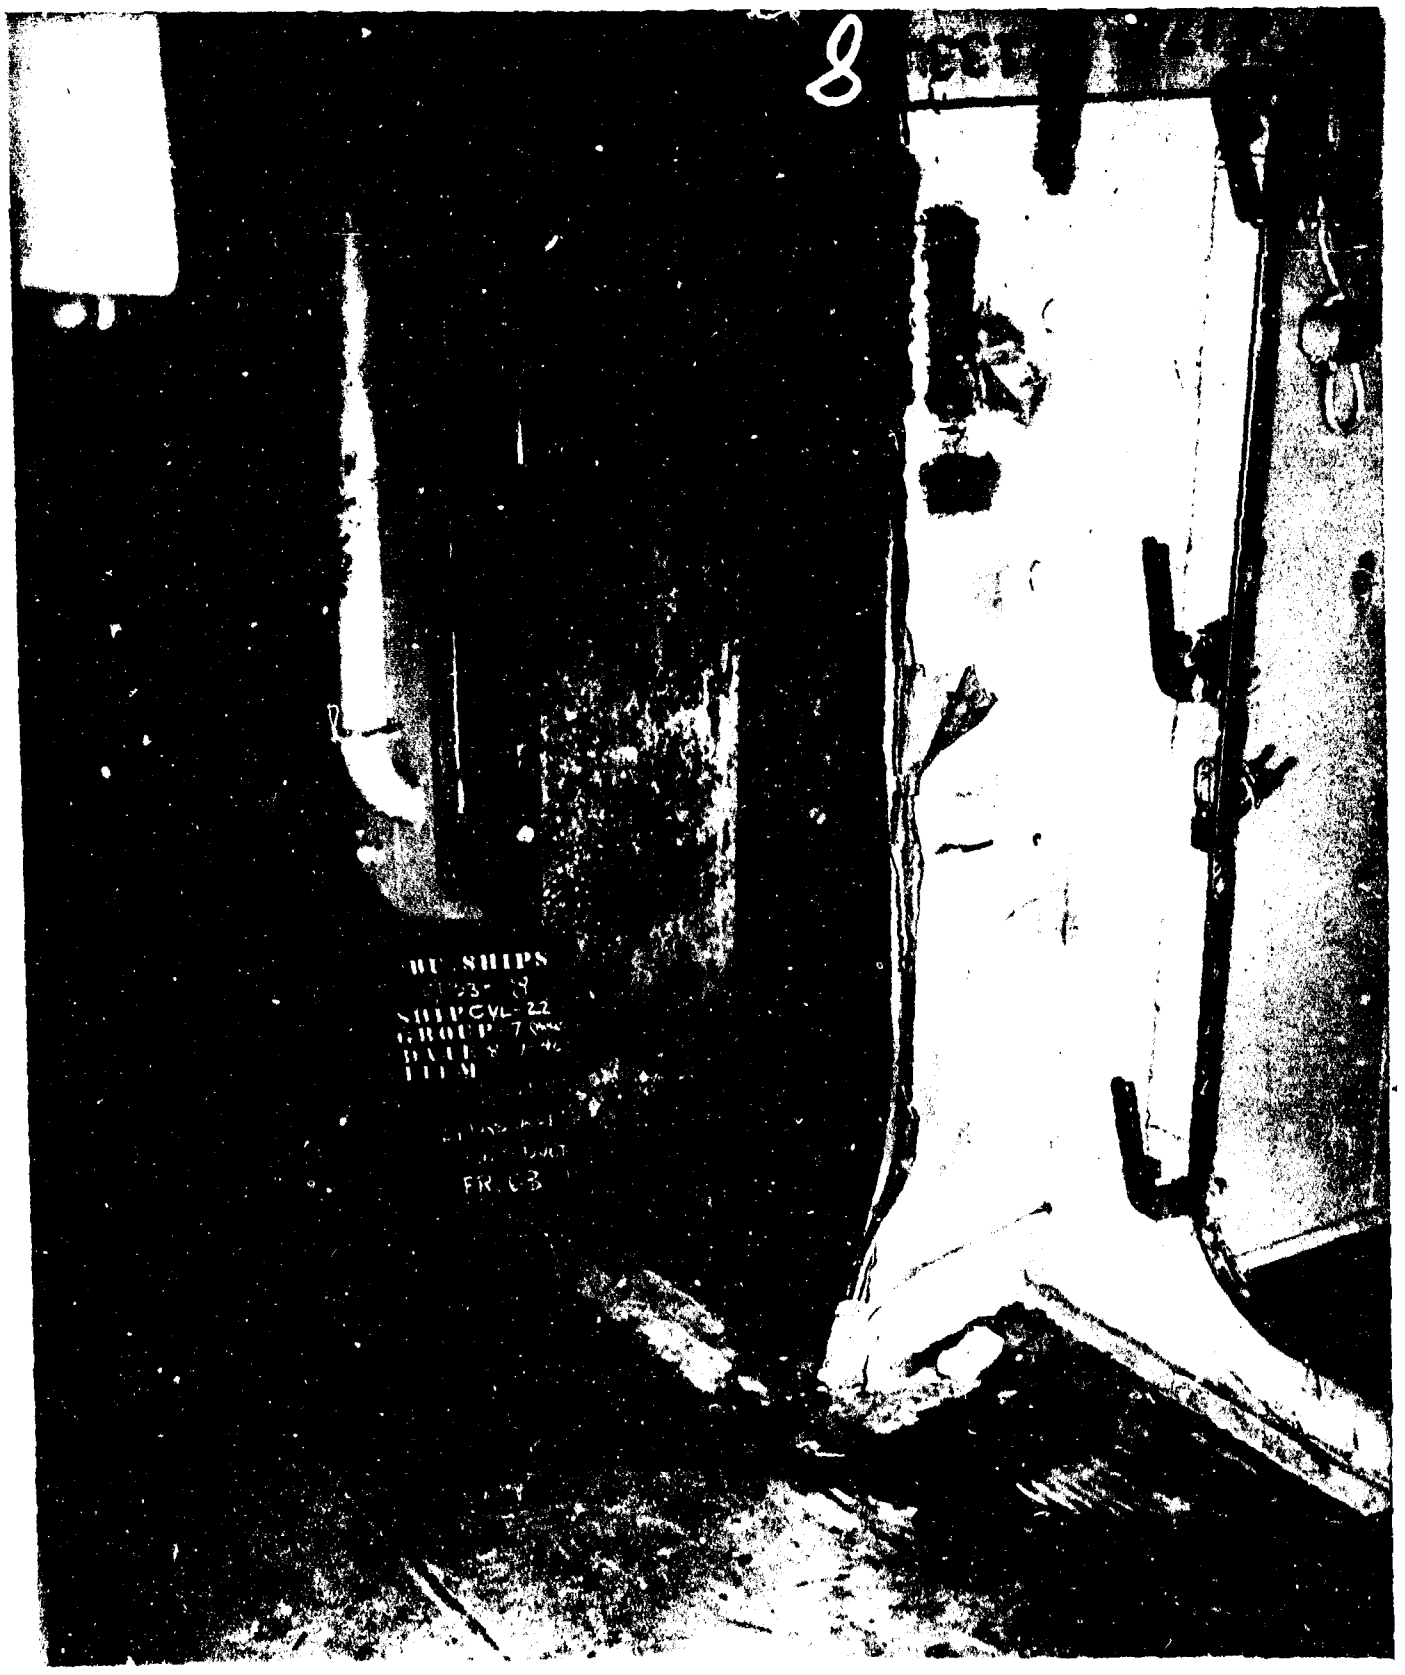
AA-CR-175-2133-8. USS INDEPENDENCE (CVL22). Failure of arc welded ventilation duct. Second deck, port passage, frame 63. Blast penetrated ventilation system.

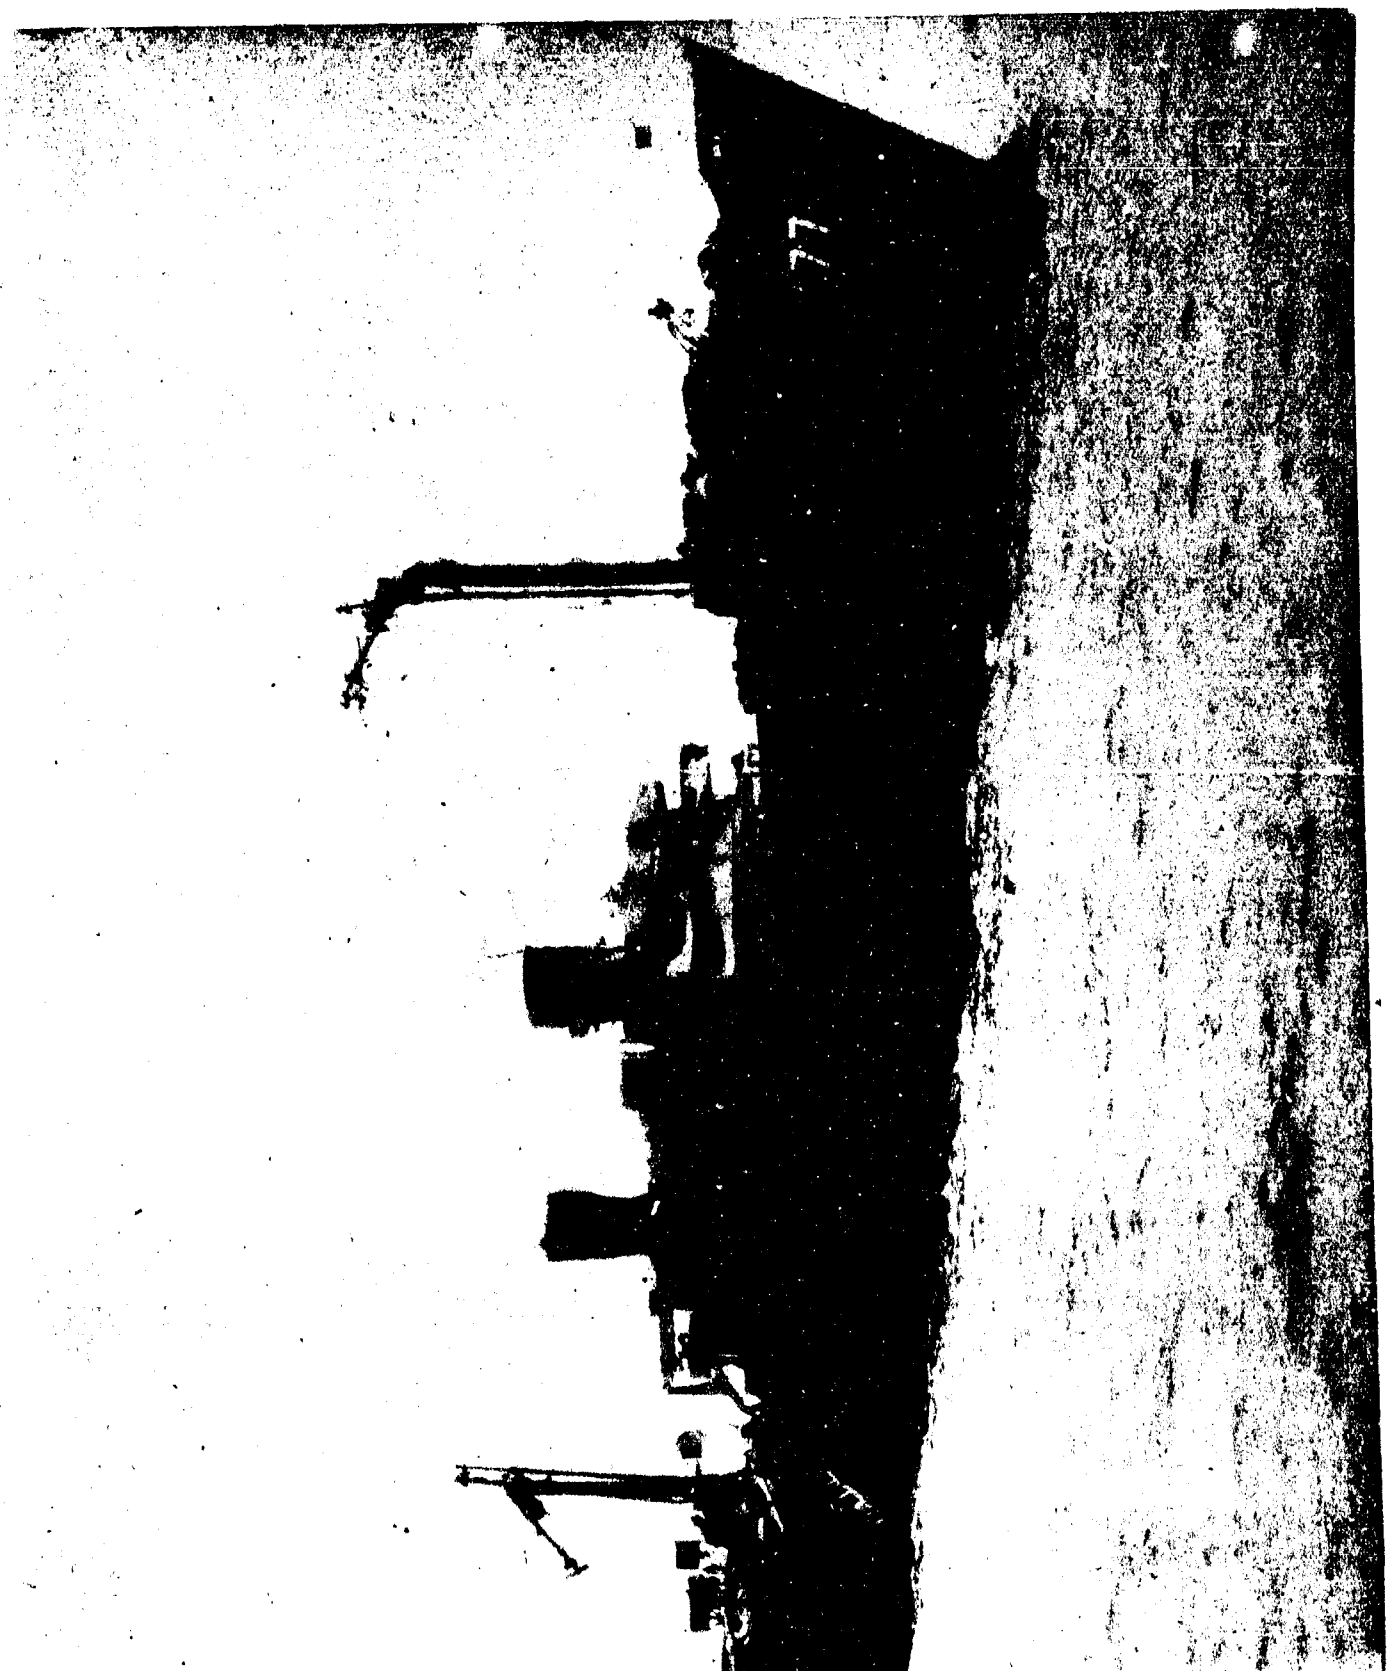
AA-CR-227-49-117. USS CRITTENDEN (APA77). General view of blast damage to superstructure - starboard bow view.

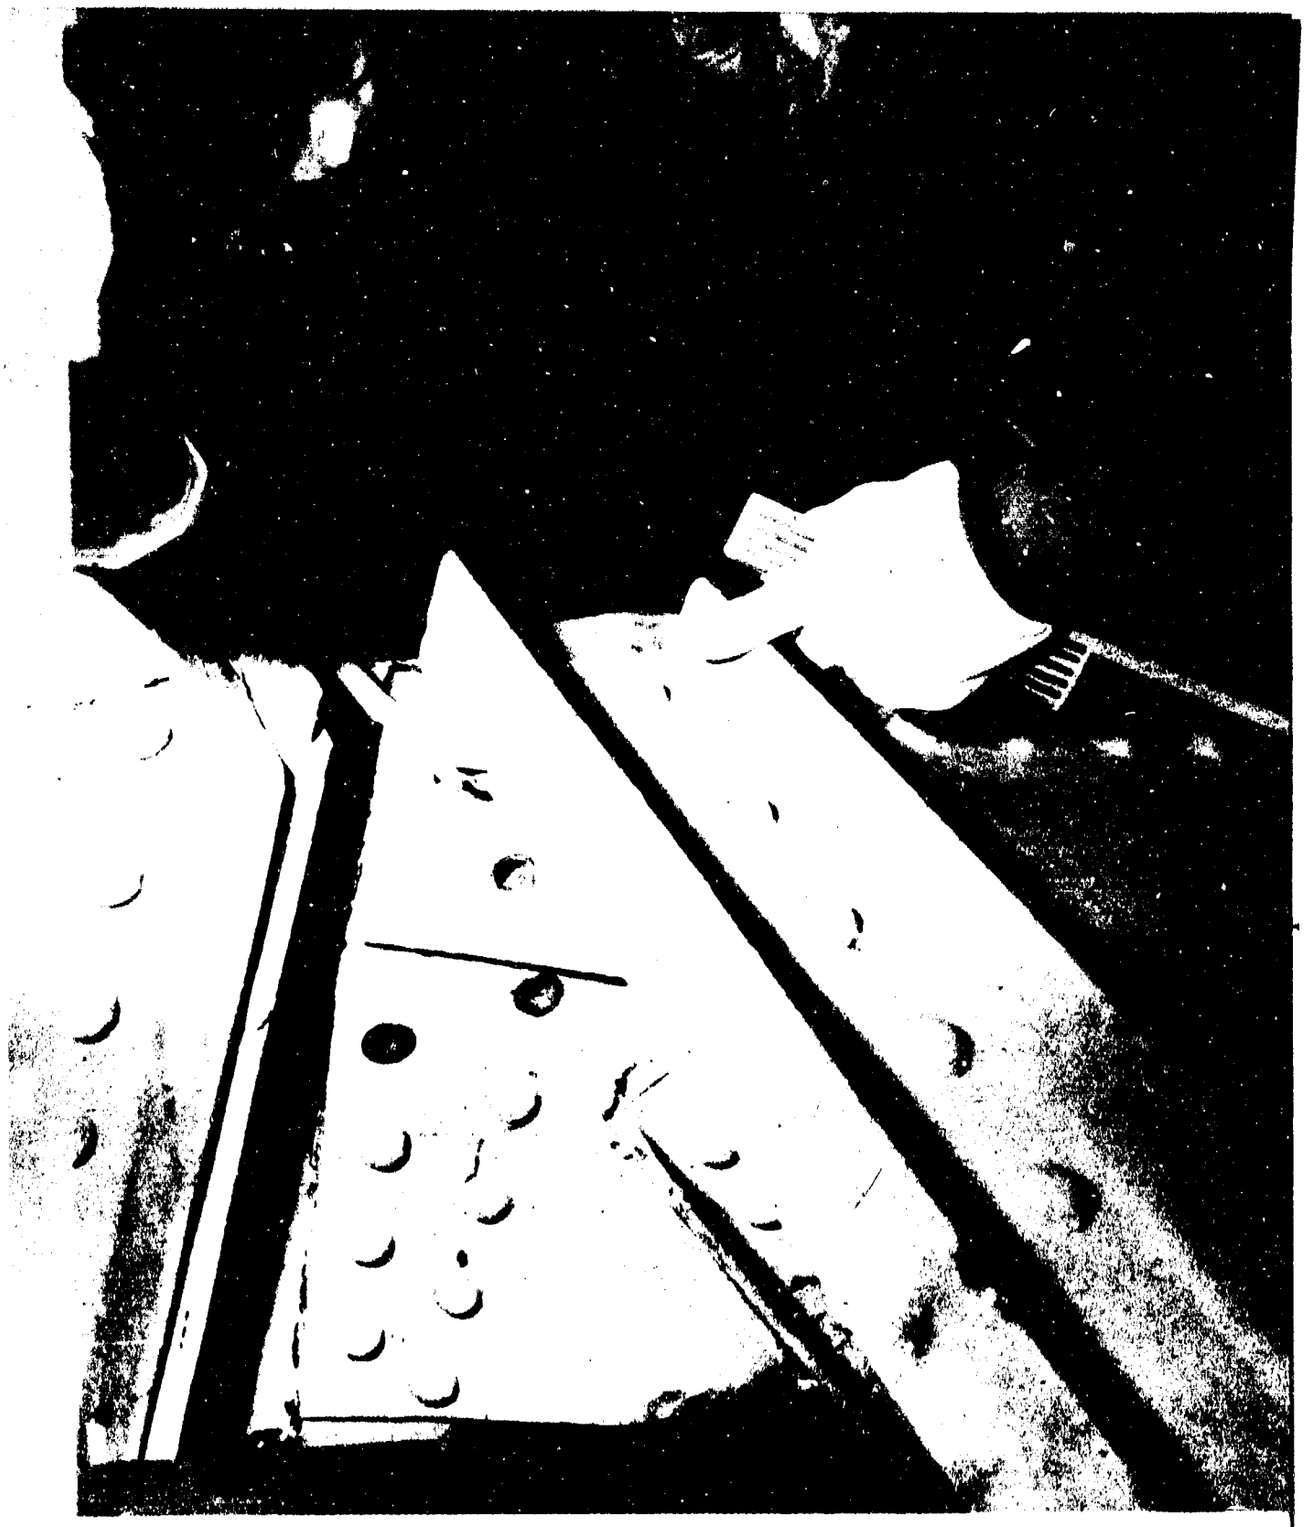
AB-CR-68-1691-8. USS PENSACOLA (CA24). Failure of port main condenser foundation due to underwater shock. Note sheared rivets. Forward engine room, forward face of after end of foundation.

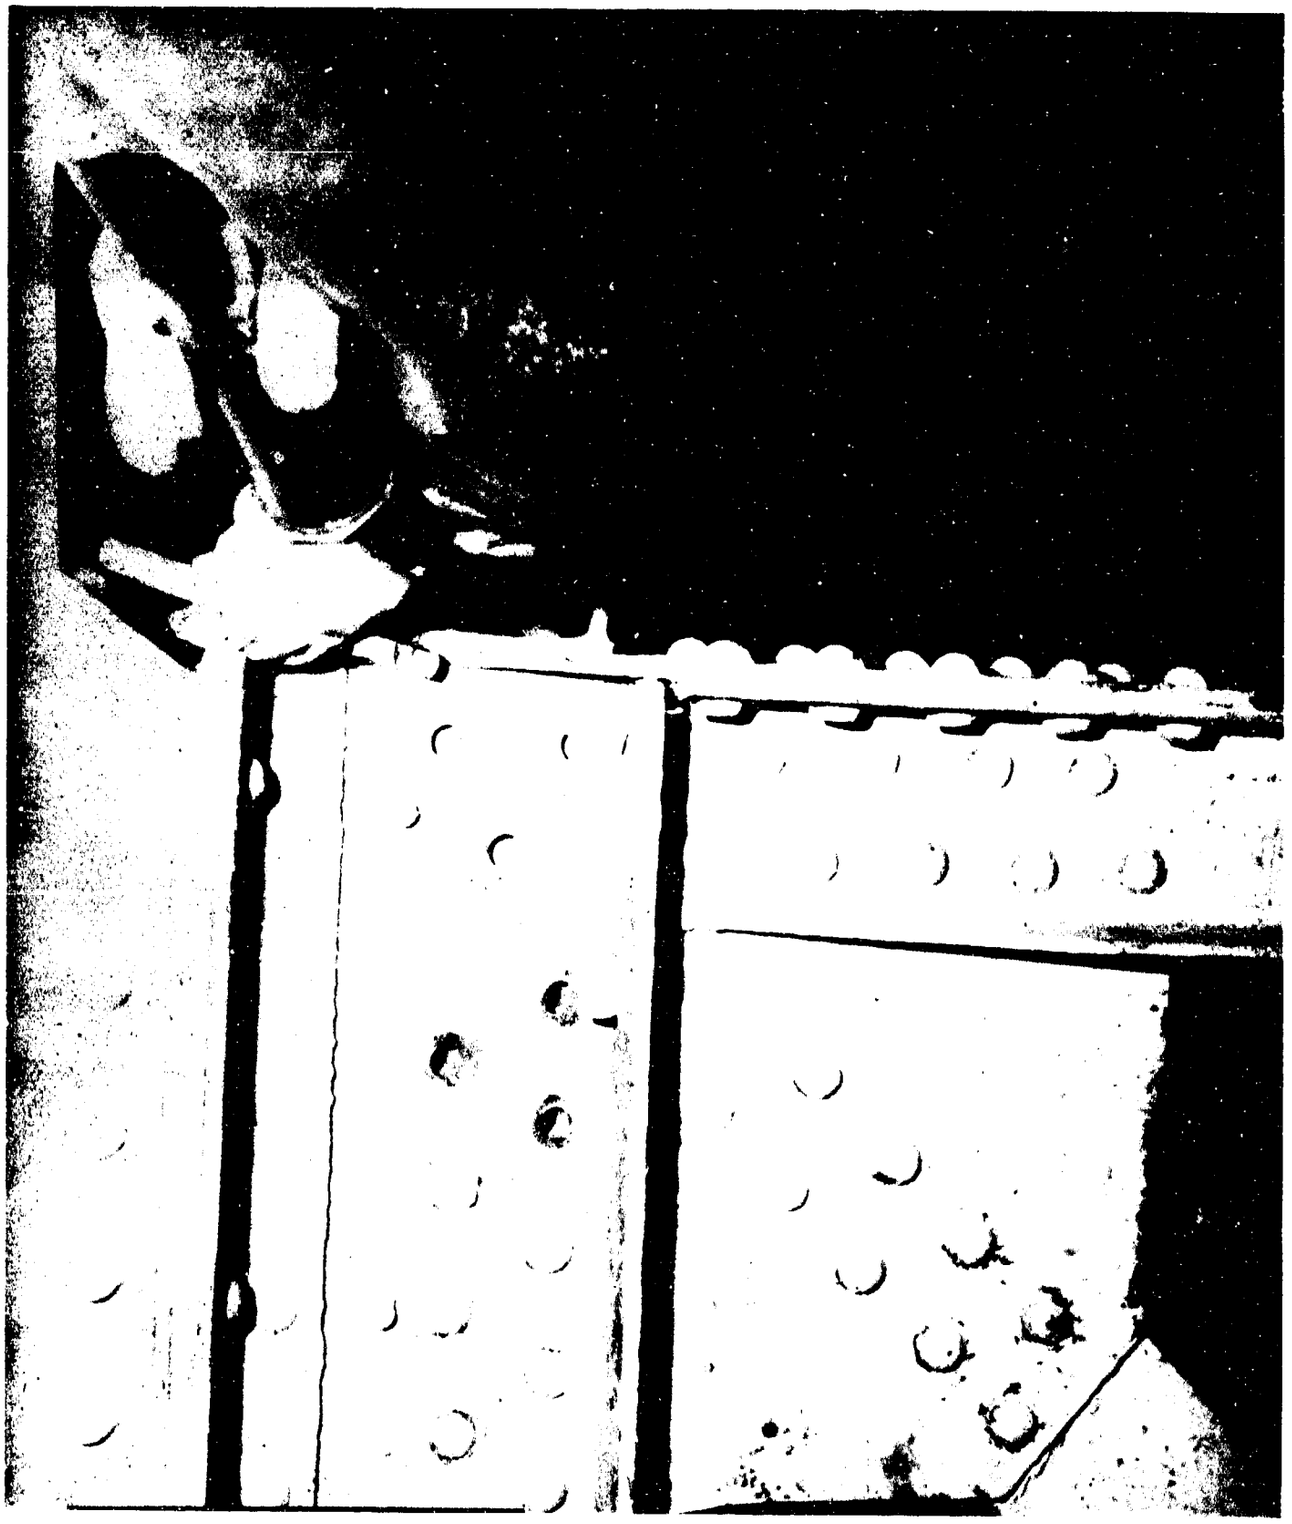
AB-CR-68-1691-5. USS PENSACOLA (CA24). Failure of forward end of port main condenser foundation due to underwater shock. Note sheared rivets.
