FRANKFORD ARSENAL

EXAMINATION OF ROTATING BANDS FROM 155MM PROJECTILE, HE, M107, FIRED WITH PROPELLANT CHARGE XM119

Test Report T64-3-1

October 1963

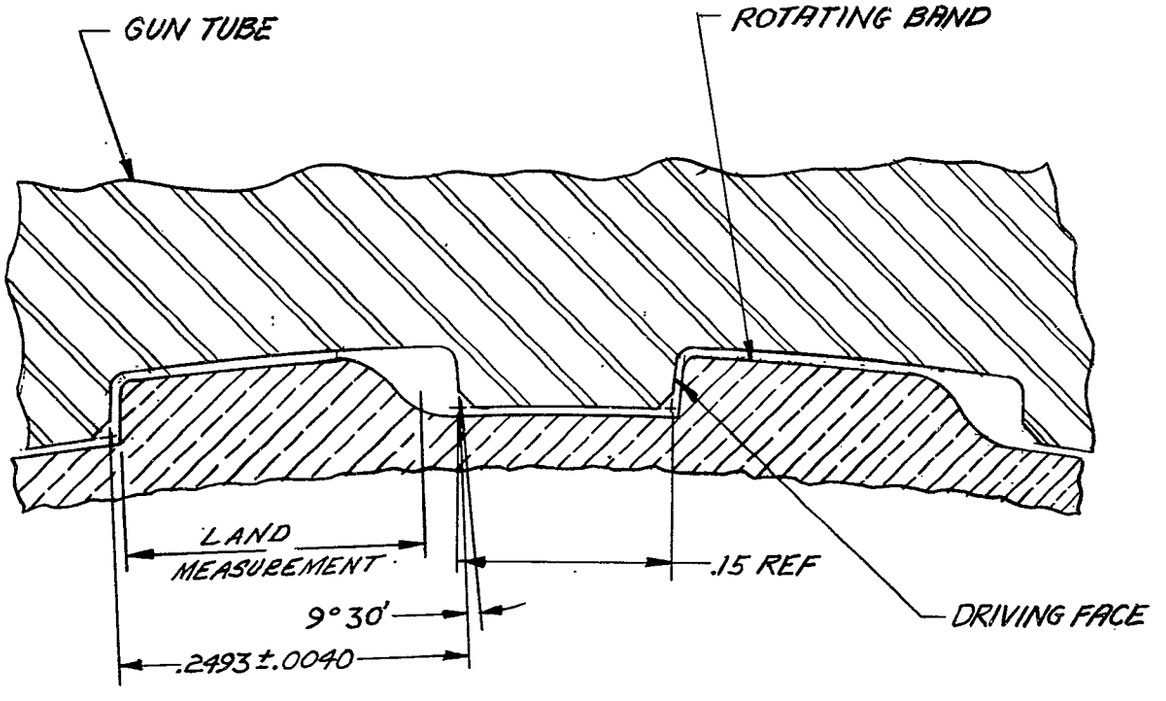
Figure 2. 155mm M107 Rotating Band Wear with Propelling Charge XM119

are given in table IV. Because of the erosion of the nondriving face, it was not possible to accurately measure the band land width. The measurements were taken as shown on figure 2 and the actual percent of band shear or wear is somewhat greater than that shown by the measurements. On three of the four rounds fired at service pressure, the band wear was 19% with one round of 31%. On three of the four rounds fired at excess pressure, the wear was 38% with one round of 47%. From a new tube, two definite wear levels are evident, proportional to pressure and velocity and fairly consistent with an occasional outlier. The wear level (17-36%) from the worn tube is comparable to that of the new tube; however, the variation of the wear level is greater for the worn tube which is expected due to the worn condition of the tube.

Although considerable wear is evident, sufficient working metal was left to satisfactorily impart full spin to the projectile and because of the consistency of the wear, the wear did not adversely effect either the velocity uniformity or range dispersion of the shell (PE range .20% at 18,000 meters). The rotating bands of four recovered T387E1 projectiles fired at 120% of rated maximum pressure were measured for comparison with M107 and the wear of the T387E1 was 3 to 5%. Diametrical measurements of the band do not appear to be too meaningful or significant. Band land and groove diameters are shown in tables II and III. They exceeded the maximum rifling diameters, although the excess cannot be related to excessive band gap. A possible explanation may be that of elastic deformation of the shell body due to the engraving pressure. Similar measurements of the T387E1 shell were generally within dimensional limits, however, the T387E1 band is supported by the solid base section thus minimizing, if not eliminating, elastic deformation of the shell body.

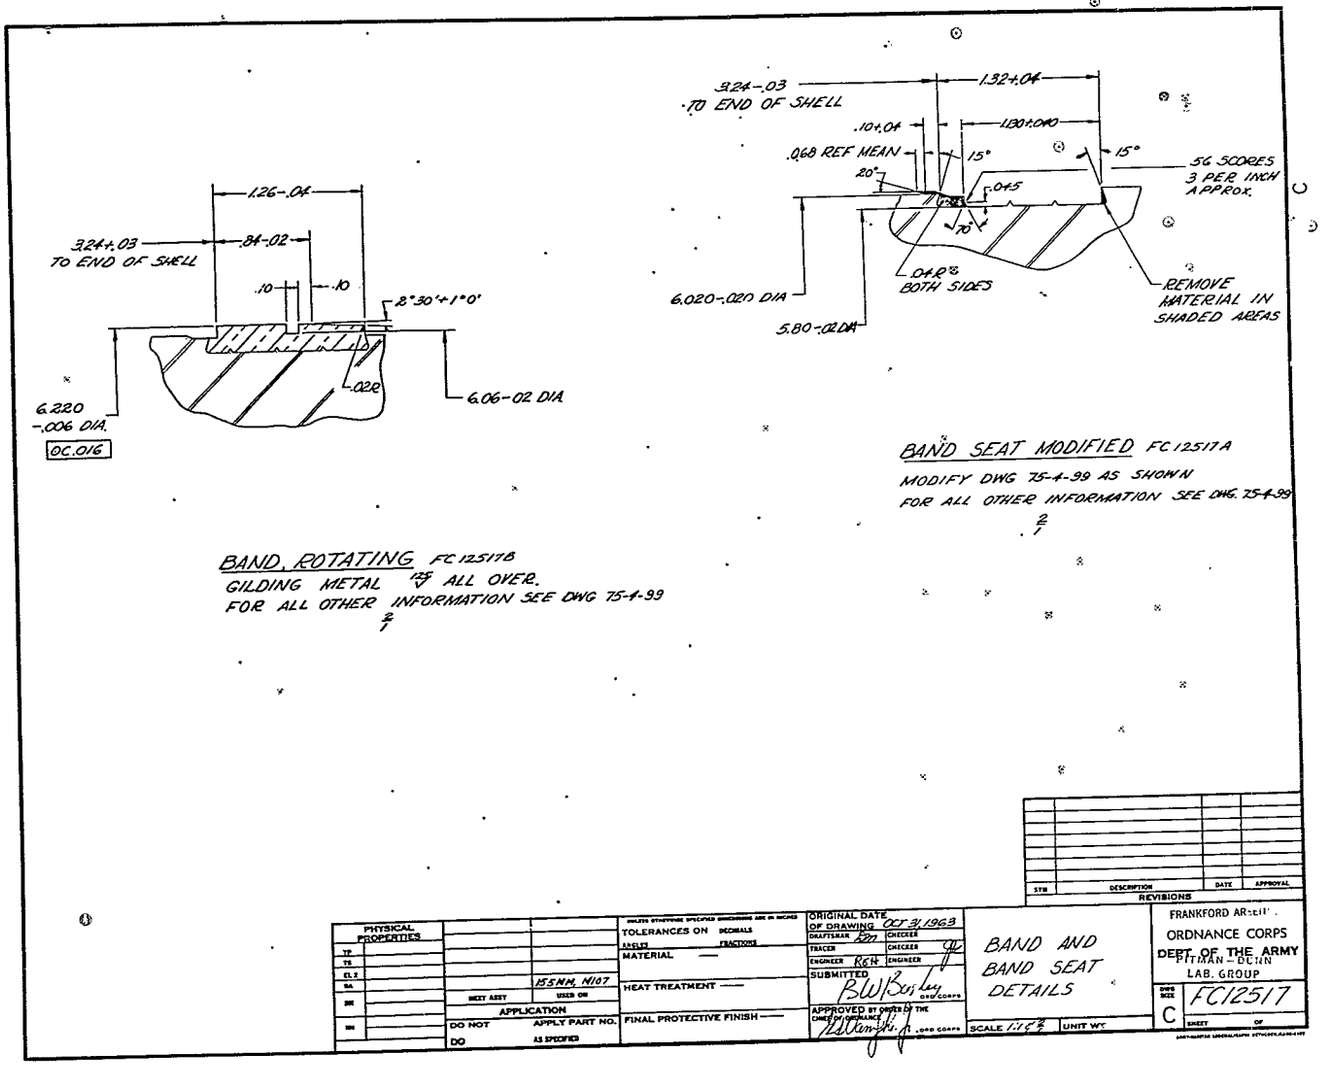
Figure 4. Band and Band Seat Details

Finally, the band seat profile was examined for its ability to retain the band. The edges of the band seat are not undercut and due to the large relief groove behind the band, the depth at the rear of the seat is only about .070" or one-half that of the forward edge of the seat (.140"). Therefore, band retention is primarily dependent upon the strength and tightness of the band.

The above is the most probable cause of band failure except for failure of the band in hoop tension, and could probably be overcome by proper application of the bands. However, if the problem is serious enough to warrant rebanding, then it is recommended that the seat profile be modified to include 15° undercuts of the edges and widened to increase the depth of the rear edge of the seat to a minimum of 85% of the depth of the forward edge. A proposed band seat and band profile is given in figure 4.
