TECHNICAL MEMORANDUM No. 10/M/68

The Testing of Safety Spectacles, Lenses, Goggles and Visors

Part 2

L.D. Cole
R. Pape

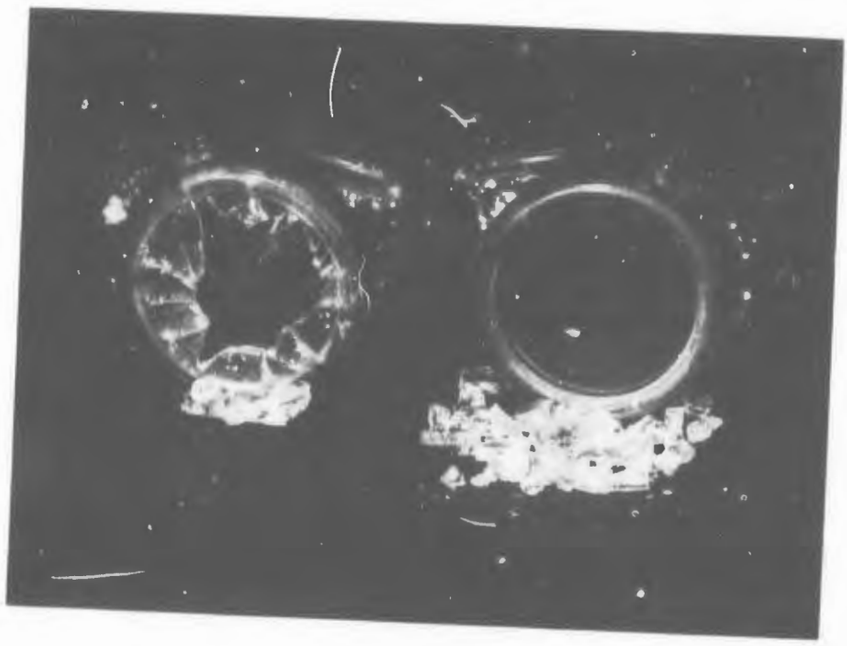
FIG. 4

The value of a double lens system in goggles, when the rear lens is of cellulose acetate, has been clearly demonstrated in the results on Types 9, 10A, 10B and 12A (Figs. 4, 5, 6, 7 and 9). Cellulose acetate is preferred to glass for the front lenses because it suffers from scarring only. If optical considerations favour the use of glass front lenses then laminated glass is preferred to toughened glass because the former tends to hold together even when severely cracked. The tests on Types 12A, 12B and 12C goggles illustrate the advisability of following the manufacturer's instructions to mount the lenses in contact, with the thinner lens in front (see Figs. 9, 10 and 11).
