NRL Memorandum Report 5697

Projectile Impact Effects on Aircraft Wire Harnesses

January 8, 1986

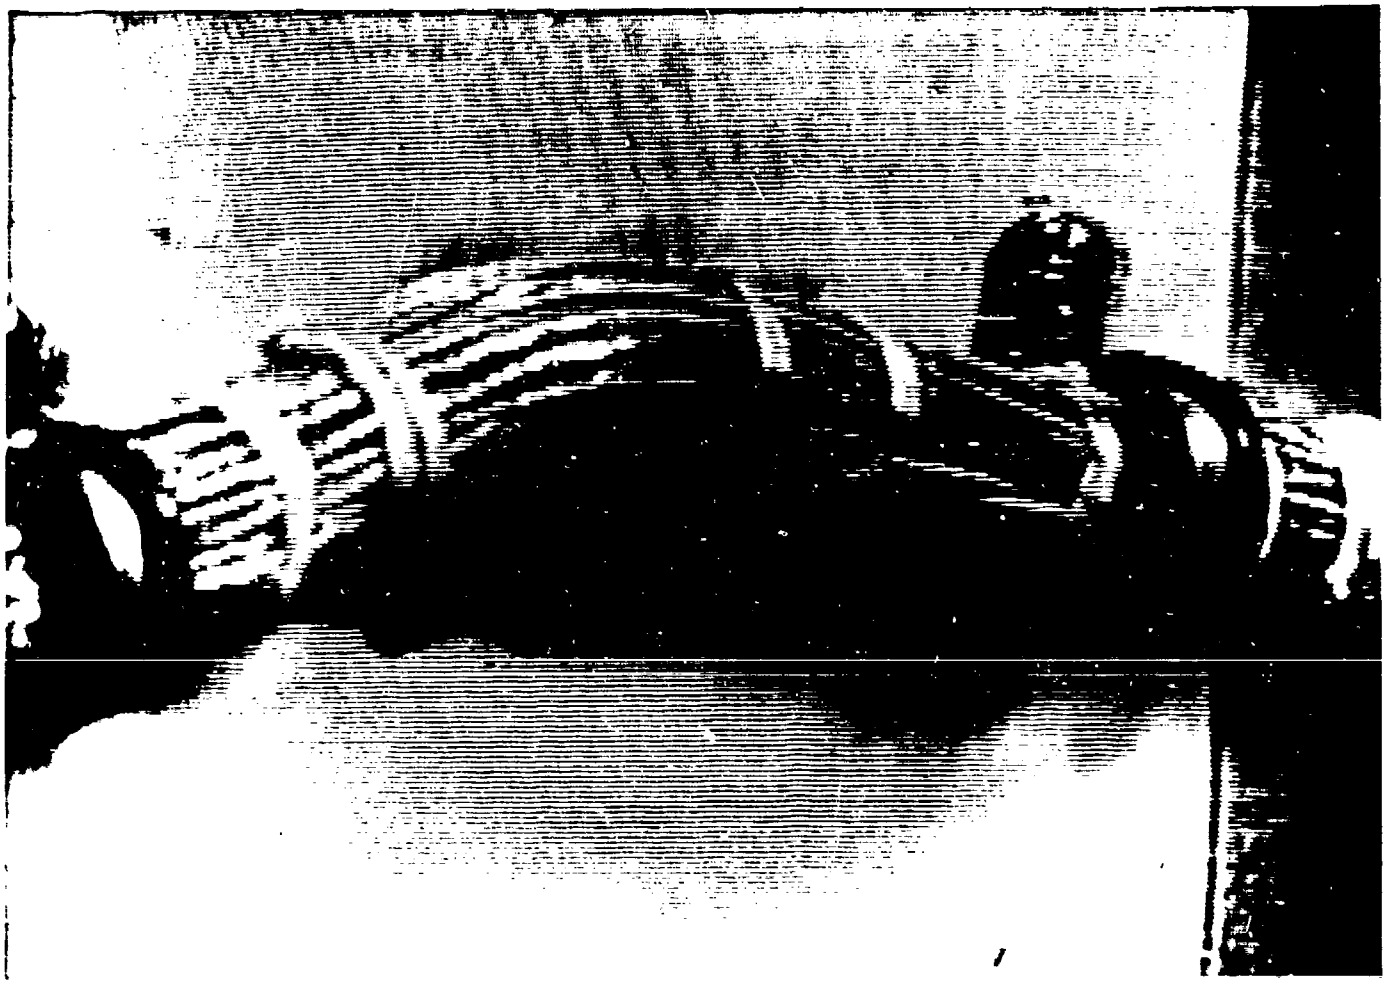
The first shot was conducted with the 30-caliber ball, fired at the MIL-W-81381/11 type harness. The projectile severed wires in the lower part of the harness, and deformed the remaining wires of the bundle. The close-up view in Figure 7 shows the deflection produced by the impact, the carbon deposited on the painted surface, and the hole in the plate where the projectile passed through. A short circuit during the penetration caused arcing that tripped one ac breaker.

Fig. 7 — The initial damage to the MIL-W-81381/11 harness from the impact of a .30-caliber bullet. 81612-3

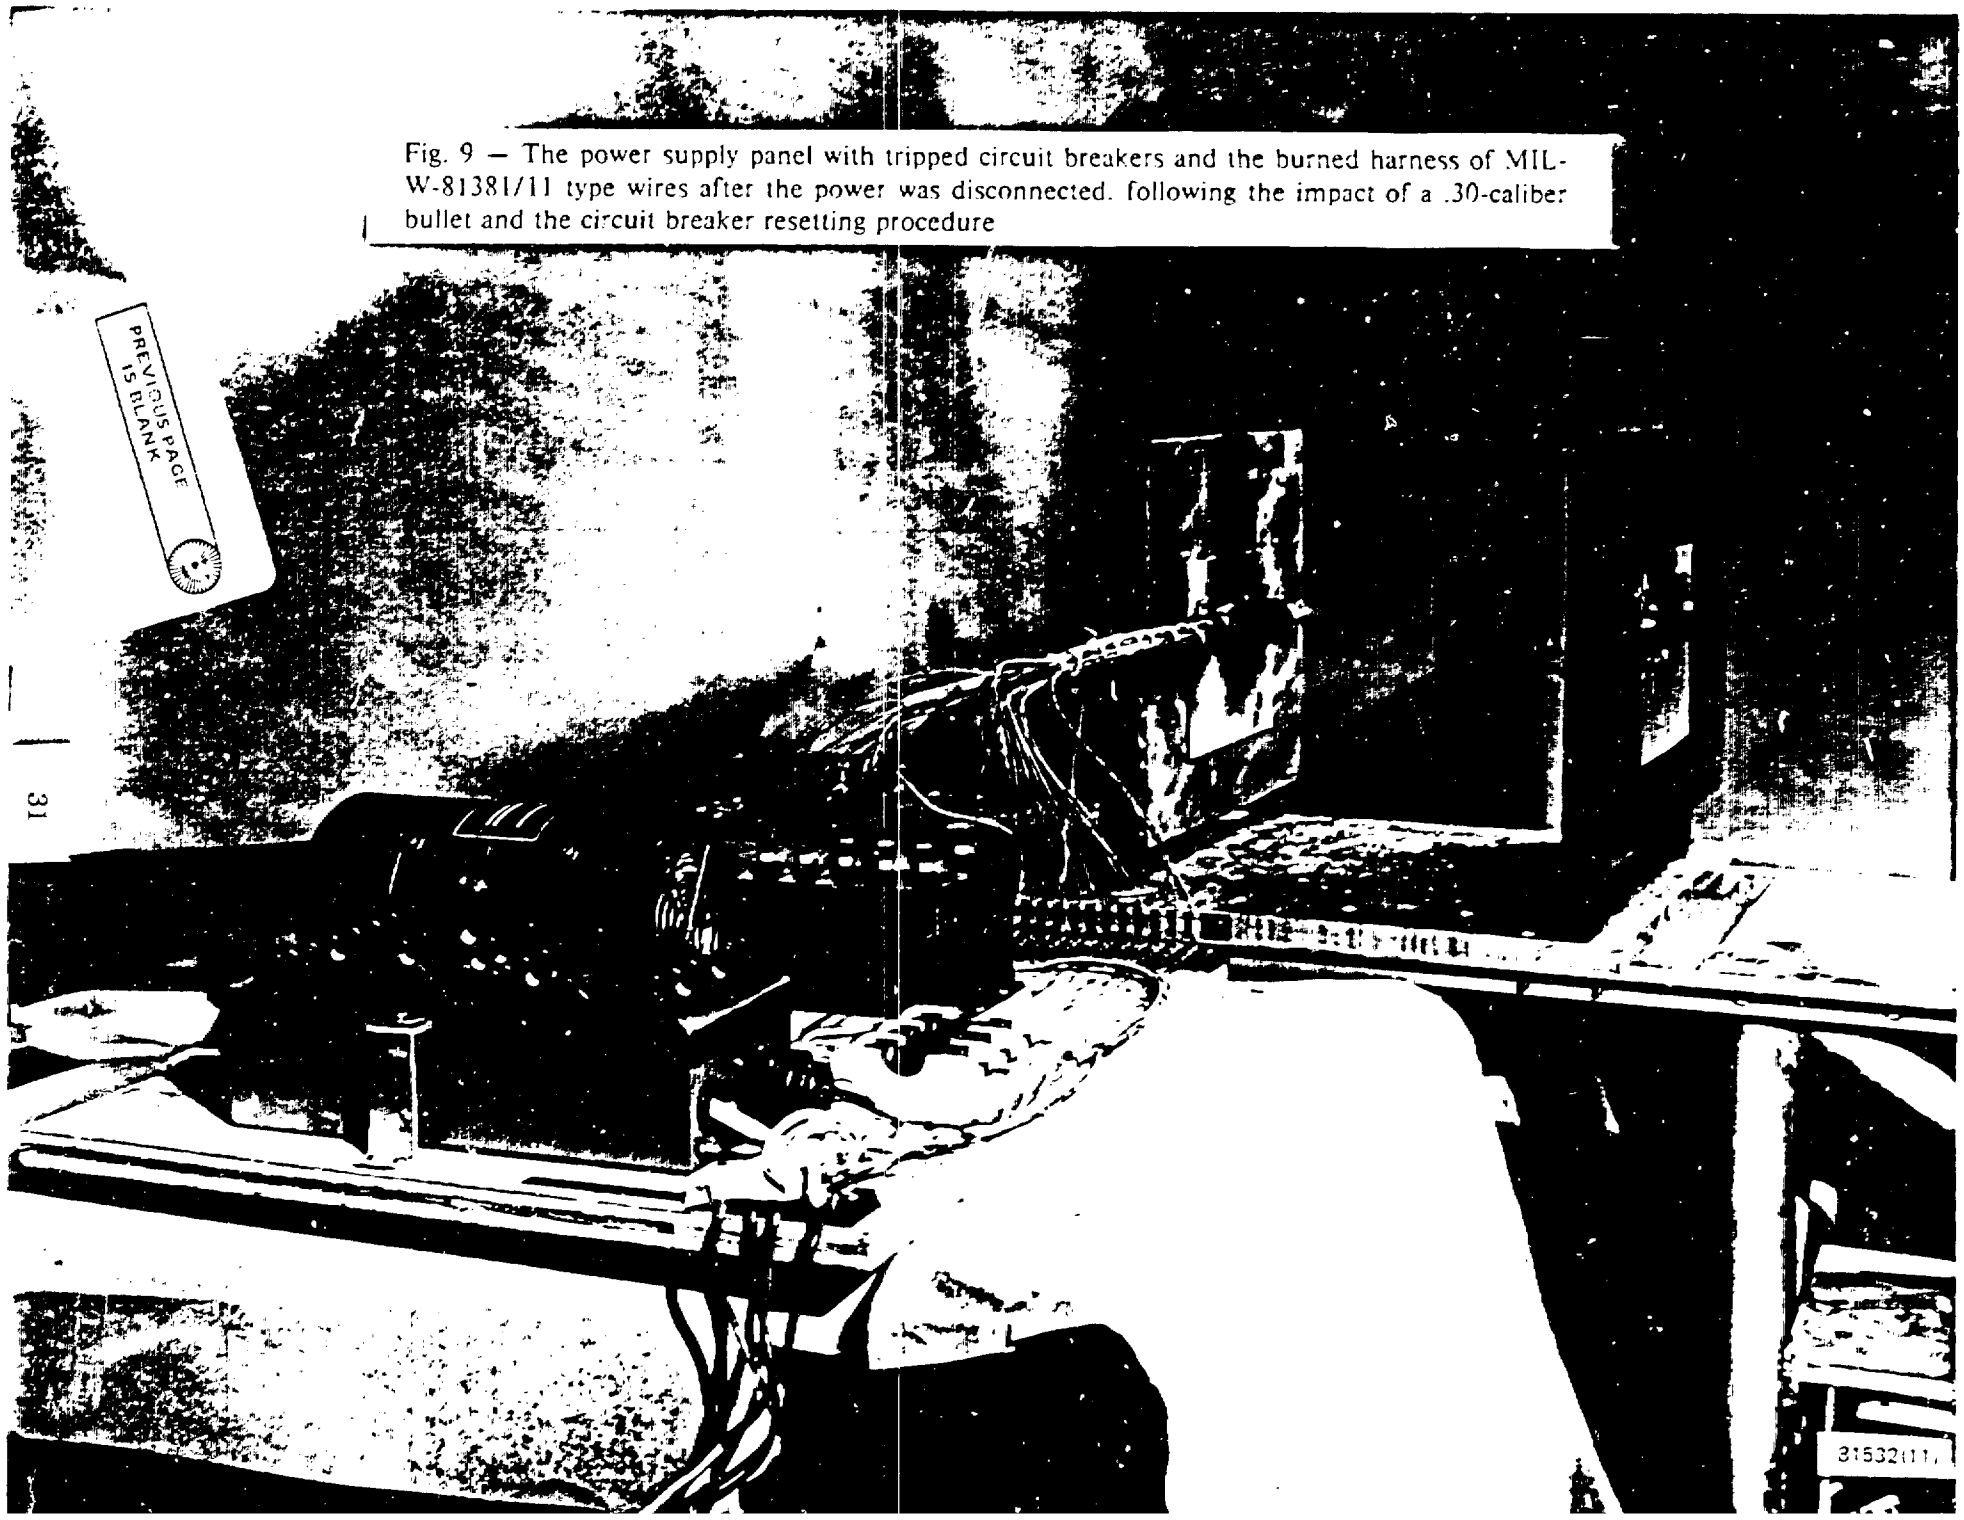
Figure 9 is a view of the power panel and target area after power was disconnected, showing the breakers that tripped during the arcing and flaming. In all there were 9 ac breakers and 12 dc breakers that tripped open as a result of this fire propagation along the harness.

Fig. 9 — The power supply panel with tripped circuit breakers and the burned harness of MIL-W-81381/11 type wires after the power was disconnected. following the impact of a .30-caliber bullet and the circuit breaker resetting procedure

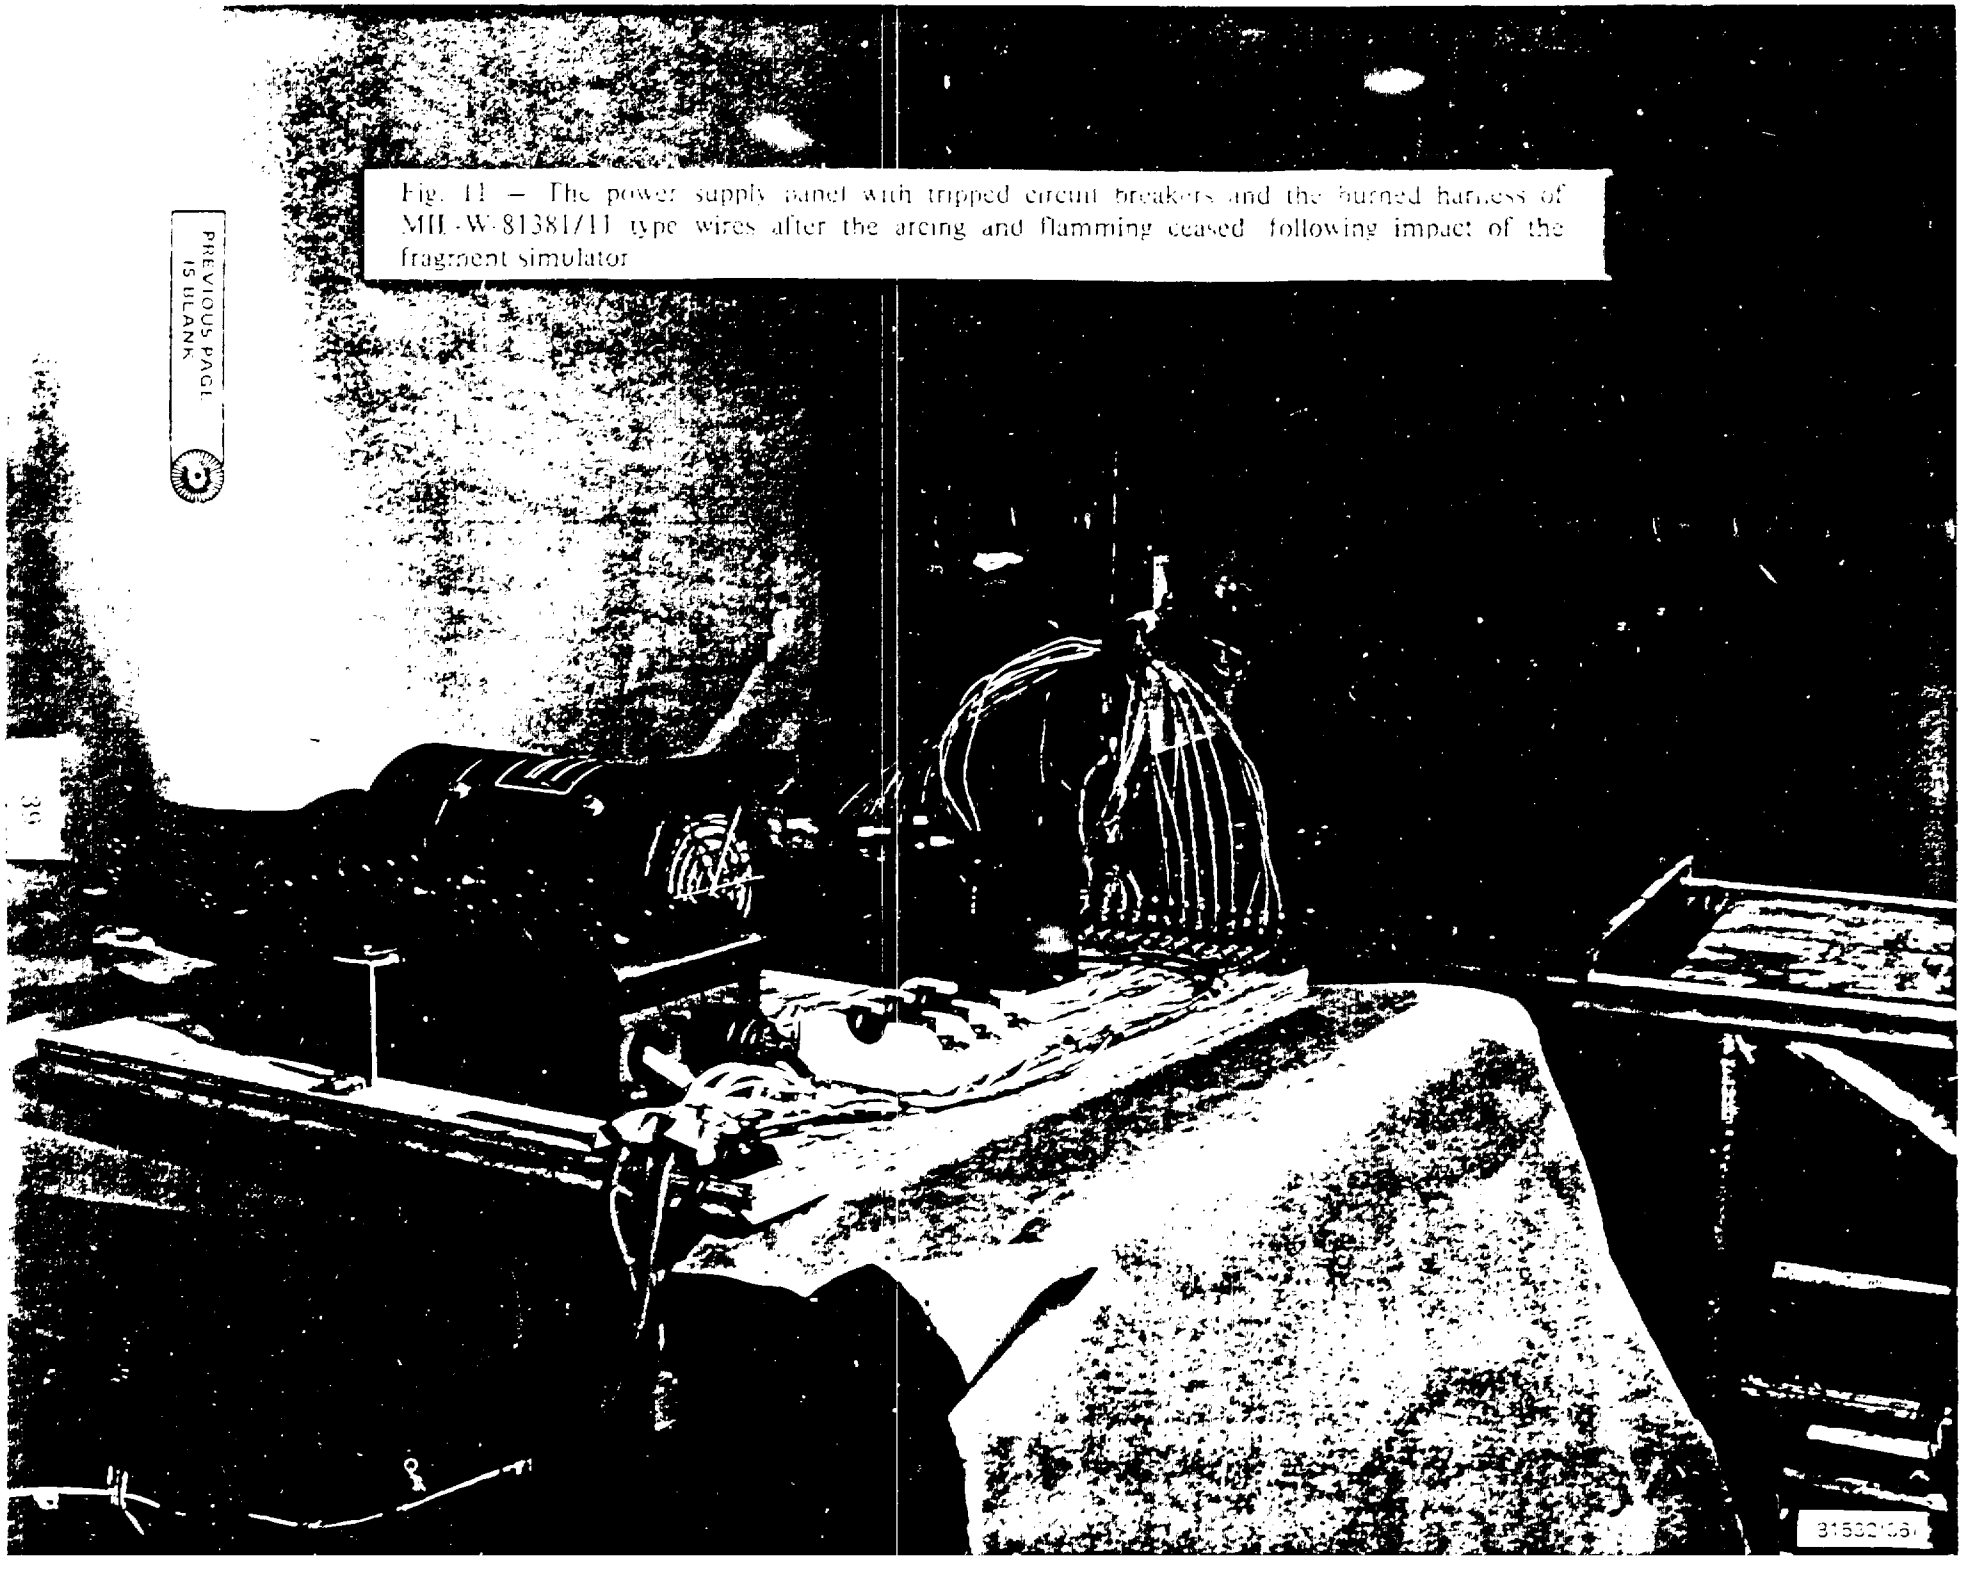
The second test in this experiment was conducted on another harness of MIL-W-81381/11 type wire, of the same construction as the first one tested. In this one a .50-caliber fragment simulator projectile was fired. The projectile impacted near the midline of the harness and broke many wires. Arcing and flames began immediately and traveled along the harness for about 10 seconds after the impact. Thesequence of arcing and flaming around the damaged section is clearly visible in the three successive photos of Figures 10.a, b and c. The circuit breakers that tripped are shown in Figure 11, which is a view of the circuit breaker panels and the damaged wire harness in the background. There were 3 ac breakers and 5 dc breakers that tripped as a result of the impact. They were not reset and the test was ended so that the damaged harness could be more closely examined in the laboratory.

Fig. 11 — The power supply panel with tripped circuit breakers and the burned harness of MIL-W-81381/11 type wires after the arcing and flamming ceased following impact of the fragment simulator

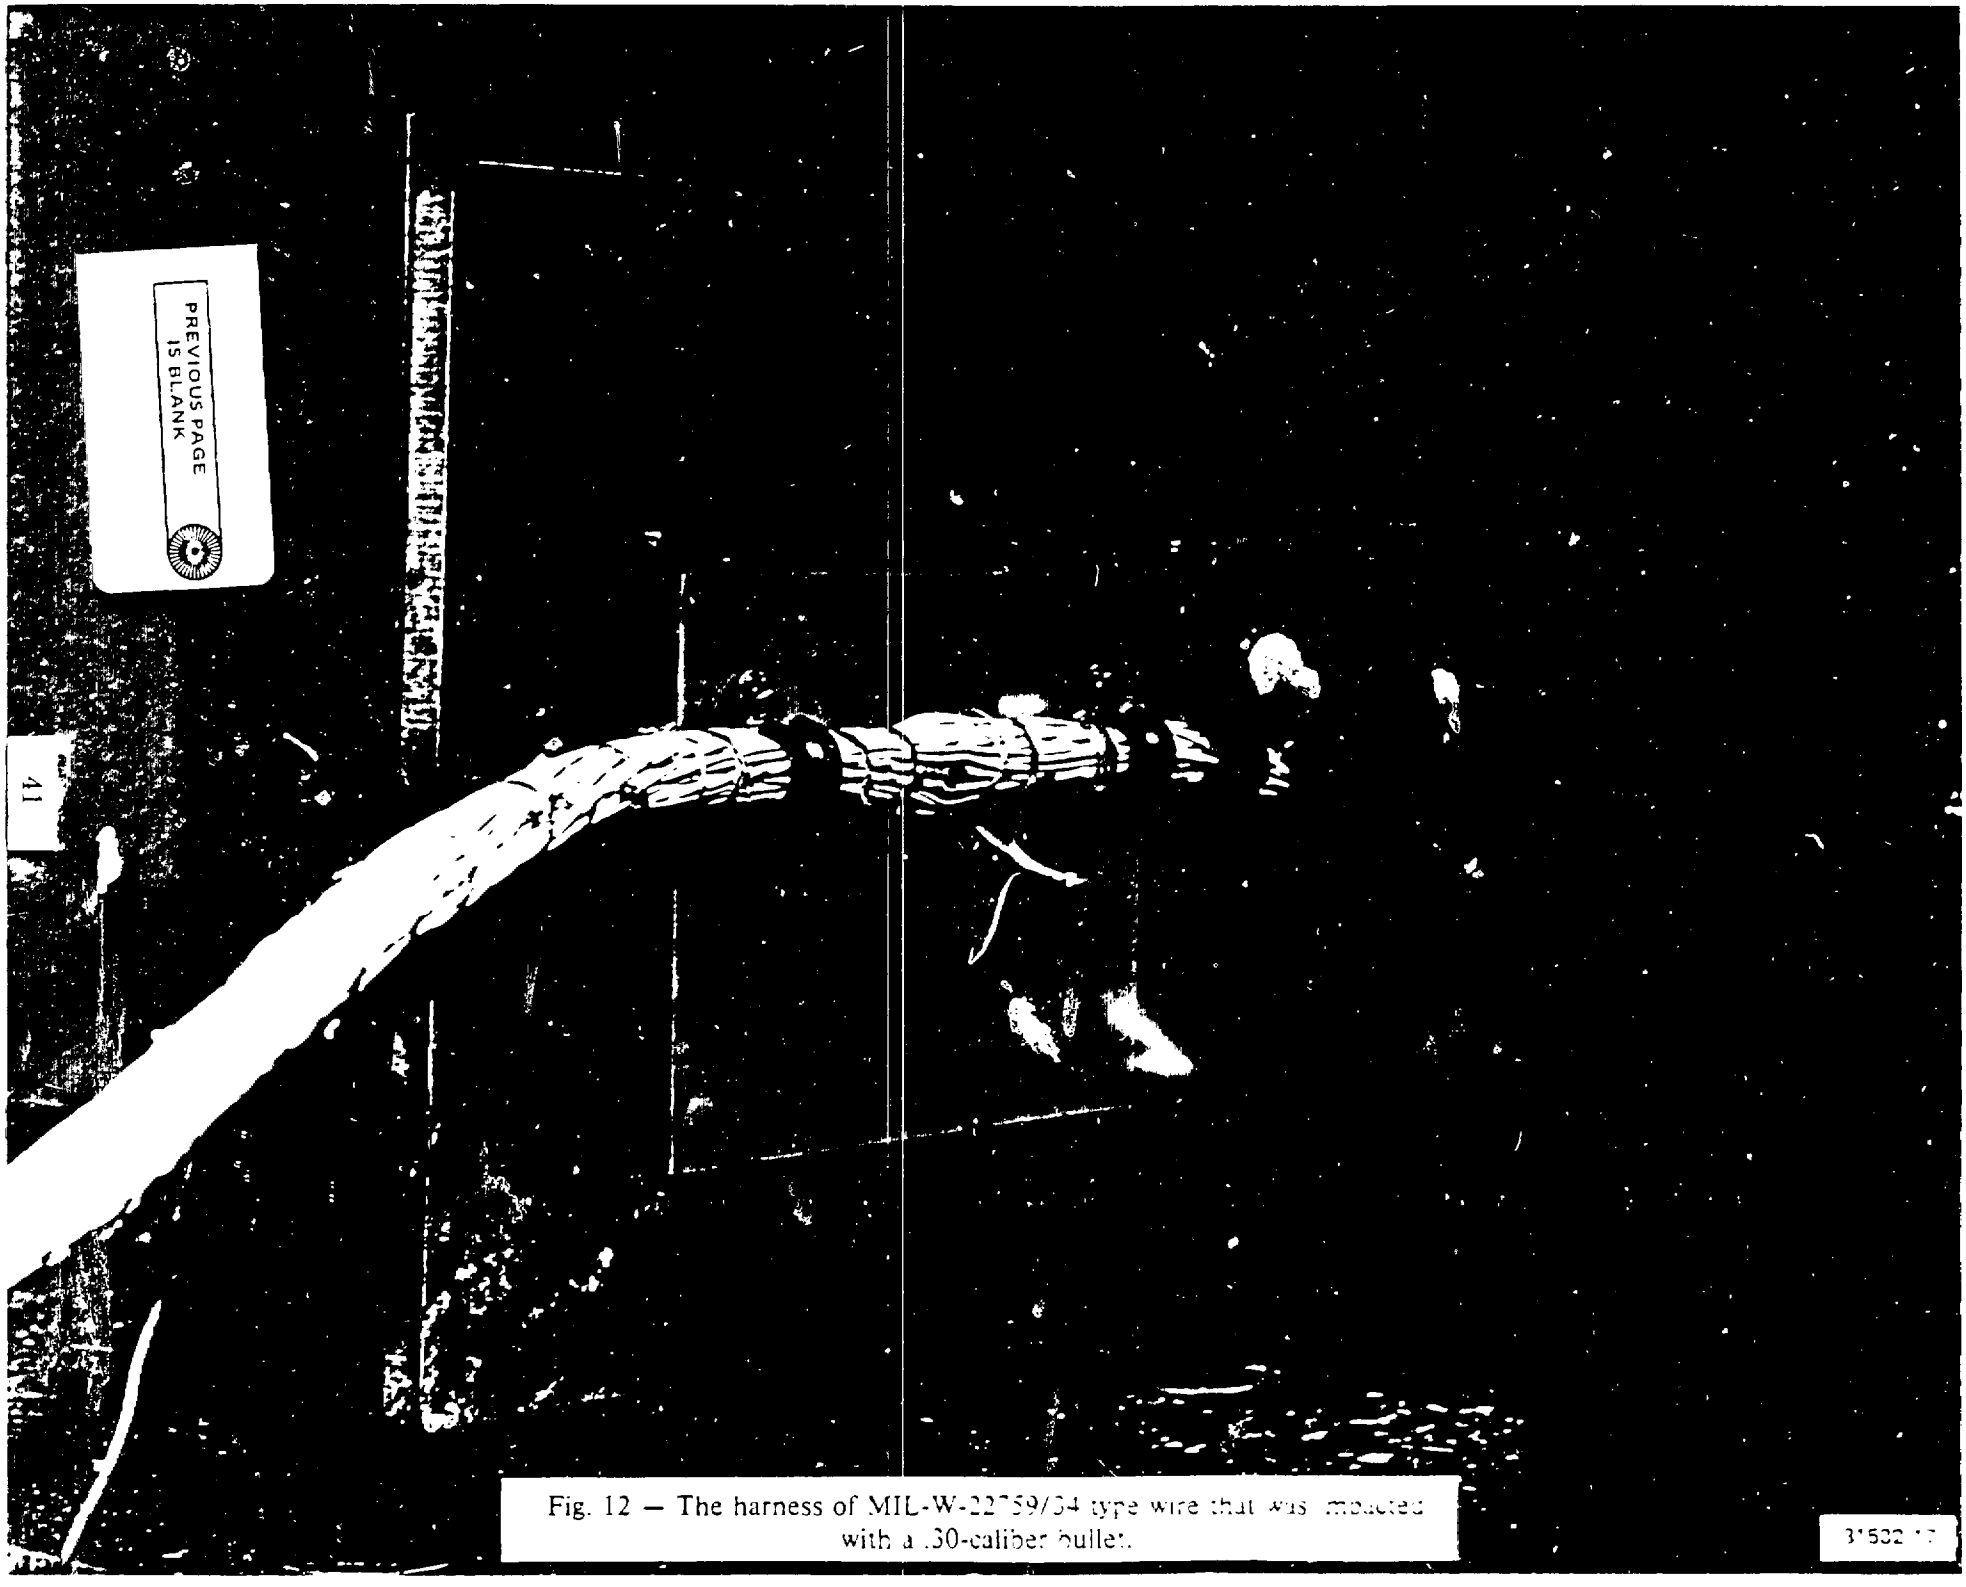
The projectile hit the midline of the harness. At the point of impact shown in Figure 12 it can be observed that at least one wire was severed, but no carbon formation can be seen and no circuit breakers were tripped.

Fig. 12 — The harness of MIL-W-22759/34 type wire that was impacted with a .30-caliber bullet.

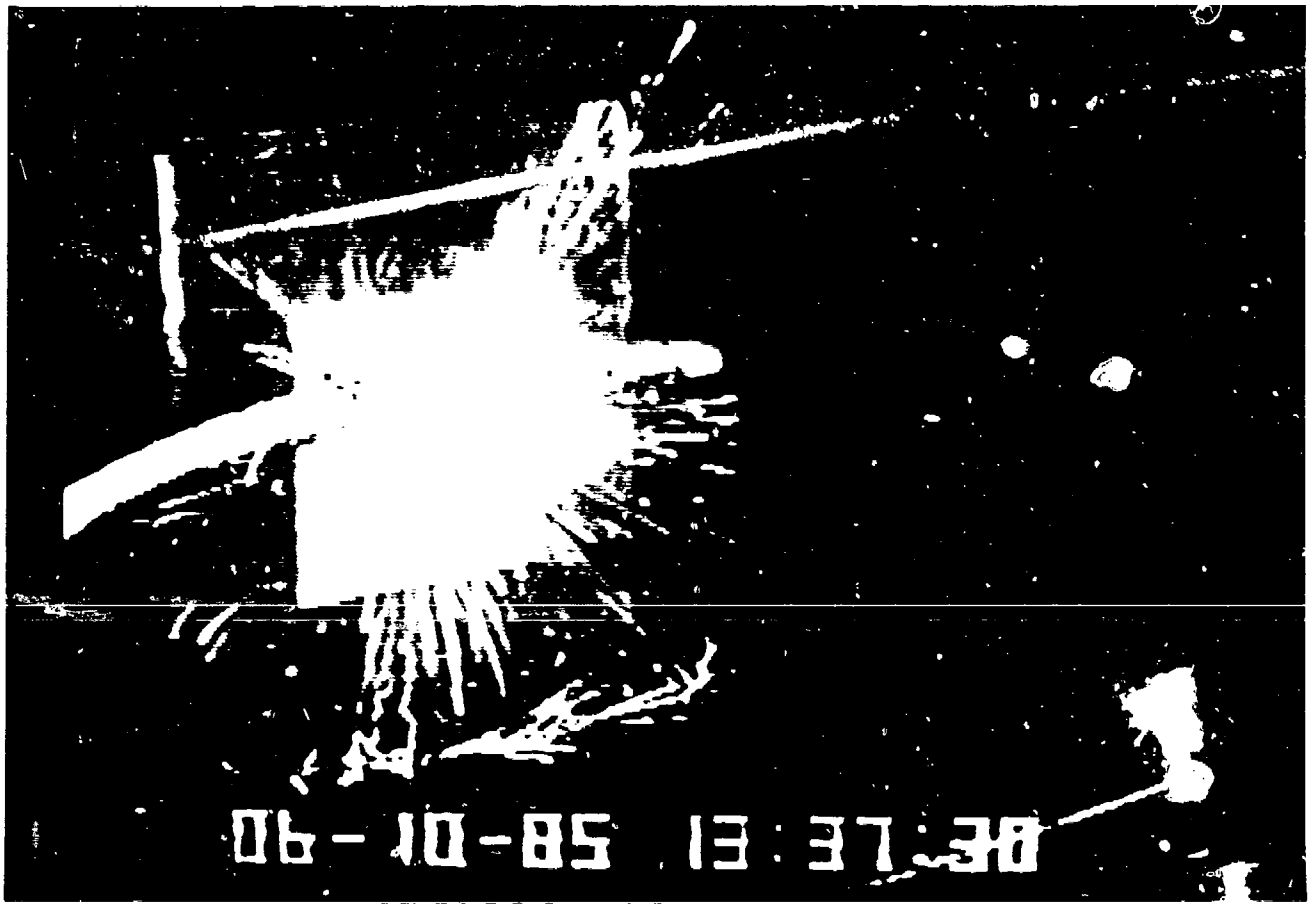
R1602-6

The same harness was then repositioned to place an undamaged section closer to the terminal strips into the target area for another impact test. This time the .50-caliber fragment simulator projectile was used. Upon impact, this projectile produced much greater damage to the wire harness and caused a bright arc and a short circuit which tripped one circuit breaker. The duration of the arc was about 0.1 second (three frames of videotape). Figure 13 shows this arc immediately following the impact. When reset, there was no arc and the breaker remained closed.

Fig. 13 — The arc produced by the impact of a .30-caliber fragment simulator on a harness of MIL-W-22759/34 type wire.

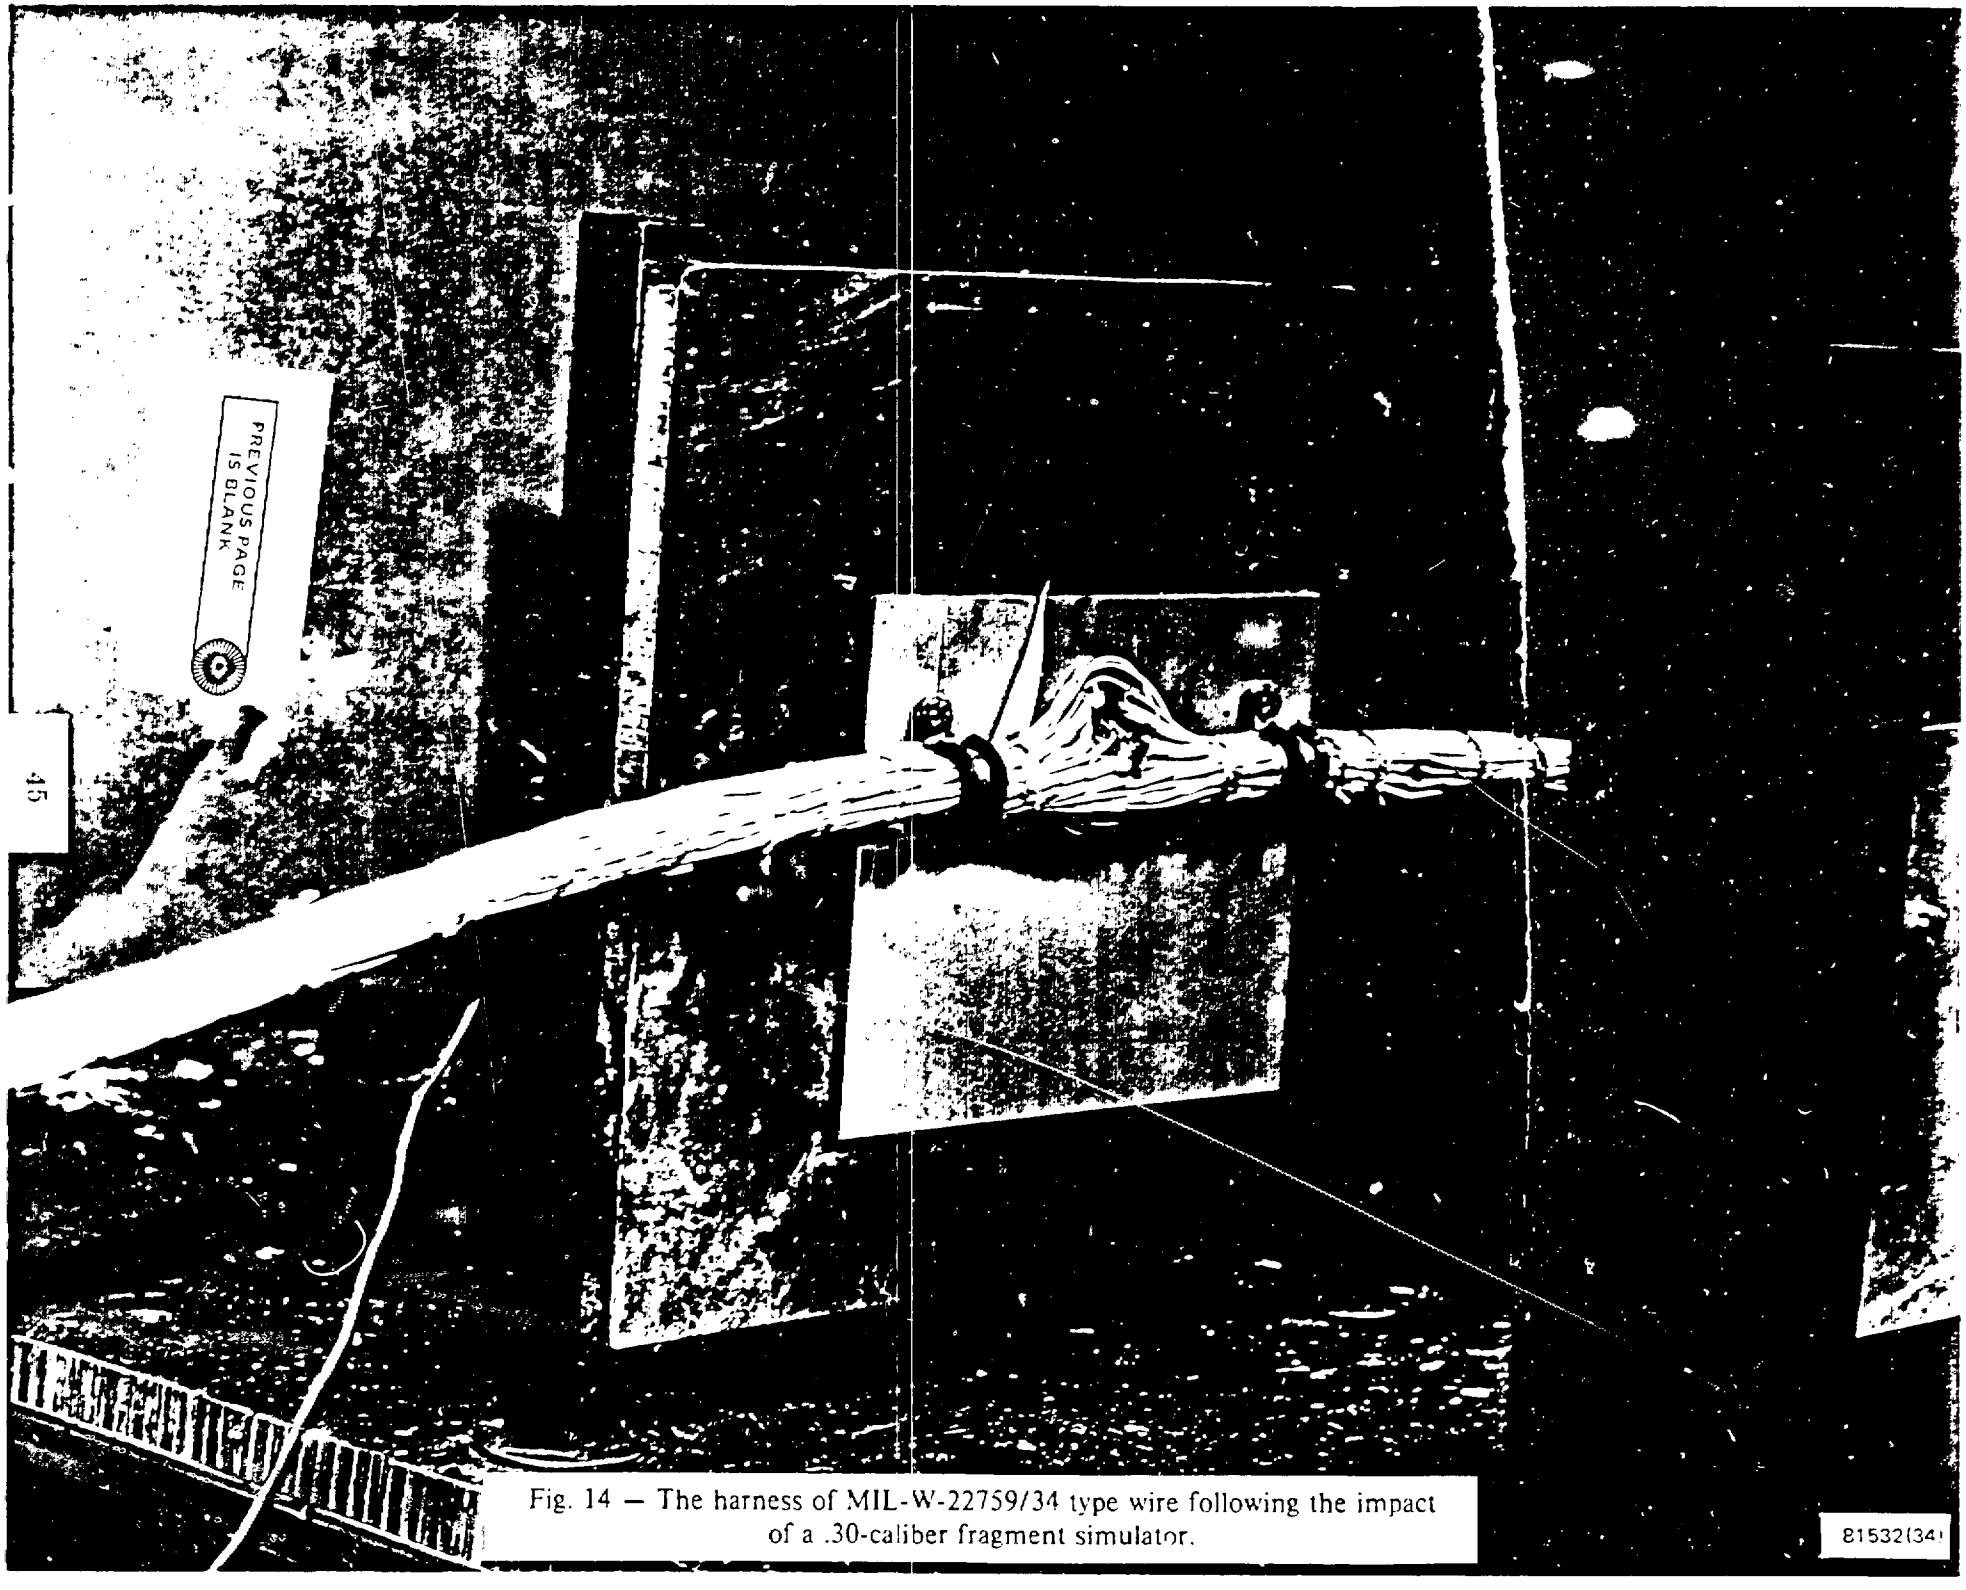
Figure 14 shows the harness with the damaged wires. Even though many of the wires in the harness were badly damaged by the impact there were no flames or ensuing fire to further damage the remaining wires.

Fig. 14 — The harness of MIL-W-22759/34 type wire following the impact of a .30-caliber fragment simulator.
