USAAVLABS TECHNICAL REPORT 67-24

INVESTIGATION OF THE FEASIBILITY OF BURNING EMULSIFIED FUEL IN GAS TURBINE ENGINES

March 1967

U. S. ARMY AVIATION MATERIEL LABORATORIES
FORT EUSTIS, VIRGINIA

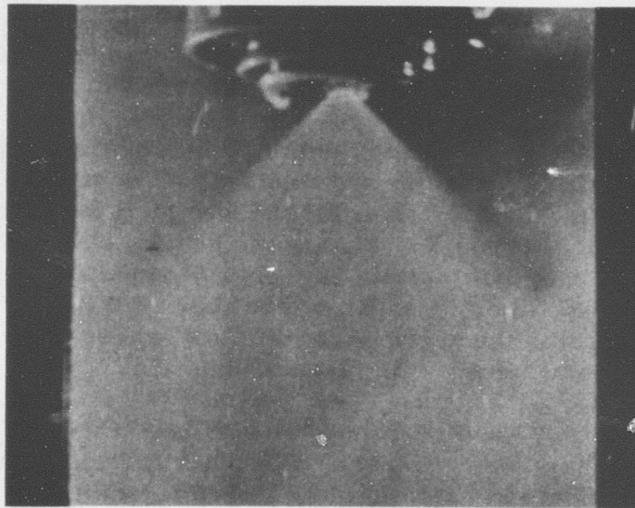
Figure 28. Engine fuel nozzle spray flowing emulsified JP-4 at takeoff conditions, approximately 220 p.p.h.

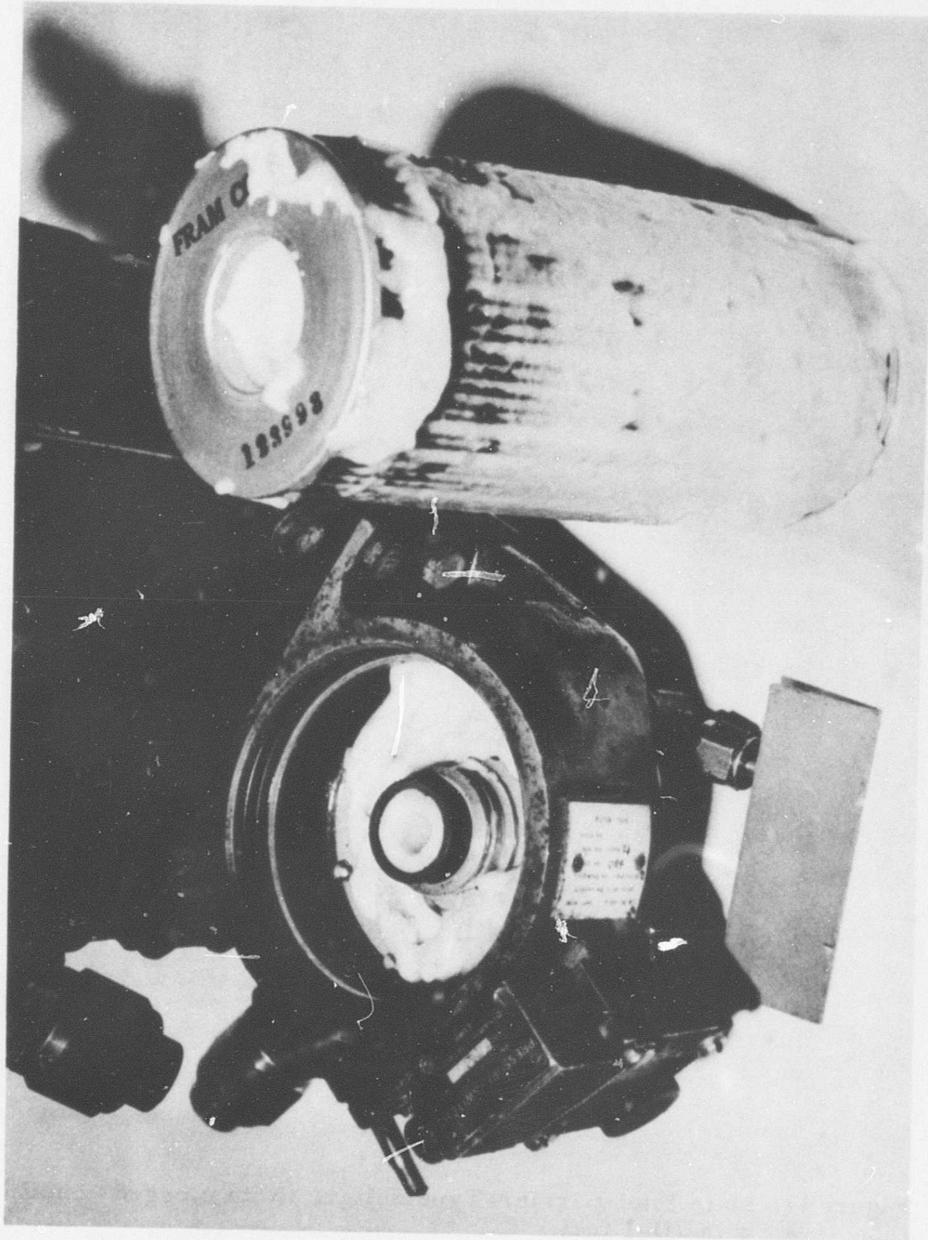
Figure 46. Main Fuel Filter Body and 10-Micron Barrier-Type Filter. (Note clogged condition with JD-1 fuel.)

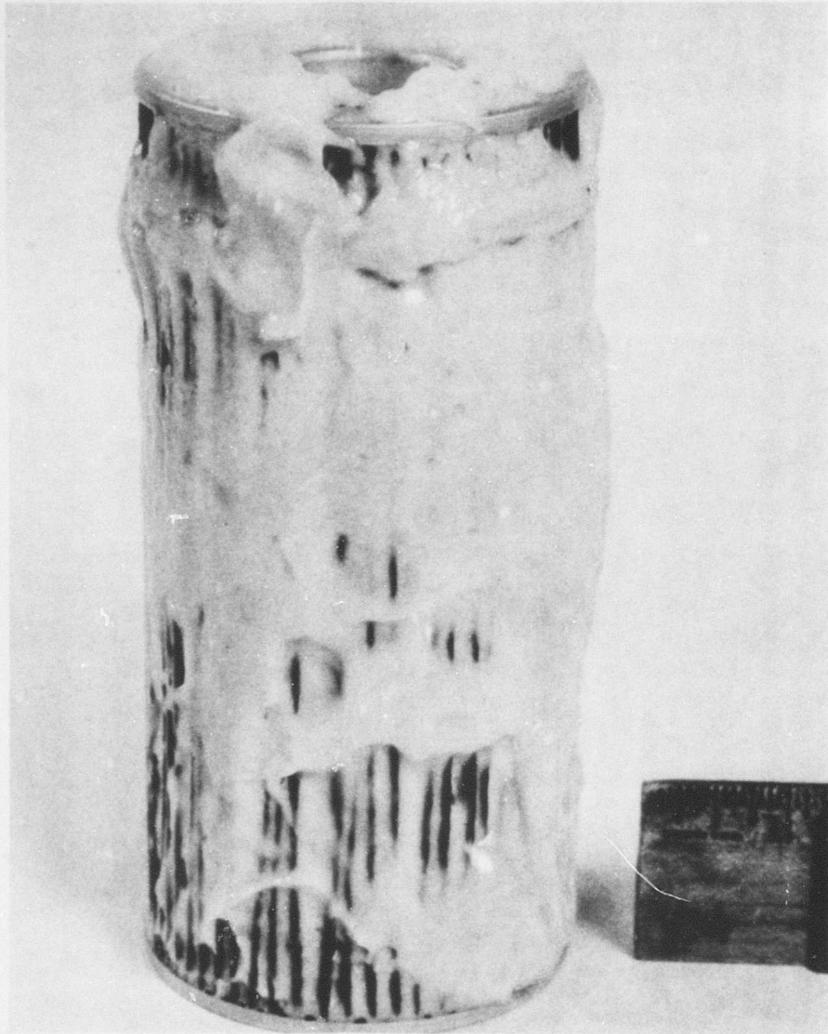
Figure 47. Main Fuel Barrier-Type Filter. (Note clogged condition with JD-1 fuel.)

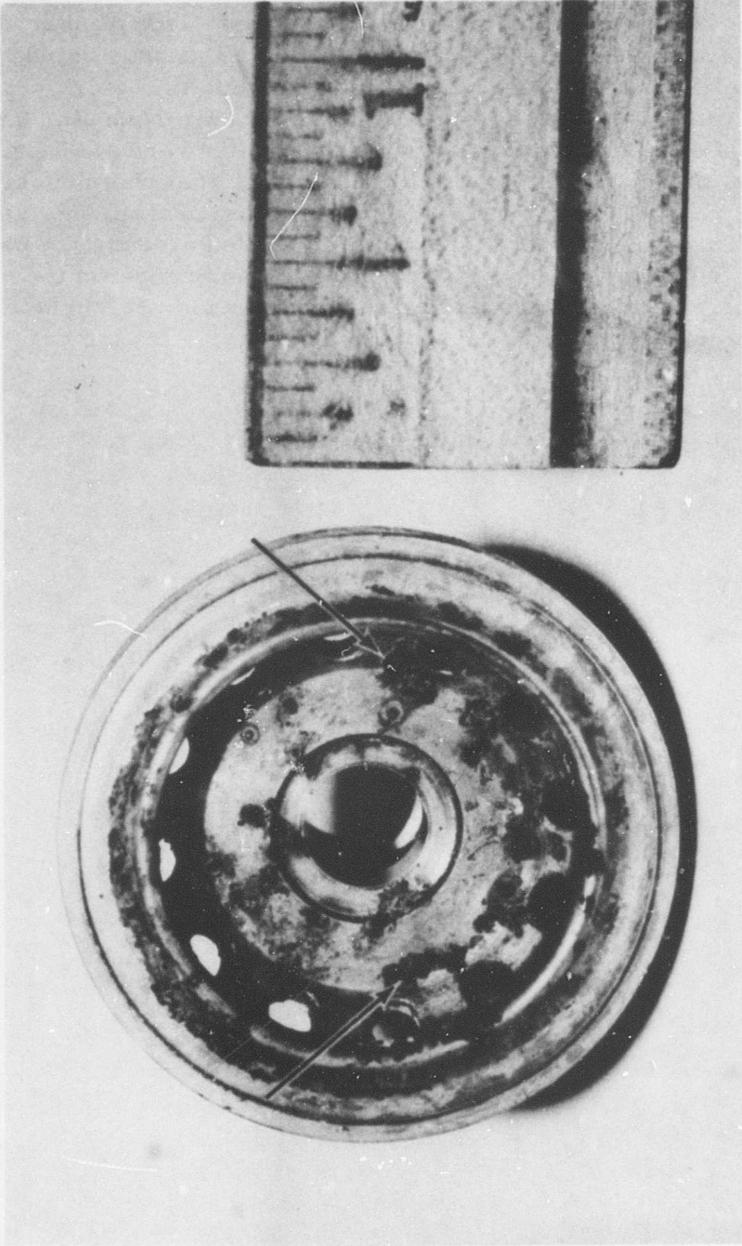
Figure 49. Pressure Regulator Valve Sleeve. (Note rust deposits.)

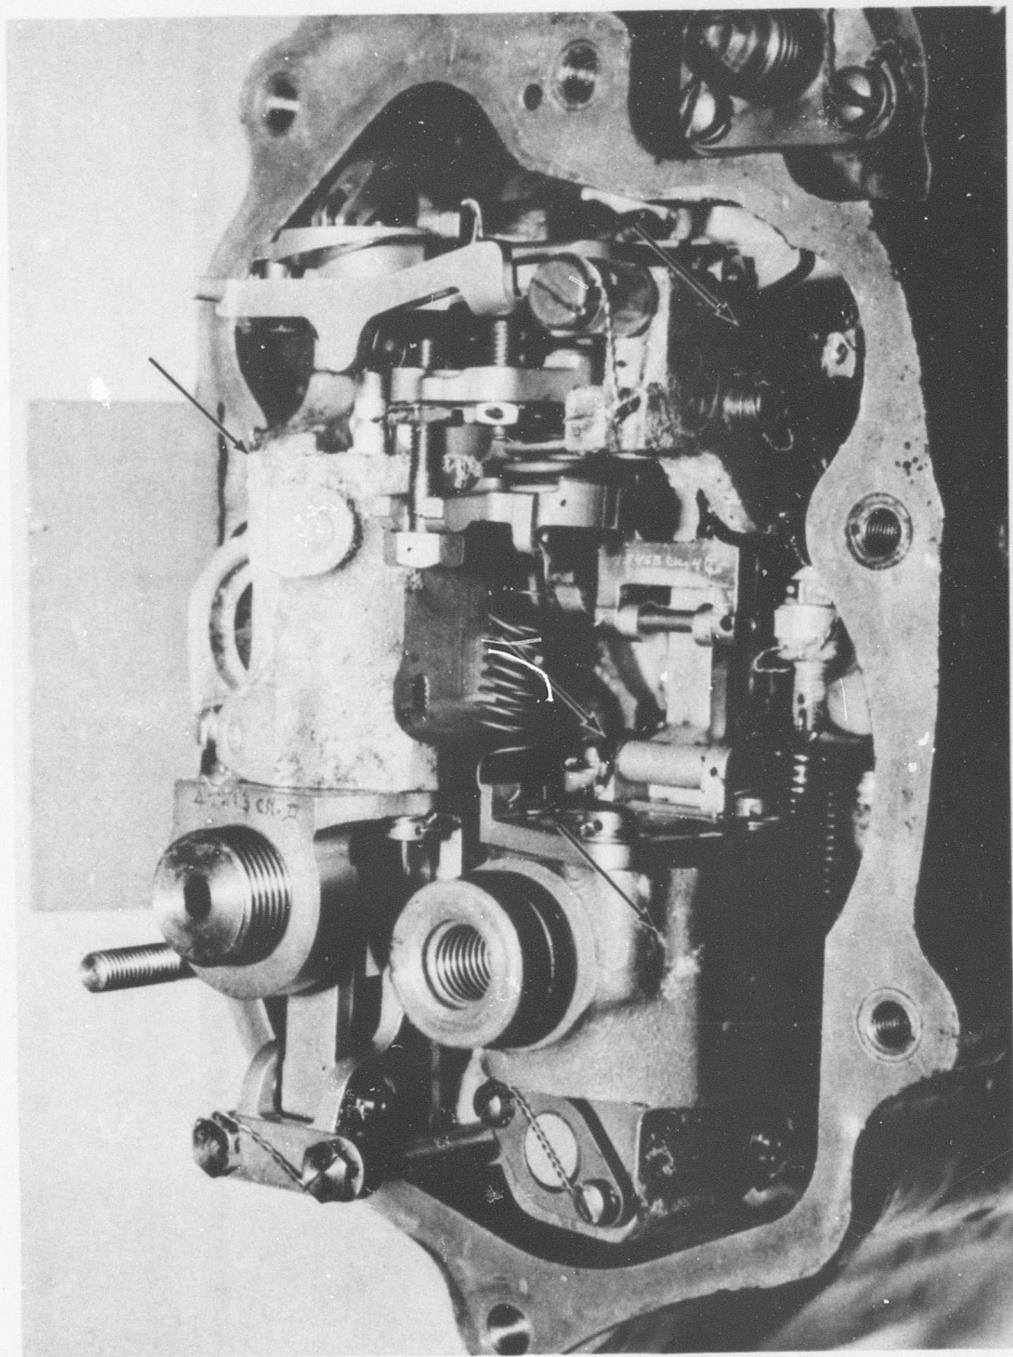
Figure 50. Fuel Control Computer Assembly; Overall View. (Note rust deposits and corrosion of the anodized surfaces.)

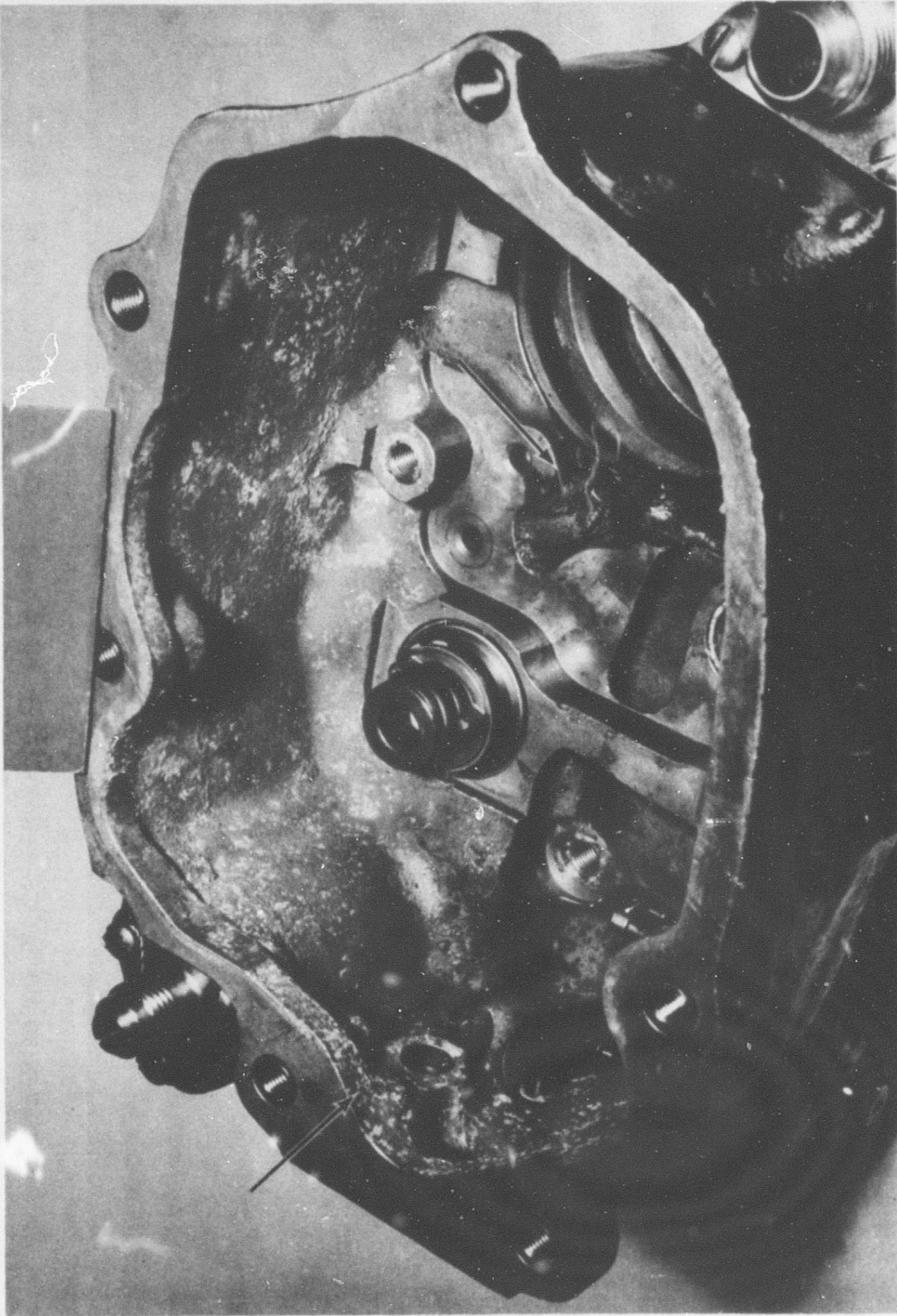
Figure 51. Fuel Control Housing. (Note rust deposits and corrosion of the anodized surfaces.)

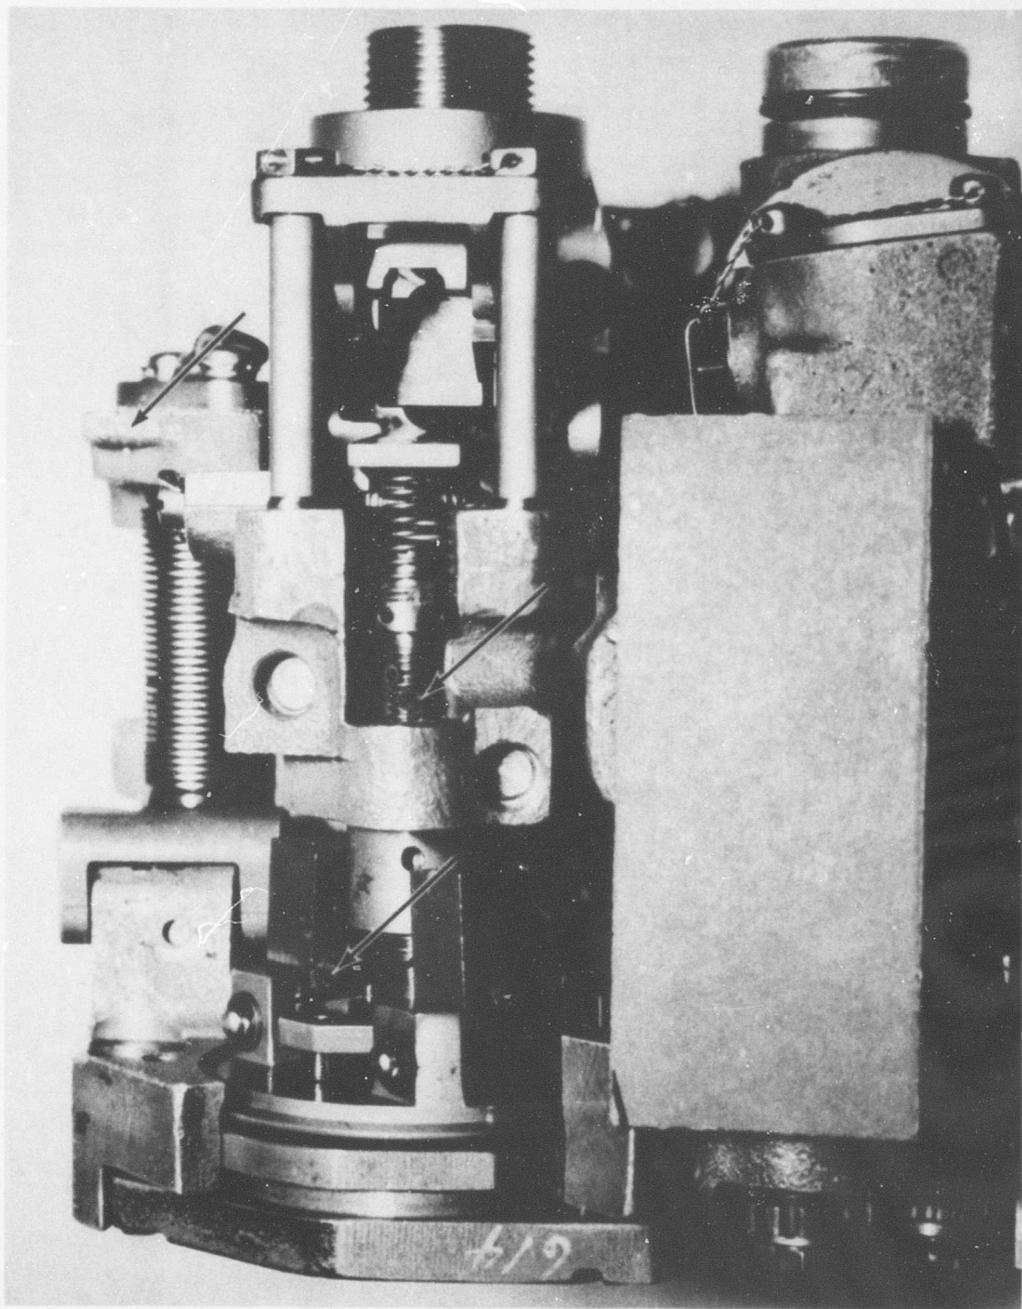
Figure 52. Fuel Control Computer Assembly Removed from Housing;
End View. (Note rust deposits.)

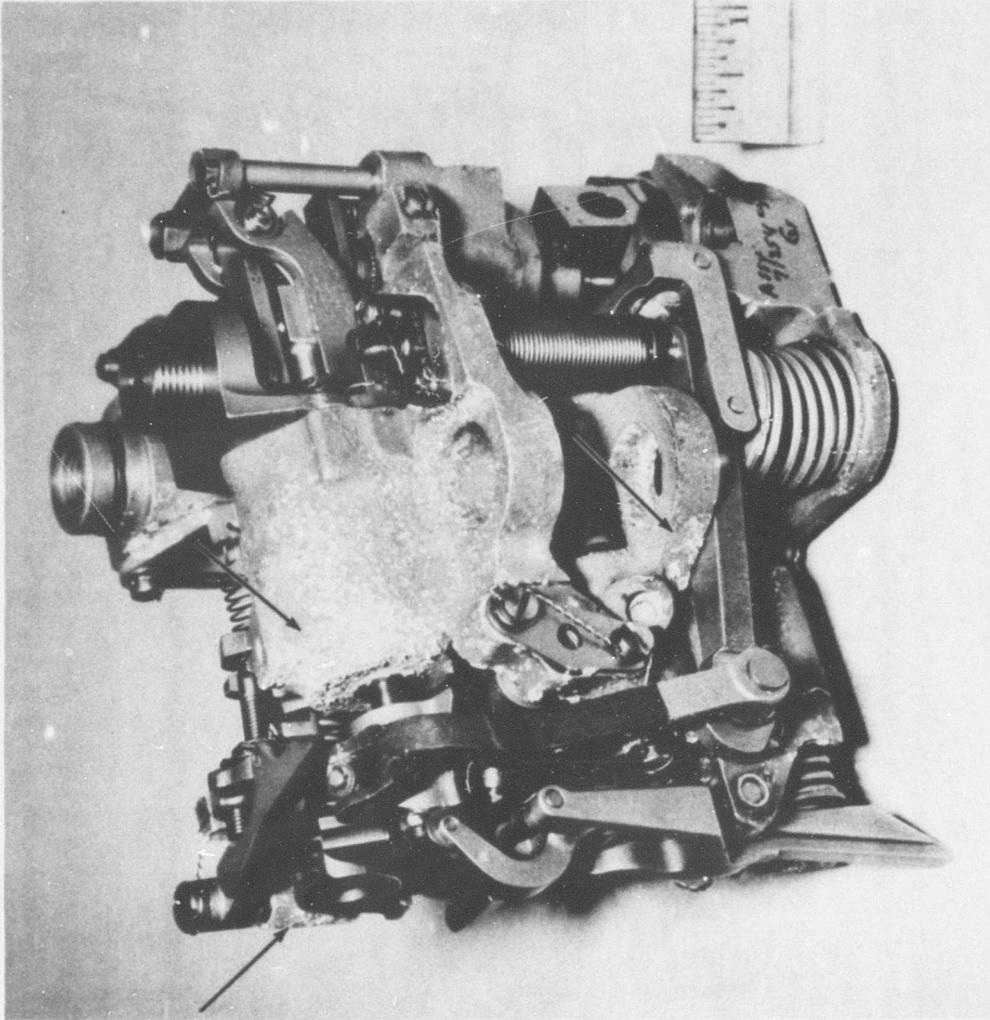
Figure 53. Fuel Control Computer Assembly Removed from Housing;
Overall View. (Note corrosion of anodized surfaces.)

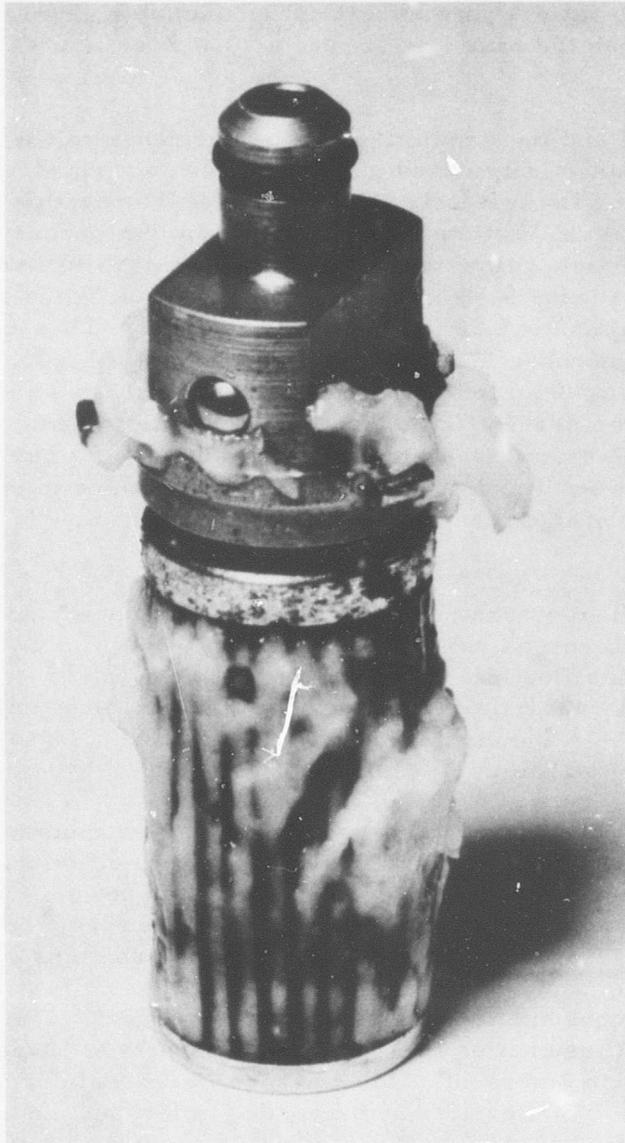
Figure 55. Fuel Control Servo Fuel Filter. (Note clogged
condition with JD-1 fuel.)

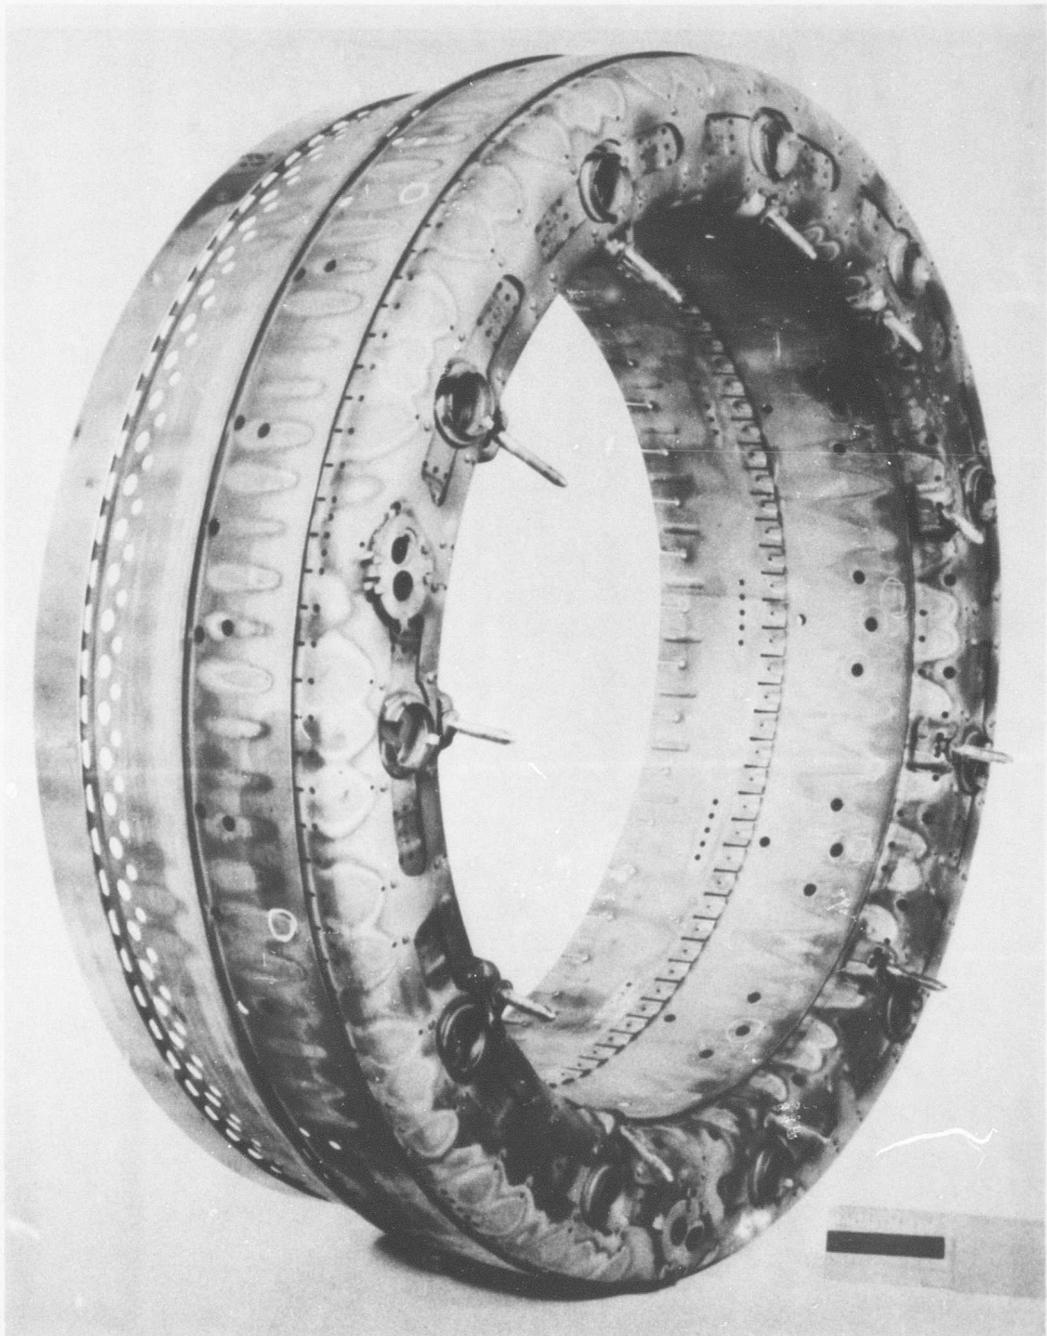
Figure 62. Vaporizing Combustor Liner; Overall View.

The condition of the combustor turbine section of the engine after completion of the test was good. The combustor liner had some moderate coke deposits on the baffle plates (Figures 62 and 63). These coke deposits are believed to have been caused by emulsified fuel (not in liquid form) deposited on the liner during attempts to run at ground idle. JP-4 deposits on liner baffles are usually in the form of soot. Diesel and leaded fuels have shown crater-like buildups in past engine operating experience. Emulsified fuel, compared with diesel and leaded fuels, was seen to produce coke buildup within a shorter period of engine operation. Inspection of the vaporizers showed considerable rusting of the fuel flow dividers. Inspection of the engine accessories showed corrosion problems similar to those encountered during Phase I testing.

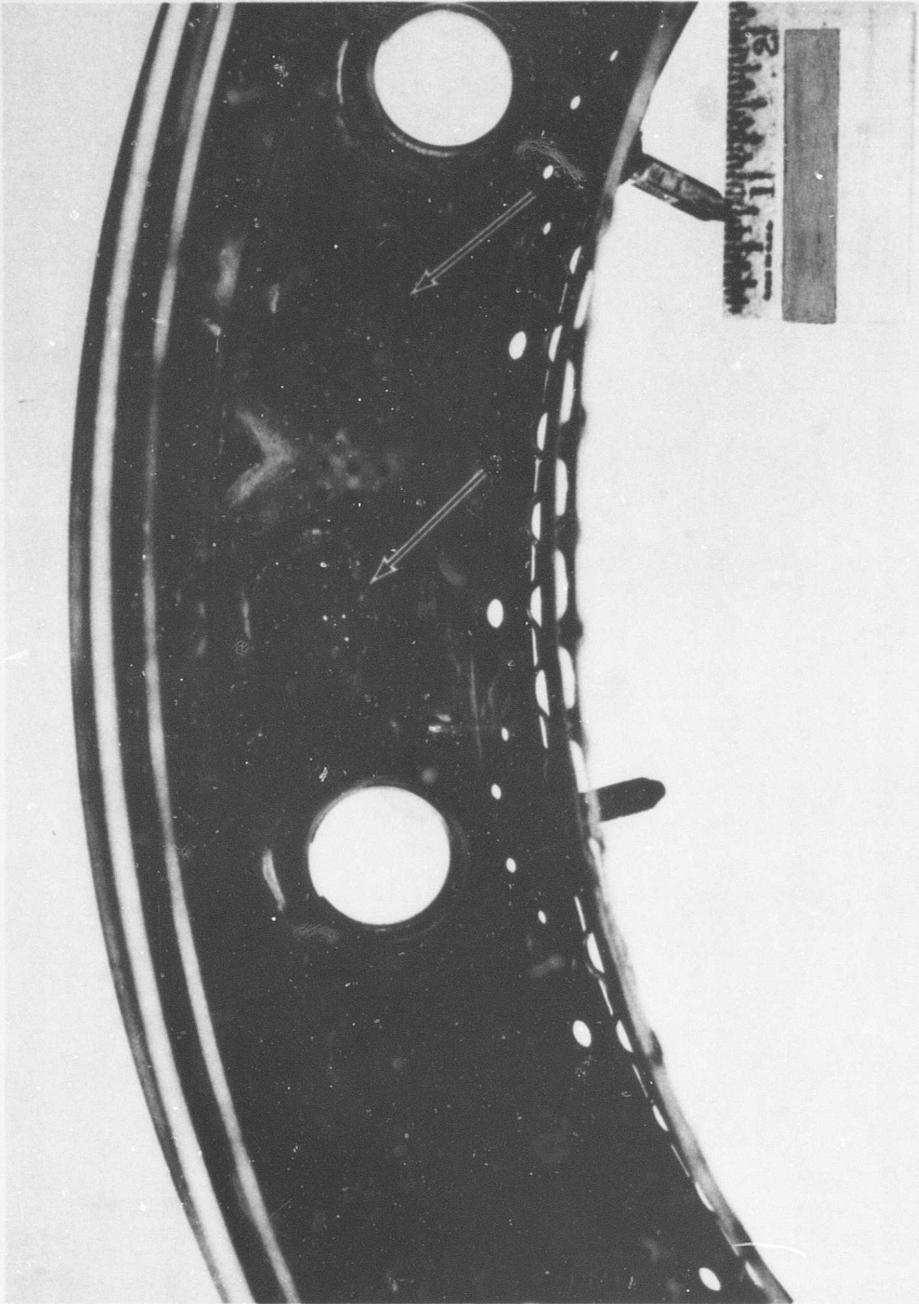
Figure 63. Combustor Liner Interior; Close-Up View. (Note coke deposits.)

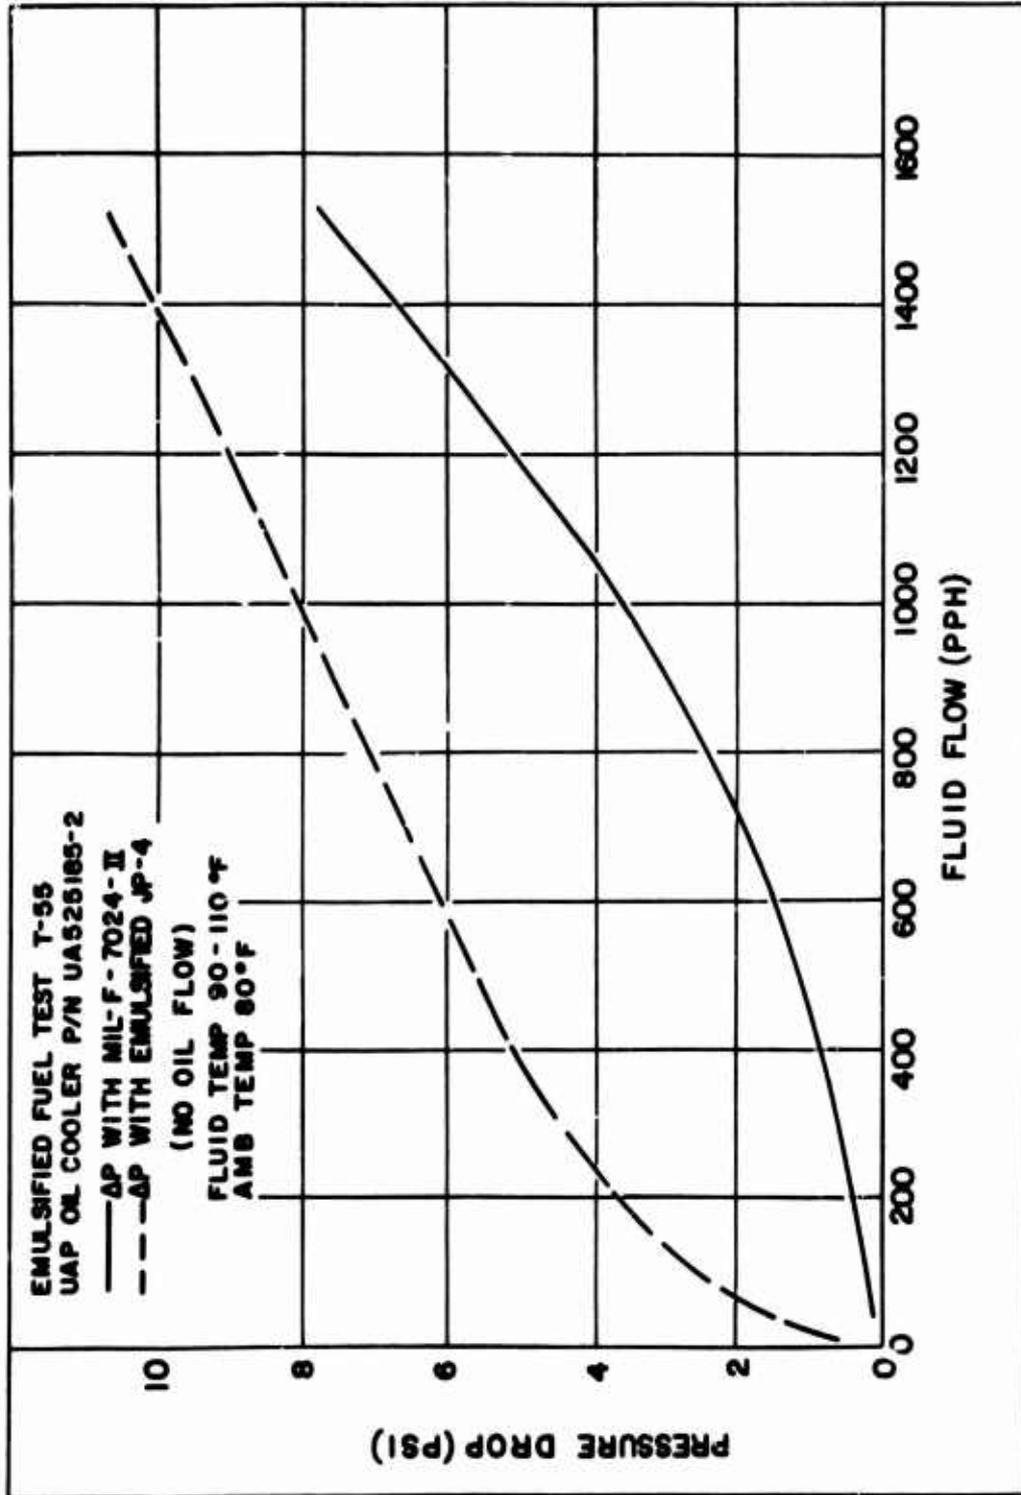
The heat exchanger had a 3- to 5-psi increase in pressure drop versus fuel flow with the emulsion (Figure 69).

Figure 69. Oil Cooler Pressure Drop Versus Fuel Flow for JP-4 and Emulsified Fuel.

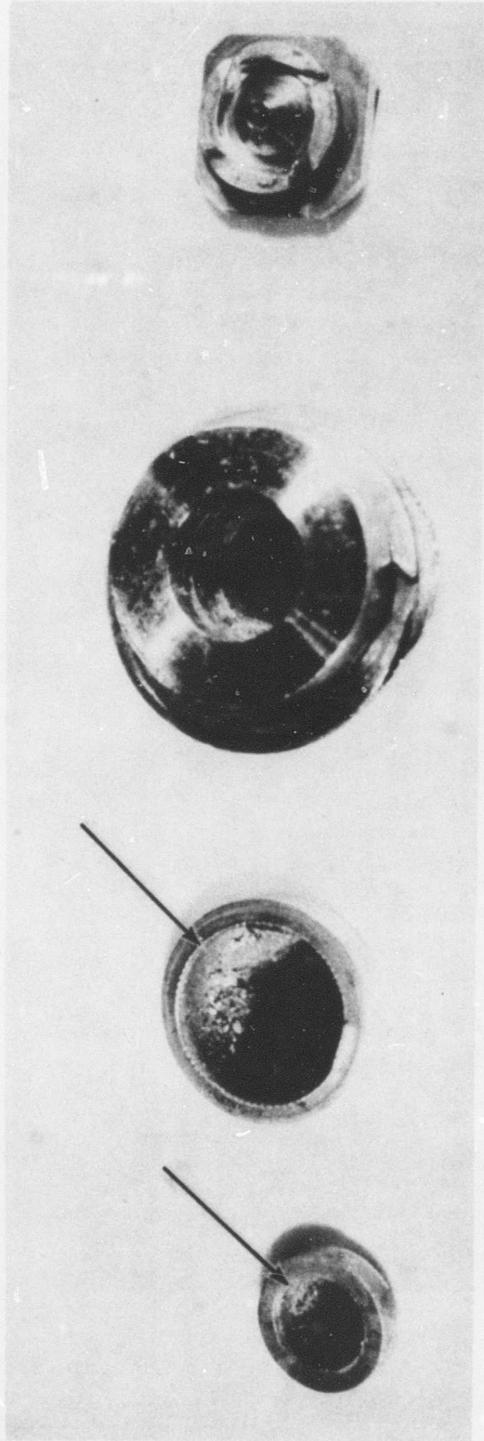
Figure 77. Fuel Nozzle Components After Engine Test. Left to Right:

Primary Screen, Secondary Screen, Nozzle Body, Swirl Chamber.
Note accumulation of deposits in both screens (arrows). Magnification: 6X

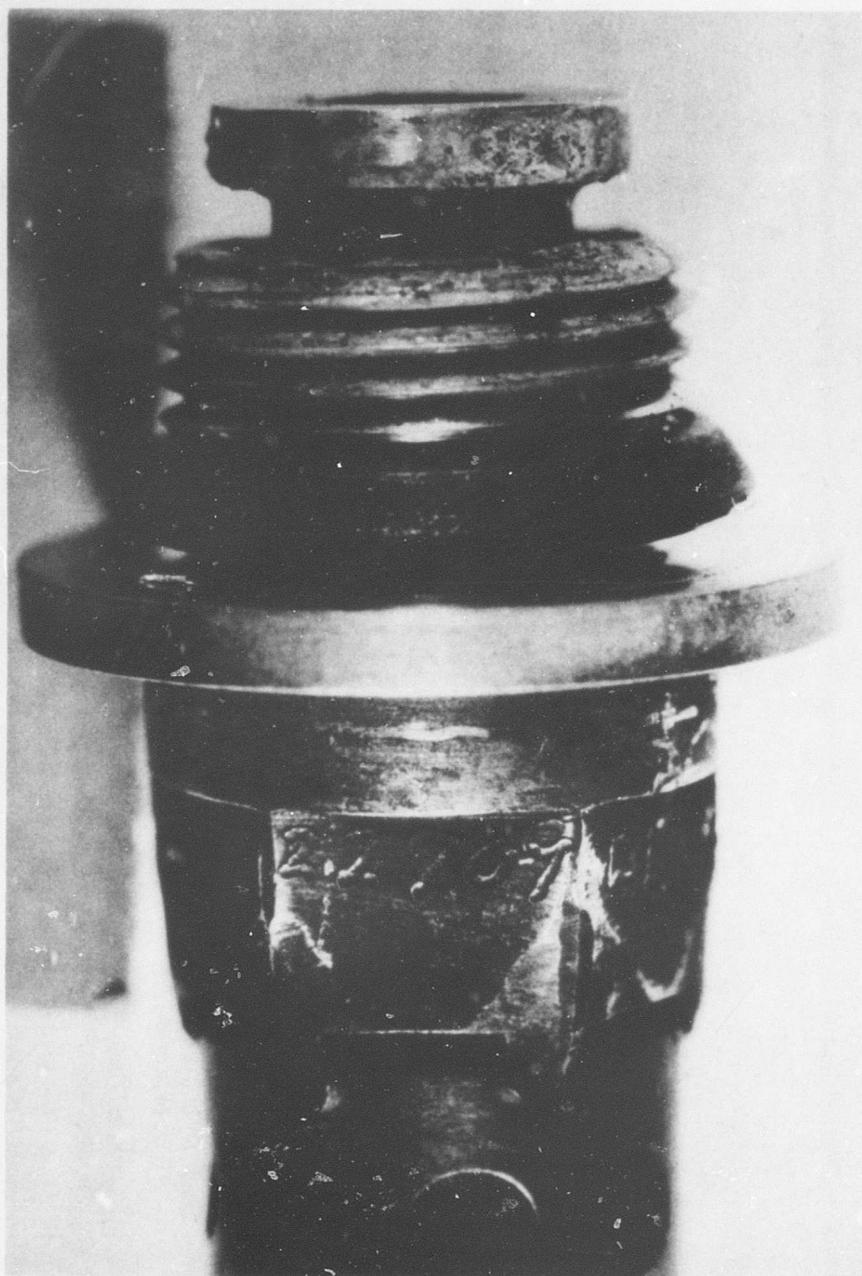
Figure 78. Fuel Nozzle After Engine Test Showing Deposits on Inlet End; Close-Up View. Magnification: 10X

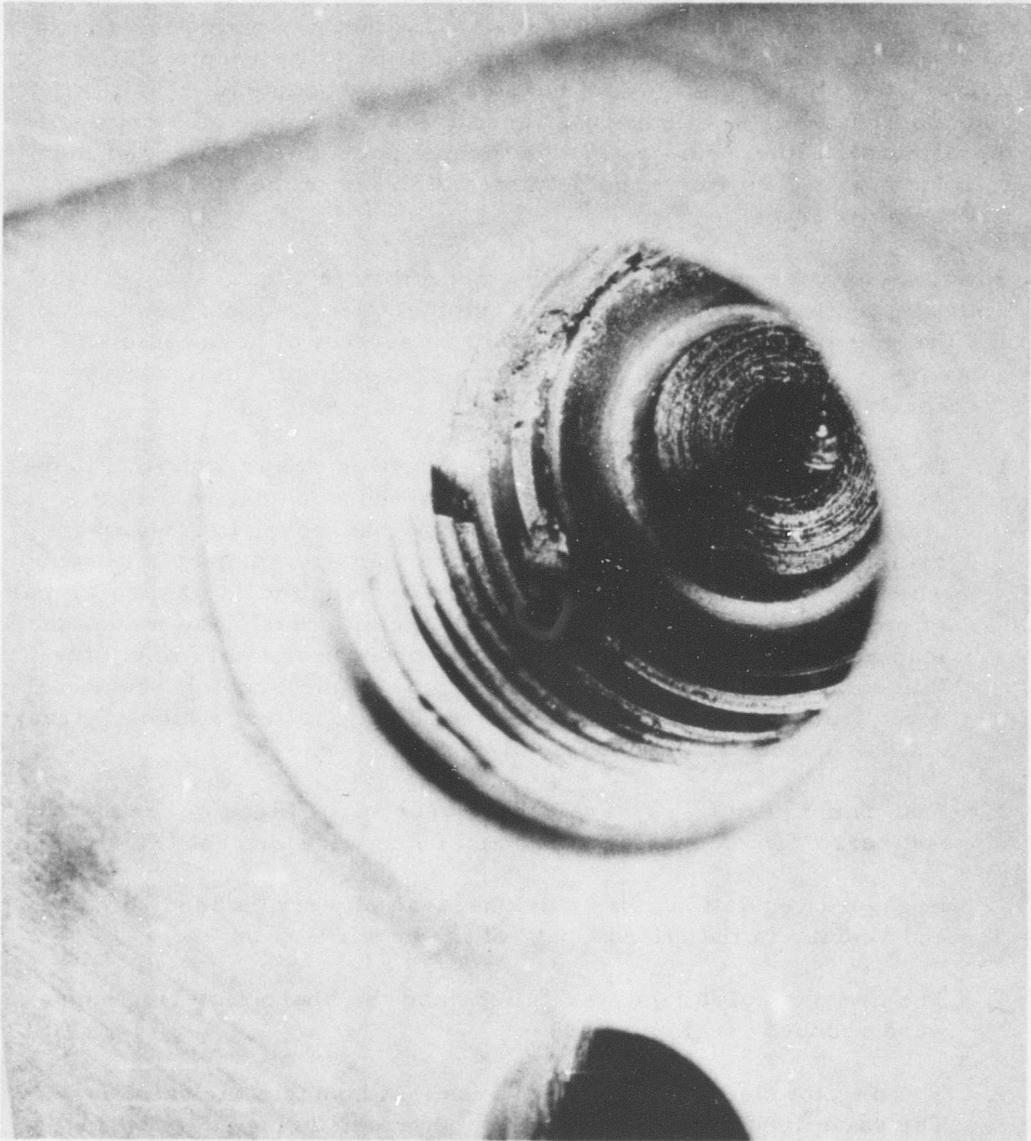
Figure 79. Fuel Manifold After Engine Test Showing Deposits
in Nozzle Receptacle; Close-Up View. Magnification: 8X

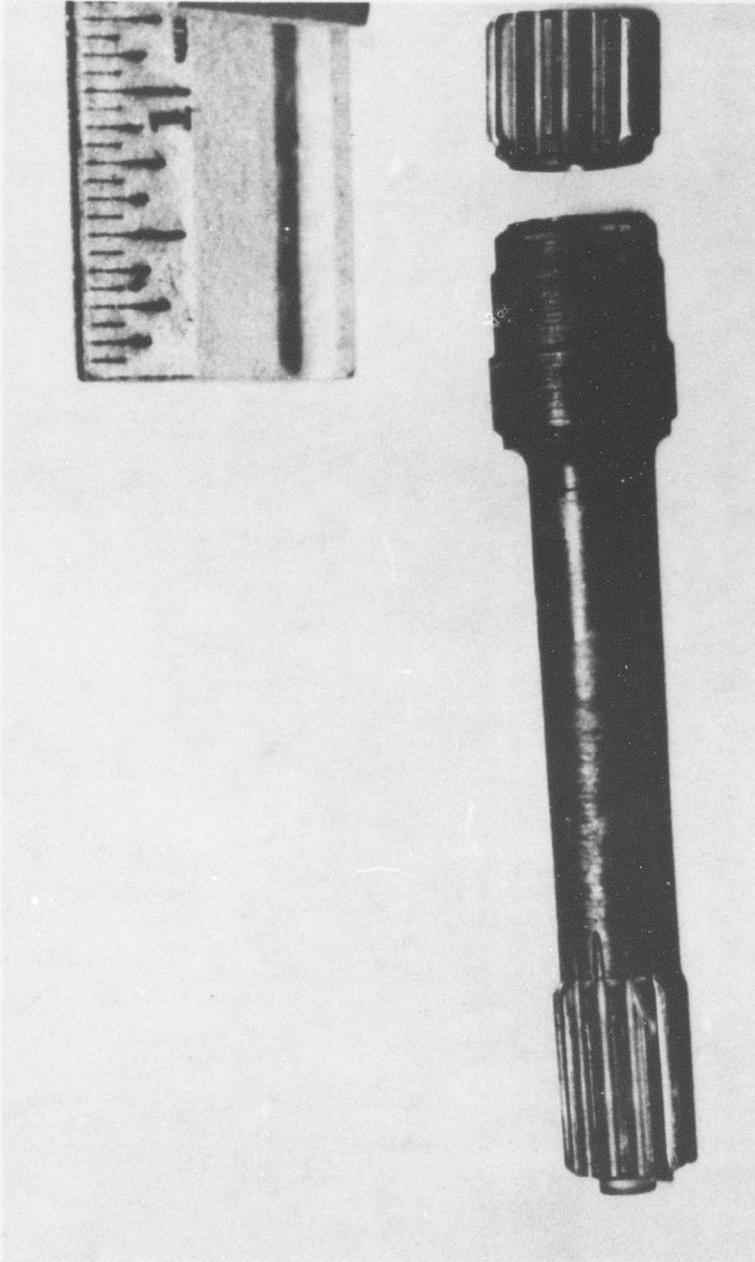
Figure 80. Fuel Pump Drive Shaft Showing Failure at Shear Section.

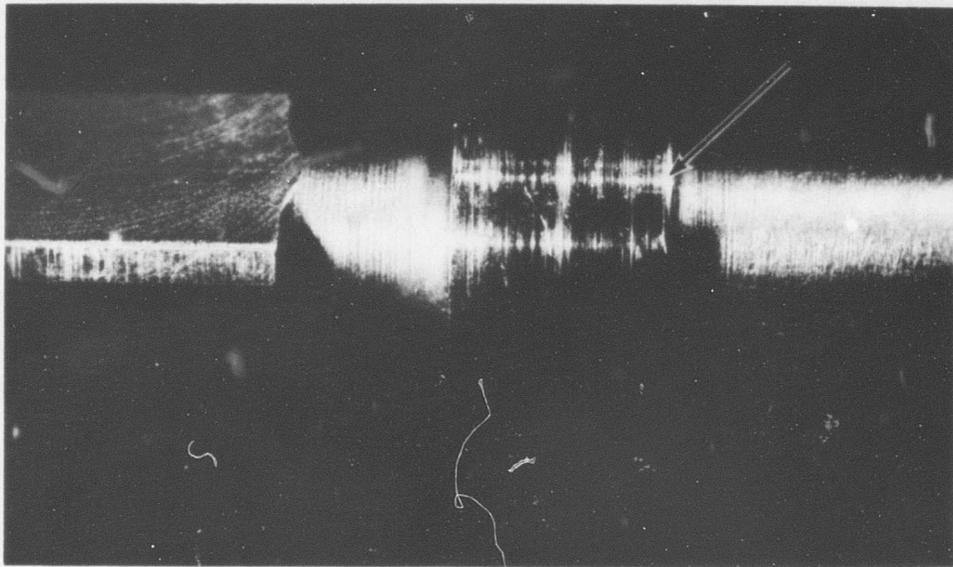
Figure 82. The n$_{II}$ Pilot Valve Showing Scored Land With
Rounded Metering Edge (Arrow).

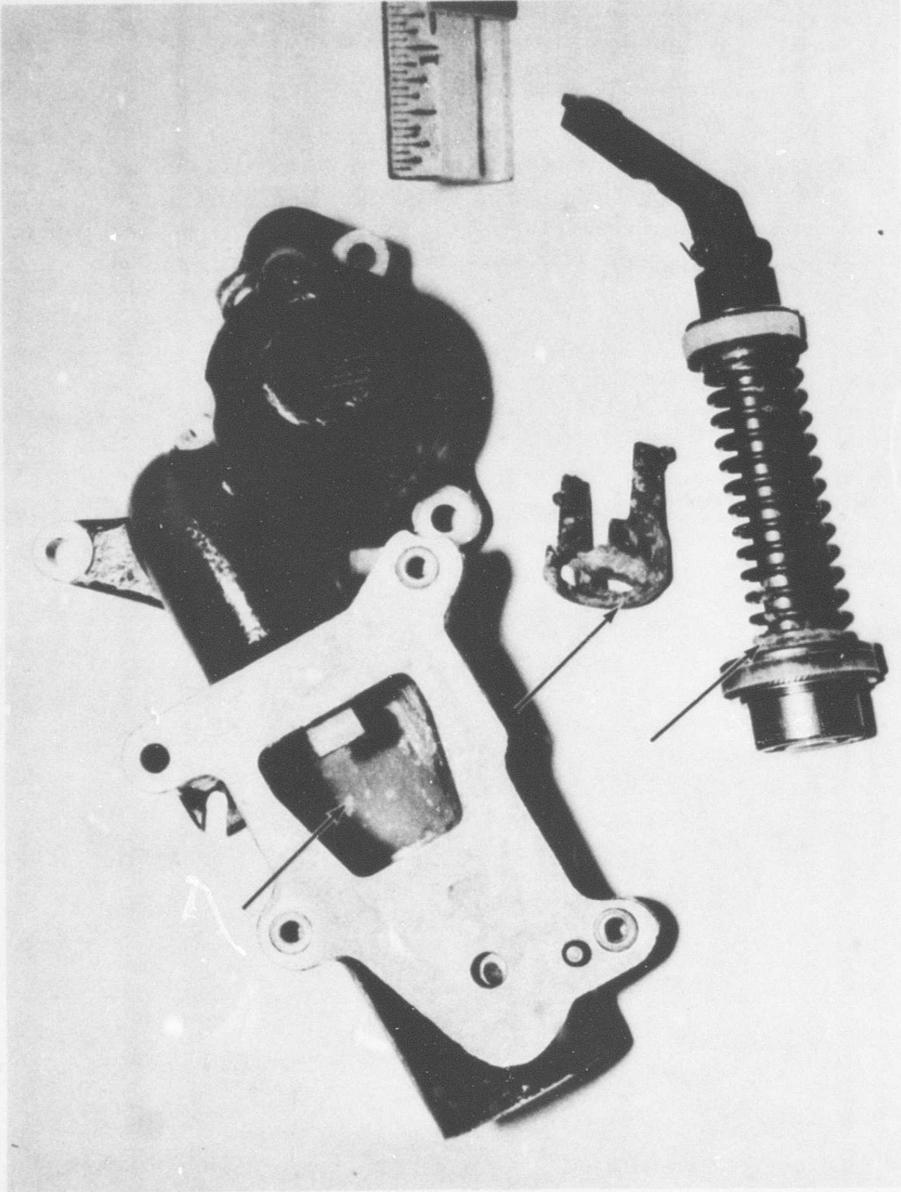
Figure 84. P₃ Servo and Housing and Linkage Showing Oxidation and Deposits (Arrows).

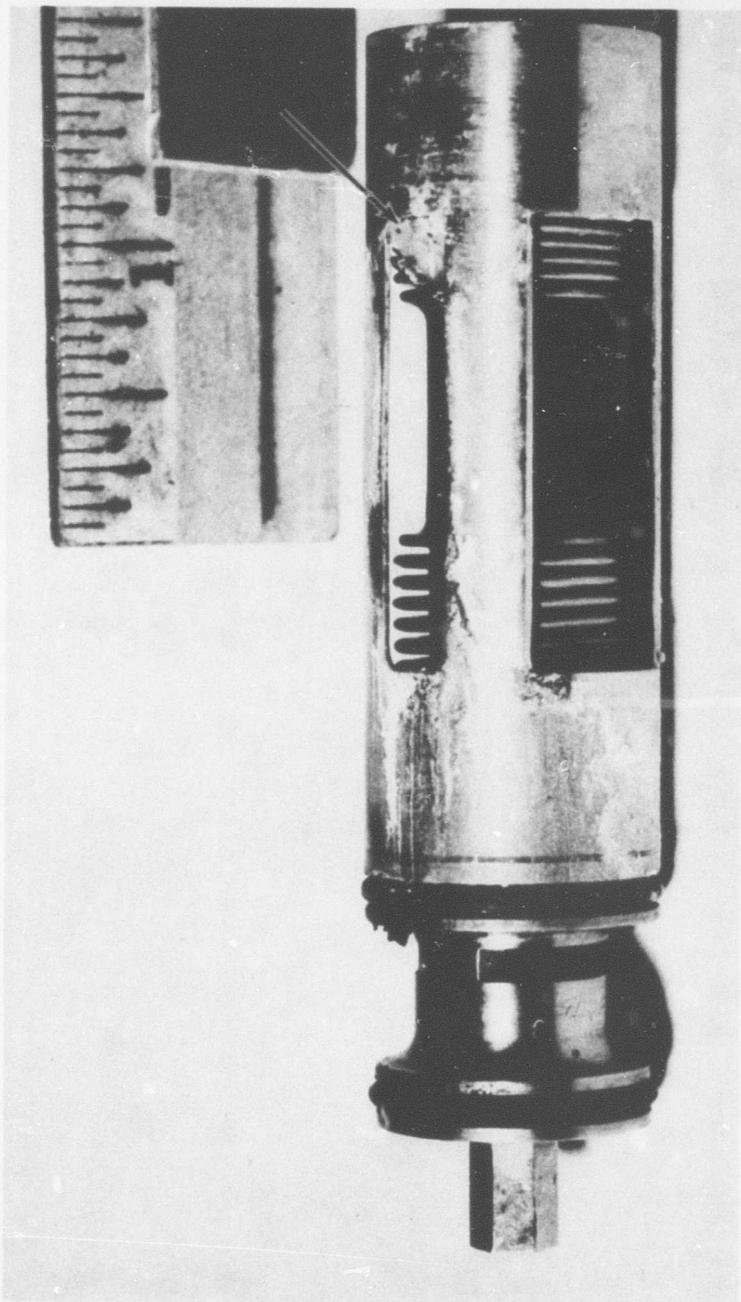
Figure 85. Bellows Assembly Partially Plugged With Oxide and Emulsion (Arrow).

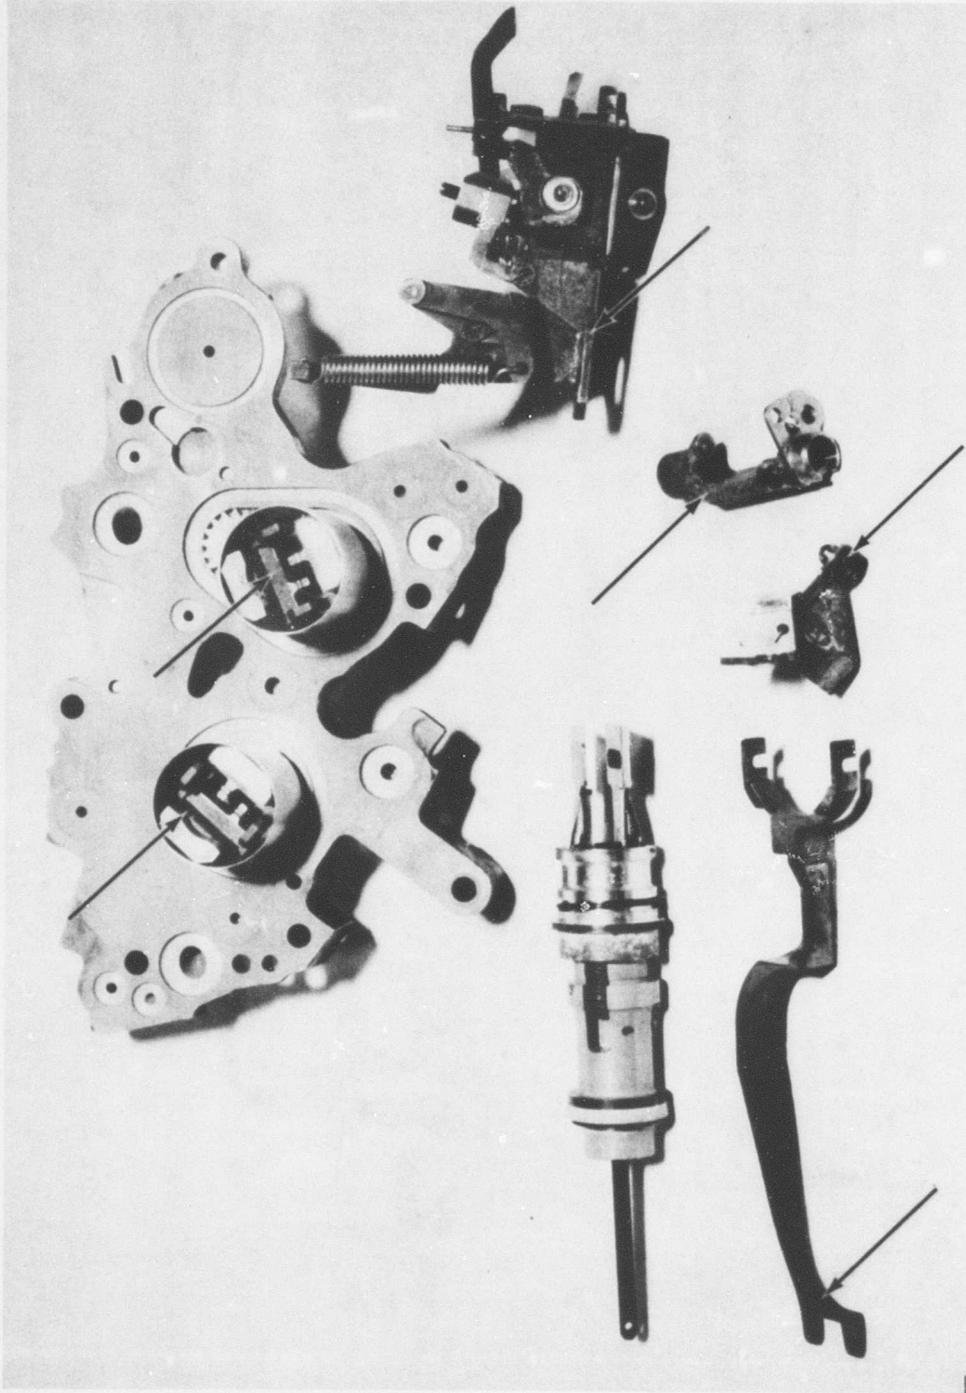
The rust generated by the emulsion within the control adhered to the computer links and did not reach the point of scaling off. Therefore, galling and wear of the hardened surface parts are most likely caused by the contaminant carried into the control from the fuel supply system.

Figure 86. Flyweight Housing (Top), W_f/P_3 Servo (Left Center), and Various Linkages. Arrows indicate rusted areas.

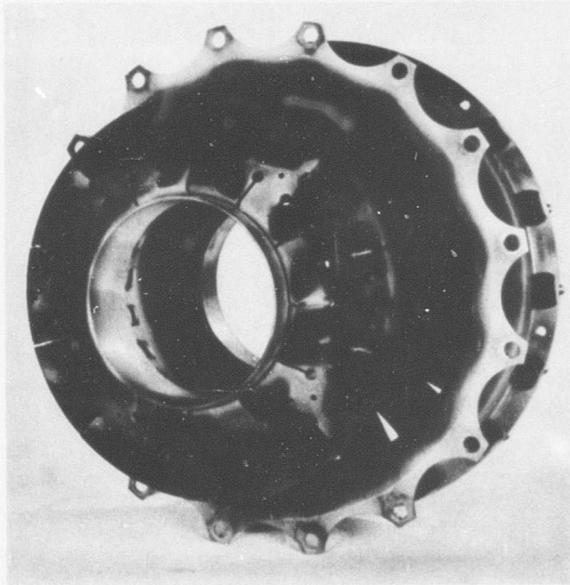
Figure 105. Outer Combustor Shell.

The engine was completely disassembled for inspection; Figures 105 and 106 illustrate the excellent deposit-free condition of the outer and inner combustor shells. Examination of the entire hot section of the engine proved that all parts were in normal condition; there was no evidence of difference from running with the different test fuels. The turbine nozzles and wheels were also deposit free and completely normal in all respects. The same igniters were used throughout the entire series of tests. Primer nozzles were changed during the gelled fuel testing, before a cleaning procedure was established.
