STUDY OF HELICOPTER TRANSMISSION SYSTEM DEVELOPMENT TESTING

SIKORSKY ENGINEERING REPORT SER-50547

JUNE 1968

SIKORSKY AIRCRAFT
DIVISION OF UNITED AIRCRAFT CORPORATION

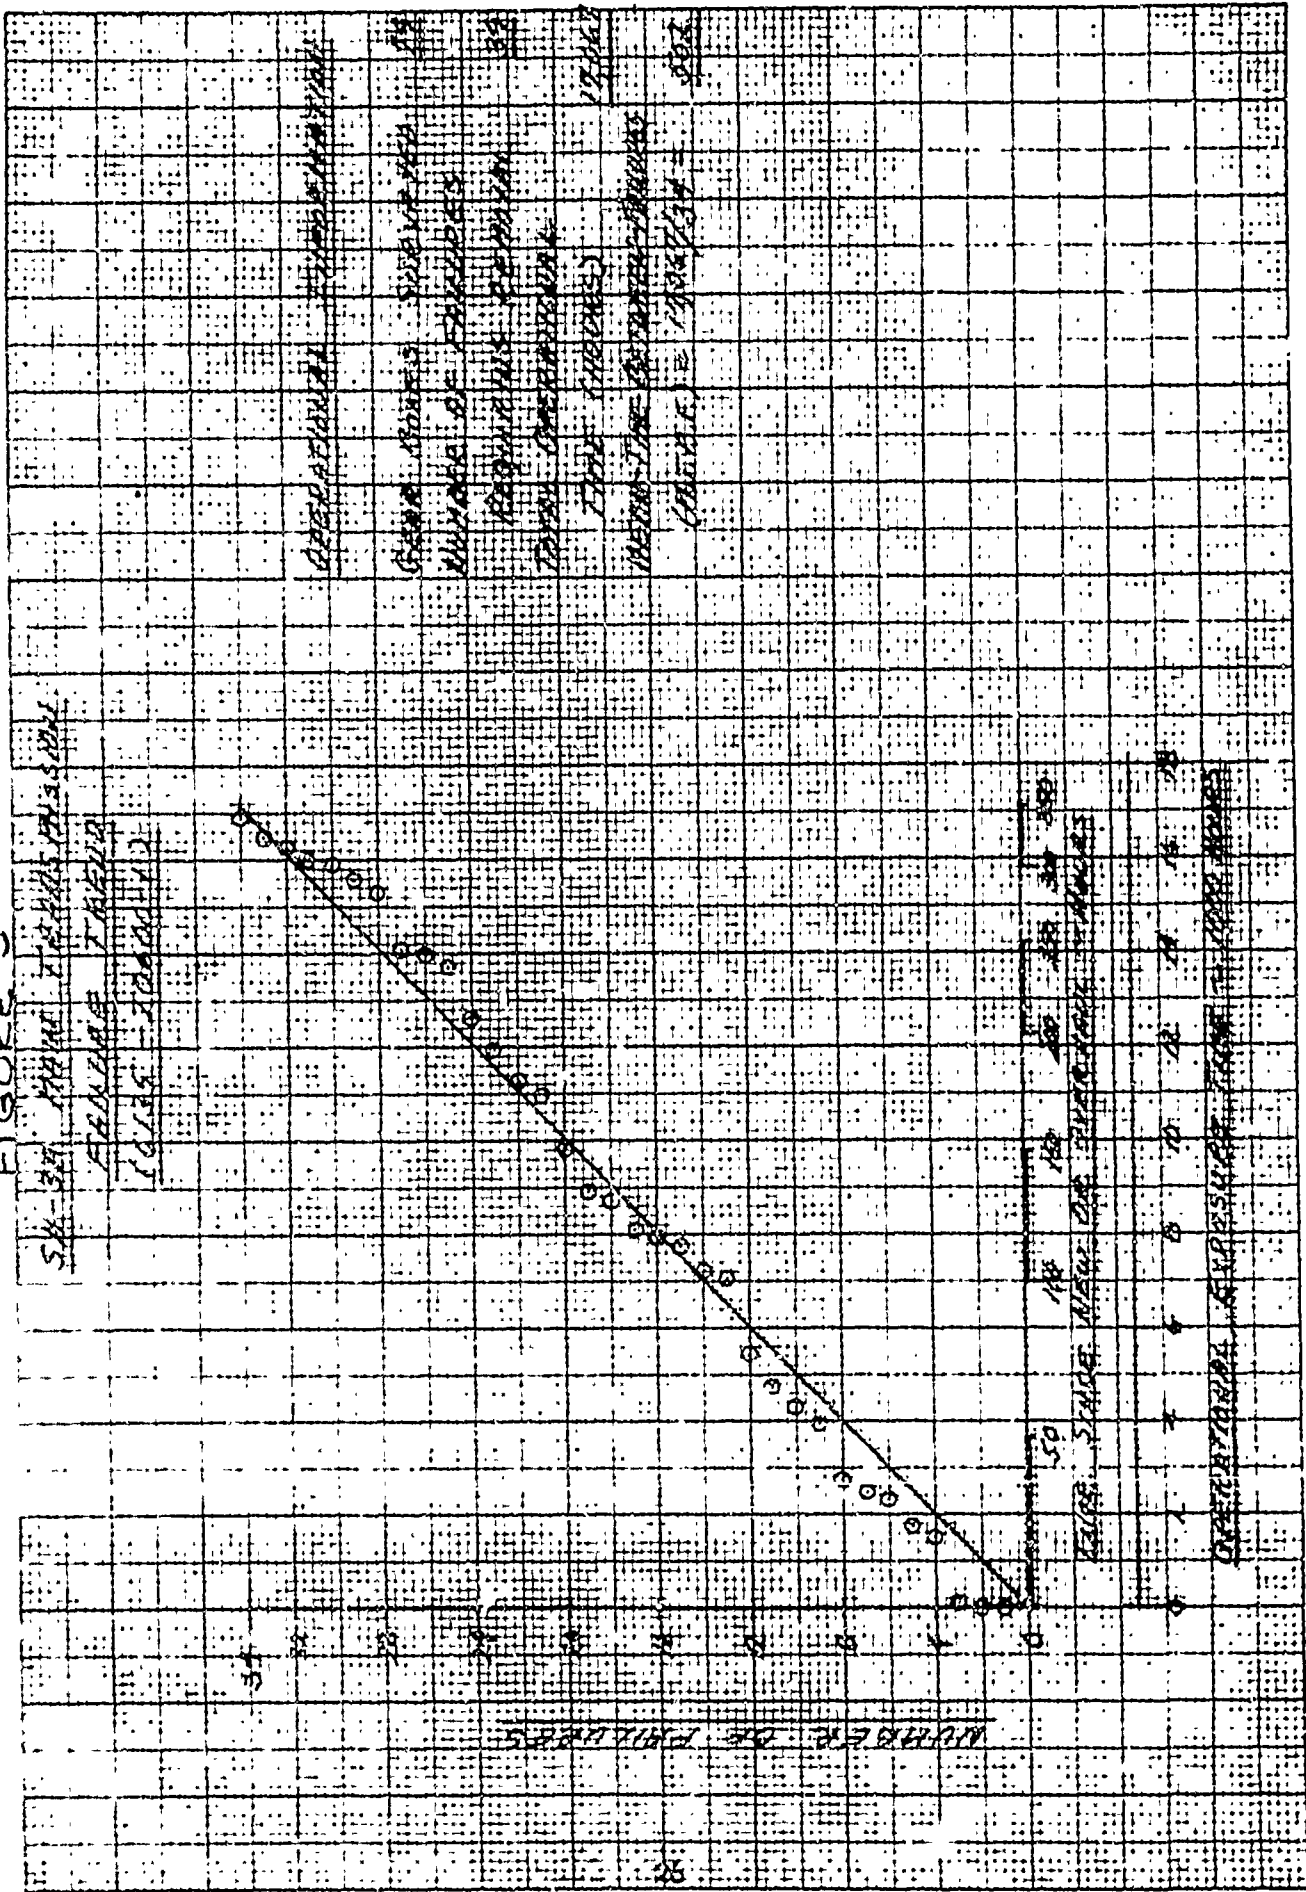
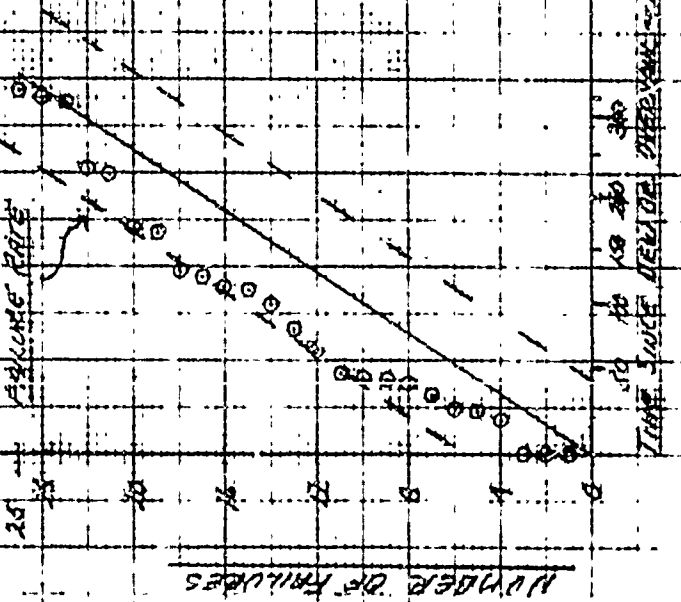
- Figure (4) shows the failure trend of a modified version
  of this gearbox. The failure trend for this unit exceeds
  the upper statistical limit of the normally-expected
  variation about the constant rate. This validates the
  conclusion that for this gearbox the rate is not constant
  but is governed by an unusually high early failure rate
  occurring in the initial hours after installation on the
  aircraft. Improper preloading of a bearing and failure
  of a snap-ring were found to be the causes of this

failure rate. Time histories of these two failures are shown in the upper two diagrams of Figure (4a). The first curve illustrates that the preload problem was essentially a zero-time failure. The second shows that the snap-ring malfunction was an "infant mortality" (usually occurring within the first sixty hours of gearbox operation).

The lower diagram shows that the remaining failures of the gearbox exhibit a constant failure rate pattern. (MTBF = 321 hours)

- Figure (5) shows the failure data for the transmission incorporation improvements for the above problems, demonstrating that the unit again operates in the constant failure rate region. (MTBF = 510 hours)

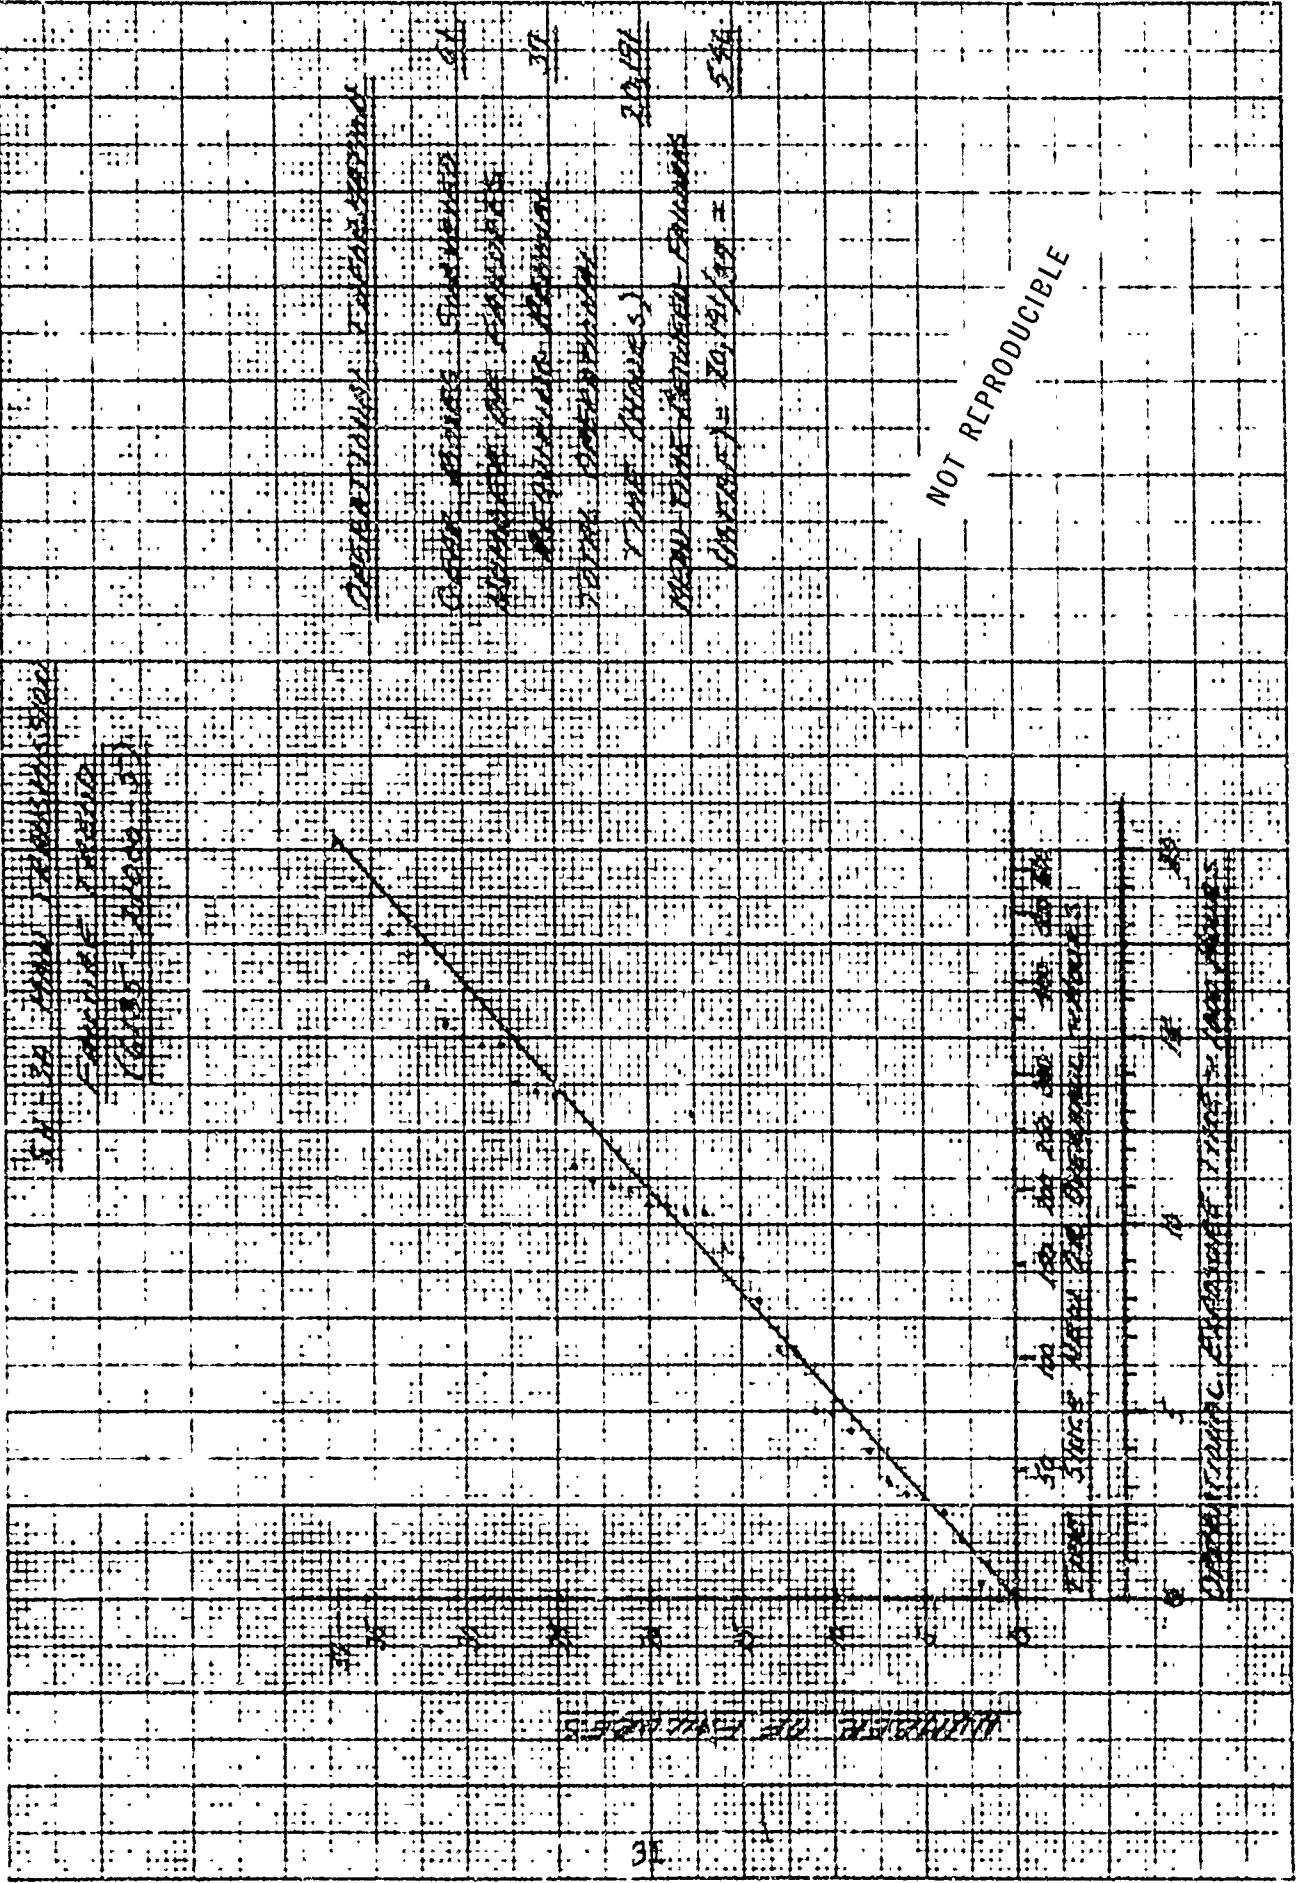
FIGURE 6.

- Figure (6) covers data on the S6135-21000-5 gearbox which was the next production version of the H-3 gearbox. This unit incorporated further design improvements lowering the failure rate (still constant). (MTBF = 546 hours)

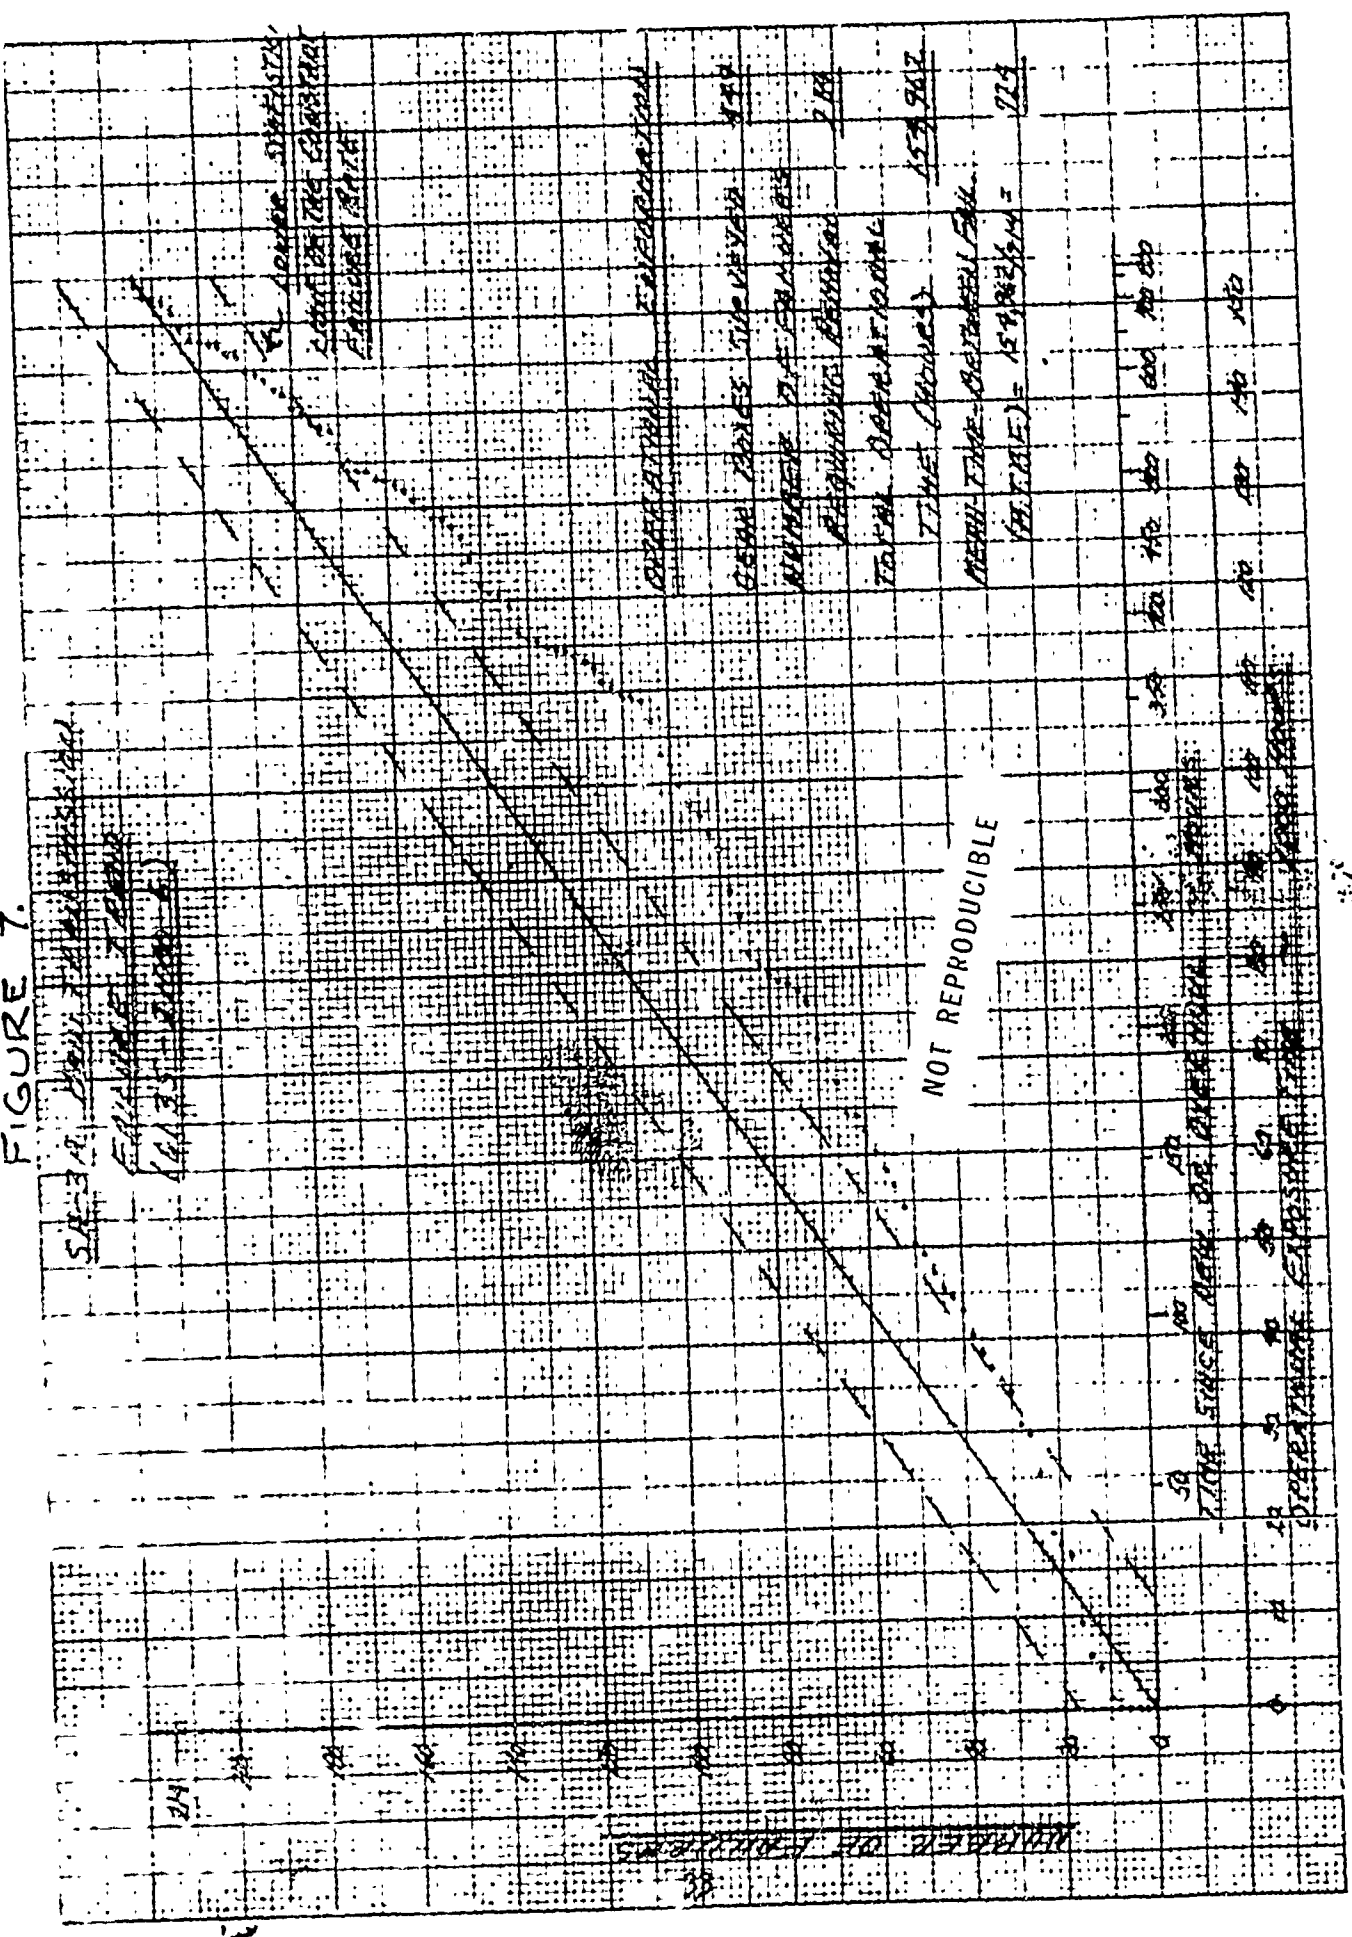
FIGURE 7a

- Figure (7) shows failure trend data on a gearbox
  with a higher service interval and reflects a
  substantial amount of high time gearbox operation.
  This curve shows a "wear-out" pattern[*] or trend
  associated with an increasing failure rate of the
  driven bevel gear. The degree to which the driven
  bevel failure dominates the MTBF of this gearbox
  is shown in Figure (7a).

There were essentially no driven bevel gear failures
  in the first 125 hours of operation since new or over-
  haul, some failures before 400 hours and a rash of fail-
  ures after 400 hours. Other less significant modes of
  failure also influenced this "wear-out" pattern.
  Figure (7b) shows the slight but noticeable influence
  of failures of the planetary pinion.
  (MTBF = 724 hours)

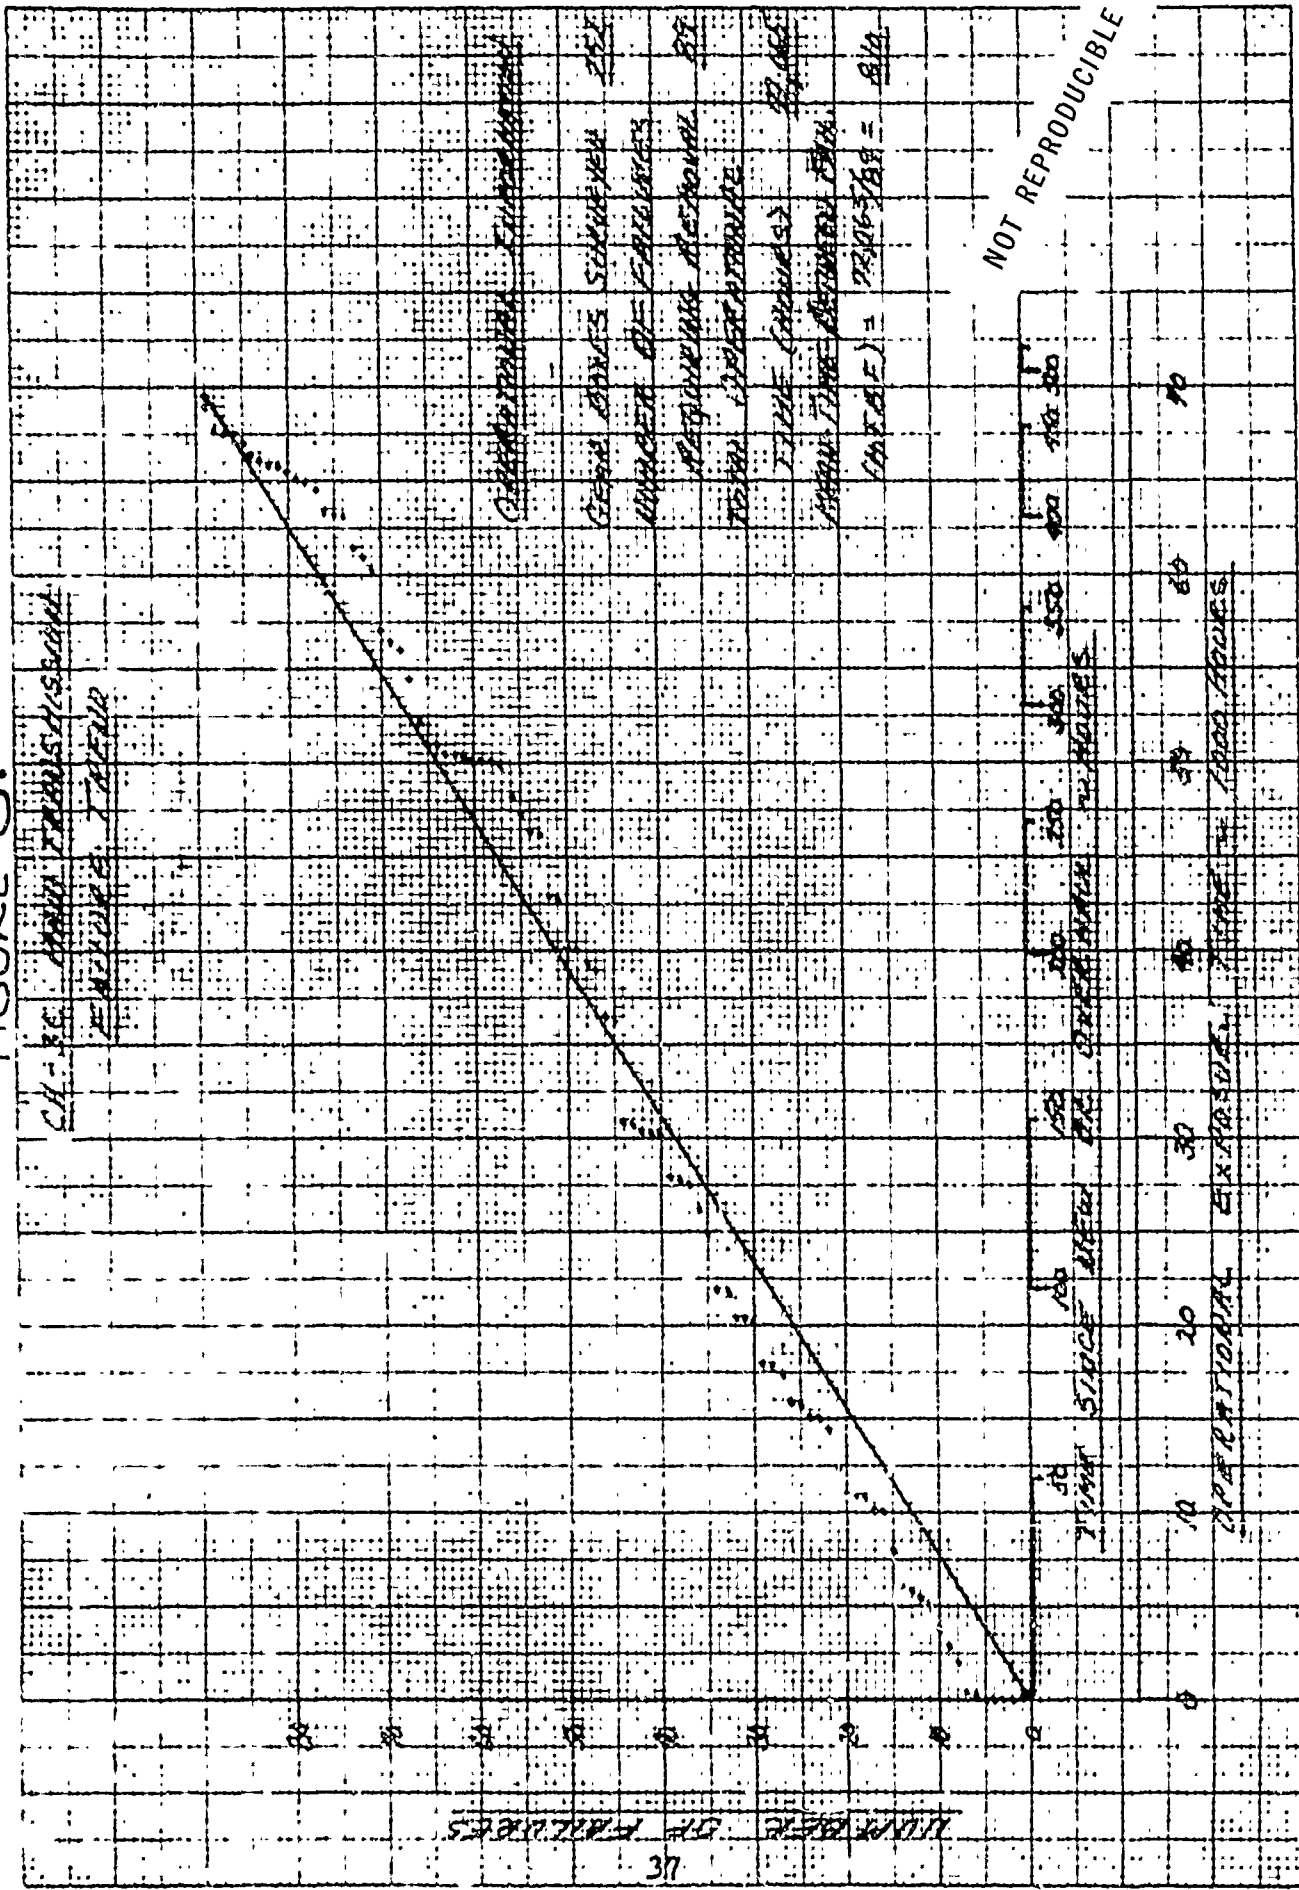
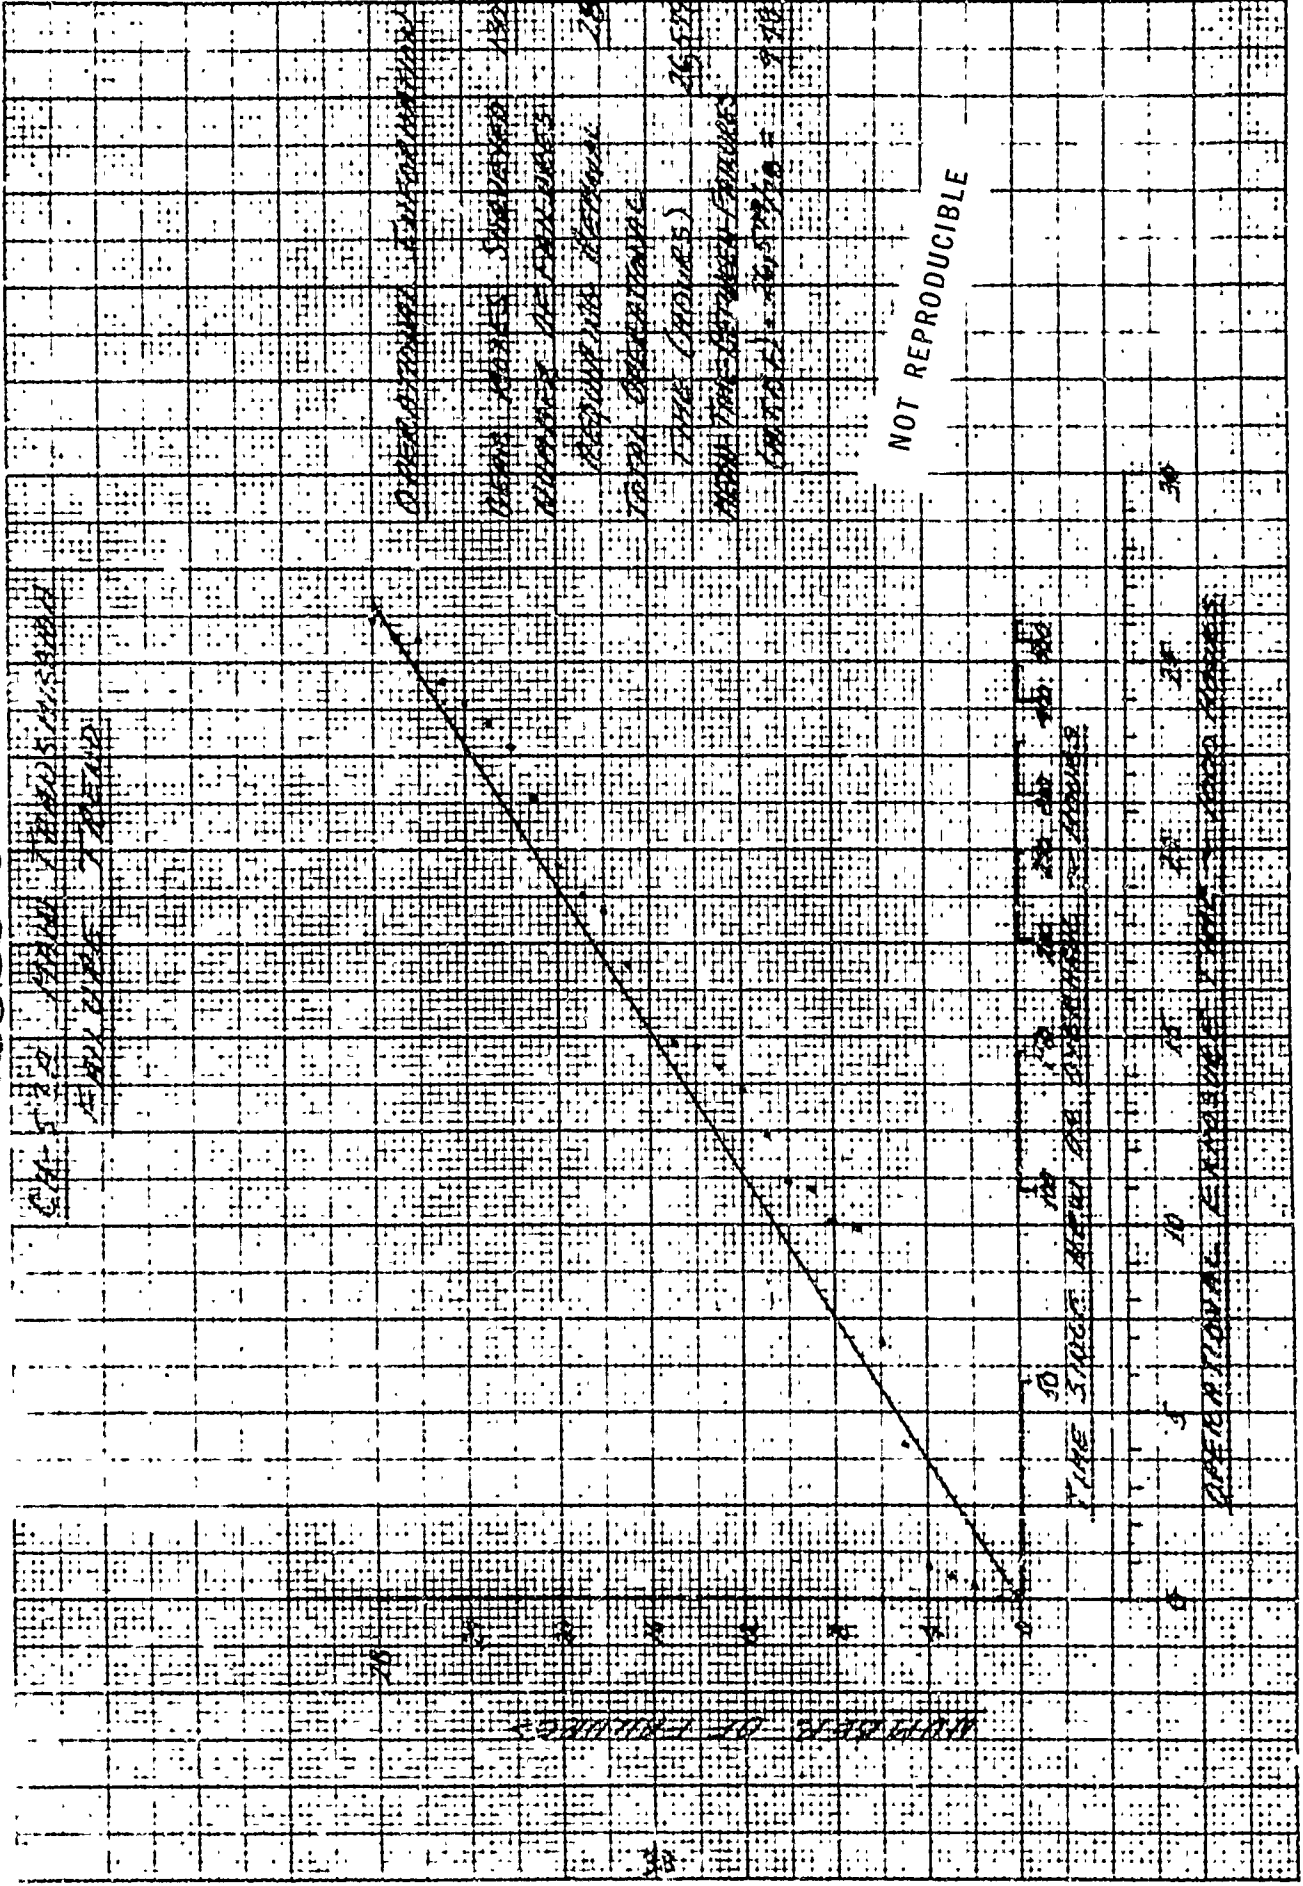
FIGURE 8.

- Figure (8) shows the failure rate (constant) for the
  U.S. Air Force CH-3C main gearbox.
  (MTBF = 810 hours)

- Figure (10) shows the failure rate of the main gearbox of
  the U.S. Army CH-54A. Most of the early removals were due
  to overtemperature problems and lubrication pump seizures.
  Improved gear shielding and the use of a higher viscosity oil
  (SATO 35) eliminated these problems.
  (MTBF = 734 hours)

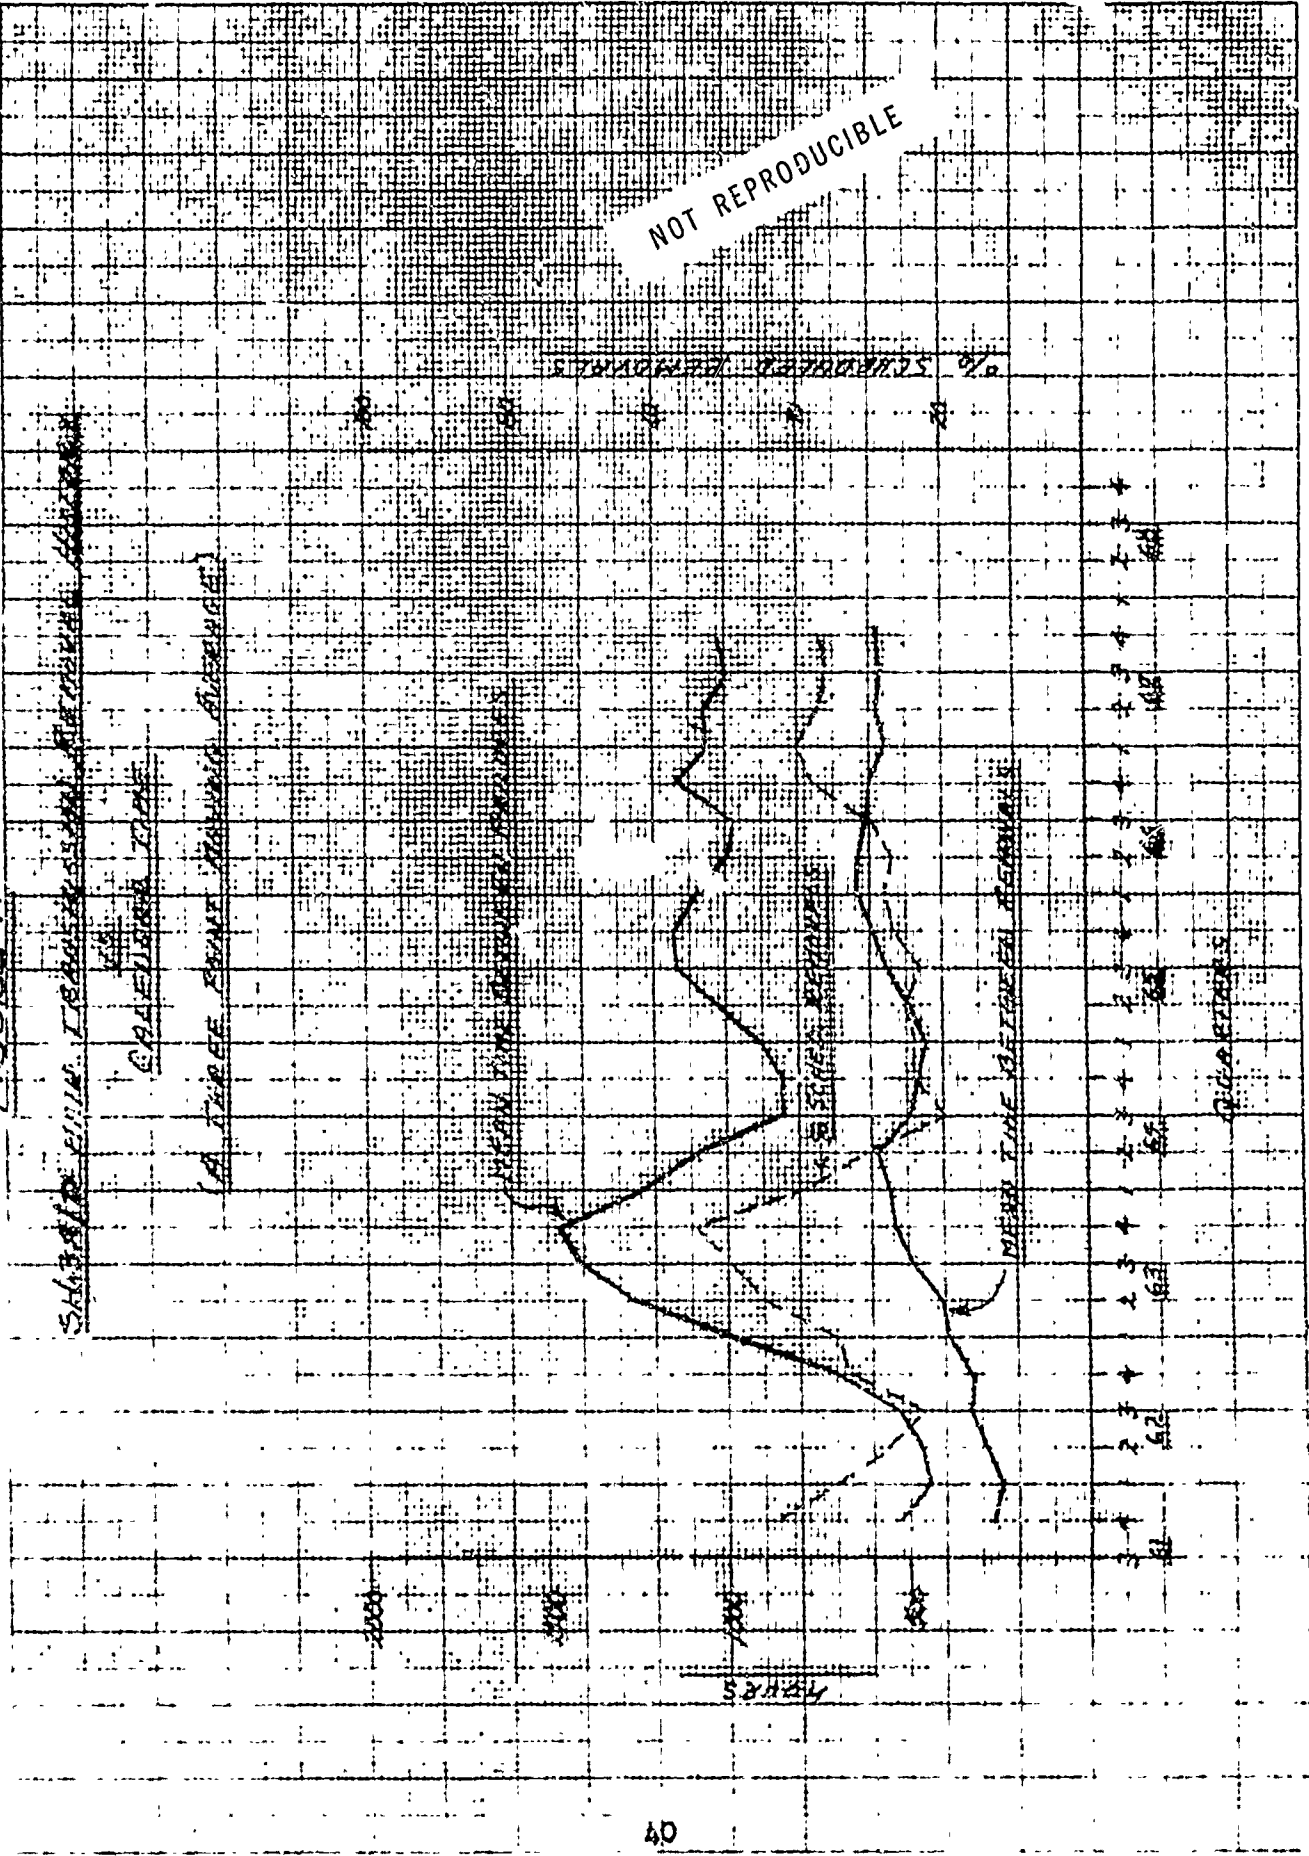
FIGURE 11

- Figure (11) shows the failure and removal history of the SH-3A
  and SH-3D main transmissions obtained from data gathered,
  averaged and plotted quarterly. The MTBF improvement
  noted at the end of 1963 was the result of successive
  gearbox refinements. The MTBF degradation

during 1964 was due to failures of the planetary pinion
gear teeth caused primarily by the introduction of an
engine with increased power capability. With the incor-
poration of further refinements and the incorporation of
the "beefed-up" SH-3D transmission (larger bevel gears
and planetary), the MTBF has improved and remained
relatively stable.

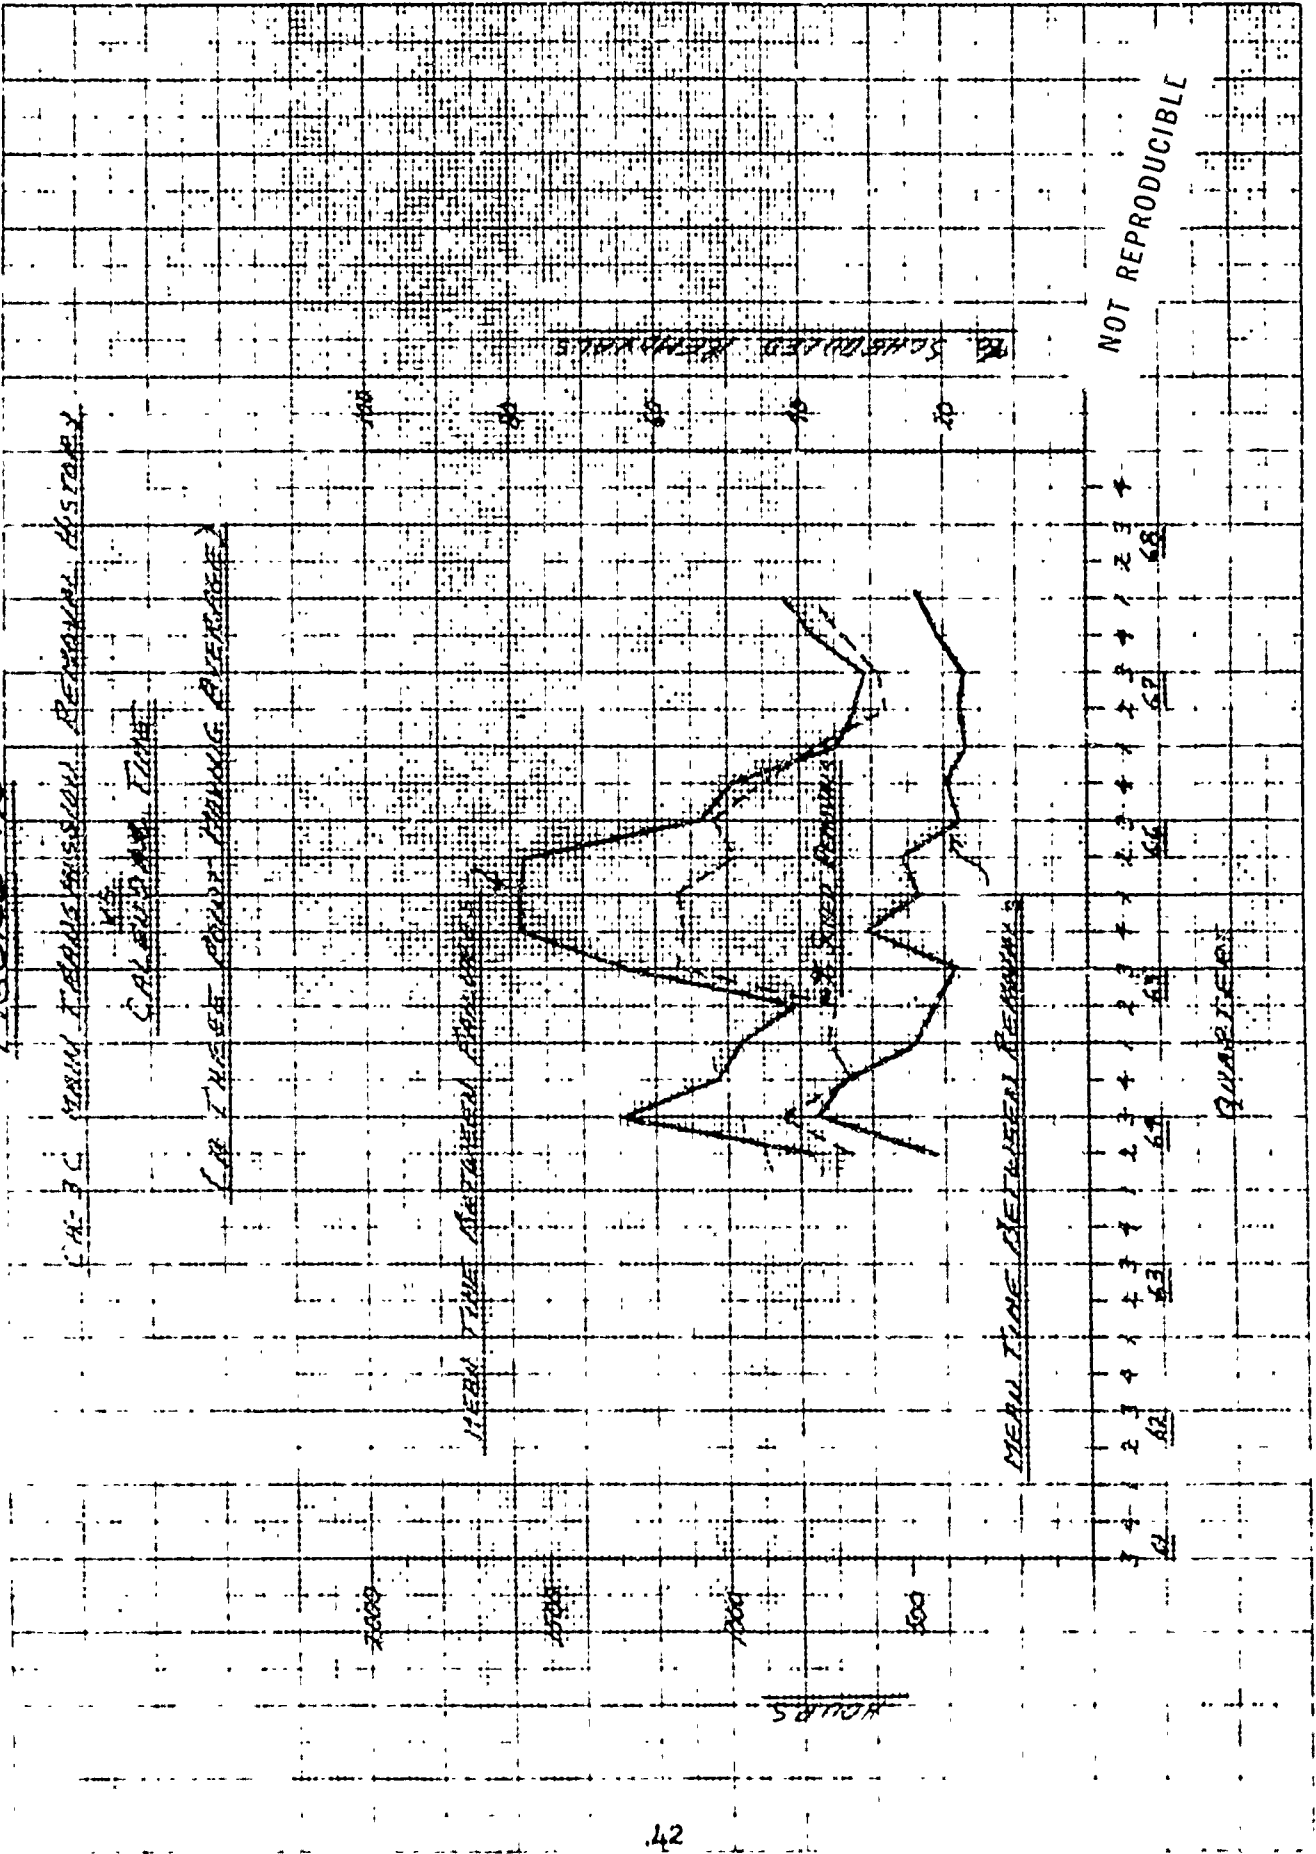
FIGURE 12

- Figure (12) shows the chronological history of the CH-3C
  main gearbox MTBFs. The large degradation of the MTBF
  in 1966 and 1967 was due primarily to stripped threads
  in gearbox housings at lubrication fittings. The in-
  corporation of steel inserts at all fitting locations
  (late 1967 - early 1968) has improved this situation.
  Several of the removals of this unit were based on
  exceeding arbitrarily established SOAP (Spectrographic
  Oil Analysis Program) levels. In nearly every case, no
  discrepancy was found in the gearbox on disassembly. A
  further discussion of Spectrographic Analysis is included
  in a later section.
