Report 1974

UNIVERSAL FOLDED PLATE (UFP) STRUCTURAL SYSTEM

Edward J. Schultze and Lloyd E. Krivanek

January 1970

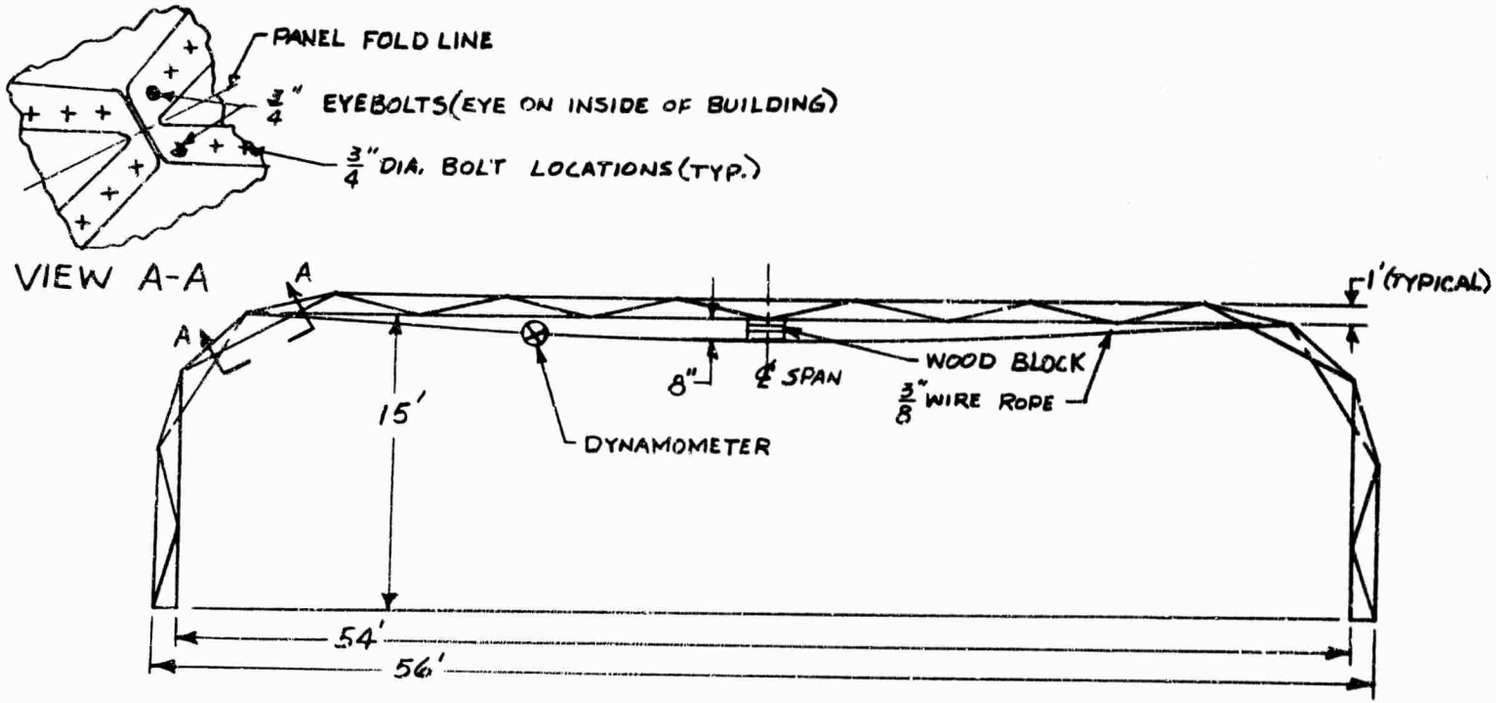
Fig. 66. Flat-roof building configuration post tension setup.

d. **Post Tensioning.** The post tensioning performed by applying 4,000-lb tension in each of the 11 cables was totally insufficient to hold camber in the flat roof with the methods used. When load was released from the crane, the roof returned to its original sag condition.

Post tensioning of the flat roof was attempted without success. The system used was inadequate to eliminate roof sag. Post tensioning can be accomplished to remove the roof sag provided time, personnel, and funds are furnished to design the required system. It is also possible to use some other method to eliminate the roof sag condition. One method would utilize columns to support the roof except that this would interrupt the clear span.

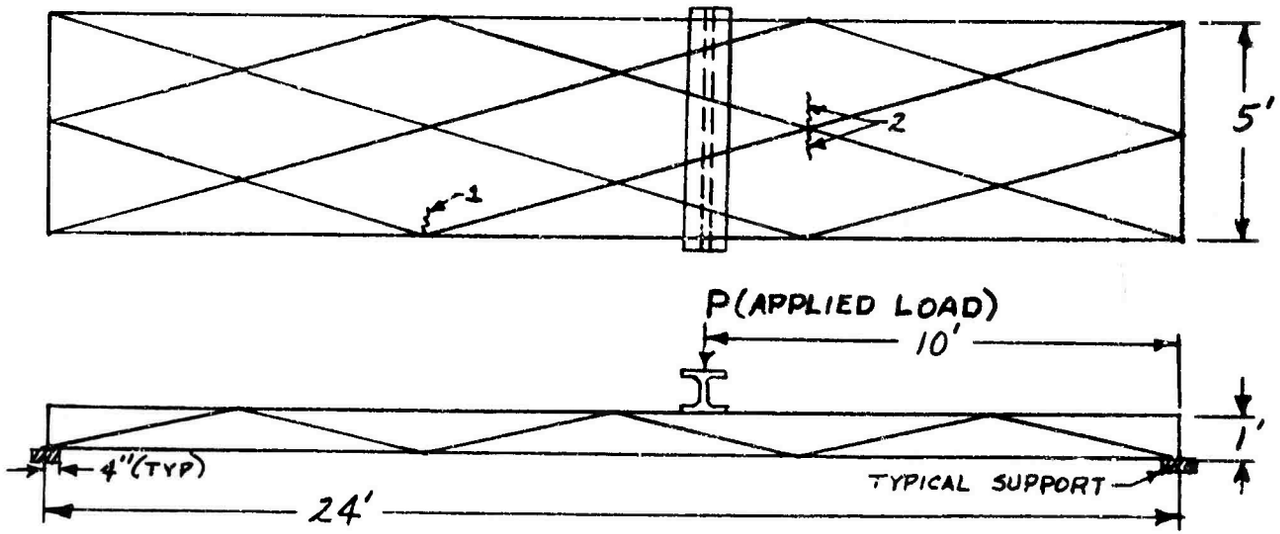
Fig. 70. Straight test beam with angle transverse stiffeners.

(a) **Straight Beam with Angle Transverse Stiffeners.** The maximum concentrated load applied to this beam was 8,000 lb. A weld failure occurred at a loading between 7,000 and 8,000 lb (Fig. 70). After this weld failure, load was increased to and held at 8,000 lb. Due to the test fixture setup, the piston travel of the hydraulic jack was not sufficient to increase the applied load beyond 8,000 lb. Therefore all load was removed from the beam to modify the test setup for greater load application. Prior to additional load application, the beam was inspected and weld failure had occurred at another nodal point (Fig. 70). At this time, further testing of this beam was canceled. (See Fig. 71 for a plot of load versus deflection for the loading completed.)

1 Denotes location of crack which occurred at loading of 7,000 to 8,000 lb. This crack exists in the full panel flange. Length of crack is flange width.

2 Denotes location of cracks which were located after the maximum load of 8,000 lb was removed from the beam. Load at which cracks occurred is unknown. Length of both cracks is the flange width.

(1) **Weld Failure in Flange at Obtuse Angle.** This failure (Fig. 81) accentuated the result of poor welding. After failure, inspection of this area showed that improper welding existed. Weld penetration was less than 50 percent with weld bead buildup shaved flush to the flange material surface.

a. **Transverse Stiffener Modification.** Because of the inadequate welding of the flanges at the obtuse angle of the panels and the existence of cracks along the fold line at the acute angle of the panels, the inventor proposed to furnish the six-hole transverse stiffener as a method of reinforcing the weakened structural areas. The six-hole transverse stiffeners were furnished at no cost to USAMERDC under a contract modification. Both of the building configurations were complete when the six-hole transverse stiffeners were received. Therefore, the angle stiffeners were replaced on the flat-roof building only, to avoid interruption of the test program.

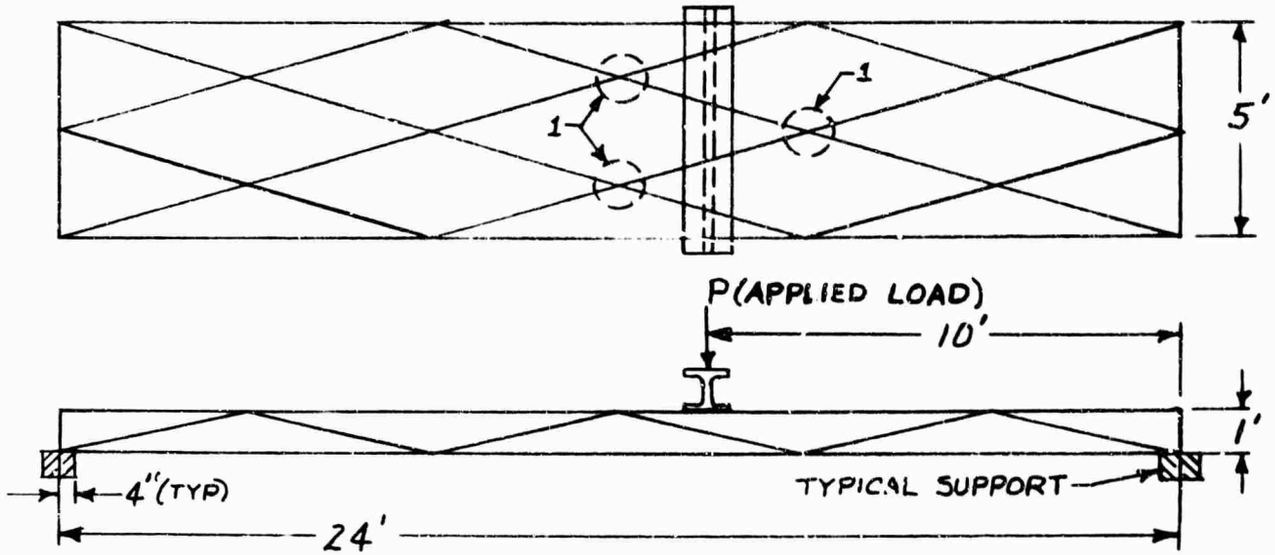
Fig. 72. Straight test beam with six-hole transverse stiffeners.

(b) **Straight Beam with Six-Hole Transverse Stiffeners.** Structural failure occurred at three nodal points (Fig. 72). Distortion of these nodal points was noticeable at a load of 8,000 lb. Failure load was 10,000 lb. Typical failure was as shown in Figs. 73 and 74. (See Fig. 75 for a plot of load versus deflection.)

1 Denotes nodal points at which structural failure occurred. See Fig. 73 and Fig. 74 for detail of the failures.

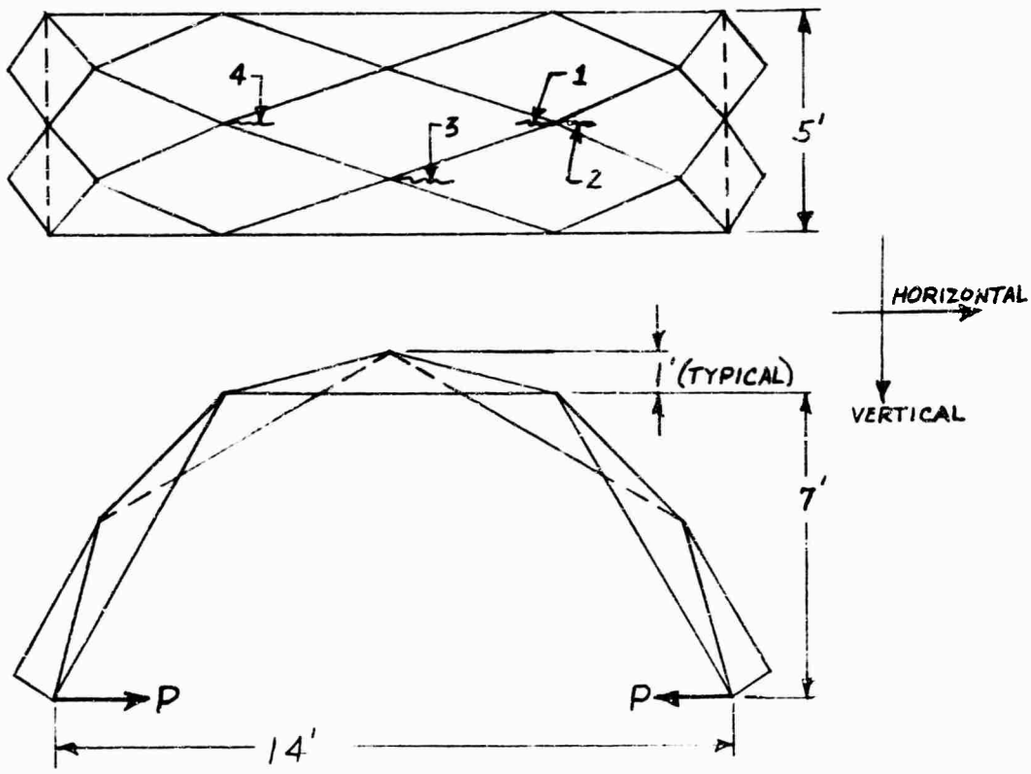
Fig. 76. Curved beam test beam without transverse stiffeners.

(a) **Curved Beam Without Transverse Stiffeners.** Structural failure occurred at a nodal point (Fig. 76). Failure load was 2,600 lb. Cracks propagated along the panel fold line in both directions from this nodal point. A plot of load versus deflection is shown in Fig. 77.

NOTE:
1, 2, 3, & 4 Denote cracks along panel fold line at locations shown.
Crack 1 = 1-3/4" length.
Crack 2 = 3" length.
Cracks 3 & 4 = 1-5/8" length.
Structural failure occurred at the nodal point common to location of cracks 1 & 2.
P Denotes location and direction of applied load.

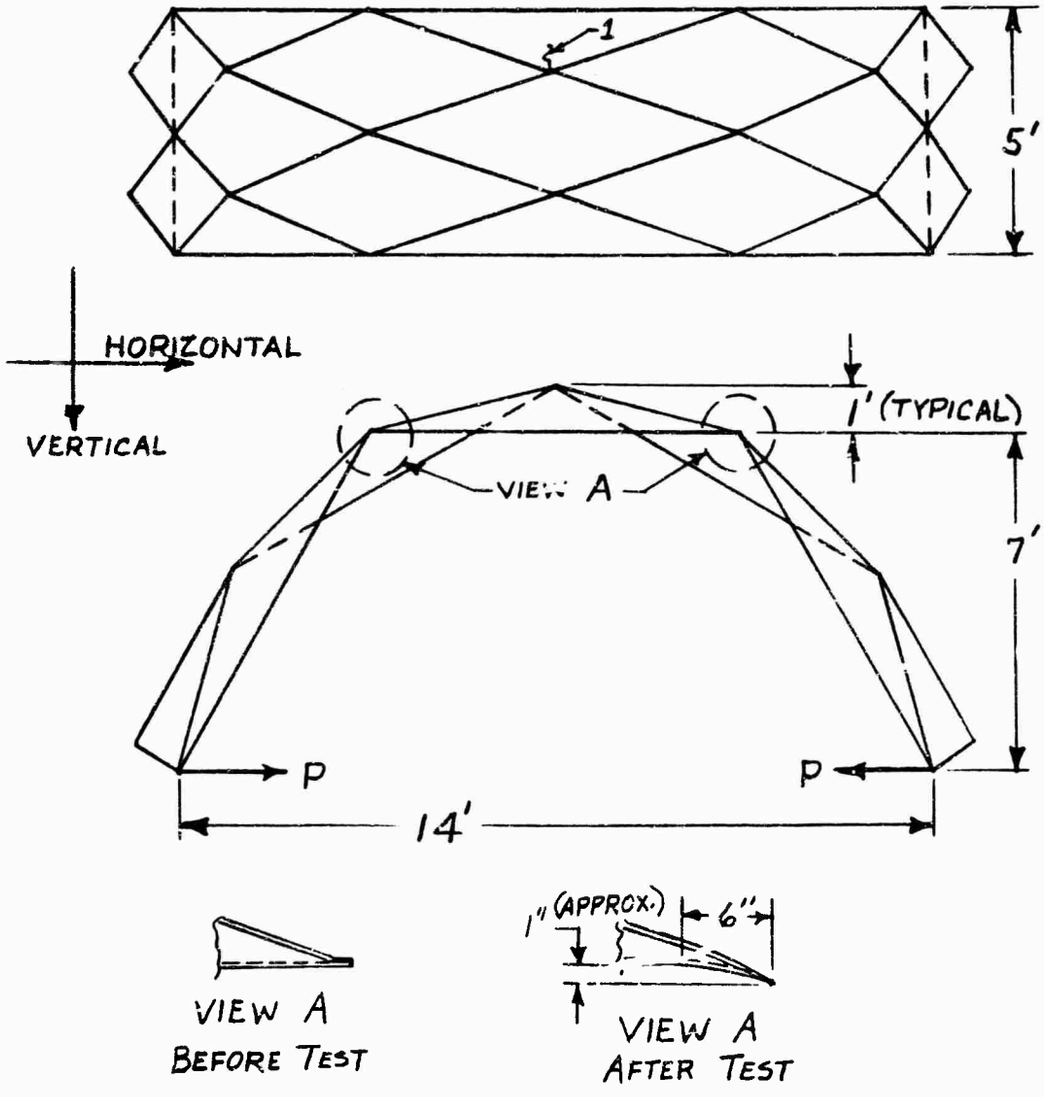
Fig. 78. Curved test beam with angle transverse stiffeners.

(b) **Beam with Angle Transverse Stiffeners.** Structural failure occurred at 6 in. from a nodal point at two locations as shown in Fig. 78. Failure load was 5,500 lb. A plot of load versus deflection is shown in Fig. 79.

1 Denotes location of weld crack which occurred at an applied load of 3,500 lb. This crack exists in the longitudinal half panel flange. Length of crack is the flange width.

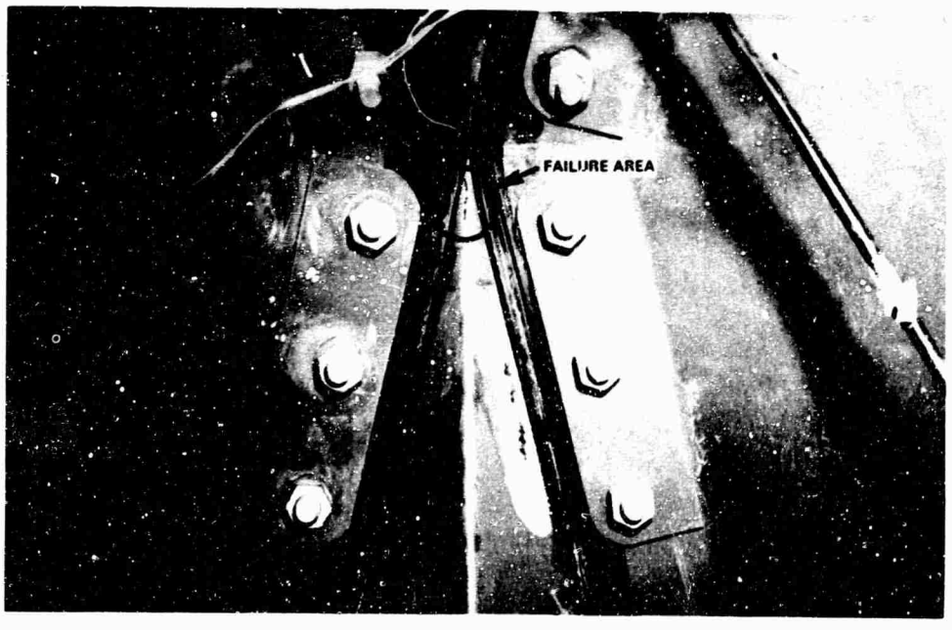
Fig. 82. Crack in parent material along panel fold line propagating from obtuse angle end of panel.

(2) **Crack in Parent Material Along Panel Fold Line.** This failure (Fig. 82) was the result of crack propagation of a forming crack which was not repaired. At time of panel fabrication, welding was accomplished as an attempt to eliminate this defect, but the crack was not removed.

b. **Manufacturing Quality.** During fabrication, cracks occurred in the steel along the UFP panel fold line at the acute angle end. These cracks start at the edge and propagate into the metal with length varying from 1/4 in. to 1 in. The cracks existed in a majority of the UFP panels obtained for this test and evaluation. A weld repair of the crack areas was attempted without much success as 100-percent penetration was not obtained and the cracks remained visual on one side of the material. The flanges were cut at the obtuse angle to allow for forming. After forming, the flanges were welded to form a continuous flange, but a majority of these weld areas exhibit less than 50-percent weld penetration with basically no weld in some areas.

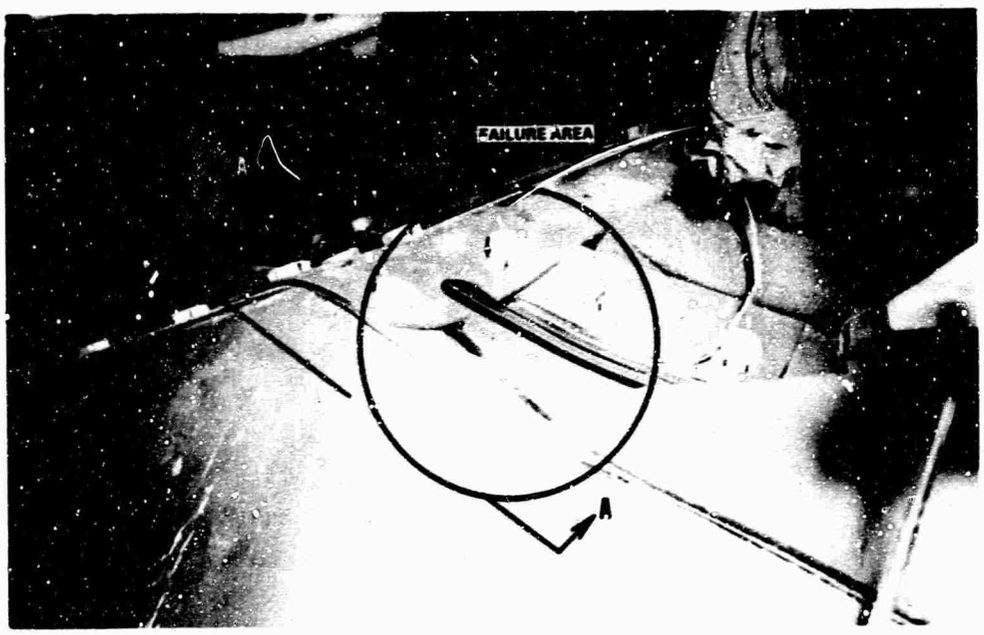
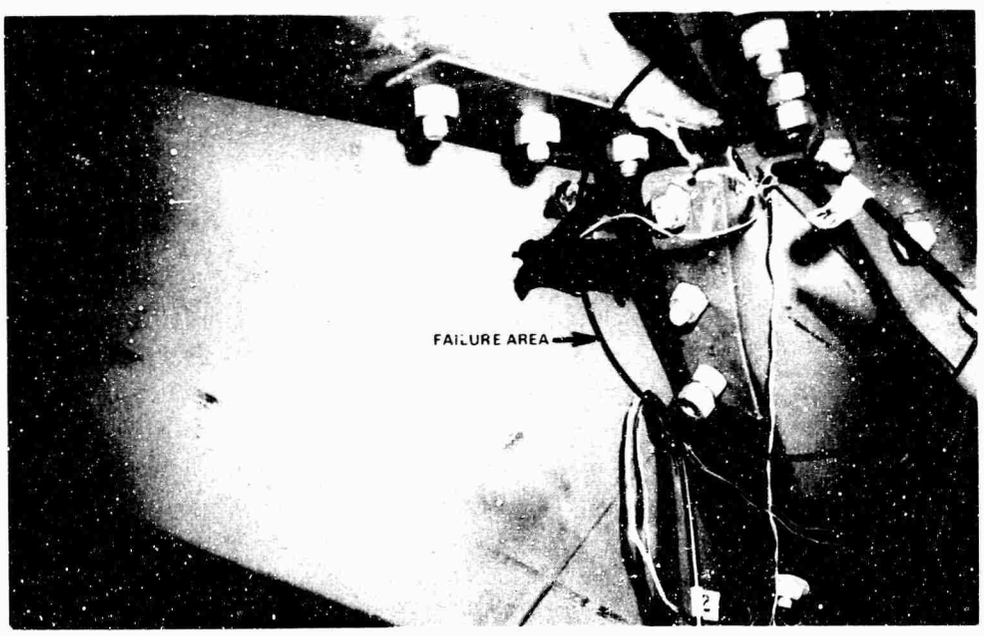
Fig. 83. Failure at and adjacent to nodal point.
(View A–A shown in bottom photograph.)

(3) **Failure At and Adjacent To a Nodal Point.** This failure (Fig. 83) occurred in the straight beam with the six-hole transverse stiffeners. The crack is approximately 2 in. long with panel failure occurring within 10 in. in from the end of the panel at the acute angle. This failure occurred on only one side of the nodal point.

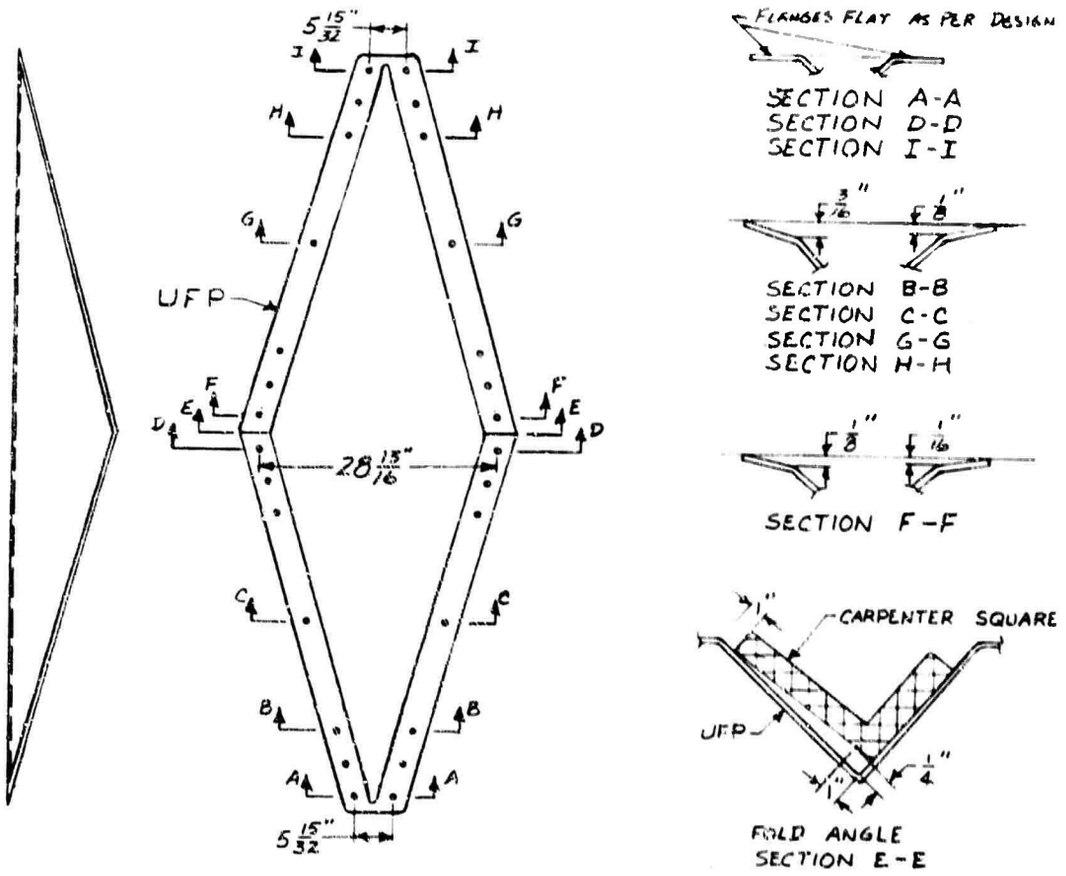
Fig. 84. Manufacturing tolerance check – panel 1.

NOTE:
Only dimensions other than design ± 1/32 are shown.

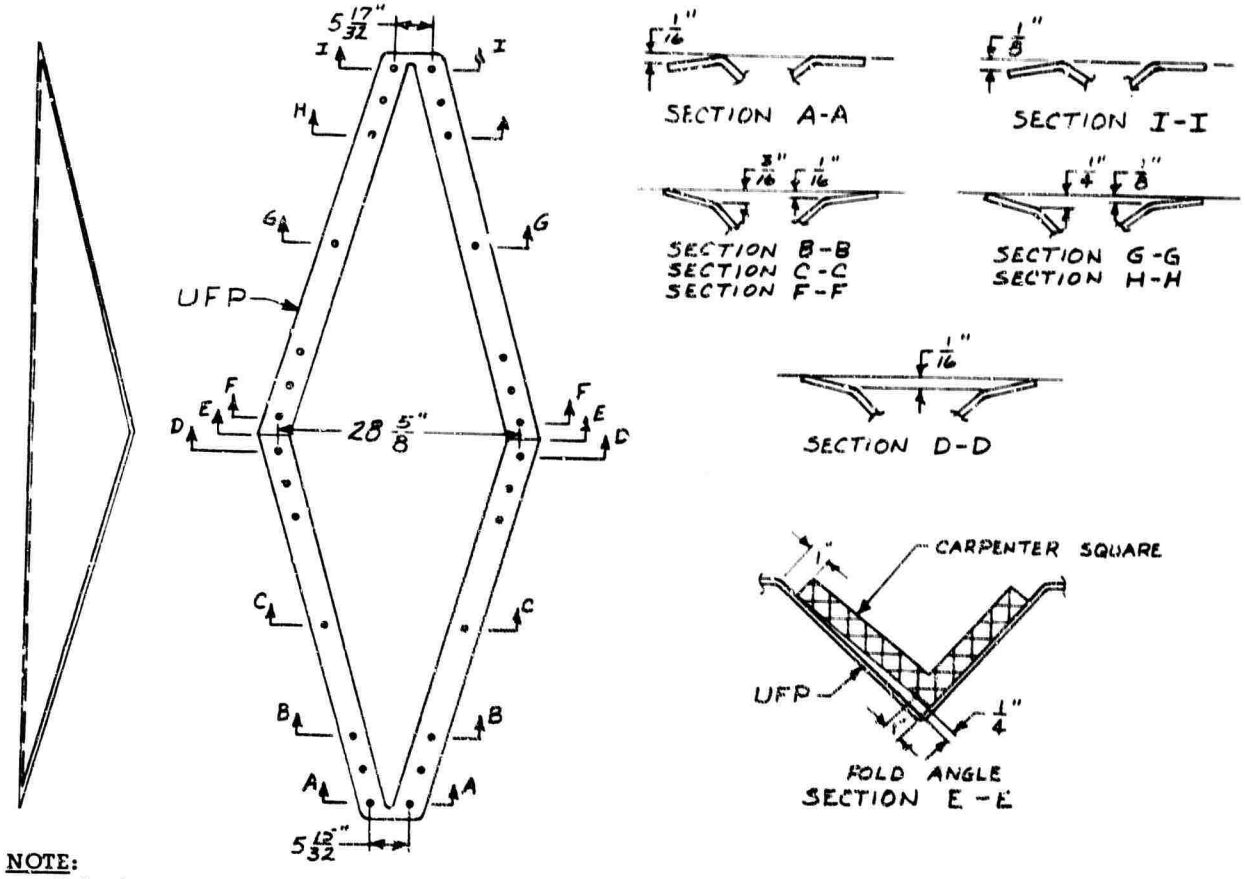
Fig. 85. Manufacturing tolerance check — panel 2.

NOTE:
Only dimensions other than design ± 1/32 are shown.
