TR 125

APPROACH ROADS, GREENLAND
1958-59

Robert M. Davis

June 1971

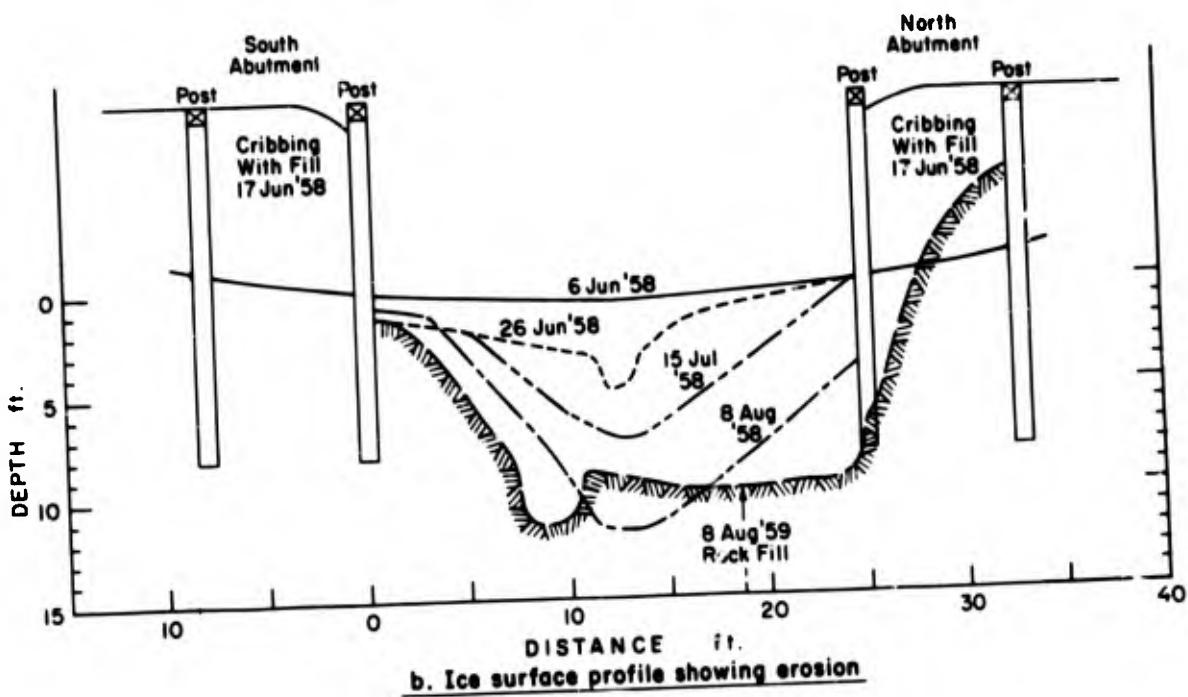
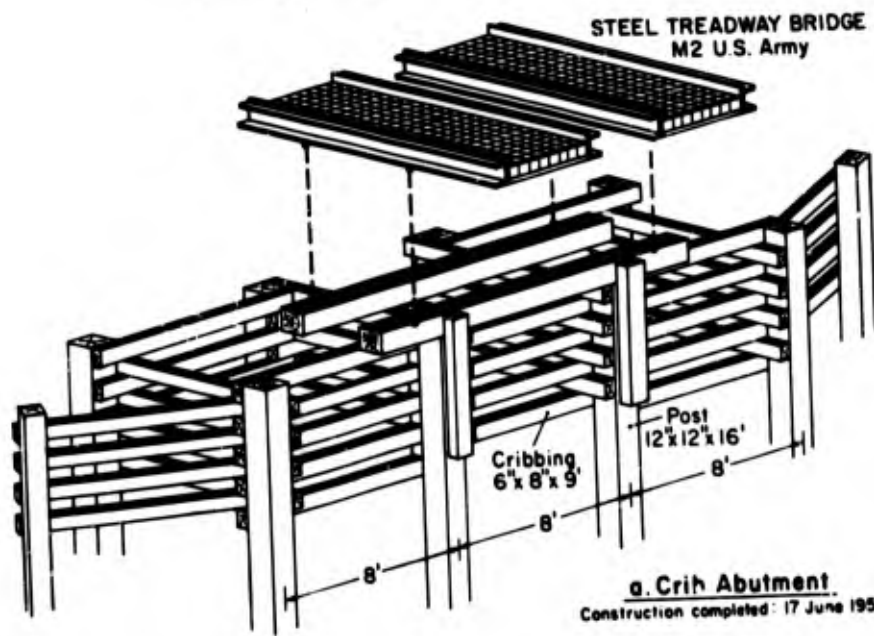
Figure 5. Crib abutment bridge.

a. Crib Abutment
Construction completed: 17 June 1958

b. Ice surface profile showing erosion

Bridge. There was a larger amount of melt water beneath the bridge than expected. Profiles
along the centerline of the ice beneath the bridge are shown on Figure 5. Melt-water erosion
rapidly undermined the cribs and twice during the 1958 field season additional fill was added to
the cribs. At the end of the 1958 season two large culverts composed of oil drums welded end
to end were placed in the channel and covered with coarse fill.

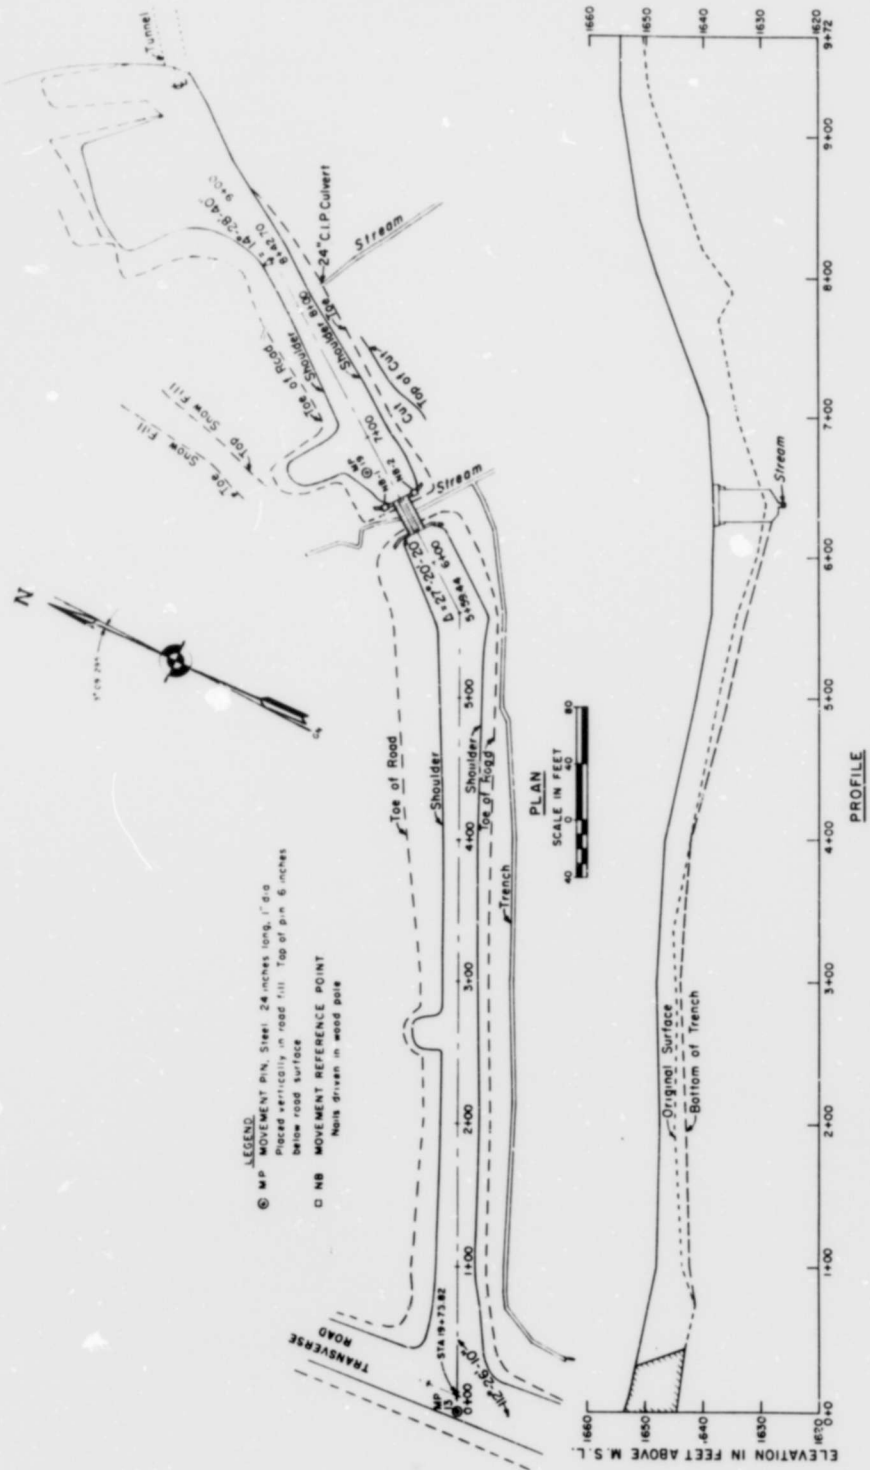
Figure 6. Plan and profile of Tunnel Road.

The road was constructed with a cross section of 30 ft and side slopes of 1 : 1½. This was the same design that had been used in all previous road construction on the ramp. Figure 6 shows that the depth of fill was usually in excess of 3 ft to maintain the desired grade. Turn-arounds were constructed at Stations 6+60 and 7+00 on the north side of the road to aid in road construction. These were not designed to serve as so-called "dikes." In this area, with steep slopes leading in to the road on the south and away from the road on the north, "dikes" would not be effective.

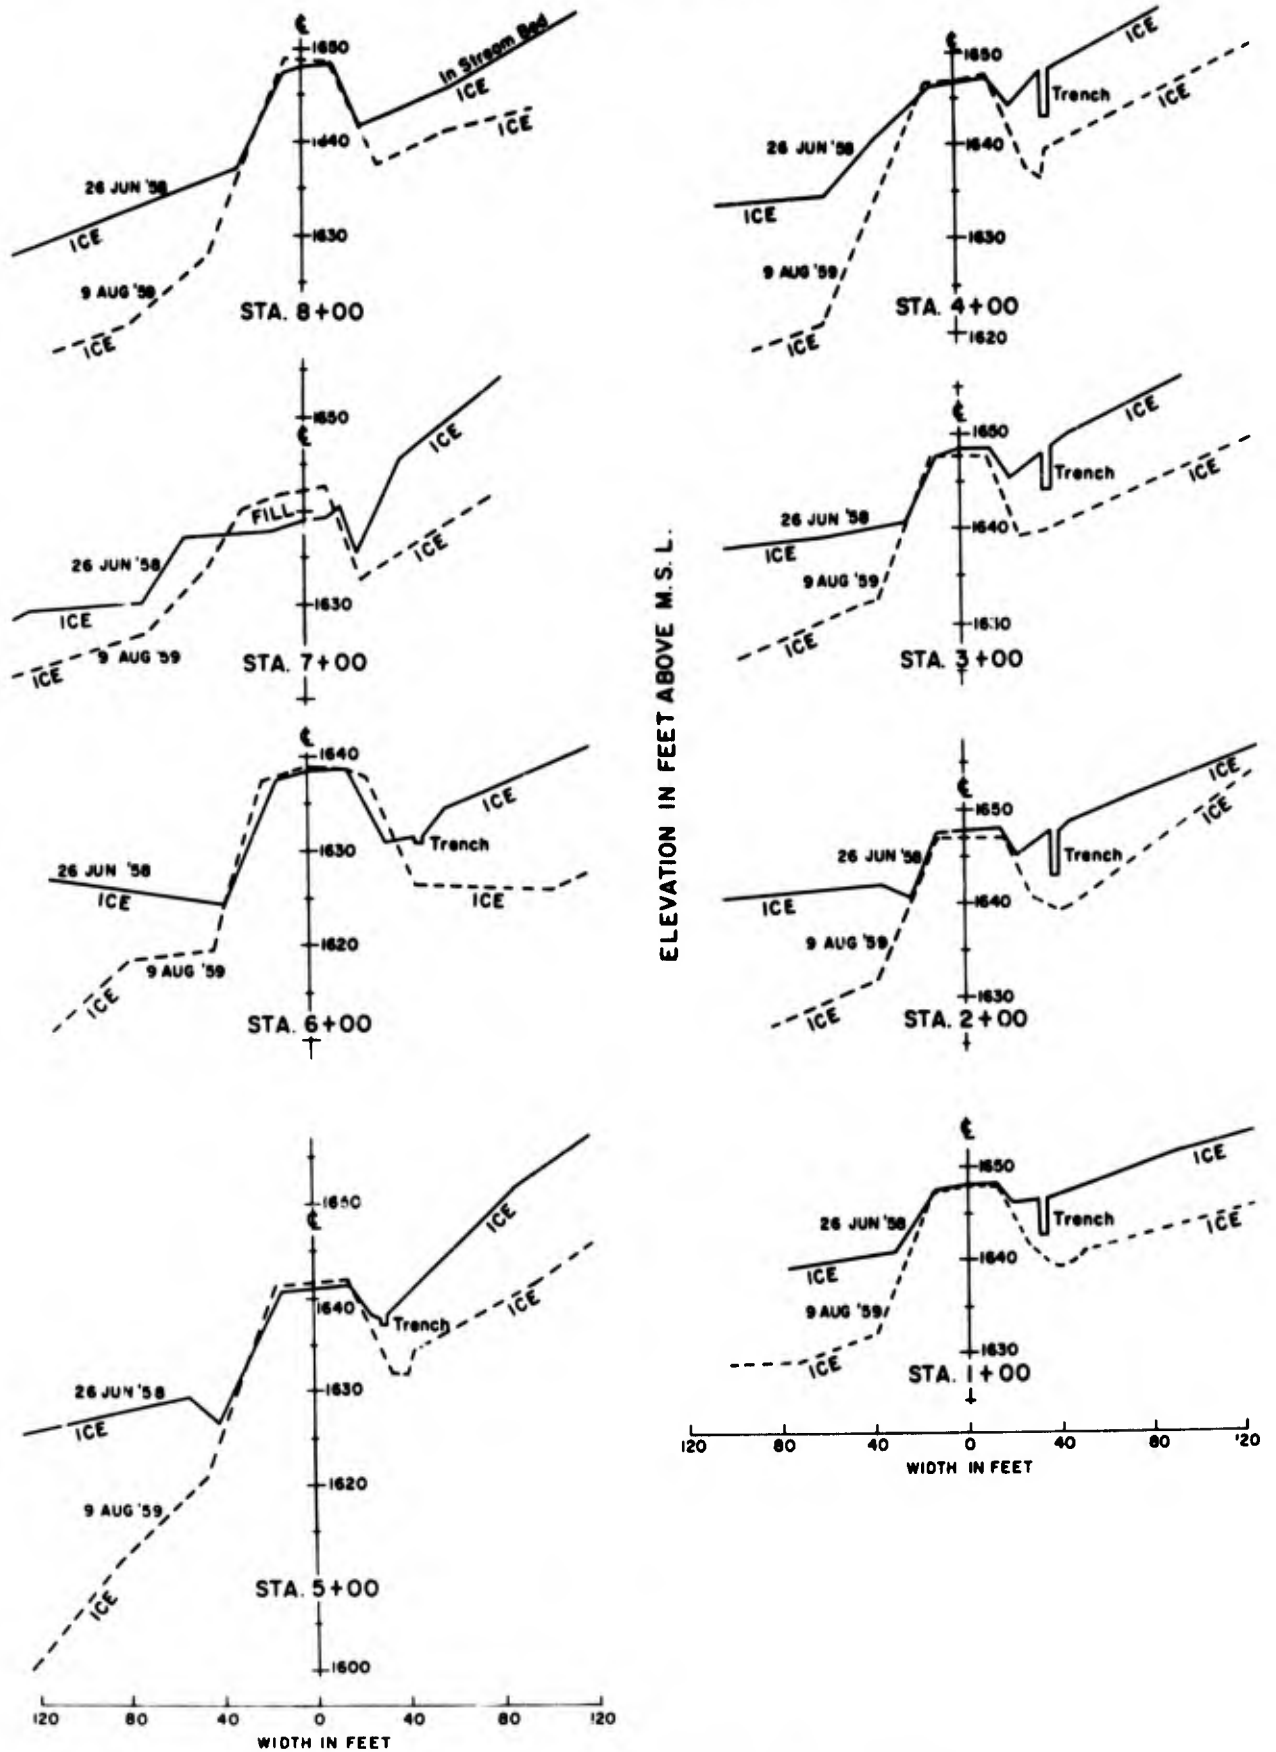
abnormal perching. Figure 10 shows a comparison of the cross sections at each station along the
road in June 1958 and August 1959. The extremely rapid ablation at Stations 5+00 and 6+00, on
the north side, is due to erosion by the melt water. Additional fill was added along the south side
of the road in August 1958. The road remained serviceable throughout 1959 without repairs.

Figure 10.   Cross sections of Ice Tunnel Road, 1958 and 1959.

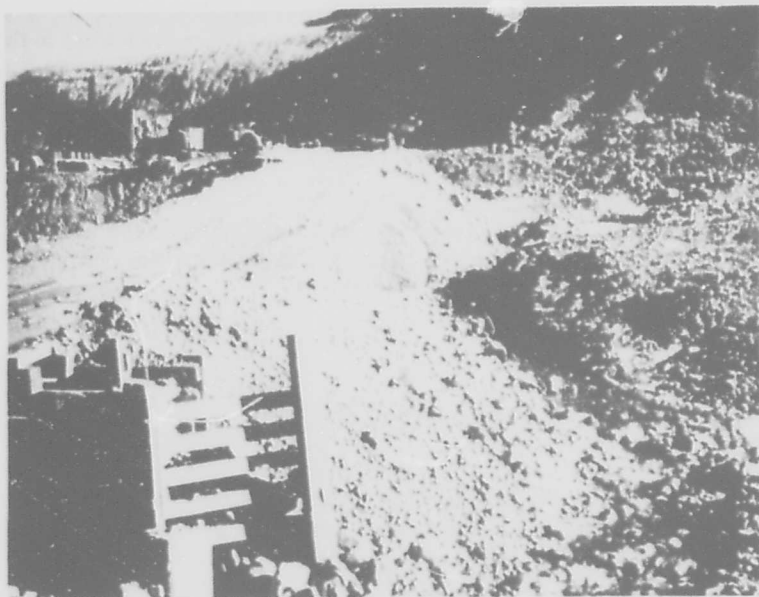
Cut section. No problems resulted from the cut section. The exposed ice along the side
melted rapidly; by the end of the 1958 season the ice was level with the road surface and by the
end of the 1959 season, it was below the road surface (Fig. 11).

Figure 11. Cut section on Ice Tunnel Road at end of 1959 thaw season, 13 August 1959.

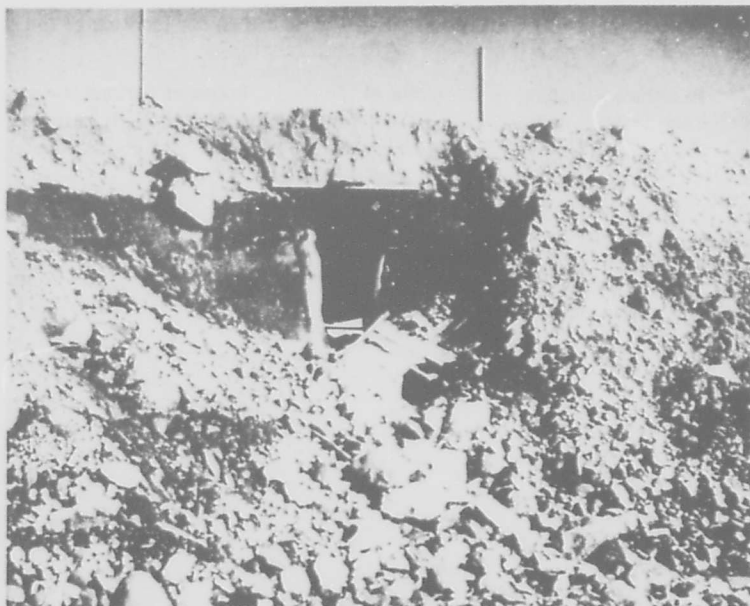
Cut-and-cover culvert. The culvert was finished on 25 July and the largest amount of melt-
water flow measured was 18 ft³/sec on 5 July. Excessive erosion at both ends of the culvert re-
sulted in narrowing of the Transverse Road. As a safety measure, the culvert was filled in and
fill placed along both sides of the road. By the time the culvert was filled in the ice on the uphill
side had melted below the elevation of the bottom of the trench so that melt water was bypassing

the culvert (Fig. 12).

Figure 12. East end of culvert C-12, 24 July 1958.

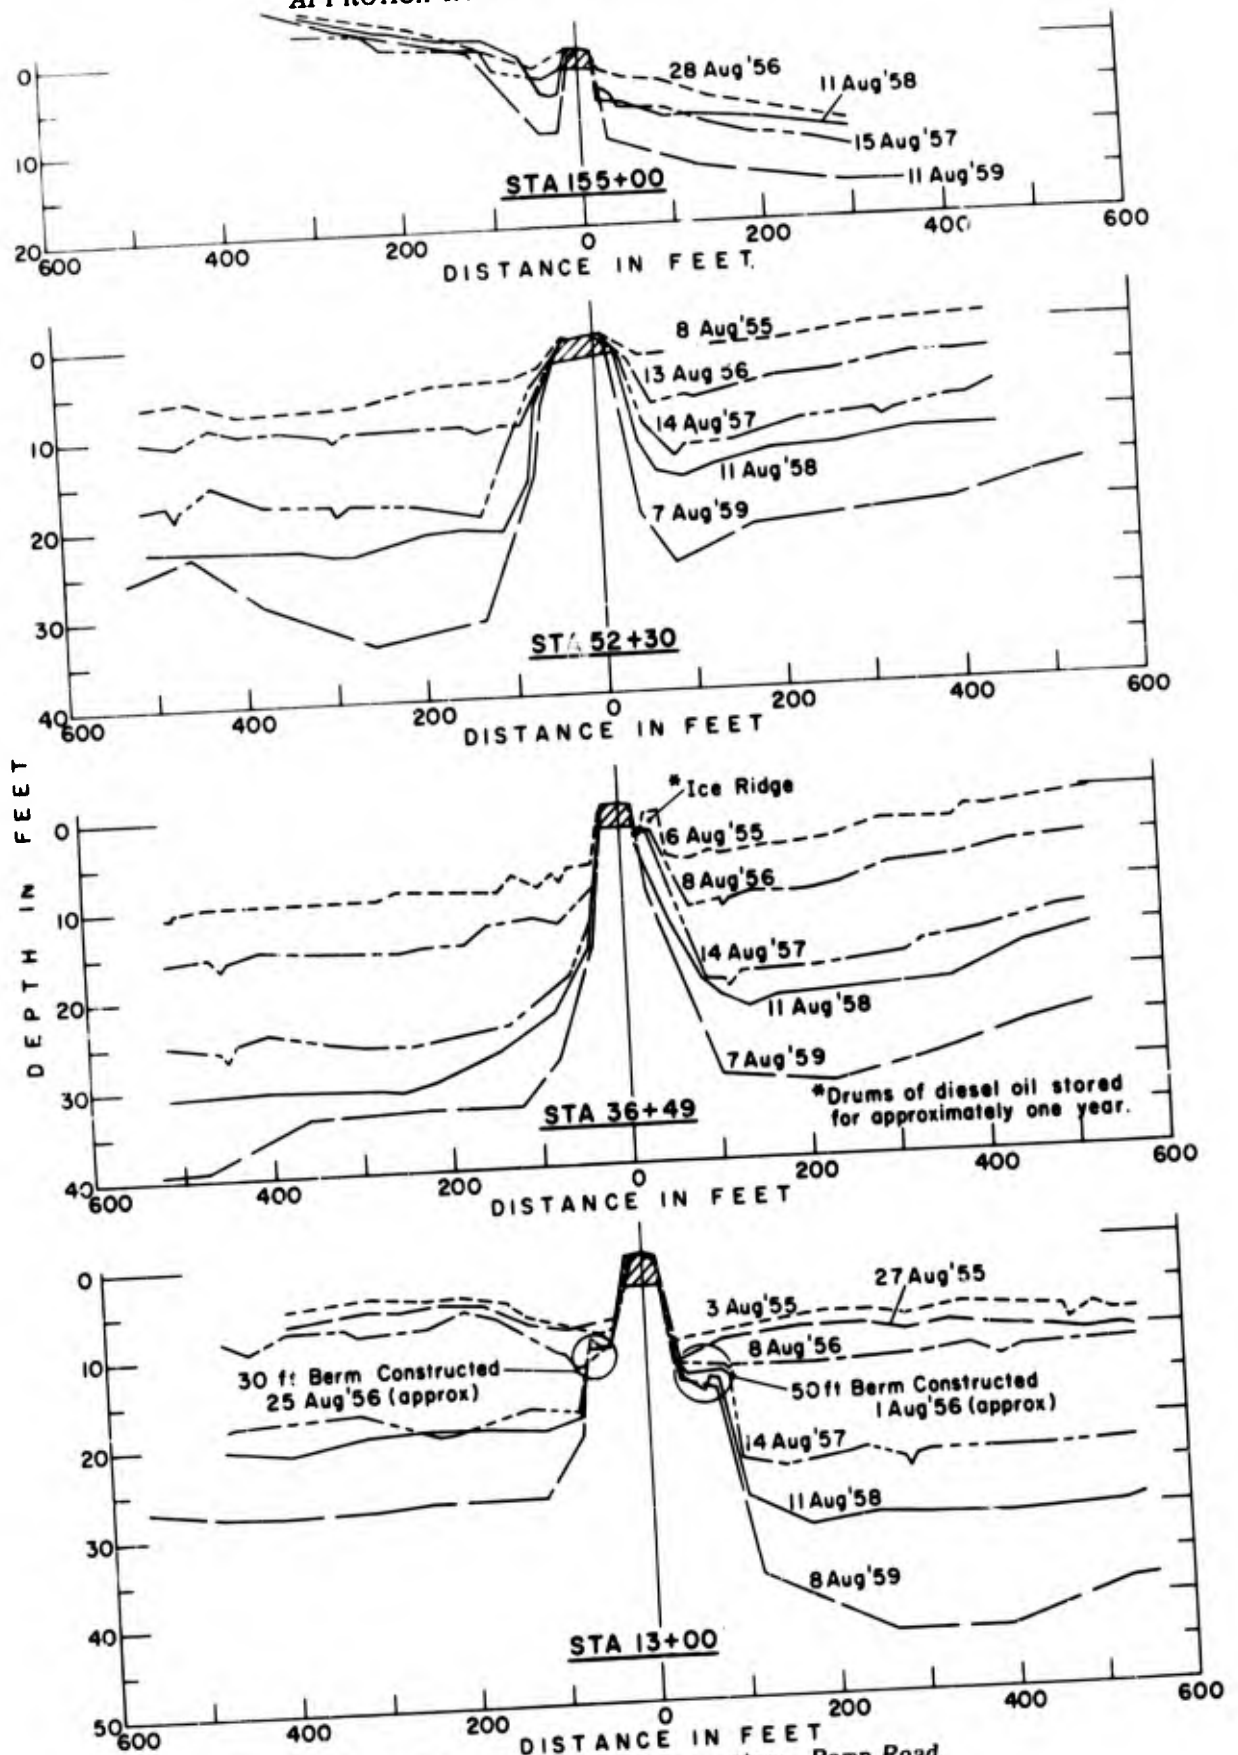
Figure 14. Ice ablation cross sections, Ramp Road.

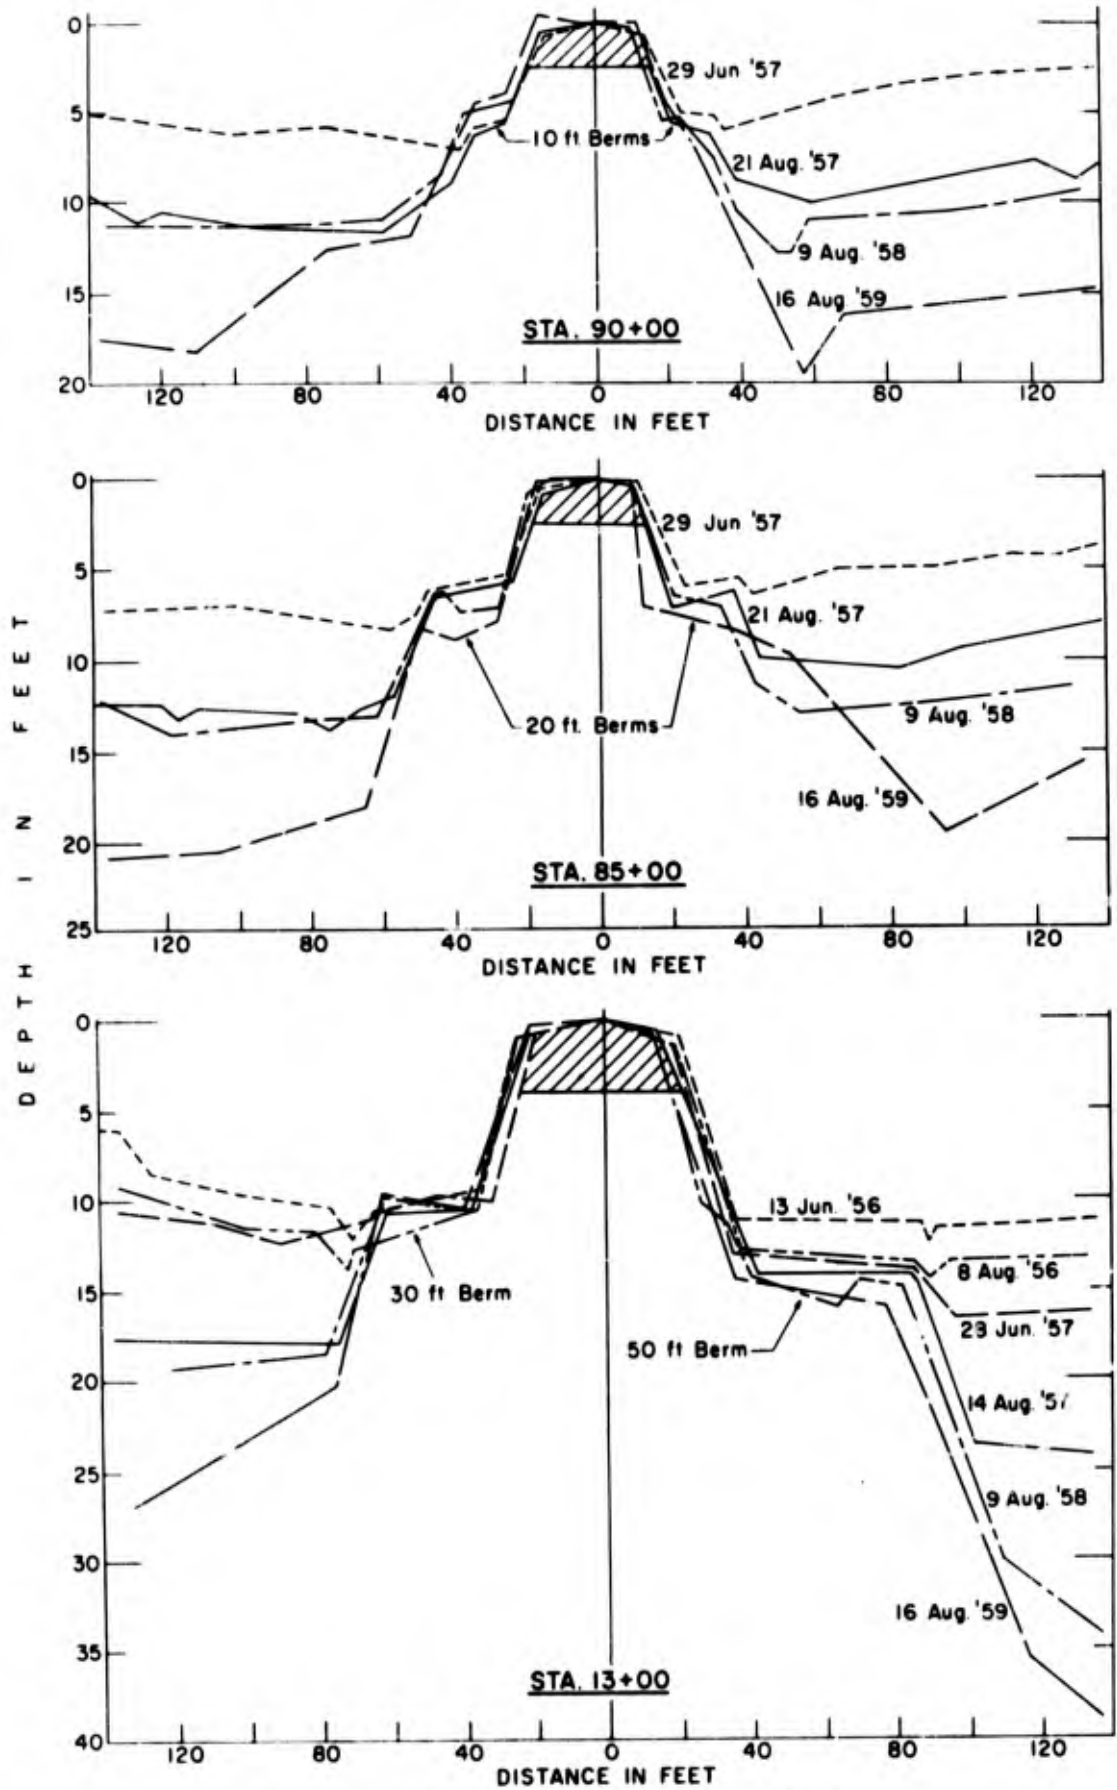
At Station 85+00 the 20-ft berms were in satisfactory condition. The receding of the edges was minor on both sides but 3 to 4 ft of ice had melted beneath the berms.

Although measurements and observations show that the berms do not completely prevent the shoulders from sloughing, they retard it enough to be of value. On the Tuto Ramp, for a 10-year design life, the berms should be 30 ft wide for the first 1½ miles, taper to 20 ft at 2½ miles and

Figure 15. Cross section of berms, Ramp Road.

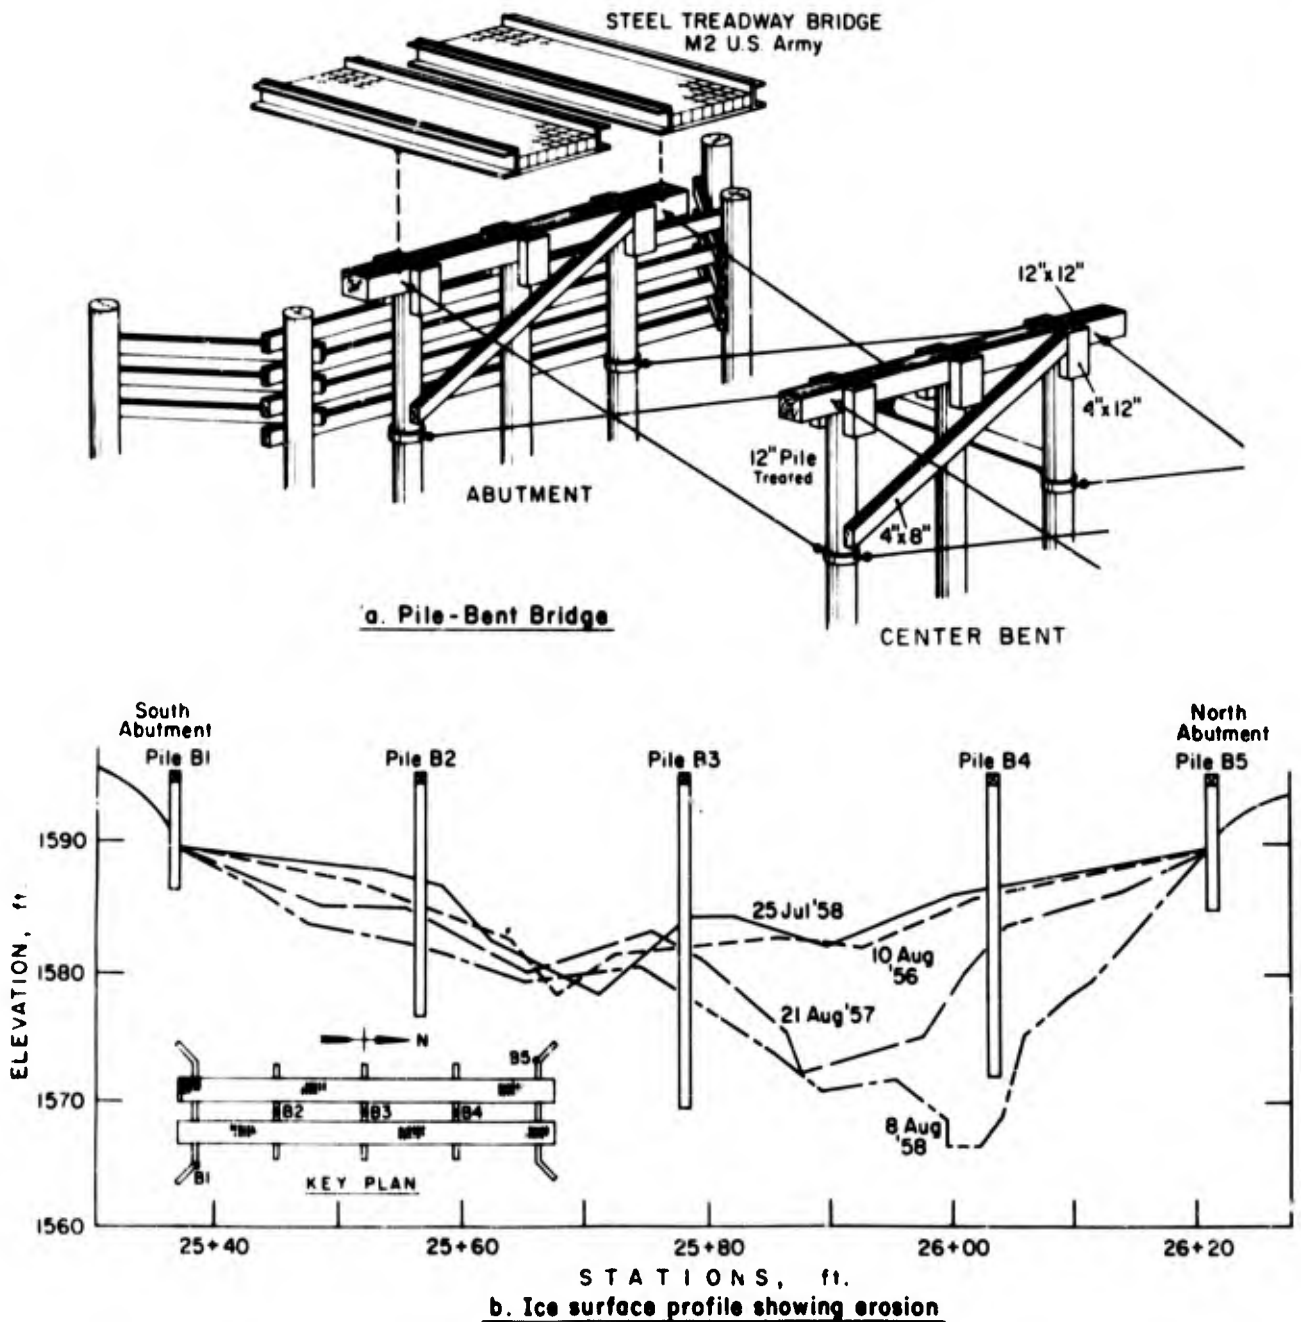
When the bridge was built in 1956, the main melt-water channel was at Station 25+70 with a secondary channel at 25+90. In 1957 the main channel moved to Station 25+90 and began to undercut the pile bent at Station 26+00. During the 1958 season the ice was eroded completely from beneath and around this pile bent. This rapid erosion of the ice beneath the bridge was due to the failure of the culverts along the Transverse Road so that a large area of the ramp drained through the channel.

Figure 16. Pile-bent bridge.

5. One bent of the pile-bent bridge was undermined when about 21 ft of ice melted below the bridge in slightly over 2 years. With the failure of all the culverts on the Transverse Road a large area of the ice cap was drained through the bridge, resulting in extreme erosion of the ice.

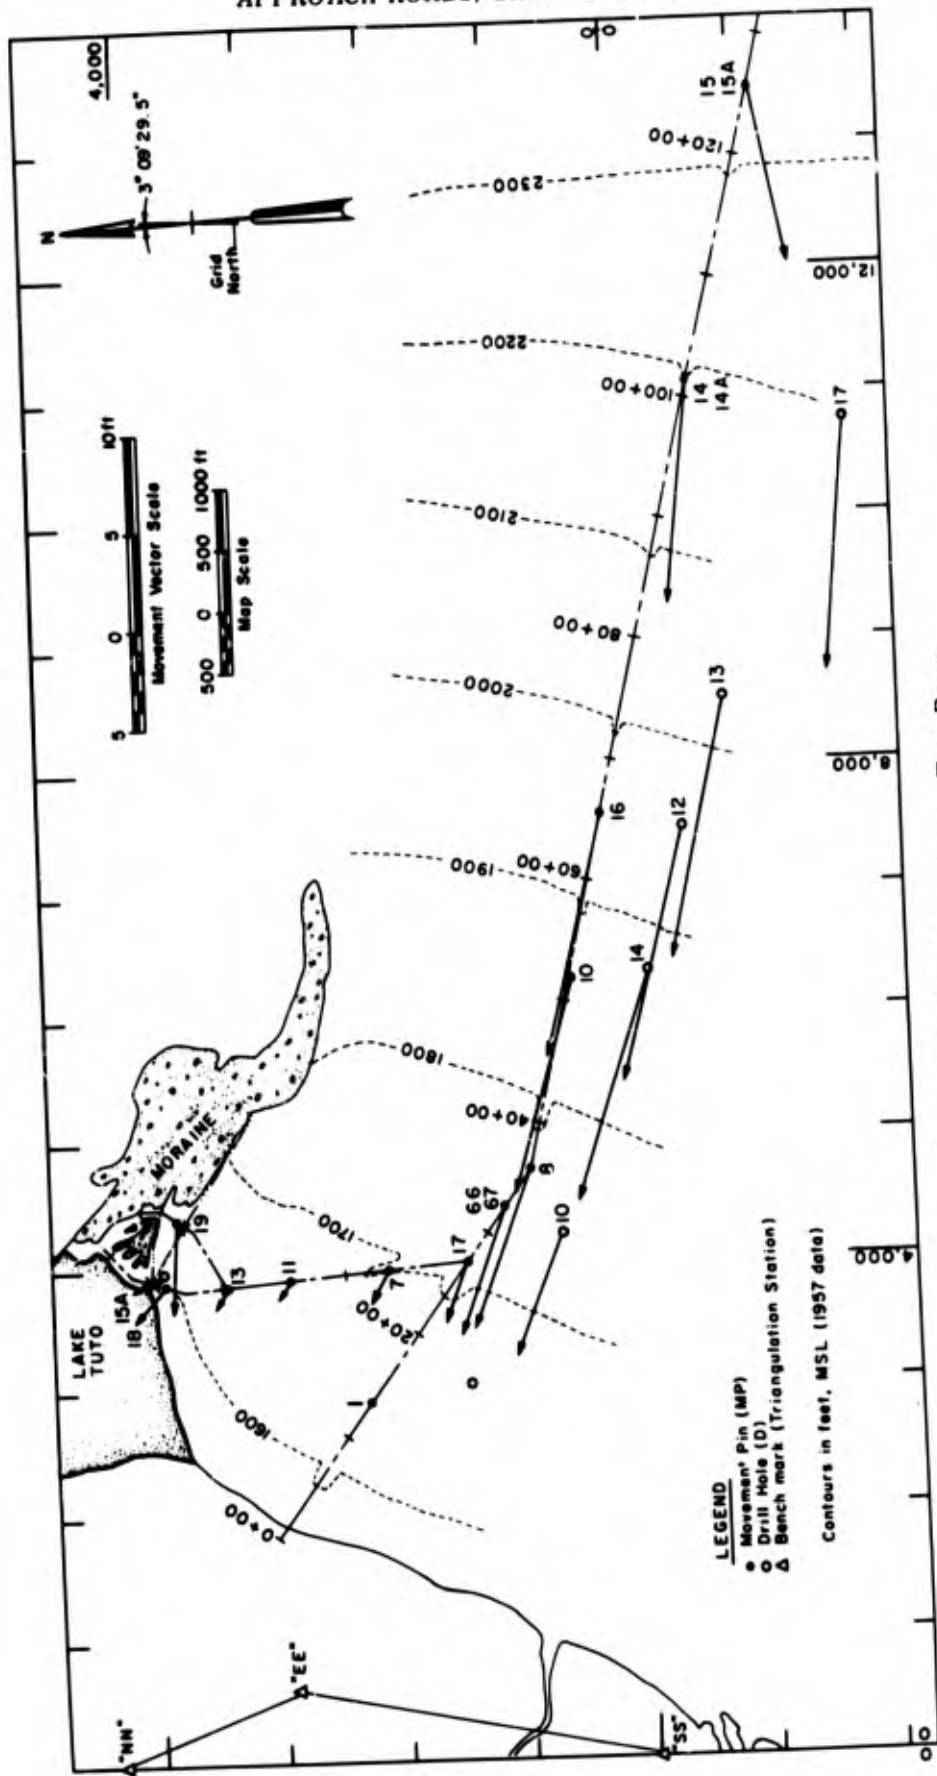
Figure 19. Movement pattern. Tuto Ramp.

Horizontal movement. Figure 19 shows that the movement of the points reached a maximum rate about 1½ miles from the edge of the ice and decreased in both upslope and downslope directions. Based on all measured data the greatest rate of movement probably occurred in the vicinity of Station 80+00. At MP-1 in the road fill and D-11 in the ice, movement was small, averaging less than 0.2 ft/yr. This confirms the theory that approximately the first 2000 ft of the ramp was a stagnant wedge.

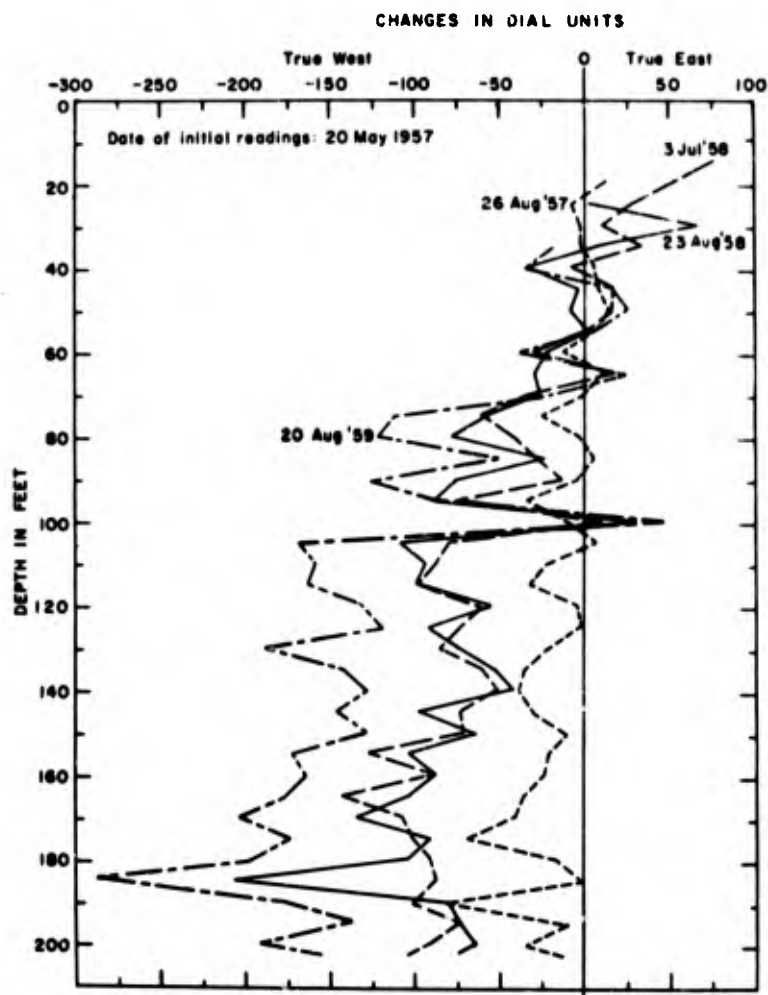
Figure B1. Hole D-10, east-west component of dial changes, 1957, 1958 and 1959.

From Figure B1, it is concluded that 1) The 1958 data show local irregularities of generally the same order of magnitude as that reported at the end of the first season; however, there is little, if any, correlation of such irregularities at equal depths. 2) The data of 3 July and 23 August 1958 are nearly identical; i.e., there was no E-W component of movement during the 1958 summer season.

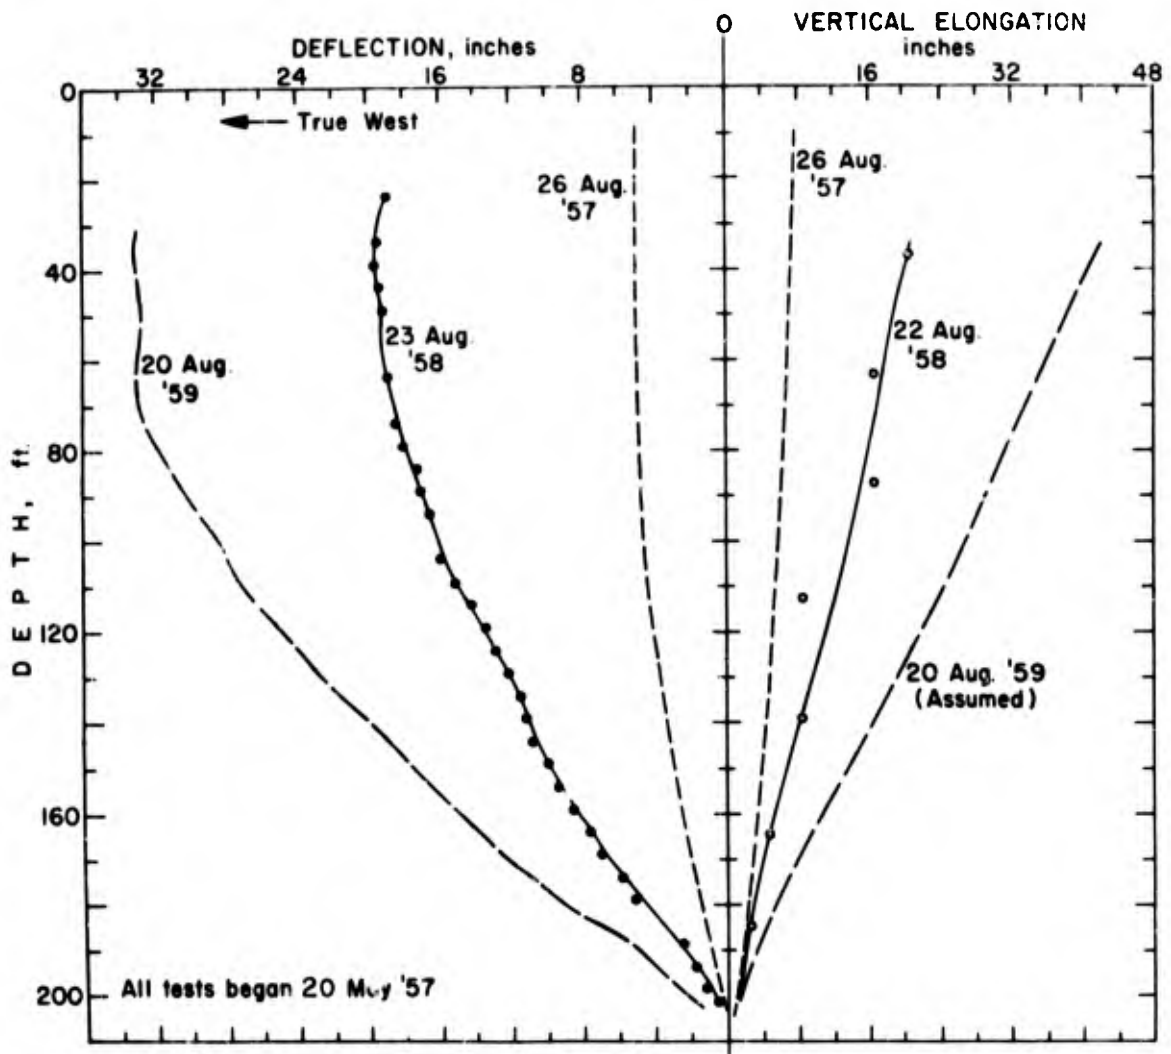
Figure B3. Hole D-10, east-west deflections and vertical elongations, 1957, 1958 and 1959.

On Figure B3 is plotted the true E-W component of movement from the date of installation to 23 August 1958. The data for 3 July checked those for 23 August 1958 within a fraction of an inch. Shown for comparison are the corresponding data from the 1957 report.

Vertical elongation measurements were continued, but with considerably less precision. Figure B3 also gives plots of the most reliable data that could be computed from the field data; this involved some interpolation of original data, as shown in Table BI.

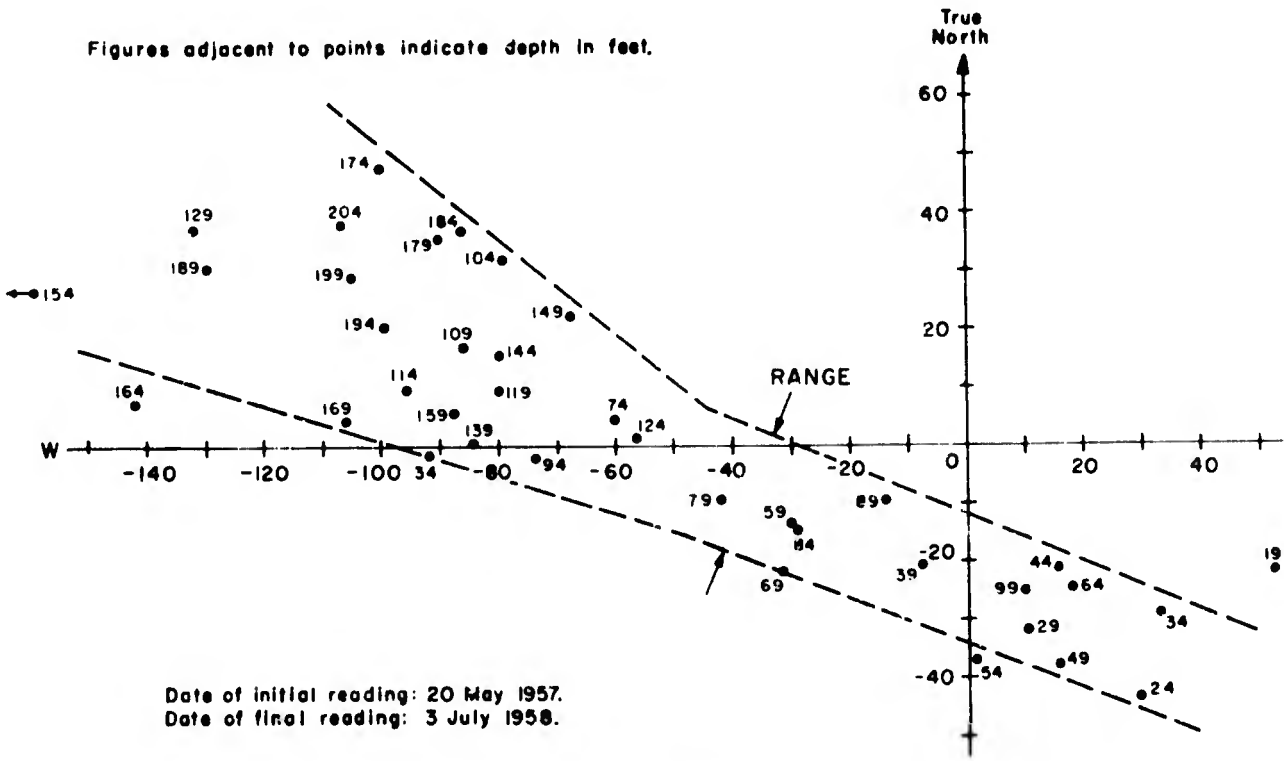
Figure B4a. Hole D-10, dial changes, 1957-1958.

Because of the apparent lack of E-W movement during the 1958 season, considerable effort was made to determine the true magnitude and direction of total movement. The total dial unit changes from 20 May 1957 to 3 July 1958 are plotted in Figure B4a. These data are very consistent with respect to orientation and magnitude of movement. Figure B5 gives plots of total dial changes from the initial date to 23 August 1958 and the measured changes from 3 July to 23 August 1958. Note the rather marked change in orientation that developed during the summer.

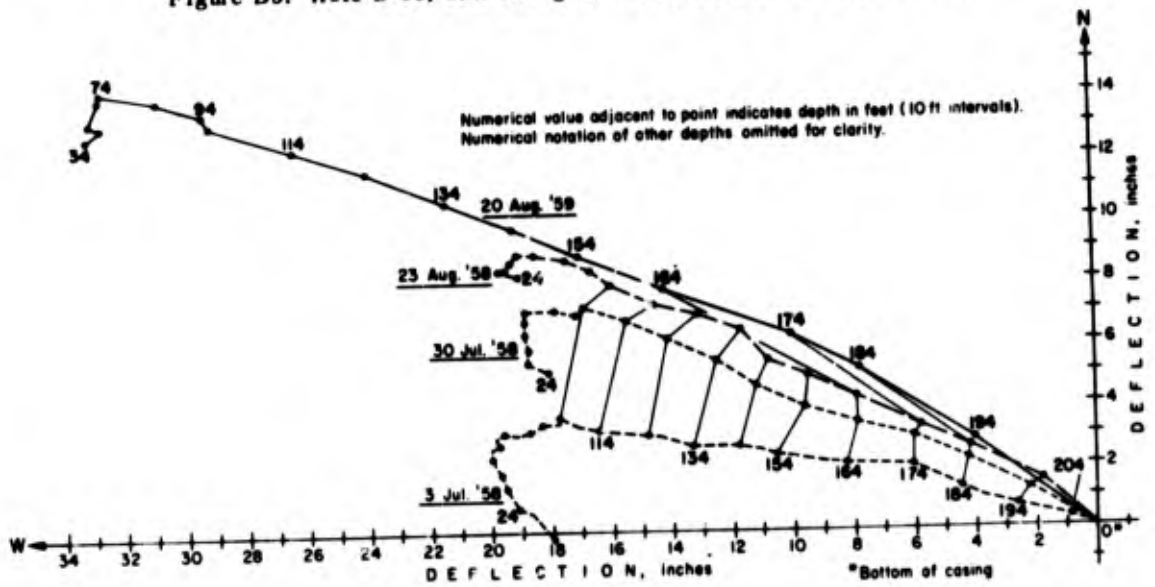
Figure B6. Hole D-10, deflections, 1958 and 1959.

In Figure B6 are plotted true displacements (corrected for spiral) of the plastic casing from the initial installation to 3 July, 30 July and 23 August 1958. This plot shows an exceptionally well defined orientation of total movement up to the end of August 1958, oriented N62°W. During the months of July and August, however, the movement of all individual points was actually due north or even a little east of north. Note also that most of this movement developed in July.

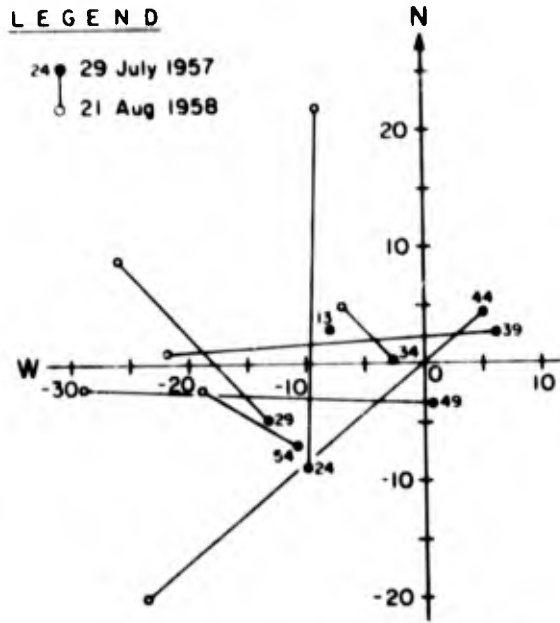
Figure B8. Hole D-11, dial changes, 29 July 1957 and 21 Augus. 1958. Initial reading 14 June 1957.

In Figure B8 are plotted the corrected total dial changes from the initial date of 14 June 1957 to 29 July 1957 (taken from Fig. 7 of the 1957 report) and from the initial date to 21 August 1958. There appears to be an E-W trend, although the data are rather erratic. Figure B9 shows the E-W component of dial changes and Figure B10 the computed E-W movements. A total westward movement of the upper 55 ft of ice of about 1 in. in 14 months was recorded.

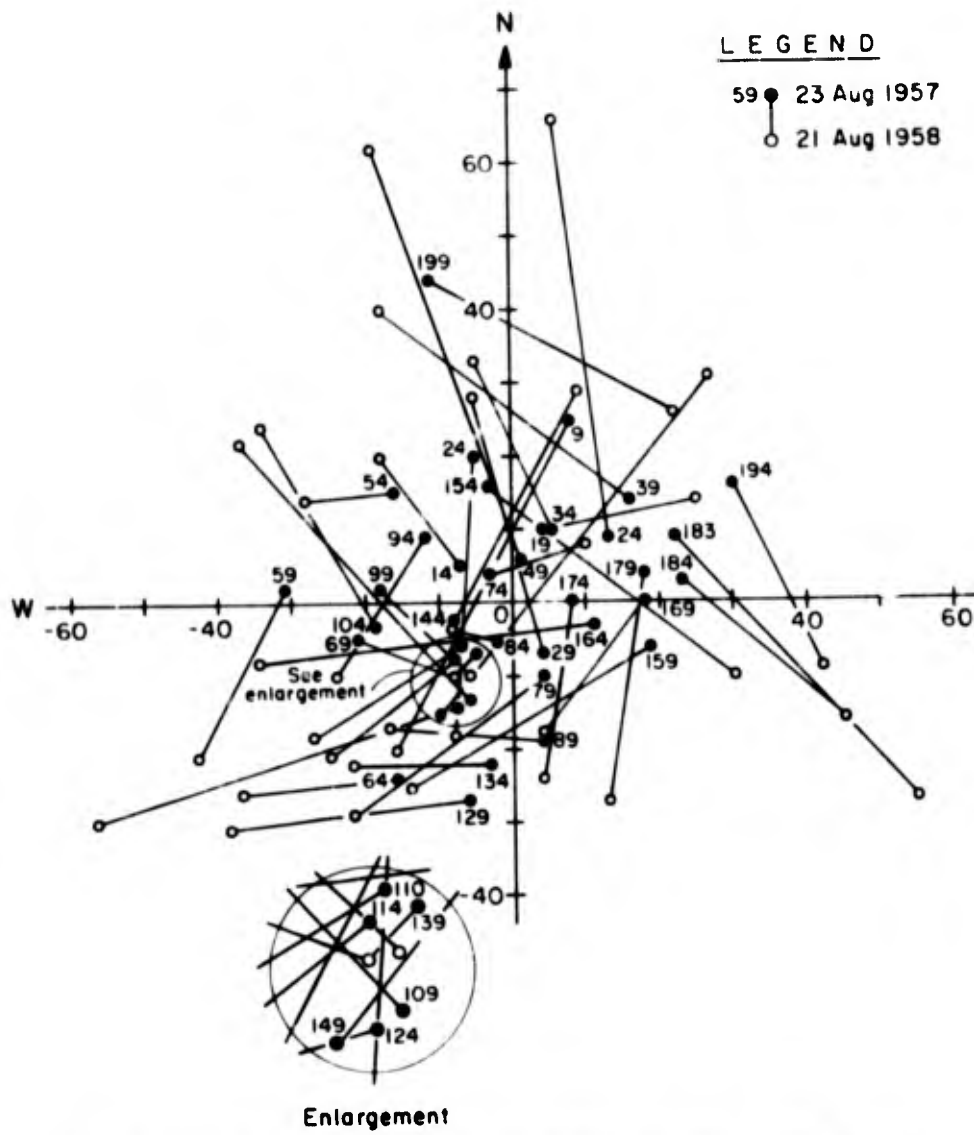
Figure B11. *Hole D-12, dial changes, 23 August 1957 and 21 August 1958.*
Initial reading 17 June 1957.

Hole D-12. Figure B11 shows the total two-dimensional dial changes that were recorded between the initial set of 17 June 1957 and 23 August 1957, and the total as of 21 August 1958. Note the random scatter. In Figure B12 are plotted the E-W component of these changes and in Figure B13 the computed movements. The total differential movements from August 1957 to August 1958 certainly do not exceed 1 in., and even this amount may be due to instrument inaccuracies. Elongation measurements in D-12 were inconclusive and are not reported.

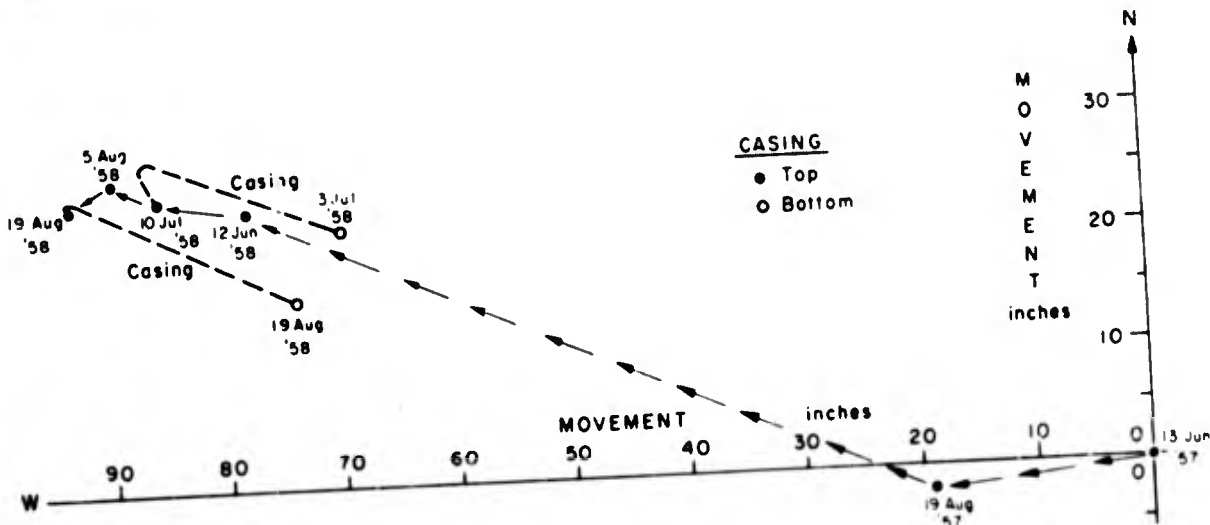
Figure B17. Hole D-10, casing movements, 1957 through 1958.

Subsequent to the submittal of the preceding part of Appendix B, information concerning the 1958 surface movements became available. These data help explain the apparent northward component of movement of D-10 during the summer months of 1958. Figure B17 shows the measured surface position of the top of the casing on various dates and the relative position of the plastic casing in early July and late August 1958, taken from Figure B6. Note that the top of the casing has moved nearly due west, whereas the lower position of the casing has moved southwest. Thus, the relative movement of the top with respect to the bottom has been northerly, as shown in Figure B6.

The surface measurements show that the top of the casing is moving at an average rate of
6.5 ft/year, or 6.5 in./month. Thus, from 20 May 1957 to 19 August 1958, the top would have
moved about 97 in. Since the relative movement top to bottom is only 21 in., more than ¼ of the
total movement occurs below the bottom of the casing. This checks quite well the findings reported
in our 1957 report.
